CHURCH OF ST PETER, WEST LISS, HAMPSHIRE

TREE-RING DATING OF TIMBERS

SCIENTIFIC DATING REPORT

Alison Arnold and Robert Howard

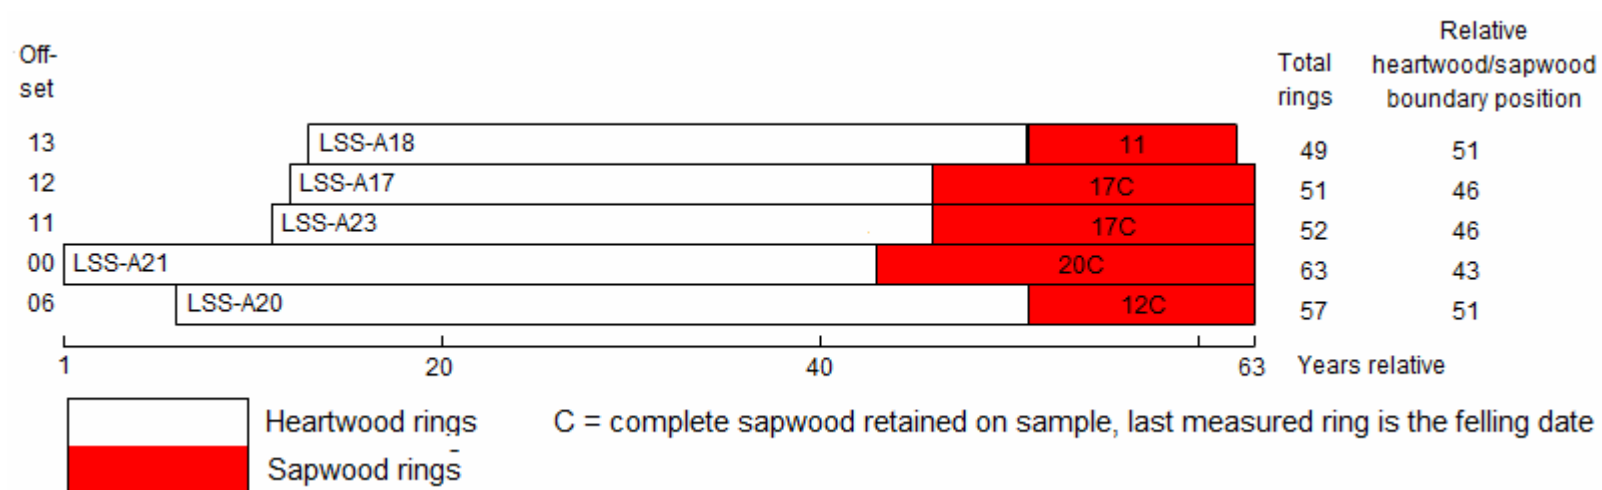
Figure 46: Bar diagram of samples in undated site sequence LSSASQ03

Five samples were grouped and combined to form LSSASQ03, a site sequence of 63 rings (Fig 46). Attempts to date this site sequence against the reference chronologies were unsuccessful and again the site sequence remains undated.

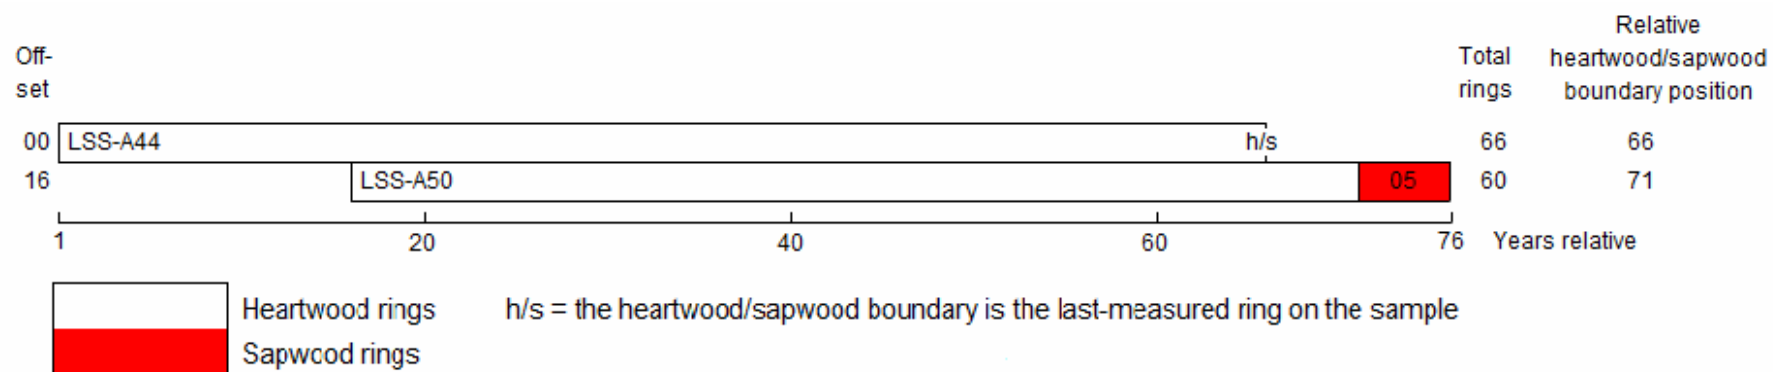
Figure 47: Bar diagram of samples in undated site sequence LSSASQ04

Two samples grouped and were combined to form LSSASQ04, a site sequence of 76 rings (Fig 47). This site sequence could not be matched and is undated.

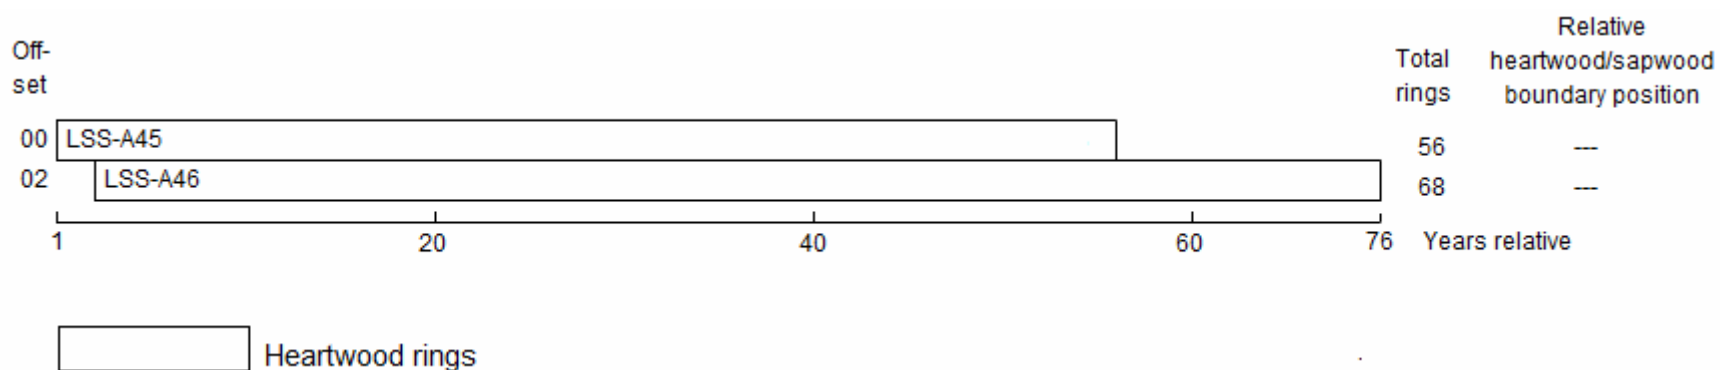
Figure 48: Bar diagram of samples in undated site sequence LSSASQ05

Finally, two further samples matched and were combined to form LSSASQ05, a site sequence of 70 rings. This site sequence is also undated.

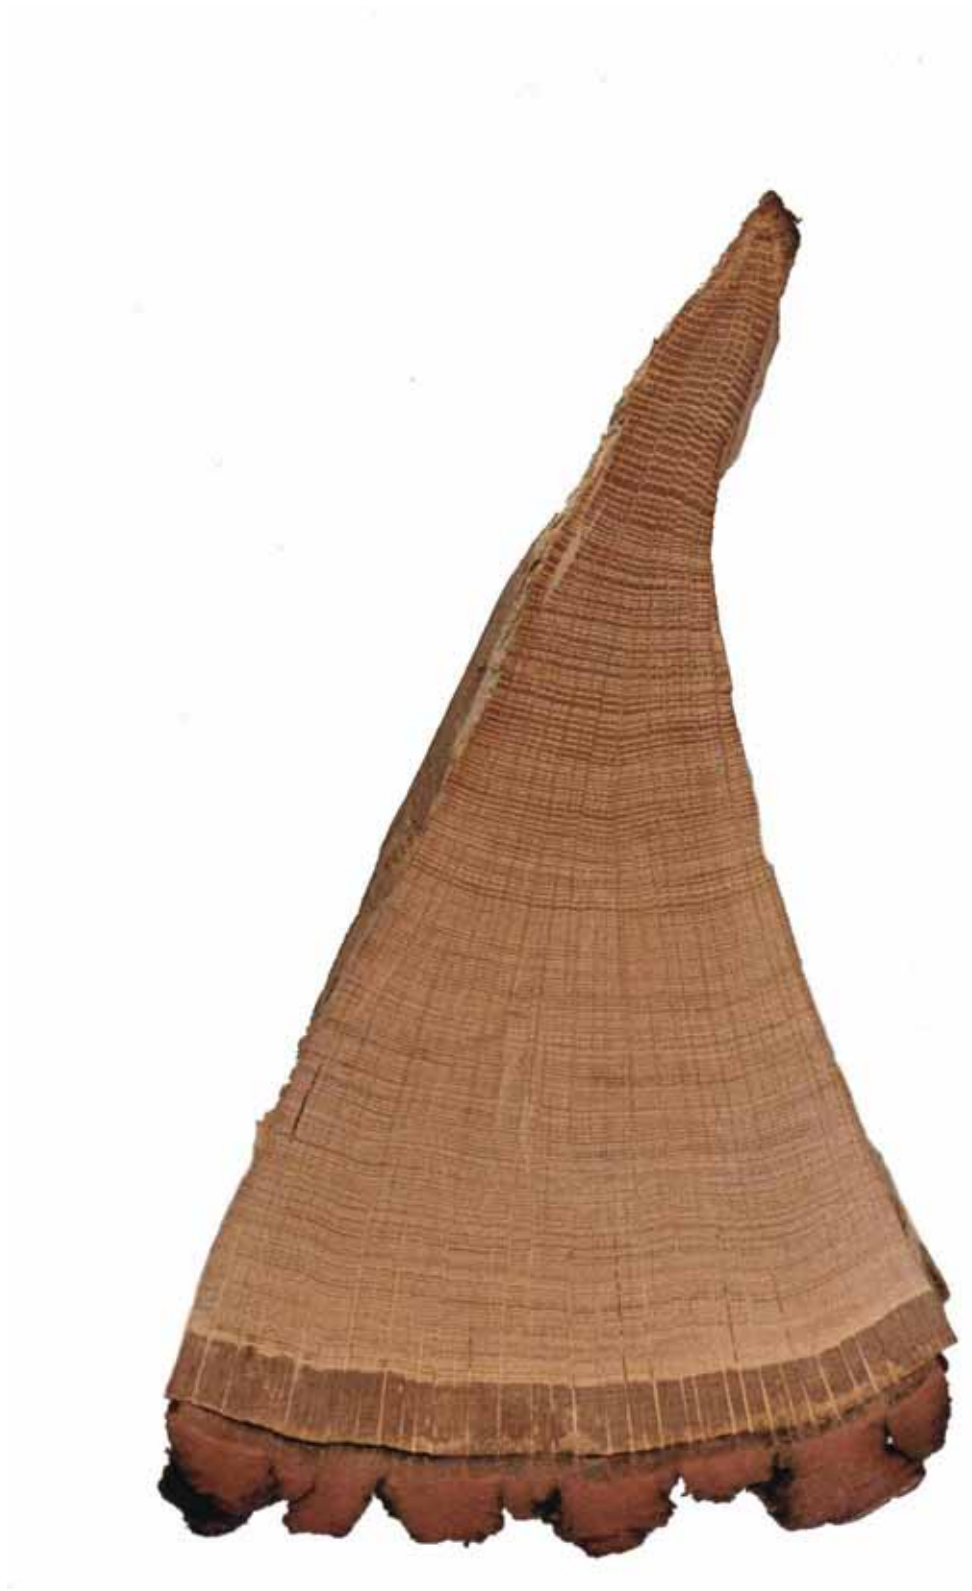
Figure A1: A wedge of oak from a tree felled in 1976. It shows the annual growth rings, one for each year from the innermost ring to the last ring on the outside just inside the bark. The year of each ring can be determined by counting back from the outside ring, which grew in 1976

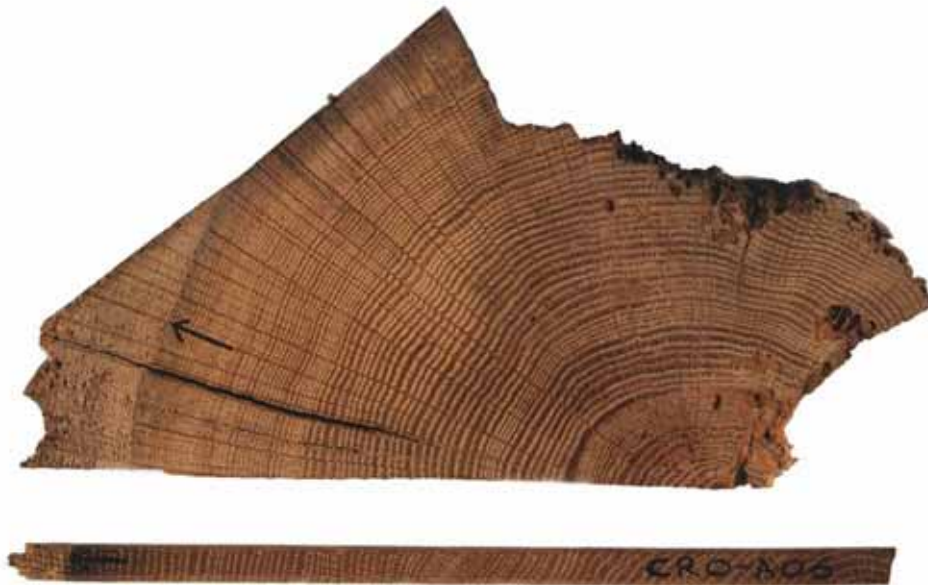
Figure A2: Cross-section of a rafter, showing sapwood rings in the left-hand corner, the arrow points to the heartwood/sapwood boundary (H/S); and a core with sapwood; again the arrow is pointing to the H/S. The core is about the size of a pencil

Quite often some, though not all, of the original outer rings are missing on a timber. The outer rings on an oak, called sapwood rings, are usually lighter than the inner rings, the heartwood, and so are relatively easy to identify. For example, sapwood can be seen in the corner of the rafter and at the outer end of the core in Figure A2, both indicated by arrows. More importantly for dendrochronology, the sapwood is relatively soft and so liable to insect attack and wear and tear. The builder, therefore, may remove some of the sapwood for precisely these reasons. Nevertheless, if at least some of the sapwood rings are left on a sample, we will know that not too many rings have been lost since felling so that the date of the last ring on the sample is only a few years before the date of the original last ring on the tree, and so to the date of felling.

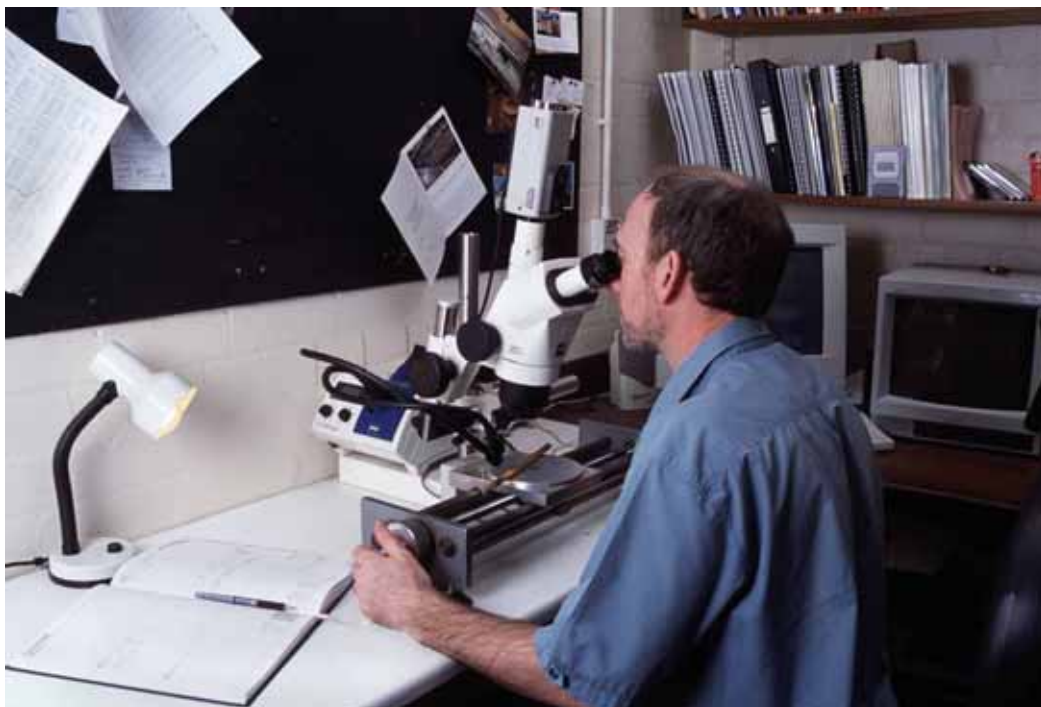
Figure A3: Measuring ring widths under a microscope. The microscope is fixed while the sample is on a moving platform. The total sequence of widths is measured twice to ensure that an error has not been made. This type of apparatus is needed to process a large number of samples on a regular basis

2. **Measuring Ring Widths.** Each core is sanded down with a belt sander using medium-grit paper and then finished by hand with flourgrade-grit paper. The rings are then clearly visible and differentiated from each other with a result very much like that shown in Figure A2. The core is then mounted on a movable table below a microscope and the ring-widths measured individually from the innermost ring to the outermost. The widths are automatically recorded in a computer file as they are measured (see Fig A3).

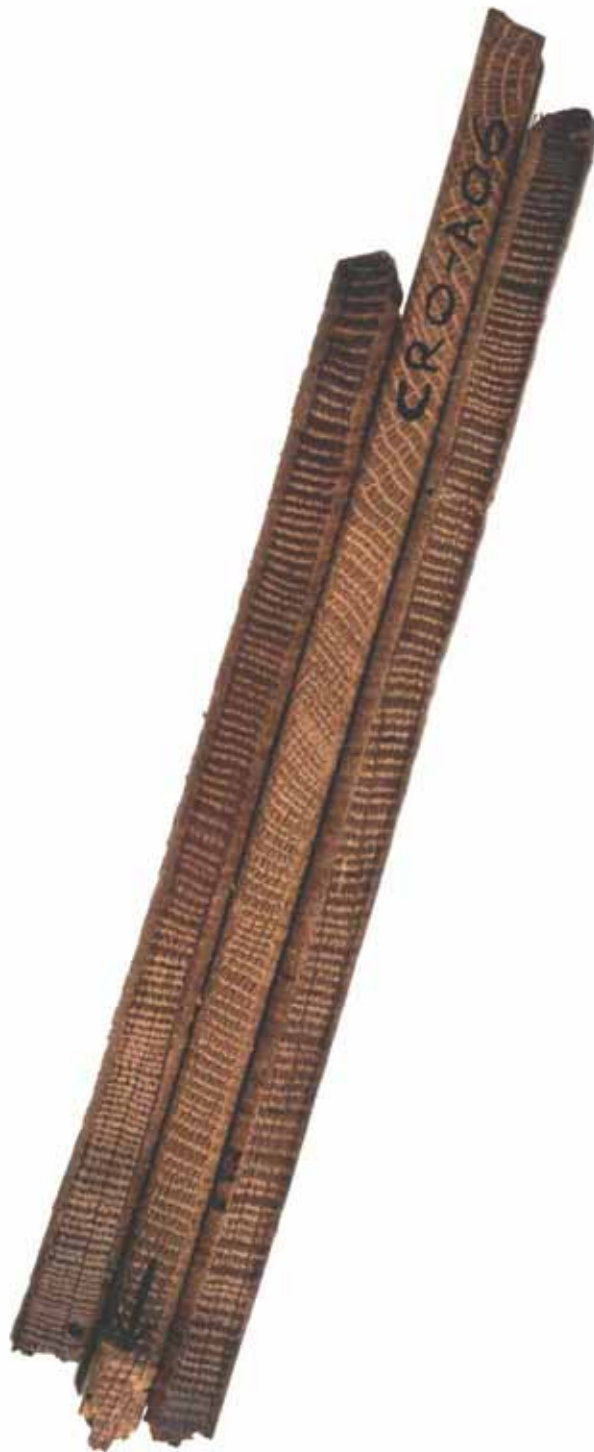
Figure A4: Three cores from timbers in a building. They come from trees growing at the same time. Notice that, although the sequences of widths look similar, they are not identical. This is typical

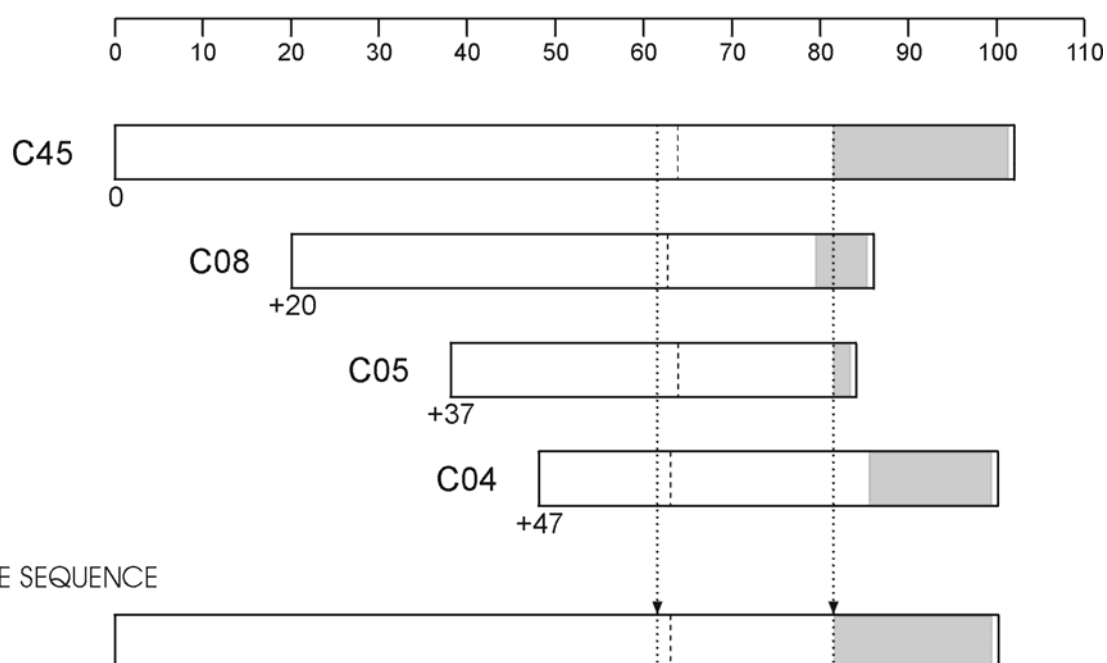
Figure A5: Cross-matching of four sequences from a Lincoln Cathedral roof and the formation of a site sequence from them

The bar diagram represents these sequences without the rings themselves. The length of the bar is proportional to the number of rings in the sequence. Here the four sequences are set at relative positions (offsets) to each other at which they have maximum correlation as measured by the t-values. The t-value/offset matrix contains the maximum t-values below the diagonal and the offsets above it. Thus, the maximum t-value between C08 and C45 occurs at the offset of +20 rings and the t-value is then 5.6. The site sequence is composed of the average of the corresponding widths, as illustrated with one width.

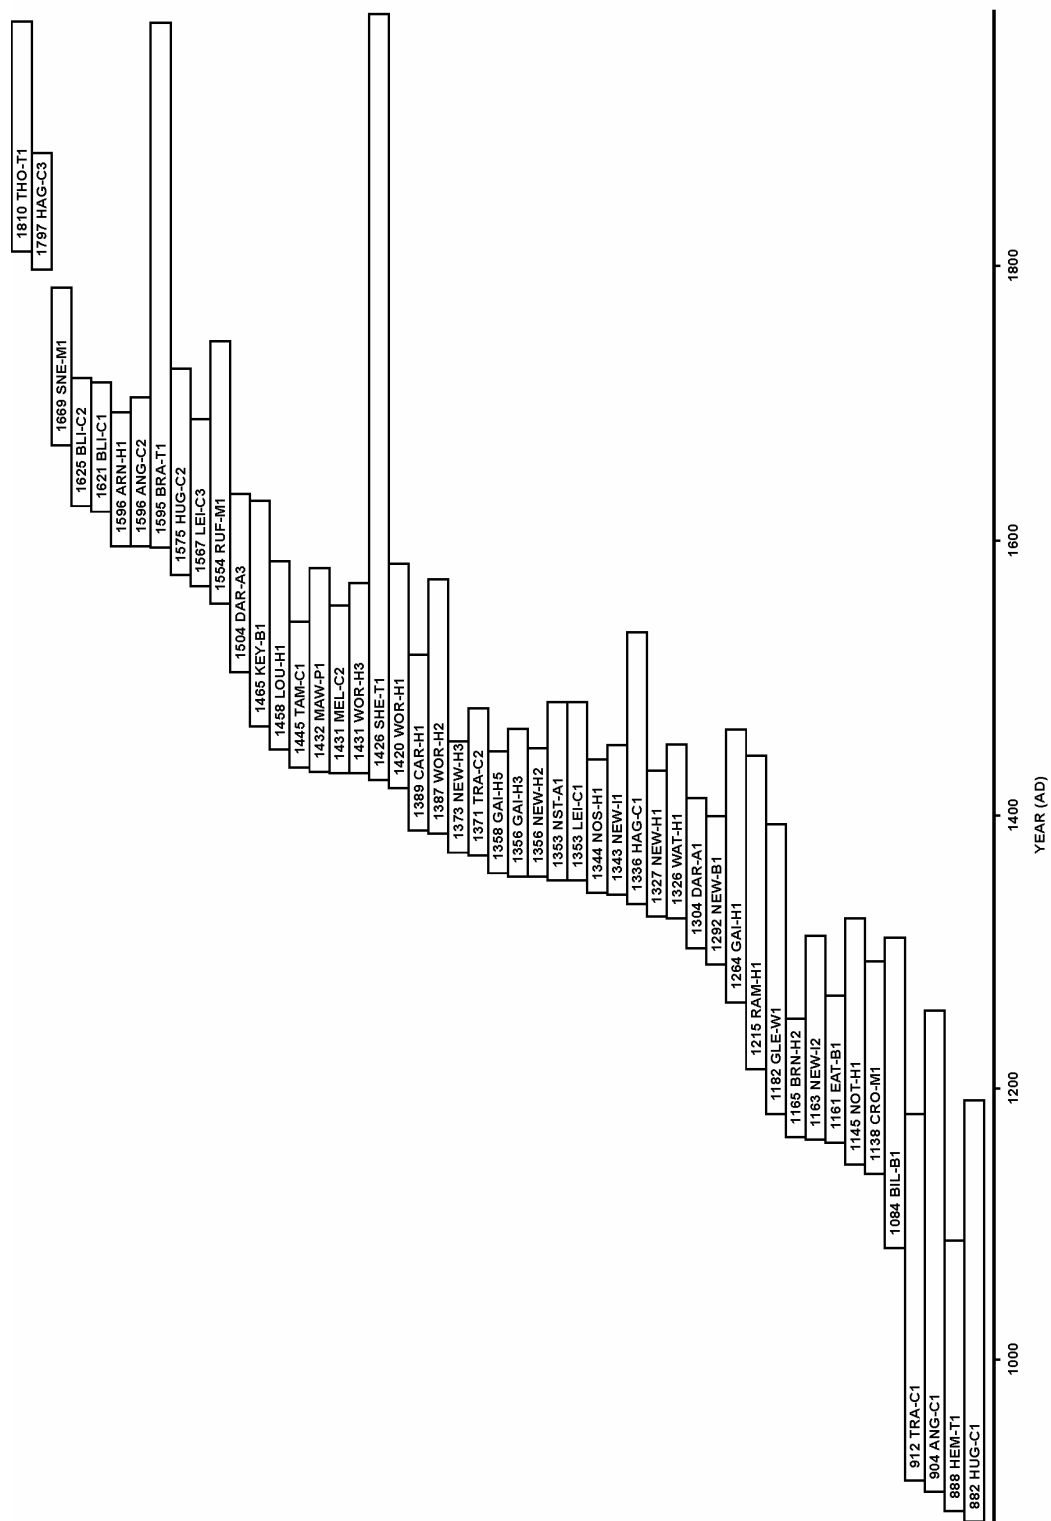
Figure A6: Bar diagram showing the relative positions and dates of the first rings of the component site sequences in the East Midlands Master Dendrochronological Sequence, EM08/87

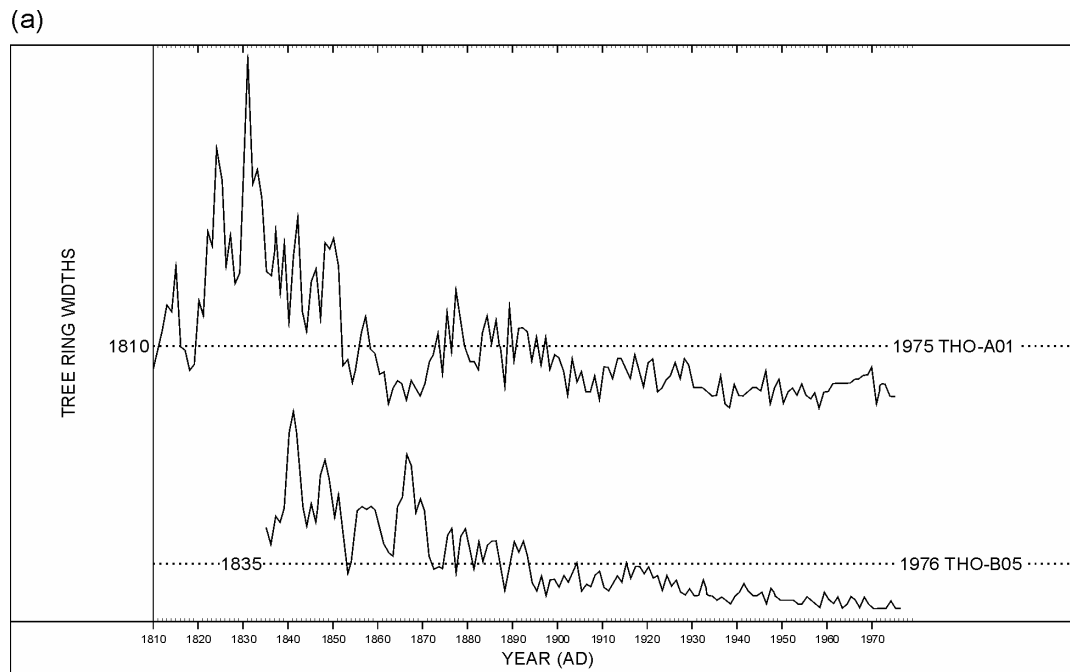
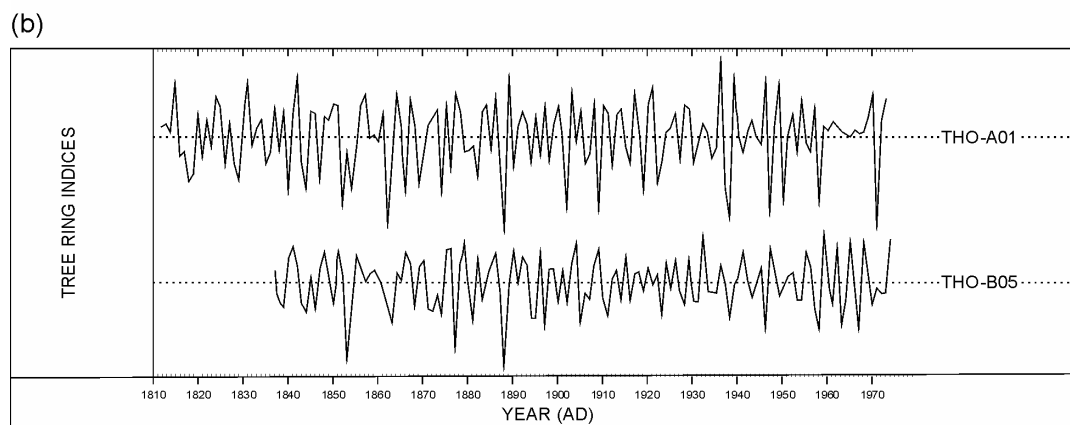
Figure A7 (a): The raw ring-widths of two samples, THO-A01 and THO-B05, whose felling dates are known

Here the ring widths are plotted vertically, one for each year, so that peaks represent wide rings and troughs narrow ones. Notice the growth-trends in each; on average the earlier rings of the young tree are wider than the later ones of the older tree in both sequences
