FAIRFIELD HOUSE, STOGURSEY, SOMERSET

TREE-RING ANALYSIS OF TIMBERS

SCIENTIFIC DATING REPORT

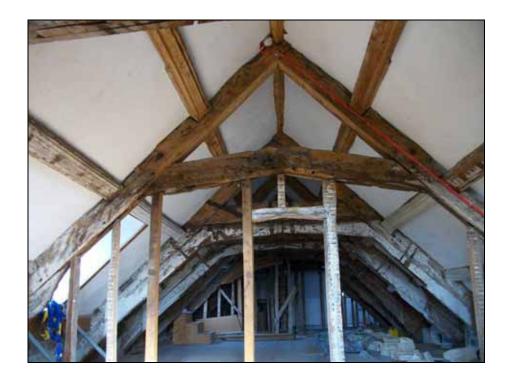
Figure 4: West range roof; truss 3 in the foreground, photograph taken from the south-east (Robert Howard)

The roof over this range consists of seven trusses of principal rafters, collars, and the remains of carved and decorated arch-braces. Some windbraces survive and there is a ridge and three sets of moulded purlins to each slope (Fig 4). This range is believed to be the oldest surviving part of the building, with the roof thought to date to the late-fifteenth century. The southern hipped end is a later modification, undertaken some time after the early eighteenth century as paintings of the house from this period still show the original gable end.

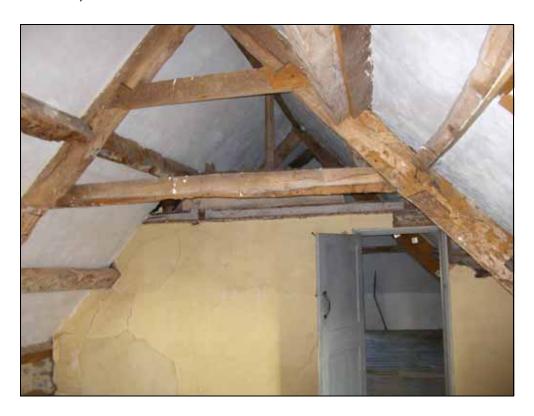
Figure 5: East range roof; truss 19 in the foreground, photograph taken from the south-east (Robert Howard)

The roof over this range is of six trusses consisting of principal rafters and two collars, with ridge and three sets of purlins to each slope (Fig 5). It is thought to date to the sixteenth century. A later modification was made to a hip at the southern end of this roof.

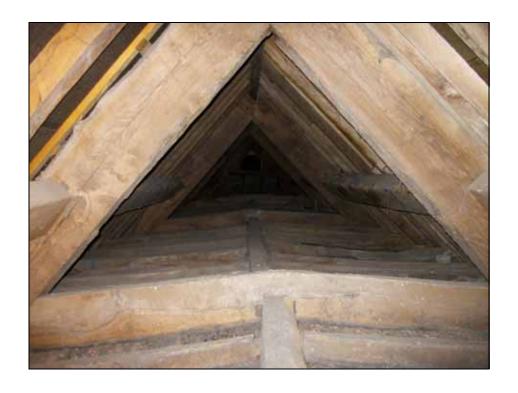
Figure 6: Connecting range roof; truss 15 in the foreground, photograph taken from the northeast (Robert Howard)

The roof of this range has nine trusses of principal rafters and single collar, with ridge and three sets of purlins to each slope (Fig 6). It is possible that this roof might be of two phases which is suggested by a division within the lower walls. The date of this range is however, uncertain.

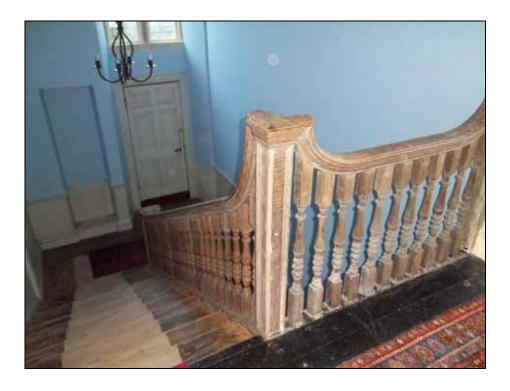
Figure 7: Connecting range; staircase, photograph taken from the first floor (Robert Howard)

planted detailing and ramped handrail rising to merge with the newel caps (Fig 7). It is thought to date to remodelling work carried out in the eighteenth century.

A total of 57 timbers was sampled by coring and additionally, two newel caps of the staircase (Fig 7) in the Connecting range were measured *in situ* using a graticule. Each sample was given the code FRF-D (for Fairfield) and numbered 01–59. Nineteen of these were from the East range roof (FRF-D01–19), 18 from the West range roof (FRF-D20–37), 20 from the Connecting range roof (FRF-D38–57), and the two sets of in situ measurements from the staircase newel posts (FRF-D58–9). The location of samples was noted at the time of sampling and where possible, is shown on Figures 8–29. Further details relating to the samples can be found in Table 1.

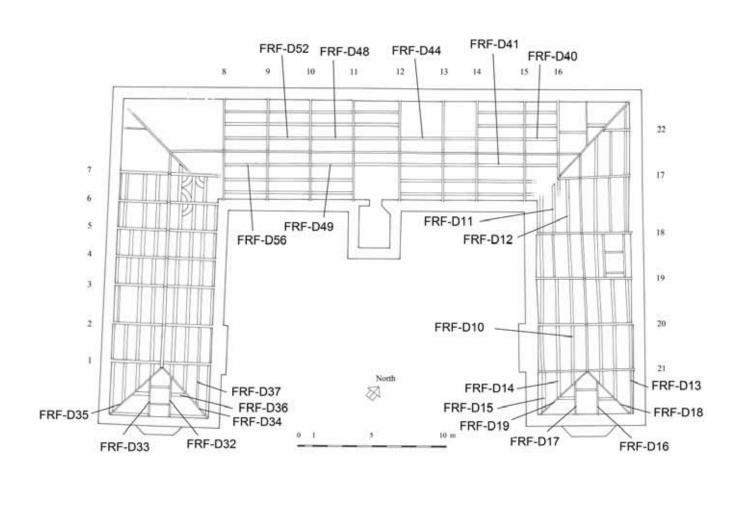
Figure 8: Attic plan, showing truss numbering and the location of samples FRF-D10–19, FRF-D32–7, FRF-D40–41, FRF-D44, FRF-D48–9, FRF-D52, and FRF-D56 (after Alan Graham)

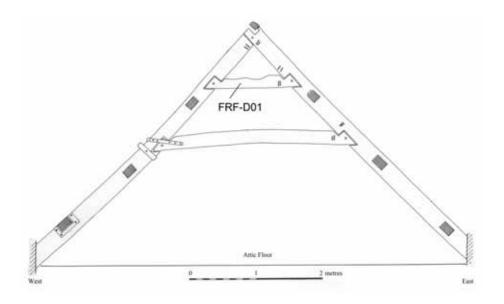
Figure 9: East range; truss 21, showing the location of sample FRF-D01 (Alan Graham)

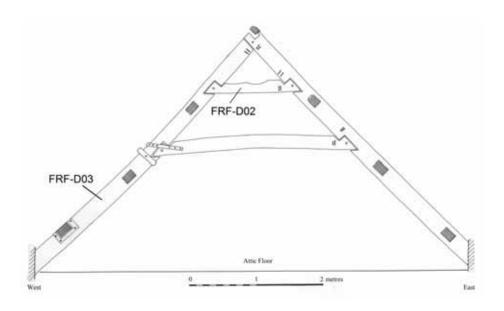
Figure 10: East range; truss 20, showing the location of samples FRF-D02 and FRF-D03 (Alan Graham)

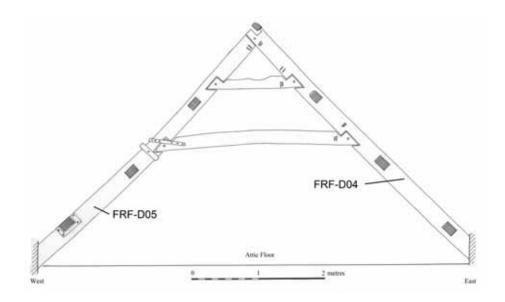
Figure 11: East Range; truss 19, showing the location of samples FRF-D04 and FRF-D05 (Alan Graham)

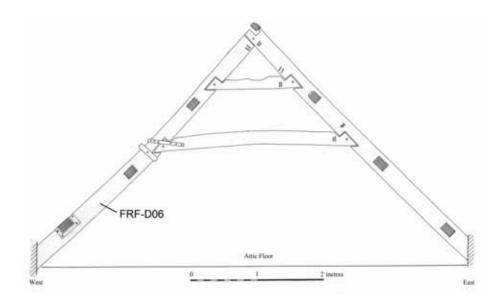
Figure 12: East range; truss 18, showing the location of sample FRF-D06 (Alan Graham)

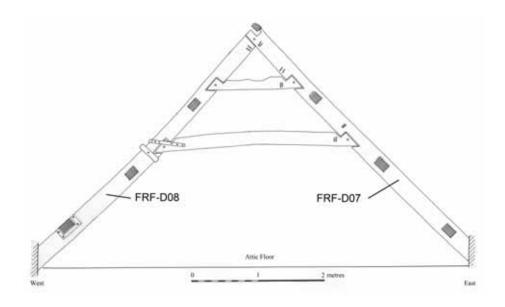
Figure 13: East range; truss 17, showing the location of samples FRF-D07 and FRF-D08 (Alan Graham)

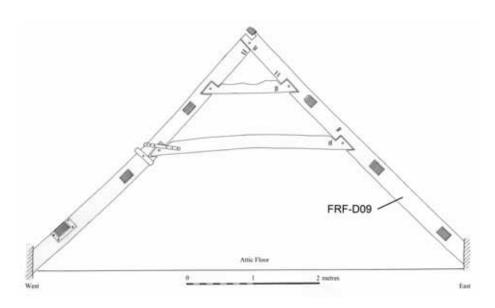
Figure 14: East range; truss 22, showing the location of sample FRF-D09 (Alan Graham)

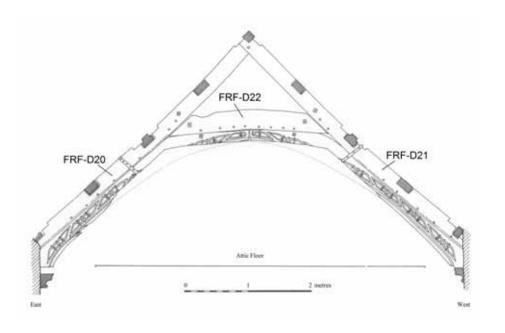
Figure 15: West range; truss 1, showing the location of samples FRF-D20-2 (Alan Graham)

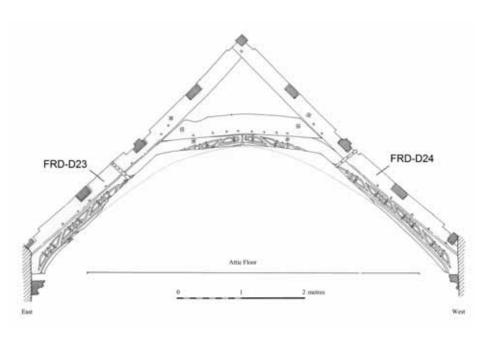
Figure 16: West range; truss 2, showing the location of samples FRF-D23-4 (Alan Graham)

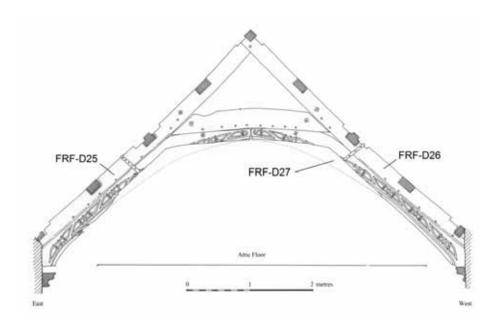
Figure 17: West range; truss 3, showing the location of samples FRF-D25-7 (Alan Graham)

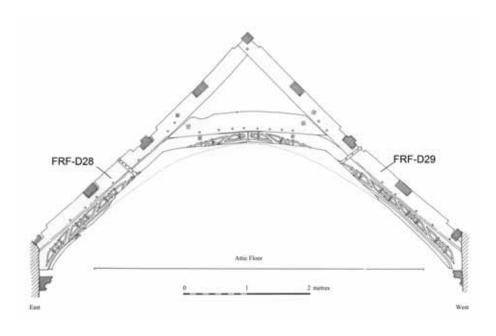
Figure 18: West range; truss 4, showing the location of samples FRF-D28 and FRF-D29 (Alan Graham)

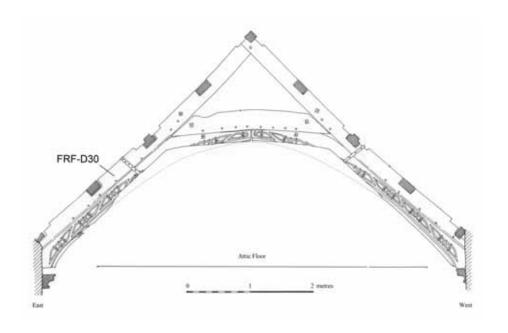
Figure 19: West range; truss 5, showing the location of sample FRF-D30 (Alan Graham)

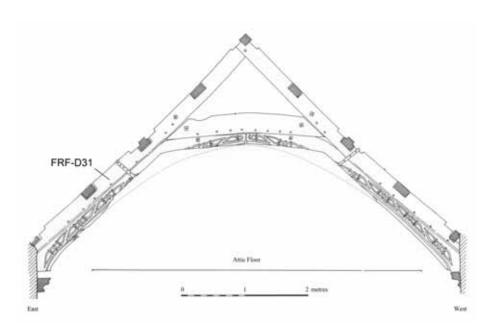
Figure 20: West range; truss 6, showing the location of sample FRF-D31 (Alan Graham)

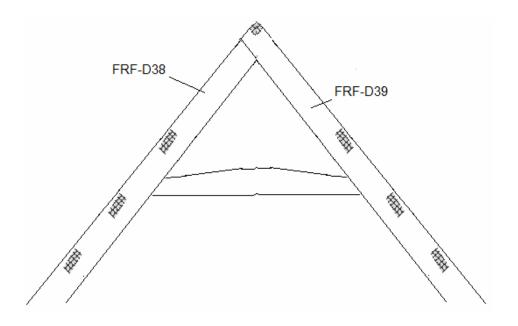
Figure 21: Connecting range; sketch of truss 16, showing the location of samples FRF-D38 and FRF-D39

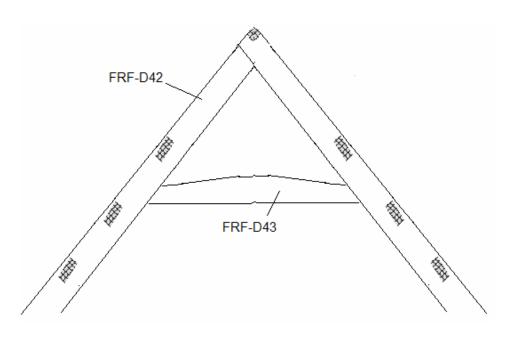
Figure 22: Connecting range; sketch of truss 13, showing the location of samples FRF-D42 and FRF-D43

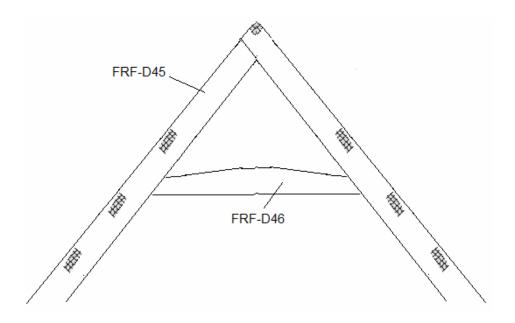
Figure 23: Connecting range; sketch of truss 12, showing the location of samples FRF-D45 and FRF-D46

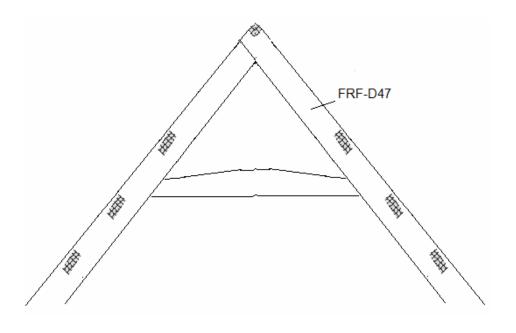
Figure 24: Connecting range; sketch of truss 11, showing the location of sample FRF-D47

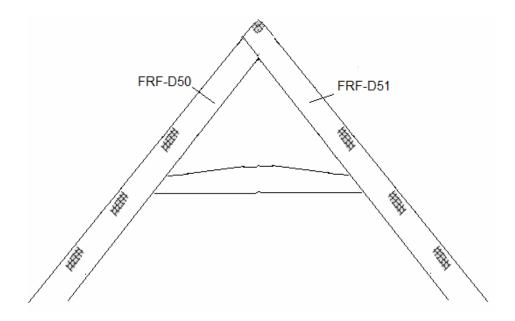
Figure 25: Connecting range; sketch of truss 10, showing the location of samples FRF-D50 and FRF-D51

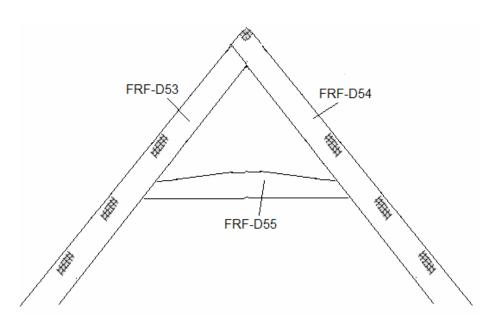
Figure 26: Connecting range; sketch of truss 9, showing the location of samples FRF-D53-5

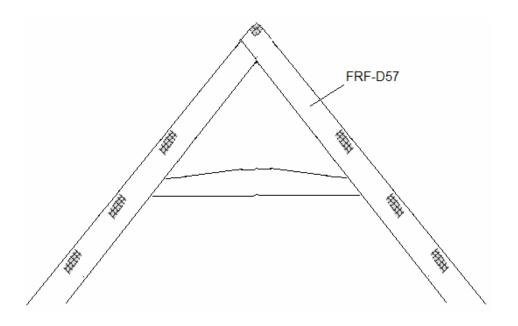
Figure 27: Connecting range; sketch of truss 8, showing the location of sample FRF-D57

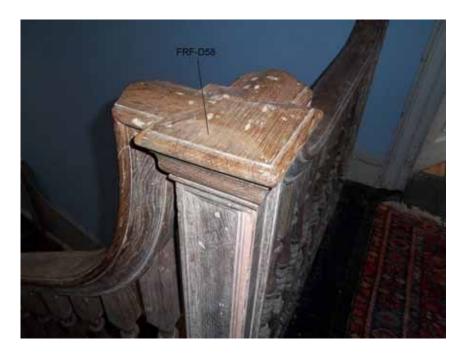
Figure 28: Photograph of first-floor newel post cap, showing the location of sample FRF-D58 in the Connecting range (RobertHoward)

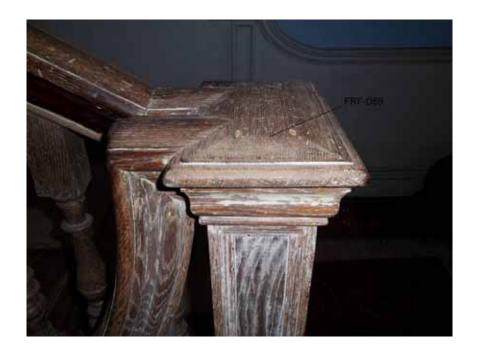
Figure 29: Photograph of the mid-landing newel post cap, showing the location of sample FRF-D59 in the Connecting range (Robert Howard)

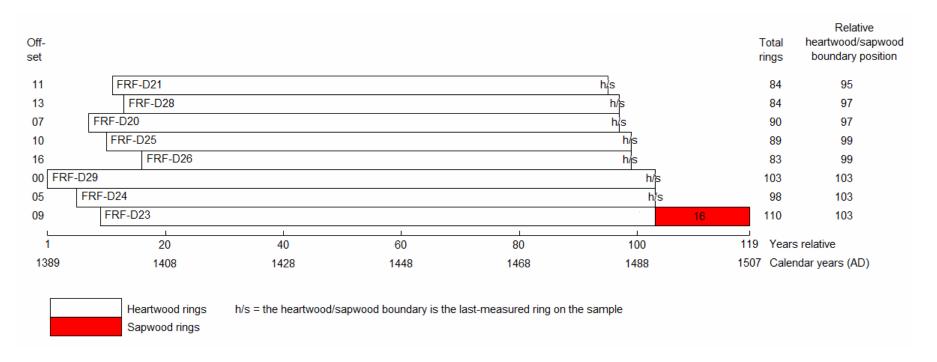
Figure 30: Bar diagram of samples in site sequence FRFDSQ01

Firstly, eight samples from the West range roof matched each other to form FRFDSQ01, a site sequence of 119 rings (Fig 30). This site sequence was compared against a series of relevant reference chronologies where it was found to match consistently and securely at a first-ring date of AD 1389 and a last-measured ring date of AD 1507. The evidence for this dating is given by the *t*-values in Table 2.

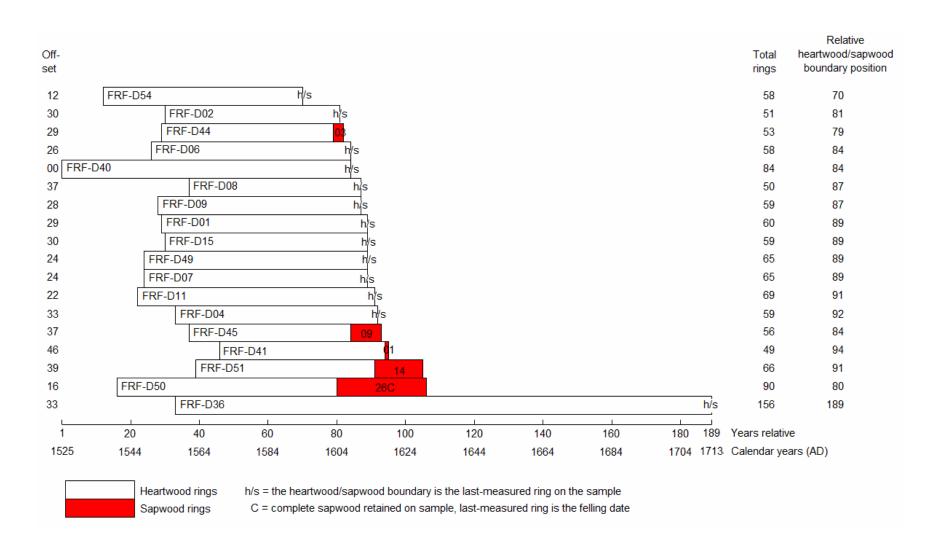
Figure 31: Bar diagram of samples in site sequence FRFDSQ02

Next, 18 samples (eight from the East range, eight from the Connecting range, and one each from the East and West range hips) grouped and were combined at the relevant offset position to form FRFDSQ02, a site sequence of 189 rings (Fig 31). This was found to span the period AD 1525–1713. The evidence for this dating is given by the *t*-values in Table 3.

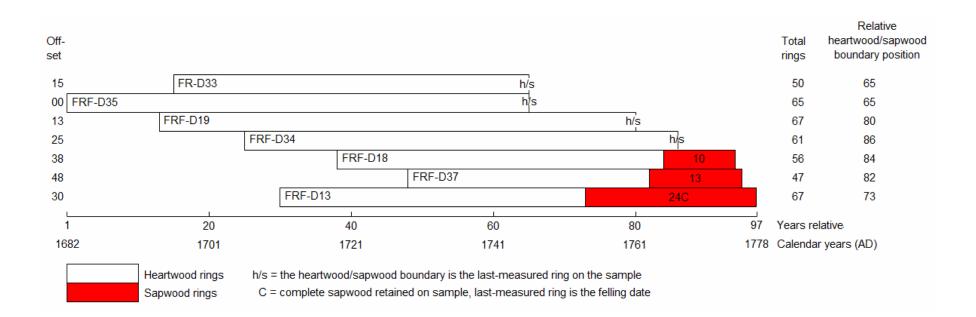
Figure 32: Bar diagram of samples in site sequence FRFDSQ03

Seven samples (three from the East and four from the West range hips) matched and were again combined at the relevant offset positions to form FRFDSQ03, a site sequence of 97 rings (Fig 32). This site sequence was found to match against the reference

chronologies at a first-ring date of AD 1682 and a last-measured ring date of AD 1778. The evidence for this dating is given by the *t*-values in Table 4.

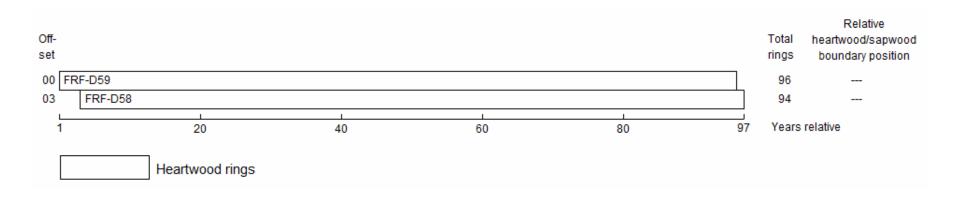
Figure 33: Bar diagram of samples in undated site sequence FRFDSQ04

A further five site sequences were constructed (Figs 33–37). These site sequences contained a maximum of four samples and ranged in length from 70 to 105 rings. They were compared against the reference chronologies but could not be securely matched and are undated. Attempts to date the remaining ungrouped samples were unsuccessful and these are also undated.

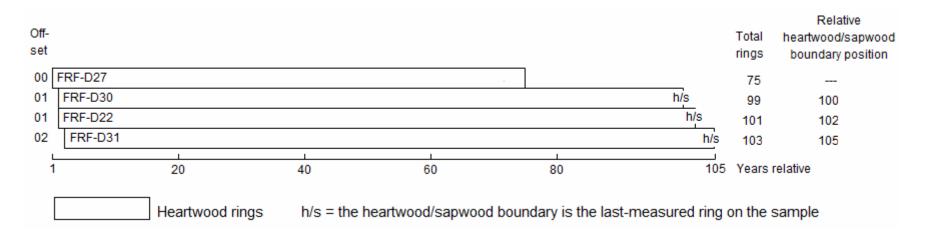
Figure 34: Bar diagram of samples in undated site sequence FRFDSQ05

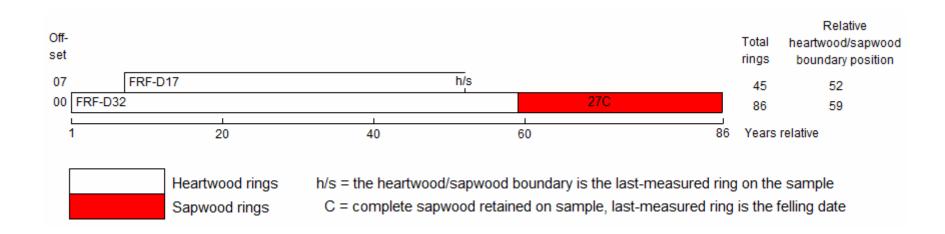
Figure 35: Bar diagram of samples in site sequence FRFDSQ06

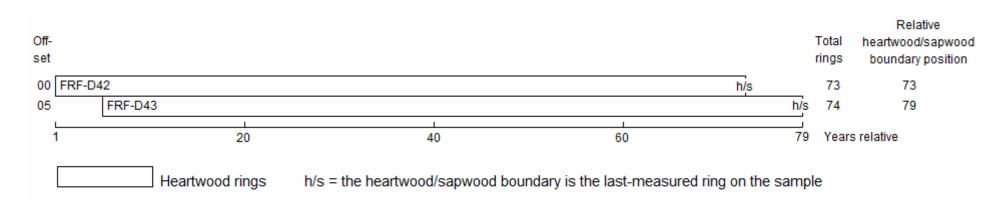
Figure 36: Bar diagram of samples in undated site sequence FRFDSQ07

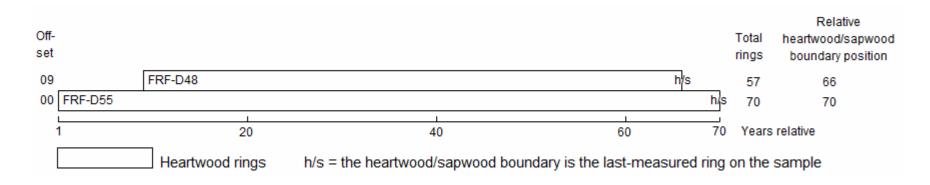
Figure 37: Bar diagram of samples in undated site sequence FRFDSQ08

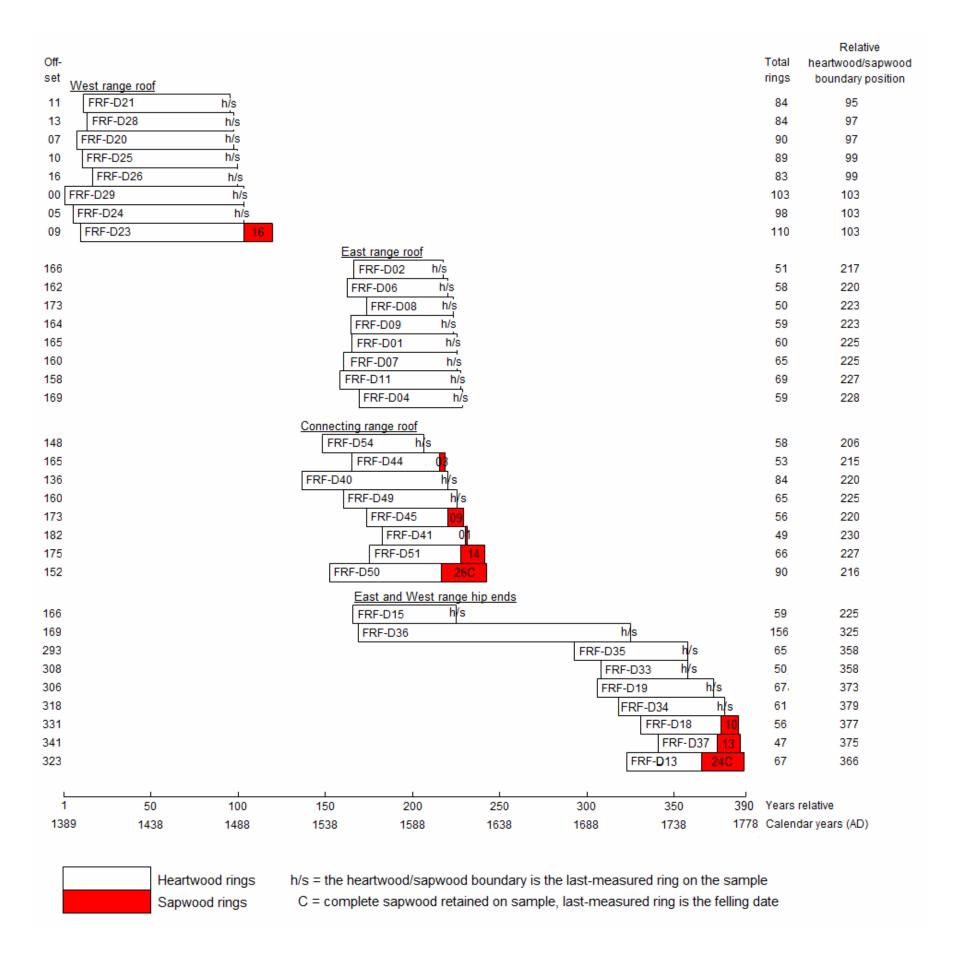
Figure 38: Bar diagram of dated samples, sorted by area

Tree-ring analysis has resulted in the successful dating of three site sequences which together contain 33 samples. To aid interpretation, samples from each area have been dealt with separately (Fig 38).

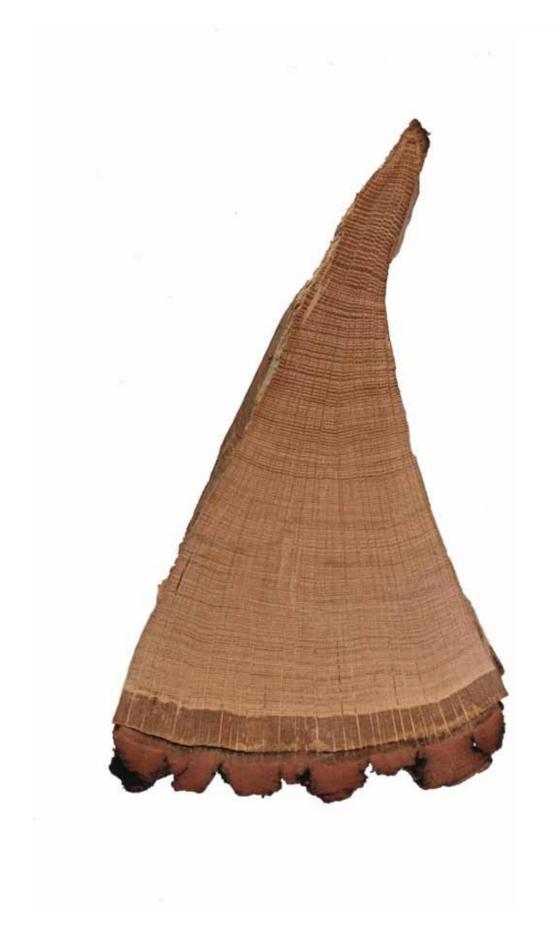
Figure A1: A wedge of oak from a tree felled in 1976. It shows the annual growth rings, one for each year from the innermost ring to the last ring on the outside just inside the bark. The year of each ring can be determined by counting back from the outside ring, which grew in 1976

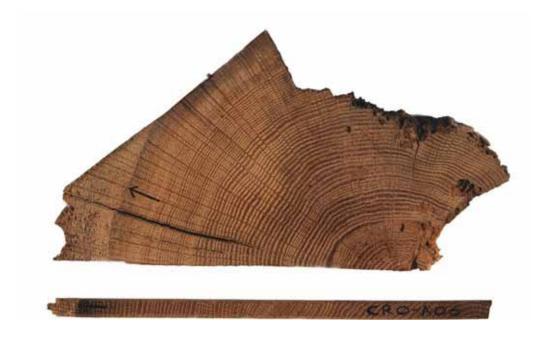
Figure A2: Cross-section of a rafter, showing sapwood rings in the left-hand corner, the arrow points to the heartwood/sapwood boundary (H/S); and a core with sapwood; again the arrow is pointing to the H/S. The core is about the size of a pencil

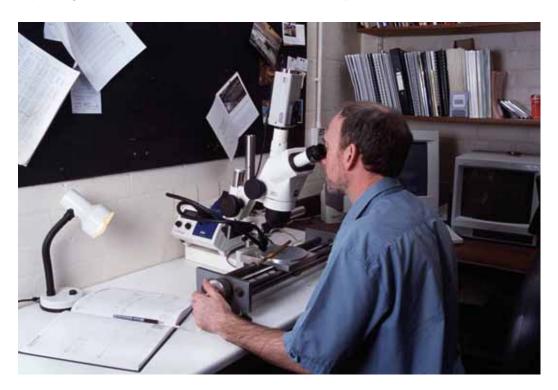
Figure A3: Measuring ring widths under a microscope. The microscope is fixed while the sample is on a moving platform. The total sequence of widths is measured twice to ensure that an error has not been made. This type of apparatus is needed to process a large number of samples on a regular basis

- 2. Measuring Ring Widths. Each core is sanded down with a belt sander using medium-grit paper and then finished by hand with flourgrade-grit paper. The rings are then clearly visible and differentiated from each other with a result very much like that shown in Figure A2. The core is then mounted on a movable table below a microscope and the ring-widths measured individually from the innermost ring to the outermost. The widths are automatically recorded in a computer file as they are measured (see Fig A3).

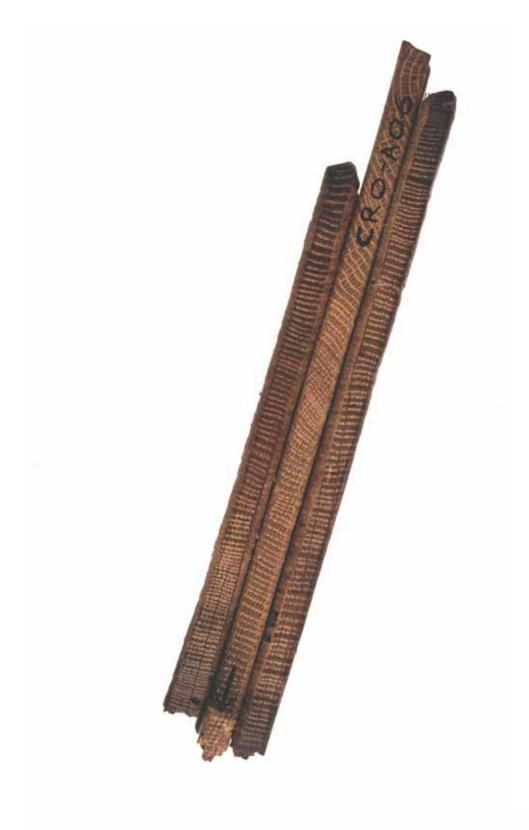
Figure A4: Three cores from timbers in a building. They come from trees growing at the same time. Notice that, although the sequences of widths look similar, they are not identical. This is typical

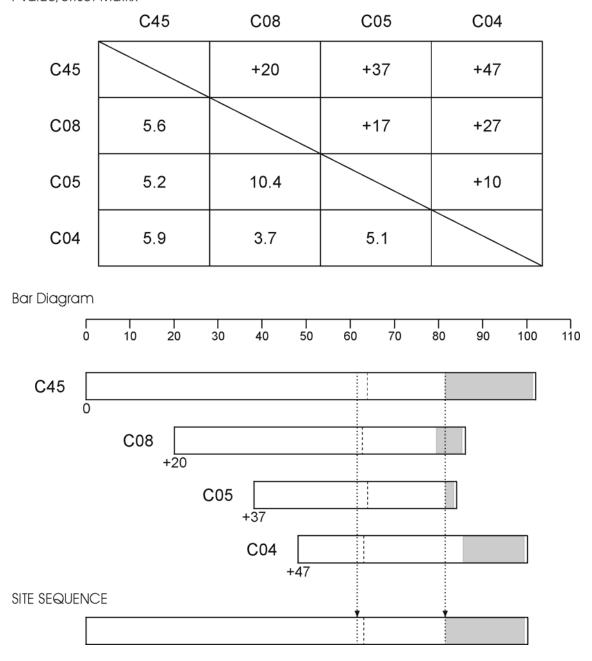
Figure A5: Cross-matching of four sequences from a Lincoln Cathedral roof and the formation of a site sequence from them

The bar diagram represents these sequences without the rings themselves. The length of the bar is proportional to the number of rings in the sequence. Here the four sequences are set at relative positions (offsets) to each other at which they have maximum correlation as measured by the t-values. The t-value/offset matrix contains the maximum t-values below the diagonal and the offsets above it. Thus, the maximum t-value between C08 and C45 occurs at the offset of +20 rings and the t-value is then 5.6. The site sequence is composed of the average of the corresponding widths, as illustrated with one width.

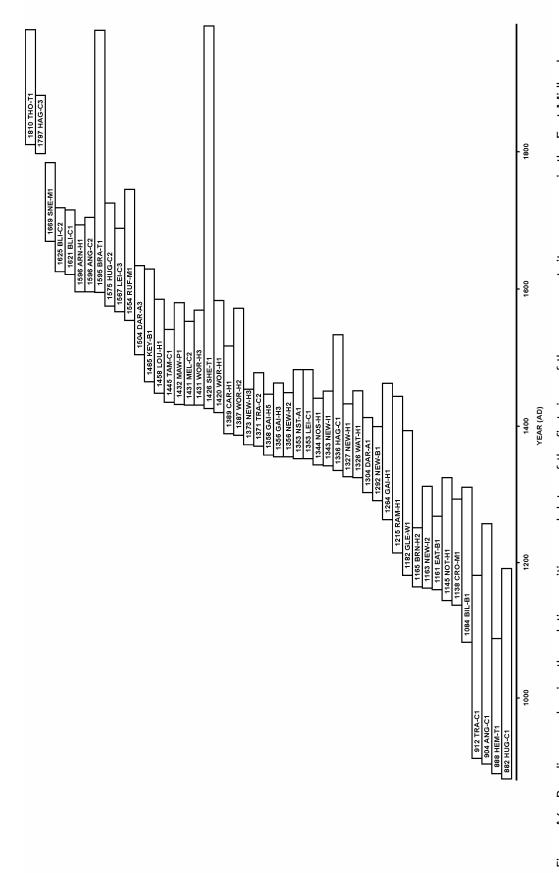
Figure A6: Bar diagram showing the relative positions and dates of the first rings of the component site sequences in the East Midlands Master Dendrochronological Sequence, EM08/87

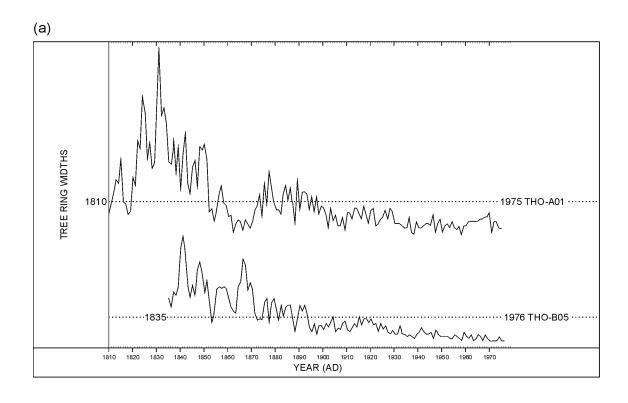
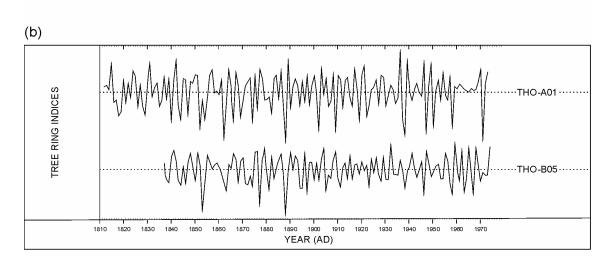
Figure A7 (a): The raw ring-widths of two samples, THO-A01 and THO-B05, whose felling dates are known

Here the ring widths are plotted vertically, one for each year, so that peaks represent wide rings and troughs narrow ones. Notice the growth-trends in each; on average the earlier rings of the young tree are wider than the later ones of the older tree in both sequences
