RESEARCH REPORT SERIES no. 44-2013

NAPPA HALL, ASKRIGG, NORTH YORKSHIRE AN INVESTIGATION AND ASSESSMENT OF THE LATE MEDIEVAL HALL IN ITS IMMEDIATE SETTING

Adam Menuge and David Went

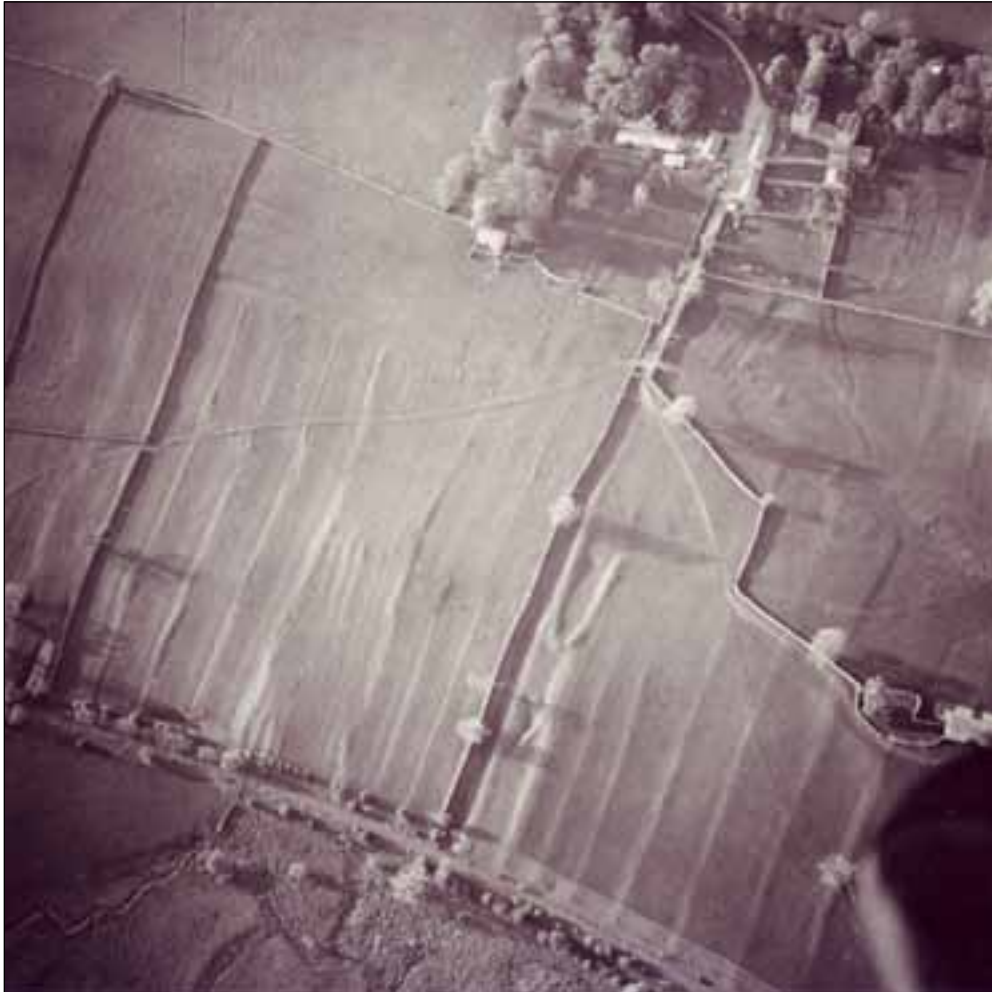
Figure 1. Nappa Hall from the south, photographed from the air in May 1985, showing the hall (top right) the early post-medieval gardens immediately to the east, fishponds running diagonally across the field to the south, the mill dam (centre frame) and the medieval field pattern descending to the river. NMR 9690/3 – YDP 13201/05 reproduced by permission of the Yorkshire Dales National Park.

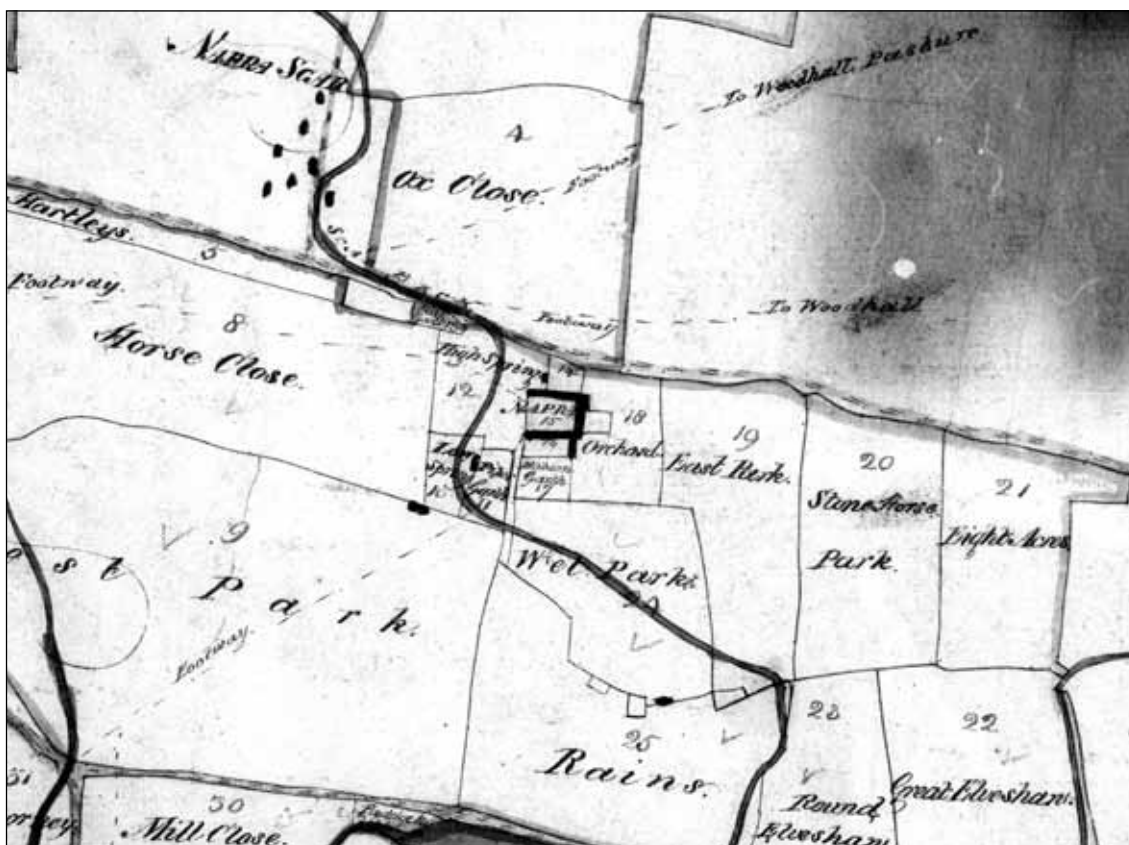
Figure 3. Extract from E. Atkinson's map of Askrigg 1756. Courtesy of North Yorkshire County Record Office ZM17 MIC 1496-86.

Atkinson's 1756 map provides the earliest visualisation of Nappa Hall. Though it may of course reflect changes undertaken after the first construction phase, it is potentially our best guide to the early layout of the complex. In addition to the present ranges it shows a third extending along the south side of the courtyard. The west side of the courtyard is depicted as a single line – probably a wall, doubtless pierced by a gateway – coinciding with the east side of the track. The principal apartments closing the north side of the courtyard are shown extending westwards as far as this wall, suggesting either that a structure west of the high-end tower has been lost or that the depiction of buildings is comparatively sketchy (the absence of an indication of the northwards projections of the two towers favours the latter interpretation). A further range, outside the courtyard, is shown extending southwards from near the east end of the south range, not quite in line with the north-south service range. Even allowing that Atkinson's depiction of the buildings is not precise, the representation of a complex built up on three sides of a courtyard which was walled off, but not otherwise built up, on the west side appears convincing. The earliest representation of a west range is on Belwood's plan (Figure 13) and the present west range appears to be of mid 19th-century appearance; both circumstances are consistent with this interpretation of Atkinson's map. The range along the south side of the courtyard appears to be a substantial structure, not the slender terrace walk depicted by Belwood a few decades later, and is perhaps the likely location for the stable '[with]in the gates'. The attached range to the south, which faces west onto another yard or enclosure, is a possible location for the out-stable and ox house (see Section 4 below).

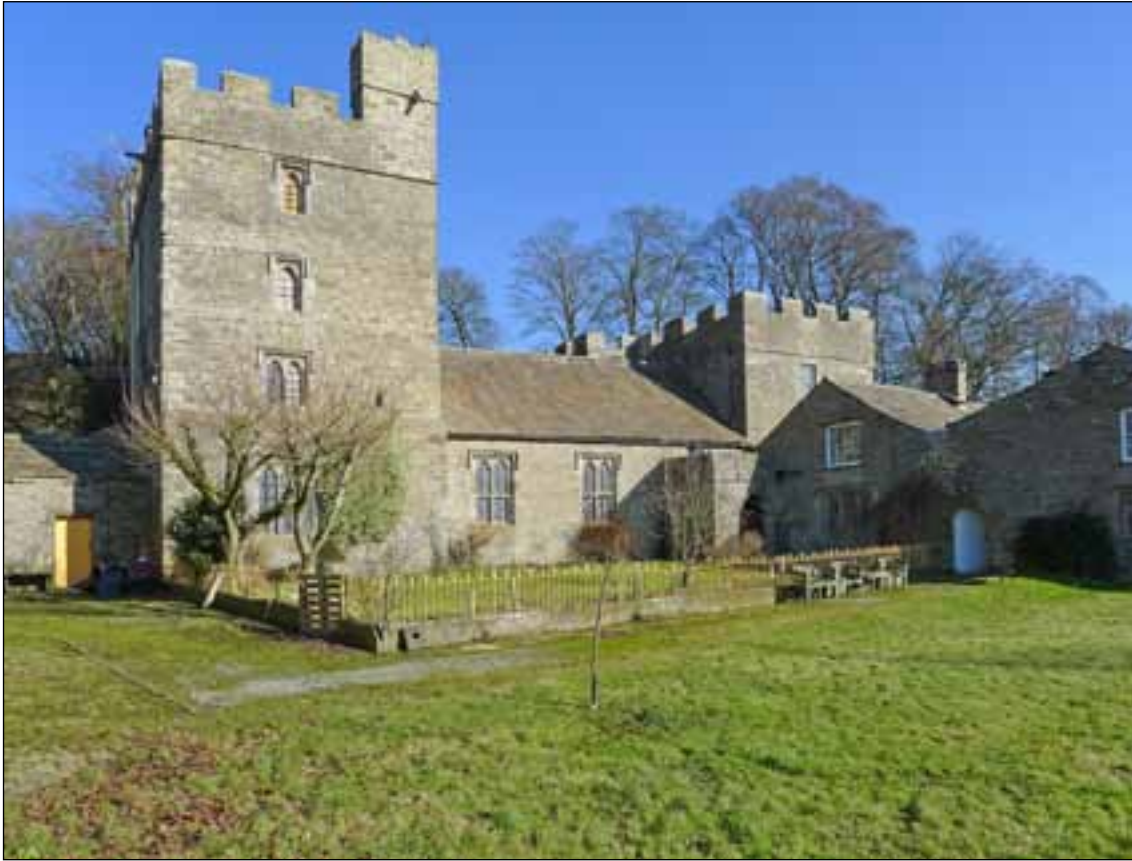
Figure 4. The hall range viewed from the south (photograph: Lucy Jessop, English Heritage)

The distribution and relative quality of the windows announce the south as the principal elevation, in keeping with its more favourable aspect and commanding views. All the surviving hood-moulded windows occur on this elevation, on the hall range and on the high-end tower, and they are all characterised by distinctive cinquefoil-cusped heads to the lights in which the central foil is much broader than the others and assumes a four-centred arched form. One former hood-moulded window can be identified on the east elevation of the low-end tower, lighting and conferring status on the north ground-floor room, and it is therefore possible that the east elevation, or the views eastward, were also accorded some status, perhaps relative to formal gardens laid out on this side (see Section 4 below) . Further cinquefoiled lights occur on the west elevation of the high-end tower, lighting the southern room on each of the three upper floors, but none has a hood-mould.⁵³ A similar ground-floor window may have been lost when the present west entrance was inserted. Towards the northern end of the west elevation there is a diminution in the level of display, with just a single unchamfered single-light window on the third floor, now blocked, also without a hood-mould and probably square-headed. There is also on this elevation a single stone spout draining the wall-walk, and an original brattished stone chimney interrupting the crenellations.

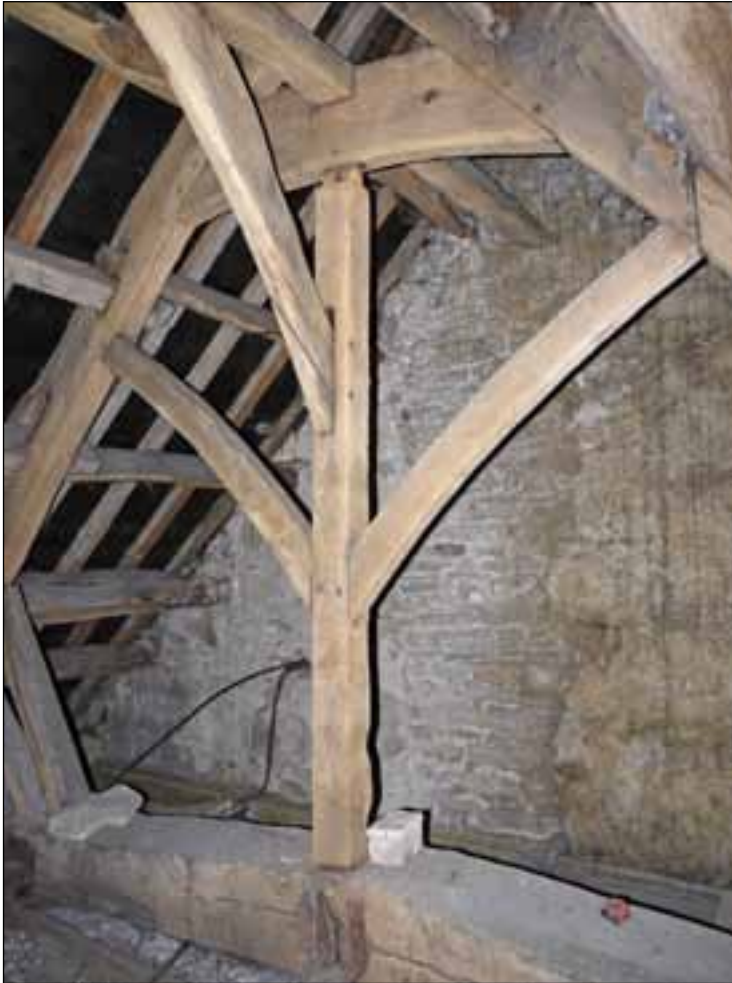
Figure 5. The hall's roof structure with inserted flue behind. (photograph: Adam Menuge, English Heritage).

The hall range retains its original four-bay crown-post roof, now concealed above, and modified to accommodate, 18th- and 19th-century ceilings. The two western trusses are fully accessible in the roof-space above the present three-bay hall, while a third can be viewed above the fragile first-floor ceiling in the easternmost bay, above the former cross-passage. The construction of the roof is relatively unusual, the trusses combining a crown-post form with principal rafters (Figure 5). They consist of a cambered tie-beam, principal rafters rising to a butt apex, a plain crown-post without expansion, a cambered collar, slender single-pegged curved struts rising from low on the crown-post to the principal rafters, and double-pegged curved struts of more elongated cross-section rising from higher up the crown-post to the collar-purlin. Originally, as indicated by long pegged mortices in the tie-beam soffits, short braces descended from the ends of the tie-beams to wall-posts, the latter probably supported on corbels set high on the hall walls.⁵⁸ The corbels are no longer apparent but may survive, struck back, behind later wall plaster below the present ceiling. Wind-braces rose from the principal rafters to two sets of butt purlins. The roof is composed of sturdy and good quality timber but the decoration

is sparing, confined to mouldings on the tie-beams and small chamfers on some of the other timbers. The timbers are free from soot and clearly point to the existence from the outset of a hearth enclosed within a fireplace.

The roof is divided into three long bays and a short one at the western end. This identifies the westernmost truss as a dais truss, and it differs in that there is no mortice for a brace up to the collar-purlin on the western face of the crown-post. This diminution in the decorative impact of the roof at this point might suggest that it was less conspicuous owing to the presence of a dais canopy, and it is therefore interesting that Whitaker noted in 1823 the survival of 'the skeleton and part of the wainscot of the canopy over the high table'.⁵⁹ This feature does not survive, however, and no evidence has been found on the western face or soffit of the tie-beam to indicate the attachment of such a feature.⁶⁰ In the easternmost bay (i.e. at the low end) the collar purlin has been removed and a brace rising to a later ridge-purlin has been substituted. A corbel projecting from the wall of the low-end tower at a height corresponding to the bases of the crown-posts suggests that a crown-post may have existed here formerly. Evidence for a corresponding arrangement at the high end is not apparent, perhaps because a dais canopy made it superfluous, but also perhaps because of the disturbance resulting from the inserted hall flue here.

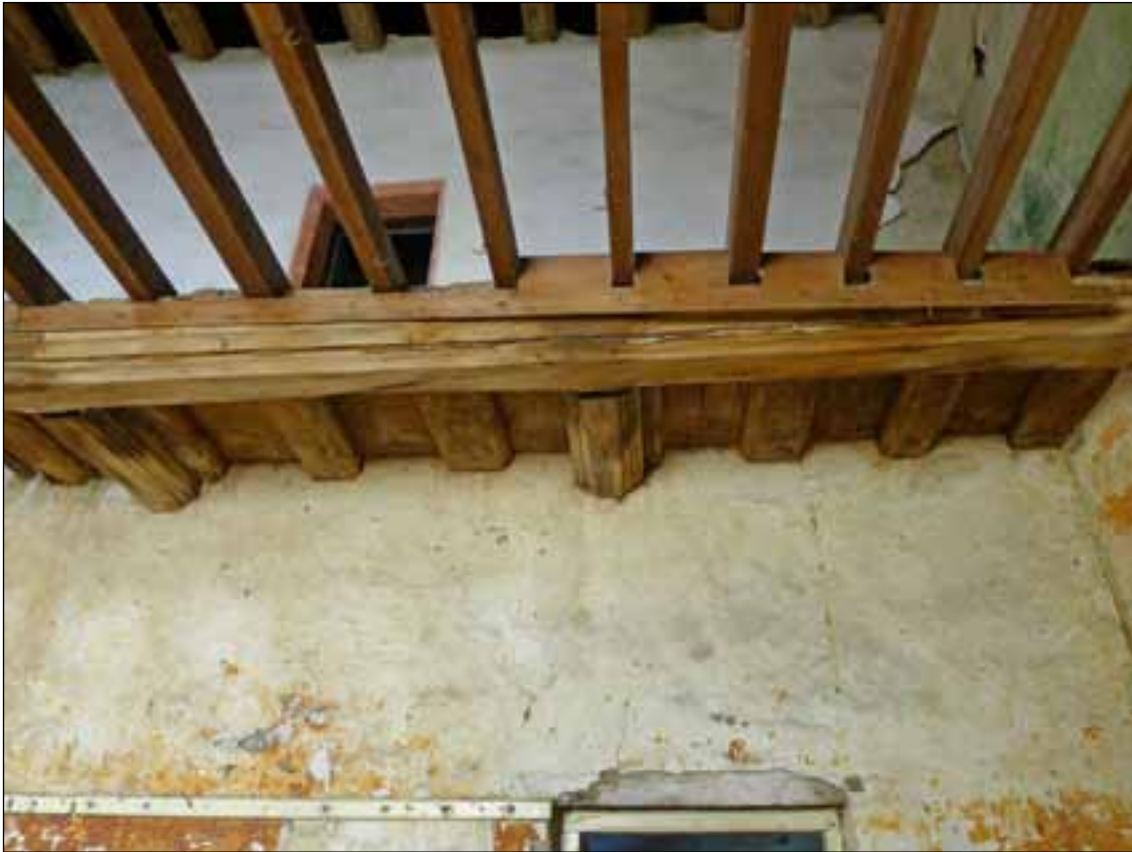
Figure 6. The medieval flooring technique employed in the high-end tower: boards resting in rebates along the joist and beams (photograph: Lucy Jessop, English Heritage).

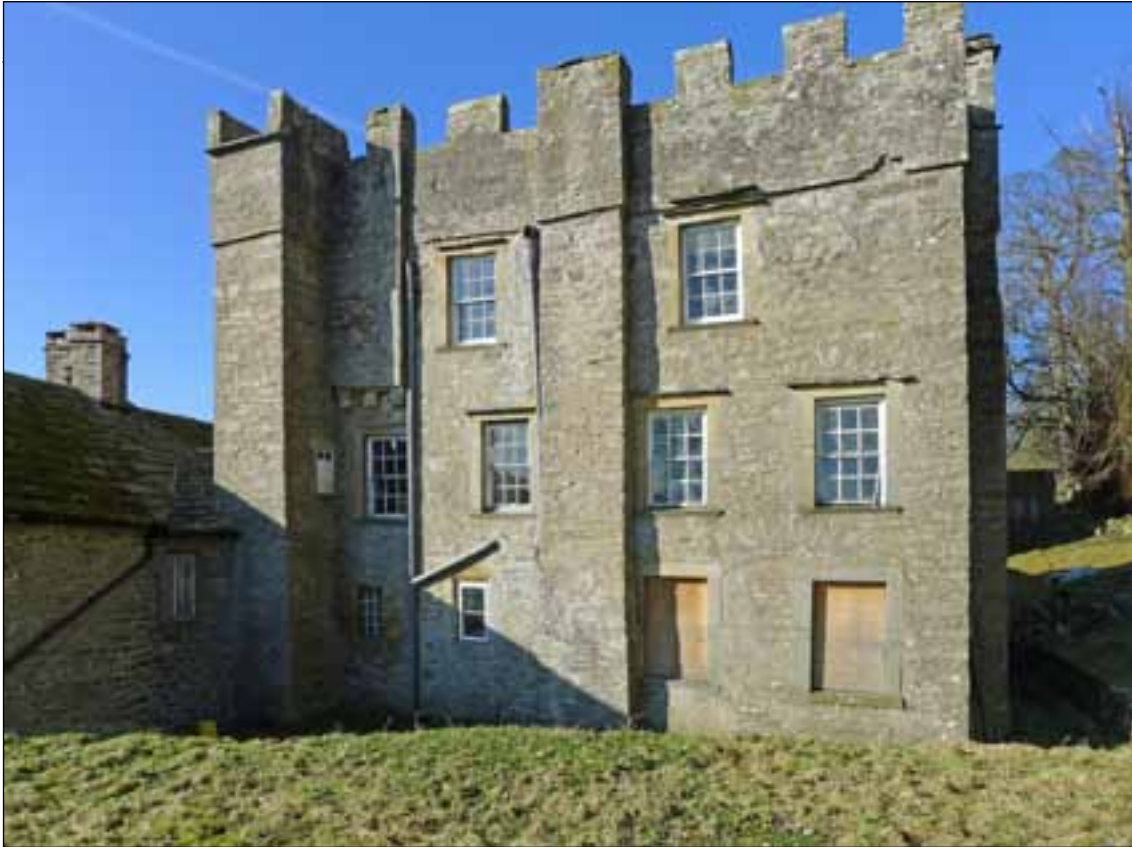
Figure 7. The east elevation of the low-end tower (photograph: Lucy Jessop, English Heritage)

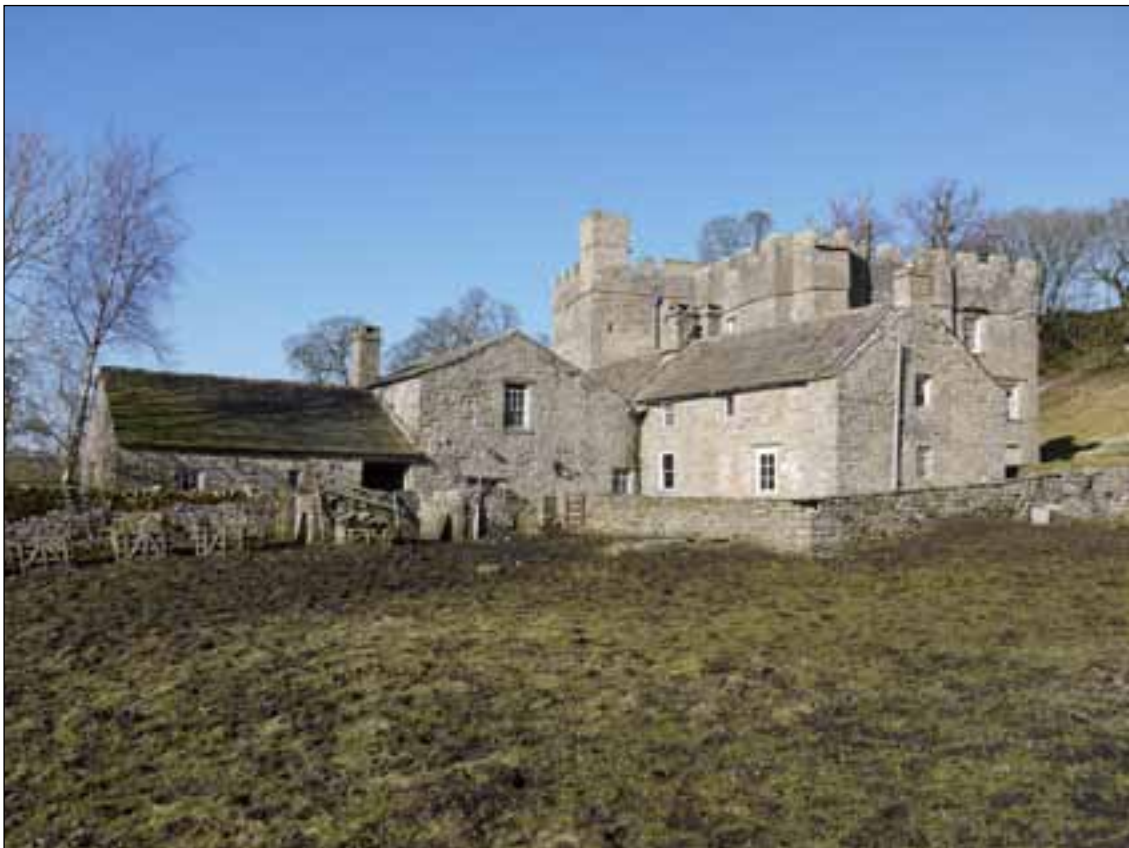
Figure 8. The service range viewed from the east (photograph: Lucy Jessop, English Heritage).

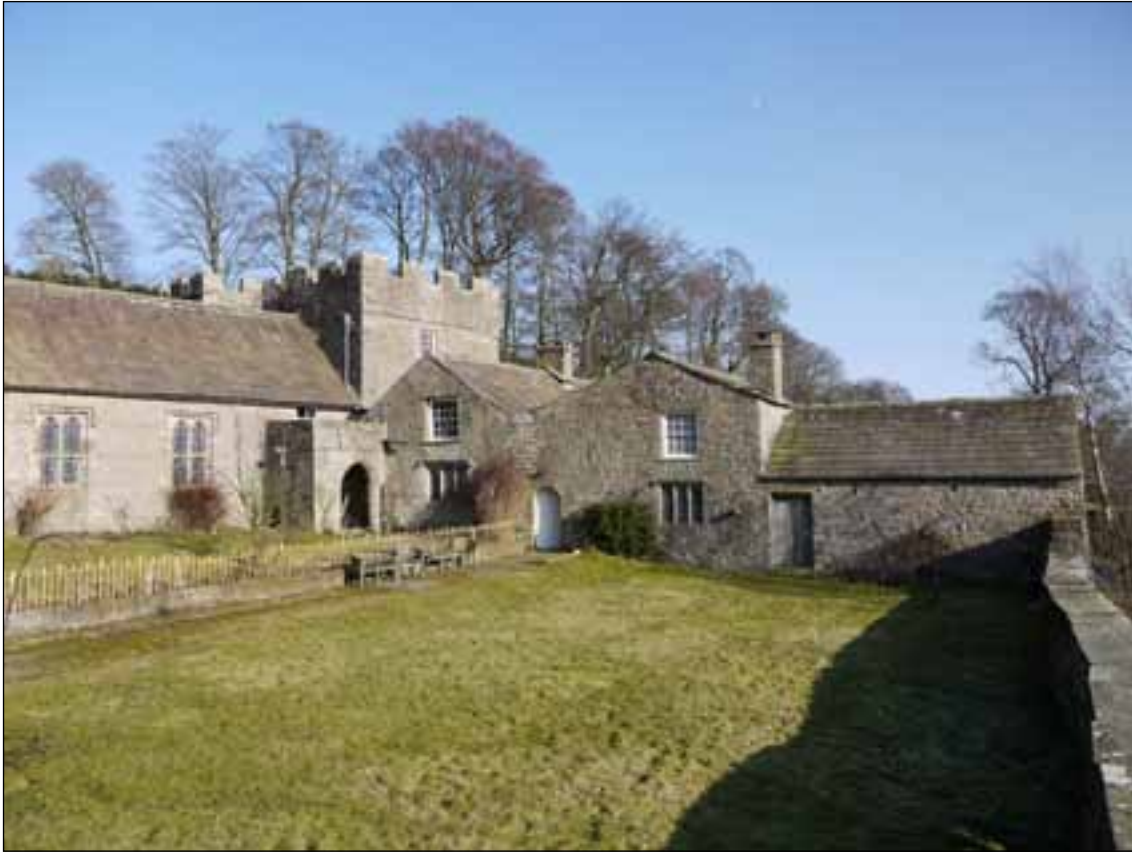
Figure 9. The service range viewed from within the courtyard (photograph Adam Menuge, English Heritage).

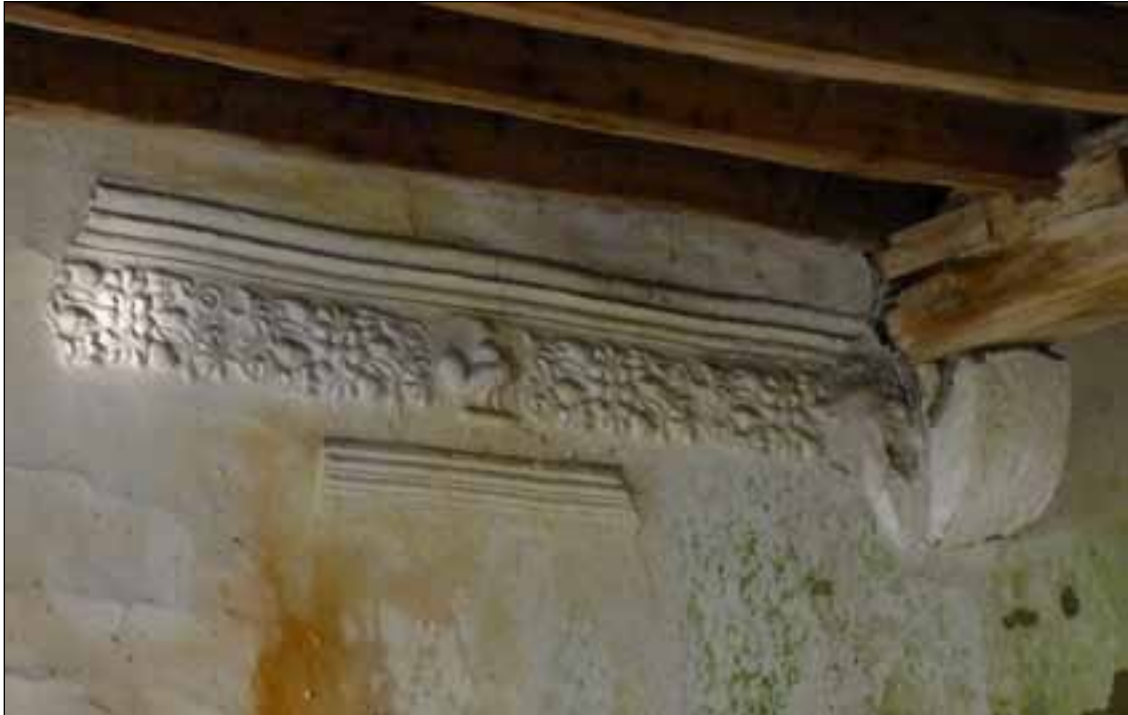
Figure 10. The decorative frieze on the first floor of the high-end tower (photograph: Adam Menuge, English Heritage).

There are fragmentary survivals of decorative plasterwork and of perhaps contemporary plain plasterwork in the best rooms of the high-end tower, pointing to some embellishment of the accommodation, most likely in the early 17th century. They can be attributed with some confidence to Sir Thomas Metcalfe (1579-1655), who entered into his inheritance in 1601, following a long minority, and perhaps belong to the succeeding decade, before his circumstances deteriorated. In the south ground-floor room there is a small fragment of decorative plaster high on the east splay of the south window, and there are slight traces of plaster applied over the moulding of the northern ceiling beam. In the corresponding first-floor room, above the fireplace on the west wall, there is a length of frieze between two horizontal mouldings. The frieze incorporates a cock, the crest of the Metcalfes (Figure 10).

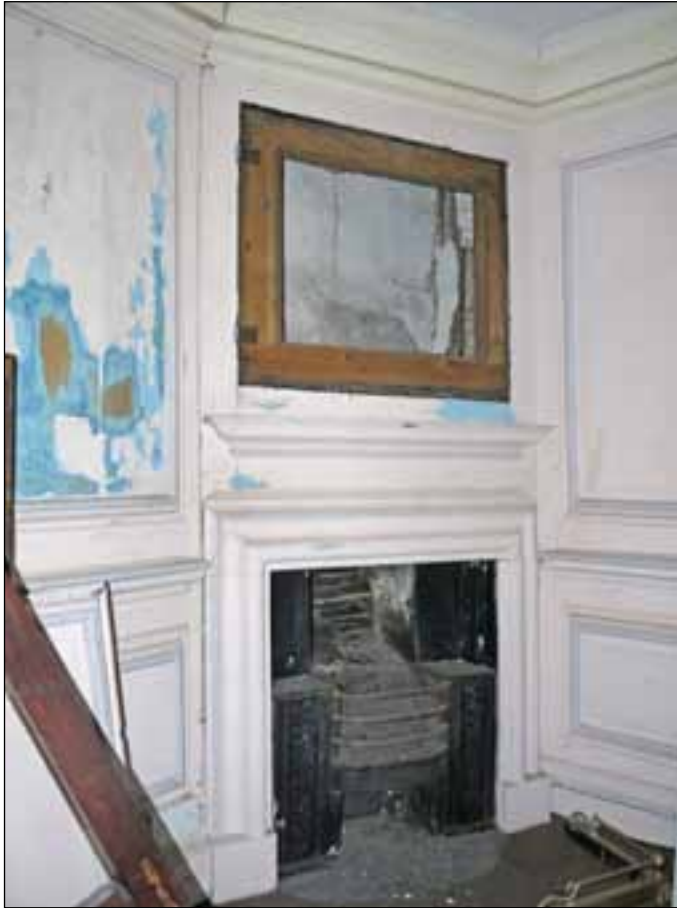
Figure 11. The interior of what appears to have been Thomas Metcalfe's 'own room' at the south end of the first floor of the low-end tower c.1722-35 (photograph: Adam Menuge, English Heritage).

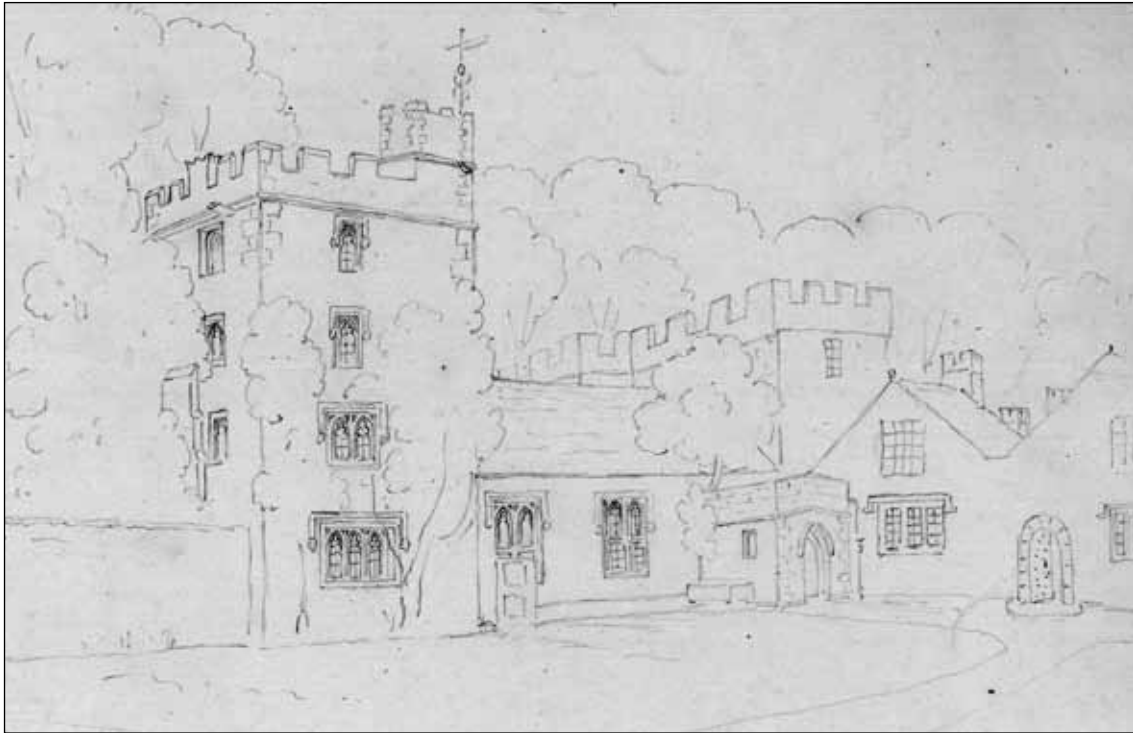
Figure 14. *Nappa Hall (1846)* by Samuel Allen. York City Archives, Allen Collection 100/SO1/096.
 © City of York Libraries, Archives and Local History (<http://www.york.gov.uk/archives>).

Samuel Allen's sketch of the house, dated 1846 (Figure 14), shows a doorway inserted beneath the transom of the western hall window, presumably to provide independent access to the remainder of the building.¹⁰⁶ The inserted doorway, which post-dates Buckler's 1816 view, was blocked by 1889 and the missing elements of the window were reinstated, but the disruption to the medieval fabric remains visible and the lower parts of the window are clearly late replacements.¹⁰⁷ The provision of a second doorway may imply separate use of the hall and high-end tower, though it is a surprisingly clumsy alteration. Service access was provided, perhaps during the second quarter of the 19th century, by creating a doorway in the west wall of the great parlour on the south side of the original fireplace, which may have been upgraded at the same time. This has a raised cement surround externally, simulating rusticated quoins and voussoirs. The style is comparable to that of the segmental-headed hall fireplace. This contains a range with a Gothic arcaded back with a central ogee arch – a motif commonly used in the Gothick style but rarely used after about 1845; the oven and water boiler are more conventional mid 19th-century work. Eyes survive for hanging a crane. The timber mantle has a contemporary Gothic moulding.

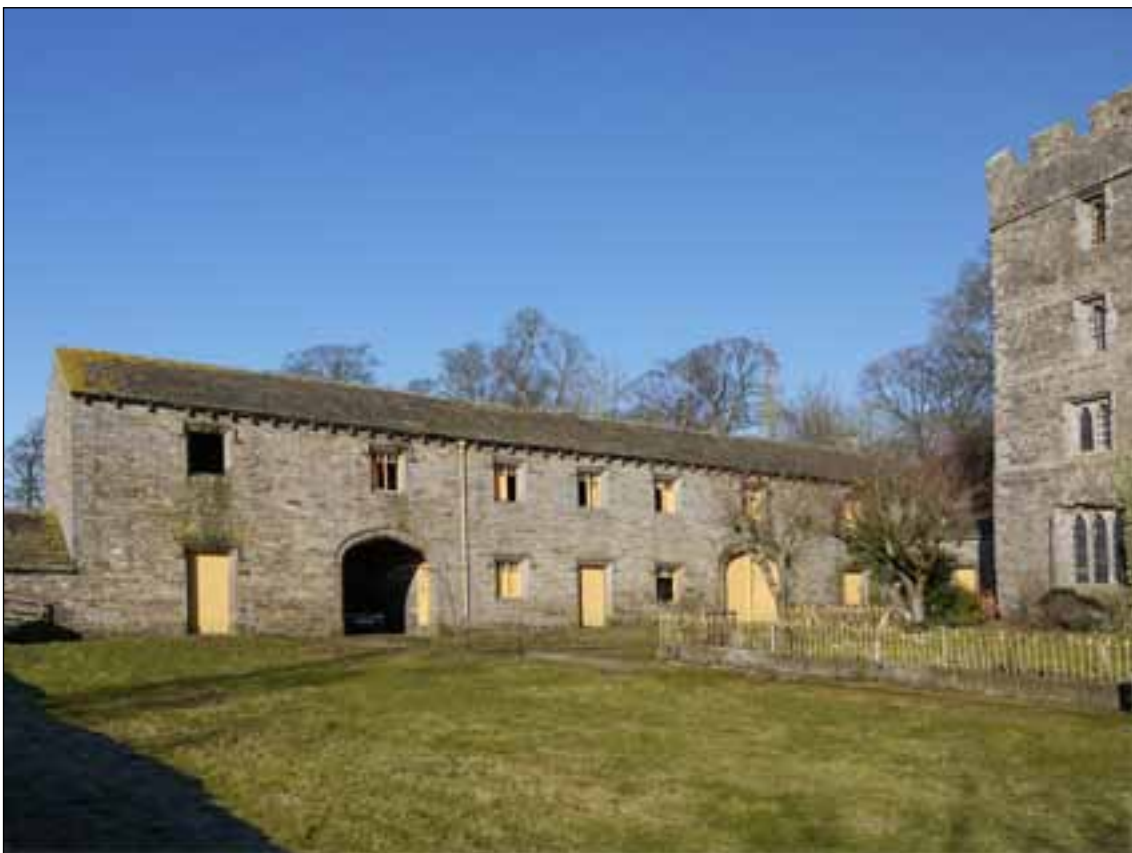
Figure 15. The eastern elevation of the coach house and stable block range (photograph: Lucy Jessop, English Heritage)

Probably in the third quarter of the 19th century the west range was extensively rebuilt and a small new single-storey range, now used as a wood store, was added between it and the high-end tower, abutting the latter.¹⁰⁹ The new work is characterised by coursed rubble on the principal elevations, and chamfered hood-moulded surrounds to the doorways and windows (Figure 15). Both buildings incorporate re-used oak roof timbers (in otherwise softwood roofs) with felling dates consistent with the original construction phase. Eleven timbers in the stable and coach house range yielded a likely felling date of

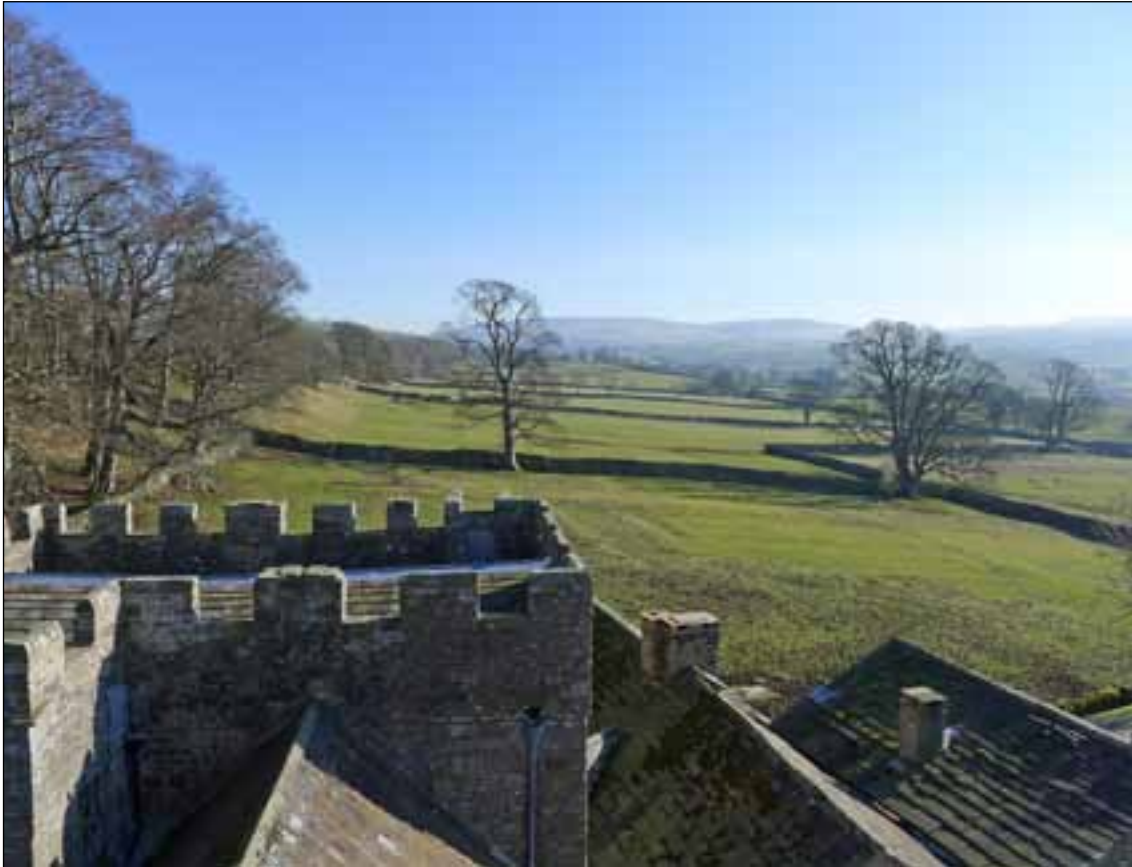
Figure 18. The quartered garden viewed from the high-end tower roof (photograph: Lucy Jessop, English Heritage).

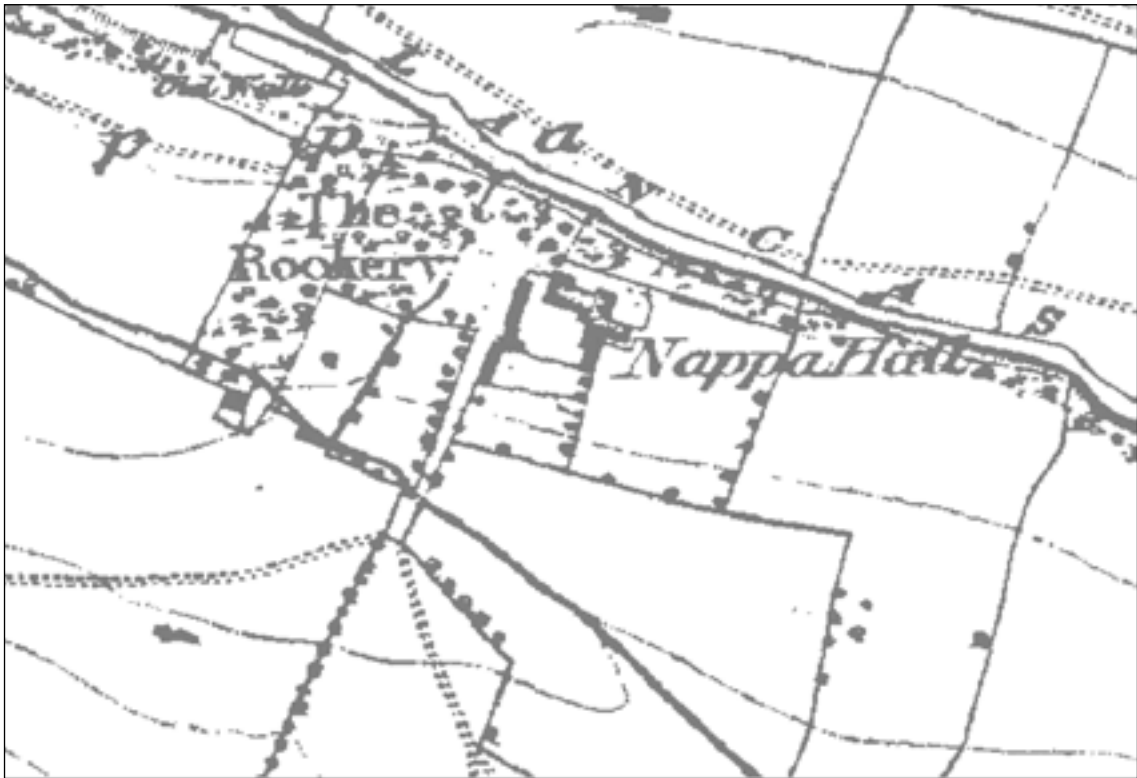
A final 'missing' building is that shown on the 1st edition 6 inch OS map (1856): a narrow structure running the length of the western boundary of the paddock to the south of the hall's present garden (see Figure 19). There is nothing shown in this location on the 1756 map, and it may have been little more than a lean-to, set against an unusually substantial section of dry-stone wall.

Figure 19. Extract from the 1856 6-inch Ordnance Survey map sheet LXVI-8.
