RESEARCH REPORT SERIES no. 35-2014

APETHORPE HALL, APETHORPE, NORTHAMPTONSHIRE RECORD OF OPENING UP: VOLUME SIX

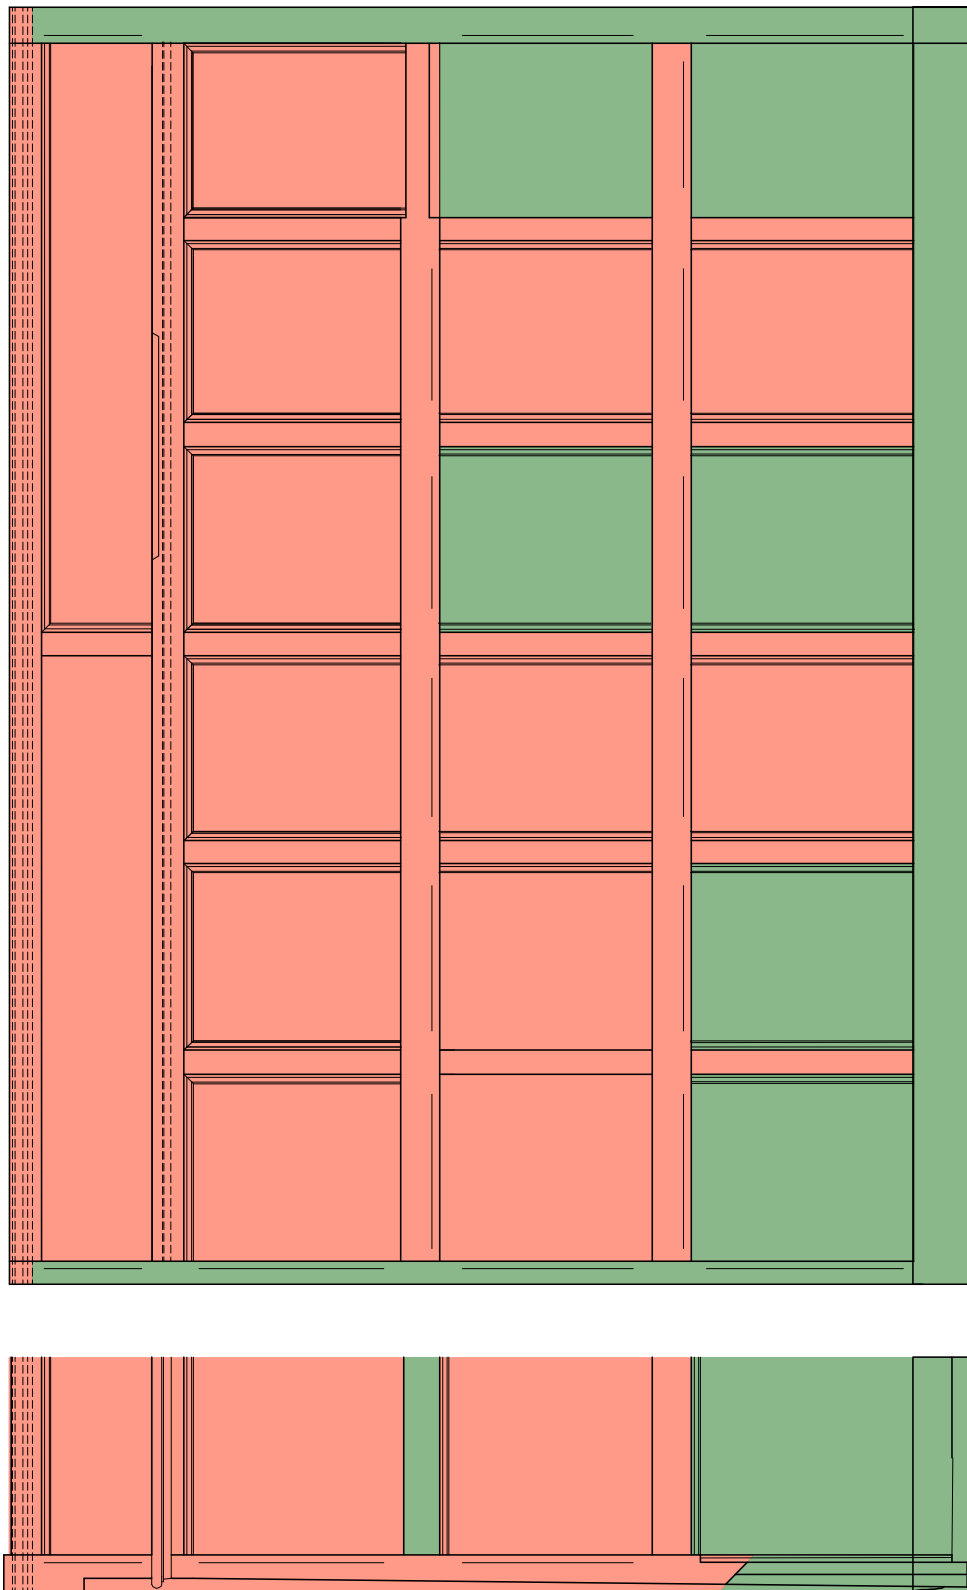
Original 17th century
 Later replacement

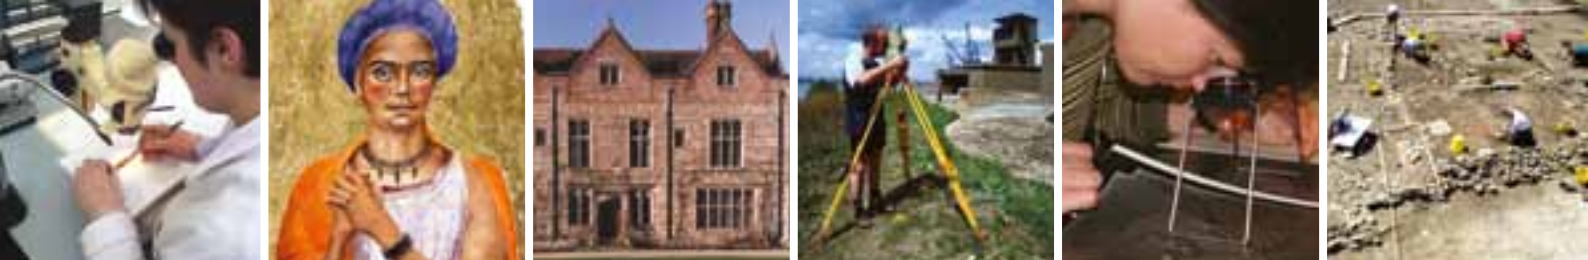
ENGLISH HERITAGE RESEARCH AND THE HISTORIC ENVIRONMENT
