RESEARCH REPORT SERIES no. 34-2014

CASTLE HEATON, CORNHILL-ON-TWEED, NORTHUMBERLAND AN INVESTIGATION AND SURVEY OF THE VAULTED BUILDING AND ADJACENT EARTHWORKS

Clare Howard and Rebecca Pullen

NGR: NT 90113 41916

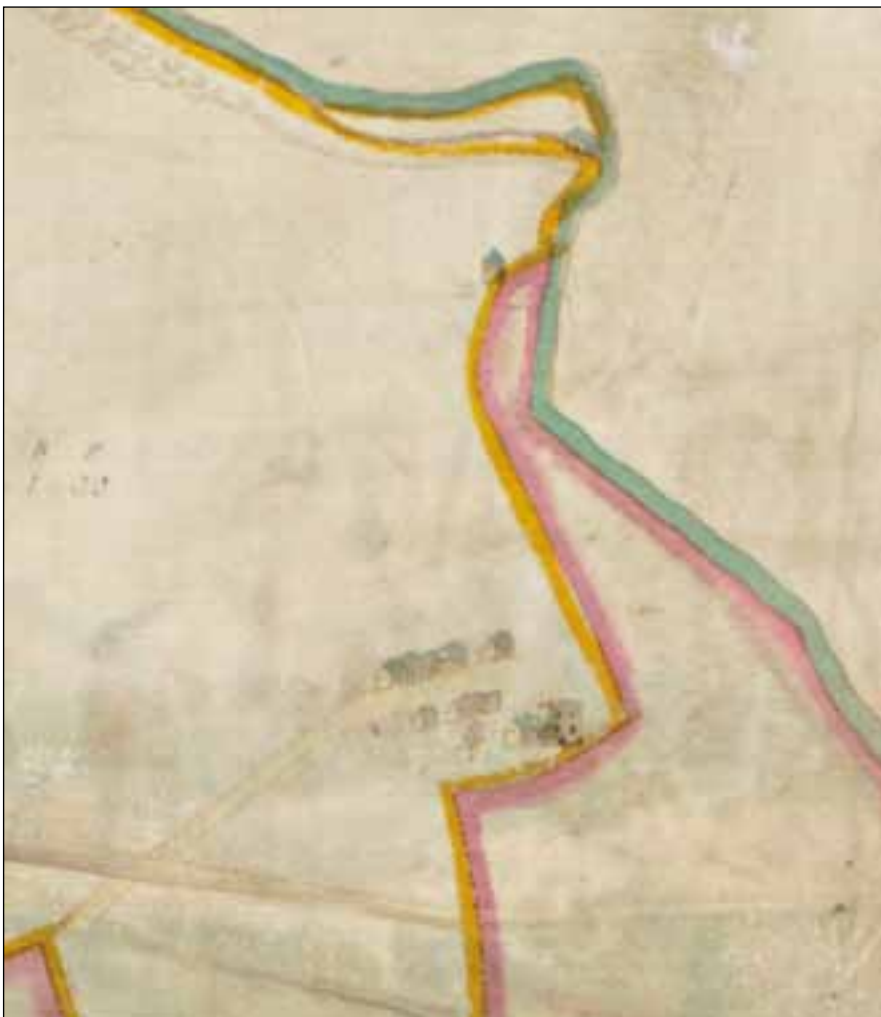
Figure 4: Drawing from a survey of all Lord Ossulton's land and manors undertaken in 1711 (NRO 4206/12 © Northumberland Archives. Reproduced with permission of the Tankerville family).

Bennett line until 1931. A survey of all Lord Ossulton's land and manors, undertaken in 1711, lists Thomas Younghusbands as the main occupant and tenant at Heaton. It includes a drawing (Fig 4) of the settlement which appears to show nine houses, but the drawing is difficult to interpret and not sufficiently accurate to allow confident comparisons with the buildings which stand today. A large castellated structure of three storeys and an attached single-storeyed building with a pitched roof depicted to the south-east of the hamlet might, perhaps, have been a vestige of the last remaining corner tower of the castle. This structure is similar in some respects to a castellated tower with an attached wing which now stands some 50m to the south-west of the vaulted building. However, this standing building is probably 19th-century in date, was extensively remodelled in 1996, and is probably no more than a conscious echo of that shown on the drawing. It is not possible to accurately identify the vaulted building, the subject of this report, on the 1711 drawing, suggesting perhaps that the drawing is inaccurate in terms of the buildings' positions. Given the orientation of the River Till and the road on the plan, the vaulted structure should be in the north-eastern corner of the farmstead, but the buildings depicted there (one of which might be of the right length and height) are on a different alignment running east to west. Alternatively, it is possible that the vaulted structure was, for some reason, simply not included in the drawing.

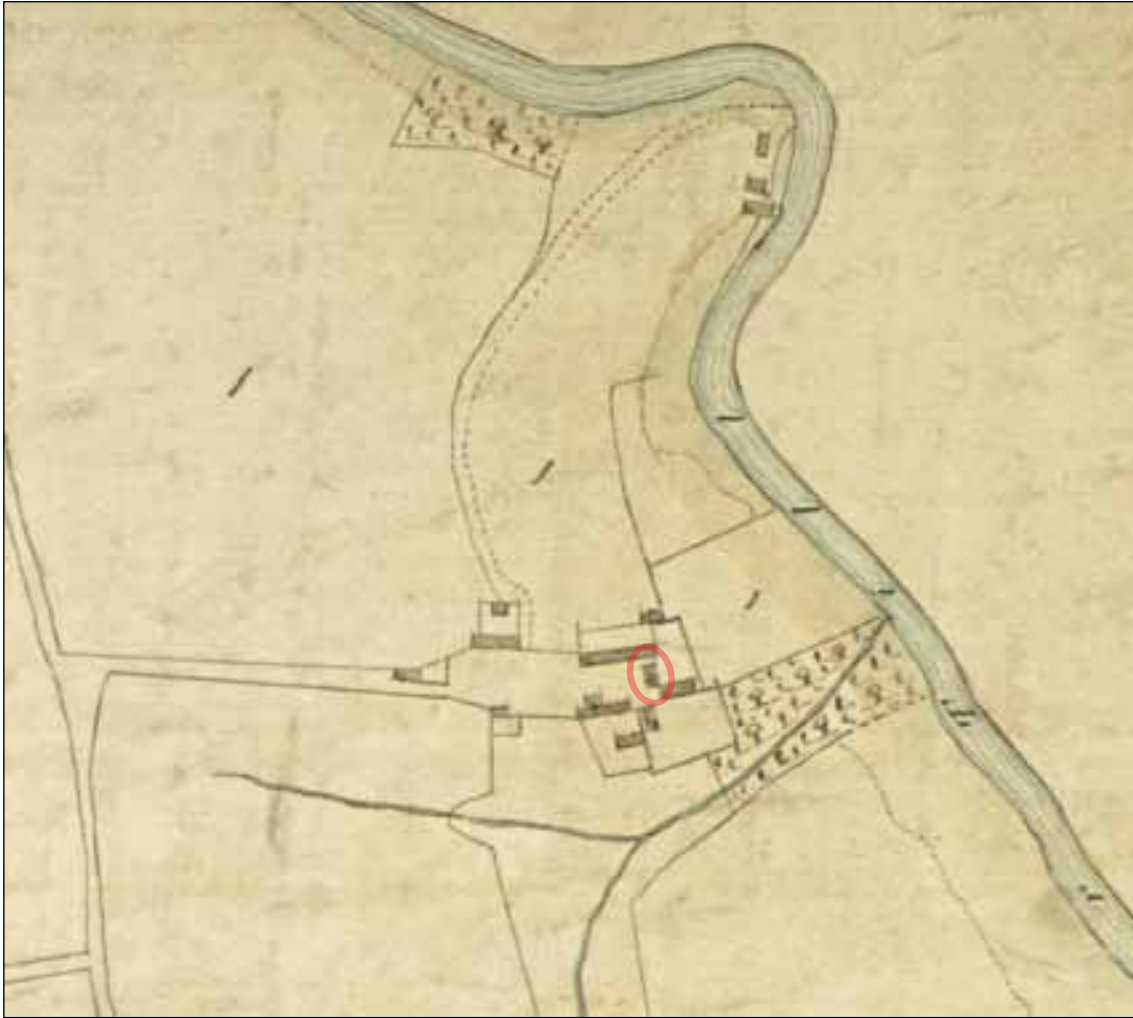
Figure 5: Extract from the 1843 tithe map of Castle Heaton (DT 228 © Northumberland Archives. Reproduced with permission of the Diocese of Newcastle).

as a field boundary as shown on the 1843 tithe map (see Fig 5)¹⁰⁵ and on the first edition 6-inch OS map surveyed in 1860 (see Fig 6).¹⁰⁶ This wall or fence was removed prior to the survey revision for the 1897 25-inch OS map (see Fig 7).¹⁰⁷

Castle Heaton farmhouse (2) stands 25m to the south-east of the vaulted building. It is not shown on the tithe map of 1843 (see Fig 5) but, as stated above, it does appear on the first edition OS map, surveyed in 1860, with a smaller footprint (see Fig 6). The main house is two-storeys high, and was originally square in plan and is of roughly coursed stone rubble with a Welsh-slate roof; a gabled extension was added to the south-west side later in the second half of the 19th century (it is not shown on the OS map surveyed in 1860 but is shown on that revised in 1897). The house faces south-east and the front elevation, as it is now composed, has projecting end bays, one canted the other square

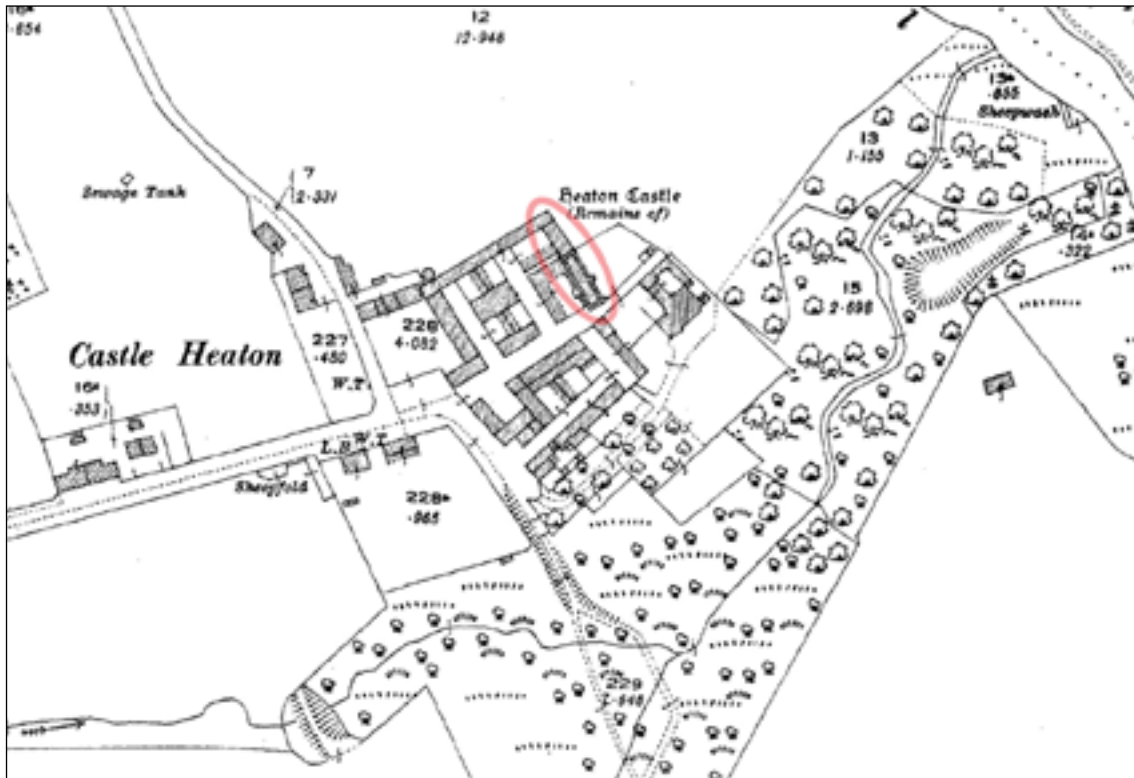
Figure 8: Extract from the 1924 (revised 1922) 25-inch OS map sheet X-NW.

Castle Heaton Farm, along with Stickle Heaton Farm, was sold by Charles Mitchell in August 1921 to John Robert Wood, who was already resident and tenant at the farm,⁶⁷ and the large size of the complex at this time is clear from its depiction on the OS map revision of 1922 (Fig 8).⁶⁸ In 1927 the tithe for Castle Heaton was altered and the new apportionment indicated that Mr J H Wood held the farm at that time; the accompanying plan shows that a number of buildings had also been added to the farm complex.⁶⁹ In May 1941 Castle Heaton Farm was sold to the Lazard Brothers and Company, but an agreement of the same date suggests that Mr Wood was retained as the tenant.⁷⁰ The tenancy agreement, made on the 13th May 1941, valued the land of 845.420 acres (342 ha) at a yearly rental of £1,293. An accompanying plan shows a farmhouse, cottages and associated buildings, but the individual buildings are not described in any detail.⁷¹ The tenancy agreement with Wood was terminated in 1963 following an agreement to sell part of the property to Mr Michael Langhorne Astor.⁷² Mr Astor died before the sale was completed but it was finalised shortly after his death.

Between 1860 and 1897,⁸⁷ a long single-storeyed shed, extant at the time of writing, was added to the north-west end of the vaulted building, nearly doubling the length of the overall range (Fig 26). The OS map revision of 1897 shows this building adjoining the north-east end of a second, long narrow range which projected to the south-west. This latter range has been largely demolished, but its north-east end appears to survive as the end of the present shed and a stub of its north-west wall has been retained. A pair of ragged joints in the south-west wall of the present shed presumably indicates the former position of the south-east wall of the lost range. Another block had been added to the south-west side of the shed but this has also been demolished by the time of the 1922 OS map revision (see Fig 8).

elevation (Fig 27). The window frames are timber with four panes above and boarding below and may be replacements. The two northernmost windows may be contemporary with the extension and would have opened onto a small yard as indicated on the 1922 OS map. The southernmost window has a blocking beneath the sill, particularly visible inside, which suggests it was formerly a doorway, and there is a further doorway, also blocked with stone, with a rectangular stone lintel, at the south end of the south-west elevation. The 1922 map suggests that the former door (now a window) may have led into the building projecting to the south-west of this elevation while the second blocked doorway would have provided access directly to the exterior between two buildings projecting from the south-west elevation (see Fig 8).

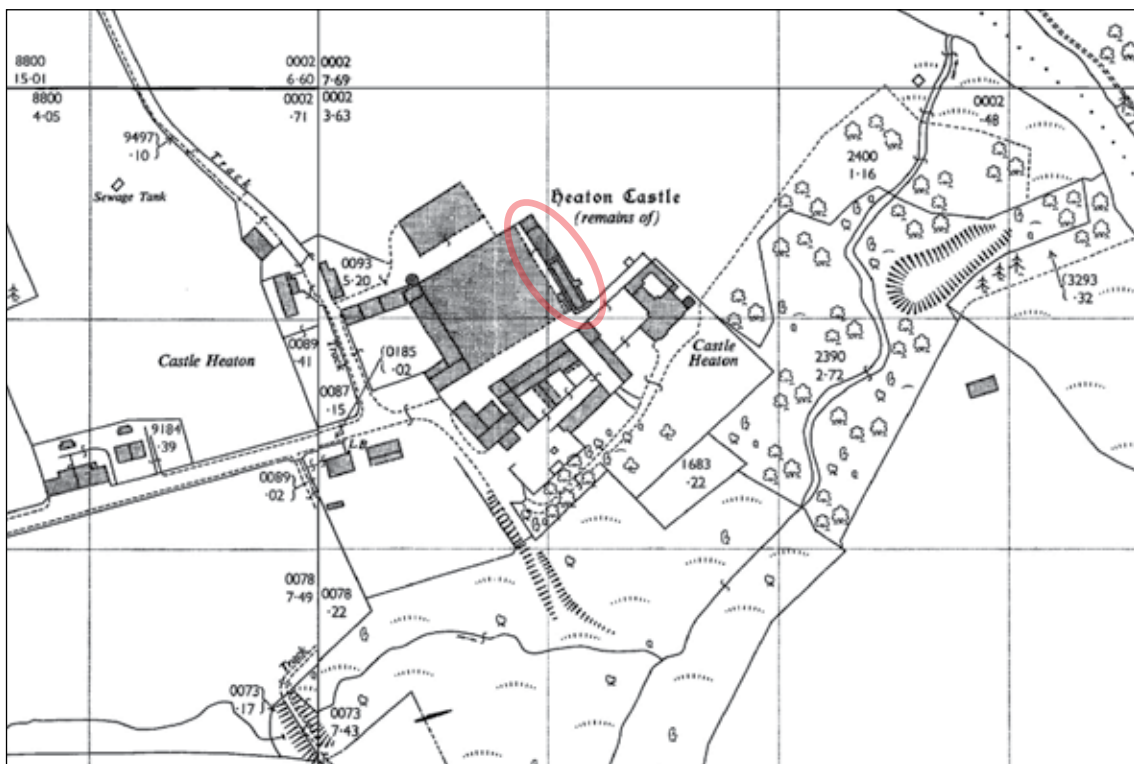
Figure 9: Extract from the 1964 25-inch OS map (© Crown copyright and database right 2014. All rights reserved).

Cartographic evidence indicates that between 1957 and 1964⁷³ a complex of 19th-century cattle yards and sheds to the west of the vaulted building was roofed over (Fig 9). The vaulted building was inspected by OS field investigators in 1955 and 1967 and their findings were recorded on three National Archaeological Record antiquity cards (see Appendix I).⁷⁴ A simple block plan of the building was drawn during the 1955 visit which shows the building with the same footprint as at present and the annotations indicate a rampart, an upper-level doorway to the rampart and a lower-level arrow slit. Two wells were also noted. In 1967 the building was described as a large vaulted stable measuring 70 feet by 17 feet (21.33m x 5.18m) and the lack of associated castle earthworks was also noted. The site of one well, situated approximately 11m to the north-east of the vaulted building (at NT 9012 4192), was also identified in 1967, with guidance from the tenant, Mr Clark. This was presumably the same deep, disused well

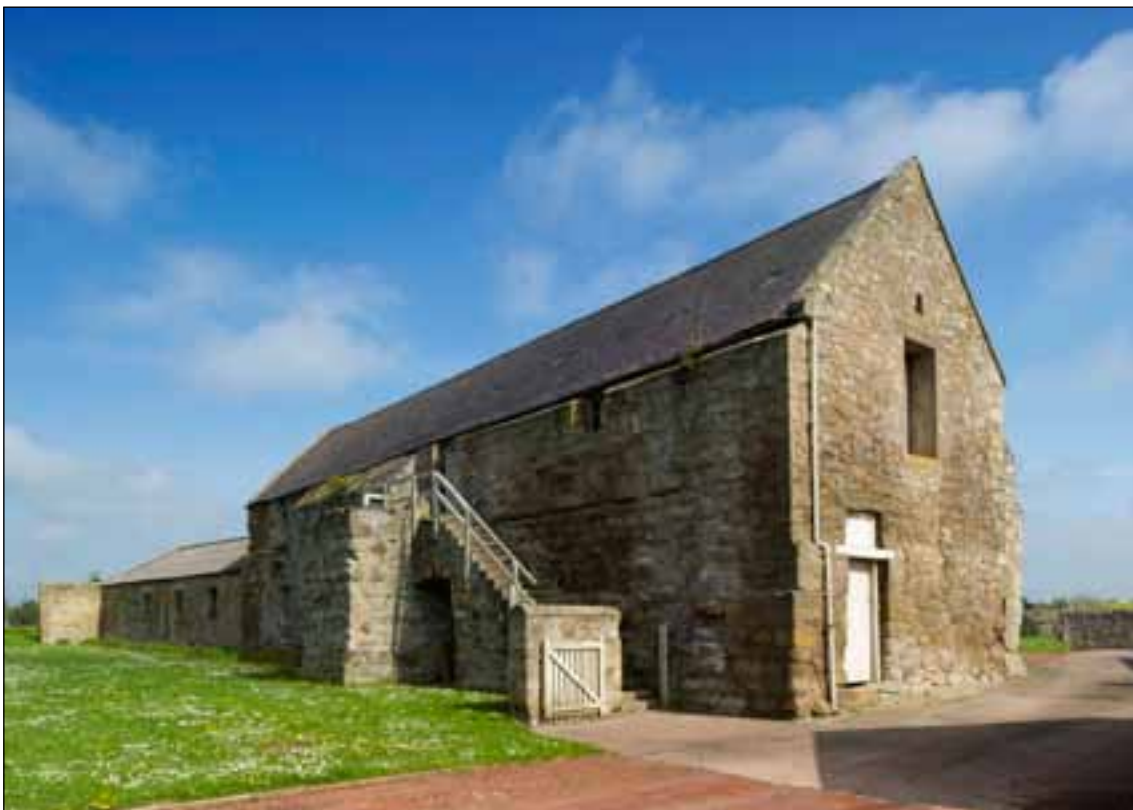
Figure 10: The vaulted building at Castle Heaton from the south (DPI56882 © English Heritage, photograph: Alun Bull).

The two-storeyed, vaulted building at Castle Heaton is located on the eastern side of the present farmyard and is aligned north-west to south-east (Fig 10). The building is about 26.9m by 7.16m externally and 25m by 5.2m internally with a tunnel-vaulted ground-floor chamber and single open room above. It displays many of the characteristics of a bastle or strong house, namely a robust, stone-built dwelling with limited points of access raised above a byre. Although it is not dissimilar to the examples at Akeld (described in 1541 as a 'bastle or fortlet') and Pressen, it is not a typical bastle, due to its great length. The vaulted building at Castle Heaton, for the most part, probably dates from the 16th century, but it does incorporate earlier fabric thought to be the only upstanding remains of the 14th-century Heaton Castle, and it is possible that the vault itself originally formed part of one of the walls or ranges of the quadrangular castle. Alterations were made to the structure in the late 18th and/or 19th century including the addition of an extension to the north-west elevation, a new external stair and the reconstruction, and re-roofing, of the first floor.

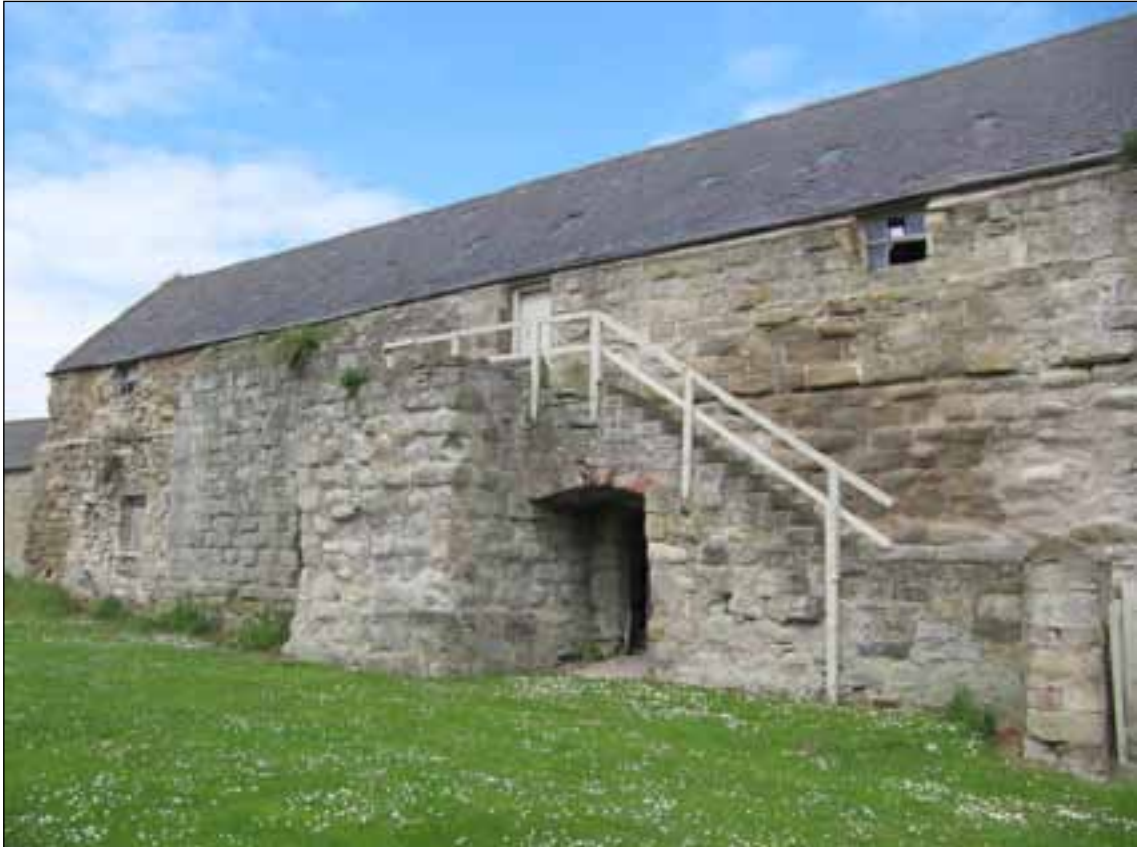
Figure 11: The south-west elevation of the vaulted building (© English Heritage, photograph: Clare Howard).

Externally, the early section of the south-west wall is constructed of large, roughly-squared and coursed stone blocks, some of which have been substantially weathered, indicative of their age (Fig 11). The central section (6.7m long) of this south-west elevation projects forward with, at its north end, a splayed return to the main wall face. The turret in turn projects 2.2m from the southern end of the central projection and is 2.8m wide with a 3.1m return to the main wall face to the south. The turret has been reduced in height and has probably been filled with rubble which now also forms a ragged cap. However, the turret once evidently contained a chamber, or perhaps a vice, as there is a small but fairly well-formed slit or loop, with lintel and sill, to the right side of the turret's north-west flank (Fig 12). There is also what might be a ragged joint in the south-west elevation which might indicate partial rebuilding at some point, or the existence of a former projection. Similar turrets survive at Chillingham Castle where the

A substantial fragment of early fabric can be detected in the south-western elevation of the vaulted building which is thicker, at 1.06m, than the other three sides of the vaulted chamber (which are only about 0.88 to 0.95m thick). In form and plan this earlier material may belong to a portion of the south-west curtain wall of the quadrangular castle, including the stump of a square interval turret projecting south-west, and possibly a fragment of stone rampart and a buttress. At first-floor level the south-west elevation shares the same form of construction, but is narrower at roughly 0.65m although this may be accounted for by the cutting back of the wall face to accommodate 19th-century additions since demolished (see 18th- and 19th-century alterations section below).

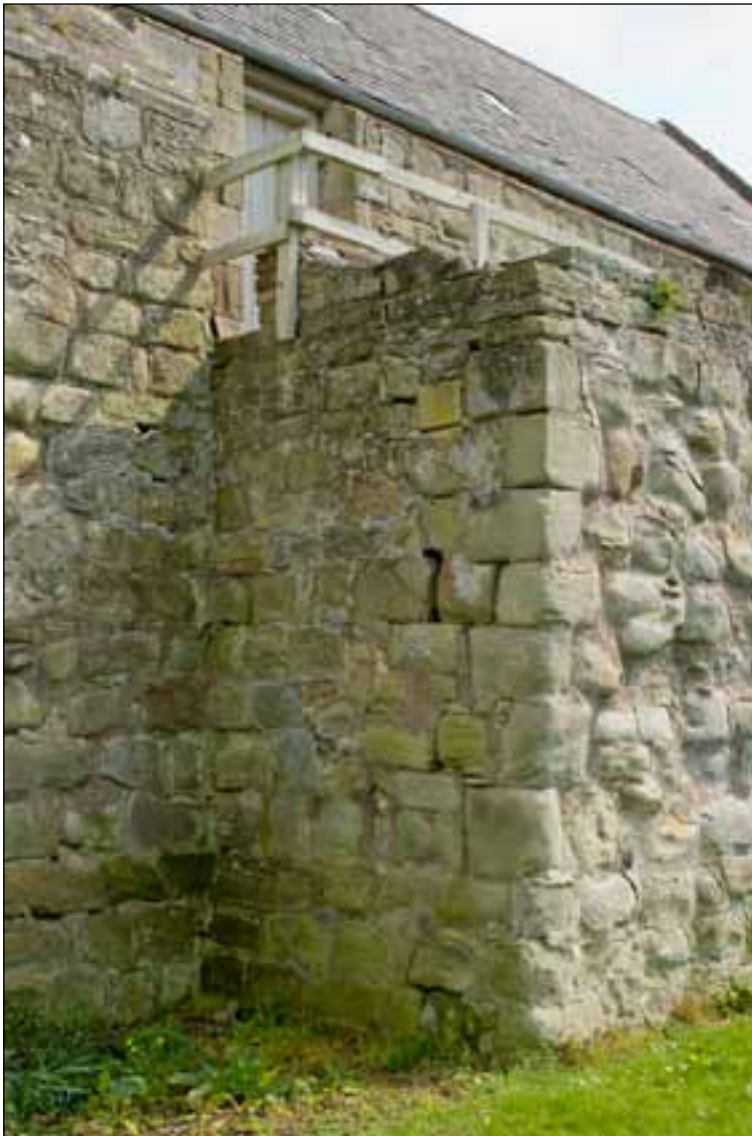
Figure 12: Turret on the south-west elevation of the vaulted building (DPI56908 © English Heritage, photograph: Alun Bull).

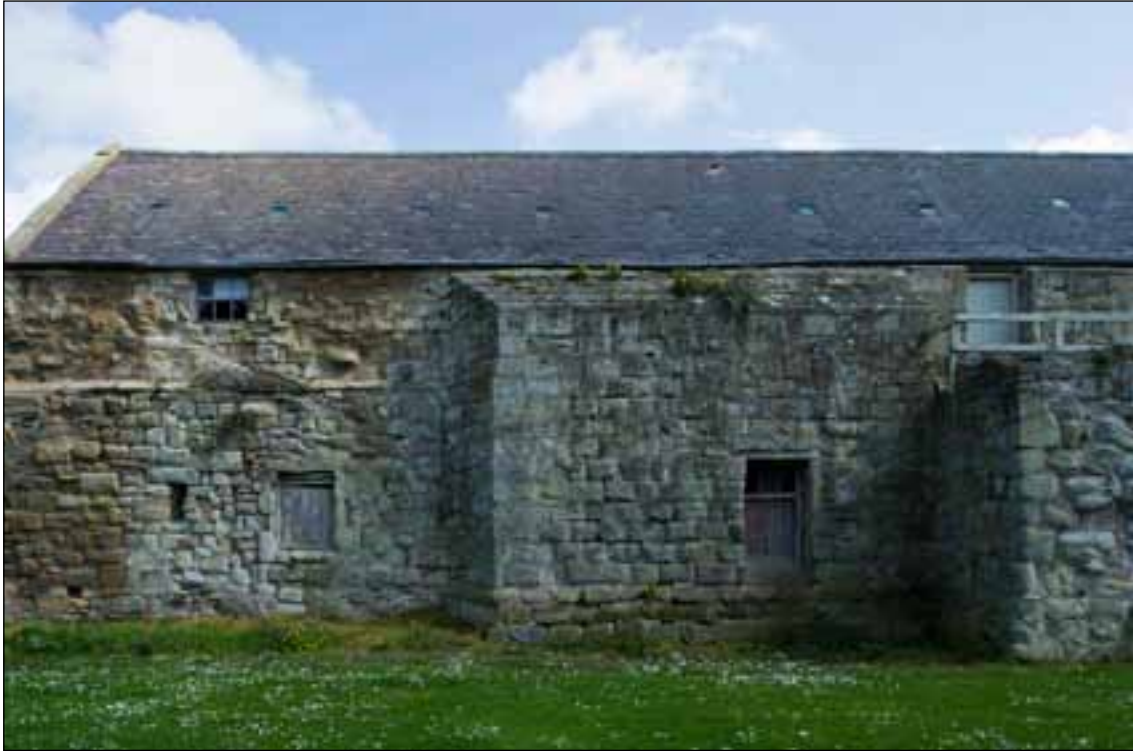
The shallower but longer projection to the north of the turret also has a splayed opening within its splayed return, now blocked. The upper part of the projection, which terminates at a 45-degree slope meeting the eaves of the vaulted building, and possibly its splayed return, appear to have been rebuilt as the stonework is of a darker colour than lower down and is less weathered (Fig 13). This rebuild might have been to accommodate a flue associated with a fireplace on the first floor of the vaulted building

Figure 13: The projecting wall on the south-west elevation of the vaulted building (DPI56896 © English Heritage, photograph: Alun Bull).

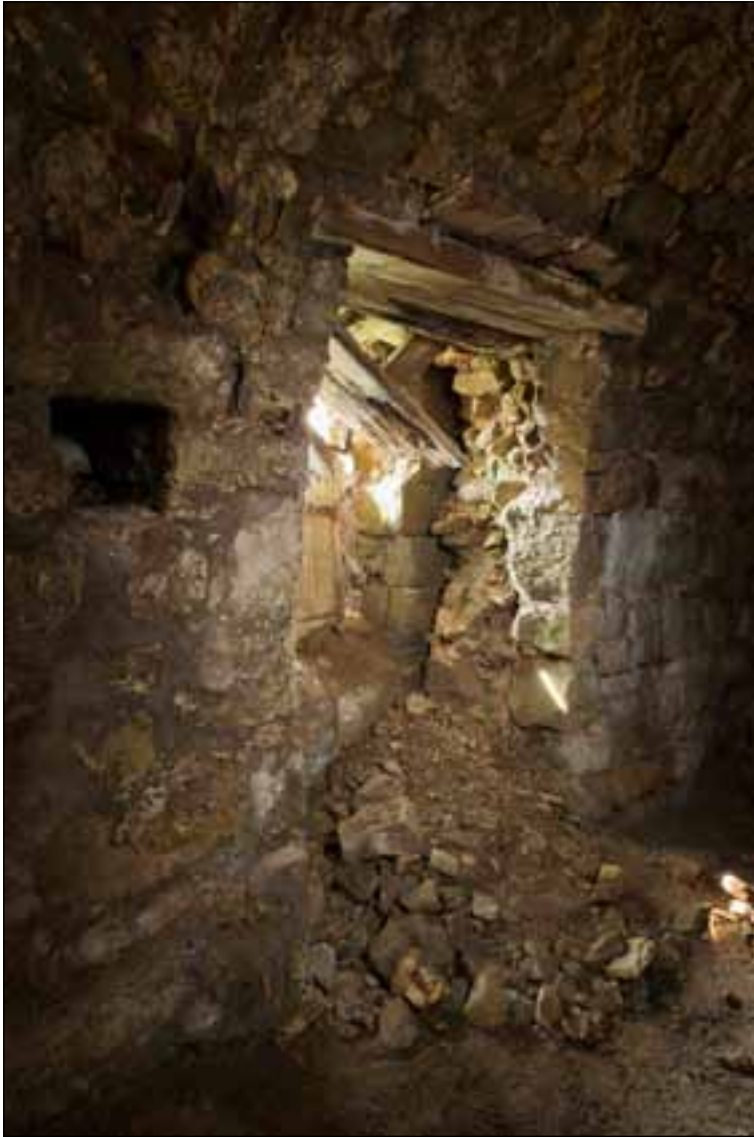
Internally there is evidence to suggest that the construction of the vault post-dates the building of the south-west wall. The collapse of the soffit and west jamb of an inserted opening in the centre of the south-west elevation has revealed what appears to be a north-east face of well-dressed stone extending behind the rubble core that fills the void between itself and the spring of the vault (Fig 14). The quality of the wall-face finish

Figure 14: The dressed-stone wall face revealed behind the collapsed soffit and jamb of the opening in the centre of the south-west wall (DPI56931 © English Heritage, photograph: Alun Bull).

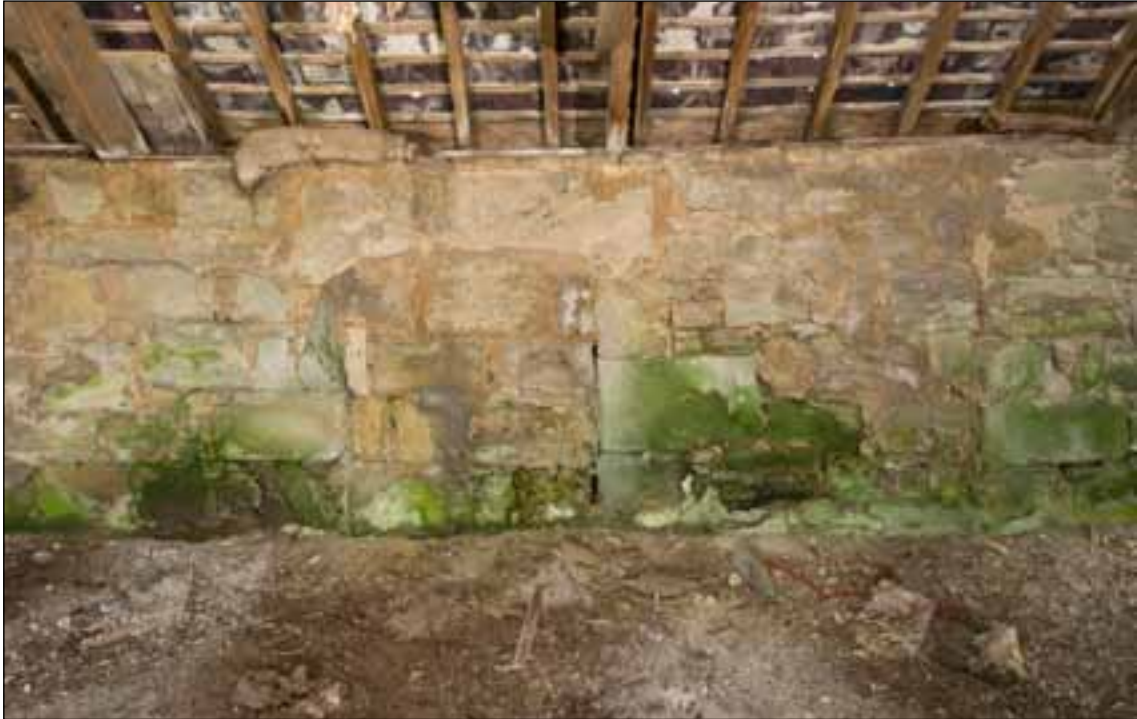
Much of the first floor of the vaulted building was rebuilt in the late 18th and 19th centuries but, as discussed above, the south-west wall at this level appears to be part of the earlier castle phase. Internally this wall contains a number of straight joints. One of these is located 1m to the right of the present external doorway and aligns with the southern end of the central projecting section of wall, to which it probably relates, and the north-west side of the turret (Fig 15). A further straight joint, 7m to the right of the doorway, has a well-formed right-hand edge of quoins, suggesting a former wall end or window or door jamb against which infill walling of irregularly-coursed smaller stones, between the two straight joints, has been butted. Within this infill is a well-formed but blocked opening, 1.1m across, with a low head and large dressed jamb stones which

Figure 15: The south-west wall at first-floor level showing internal straight joints and blocking (DPI56959 © English Heritage, photograph: Alun Bull).

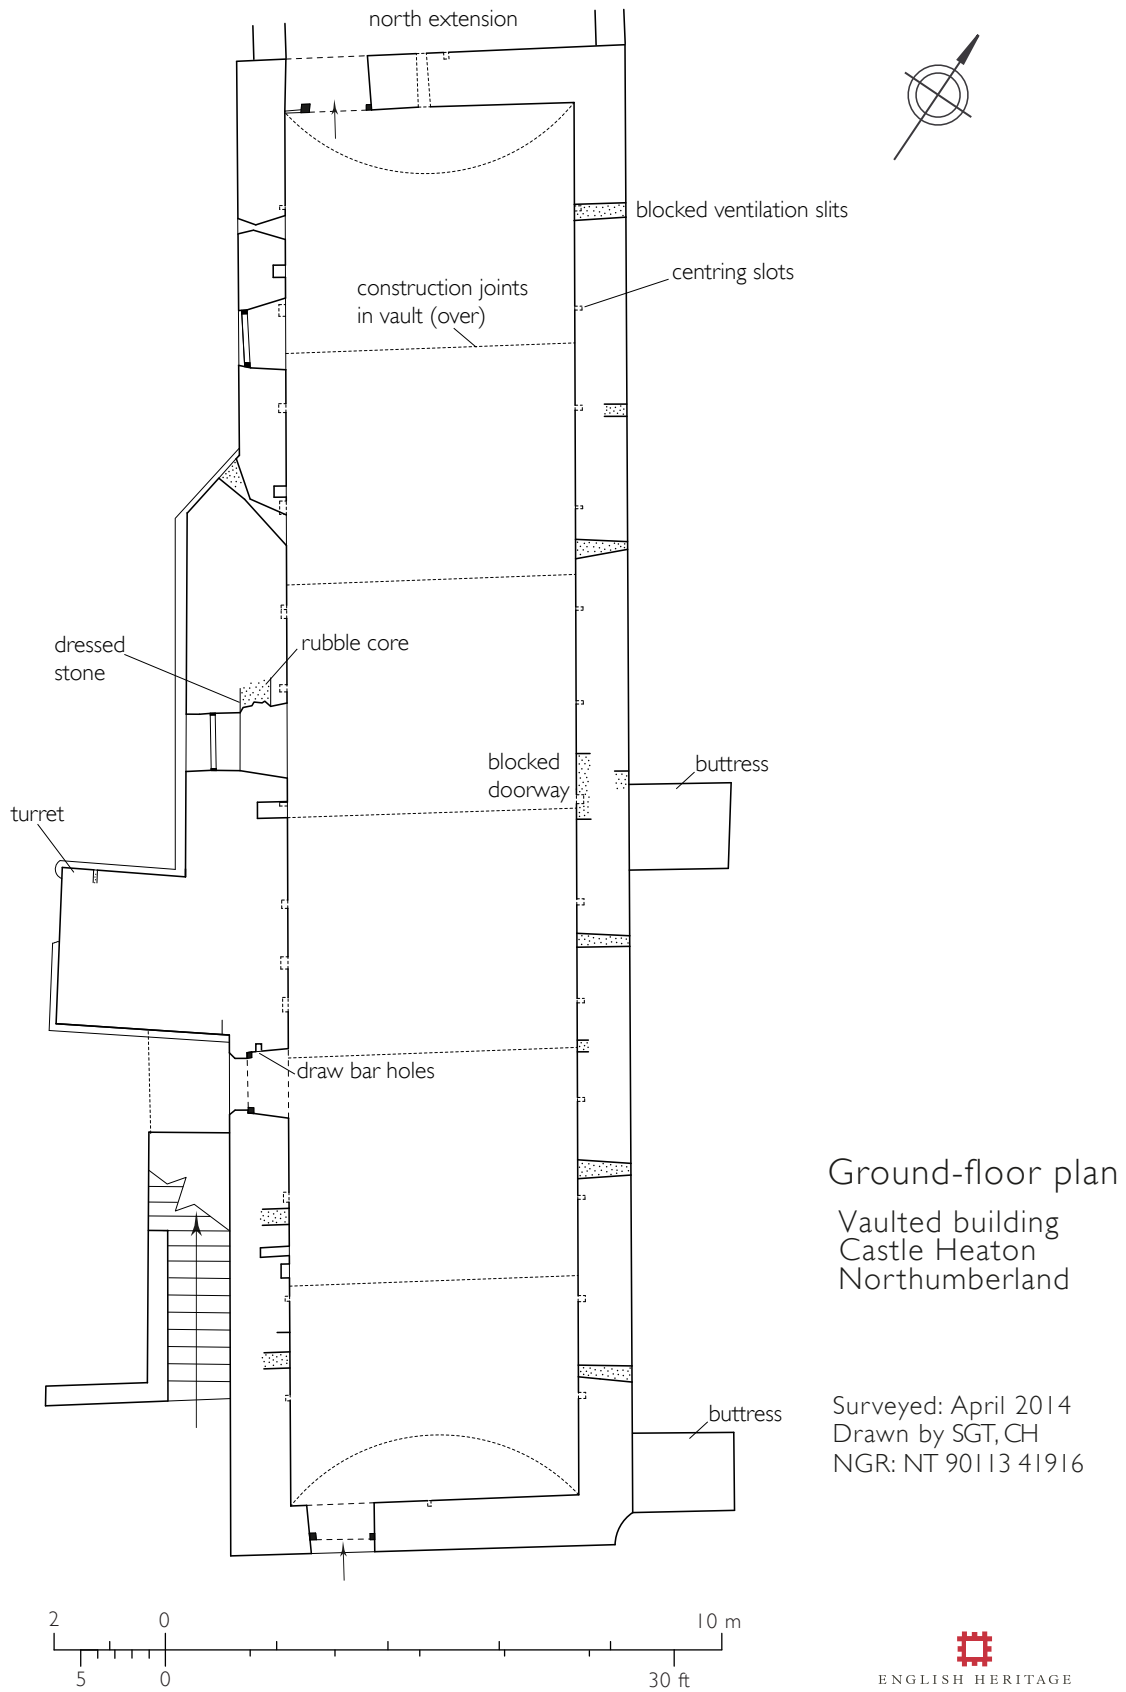
Figure 16: Ground-floor plan of the vaulted building, © English Heritage.

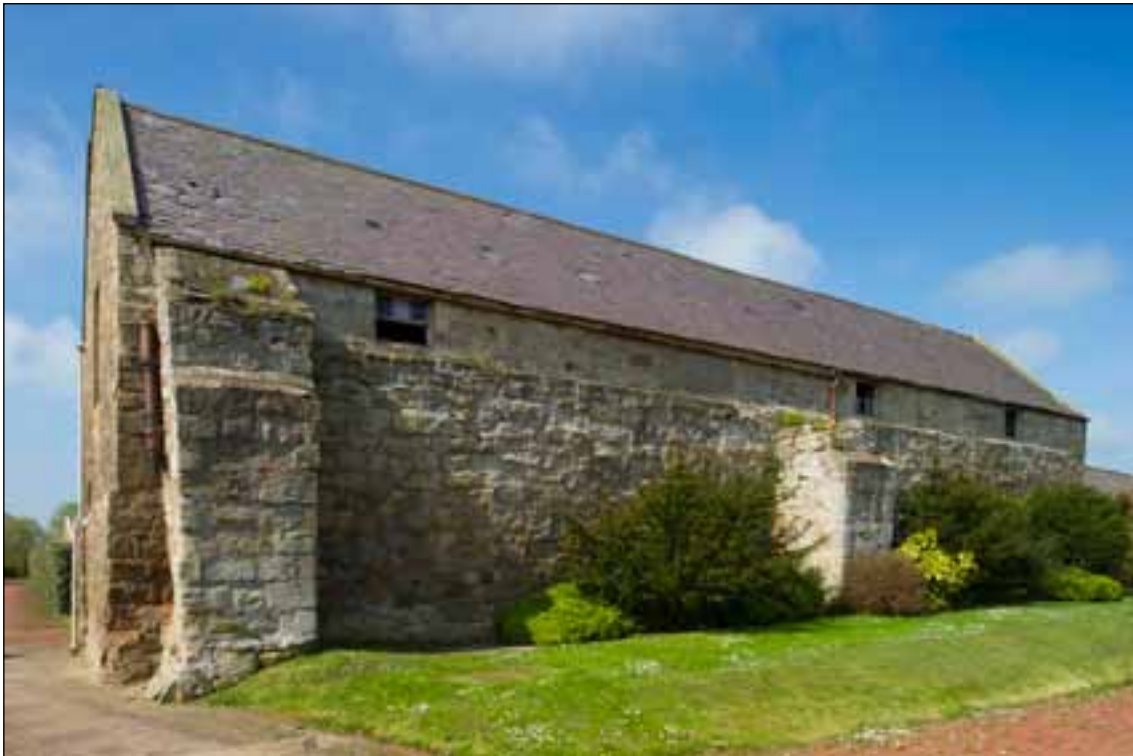
Externally, the lower parts of the north-east elevation and most of the north-west elevation of the vaulted building at Castle Heaton appear contemporary with the vault and are of roughly-coursed, squared stone. The south-east elevation contains more rough rubble and stones of irregular sizes, particularly to its upper part, which may suggest a different phase of construction to the other walls, perhaps due to truncation,

Figure 17: The north-east wall of the vaulted building (DPI56884 © English Heritage, photograph: Alun Bull).

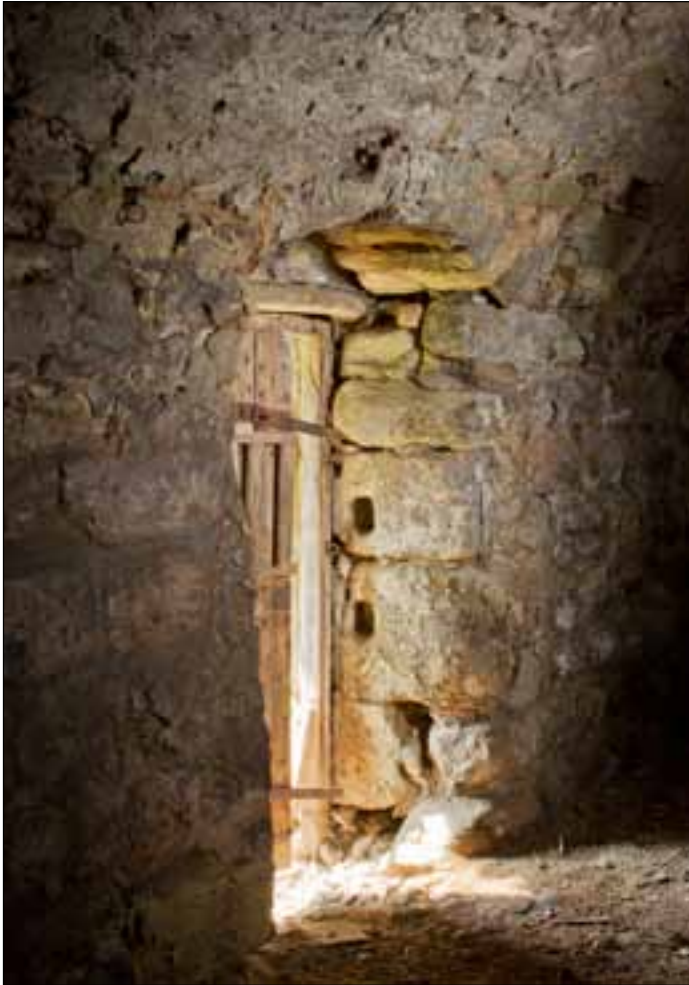
The original entrance to the ground floor was a doorway in the south-west wall which has a surround of large chamfered ashlar blocks and an ashlar lintel (supplemented by a stone relieving arch visible internally), the latter now partially obscured by a later flight of steps. Stylistically, this entrance is typical of the 16th or early 17th century. The left jamb contains a pair of sockets, one above the other, for the ends of draw bars (Fig 18). The corresponding tunnels are lacking in the south jamb, possibly because they have been filled or because this jamb has been severely damaged, eroded and perhaps

Figure 18: The doorway in the south-west wall including draw-bar holes (DPI56936 © English Heritage, photograph: Alun Bull).

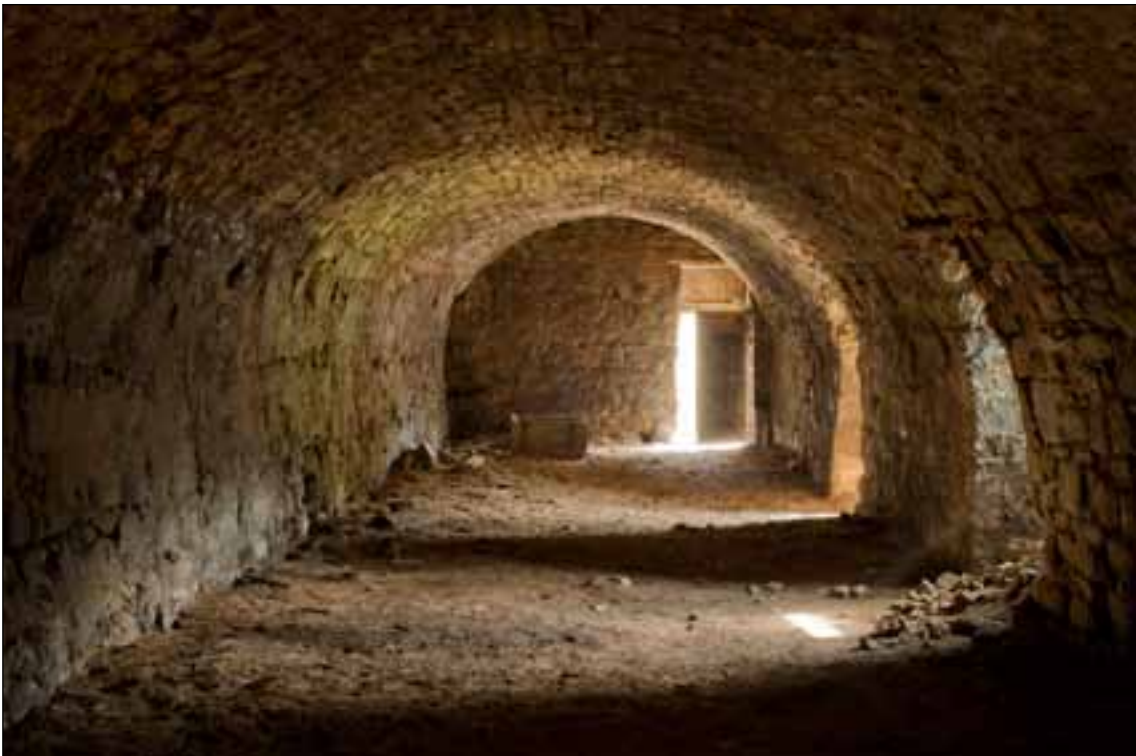
Figure 19: The tunnel-vaulted ground floor (DPI56937 © English Heritage, photograph: Alun Bull).

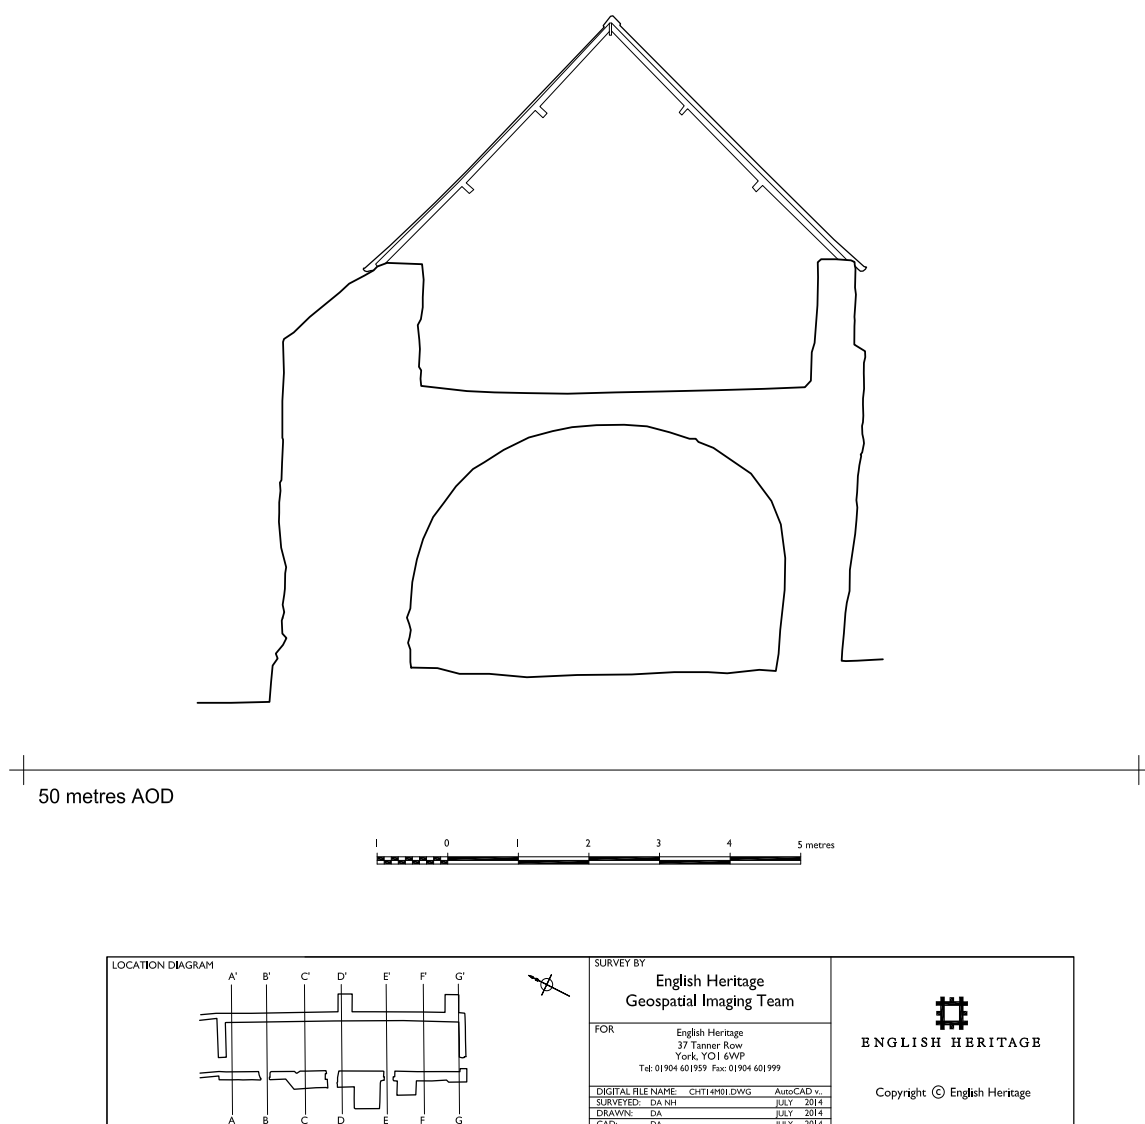
CROSS SECTION C-C'

Figure 20: Section through the vaulted building, © English Heritage

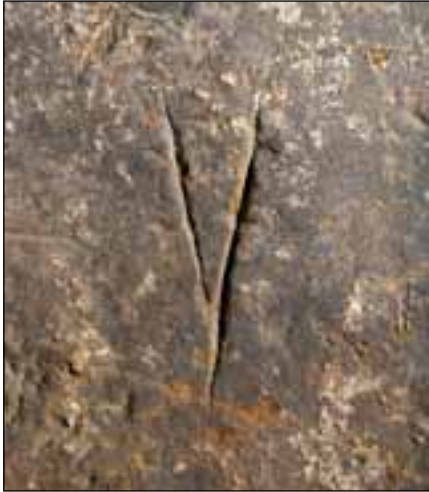
Figure 21: The Y-shaped, possible mason's mark above a recess in the interior south-west wall (DPI56889 © English Heritage, photograph: Alun Bull).

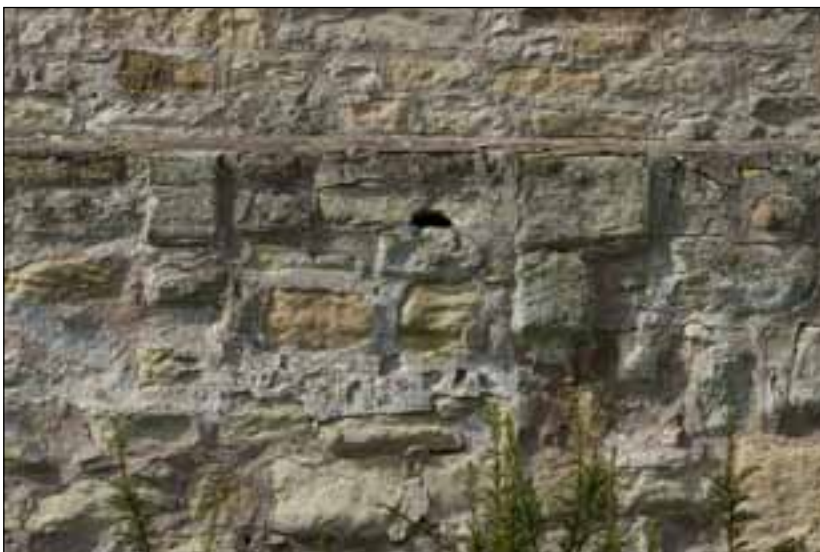
reconstructed. There is also evidence, in the form of joints, of a blocked doorway in the centre of the north-east elevation but without a surviving surround this is difficult to date. The interior of the ground floor is a single long undivided chamber with a tunnel vault of stone; the asymmetrical nature of which (canted slightly to the north-east) might be the result of subsidence (Fig 19 and Fig 20). A sequence of evenly-spaced joints indicate that the vault was advanced in six construction phases and there are rows of corresponding rectangular putlog holes in the north-east and south-west walls for the timber centring used during its construction. There are also sockets in the north-east wall which do not have correspondents in the south-west wall and were probably for stall partitions. Three socketed pad stones are visible in the floor and probably served the same purpose. Much of the stone-cobbled floor is, however, covered with an overburden of soil, straw and other material of uncertain date which may conceal

Figure 22: The possible blocked doorway in the north-east wall (DPI56873 © English Heritage, photograph: Alun Bull).

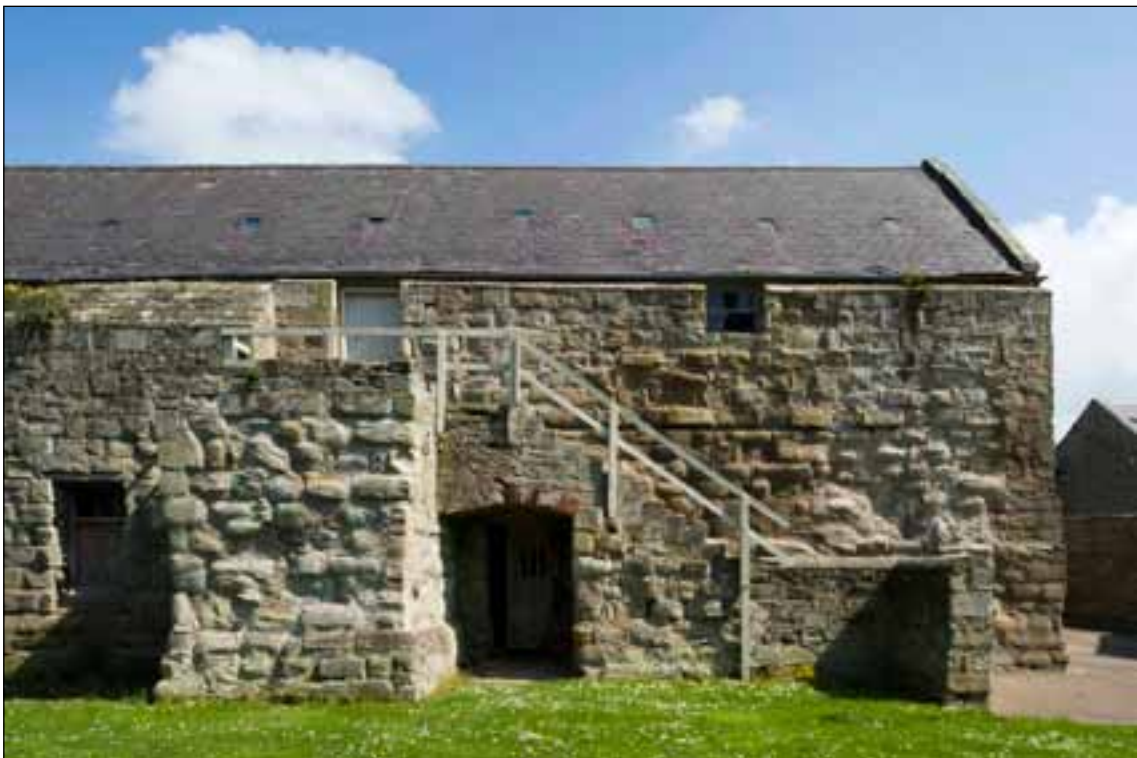
Access to the first floor may, if in the bastle tradition, have originally been provided by a removable ladder. It is now via stone steps which ascend to the present top of the medieval turret onto which a doorway opens. This entrance is probably an 18th-century or early 19th-century adaption, since the brickwork arch which carries the flight above the ground-floor entrance appears to be of that date and the wall to the left of the doorway has been rebuilt while the wall to its right is not a well-formed jamb. However, just below the first-floor set back of the north-east wall, and towards its southern end, is a pair of truncated straight joints which might be the lower part of a blocked opening, possibly a further doorway (Fig 22). This raises the possibility that first-floor access might have originally been from the north-east side, away from the ground-floor cattle entrance, although this is not a common arrangement for bastles.

Figure 23: The steps against the south-west wall (DPI56890 © English Heritage, photograph: Alun Bull).

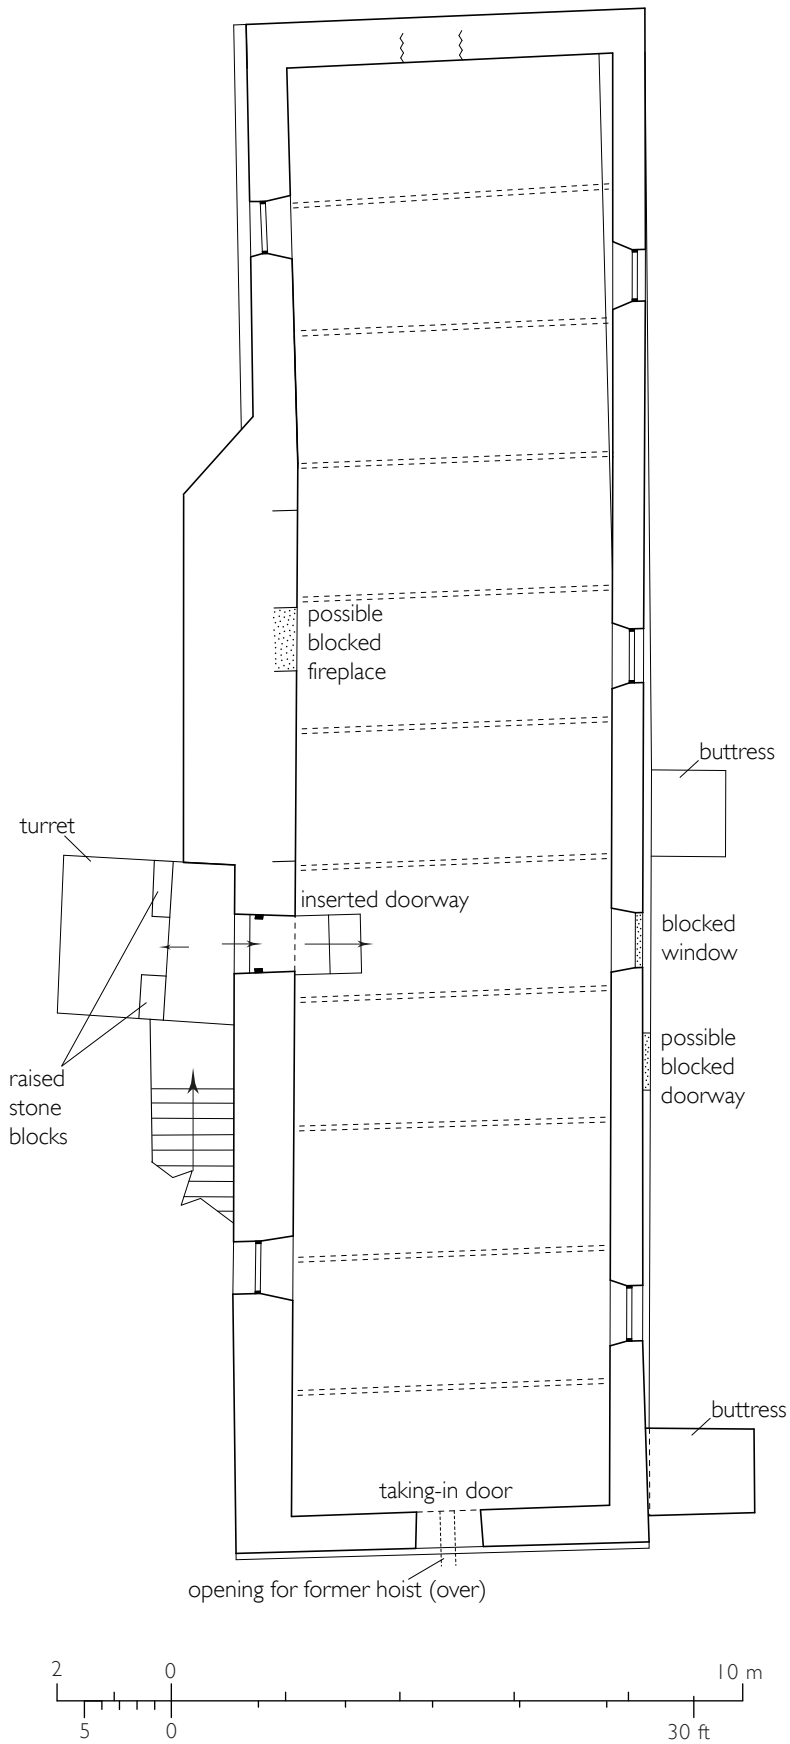
First-floor plan
 Vaulted building
 Castle Heaton
 Northumberland

Figure 24: First-floor plan of the vaulted building, © English Heritage.

The remainder of the upper storey seems to have undergone a certain amount of reconstruction at this time (Fig 24). The upper part of the north-east wall is a thinner rebuild and is more truly straight than the earlier foundation which projects beyond it for most of its external length and for roughly a third of its length internally. It is possible that the buttresses supporting the north-east elevation were modified at this time, particularly the upper courses, in order to accommodate the rebuilt upper level. The central projection on the south-west elevation has also been subject to some reconstruction or re-facing, particularly in the centre of the elevation, and this may have taken place at around the same time as other parts of reconstruction. The first floor is lit by two six-pane (three over three) windows in the south-west wall and by three similar windows in the north-east wall; the upper three panes of each window are set within bottom-hung top-opening sashes (Fig 25). The windows are likely to date from the late 19th or early 20th centuries.
