RESEARCH REPORT SERIES no. 34-2014

CASTLE HEATON, CORNHILL-ON-TWEED, NORTHUMBERLAND AN INVESTIGATION AND SURVEY OF THE VAULTED BUILDING AND ADJACENT EARTHWORKS

Clare Howard and Rebecca Pullen

NGR: NT 90113 41916

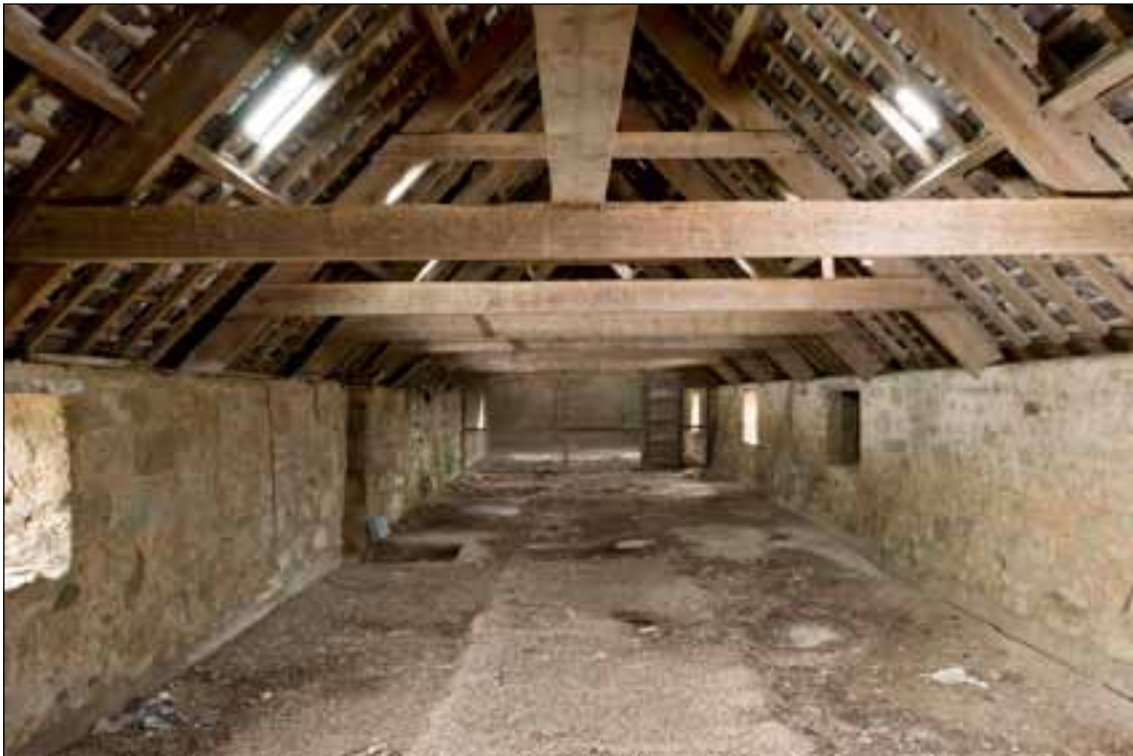
Figure 25: The first floor of the vaulted building (DPI56951 © English Heritage, photograph: Alun Bull).

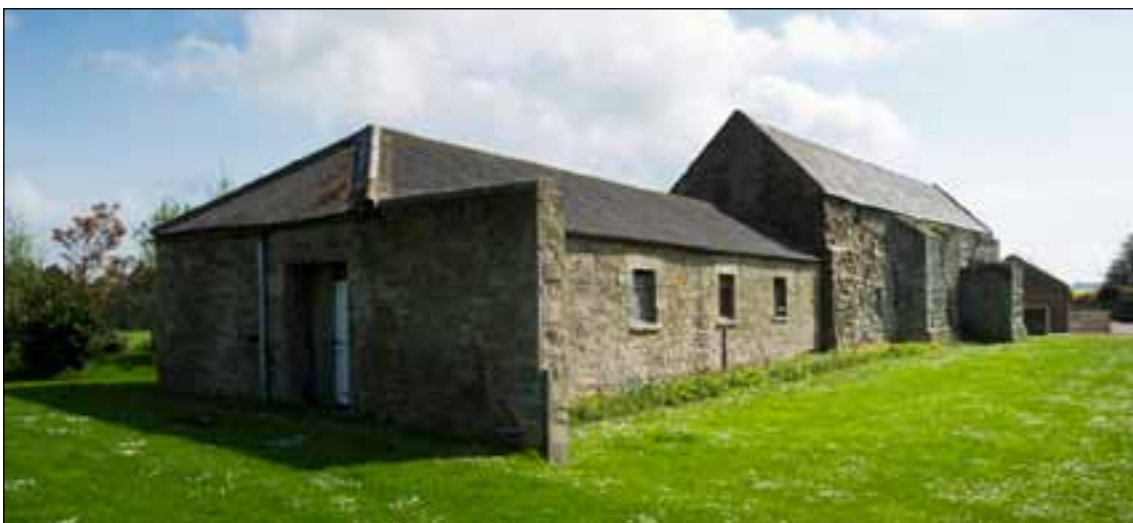
The present shed is of squared stone which is roughly coursed and it is lit by three windows with splayed openings, stone lintels and projecting stone sills, in the south-west

elevation (Fig 27). The window frames are timber with four panes above and boarding below and may be replacements. The two northernmost windows may be contemporary with the extension and would have opened onto a small yard as indicated on the 1922 OS map. The southernmost window has a blocking beneath the sill, particularly visible inside, which suggests it was formerly a doorway, and there is a further doorway, also blocked with stone, with a rectangular stone lintel, at the south end of the south-west elevation. The 1922 map suggests that the former door (now a window) may have led into the building projecting to the south-west of this elevation while the second blocked doorway would have provided access directly to the exterior between two buildings projecting from the south-west elevation (see Fig 8).

Figure 27: The north extension (DPI56901 © English Heritage, photograph: Alun Bull).

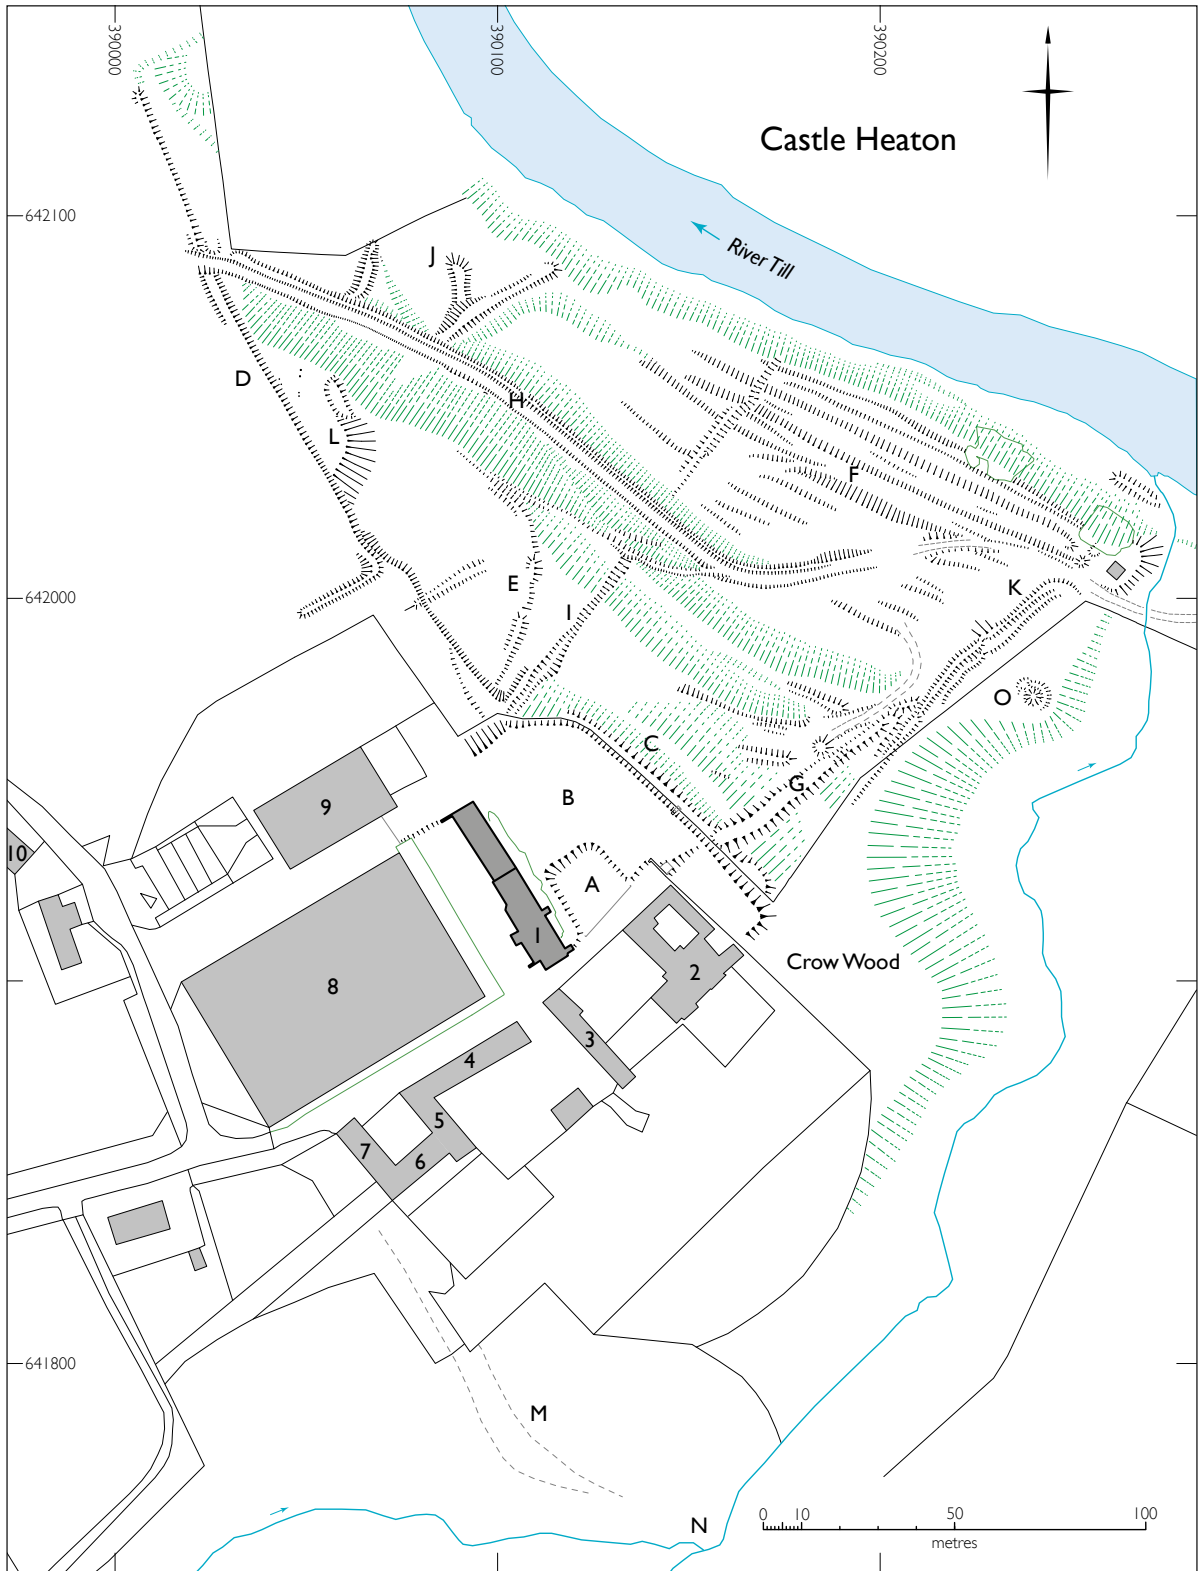
Figure 28: Castle Heaton earthwork survey drawing (© English Heritage, drawn by Philip Sinton).

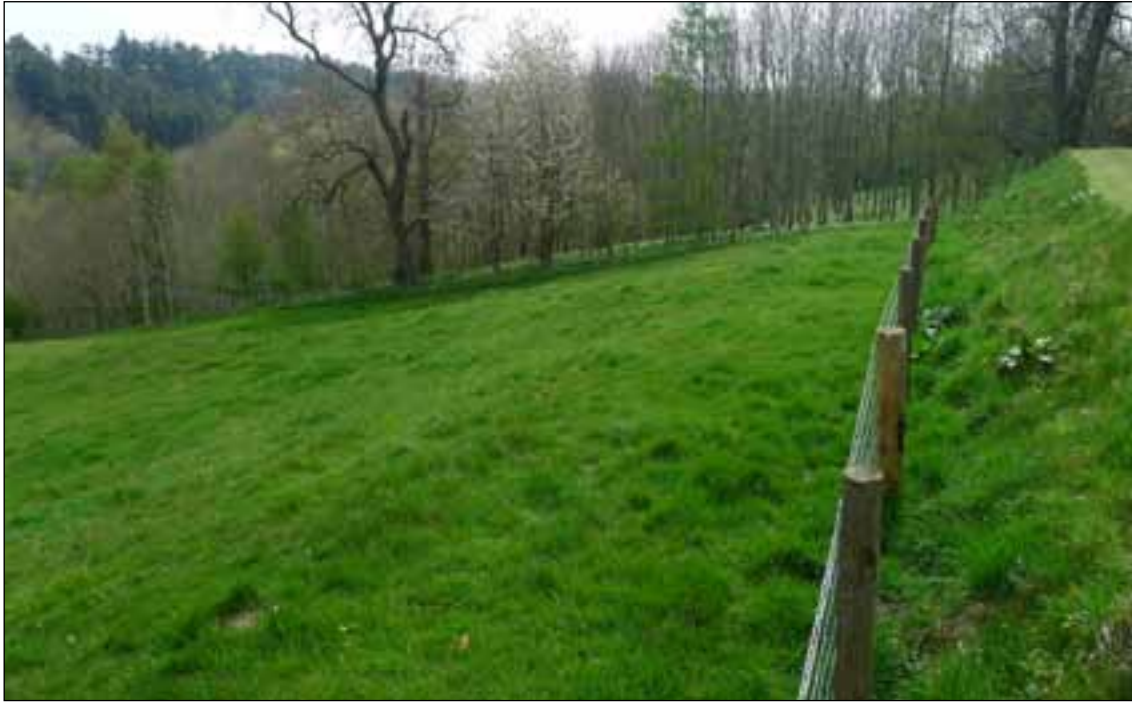
Figure 29: The earlier terrace edge (centre foreground) overlain by the modern lawn (right), looking south-east towards Crow Wood (© English Heritage, photograph: Rebecca Pullen).

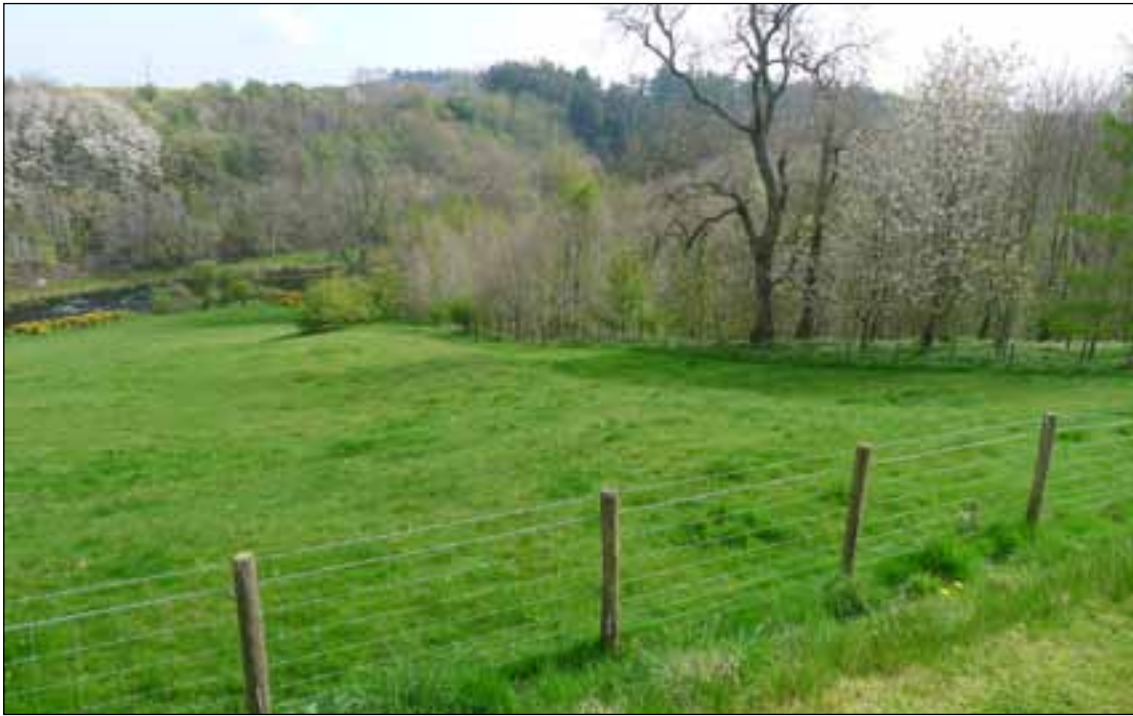
Following a similar alignment to the modern fence marking the north-west edge of Crow Wood, but about 10m beyond the extent of trees, is a broad earthwork bank (G). It begins at the top edge of the valley side and from there it rides over the presumed original plateau edge and continues about halfway down the valley slope (Fig 30), ending in a somewhat jumbled junction with the remains of an out-grown hedge bank. The broad bank has the appearance of a headland bank or a major field boundary. However, if the bank once marked the south-east extent of the strip fields (F), it might be expected to be traceable continuing downhill beneath later features; it is not. The first edition 6-inch OS map surveyed in 1860¹¹² clearly shows a straight track continuing from the line of the driveway through the Castle Heaton complex and running down the slope in this position before turning east to cross the stream immediately north of where it currently exits from Crow Wood (see Fig 6). As such, the broad bank may reflect a constructed route from the plateau to the river terrace (which is not marked on earlier or subsequent maps); perhaps the predecessor to the terraced track (H) that now snakes along the middle contours of the valley side to the north.

Figure 30: The broad boundary bank or constructed route extending down the valley side (bottom right to top left), looking east (© English Heritage, photograph: Rebecca Pullen).

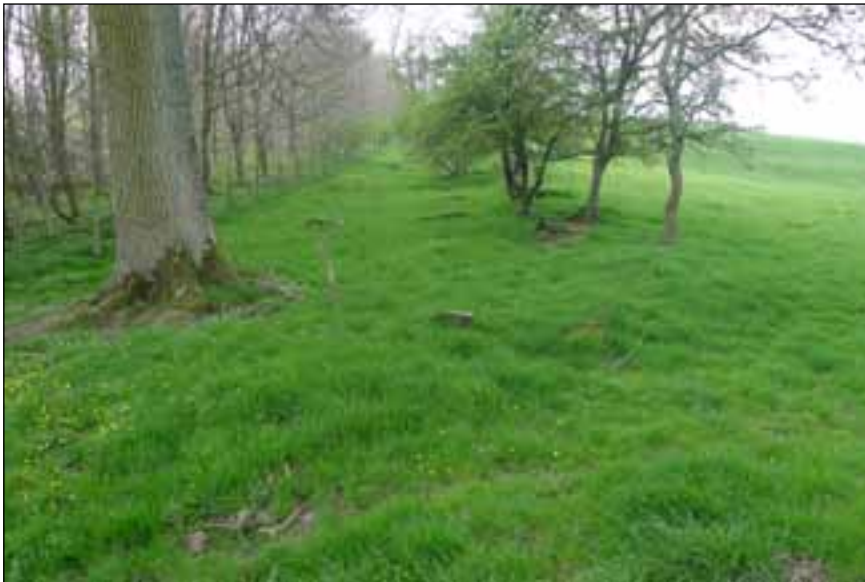
Figure 31: The out-grown former hedge bank adjacent to Crow Wood, looking south-west up the valley side (© English Heritage, photograph: Rebecca Pullen).

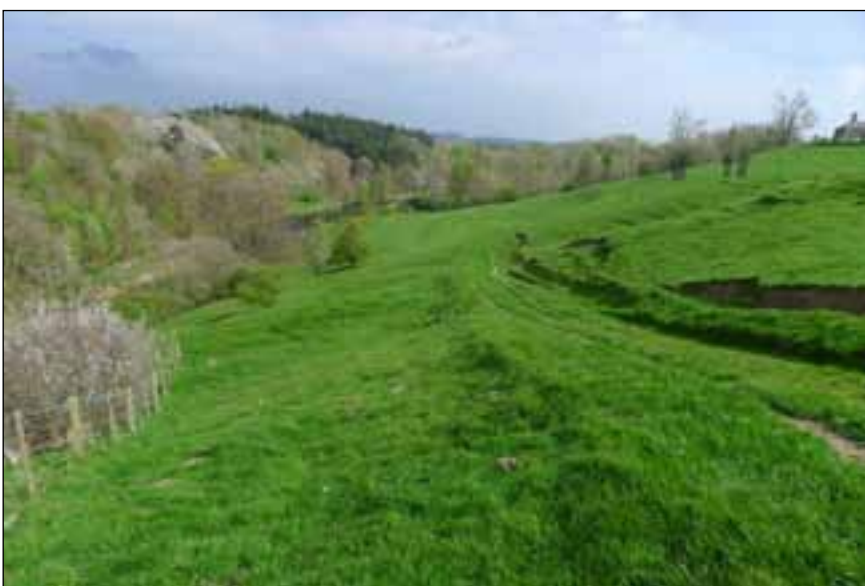
Figure 32: The terraced track progressing across and down the valley side, looking south-east (© English Heritage, photograph: Rebecca Pullen).

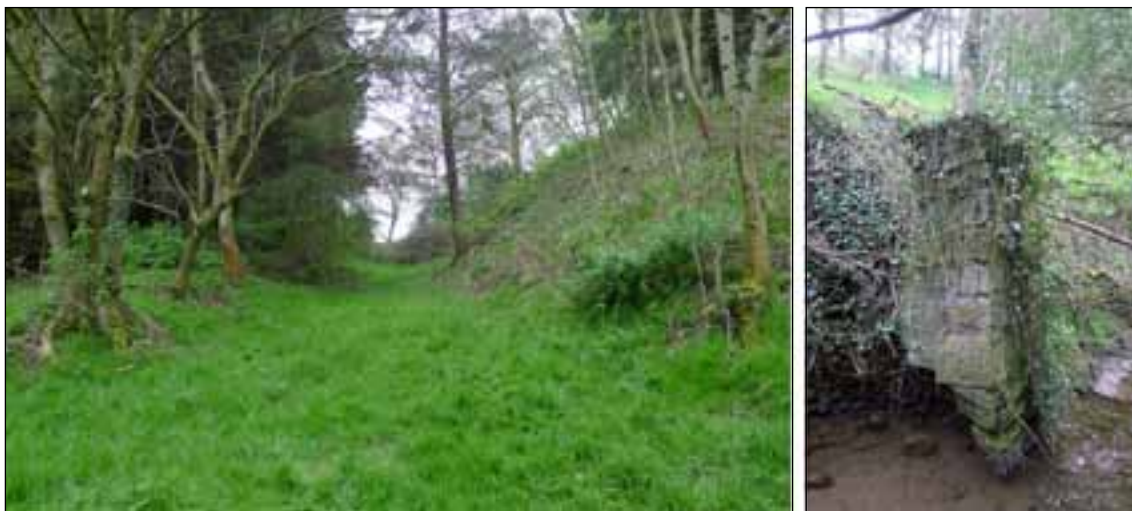
A well-worn hollow way (M) leads south-east down the valley side from the south-west corner of the farm complex to a confluence of minor streams in the valley bottom (Fig 33). This route is shown as a broad path on the first edition OS map surveyed in 1860 (see Fig 6),¹²⁰ and depicted with hachures on the 25-inch revision of 1897 (see Fig 7)¹²¹ and on subsequent editions of the same scale. The hollow broadens and turns east where it opens onto the valley floor. Close to here, a solitary pedestal of coursed, tooled masonry (N) stands 2.3m high with its foot in the water at the north edge of the stream and its upper course level with the ground (Fig 34). On the opposite bank, a similar flat area of ground implies that the pedestal is the surviving pier of a simple footbridge. A modern timber footbridge is now located a short distance downstream.

Figure 33: (above left) The well-worn hollow way south of the farm complex, looking north-west up the slope (© English Heritage, photograph: Rebecca Pullen).

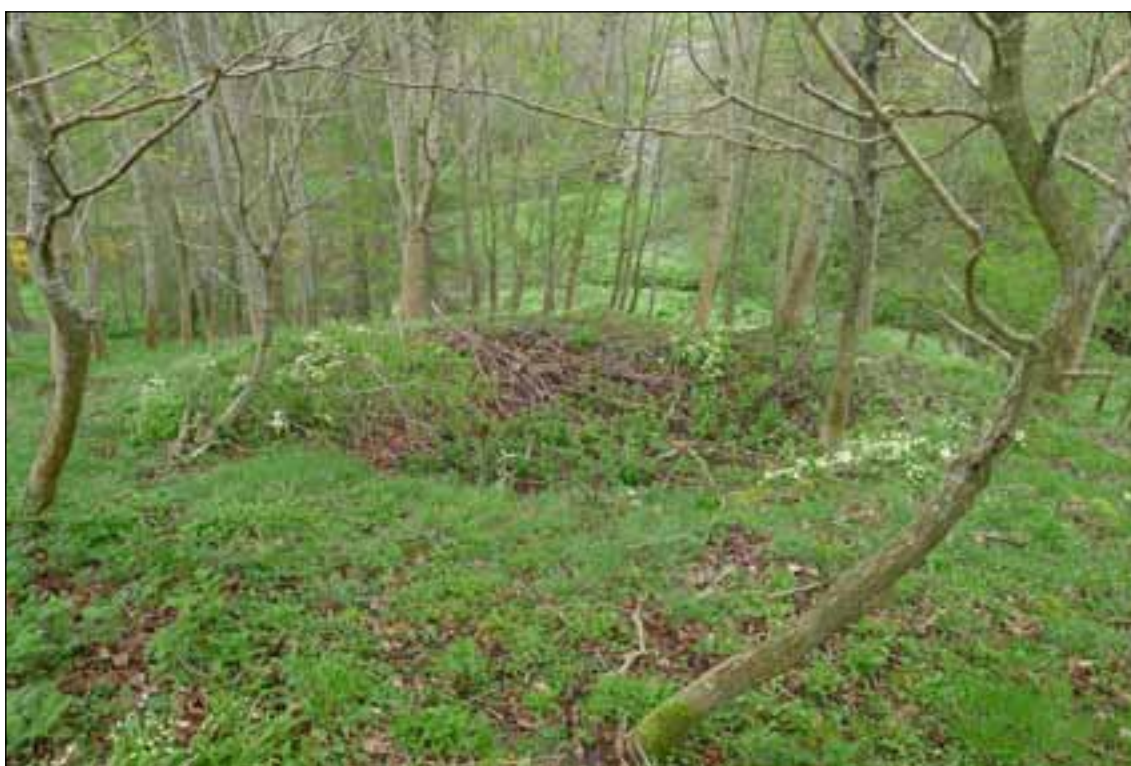
A low circular earthwork (O) sits atop a slight natural promontory on the north-west side of the stream overlooking the northern end of the valley. This marks the location and foundations of a former dovecote,¹²² labelled as 'Old Dove Cot' on the first edition OS map surveyed in 1860 (see Fig 6). There is no structure marked in this area on the carefully drawn tithe map of 1843¹²³ (see Fig 5), which taken with the term 'old' used on the OS map¹²⁴ would suggest that it was of no practical value in 1843 and probably long out of use even then. It is uncertain whether the dovecote relates to the castle or to the later farmstead. A medieval dovecote, representing status and manorial rights as well as practical considerations, might be expected among the appurtenances of Castle Heaton. On the other hand, by the 17th century dovecotes were fairly widespread and they remained a feature of many large Northumbrian farms into the late 18th or early 19th century.¹²⁵

Figure 35: The circular earthwork foundations of the former dovecote in Crow Wood, looking north-east (© English Heritage, photograph: Rebecca Pullen).

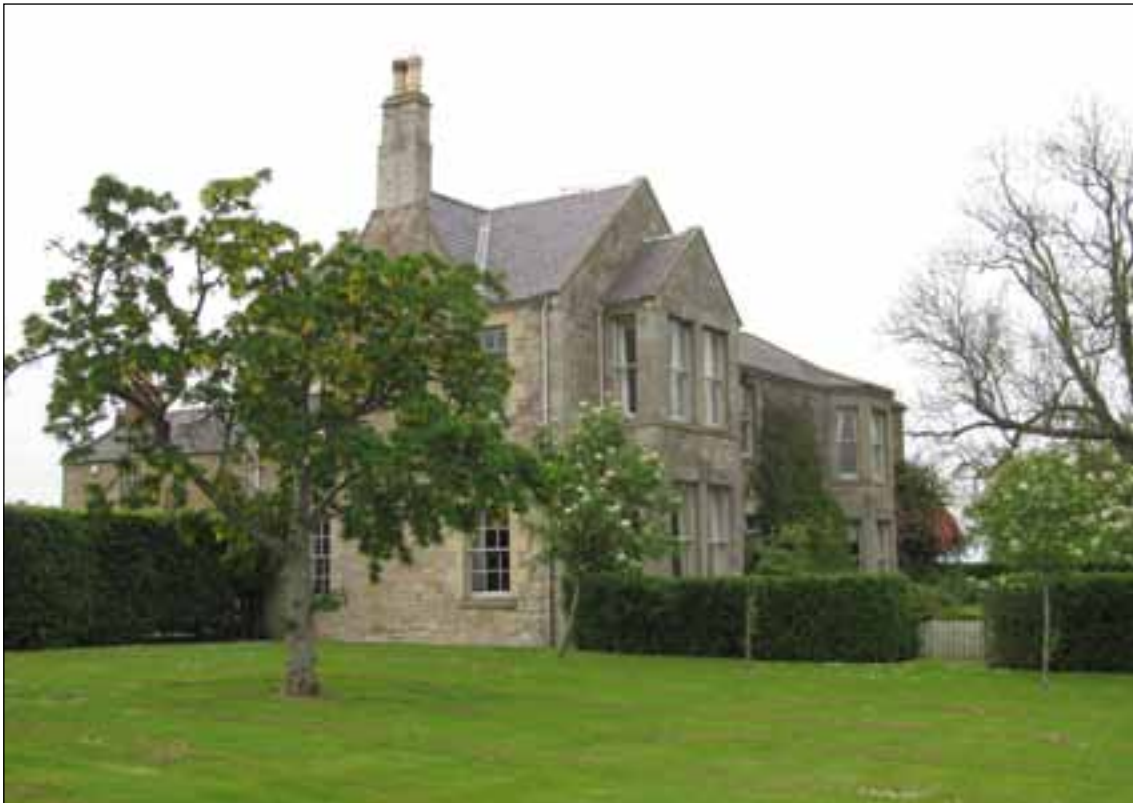
Figure 36: The farmhouse looking east (© English Heritage, photograph: Clare Howard).

Castle Heaton farmhouse (2) stands 25m to the south-east of the vaulted building. It is not shown on the tithe map of 1843 (see Fig 5) but, as stated above, it does appear on the first edition OS map, surveyed in 1860, with a smaller footprint (see Fig 6). The main house is two-storeys high, and was originally square in plan and is of roughly coursed stone rubble with a Welsh-slate roof; a gabled extension was added to the south-west side later in the second half of the 19th century (it is not shown on the OS map surveyed in 1860 but is shown on that revised in 1897). The house faces south-east and the front elevation, as it is now composed, has projecting end bays, one canted the other square

(Fig 36). The window openings have ashlar lintels, quoined reveals and contain sliding sashes while to the rear (north-west) various domestic and service blocks of one and two storeys form ranges around a roughly rectangular courtyard.

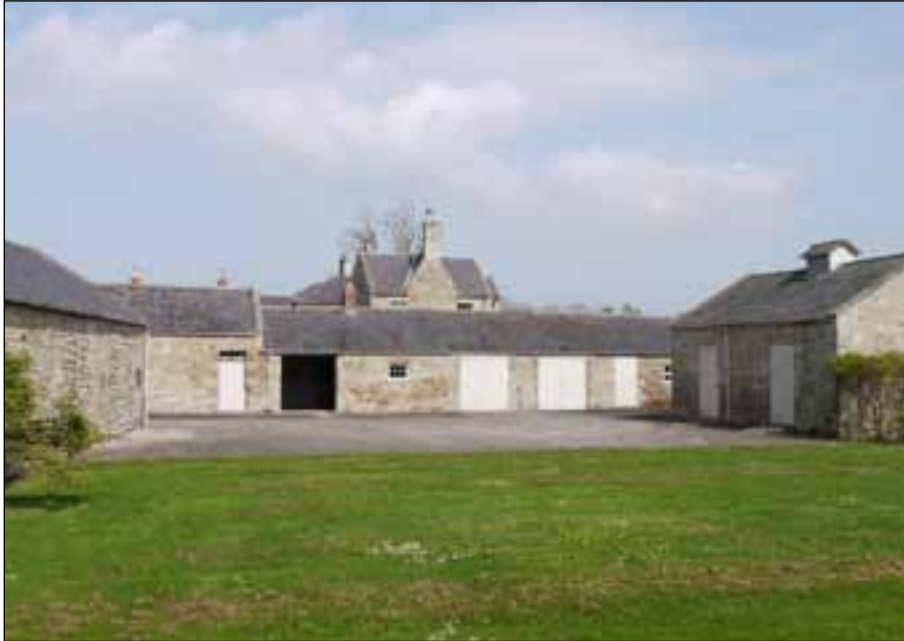
Figure 37: The outbuildings to the south-west of the farmhouse (© English Heritage, photograph: Clare Howard).

To the south-west of the farmhouse are several ranges of buildings – vestiges of the complex of domestic and farm buildings shown on the OS map revision of 1922 although they vary in age (see Fig 8). These are all built of squared random stone rubble and are single storeyed with pitched Welsh slate roofs. Roughly 17m to the south-west of the farmhouse is a long, narrow rectangular range (3) orientated north-west to south-east which was probably built in the mid-19th century and is depicted on the first edition (surveyed 1860) OS map (see Fig 6 and Fig 37). Its purpose is unknown but it was most likely of mixed use, perhaps as a barn and for vehicle storage as the large double doors allow access for machinery or animals. A fireplace with a brick chimney has been inserted in the centre of the cross wall of the open bay served by the double doors. A small rectangular extension was added later in the 19th century. Just 9m to the south-west of this extension is a long single-storeyed shed (4), 35.5m long by 6.2m wide, which also mostly dates from the second half of the 19th century. It is built of stone rubble with a slate roof which is gabled at the north-east end but has a hipped southward return at the south-west end. It is orientated north-east to south-west and is open-sided to the north-west, the elevation being formed of segmental arches and stone piers (Fig 38). It was probably a cart shed, rather than a shelter shed for cattle, due to its great depth and because, as well as facing north-west towards the coldest of the weather, it seems always to have faced a road, or track, rather than a fold yard. The two most north-easterly bays

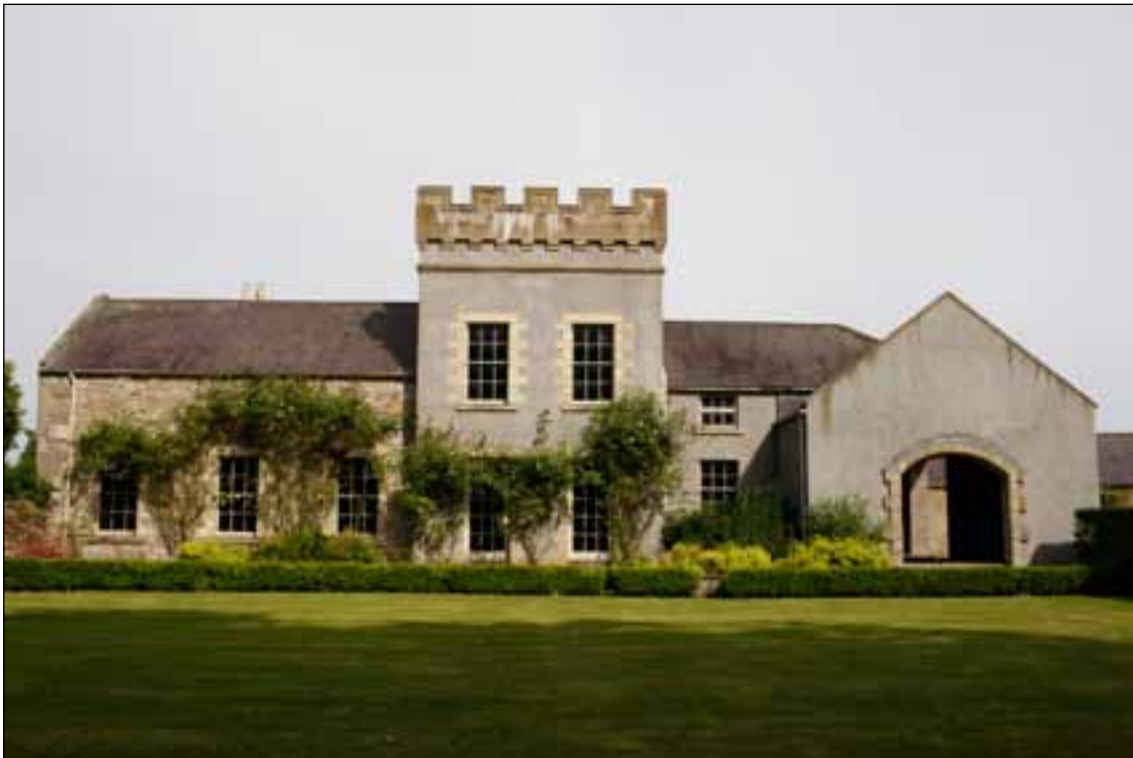
Figure 39: The barn and attached buildings with tower to the south-west of the vaulted building (© English Heritage, photograph: David Andrews).

An attached building to the south of the cart shed is a former barn (5), built of stone rubble with a gabled slate roof and a segmental-headed cart entrance in the south gable end. The barn appears on the first edition OS map, surveyed in 1860, along with a T-shaped range attached to its west side (see Fig 6). By 1897 a further rectangular block had been added to the west end of the north side of the cross of the T (see Fig 7). This entire complex, however, was extensively remodelled in the late 20th century, involving the conversion of former agricultural buildings to dwellings, and the original form and function of the buildings to the west of the barn is not known. The stem of the T is

comprised of a tall, rectangular two-storeyed tower (6), rendered except where ashlar is used for detailing, with a bracketed and crenellated parapet. It has a two-bay south elevation with rectangular window openings with ashlar quoined reveals and lintels (Fig 39). The north elevation is blind but has a large central entrance with stone quoins to the reveals and a segmental head. Above the entrance is a square panel with the date '1996' surmounted by the initial 'A' and what appears to be a stylised representation of a coronet. A two-storeyed linking block, rendered and with a pitched slate roof, joins the tower to the barn. The block to the west of the tower is of stone rubble, rendered on the north side, with a pitched slate roof. The south elevation is three window bays long and the openings are tall and rectangular with ashlar quoins to the reveals and ashlar lintels. The block is single-storeyed but high eaves suggest a large attic storey or possibly that the roof has been dropped. The block projecting to the north of this block (7) is also of stone rubble with ashlar dressings and has a pitched slate roof. It is two-storeys high and has a two-bay north gable end with large rectangular windows with ashlar quoins and lintels in the style of the 1996 remodelling. The windows to the side elevations are smaller and square. The entire group is now in domestic use. The long range to the south-east of this complex, which is shown on earlier OS maps (between the 1866 and 1964 editions), has been almost completely demolished apart from a small rectangular stub at the east end. A large portion of the south wall, still with ventilation slits, has also been retained to serve as a boundary wall.

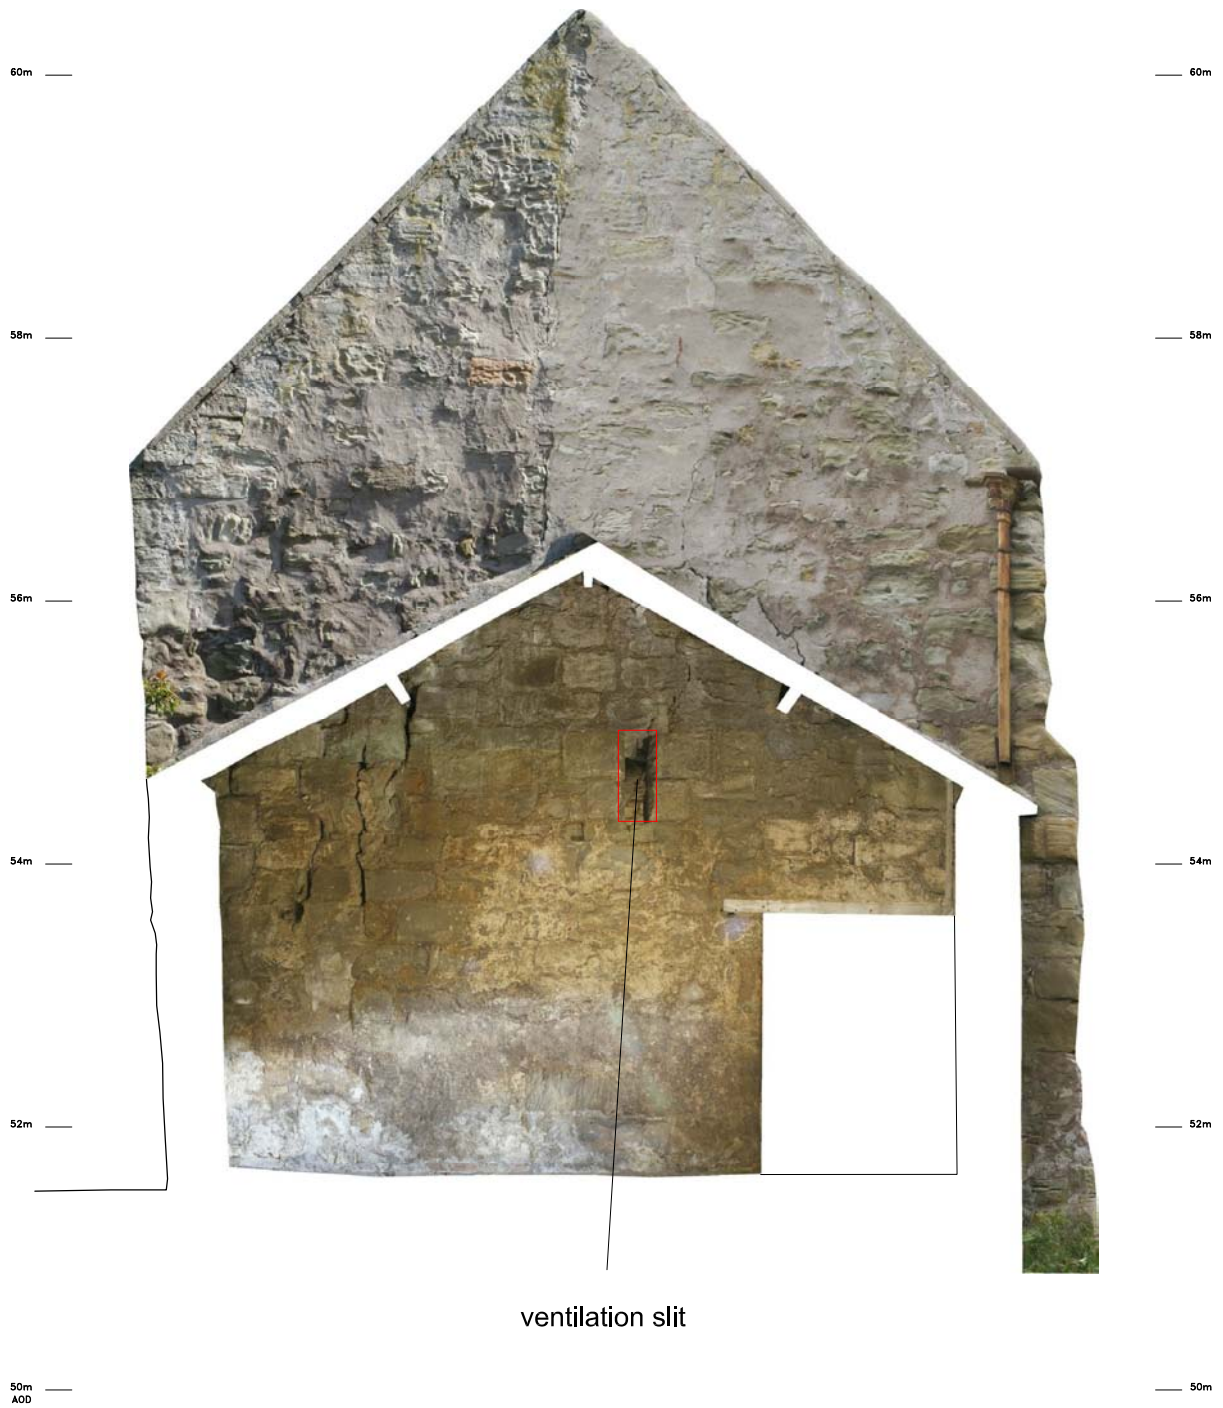
NORTH-WEST ELEVATION

ventilation slit
