Research Department Report Series 87-2010

**BUTTERLEY ENGINEERING SITE  
BUTTERLEY HILL, RIPLEY  
DERBYSHIRE**

**DESK-BASED ASSESSMENT OF THE IRONWORKS  
AND UNDERGROUND CANAL WHARF**

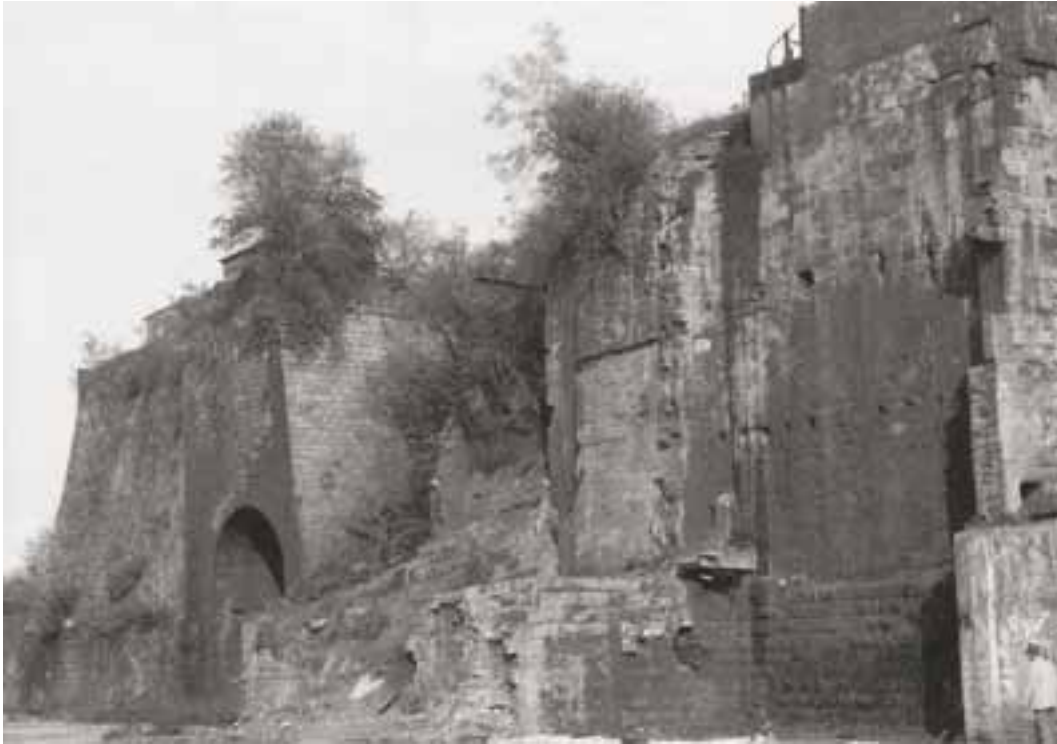
Figure 4: Remains of the two blast-furnaces incorporated within the retaining wall at the Butterley Ironworks ('Structure 1'), looking north-east (after Palmer and Neaverson 1992, 103, figure 115). Reproduced by kind permission, © Marilyn Palmer

Structure 1 This refers to the substantial sandstone retaining wall running approximately north-south down the centre of the former ironworks site footprint. The structure measures some 14m high and forms a furnace bank incorporating the remains of two 19th-century blast furnaces the southern of which has been largely demolished (Figure 4). The fabric of the wall and furnaces is affected by vegetation and sapling regeneration, and shows signs of structural instability with large cracks visible in places. In their 2007 desk-based assessment, MAP recommended that these

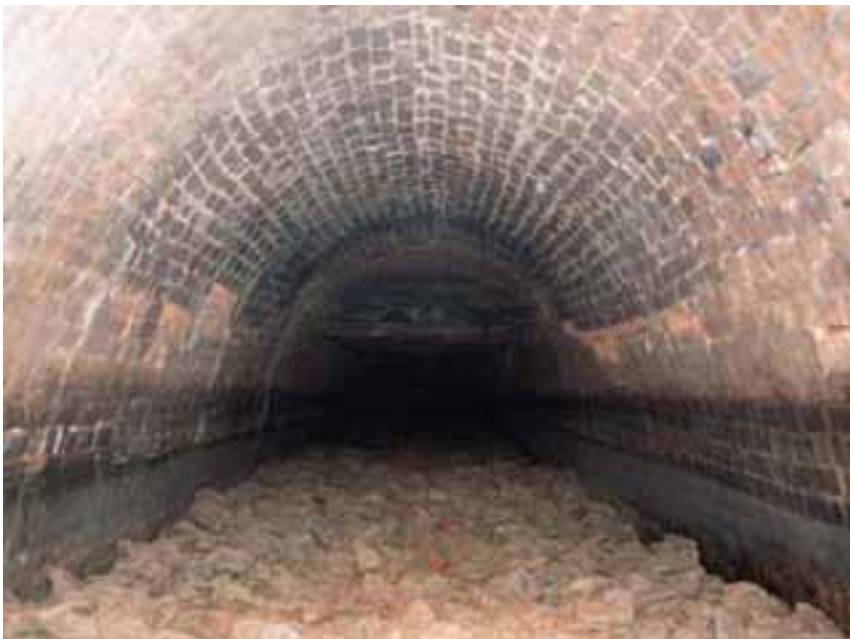
*Figure 7: Limestone infill in the Butterley Tunnel, (after Witter 1979, image 13)  
© Robin Witter, reproduced with permissions*

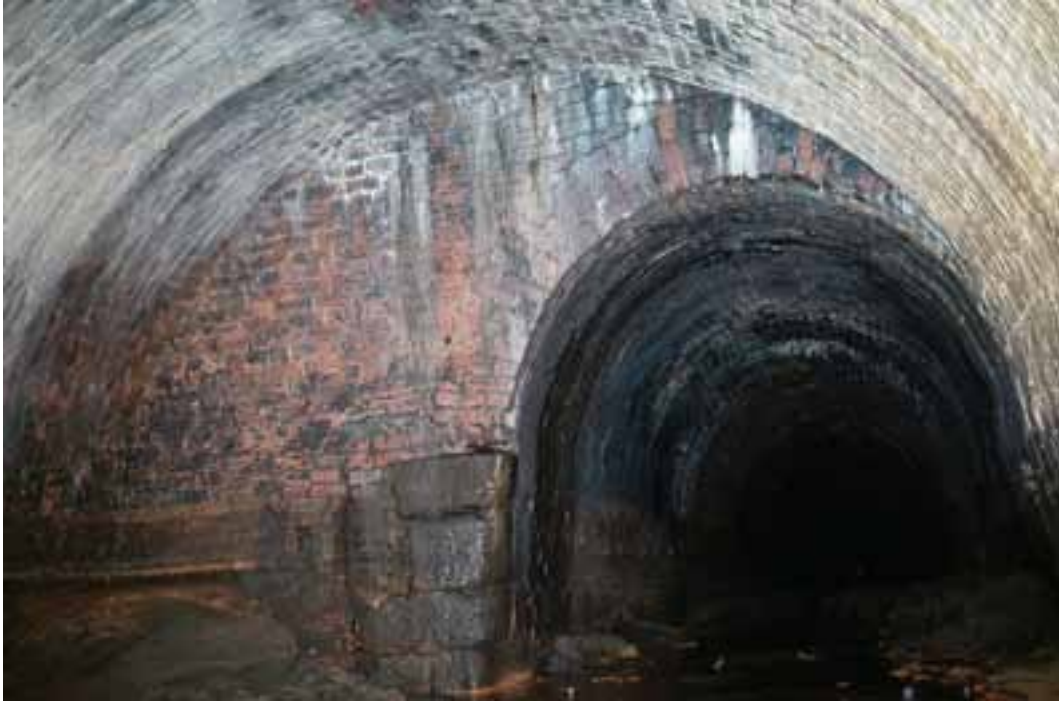
Figure 10: East facing internal elevation of the wide hole, showing stone quoins protecting the projecting west corner, looking west (after Witter 1979, image 11), © Robin Witter, reproduced with permissions

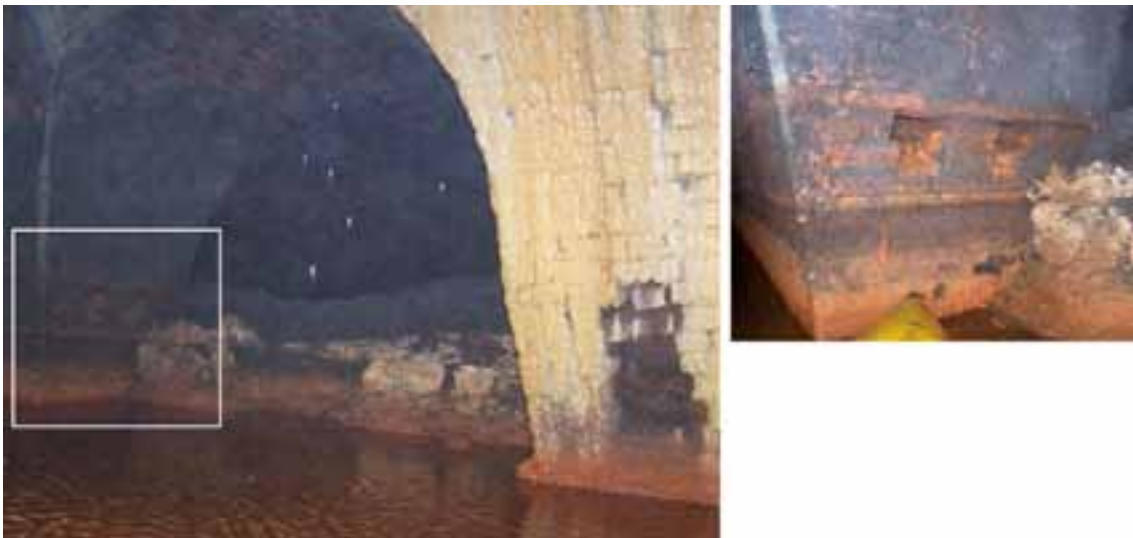
Figure 11: Rectangular recesses in the brickwork, main personnel unloading point, looking south-east (after Cordon 2006, images 67 and 69), © Tina Cordon, reproduced with permissions

10). Rectangular recesses in the brickwork within the sides of the open entrance are suggestive of some form of supported loading platform or walkway (Figure 11). It could be tentatively suggested that this was for loading and unloading people, rather than the crane system for hoisting materials through the loading shafts to the east.

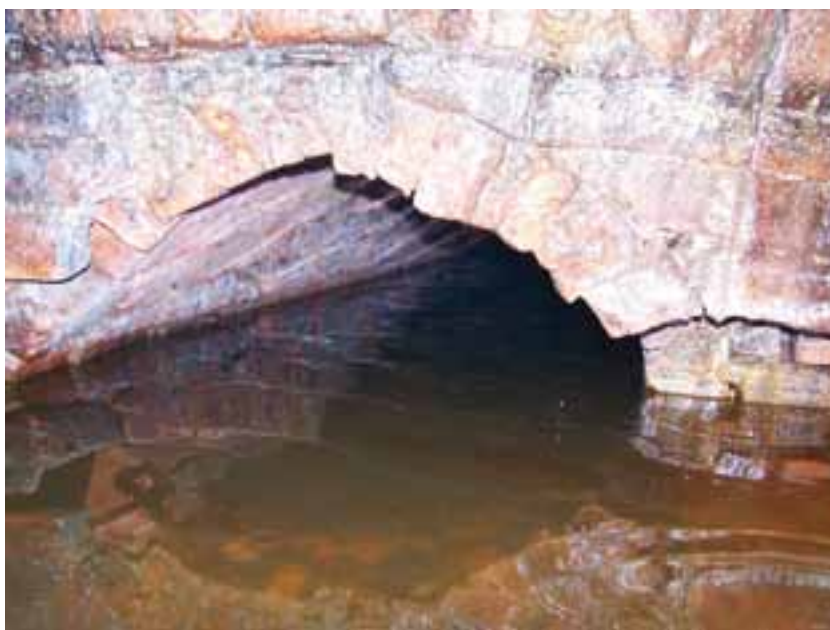
*Figure 12: Low entrance to blast receiver passage in north wall of tunnel, looking north (after Cordon 2006, image 59), © Tina Cordon, reproduced with permissions*

Although, Witter does not discuss a second adit from the reservoir, Greenwood (2003, 34, figure 29), marks a second adit from the reservoir ending at a point between two blast furnaces close to the supposed west end of the wide hole, and labelled 'reservoir suction' to satisfy the need for water in the smelting process. It is unclear whether this sump for the furnaces had any physical connection to the tunnel itself. A second curving passage carrying water used in the tuyeres for cooling the blast away from the furnace and into the tunnel, via an opening in its north wall close to the west end of the wide hole, is described in a 1907 account of a tunnel inspection by Mitton (see Greenwood 2003, 18). This feature is described as a blast receiver tunnel and photographed in some detail by Cordon (2006), showing that the base of a vertical shaft under the site of a former furnace still survives, along with some surviving iron fittings in the floor, and a very short section of tunnel continuation beyond (Figures 12 and 13).

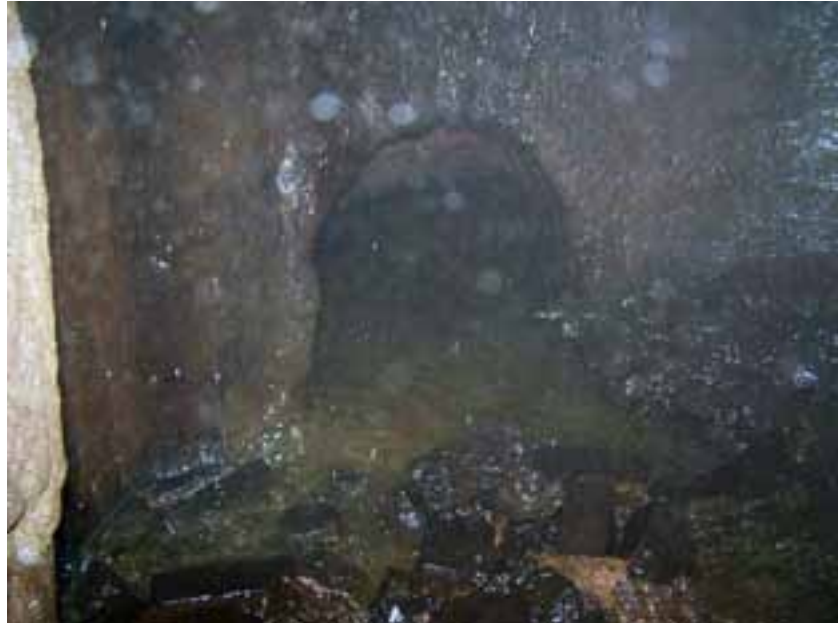
*Figure 13: Low entrance to blast receiver shaft, seen from inside shaft, looking south-east (after Cordon 2006, image 64) © Tina Cordon, reproduced with permissions*

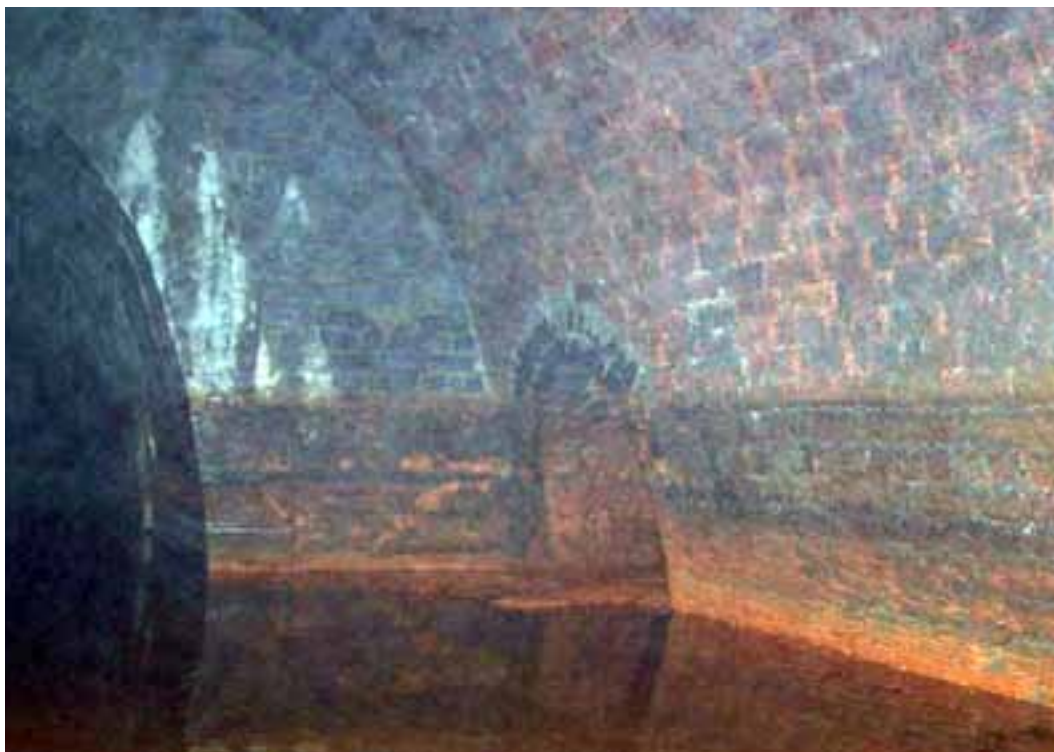
*Figure 14: Remaining open entrance to Carr Pit wagonway, seen in south wall of tunnel, just west of narrowed section of the wide hole, looking south-east (after Cordon 2006, image 79), © Tina Cordon, reproduced with permissions*

Tina Cordon (2006) records several of these side tunnels or arched gangways in her explorations which were more thorough than those undertaken by Witter in 1979. Although most points can be tied in with plans of the wide hole section of the tunnel, it is not always clear precisely which elements of the complex of galleries he is describing. From beside the blocked loading shaft bases three passages once led to the main Carr Pitt access tunnel, the easterly two are now blocked, but Cordon was able to enter the western passage and from there access the Carr Pitt tunnel and the gangway leading back to the western pair of openings (Figure 14) (see Figures 8 and 9).

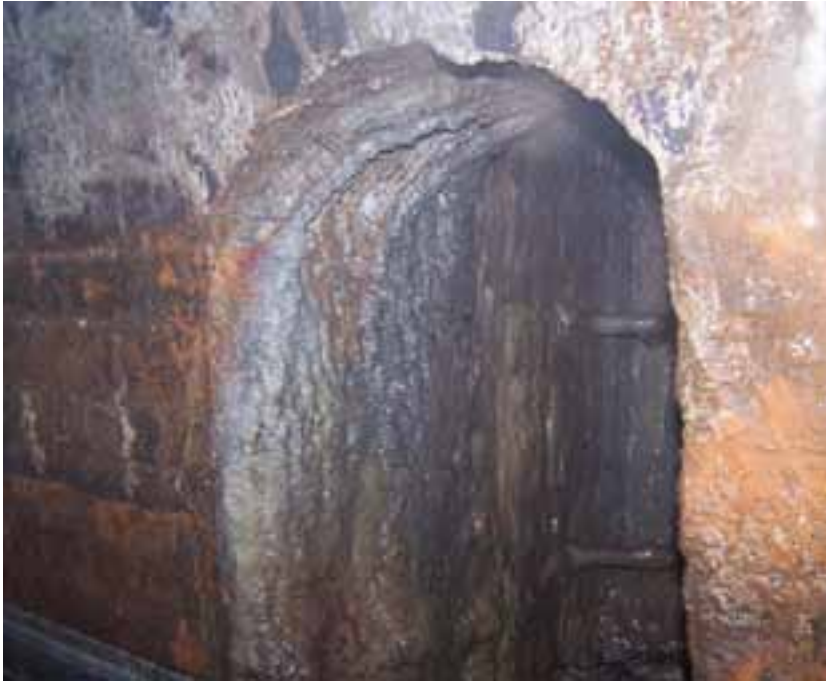
*Figure 15: Entrance to narrowed vertical shaft, showing iron rungs (after Cordon 2006, image 82), © Tina Cordon, reproduced with permissions*

In her exploration of the tunnel in 2006, Tina Cordon recorded base of a shaft thought to be the western example of the loading shaft pair. She described it as a narrow shaft with twelve iron rungs set into the wall at 14 inch (0.36m) intervals allowing access up through a square hole and into the wider base of the loading shaft (Cordon 2006) (Figures 15 and 16). This description matches the proposed remodelling of the wide hole and narrowing of shafts, relating to the 1915 wide hole shortening modifications; the arched doorway giving access to the lower iron rungs is shown in 'Elevation C' on the Midland Railway plan (see Figure 9) (see Greenwood 2003, 24).

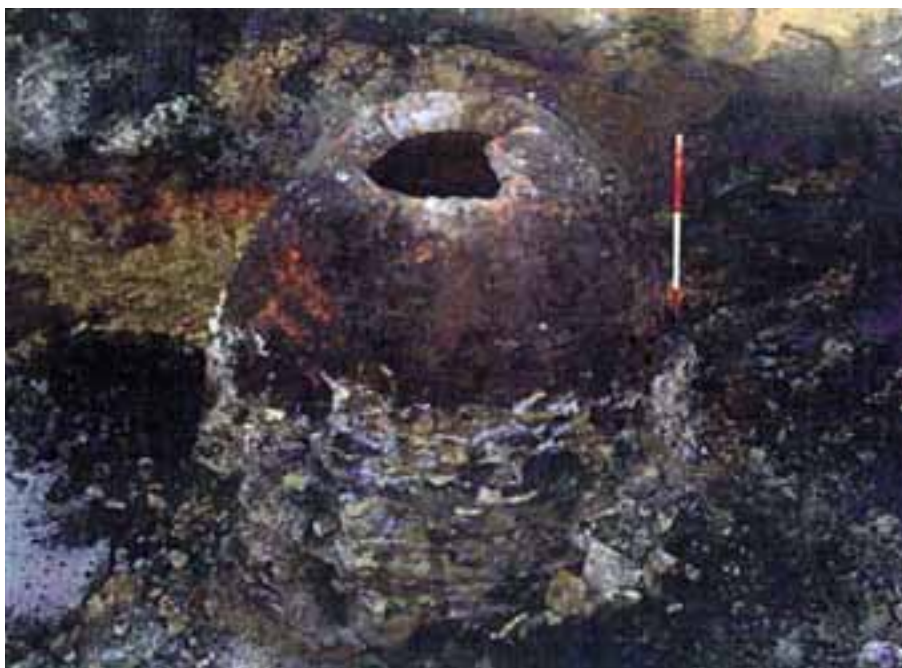
Figure 17: Domed brick capping on a shaft exposed during archaeological watching brief (after Farnworth-Jones and Boucher 2007, 7, figure 4), © ULAS, reproduced with permissions

Two vertical shafts connecting the canal tunnel to the ground surface above were exposed during groundworks in 2007, and recorded in a watching brief undertaken by University of Leicester Archaeological Services (ULAS). The upper portions of the shafts were photographed and approximately located by ULAS; the report describes the two shafts as measuring 2.13m (7ft) in diameter, and spaced at 4m apart centre to centre. The shaft itself was constructed of yellow sandstone blocks, each measuring approximately 0.26m x 0.18m x 0.07m, and bonded with a grey dry lime mortar with small white inclusions. A later 1.5m high domed cap had been constructed over the shaft opening, built using a stretcher bond construction of red bricks bonded with a pinkish dry lime mortar with small black and white inclusions (Farnworth-Jones and Boucher

2007, 6-7) (Figure 17). During the 2007 watching brief, the upper 8.5m of composite superstructure was demolished in order to insert a concrete cap over the mouth of the shaft at the level of the surrounding bedrock.

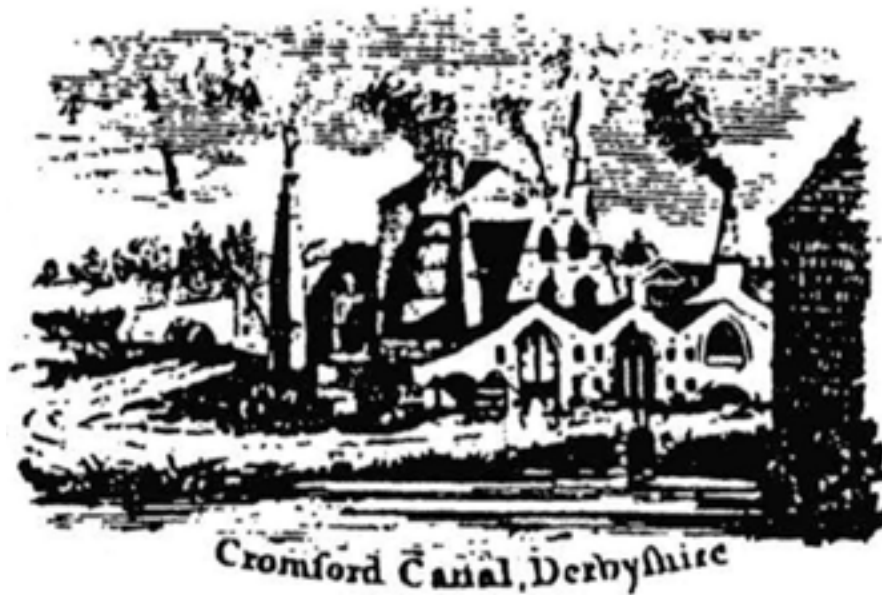
Figure 18: Detail from an 1801 Bill of Exchange showing the Butterley ironworks (after Riden 1990, 50 figure 2), reproduced with permissions

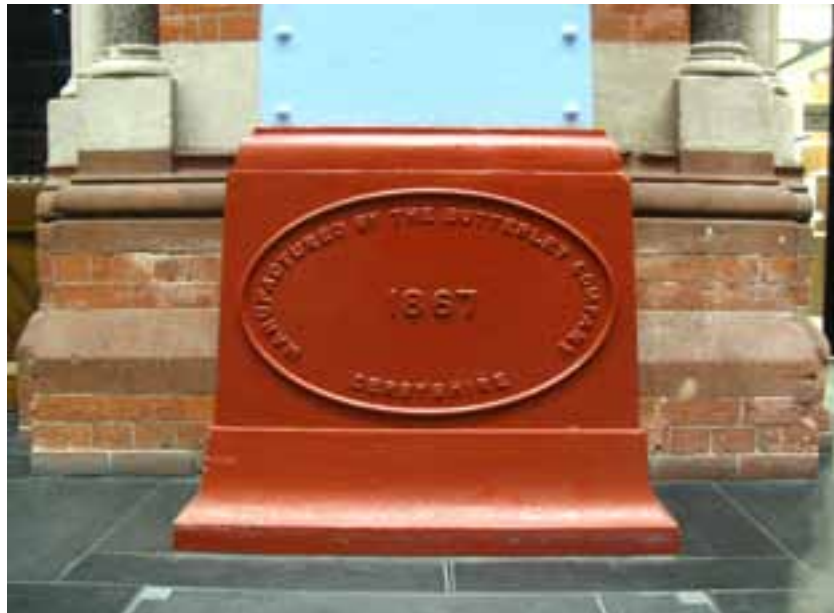
Figure 21: The Butterley Company stamp at the foot of one of the iron roof spans at St Pancras Station. Photographed by Rebecca Pullen, © English Heritage
