RESEARCH REPORT SERIES no. 75-2014

CHURCH OF ST MARY, NEEN SAVAGE, SHROPSHIRE TREE-RING ANALYSIS OF TIMBERS

SCIENTIFIC DATING REPORT

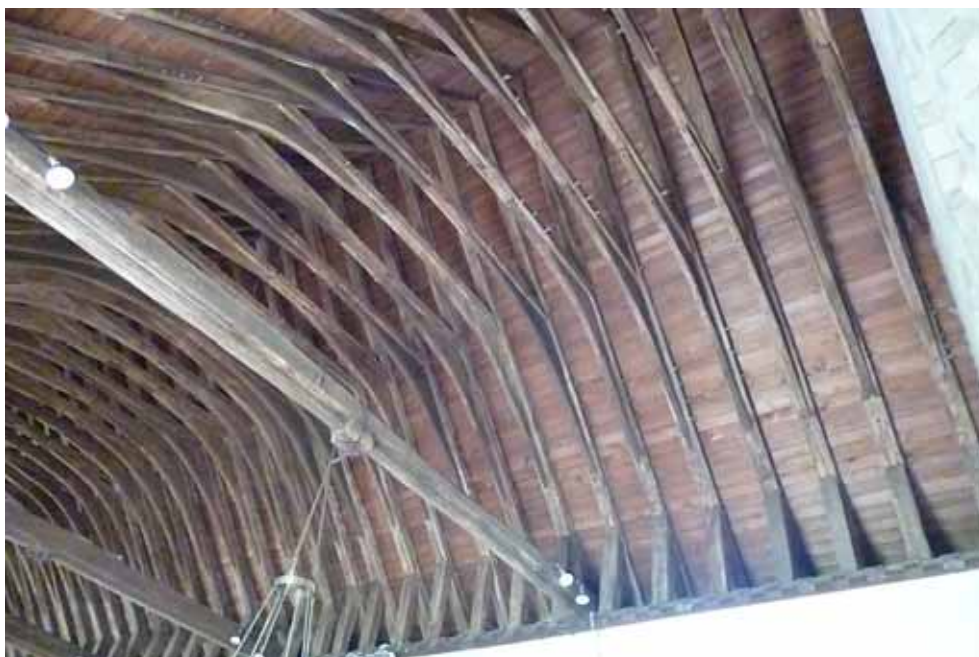
Figure 2: View of the chancel roof of St Mary's Church (photograph Robert Howard)

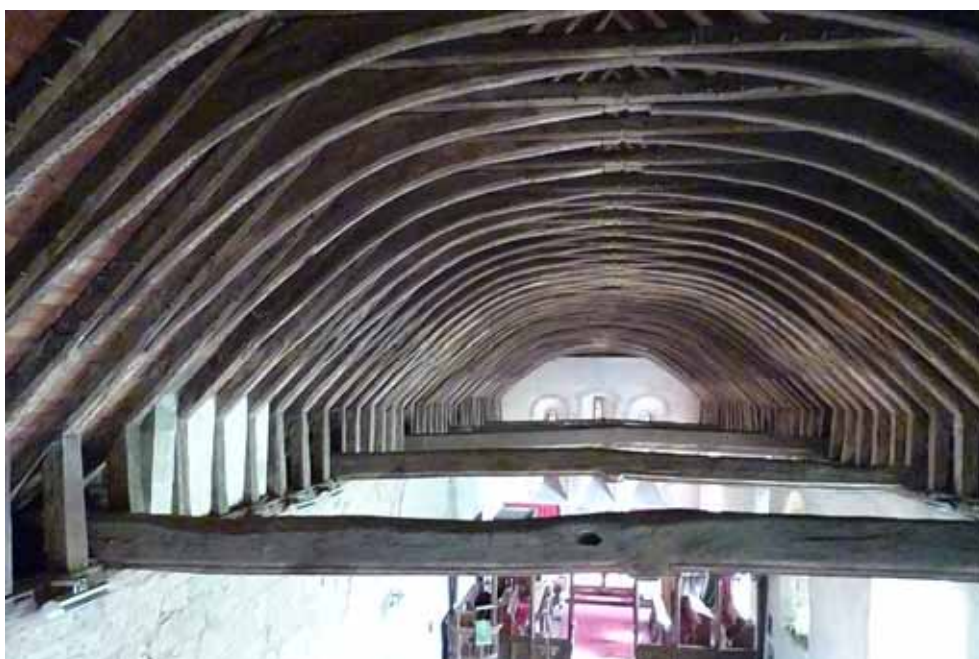
Figure 3: View of the nave roof looking west to east (photograph Robert Howard)

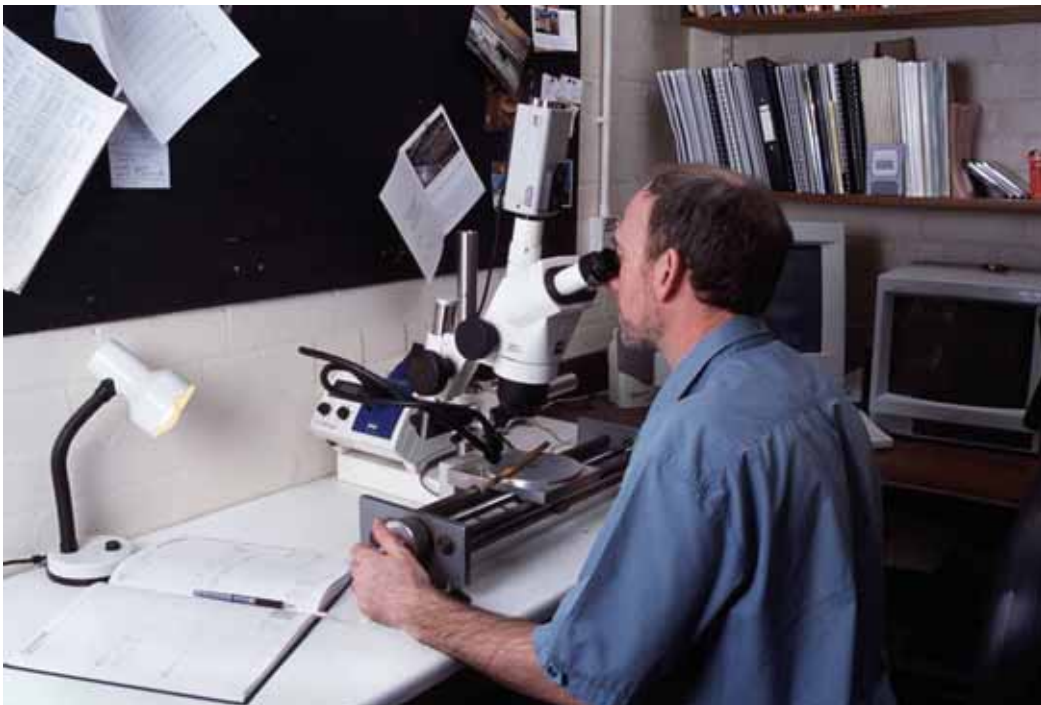
Figure A3: Measuring ring widths under a microscope. The microscope is fixed while the sample is on a moving platform. The total sequence of widths is measured twice to ensure that an error has not been made. This type of apparatus is needed to process a large number of samples on a regular basis

2. **Measuring Ring Widths.** Each core is sanded down with a belt sander using medium-grit paper and then finished by hand with flourgrade-grit paper. The rings are then clearly visible and differentiated from each other with a result very much like that shown in Figure A2. The core is then mounted on a movable table below a microscope and the ring-widths measured individually from the innermost ring to the outermost. The widths are automatically recorded in a computer file as they are measured (see Fig A3).
