THROWLEIGH COMMON, THROWLEIGH, DEVON

A 'Premier Archaeological Landscape'

Research Department Report Series 40/2007

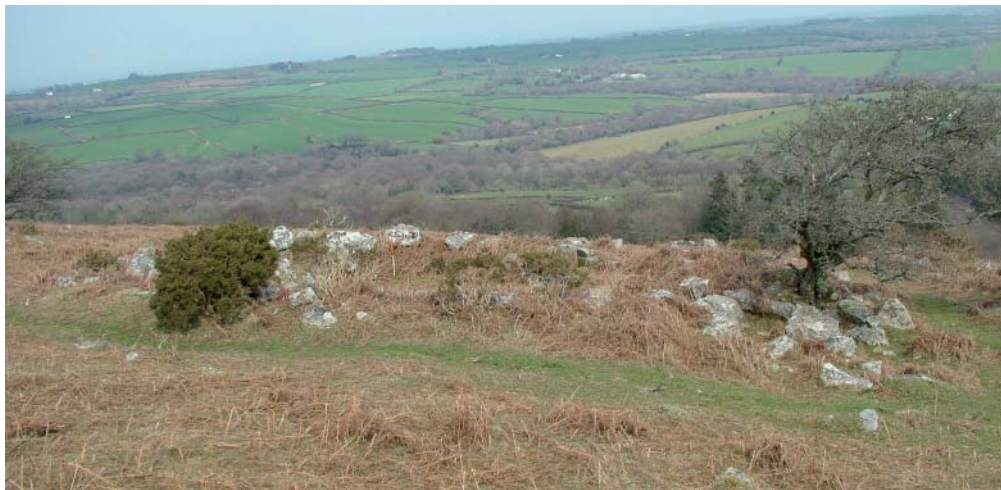
Figure 2. Hut 22.
View looking east.

A massively built stone hut built into the corner of a 'D' shape enclosure. The inner wall face is almost intact comprising large edge set slabs of granite while the outer face, though less well preserved, is extant in places. The walls are 2.3m thick and up to 0.8m high. The internal diameter is 10.1m. The entrance survives on the SE side formed by a cutting through the thickness of the wall, lined with slabs. There is very little displaced stone associated with this hut which together with its fine condition suggests it has been re-furbished and re-used at some time in the post-prehistoric period. Evidence of feather and tare granite cutting on one of the wall slabs demonstrates that the wall was partially robbed for stone, probably after c. AD1800. A tree is currently rooted in the wall beside the entrance.

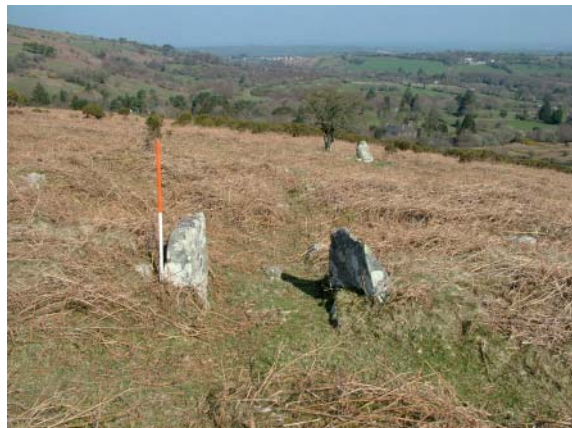
Figure 3. Door
jambs *in situ*
Hut 1.

The hut is contained within a small roughly rectangular enclosure. It has a diameter of 8m with walls up to 3m thick and 0.5m high. The entrance survives on the SE of the circumference with two jambs in situ of 0.7m high. The opening is 1.2m wide. The wall remains consist of fairly robust earthen bank containing some, mostly displaced, stone.

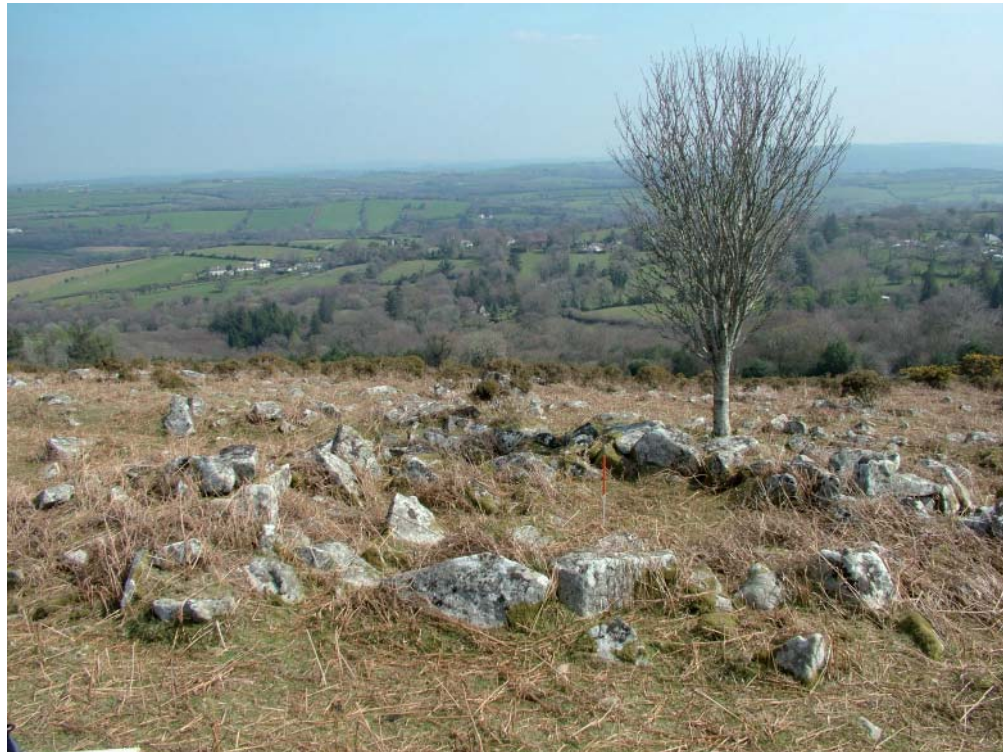
*Figure 4. Hut 13.
View looking east*

Sited just west of a post-medieval leat which avoids the hut. A substantial hut which has a high proportion of both its inner and outer stone faces of the walls *in situ*. It is constructed from large slabs of granite set on edge to form a wall which still stands to up to 0.8m high by 1.4m thick. The internal diameter of the hut is 7.3m and the floor is level. The two door jambs remain upright on either side of the entrance and consist of 1m high granite posts. The entrance is also lined with granite slabs across the thickness of the walls. A tree is growing from the within the walls on the east side.
