RESEARCH REPORT SERIES no. 108-2011

THE READER'S HOUSE, LUDLOW, SHROPSHIRE

TREE-RING ANALYSIS OF TIMBERS

SCIENTIFIC DATING REPORT

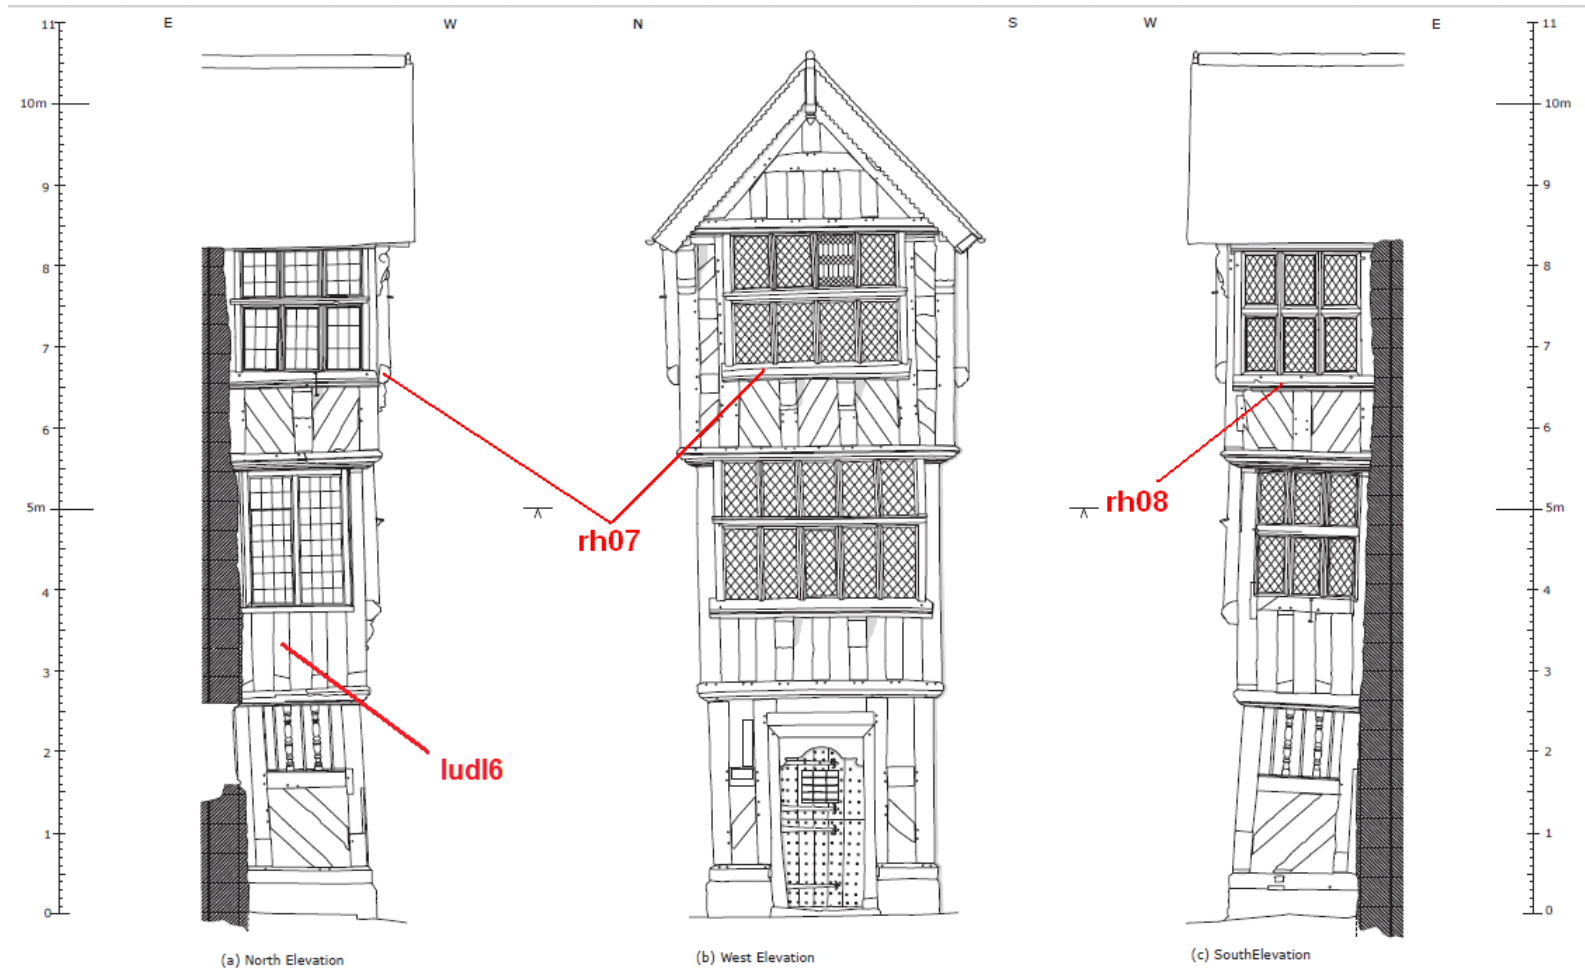
Figure 11: The porch, showing timbers sampled for dendrochronology (after Tyler)

In addition, it had been suggested that the porch may have been a later addition, and samples were therefore sought to confirm or deny this hypothesis. It was noted during the assessment that the north wall of the property was rather different in character, having generally much smaller timbers, and whilst it would have been of interest to date this wall, none of the timbers were found to be suitable, as they contained too few rings. There was some question from the building analysis as to whether the second-floor ceilings were primary or inserted, and sampling was directed to timbers that may be capable of answering this question. Two octagonal posts in the basement were almost certainly brought into the house from elsewhere, but their dates were of intrinsic interest to the property, so these too were sampled.

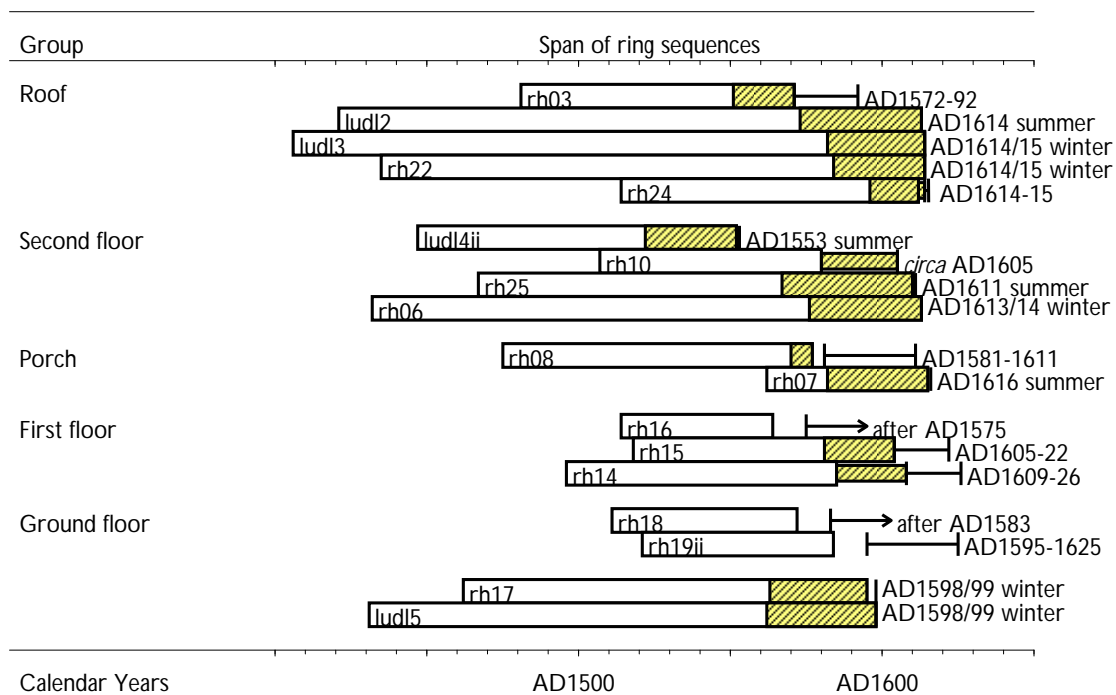
Figure 12: Bar diagram showing the relative positions of overlap between the dated series, along with their likely interpreted felling dates, sorted by area. Yellow hatched sections represent sapwood, and narrow sections are additional unmeasured rings

When considered overall there is a preponderance of material felled in the AD 1610s throughout the building and the disparate nature of the felling dates or felling date ranges obtained for the other dated timbers suggests, at the very least, a major rebuild and more likely indicates that the building was actually constructed in the mid AD 1610s (Figs 12 and 13). This would certainly agree with the inscribed date of '1616' on the porch. In this instance the earlier material would therefore appear to have been either stockpiled or reused, although evidence of reuse is clearly lacking on some of these earlier timbers. Nevertheless it seems unlikely that the tiebeam (lud14) felled in the summer AD 1553 had been stockpiled for over 60 years.

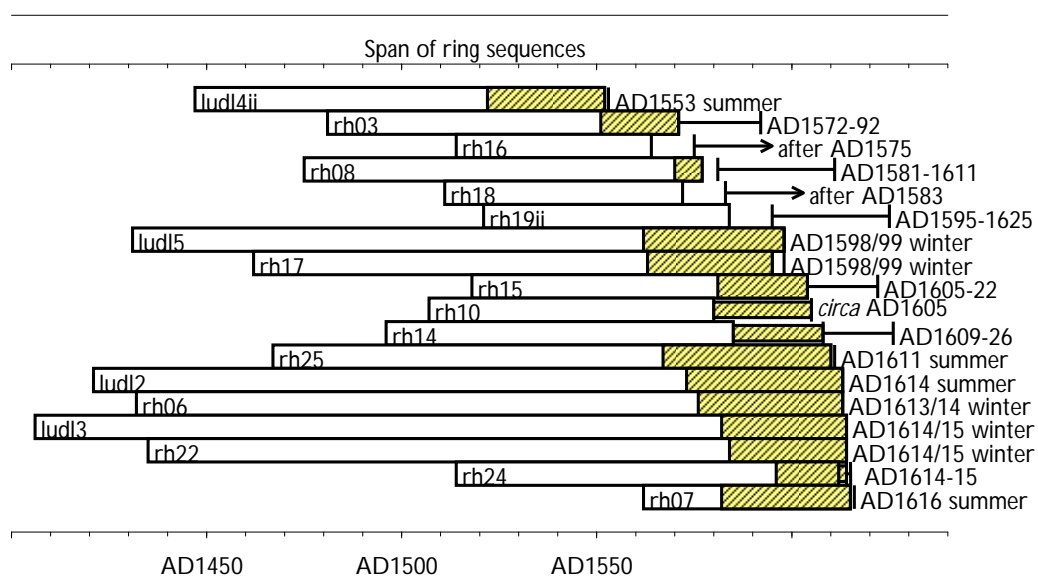
Figure 13: Bar diagram showing the relative positions of overlap between the dated series, along with their likely interpreted felling dates. Yellow hatched sections represent sapwood, and narrow sections are additional unmeasured rings
