CHURCH OF ALL SAINTS, BERRINGTON, NEAR SHREWSBURY, SHROPSHIRE

TREE-RING ANALYSIS OF TIMBERS

SCIENTIFIC DATING REPORT

Alison Arnold and Robert Howard

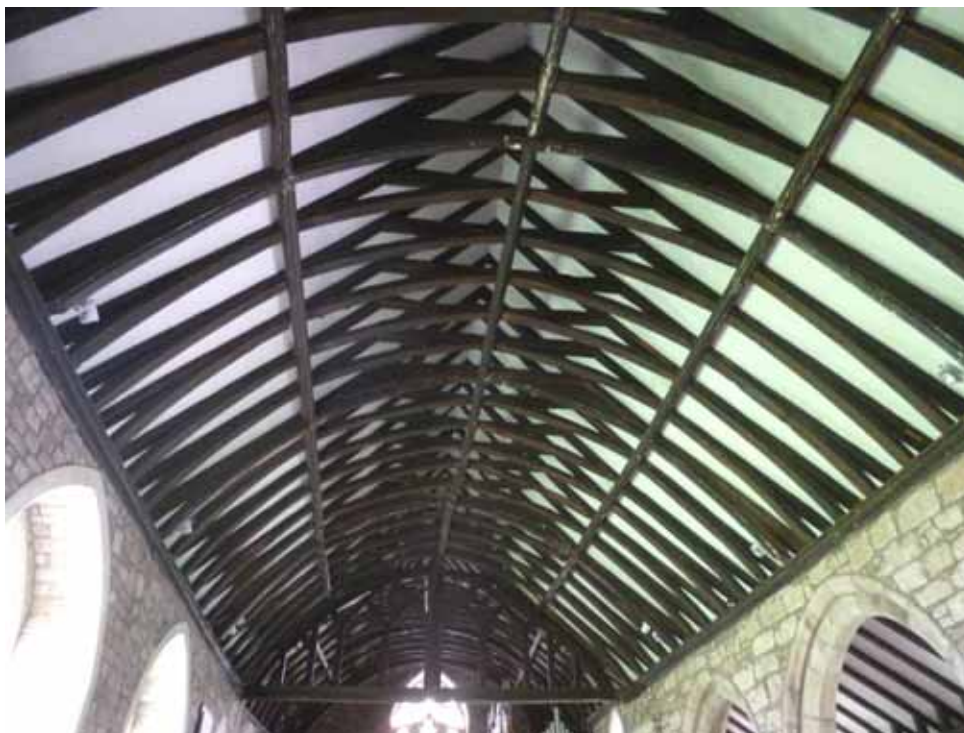
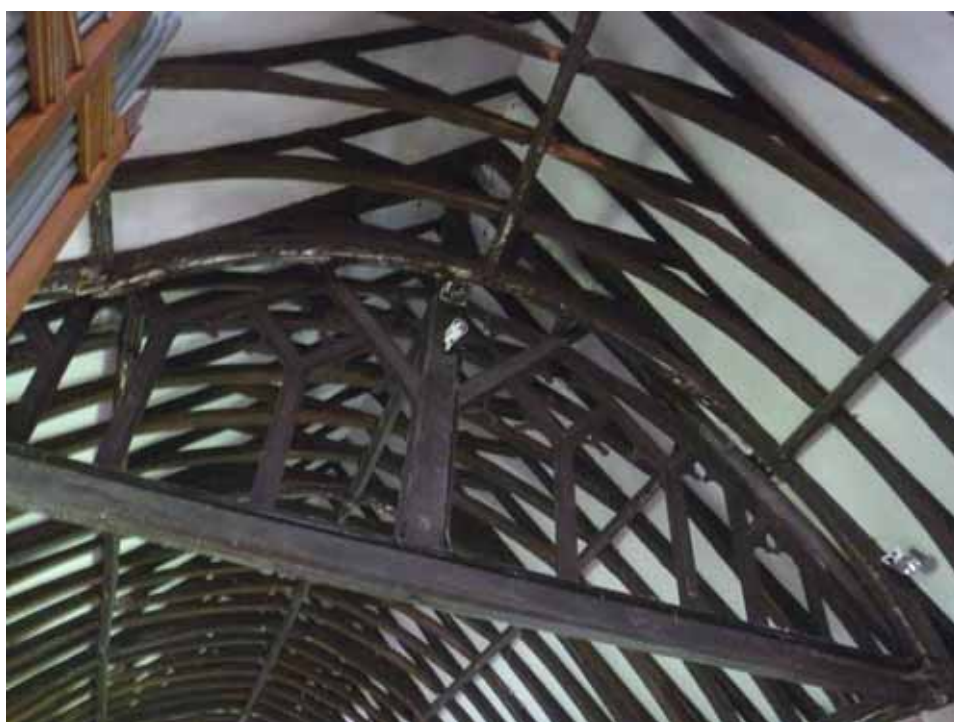
Figure 4a/b: View of the nave roof (top), looking west to east, and the screen truss at the junction of the nave and chancel roofs (bottom) (photographs Robert Howard)

The chancel roof comprises twelve close-set, arch-braced, principal-rafter-with-collar frames; the arch braces each composed of an upper and lower section. The nave roof comprises twenty similar, if not identical frames (Fig 4a). The division of the two roofs is formed not only by a change in the level of the north and south wall plates, but also by the position of a much more substantial traceried, tiebeam with kingpost, screen truss to the nave, this truss immediately abutting an arch-braced frame of the chancel (Fig 4b). All frames carry a moulded ridge beam and single purlins to each pitch of the roof.

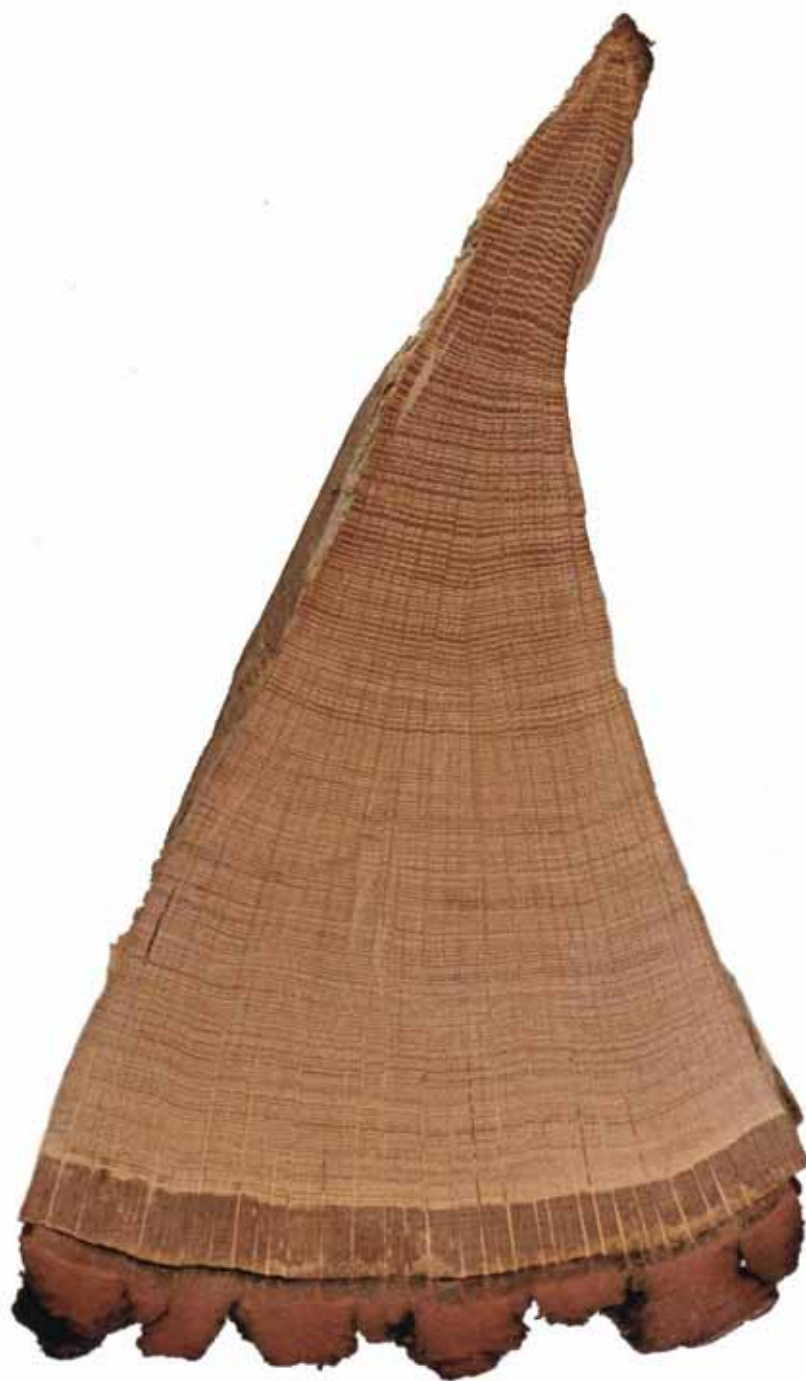
Figure A1: A wedge of oak from a tree felled in 1976. It shows the annual growth rings, one for each year from the innermost ring to the last ring on the outside just inside the bark. The year of each ring can be determined by counting back from the outside ring, which grew in 1976

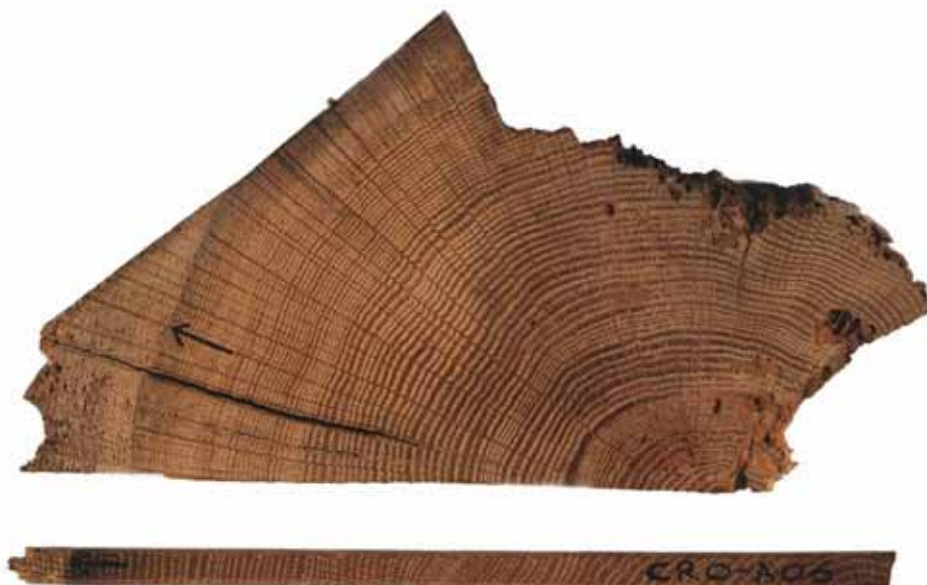
Figure A2: Cross-section of a rafter, showing sapwood rings in the left-hand corner, the arrow points to the heartwood/sapwood boundary (H/S); and a core with sapwood; again the arrow is pointing to the H/S. The core is about the size of a pencil

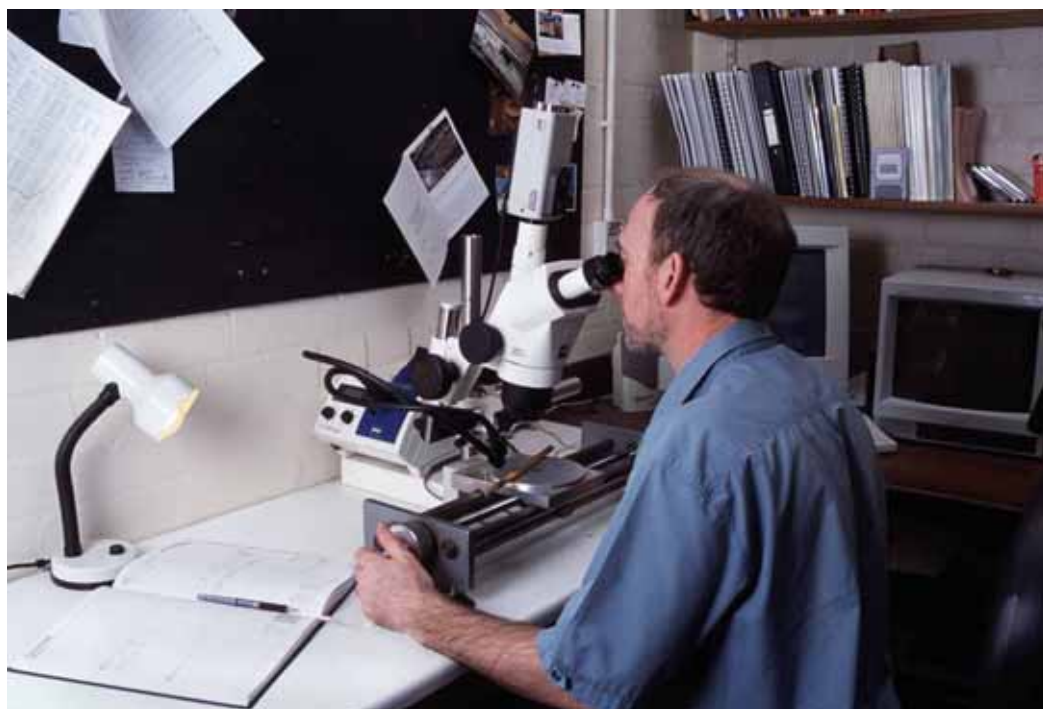
Figure A3: Measuring ring widths under a microscope. The microscope is fixed while the sample is on a moving platform. The total sequence of widths is measured twice to ensure that an error has not been made. This type of apparatus is needed to process a large number of samples on a regular basis

2. **Measuring Ring Widths.** Each core is sanded down with a belt sander using medium-grit paper and then finished by hand with flourgrade-grit paper. The rings are then clearly visible and differentiated from each other with a result very much like that shown in Figure A2. The core is then mounted on a movable table below a microscope and the ring-widths measured individually from the innermost ring to the outermost. The widths are automatically recorded in a computer file as they are measured (see Fig A3).

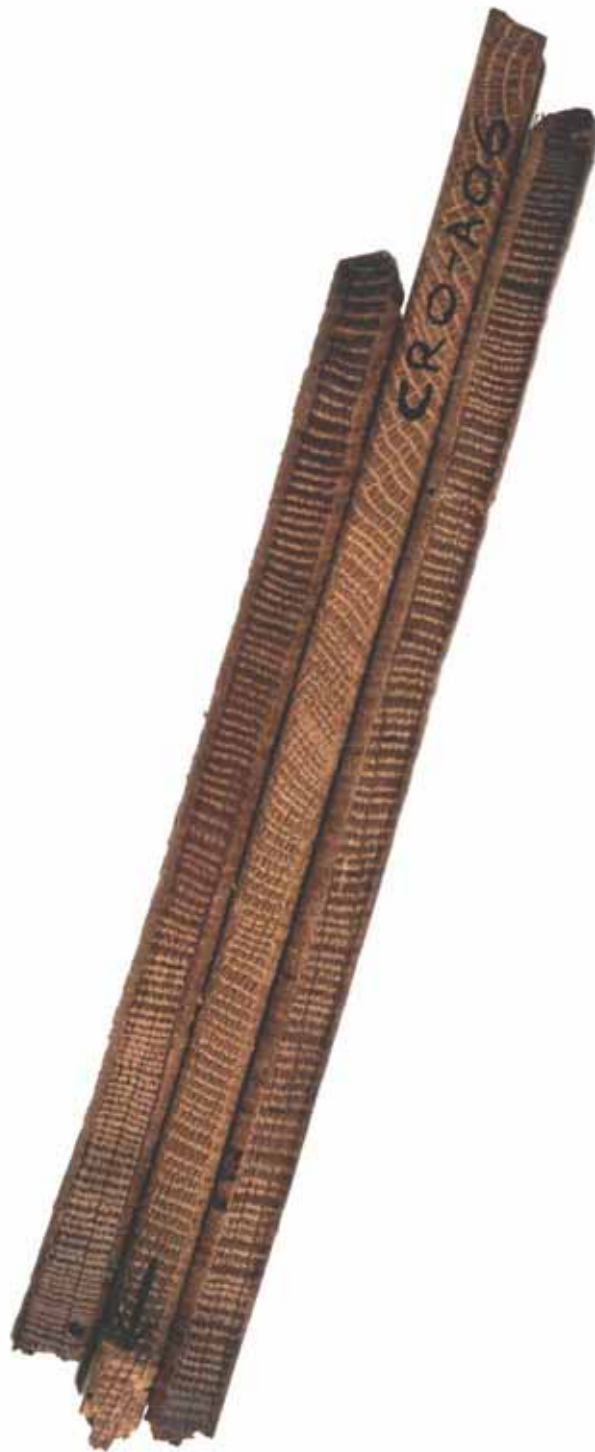
Figure A4: Three cores from timbers in a building. They come from trees growing at the same time. Notice that, although the sequences of widths look similar, they are not identical. This is typical
