Manor Farm Barn,
Manor Court, High Street, Harmondsworth,
London Borough of Hillingdon

Dendrochronological Analysis of Oak Structural
Timbers and Boards

Ian Tyers

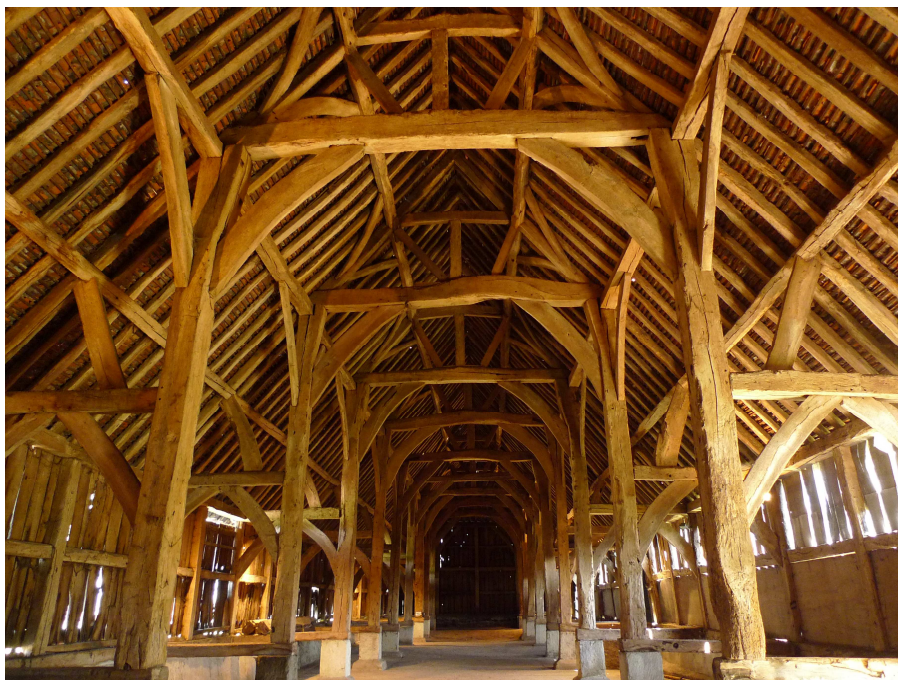
Figure 2: Harmondsworth Barn internal view, photo Peter Marshall

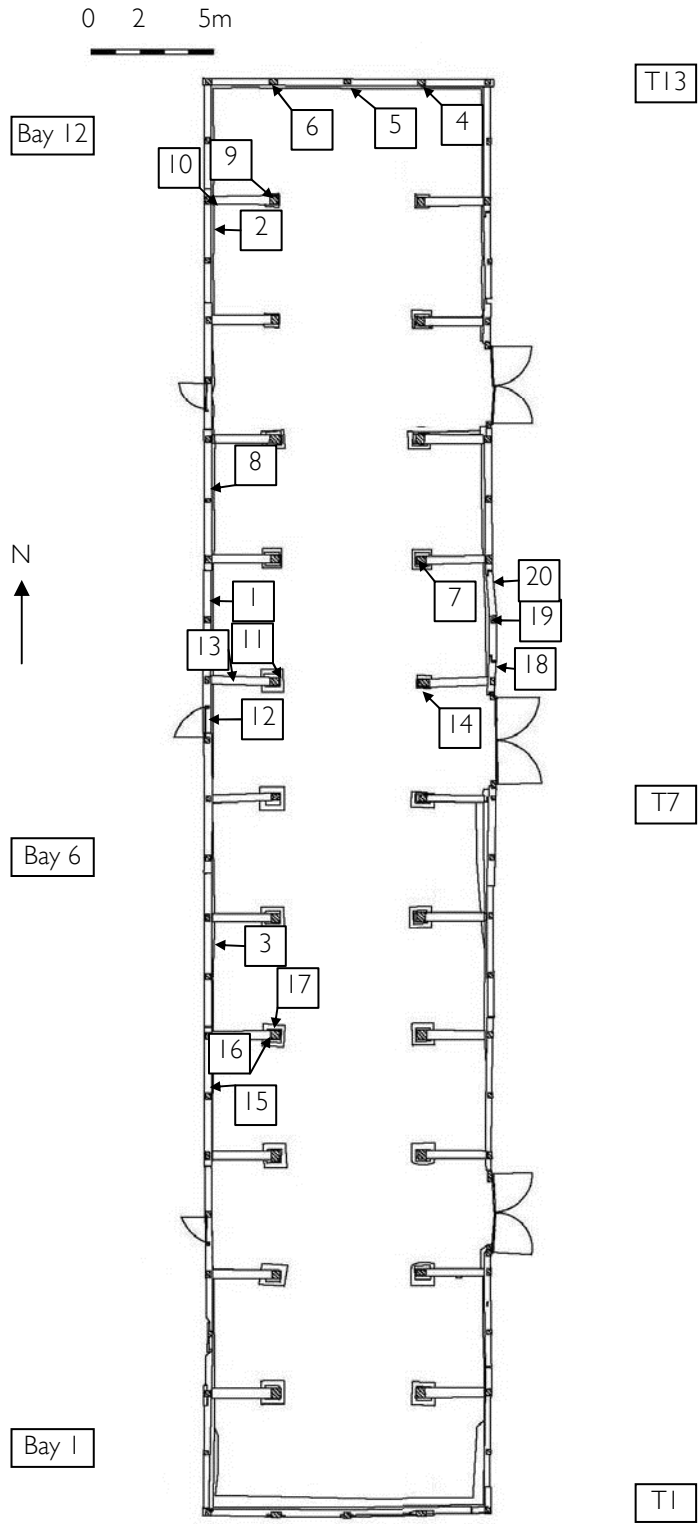
Figure 3: Harmondsworth Barn plan showing bay and truss numbering and the approximate location of the sampled timbers, survey drawing supplied by English Heritage

Six samples were analysed in c 1985, and some of these were reanalysed in 1993. These were labelled samples 1–6 inclusive. In 2012, 14 timbers from across the building were cored. These cores were labelled 7–20 inclusive. In 2013 six weatherboard offcuts were examined for direct measurement of their tree-ring sequences, these were labelled 21–26. Figure 3 shows the distribution of the core samples through the barn.

KEY For locations see Figure 3. Interpretations based on 10–46 sapwood rings. The trusses are numbered 1–13 from south to north, the bays are number 1–12 from south to north. H/S is heartwood/sapwood edge; B is bark but season indistinguishable; Bw is bark after complete ring (ie winter felled), Bs is bark after additional partial ring (ie spring felled); a number in italics gives the estimated number of unmeasured rings; *n* indicates possible loss of 1 or 2 rings between main core and detached sapwood fragment; *nn* indicates unknown loss of rings between main core and detached sapwood fragment

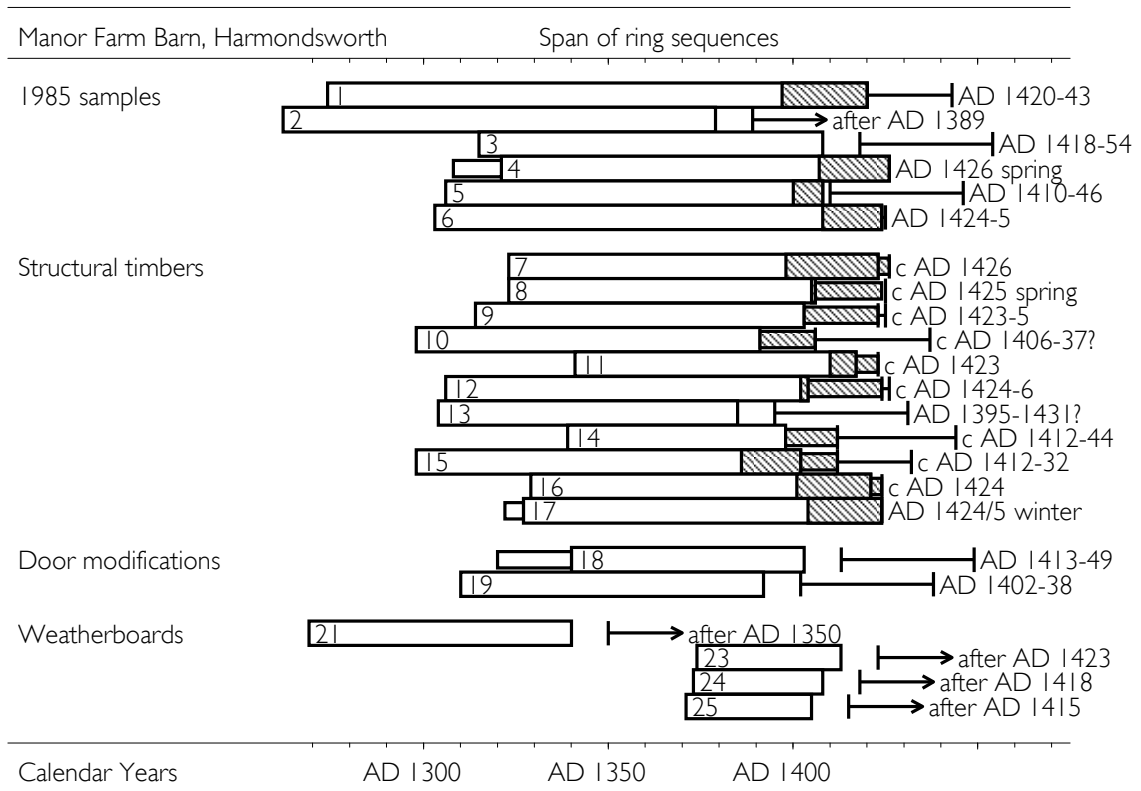
Figure 4: Bar diagram showing the absolute dating positions of the 23 dated tree-ring sequences for samples from Harmondsworth Barn. The interpreted felling dates are also shown for each sample

The 24 suitable samples from the building were prepared for analysis, measured, and the resultant ring series were initially compared with other material from the building. Various interim composite groupings were made of sequences during this process. Finally the interim composites and the individual sample series were individually compared with reference series of medieval and later oak tree-ring data from throughout Britain. These results were reviewed and a final single composite series was constructed from 23 samples from the barn. This group is formed by intra-site cross-matching (Table 2), supported by good external cross-matching. Sequence Harm_T23 is a 165-year composite that matches with reference data (Table 3) at AD 1262 to AD 1426 inclusive. A summary of the results for the component and individual samples is provided in Table 1 and Figure 4.
