## Brooke House, Hackney, London

### Tree-ring Analysis of Timbers

Ian Tyers

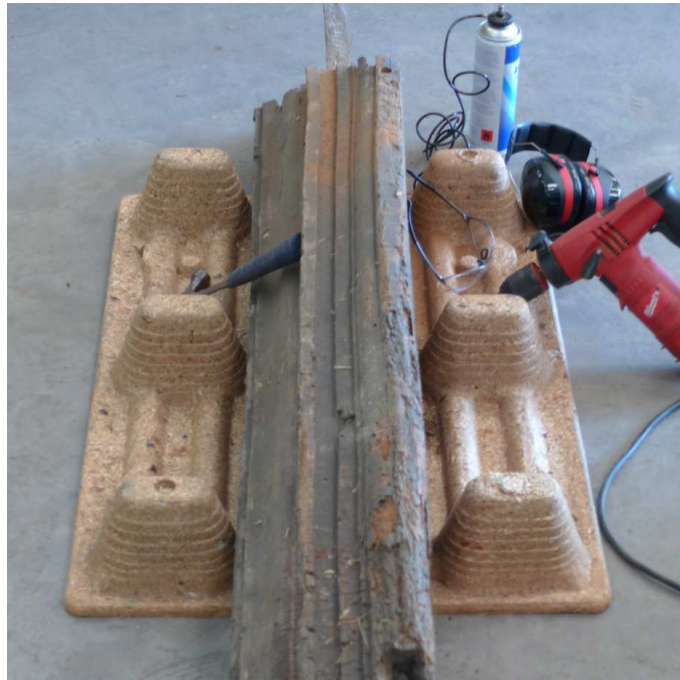
*Figure 2: Jamb 88084596/3 from Brooke House, Hackney, during coring (Core 3), photo kindly supplied by Peter Marshall*

Five cores were obtained from three large moulded oak door jambs and two unmoulded oak timbers on the same pallets in the store (Table 1), the moulded timbers are similar to those illustrated in Eden *et al*/ 1960 (fig 6, and pl 23; Figs 2 and 3). In addition a disparate group of disarticulated oak boards that are similar to those illustrated in Eden *et al*/ (1960 pl 26) were collected (Table 2; Figs 4–7). The similarity of each component of the latter group to those identifiable in the Eden *et al*/ (1960) illustration suggests these latter are likely to be from the Long Gallery.

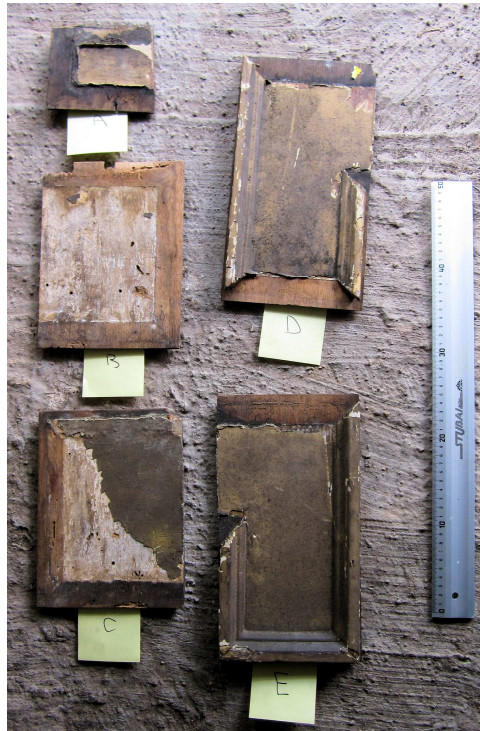
*Figure 4: Smaller boards A–E from Brooke House, Hackney; all grain running top to bottom, soot presumably from fire or bomb damage still visible (photograph Ian Tyers)*

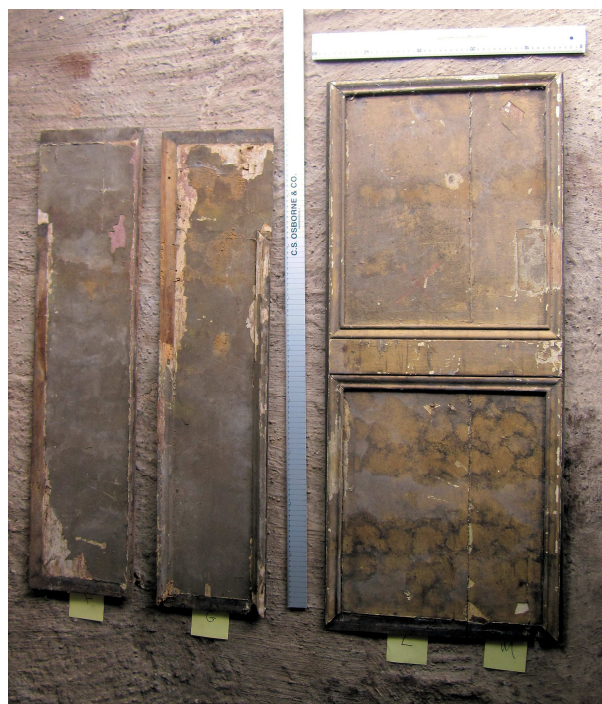
*Figure 5: Medium sized boards F, G, L, and M (left to right) from Brooke House, Hackney; all grain running top to bottom (photograph Ian Tyers)*

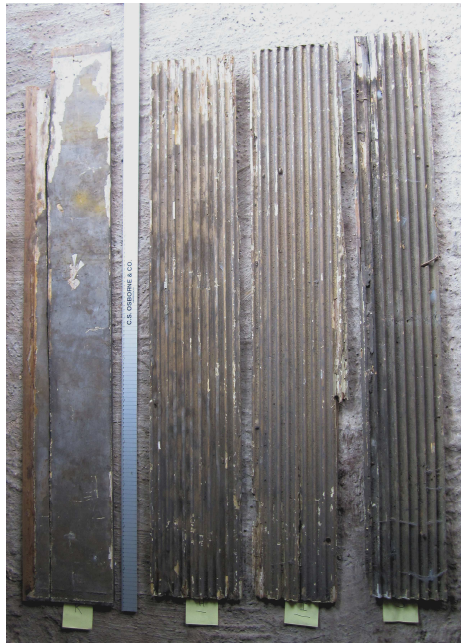
Figure 6: Larger board K, and moulded boards H, I and J (left to right) from Brooke House, Hackney; all grain running top to bottom (photograph Ian Tyers)

Most groups of panelling that have been examined are dominated by eastern Baltic oak boards and very few retain any sapwood. The Brooke House panelling thus contains a commonly identified source for the boards, and a common construction methodology where the makers appear to be deliberately removing sapwood. All the boards are a single radius, ranging from true radials to moderately tangential sections, with no centres or centrelines within the boards. The plain boards were a maximum of 6–14mm thick, with the three moulded boards at 17mm thick.

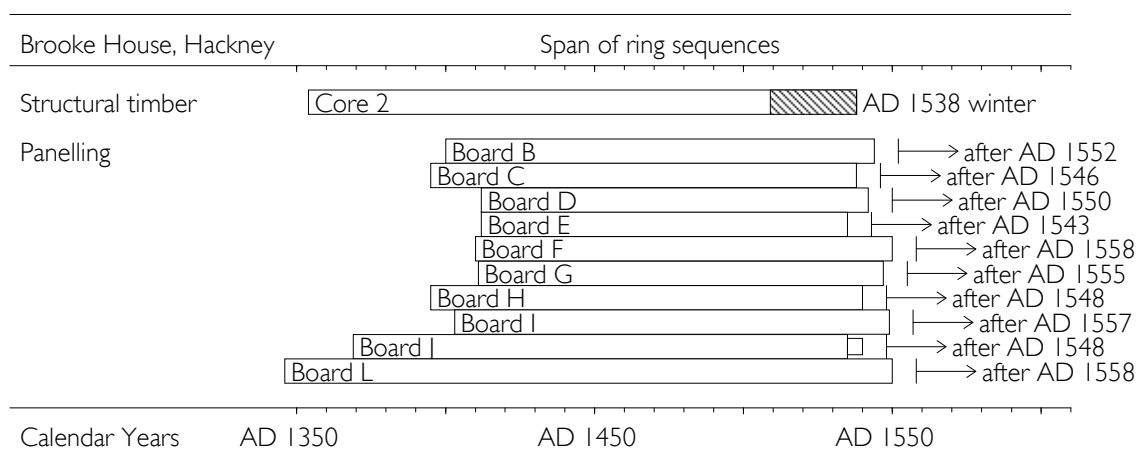
**Figure 8: Bar diagram showing the absolute dating positions of the dated tree-ring sequences for a core and ten boards from Brooke House, Hackney. The felling date and interpreted felling dates are also shown for each dated timber**

KEY. White bars are oak heartwood, hatched bars are oak sapwood, narrow bars are unmeasured rings.

The dated core is of south-eastern English origin and is complete to bark edge, with felling indicated in the winter of AD 1538. The ten dated boards are all of eastern Baltic origin (ie none are of either English or western European origin), with heartwood end dates between AD 1535 and AD 1550 (Fig 8).
