# HOLNE CHASE TIN MINE, HOLNE, DEVON AN ARCHAEOLOGICAL SURVEY

Research Department Report Series no.50/2006

**County:** Devon  
**District:** Teignbridge  
**Parish:** Holne  
**NGR:** SX 7231 7144  
**NMR No:** SX 77 SW 63  
**Date of survey:** January 2006  
**Surveyed by:** Phil Newman, Dave Field  
**Report author:** Phil Newman  
**Illustrations by:** Phil Newman  
**Photography by:** Phil Newman

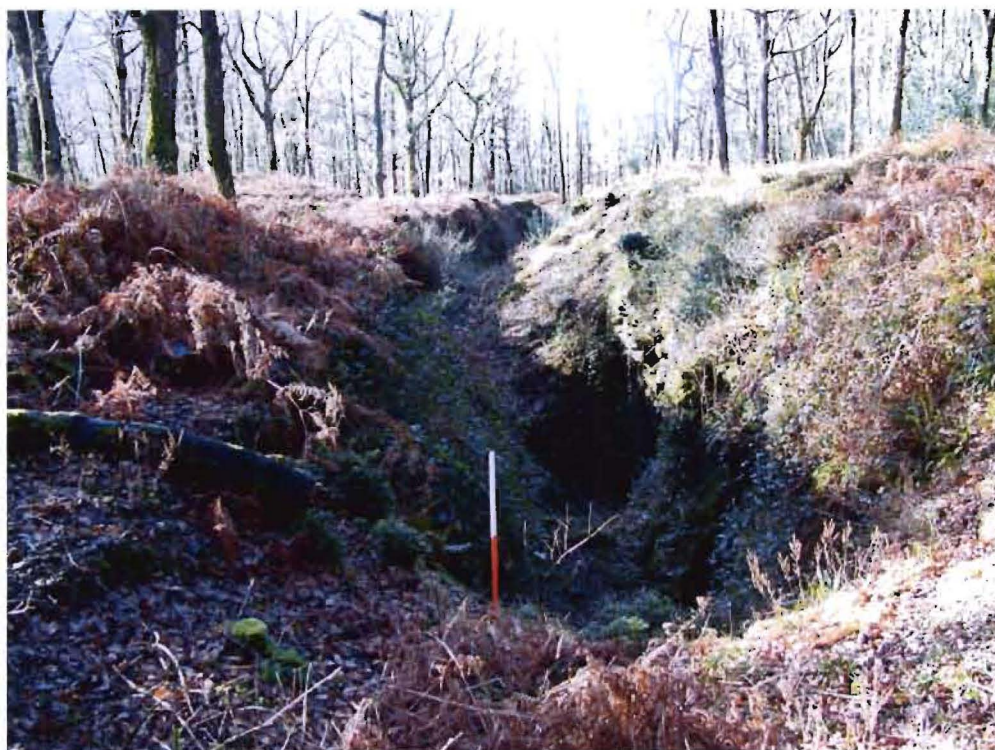
Figure 3 The openwork.

An open rock-cut gunnis, with steep sides and following a strike of approximately 35°, certainly represents the first extractive activity. This may have been formed initially by digging an alignment of closely-spaced pits or 'goffans' onto the back of the lode which outcropped close to the surface, the area between the pits being removed as a second stage in the process leaving the continuous trench which remains. The evidence of numerous shotholes in the faces of the outcrops indicate the use of explosives to remove the rock and implies a probable 19<sup>th</sup>-century date for this openwork. The lack of a spoil heap associated with this phase suggests that a good deal of the material removed was transported away for processing.

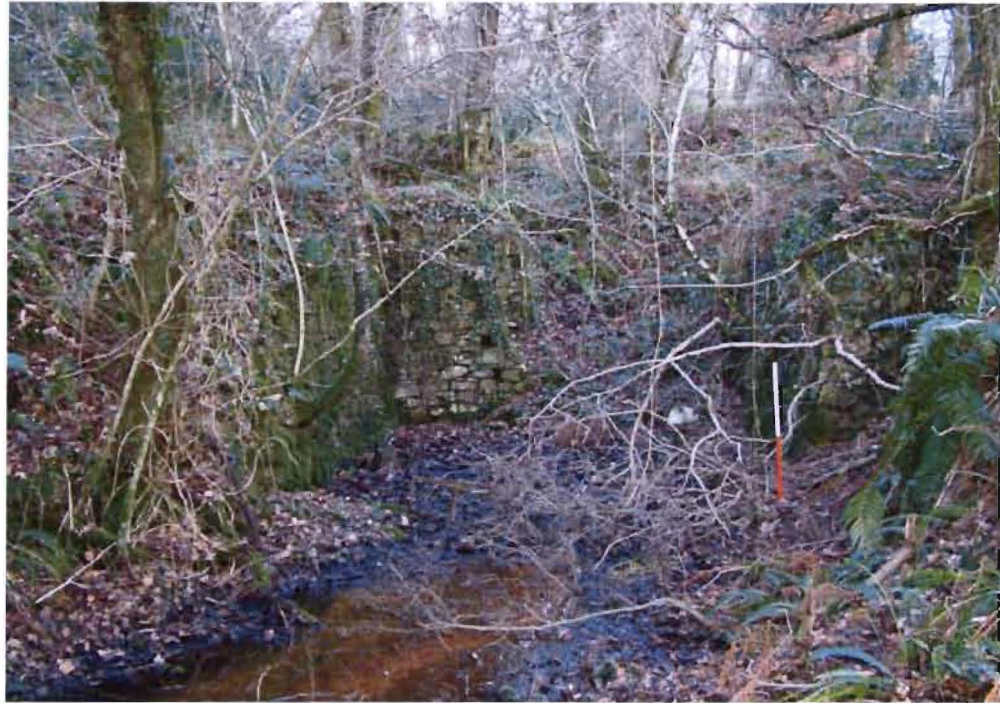
*Figure 6 The wheelpit, disguised by trees and forest debris.*

The wheelpit (wp) is of a sunken construction, approximately 4m deep and 4.2m wide, although it is probable that the wheel only occupied part of this width. The structure is 4.5m long on the west side but only 4m on the east where a back return wall reduces the length slightly. Judging by the height of the leat which is at maximum 6m above the current base of the wheelpit (allowing for silting), if overshot, the maximum diameter of the wheel would have been just under 6m (19.5 ft). This would have protruded just beyond the end of the structure and the axle would have been lower than the top of the wall. However, a breast-shot arrangement could have been used in which case the wheel would have been larger, possibly 8m diameter, and extending beyond the end of the stone structure. This arrangement would have placed the wheel in a better position to power a set of stamps on the narrow terrace on the north side of the wheelpit, but this is a large diameter for such a modest stamp mill. This stamping area (a) consists of a slightly lowered, approximately levelled area with traces of a revetment along one of its scarped edges and was too small to have accommodated more than four or six heads of stamps.

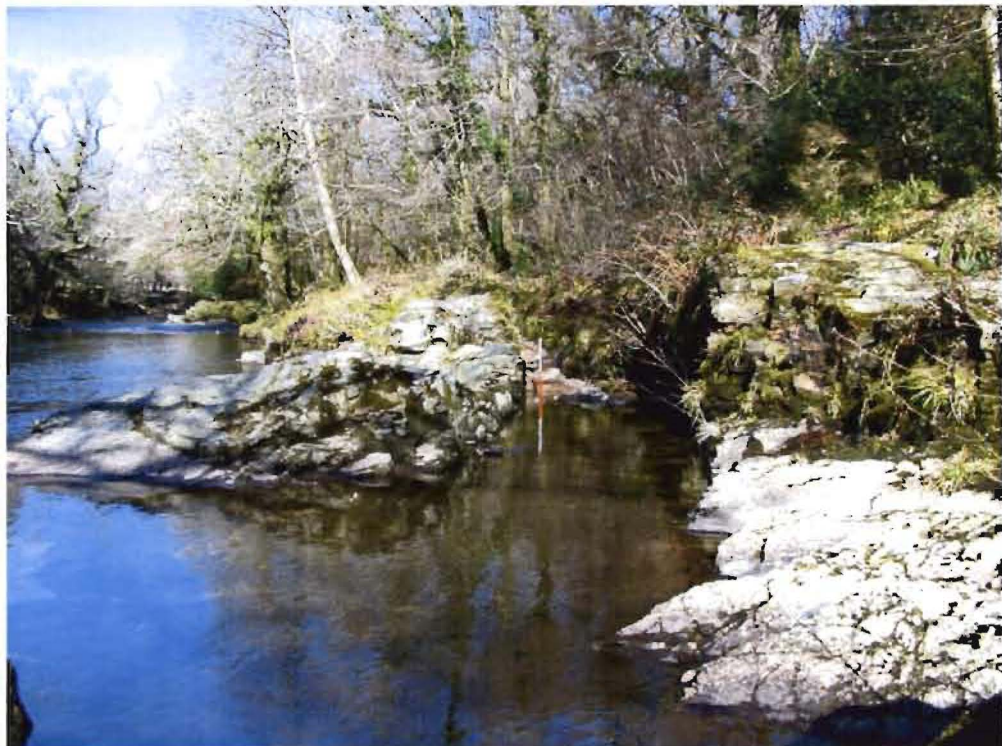
Water was provided via a substantial leat, which was dug in 1874, and diverted the water 540m from a point on the River Dart at SX 7108 7059, upstream of New Bridge, just below Salter's Pool. At this point the channel was cut through the solid rock of the river bank to establish the correct level for the weir outlet. A stone-built sluice survives a few metres downstream, bridging the deep channel of the leat, and would have been used to control

*Figure 7 The leat take-off point on the River Dart below Salter's Pool.*

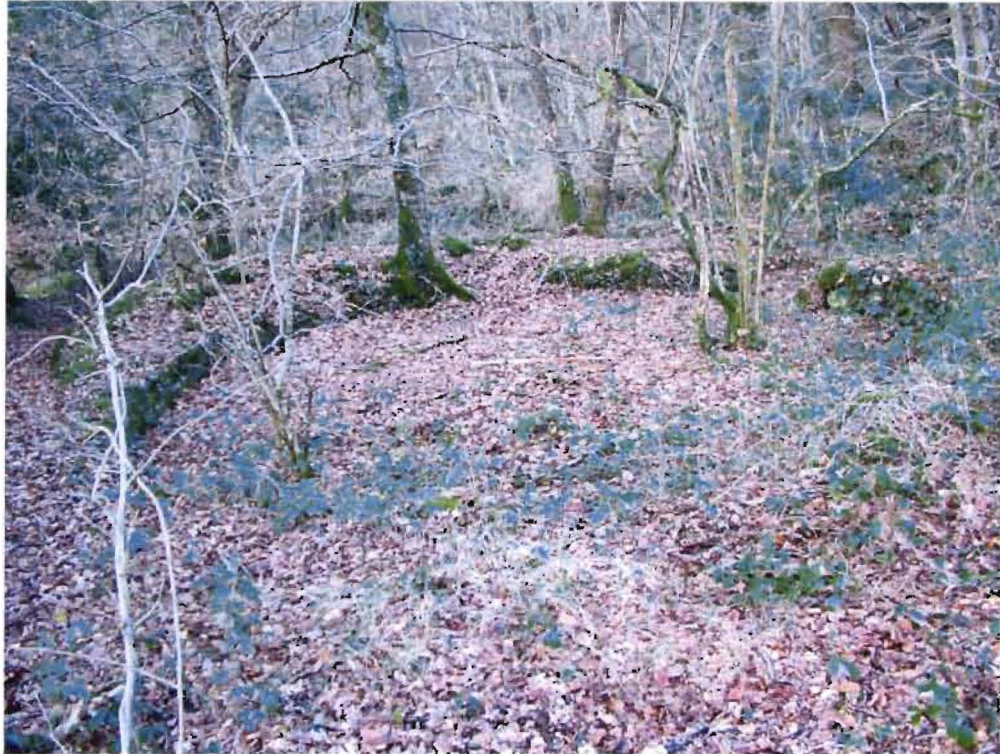
*Figure 8 The large round buddle.*

After crushing, the resulting pulp was concentrated in buddles. Four round buddles survive with masonry linings still in place; a further three are visible as earthworks. The remains of one other marked on the OS 25-inch 1<sup>st</sup> edition map of 1886 may have survived but is not currently visible due to dense brambles. The largest of the buddles (g) has a diameter of 6.55m, is approximately 0.3m deep, and has an intact masonry lining around its circumference. There is an outflow opening of 0.7m wide on the south side, which directed waste water into the tailings pit set just below. A slight mound in the centre of the buddle is probably the remains of the central dome.
