THE OLD HALL (MANOR HOUSE), CHURCH WARSOP, NOTTINGHAMSHIRE

HISTORIC BUILDINGS REPORT

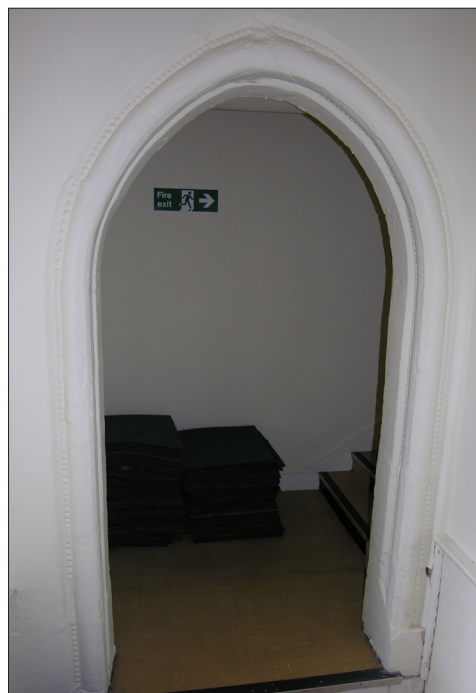
**Figure 4. 13th-century archway with nailhead decoration, as reset in c.1800 in first-floor landing.
Linda Monckton 04/06**

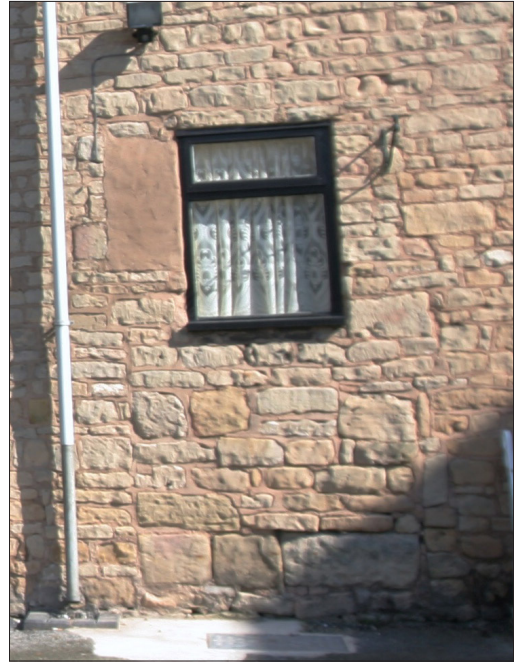
Figure 17. West facade of east range, showing blocked doorway to former great hall.

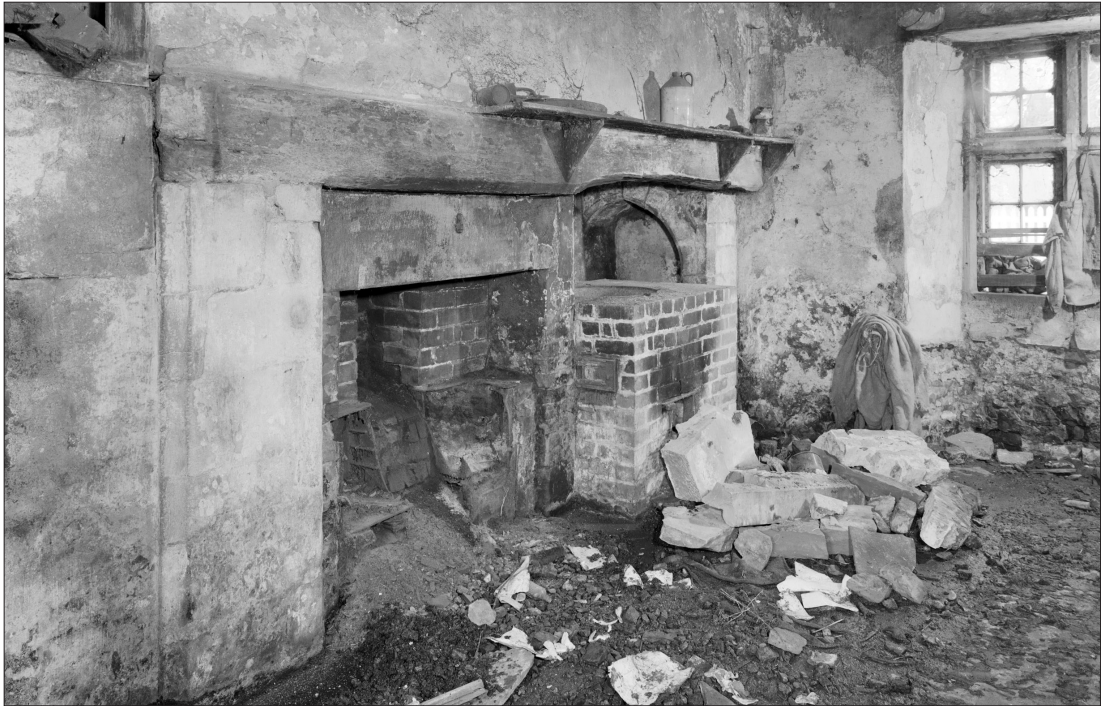
Figure 25. View of kitchen taken in 1966 showing 19th-century fireplace and late 17th-century windows inserted within what was the medieval great hall.

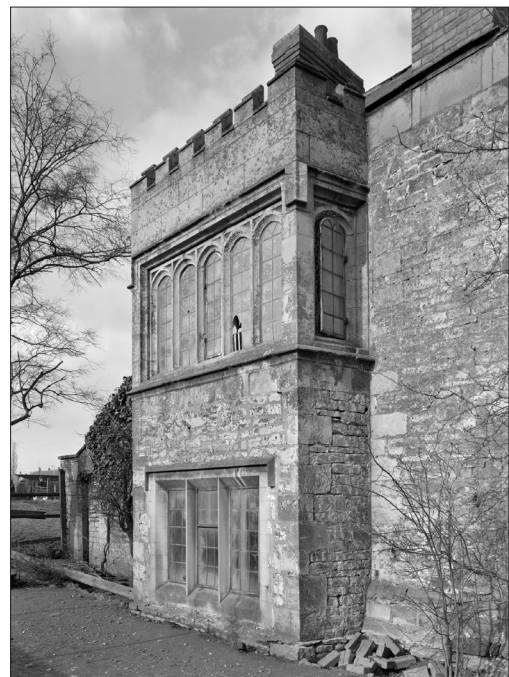
Figure 26. Bay window on south façade.

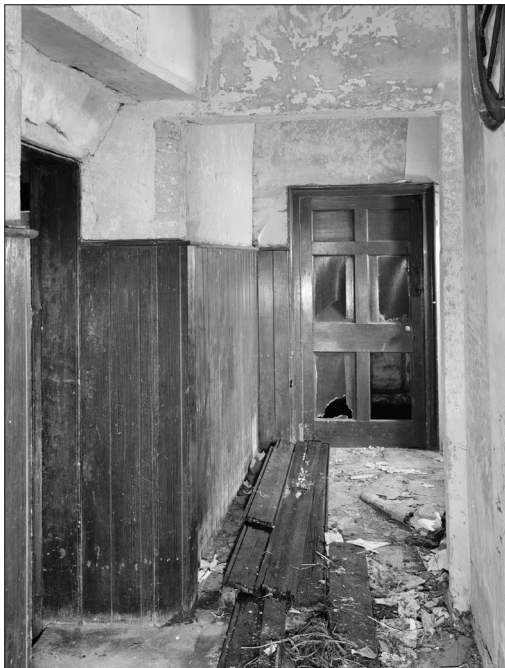
Figure 33. View along hall passage looking east, with 19th-century stairwell circular window to right. Opening to left, now location of inserted wooden staircase.

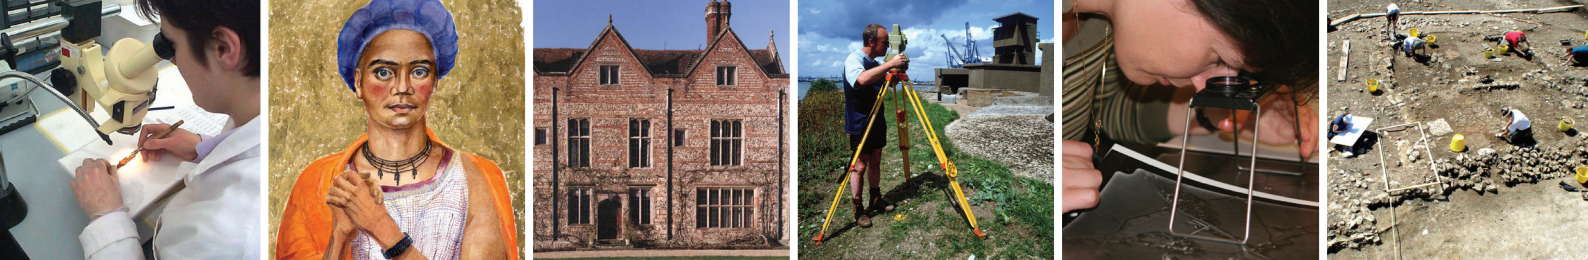
ENGLISH HERITAGE RESEARCH DEPARTMENT
