DEWAR'S LANE GRANARY, BERWICK-UPON-TWEED, NORTHUMBERLAND TREE RING ANALYSIS OF TIMBERS

SCIENTIFIC DATING REPORT

Research Department Report Series 24-2008

TREE RING ANALYSIS OF TIMBERS

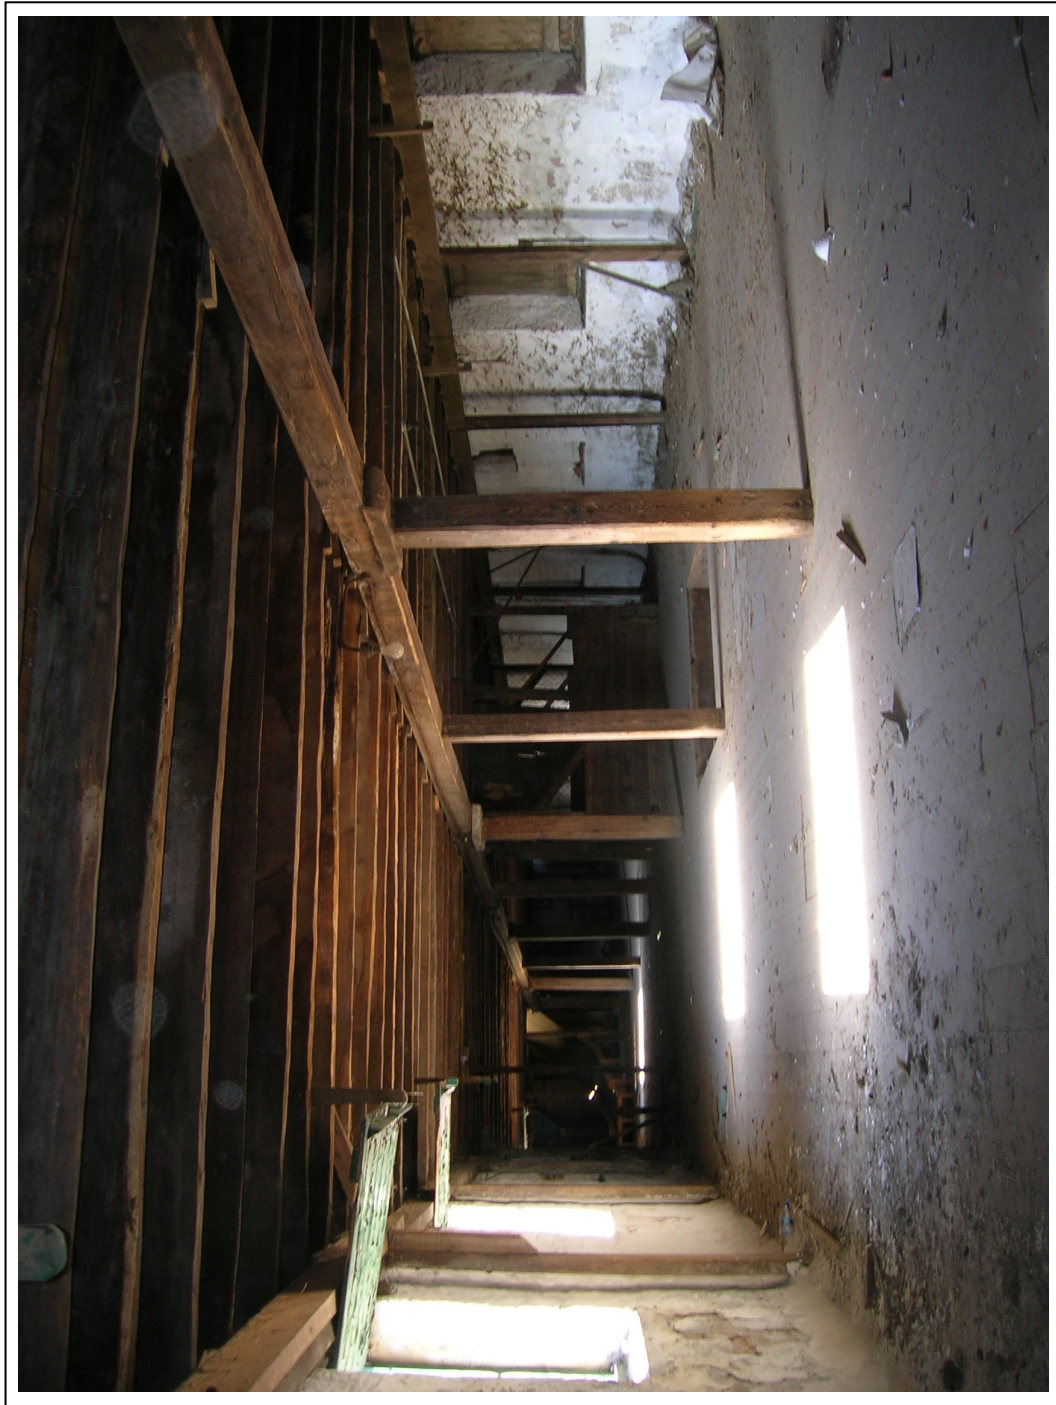
Figure 2: Second floor, looking north

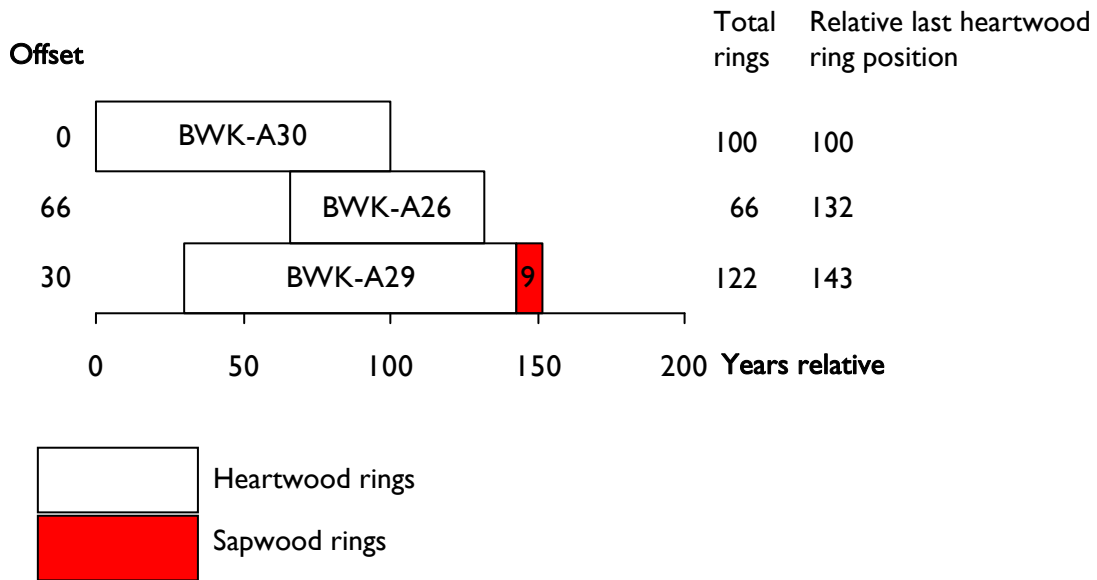
Figure 10: Bar diagram of samples in undated site sequence BWKASQ01

At a least value of $t=5.0$, two groups had formed. Three samples matched each other and were combined at the relevant offset positions to form BWKASQ01, a site sequence of 152 rings (Fig 10). The remaining three oak samples matched each other and were combined at the relevant offset positions to form BWKASQ02, a site sequence of 305 rings (Fig 11). Attempts to date these two site sequences by comparing them against a

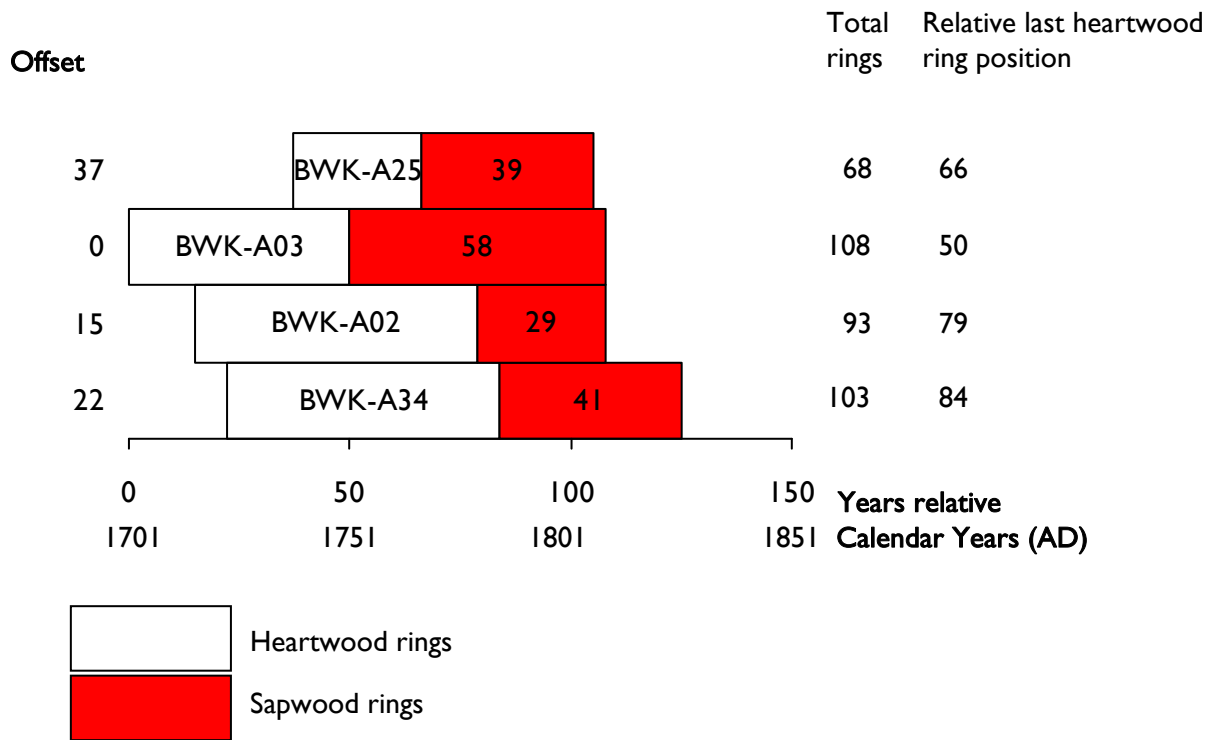
Figure 12: Bar diagram of samples in site sequence BWKASQ03

At a least value of $t=4.5$, 33 samples had formed ten groups. Four samples matched and were combined at the relevant offset positions to form BWKASQ03, a site sequence of 125 rings (Fig 12). This site sequence was then compared against a series of relevant reference chronologies for pine where it was found to have a consistent match at a first-ring date of AD 1701 and a last-ring date of AD 1825. The evidence for this dating is given by the t -values in Table 2.

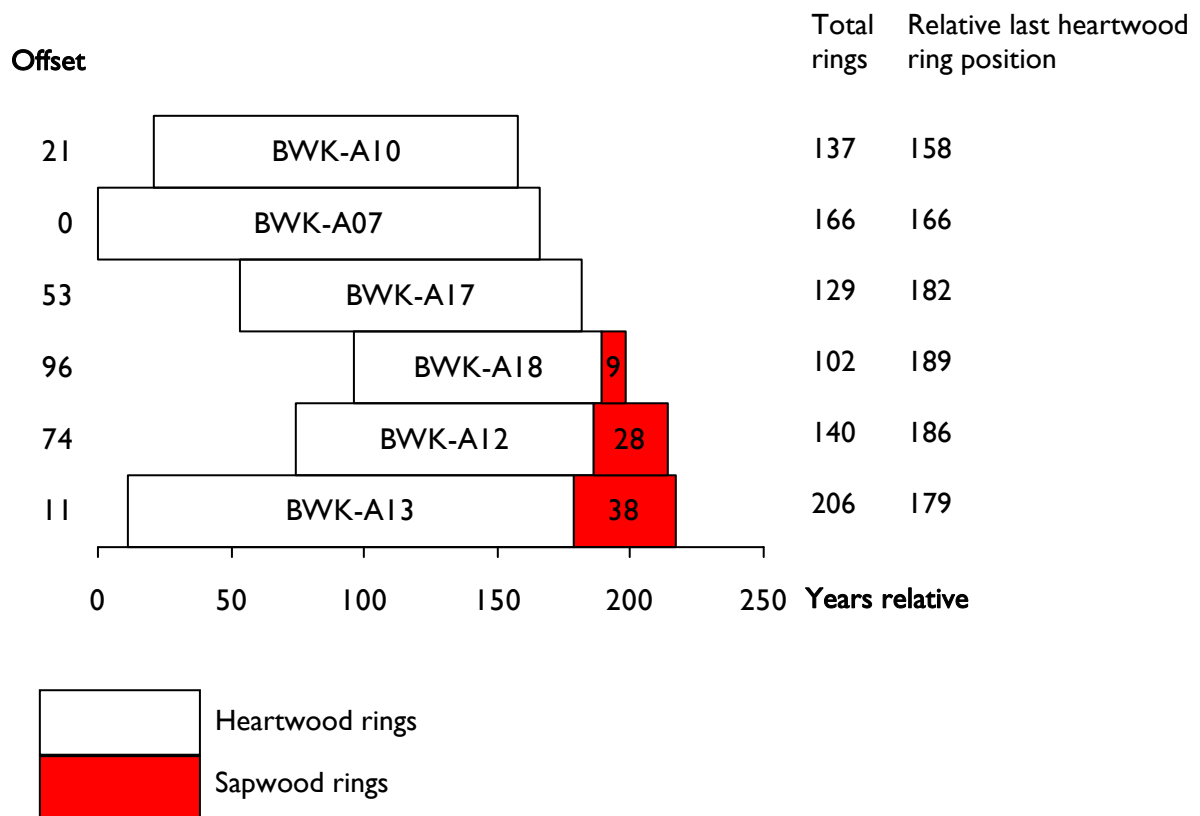
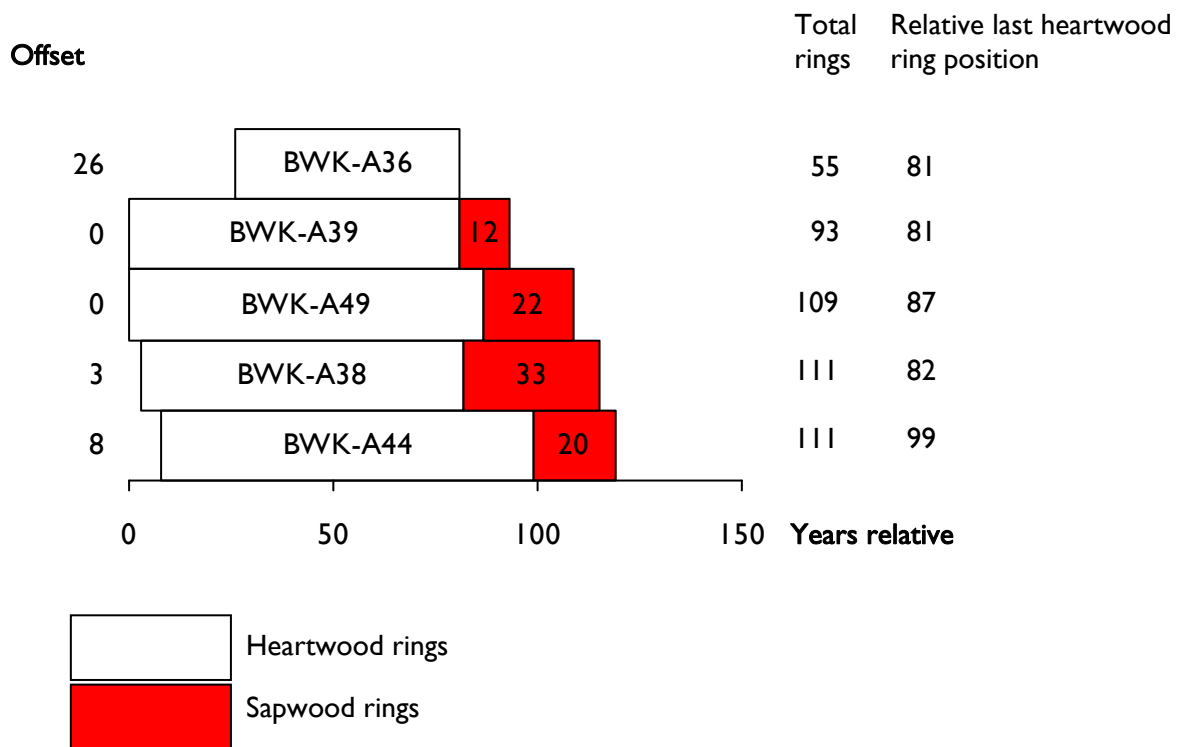
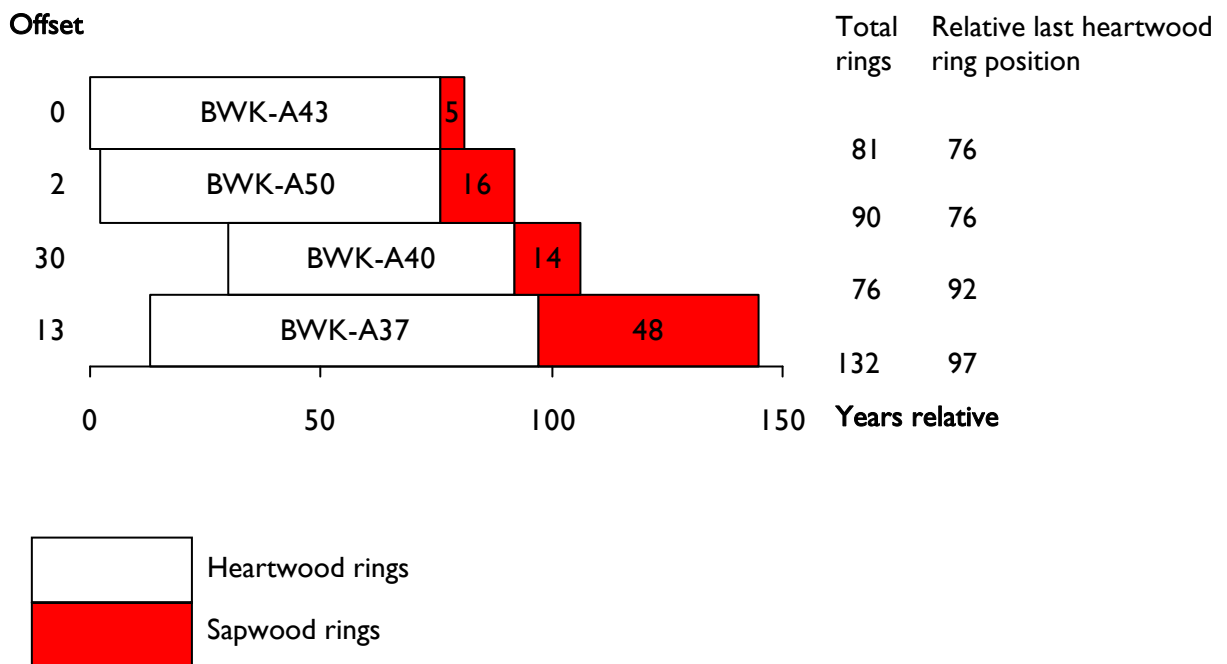
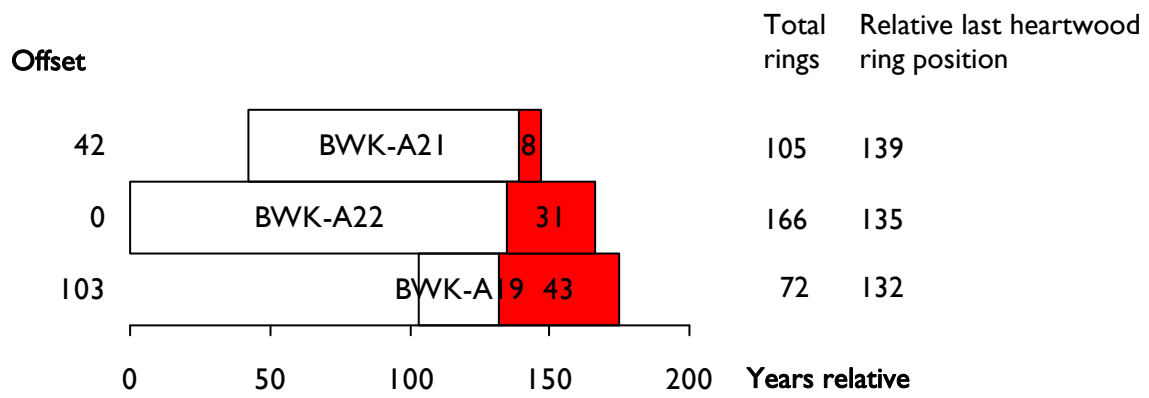
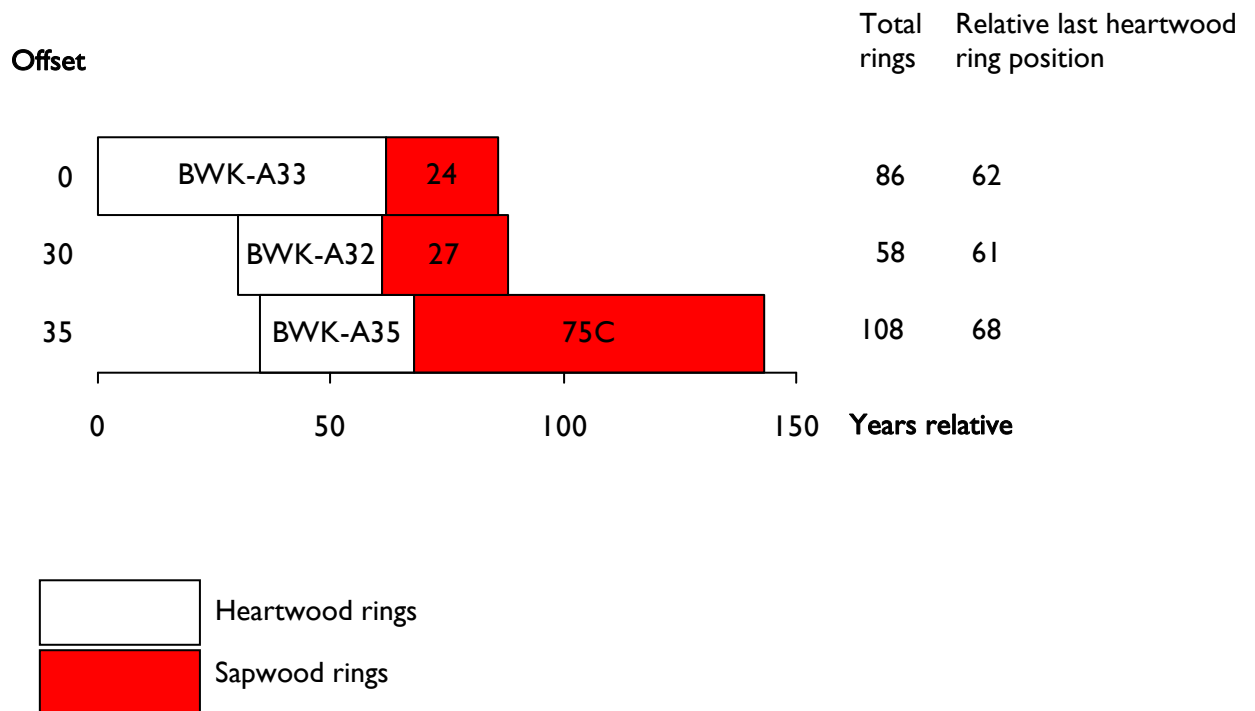
Figure 13: Bar diagram of samples in undated site sequence BWKASQ04

Figure 14: Bar diagram of samples in undated site sequence BWKASQ05

Figure 15: Bar diagram of samples in undated site sequence BWKASQ06

Figure 16: Bar diagram of samples in undated site sequence BWKASQ07

Figure 17: Bar diagram of samples in undated site sequence BWKASQ08

Figure 18: Bar diagram of samples in undated site sequence BWKASQ09

Figure 19: Bar diagram of samples in undated site sequence BWKASQ10

Figure 20: Bar diagram of samples in undated site sequence BWKASQ11

Figure 21: Bar diagram of samples in undated site sequence BWKASQ12

The other nine site sequences (Figs 13–21) formed from small groups of matching samples were also initially compared with an extensive range of European pine reference chronologies, including those available from Scottish sites, which consist of both native and imported timbers, and subsequently with chronologies from Canada and the north-eastern area of the United States of America. No satisfactory cross-matching was identified for these remaining site sequences, nor was there any conclusive cross-matching for any of the ungrouped pine samples.

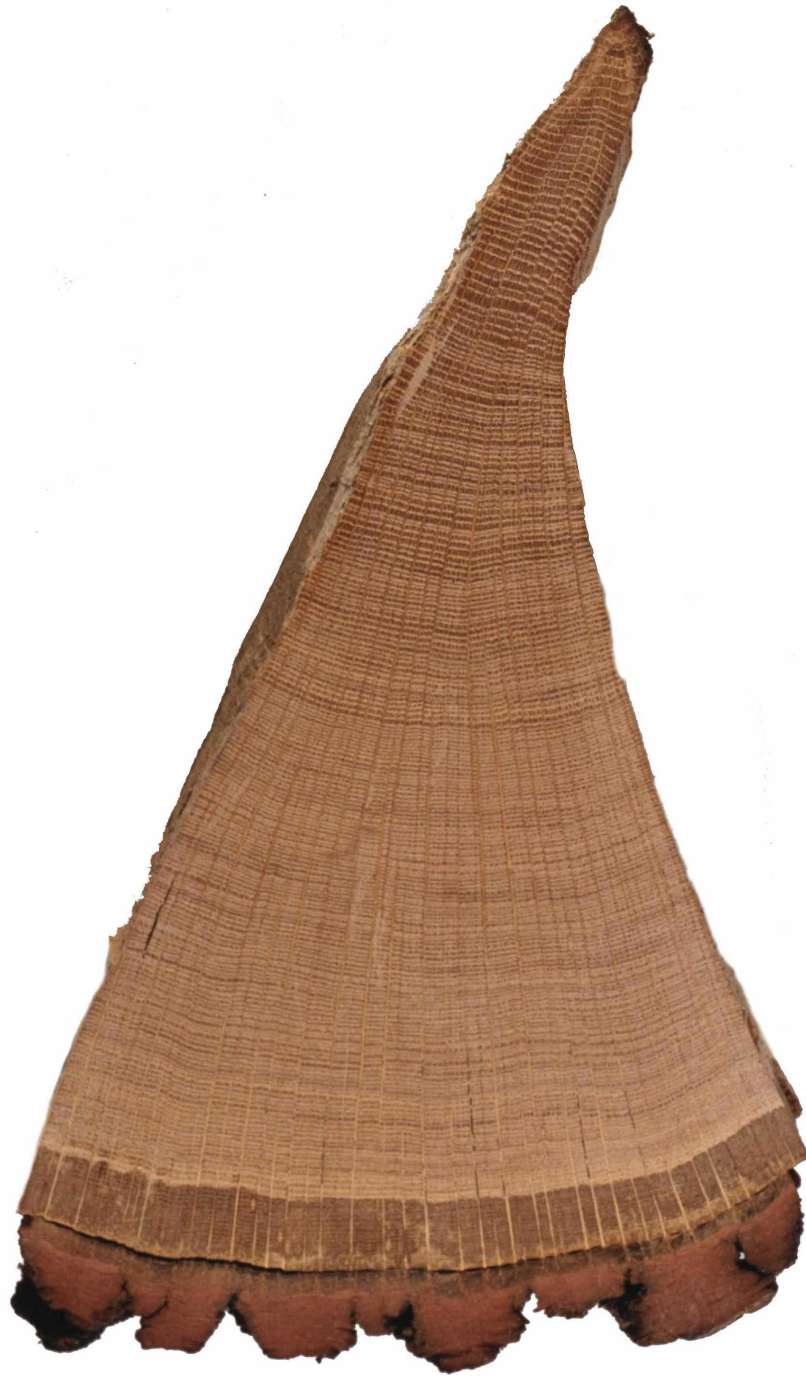
Figure A1: A wedge of oak from a tree felled in 1976. It shows the annual growth rings, one for each year from the innermost ring to the last ring on the outside just inside the bark. The year of each ring can be determined by counting back from the outside ring.

If the bark is still on the sample, as in Figure A1, then the date of the last ring will be the date of felling of the oak from which it was cut. There is much evidence that in medieval times oaks cut down for building purposes were used almost immediately, usually within the year or so (Rackham 1976). Hence if bark is present on several main timbers in a building, none of which appear reused or are later insertions, and if they all have the same date for their last ring, then we can be quite confident that this is the date of construction or soon after. If there is no bark on the sample, then we have to make an estimate of the felling date; how this is done is explained below.

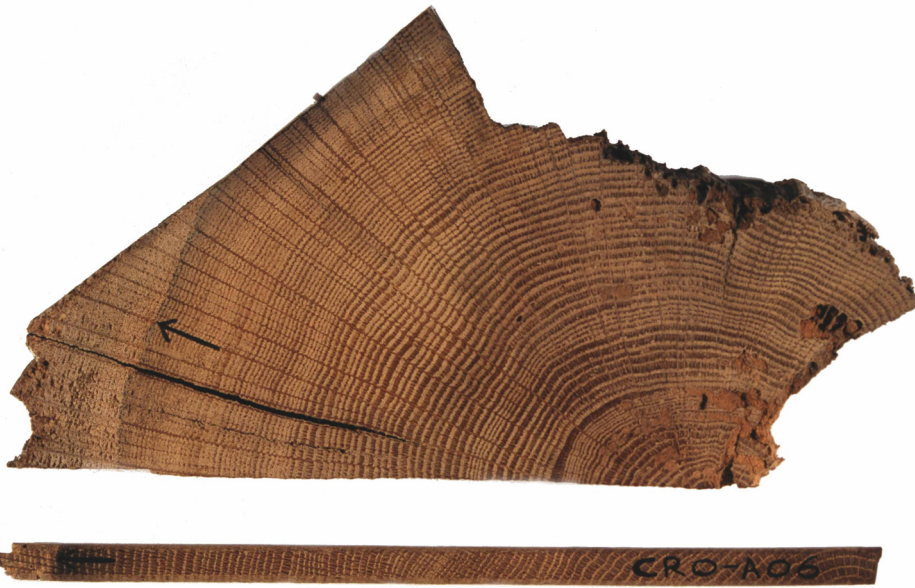
Figure A2: Cross-section of a rafter, showing sapwood rings in the left-hand corner, the arrow points to the heartwood/sapwood boundary (H/S); and a core with sapwood; again the arrow is pointing to the H/S. The core is about the size of a pencil

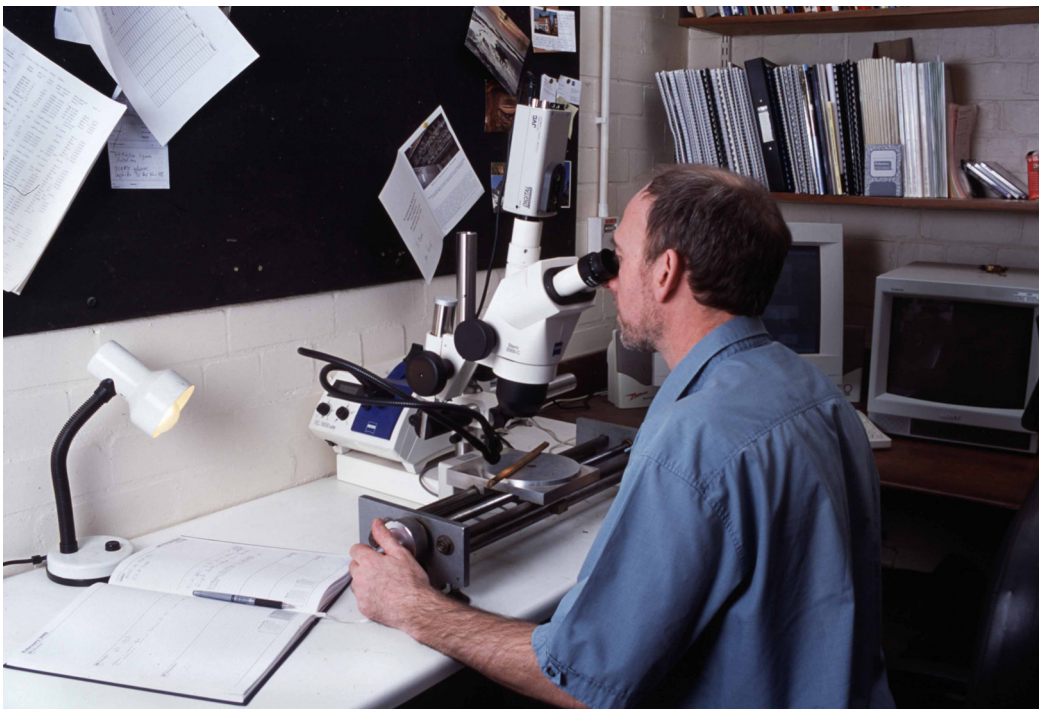
Figure A3: Measuring ring widths under a microscope. The microscope is fixed while the sample is on a moving platform. The total sequence of widths is measured twice to ensure that an error has not been made. This type of apparatus is needed to process a large number of samples on a regular basis

2. Measuring Ring Widths. Each core is sanded down with a belt sander using medium-grit paper and then finished by hand with flourgrade-grit paper. The rings are then clearly visible and differentiated from each other with a result very much like that shown in Figure A2. The core is then mounted on a movable table below a microscope and the ring-widths measured individually from the innermost ring to the outermost. The widths are automatically recorded in a computer file as they are measured (see Fig A3).

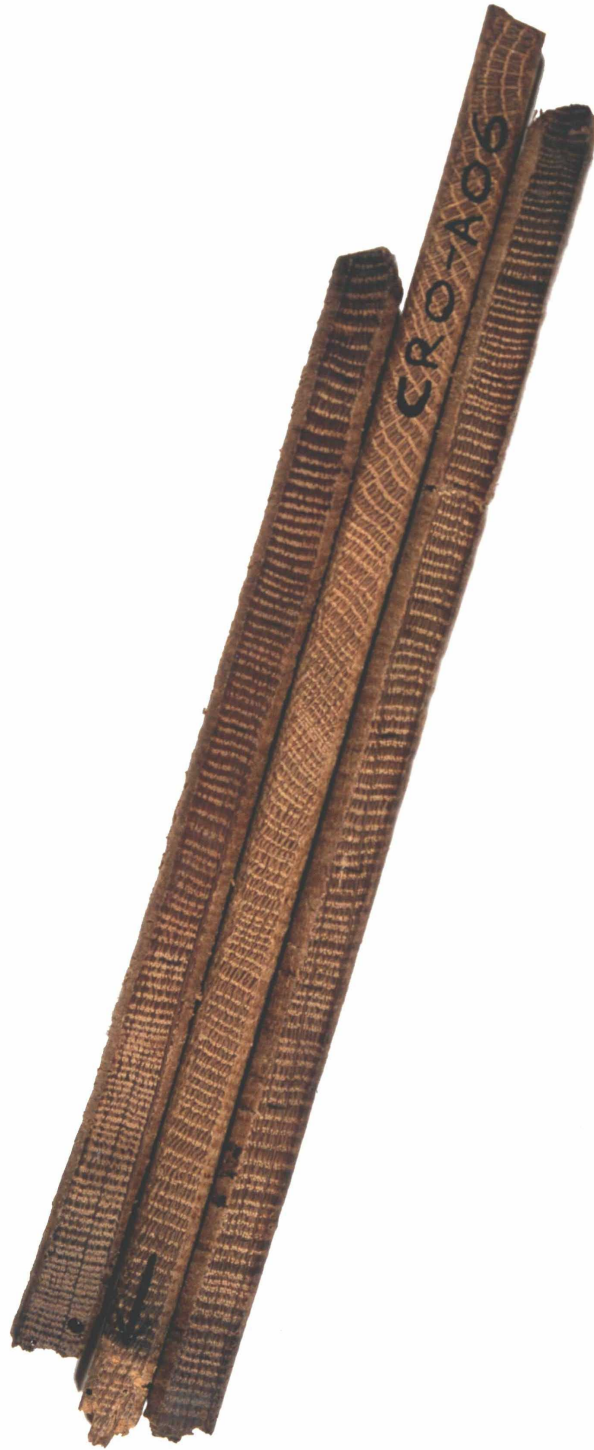
Figure A4: Three cores from timbers in a building. They come from trees growing at the same time. Notice that, although the sequences of widths look similar, they are not identical. This is typical
