## HOO PENINSULA, KENT SECOND WORLD WAR STOP LINE HOO ST WERBURGH TO HIGHAM MARSHES

ARCHAEOLOGICAL REPORT

# SECOND WORLD WAR STOP LINE HOO ST WERBURGH TO HIGHAM MARSHES

The Second World War stop line between Hoo St Werburgh and Higham Marshes is a notable surviving example of anti-invasion defence. It is the northern section of the Newhaven-Hoo General Headquarters (GHQ) Line where it crosses the Hoo Peninsula in Kent between the rivers Medway and Thames. It is an important remnant of the Second World War defended landscape of the peninsula and is a well-preserved example of this type of defence, which is part of a major chapter in the national story. The surviving remains form a coherent pattern of defence linked to the local topography and connect our perceptions of the current landscape with the fear of invasion experienced by a previous generation. The line was part of a national network of defences and was constructed in July and August 1940 to hinder invading forces from the Kent and Sussex coast. The defensive line used natural and manmade obstacles connected by sections of anti-tank ditch. The line was heavily defended and included pillboxes, anti-tank gun emplacements a

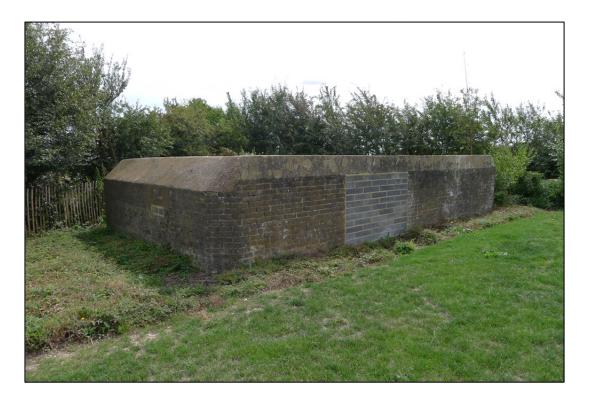
Figure 4 Type 28 artillery pillbox east of Bells Lane, Hoo St Werburgh (NRHE 1426745 )

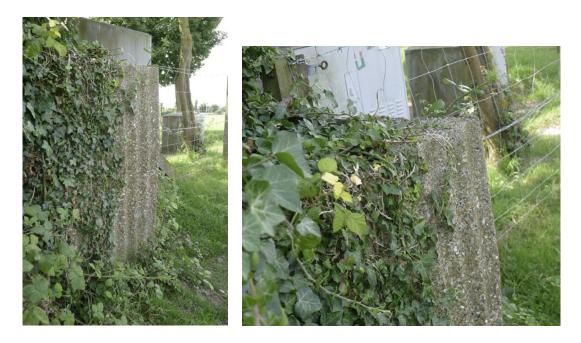
Figure 5 Concrete blocks which were part of a roadblock on a track leading north from Stoke Road, Hoo St Werburgh (NRHE 1418717)

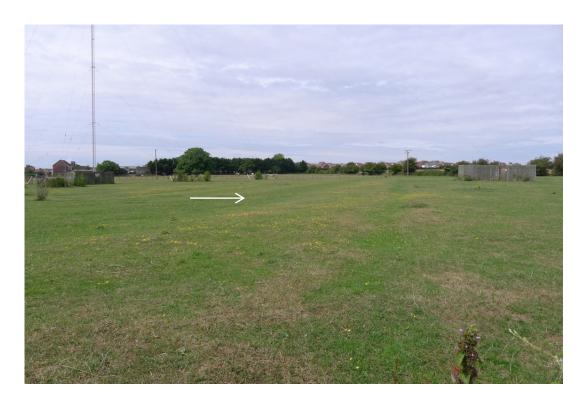
Figure 12 The anti-tank ditch visible as a low earthwork to the north of Stoke Road.

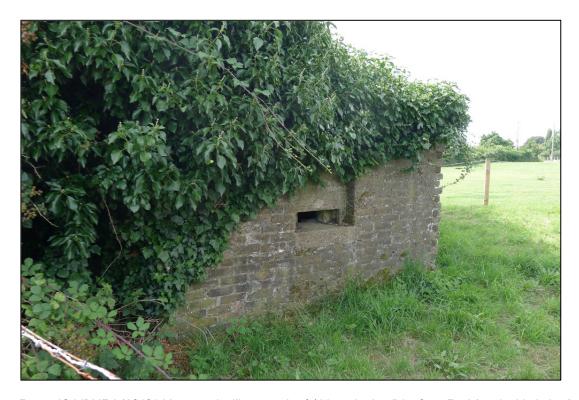
Figure 13 NRHE 1418686 Hexagonal pillbox south of Abbots Lodge (No. 2 on Fig 14 and table below).

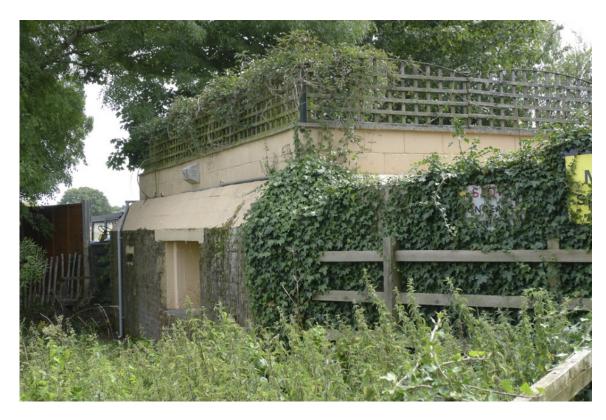
Figure 16 NRHE 1418680 Type 28 artillery pillbox, now on the edge of Hoo St Werburgh, (No. 11 in Fig 21 and table below) with a garden on top. Photographed from an adjacent road.

garden of Deangate, on the east side of Deangate Road, north of Hoo St Werburgh	was located during a field visit in 2014 and appeared (from the road) to be in good condition (Fig 16).	
12	1441600	Second World Type 24 hexagonal pillbox lies within scrubby woodland at the south-east corner of the Lodge Hill Royal Naval Armament Depot and was part of its defended perimeter. It also overlooked the course of the line.	The pillbox was visible on aerial photographs until at least 2003, and was examined by the Medway Military Research Group on a field visit in 2006, when it was found to be in good condition but overgrown. The pillbox was not recorded during a Built Heritage Baseline Assessment undertaken in 2009 in advance of possible development of the Lodge Hill Depot site (CgMs Ltd 2009). The area is under tree cover on aerial photographs of 2007 and 2013, so its present condition is unknown.	TQ 77415 73706

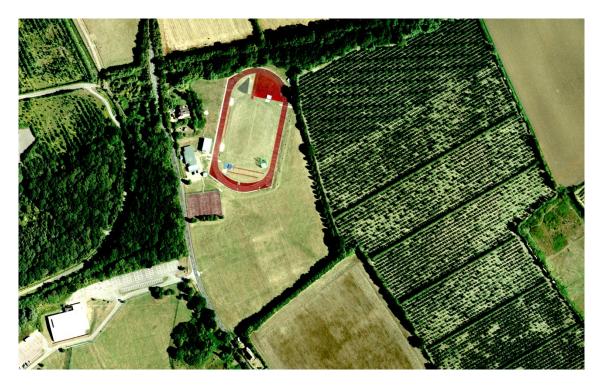
Figure 20 Buried remains of the stop line ditch show as a cropmark to the south east of Deangate Ridge Sports Ground. Next Perspectives PGA Tile Ref: TQ7773 14-AUG-2003. Aerial Photography: Licensed to English Heritage for PGA, through Next Perspectives™.

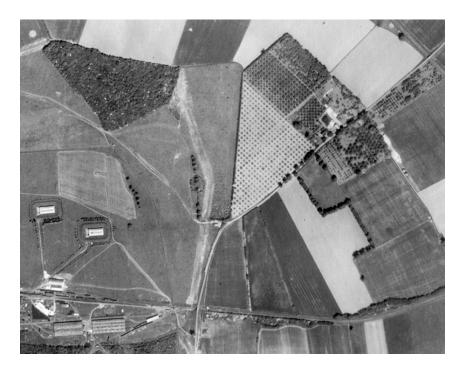
Condition: The earliest aerial photographs, taken in 1944, show this section of anti-tank ditch was already out of use and being backfilled, with mounds of earth visible alongside the former ditch (Fig 23). Sub-surface remains of sections of the ditch were indicated by cropmarks in pasture on aerial photographs of 2003 to the south of Wybornes Wood (Fig 24). There is intermittent evidence of a spread ditch in the area between the south east corner of Wybornes Wood and the First World War redoubt and pillbox to the south (observation from field visit in May 2015).

Figure 23 The anti-tank ditch from the east entrance of the Lodge Hill Ordnance Depot north to Wybornes Wood. US 7GR/LOC/348 2065 27-MAY-1944 English Heritage USAAF Photography.

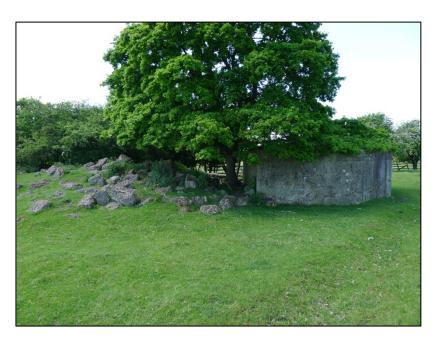
Figure 25 NRHE 1426123 Type 24 pillbox (No. 6 in Fig 22 and the table below) with adjacent rubble, possibly from a demolished pillbox.Photographed in May 2015.

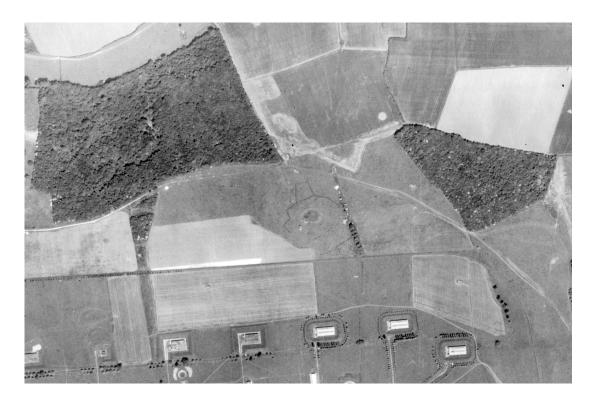
Condition: The earliest aerial photographs, taken in 1944, show the ditch is backfilled, with mounds of earth visible alongside (Fig 27). It is visible as a vegetation mark on aerial photographs of 2003 (Fig 28). A 2015 field visit confirms the ditch survives as a very low earthwork adjacent to Lodge Hill Wood and where it turns at a sharp right angle (Fig 29).

Figure 27 The angled part of the stop line between Wybornes Wood and Lodge Hill Wood in 1944. US 7GR/LOC/348 2065 27-MAY-1944 English Heritage USAAF Photography.

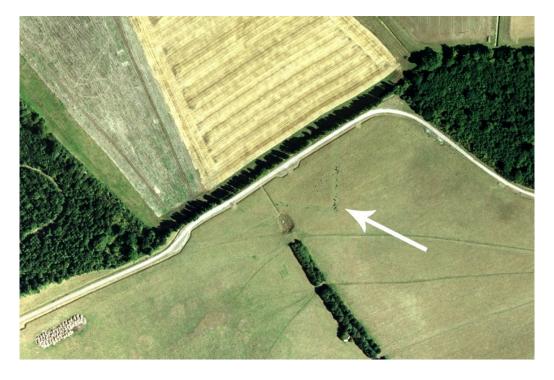
Figure 28: A section of the angled anti-tank ditch, visible as a vegetation mark, between Wybornes Wood and Lodge Hill Wood. Next Perspectives PGA Tile Ref: TQ7674 14-AUG-2003. Aerial Photography: Licensed to English Heritage for PGA, through Next Perspectives<sup>™</sup>.

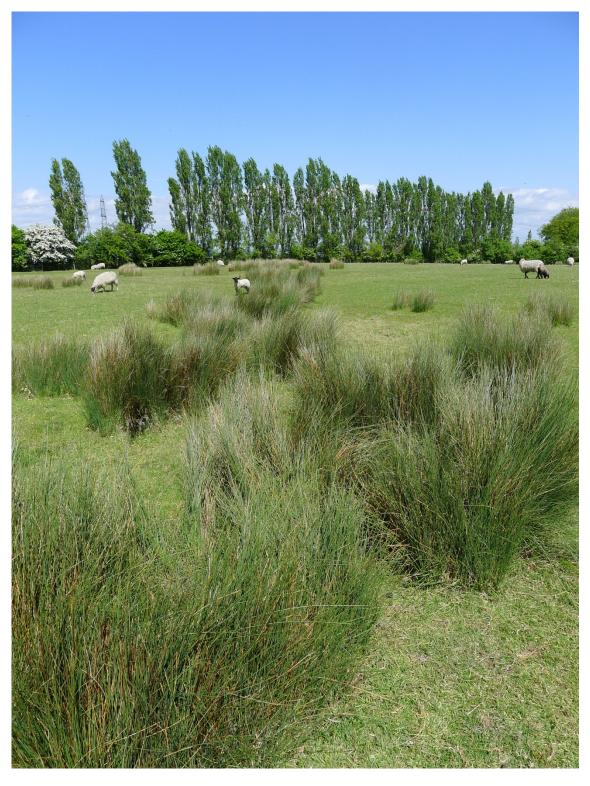
Figure 29 NRHE 1542665 The V-shaped section of anti-tank ditch seen in Fig 26 surviving as a low earthwork indicated by the reeds, photographed in May 2015.

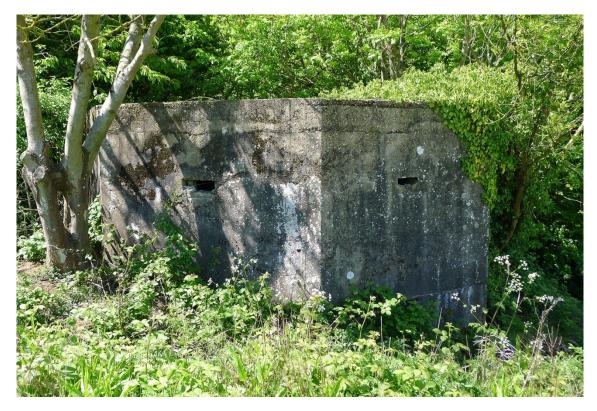
Figure 30 NRHE 1426724 Type 24 pillbox (No. 2 in the table above) with blocked embrasures, photographed in May 2015.

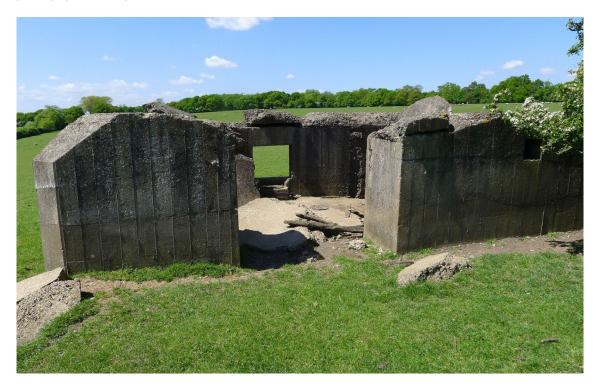
Figure 31 NHE 1426099 Type 28 pillbox (No. 5 in the table above) surviving as a roofless structure photographed in May 2015. A gun emplacement is located within the embrasure in the centre of the photograph.

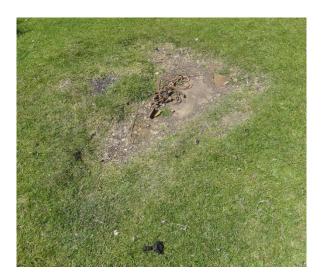
Figure 32 NRHE 1549853 Buried hatch seen on a field visit in May 2015. It is probably associated with military earthworks on the north edge of Deangate Ridge (No. 2A in table above).

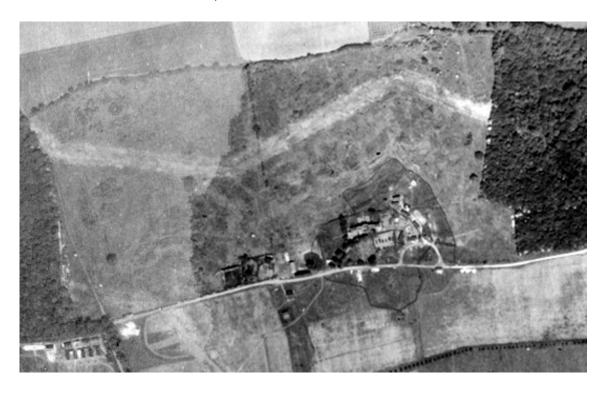
Figure 33 The stop line between Lodge Hill Wood (right) and Berry Court Wood (left). US 7GR/LOC/348 2065 & 3062 27-MAY-1944 English Heritage USAAF Photography.

Condition: The earliest photographs, taken in 1944, show the backfilled anti-tank ditch and there are mounds of earth lying alongside (Fig 33). However, the route of the stop line is still discernible as a vegetation pattern on 2003 Google Earth aerial photographs (Fig 34). Later aerial photographs show the scrubby trees are denser but you can still make out an earthwork. A concrete pathway seen on a field visit in 2014, in Berry Court Wood, may be a military track.

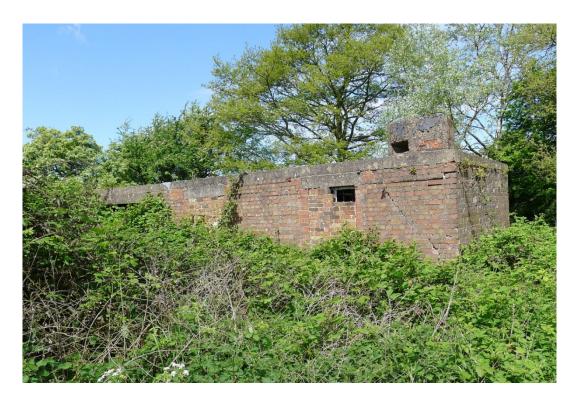
Figure 36 NRHE I 546483 First World War military support building, at Lodge Hill anti-aircraft battery, reused in Second World War. It appears to have been defended originally but may have been a generator building during the Second World War

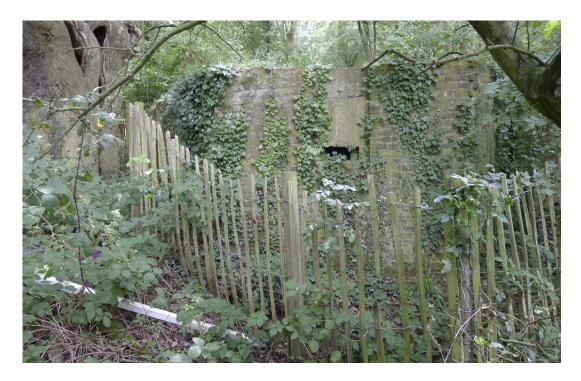
Figure 37 NRHE 1418703 Type 24 pillbox at the northern edge of Berry Court Wood (photographed from an adjacent path)

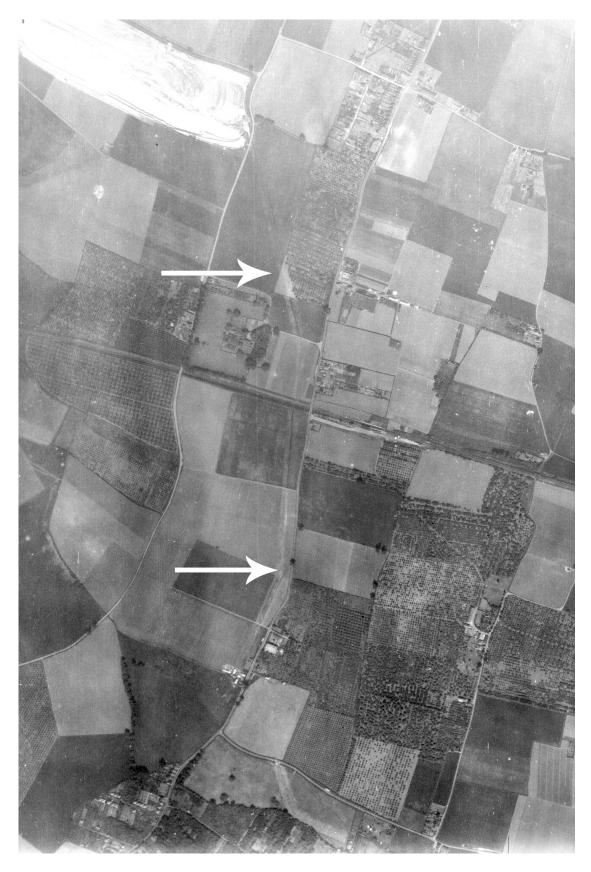
Condition: Aerial photographs taken on 20th June 1942 record the stop line near Cliffe Woods with the anti-tank ditch in place. The whole section was photographed in 1944, when the ditch was being backfilled, with mounds of earth lying alongside the former ditch (Fig 39). The buried remains of the anti-tank ditch were visible as a cropmark on aerial photographs of 1946. Aerial photographs taken in 2011 and 2013 suggest that the anti-tank ditch survives as a sub-surface feature, revealed as a cropmark between Mortimer's farm and the disused quarry (Figs 40-41). It has probably been destroyed by housing on the edge of Cliffe Woods village to the east of the B2000 road (Figs 38, 42).

Figure 39 The stop line between Cliffe Woods village and (now disused) Cliffe quarry. US 7GR/LOC348 3064 27-MAY-1944 English Heritage USAAF Photography.

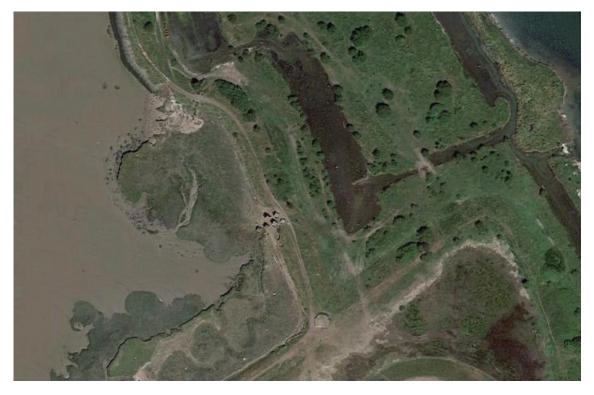
Condition: The anti-tank blocks at West Court Farm, identified on the ground by the Defence of Britain project, require a site visit Recent aerial photographs (Google Earth 2013) show a large section of anti-tank ditch was quarried away but the pillbox and concrete pillars are still in place (Figs 45-47).

Figure 46 The remains of the anti-tank ditch, concrete pillars and pillbox on the bank of the River Thames © Google Earth 07-SEP-2013
