CHURCH OF ST MABENA,  
ST MABYN, CORNWALL  
DENDROCHRONOLOGICAL ANALYSIS  
OF OAK TIMBERS

SCIENTIFIC DATING REPORT

Research Department Report Series 74-2008

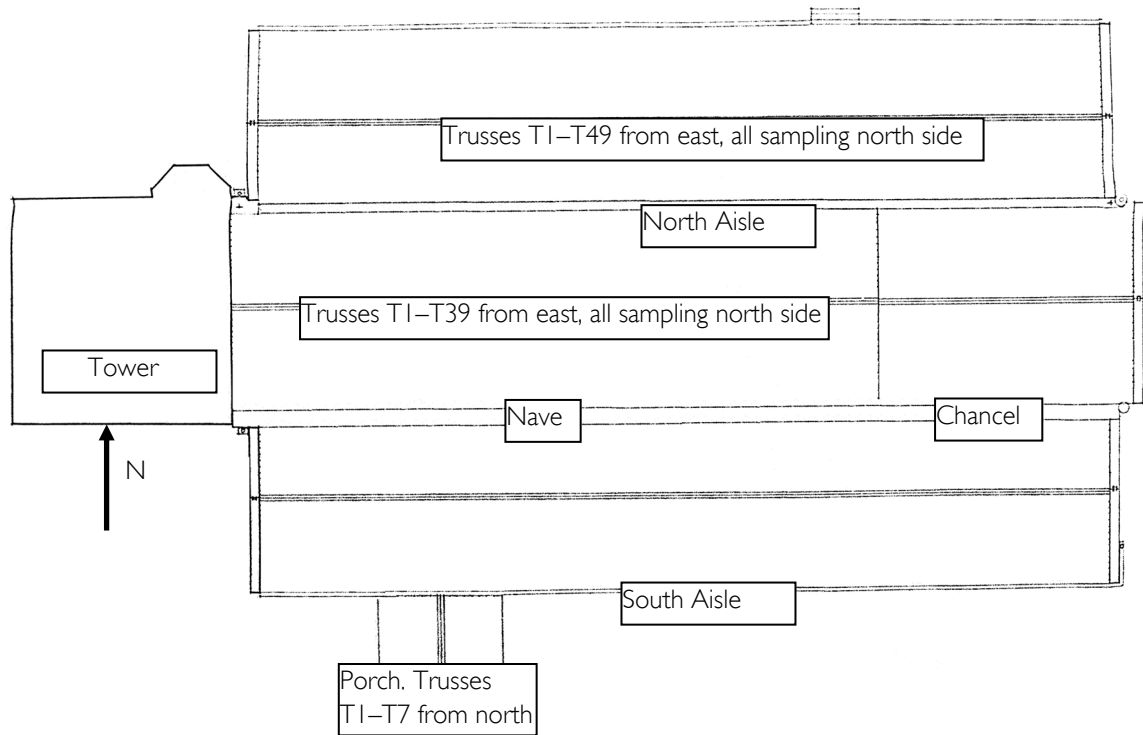
*Figure 2. Plan of the church of St Mabena, St Mabyn, Cornwall. The truss numbering schemes followed in this report, and the location of the sampled areas are shown. Based on a plan by Bazeley, Miller-Williams and Corfield, Architects, supplied by English Heritage 2008*

The original timbers exhibit clear evidence for trestle sawing, and retain a series of scribed carpenters' numbers in Roman numerals. This report arbitrarily assigned truss numbers for each discrete area of roof, running from 1 at the east end of each of the east-west roofs, and from the north end of the porch (Fig 2).

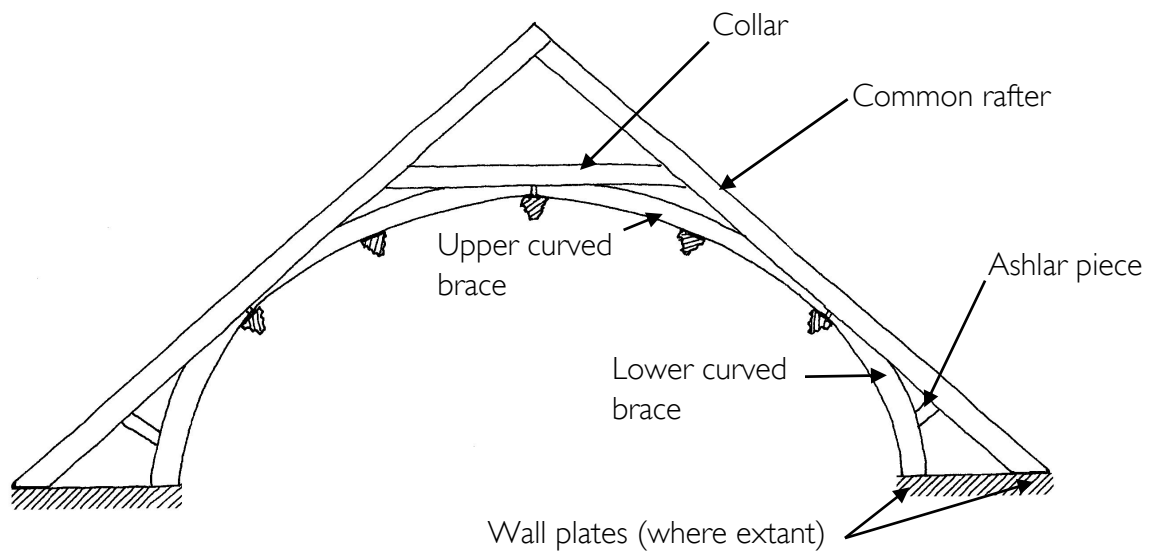
*Figure 3. Sketch of a typical truss from the church of St Mabena, St Mabyn, Cornwall, showing the nomenclature followed in this report*

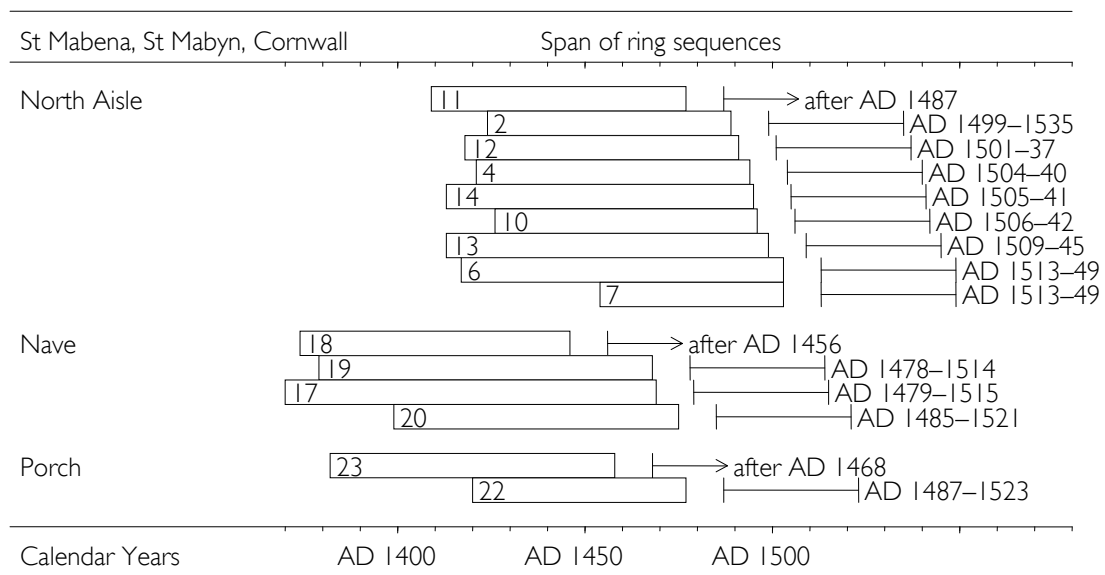
*Figure 4. Bar diagram showing the absolute dating positions of the 15 dated tree-ring sequences for samples from the church of St Mabena, St Mabyn, Cornwall. The interpreted felling dates are also shown for each sample.*

KEY White bars are oak heartwood.

The samples were prepared for analysis, measured, and then compared with each other. A group of nine timbers from the north aisle roof were found to cross-match each other strongly (Table 2), whilst a group of four samples from the nave roof and the two samples from the porch were also found to form an internally consistent group (Table 3). Each cross-matched group was then combined into a single composite data set. These were compared with each other without identifying any significant correlation between them. These two composite data sets were then compared with medieval and later tree-ring data from throughout England and Wales. Both the composite sequences were found to cross-match against medieval data from sites in the South-West region. This cross-matching provided consistent calendar dates for both sequences (Table 4), and also coincided with a weak match between the two sequences. A summary of the results for the component samples of these two chronologies are provided in Table 1 and Figure 4. The other seven individual series failed to provide any consistent dating evidence. The measurement data for all the measured samples are listed in Appendix 1.

The tree-ring analysis dates the rings present in the cores. The correct interpretation of those dates relies upon the characteristics of the final rings in them. No sapwood survived on any of the timbers, previous problems of water entry into the roofs had presumably ensured this, but almost all the samples were targeted at timbers with surfaces that appeared to be their original heartwood/sapwood boundaries. Making allowances for minimum and maximum likely amounts of missing sapwood provides individual felling date ranges for each of the datable timbers. Figure 4 and Table 1 includes the interpreted felling date ranges for each of the datable samples.
