Westwood Common,  
Beverley:  
an archaeological  
survey

**SURVEY REPORT**

Archaeological Investigation Report Series AI/25/2004

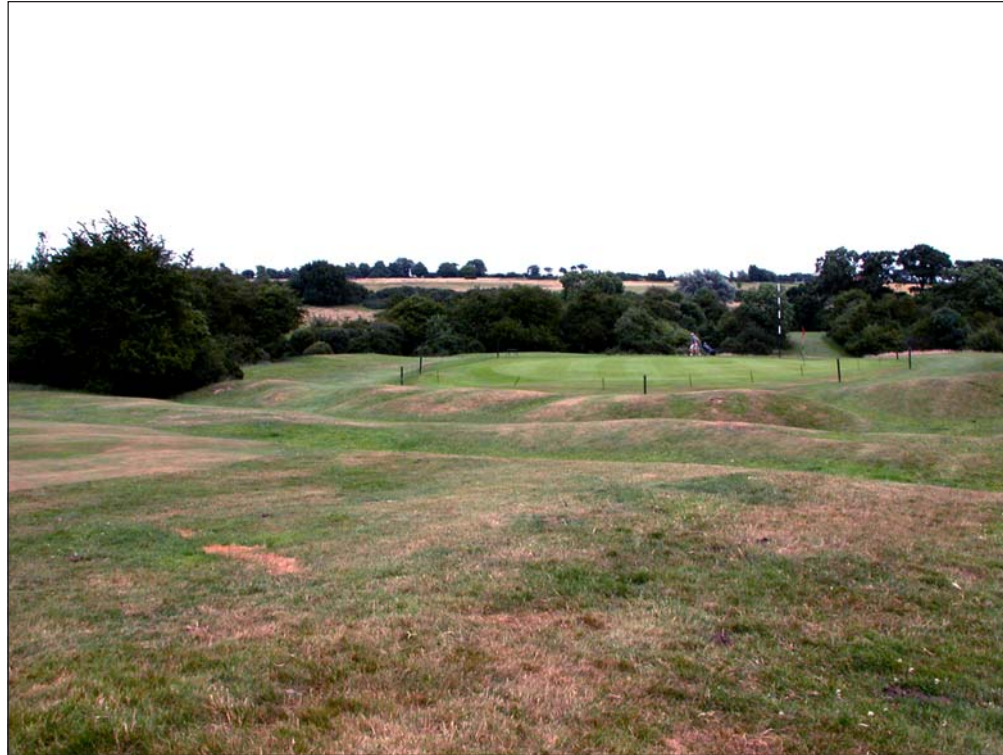
**Figure 10**  
*The north side of  
 Enclosure 2 looking  
 south*

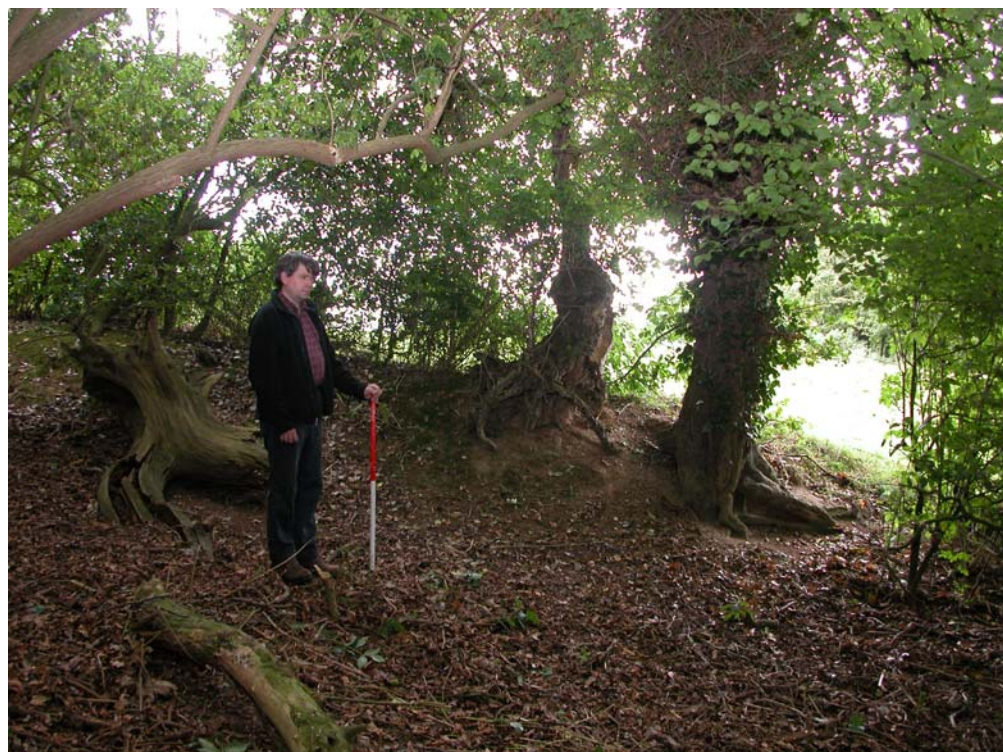
The perimeter of the enclosure emerges again as an earthwork separate from the common boundary on the south-east side (Figure 11). Here the perimeter takes the form of a slight east-facing terrace close to the bottom of the spur. As the terrace turns to the north, a short

**Figure 11**  
*The south-east side  
 of Enclosure 2  
 looking east at the  
 point where the  
 perimeter diverges  
 from the common  
 boundary*

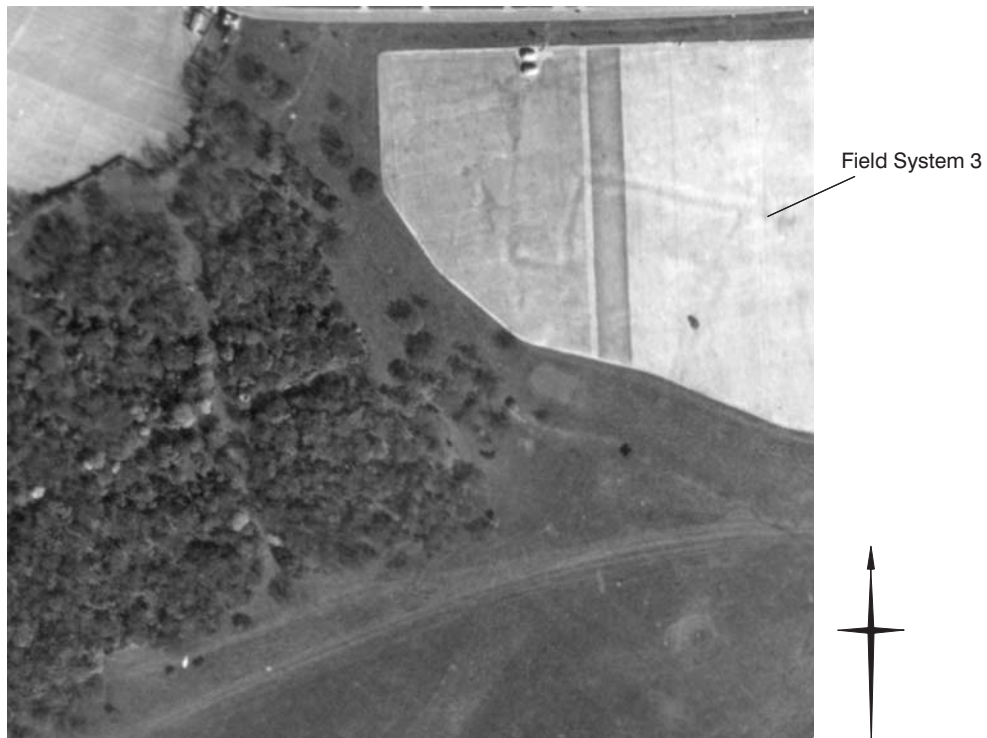
**Figure 12**  
*Aerial photograph showing Field System 3 to the east of Burton Bushes (RAF 1945a)*

Since Field Systems 1-3 have comparable rectilinear layouts, it is possible they are contemporary and represent an episode of small-scale enclosure either for cultivation or for keeping livestock. The regularity of the layout suggests the field systems were laid out in an open environment rather than a woodland setting. Tree cover would have constrained the laying out long lengths of straight boundary banks. This provides a clue to the date as it rules out the period from the Middle Ages up until the 18th century when it is documented that large parts of the common were wooded. They could be later than the 18th century but this seems unlikely given their degraded character. This points to a period before the Middle Ages when the area was devoid of woodland. Therefore an Iron Age or Romano-British date seems the most likely given the evident intensity of land-use across the Wolds in these periods (Stoertz 1997).

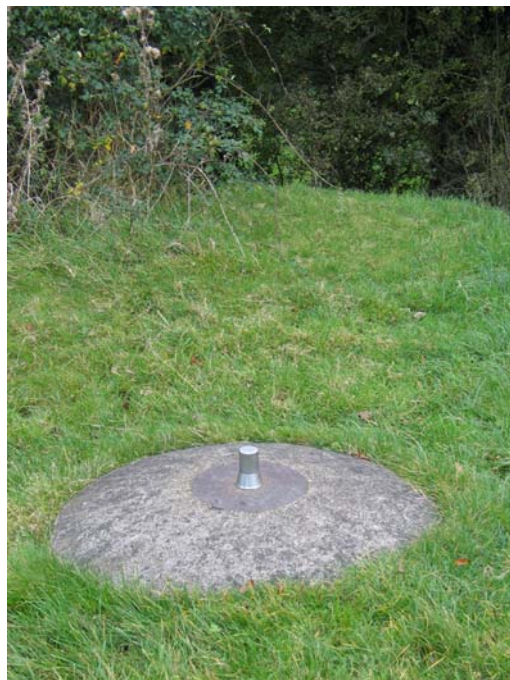
**Figure 20**  
The mounting for the  
spigot mortar

At the north-west corner of the Newbegin Pits, just above the edge of the quarry, are the remains of a concrete mounting for a Second World War spigot mortar (NMR no. TA 03 NW 96). It is where soldiers, possibly Local Defence Volunteers (later known as the Home Guard), would attach a spigot mortar in anticipation of an enemy attack. The spigot mortar was mounted on the still visible stainless steel pin which is set in the centre of the concrete

base (Figure 20). The concrete sides would have had indented areas sunk into the ground where the gun crew (usually three) would have crouched. There is a slight curving ditch on the north and east sides that could be a remnant of this infantry position.

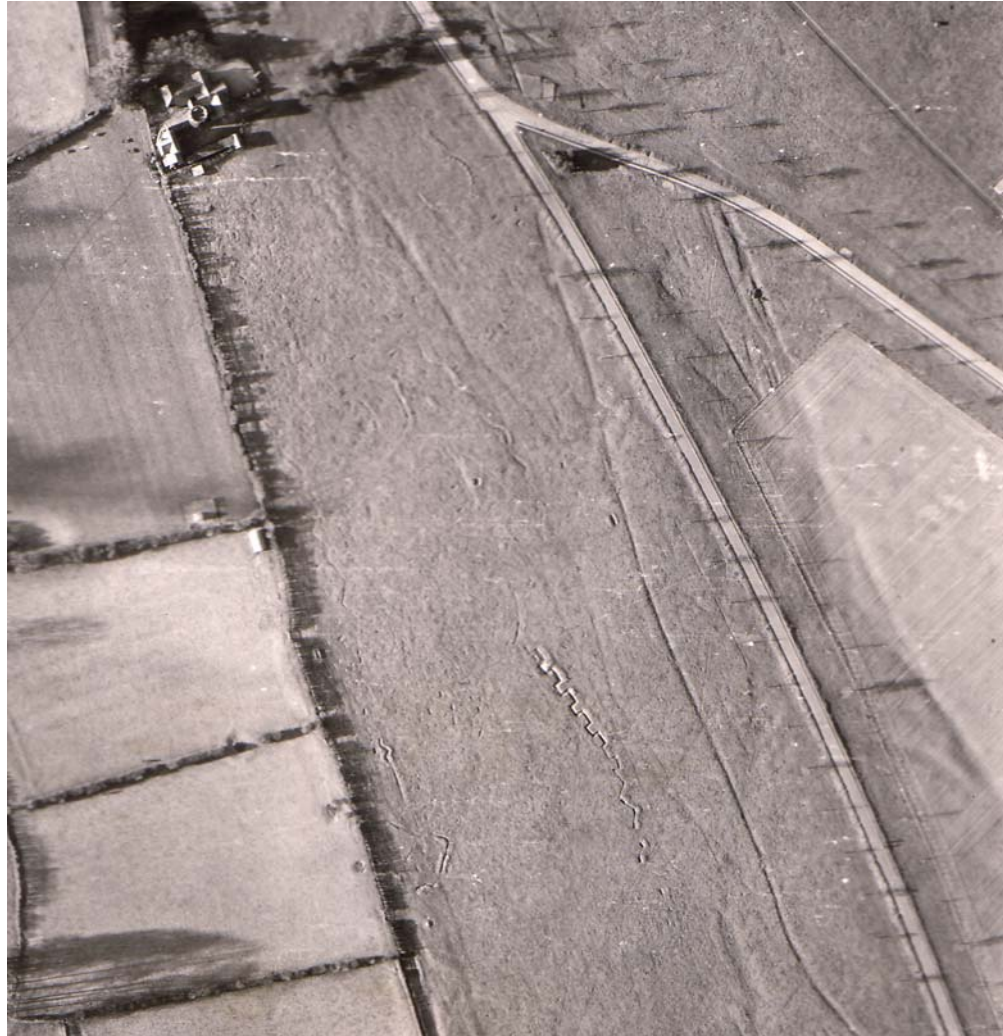
The 1917 aerial photograph shows what look like several rows of small pits, which might be military practice trenches on the south-east side of the common dating from the First World War (ERYAS 1917). Aerial photographs from December 1945 (RAF 1945b) show a variety of practice trenches in this same area including slit trenches and a long length of indented trench as

**Figure 21**  
*Aerial view showing  
 First and Second  
 World War practice  
 trenches on the south-  
 east side of the  
 common (RAF  
 1945b)*

used extensively on the western front in the First World War (Figure 21). This trench system might be of that period or alternatively could have been dug during the Second World War to introduce recruits to this form of trench warfare. It is not recognisable now on the ground because the same area was ploughed in 1946 (see above). Several two-man slit trenches survive on the ground and very probably date from the Second World War, although they could be later in date because they do not appear to have been damaged by the ploughing. Several other small rectangular trenches, possibly dug by the military, survive towards the west edge of the common, on the north side of the Newbald Valley.

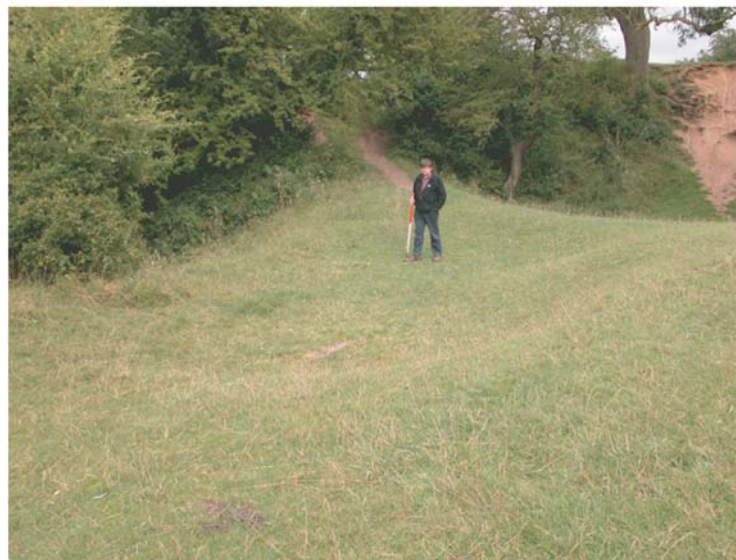
In the bottom of Newbegin Pits towards the south-east corner, a number of small quarry hollows seem to have been reshaped to form circular pits, perhaps for cock-fighting and bull baiting. The best preserved of these and the only one with a visible metal ring for tethering livestock was surveyed by English Heritage at 1:200 scale. It is situated immediately below the south-east face of the quarry (Figure 22) and is probably the site of the bull ring marked on the first edition Ordnance Survey map (Ordnance Survey 1855). It is a circular depression up to 0.5m deep and 12m in diameter (Figure 23; Pit 1) in a level area in between the edges of two quarry hollows. The metal ring is securely embedded in a slight circular depression at the centre of the pit and was presumably used for tethering the bull. Some 2m from the ring is the track eroded by the tethered animal circling around the bottom of the pit. The pit

**Figure 23**  
 (above) English Heritage plan of Pits 1 and 2 reduced from 1:200 scale original with inset photograph of the bull ring.  
 (below) View of Pit 2 looking south

is overlooked by the top of the main ready made arena for viewing the bull baiting but no evidence exists that the site had seating. A slight ledge on the north-west side of the pit could indicate where there were seats. Bull baiting was banned by the town corporation on the Westwood in 1824 (Allison 1989, 125) but it is possible that the disused bull ring continued in use for tethering livestock, explaining the eroded track around the ring. A second circular pit 15m to the east (Figure 23; Pit 2) may have been formed as a second bull ring, or, given its size, could conceivably have been for cock-fighting. Both pits have the advantage that they can be easily overlooked from the top of the quarry, allowing more people to watch the 'entertainment' than could gather around the edges of each of the pits.

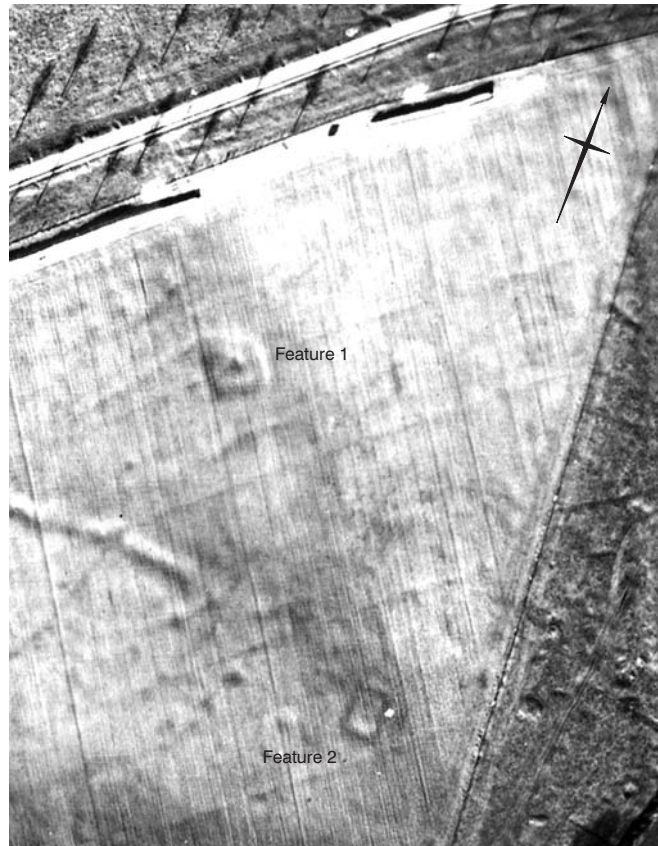
An aerial photograph from December 1945 (RAF 1945b) shows the cropmark of a possible ditched feature about halfway between the Westwood Road and the end of the hollow way defining Route 5 (Figures 22 and 24). It is not visible on the ground and has not appeared on aerial photographs since this part of the common ceased to be cultivated. The feature has straight edges about 15m in length on the south-east and south-west but is more curving on

**Figure 24**  
*Aerial photograph  
showing  
Miscellaneous  
Features 1 and 2  
(RAF 1945b)*

the other two sides. It has a circular depression at the centre. It also appears on the 1917 aerial photograph where the ploughing described earlier appears to respect it (ERYAS 1917). The feature could conceivably be another Iron Age square barrow though the fact that the First World War ploughing respects it suggests it may be contemporary with this period of cultivation or that it was a significant upstanding feature at this date..
