The Alum Works and
other industries at
Kettleiness,
North Yorkshire:
an archaeological and
historical survey

SURVEY REPORT

Archaeological Investigation Report Series AI/24/2003

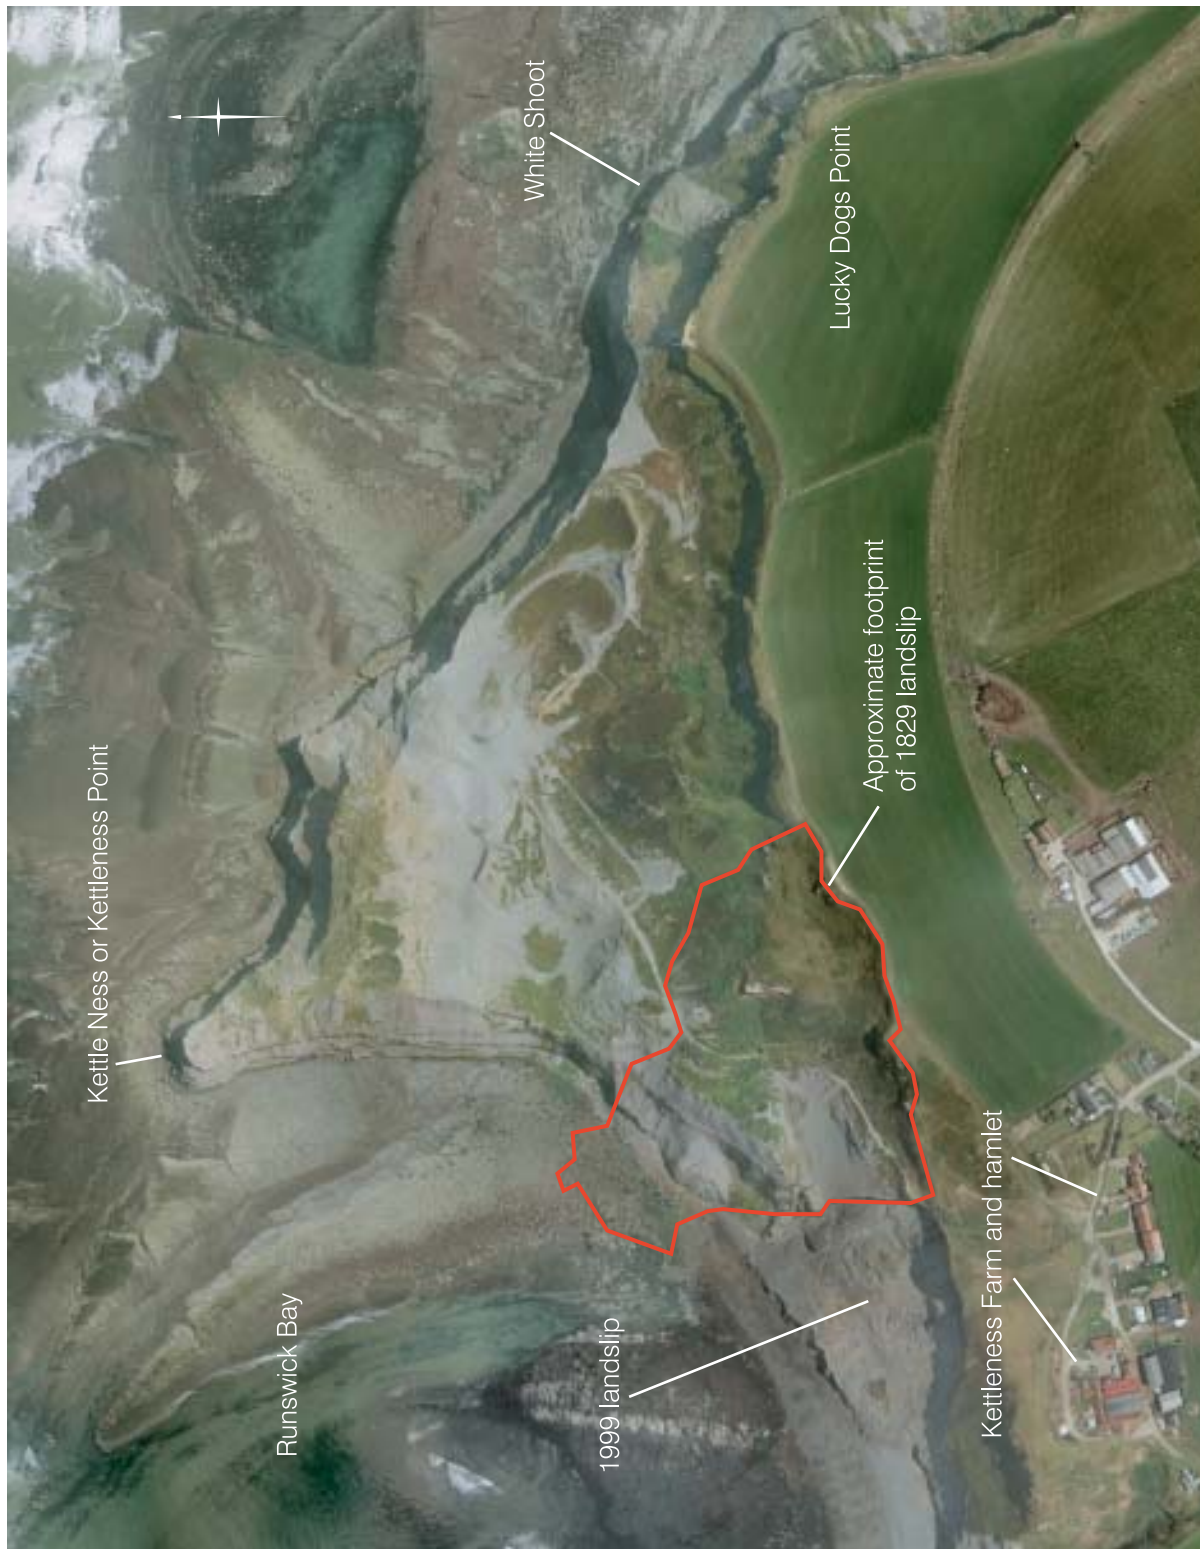
Figure 2. Digital orthophotograph of Kettleless Alum Works, produced from a run of overlapping vertical images. Topographical names and selected features mentioned in the text have been added. Note the extent of the reef which surrounds the headland at low tide (NMR AEL/00C/515, frames 9664-76)

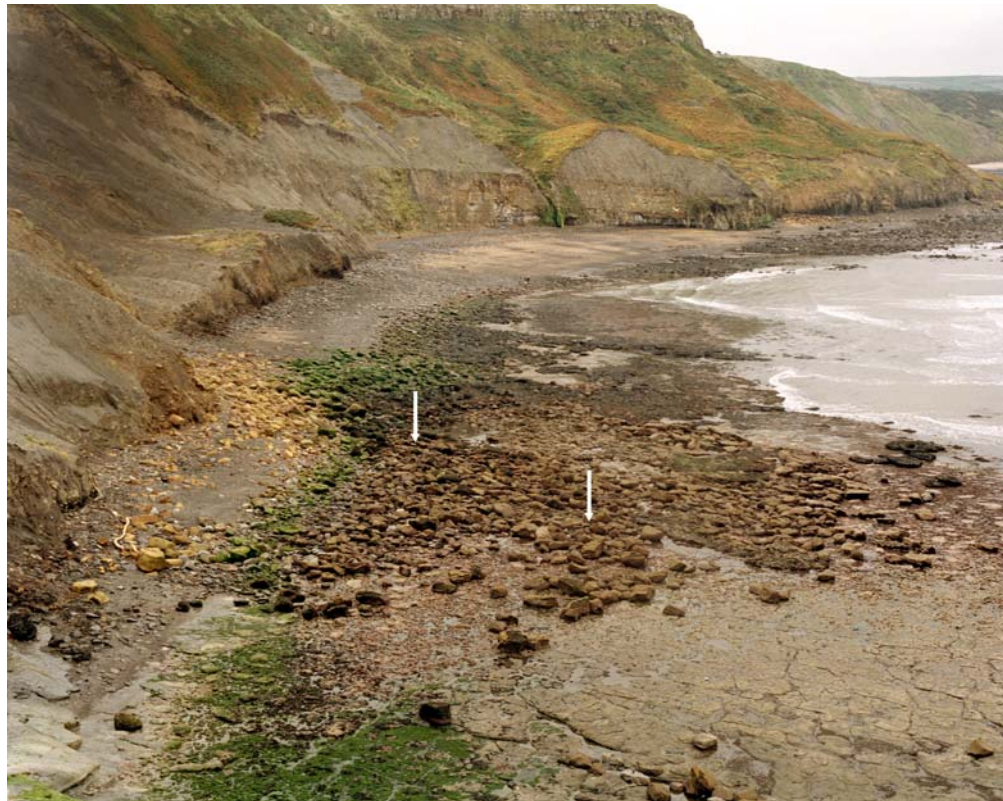
Figure 3. General view of the boulder field on the reef in Runswick Bay which marks the original extent of the 1829 landslide. The remains of the staithe which have re-emerged from beneath the toe of the slip are arrowed (NMR AA040227)

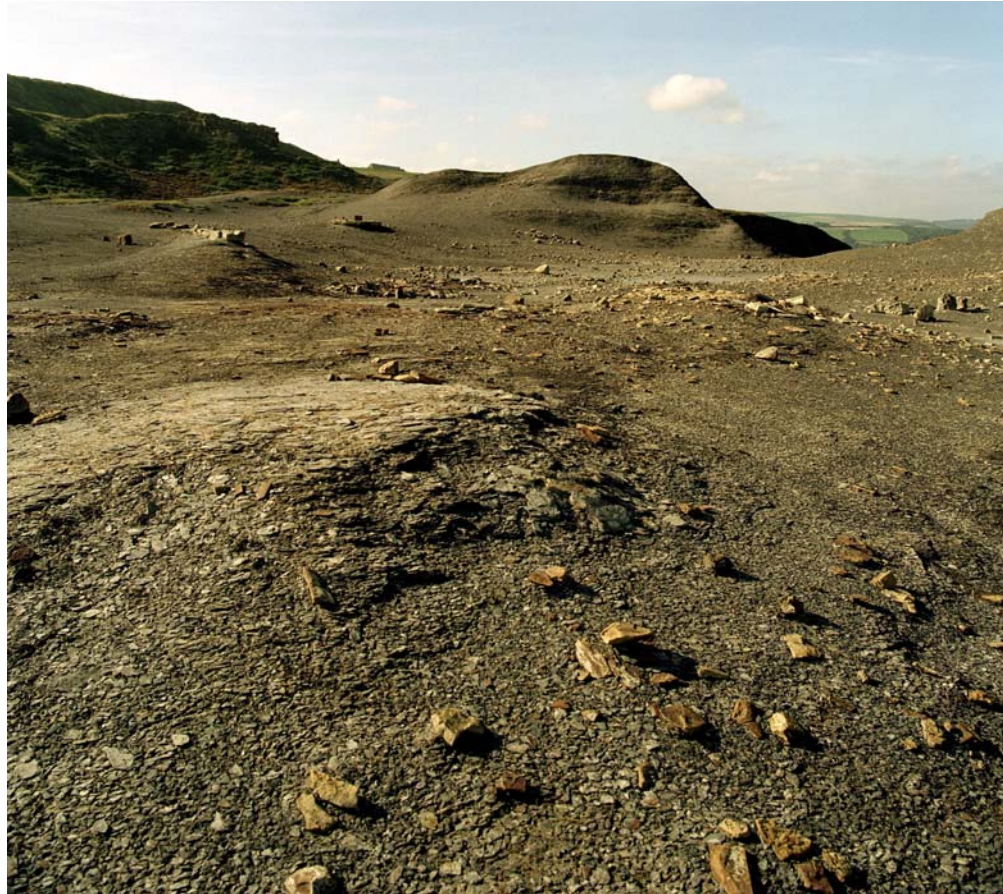
*Figure 4.
View west across the
quarry floor from close
to building 1, showing
the depth of surface
erosion. Note how in
the middle distance
the stone gutter has
protected the shale
beneath it, while
behind it the side of
the concrete base for
the coastguard
breeches buoy is
gradually being
exposed.
(NMR AA040240)*

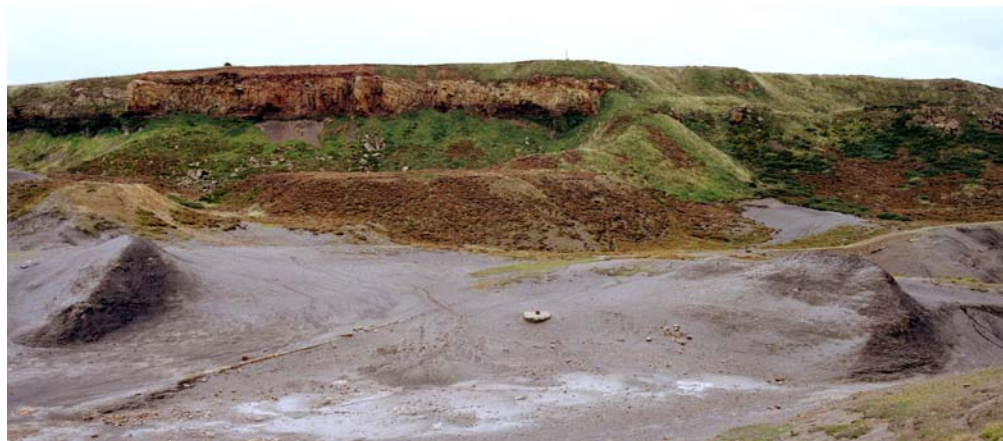
Figure 14. General view of the central portion of main quarry face, showing in-situ and eroding sections of the sandstone cap. The shale baulks in the foreground are the remains of calcining places 3 and 4. The two ends of the coastguard breaches buoy are also visible. (NMR AA040261)

top of the *in-situ* shale at the interface with the sandstone has begun to erode out, thereby undermining the overburden and in places bringing it down. Recent rock falls are evidenced by large sandstone boulders overlying the scree undercliff, and also by the surface of the sandstone cap above having a jagged, red and raw look to it, in stark contrast to areas where the original smooth, vertical quarried face survives which typically exhibits a pale buff colour. Such differences are particularly evident in the central section of the quarry face, where a long length of the original quarried face has been lost completely (Fig 14). At the

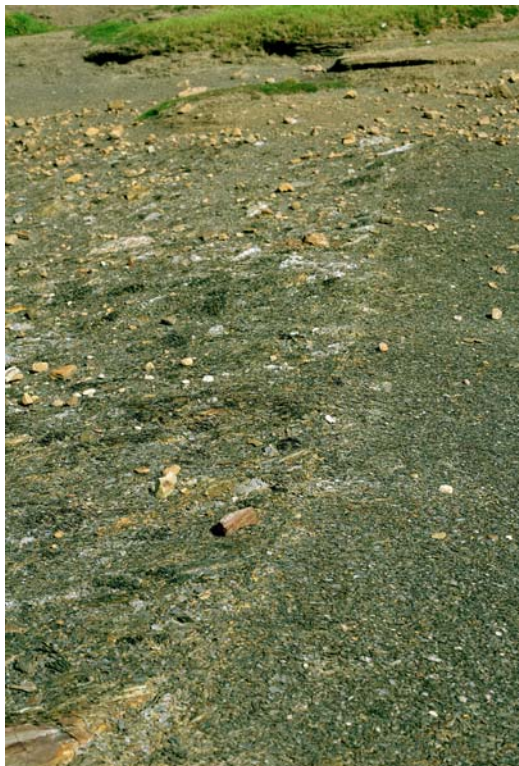
Figure 15.
Detail of the east side
of hollow 1, showing
the very clear
difference between *in-
situ* shale bedrock
on the right
and re-deposited
shale on the left.
(NMR AA040205)

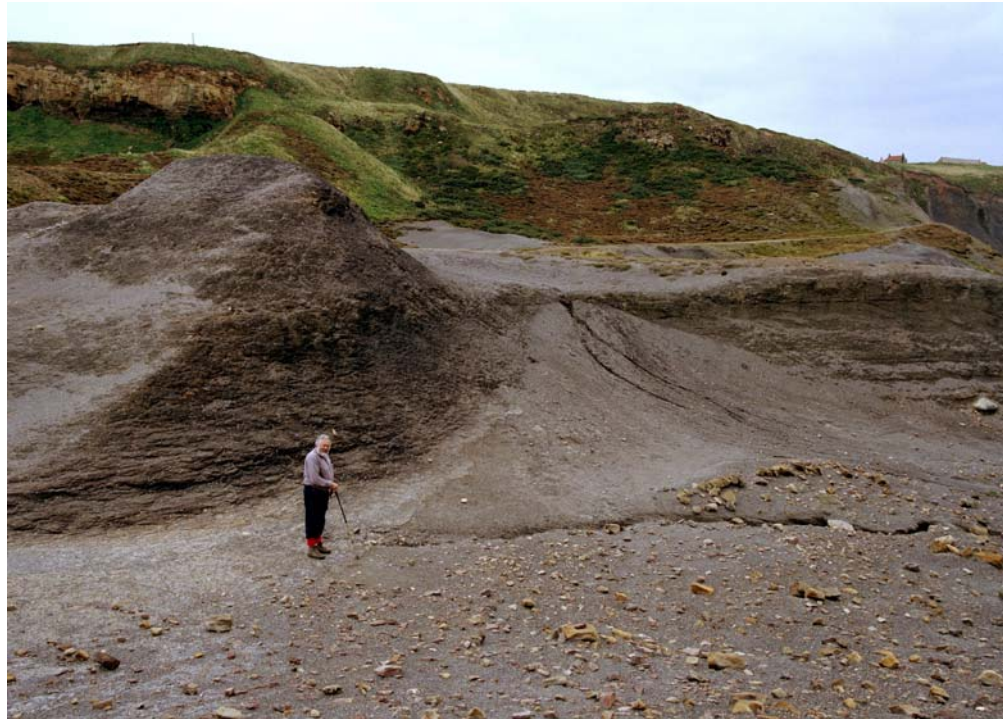
Figure 17.
Detail of the south-east corner of hollow 2, showing the surviving cut face and the edge between *in-situ* and re-deposited shale. The baulk of calcining place 4 stands above the cut face. (NMR AA040262)

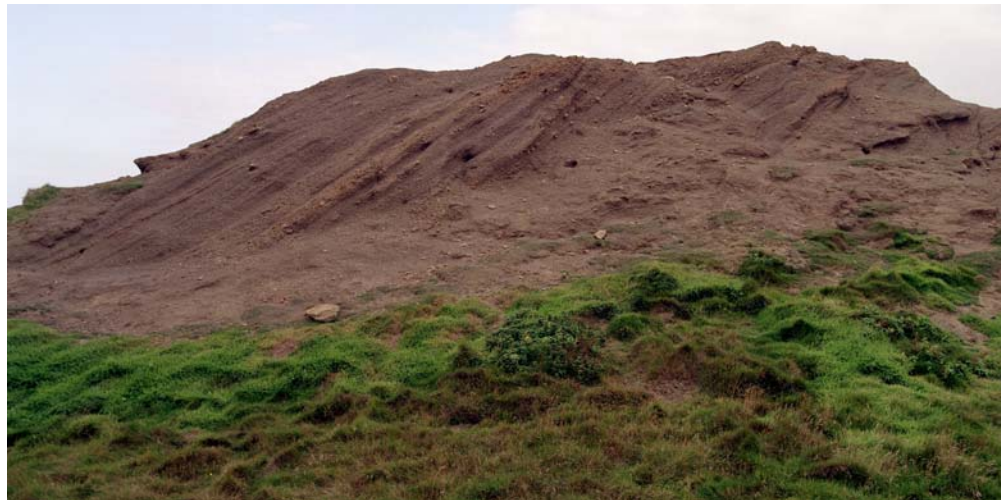
Spoil dump area 4, situated north of alum house 2, is a far larger area of dumping of different make-up again. At its west end, apparently unmined shale is overlain by an orange sandy clay, in turn overlain by a fine-grained darker deposit; while at the east end the orange clay is not so visible, and the fine-grained deposit gives way to dumps of predominantly medium-sized sandstone rubble. The orange clay is probably glacial till (boulder clay); the darker deposit is of uncertain origin, but includes small fragments of sandstone and unburnt shale. It is clearly dumped material, nevertheless, for tip lines are visible where it has been cut through by track 9 (Fig 18). The tip lines dip northwards, showing that the material has been dumped from the south. In the west it is unclear how far this area of tipping extends over the neck of Kettleness Point: the neck is eroding and slumping badly, but is mostly grassed over making it impossible to determine from surface inspection alone what is unmined

Figure 18.
Tip lines in spoil
dump area 4 exposed
in the east side of the
cut for track 9.
(NMR AA040266)

shale which has slumped and what is tip. However, a long ridge (spoil heap 2, see below) must mark its northern limit, for this has visible tip lines dipping southwards, not northwards. Since spoil dump area 4 is cut through by track 9 (section 6.1.9 below), it must pre-date 1856.

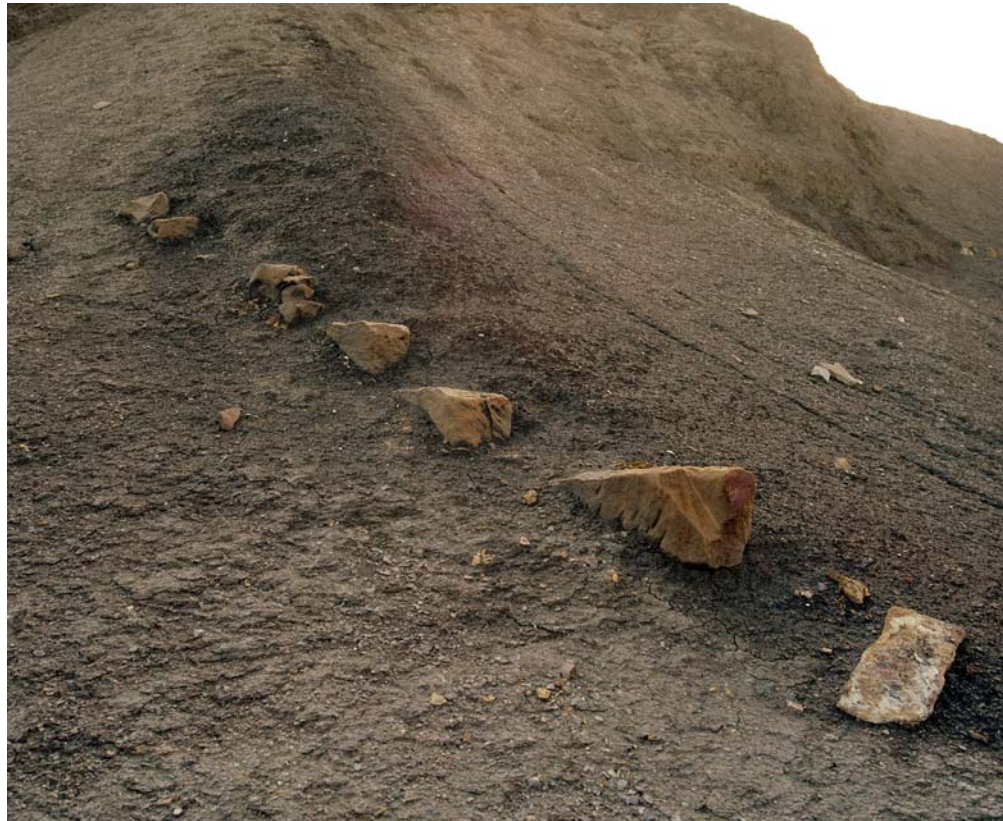
Figure 20.
Detail of stone
revetment on east side
of calcining place 1.
(NMR AA040250)

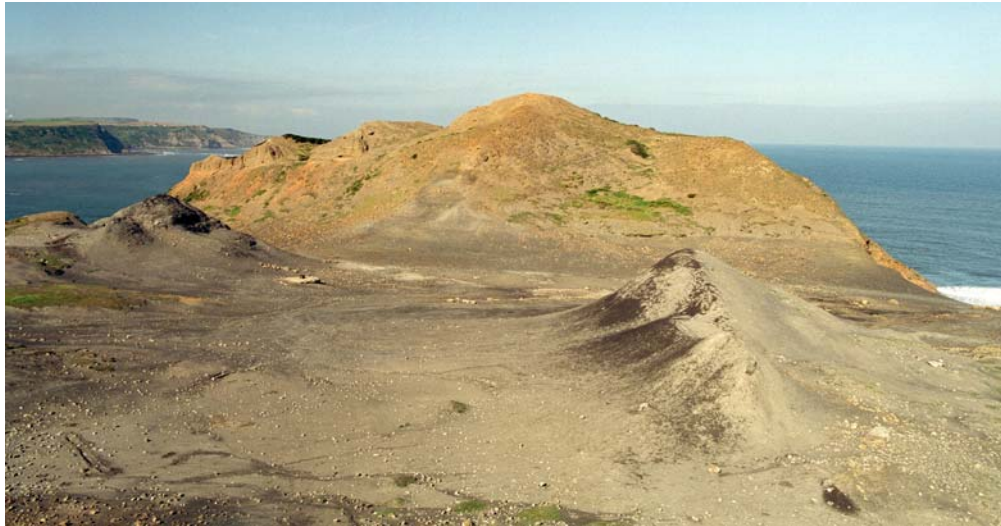
Figure 22.
General view north
over calcining places
3 and 4 towards spoil
dump area 4.
(NMR AA040231)

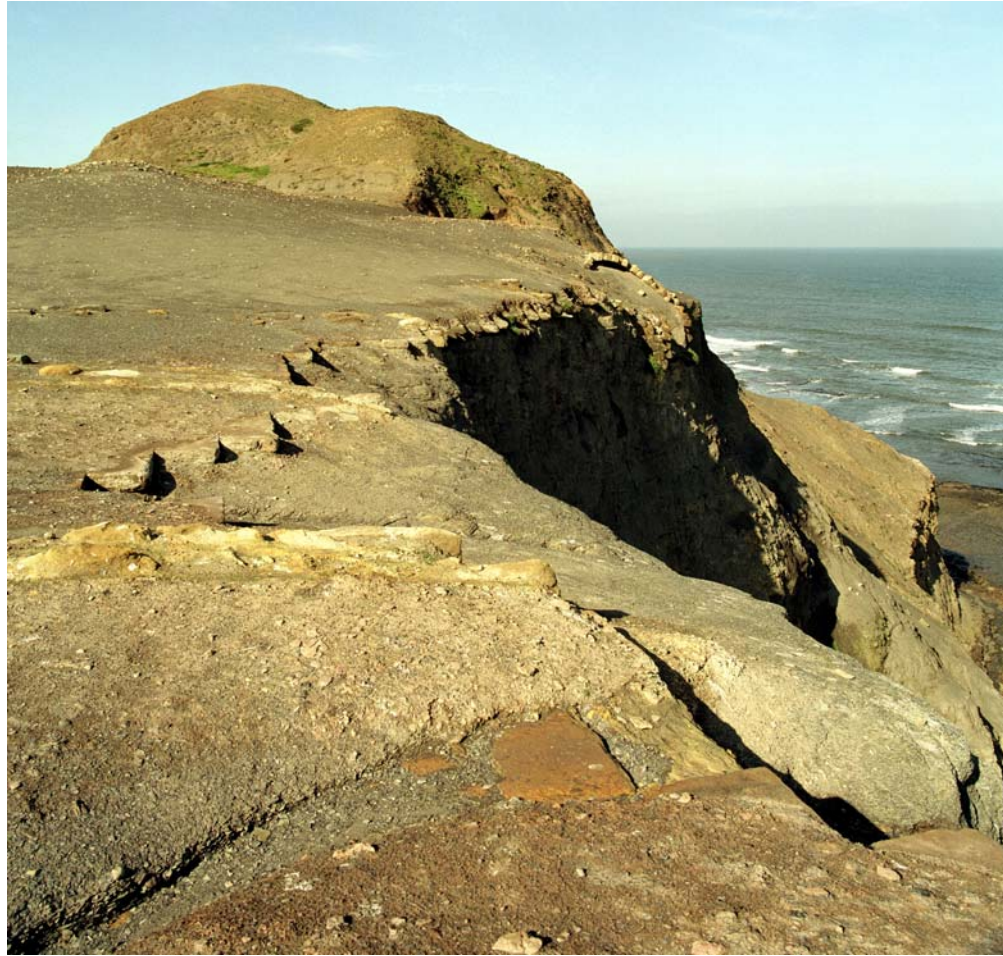
*Figure 24.
Detail of the eroding
ends of steeping pits
1-6, and of cistern 1
beyond.
(NMR AA040258)*

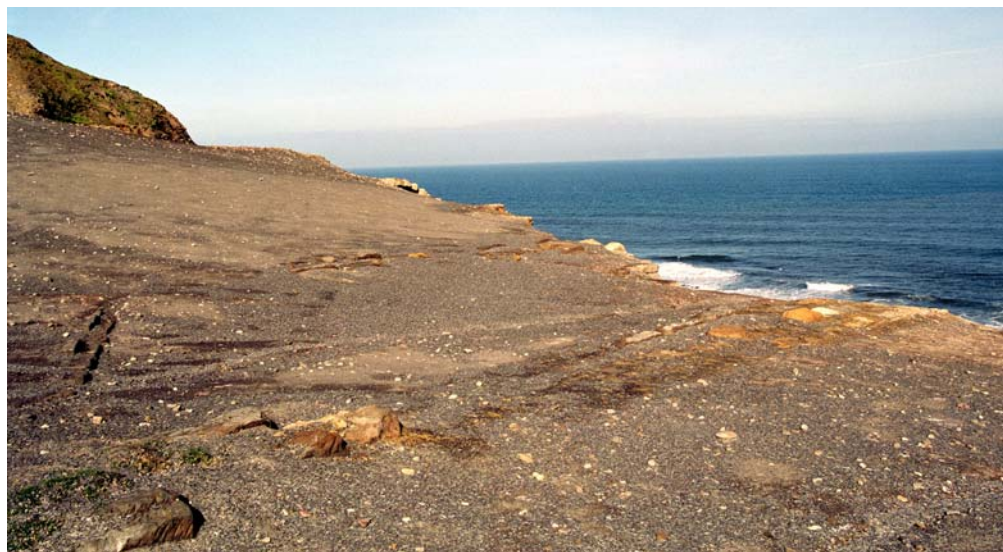
*Figure 25.
General view north
across the north-west
end of steeping-pit
bank 1.
(NMR AA040256)*

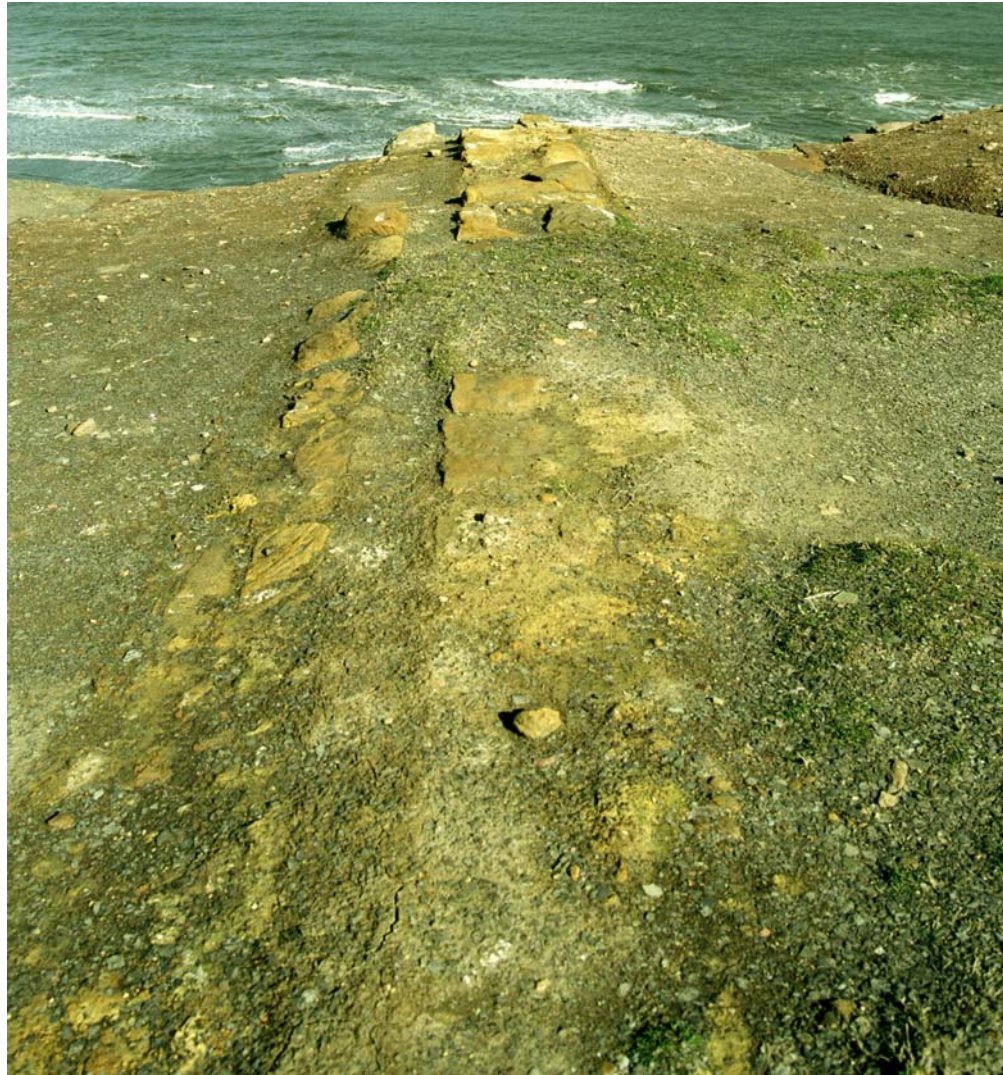
*Figure 26.
Detail of the void
between the side walls
of steeping pits
5 and 6.
(NMR AA040259)*

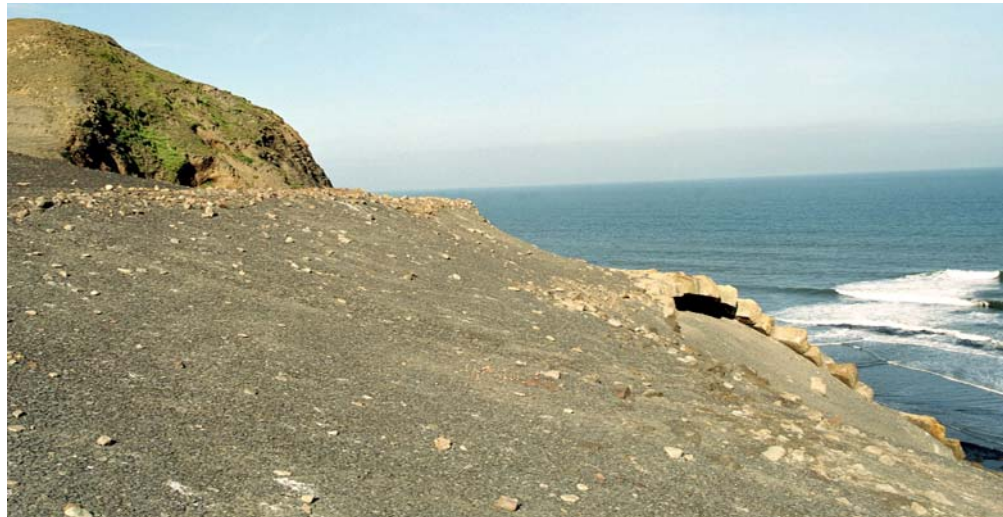
*Figure 27.
Detail of cistern 1
north of the steeping
pits. The metalling on
the left is probably
part of track 1.
(NMR AA040216)*

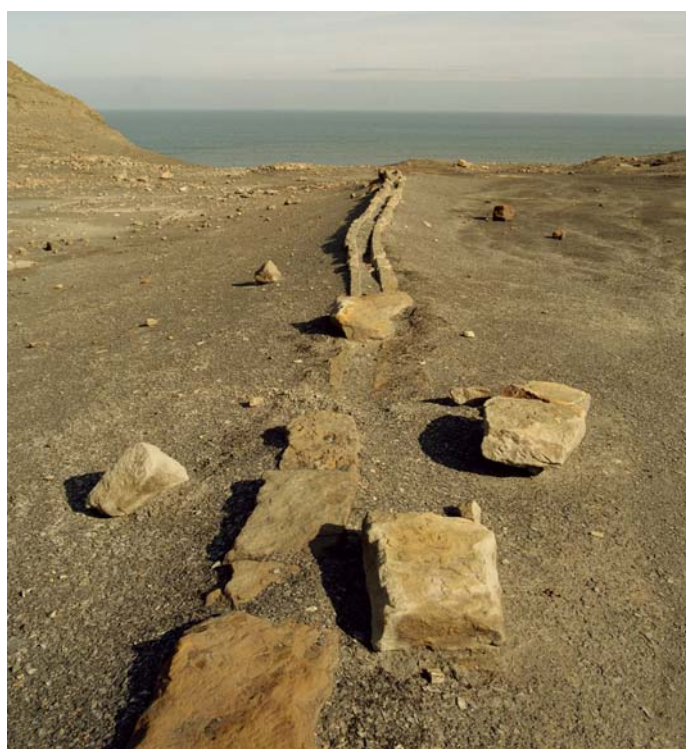
Figure 29.
View north-east along
gutter approaching
building 1.
(NMR AA040238)

about 130m within the quarry between the sites of buildings 2 and 1 (Figs 28 and 37). The visible evidence suggests that immediately east of building 2 where the track crosses a deeper part of the quarry on a raised causeway, the gutter stones were laid on a foundation of sandstone blocks, but closer to building 1 they seem simply to have been founded in a shallow slot cut into the shale bedrock. The gutter was not an open channel, but was covered with flat capstones (Fig 29). Much of the feature east of building 2 has already slipped away as the sides of the causeway have eroded, and stones lie scattered over the shale scree below. Close to building 1, the gutter now appears to run along the top of a narrow shale ridge, but this ridge is actually the product of erosion: surface run-off and wind scour have lowered the floor of this part of the quarry by at least 1m since the works closed,

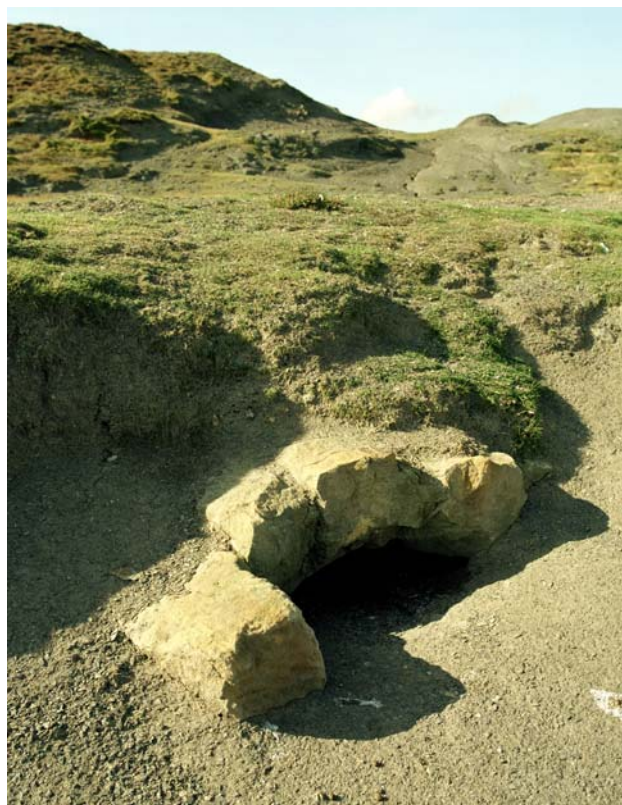
Figure 30.
Detail of the vaulted
roof at the probable
eastern portal of the
liquor-trough tunnel.
(NMR AA040222)

Gould (1993b) has claimed that such a liquor-trough tunnel exists at Kettleless, describing it as of 'particular quality' although giving no further details of either its form or position. The only possible trace of such a structure visible at the time of survey was part of a vaulted stone roof (Fig 30) mostly obscured by shale scree, at NZ 83457 16001 close to the cliff edge on the east side of the headland immediately south-west of building 3 (Figs 11 and 23). Whilst it is conceivable that the observed feature is part of a water or liquor cistern similar to that evident further north

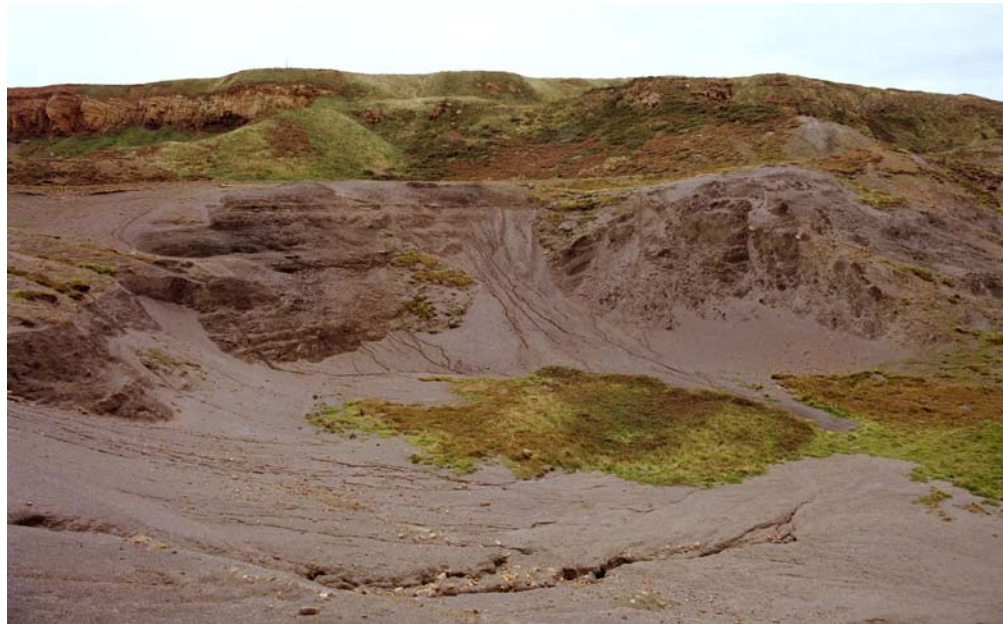
Figure 33.
General view of the
site of alum house 2
from the north,
showing the alum
house being engulfed
by scree. Tanks 1-4
lie beneath the talus
slope in the
foreground.
(NMR AA040264)

formed at their feet (Fig 33). This scree is also slowly moving across the floor of the shelf, burying the ruins of the alum-house complex in the process. Grassed-over wall lines up to 0.7m high survive in a number of places towards the centre of the shelf, mostly suggestive of a series of north-south ranges of small rectangular rooms or compartments; otherwise the main visible features are a long west-facing scarp up to 1.7m high located towards the rear of the shelf, with a bank along its top, and a wall and section of concrete floor close to the cliff edge in the process of collapsing onto the ledge (Fig 48). Short lengths of other wall lines are suggested by occasional small scarps and stones, but it is often unclear if the latter are still *in situ*.

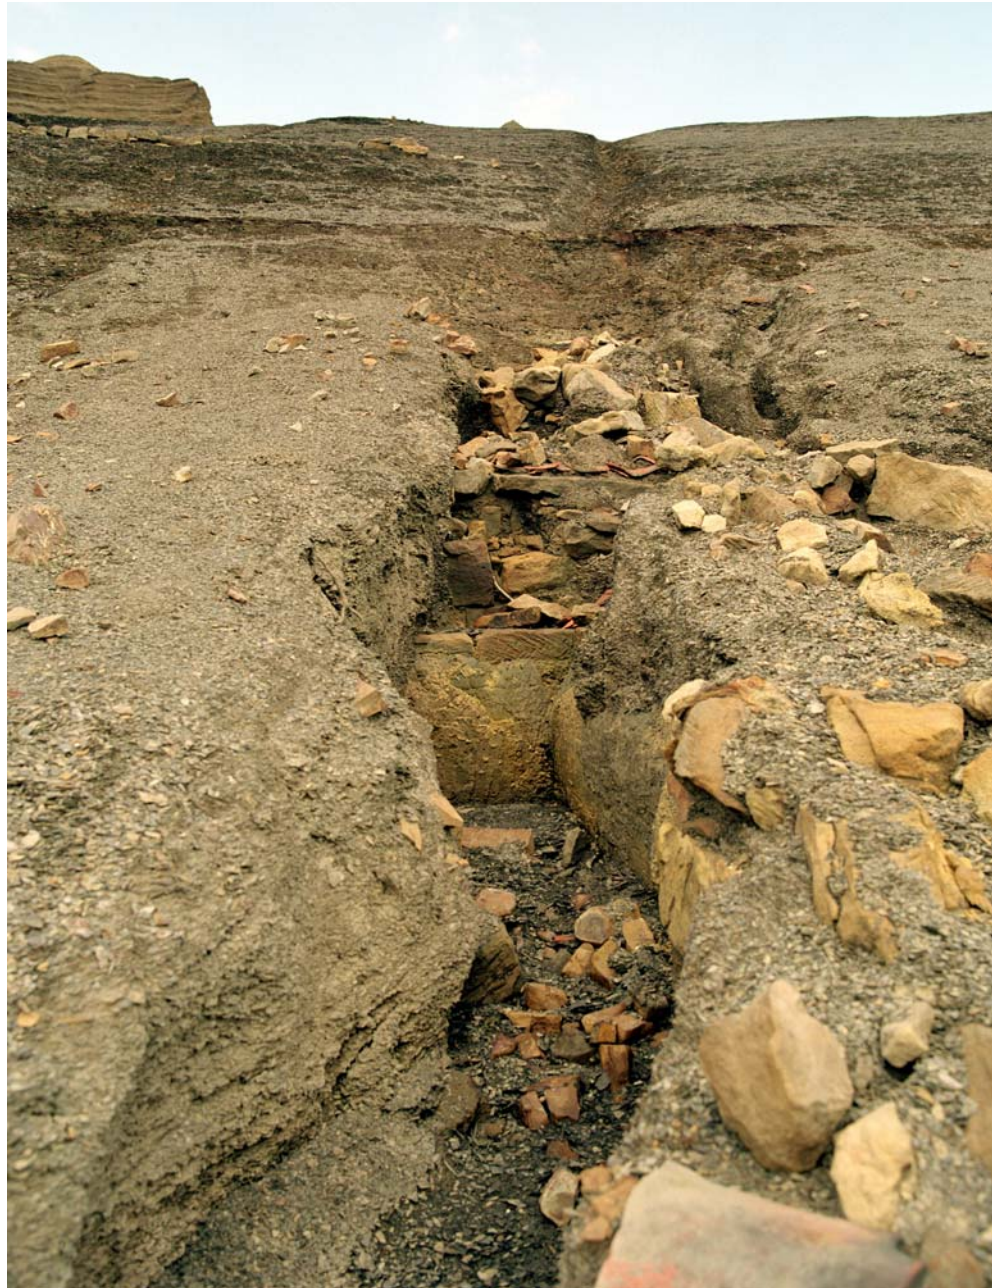
*Figure 34.
Detail of the silted
clarifying tanks north
of alum house 2.
(NMR AA040252)*

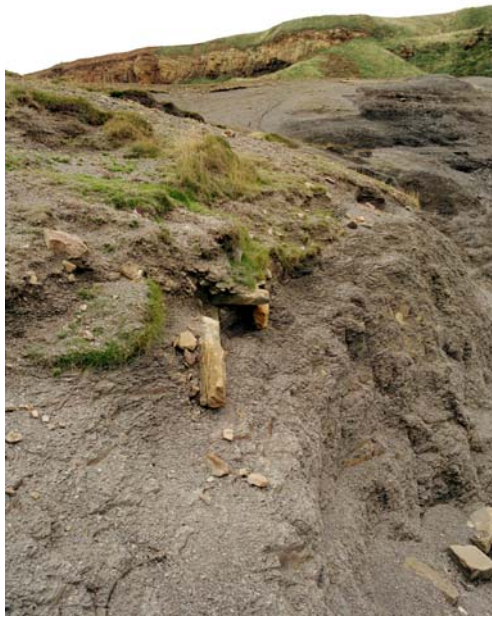
Figure 35.
Detail of conduit 1
above the north-east
corner of the alum-
house shelf.
Displaced stones
overlie the scree
below.
(NMR AA040230)

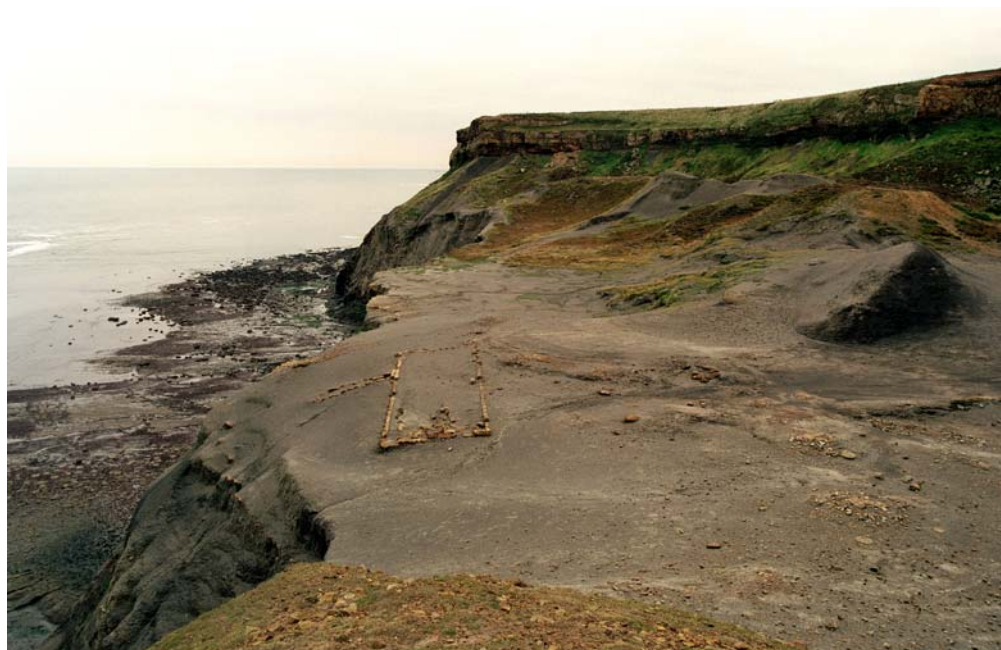
Figure 38.
View south-east
across building 1 from
spoil dump area 4.
(NMR AA040214)

by 1.93m (15 feet – 15 feet 9 inches by 6 feet 4 inches). The tops of the walls now lie at the same level as the external shale, and the interior is filled with loose, windblown scree; however, in the south-east corner, scree eroding down from elevated ground on the outside has buried and helped conserve a short length of wall to a height of c 1.2m, perhaps six courses higher than elsewhere. Where best preserved at the junction between the main range and annex (Fig 39), the walling can be seen to be c 0.25m (10 inches) thick, and to consist of a thin core of rubble sandwiched between skins of faced sandstone blocks;

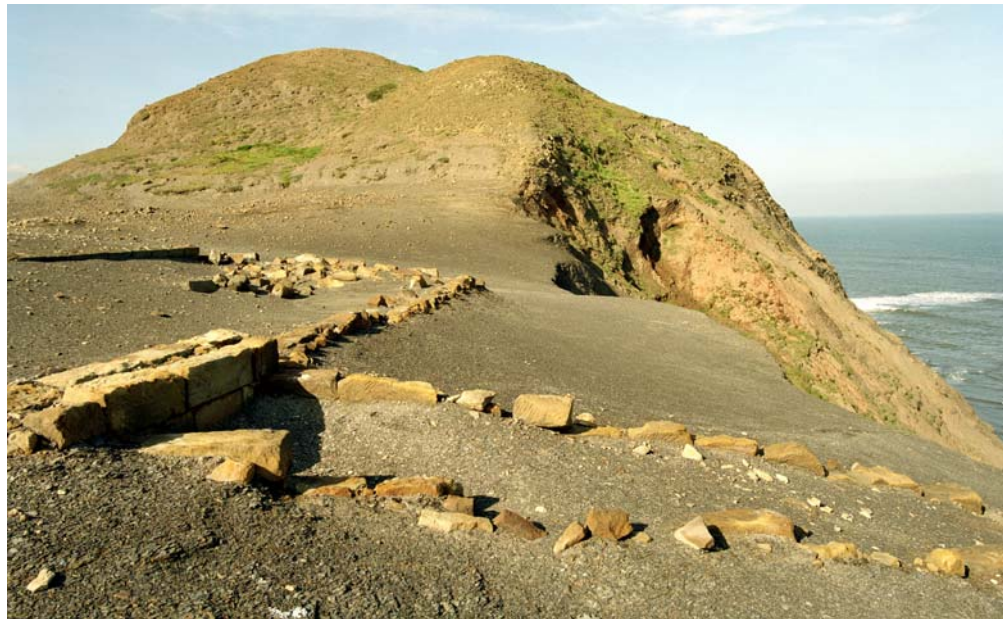
Figure 39.
Detail of the north-east side of building 1, showing the junction of the main range and northern annex.
(NMR AA040241)

however, around most of the perimeter only the inner facing blocks and rubble core are now visible, and the course of the outer skin is merely hinted at by a line dividing *in-situ* from re-deposited shale. It is unclear if this line marks the outer edge of a foundation trench – which would indicate that only the lowest foundation courses survive - or is part of a wall trench for a basement in which case a considerable height of walling survives protected by scree; occasional indications of rendering observable on the inner skin of blocks, and the fact that a patch of what appears to be rubble flooring has been exposed by erosion at the far end of the annex at a depth of over 1m below the current level of the rest of the building, support the latter interpretation. Building 1 is not shown on the OS first edition 6", suggesting it dates to after 1852. Its function is unknown. The annex was a later addition as indicated by the fact that it is butt-jointed against the main range; it may represent a loading platform leading out to the edge of track 1.

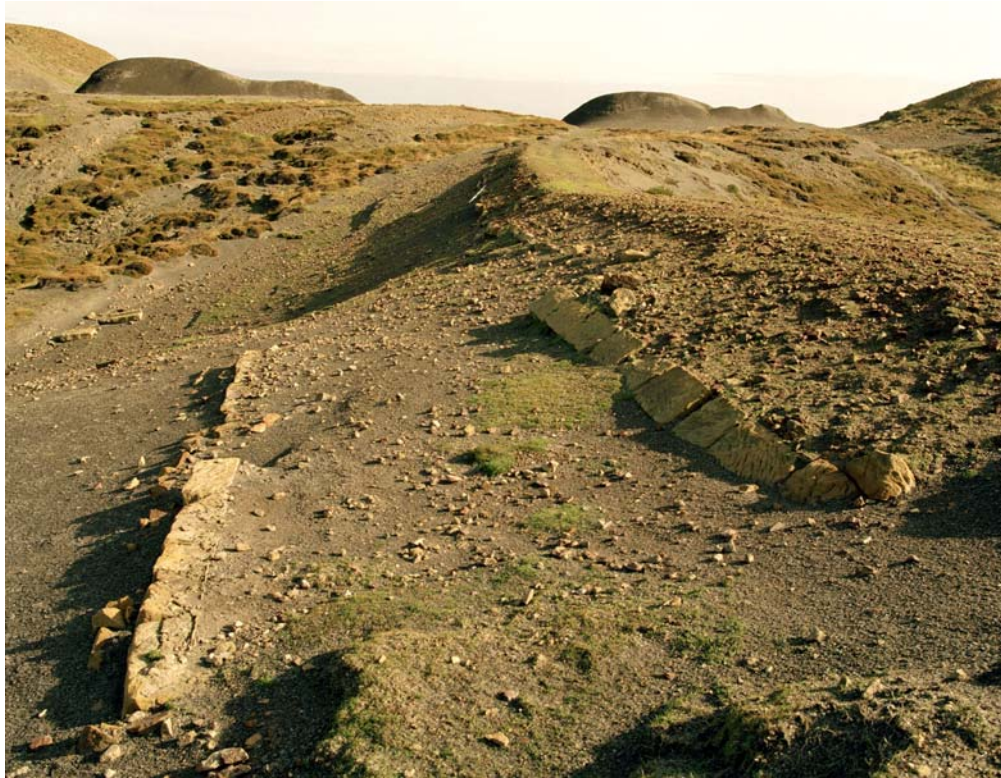
*Figure 40.
Building 2 from the
south-west.
Note the traces of
rendering on the
inside of the
left-hand wall
(NMR AA040270)*

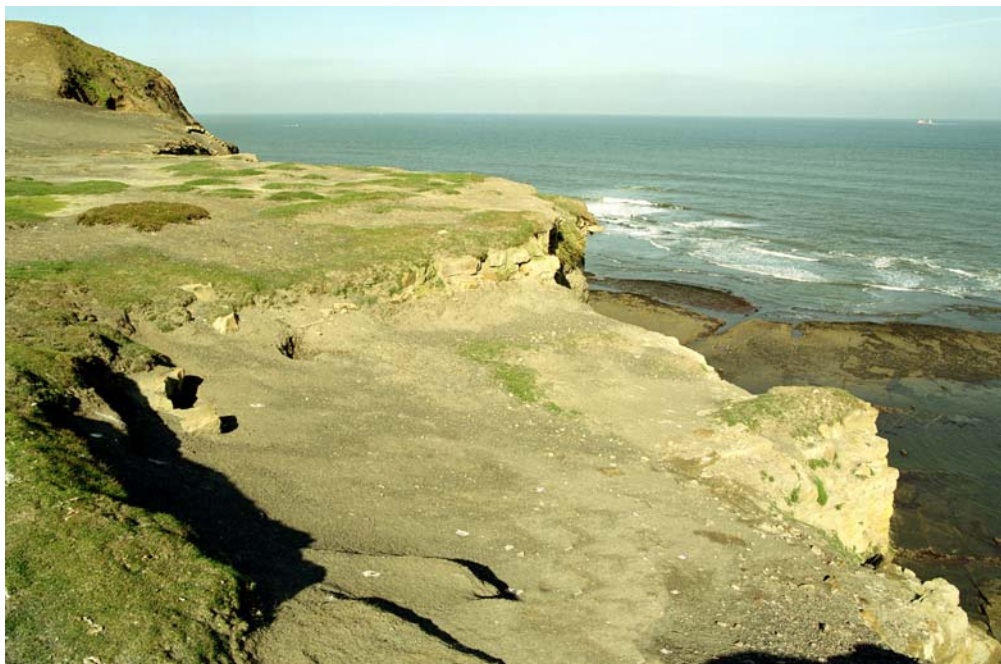
*Figure 41.
The surviving south-
western end of
building 3. The roof
of the liquor-trough
tunnel is just visible
left of frame.
(NMR AA040223)*

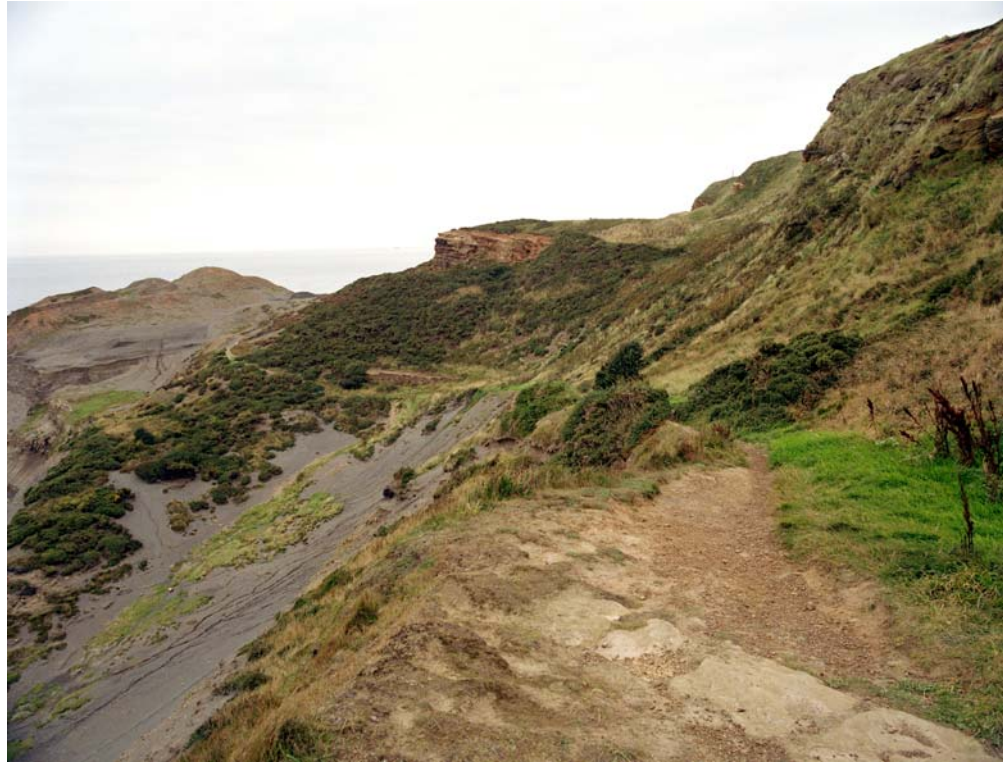
The middle section is a steep terraced way, followed for the most part by a modern footpath down to the foreshore and quarry. Patches of stone metalling are visible, but mostly the original surface has either worn away or else is buried beneath slump. A diagonal line of flat, rectangular stones which cross the track near the top of the cliff (Fig 42) probably marks the course of a covered gutter or channel taking water down to the steeping pits (see also section 6.1.4 above). Short stretches of walling survive along the track's outer edge, showing that it was formerly stone-revetted, but this revetment has now mostly fallen away, presumably taking further evidence for the gutter with it. However, half-way down the cliff where the track levels out to swing north and then back east around part of the 1829 landslide, a 24m length of the revetment is well-preserved up to c 2m high (Fig 42). The survival of this one stretch is mainly due to the fact that it does not lie immediately above a steep slope, but has no doubt been aided by the modern footpath here briefly deviating from the route of the track to run at the foot of the revetment. OS map evidence shows that the track originally forked just before the revetment with a lower branch giving access to alum house 2 (see track 2 below); the modern footpath seems to follow the start of this fork.

*Figure 42.
View north-east along
track 1 from the edge
of the 1999 cliff
collapse. In the
foreground a diagonal
line of capstones
presumably marks the
course of the gutter
taking water to the
steeping pits, whilst in
the middle distance
the slumped
sandstone marks the
heel of the 1829
landslip.
(NMR AA040237)*

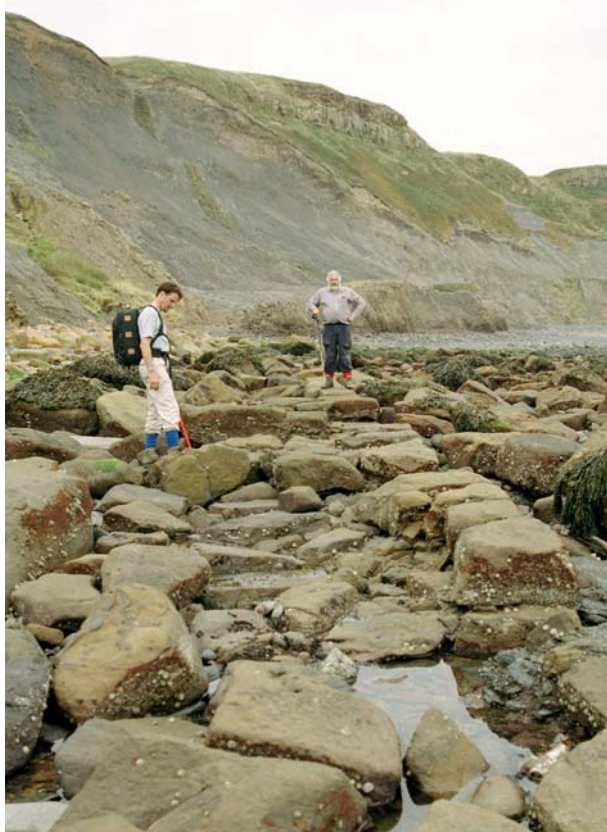
The staithe's foundations have re-emerged since 1829 as the shale which engulfed it has been eroded by the tides (Figs 11 and 43). The remains were first recognised in 1996 by David Green who sketch-plotted their position (in SMR records), although misinterpreting them as part of a breakwater. The feature is now much reduced from its original recorded height of 4 yards (3.65m), and in places is missing completely, but sections of walling oriented roughly south-south-west to north-north-east survive over a length of 36m centred at c NZ 8310 1592. The front or seaward edge is best preserved, with large, faced, sandstone blocks surviving in places two courses (0.8m) high, but short stretches of the rear edge can also be made out, indicating that the feature had a maximum width of c 2m (Fig 44). These dimensions match almost exactly the length and breadth (40 yards by 2 yards) recorded for the staithe in 1729 (section 4.1 above).

Figure 44.
The foundations of the
staithe in
Runswick Bay, looking
south-west.
(NMR AA040242)

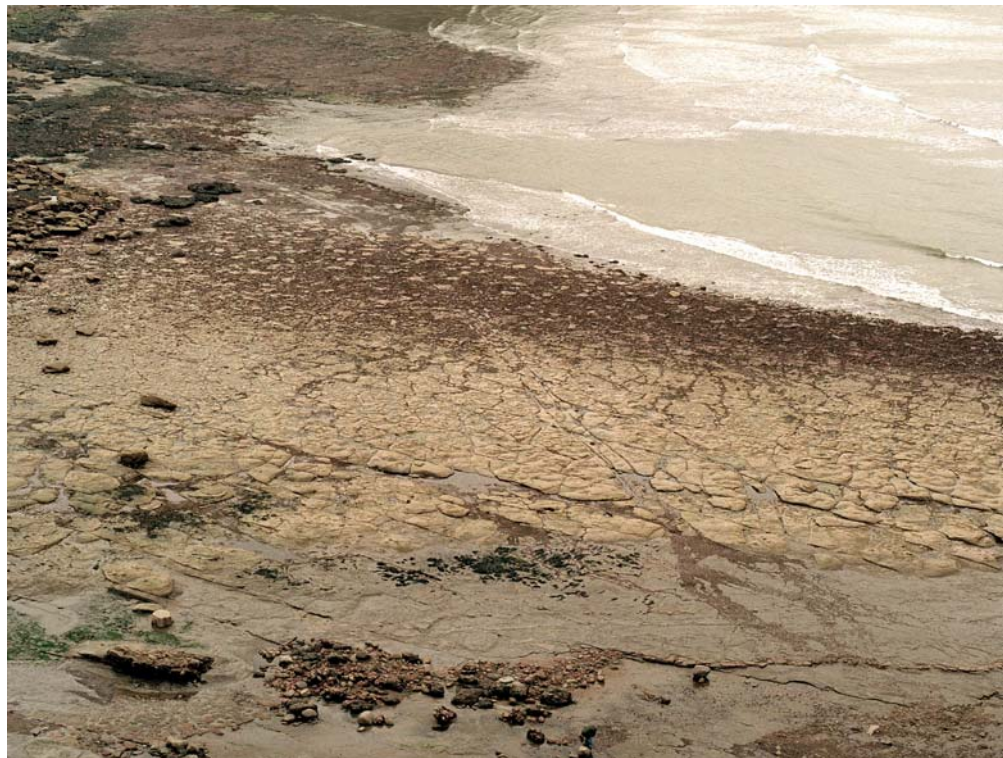
*Figure 45.
The three parallel
rutways, nos. 1-3, cut
into the reef in
Runswick Bay as
seen from the
headland.
(NMR AA040209)*

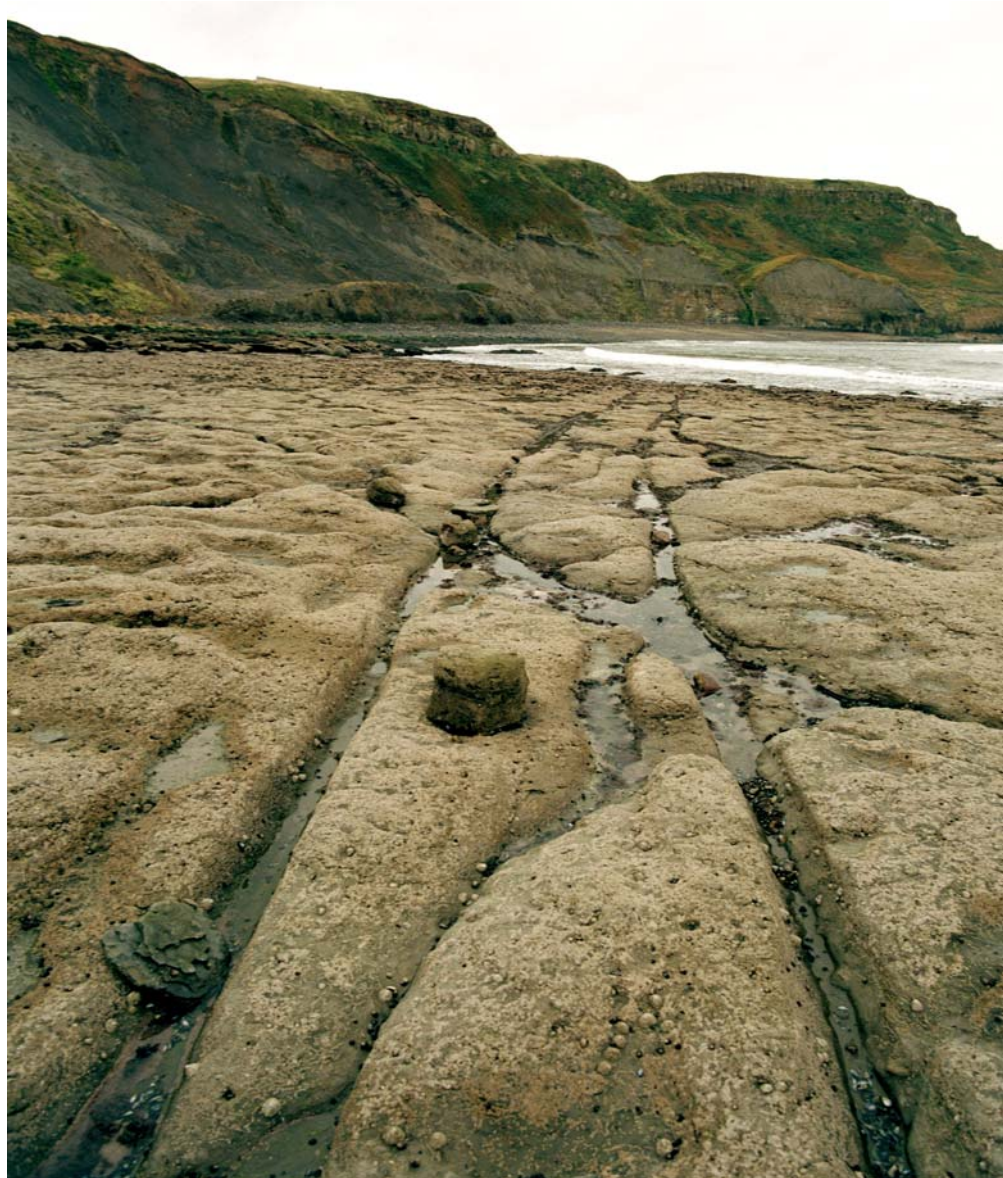
*Figure 46.
Detail of rutway 2 in
Runswick Bay, looking
south-west. Note
indications of
shallower ruts slightly
left of each of the
obvious examples.
(NMR AA040207)*
