The Alum Works and
other industries at
Kettleiness,
North Yorkshire:
an archaeological and
historical survey

SURVEY REPORT

Archaeological Investigation Report Series AI/24/2003

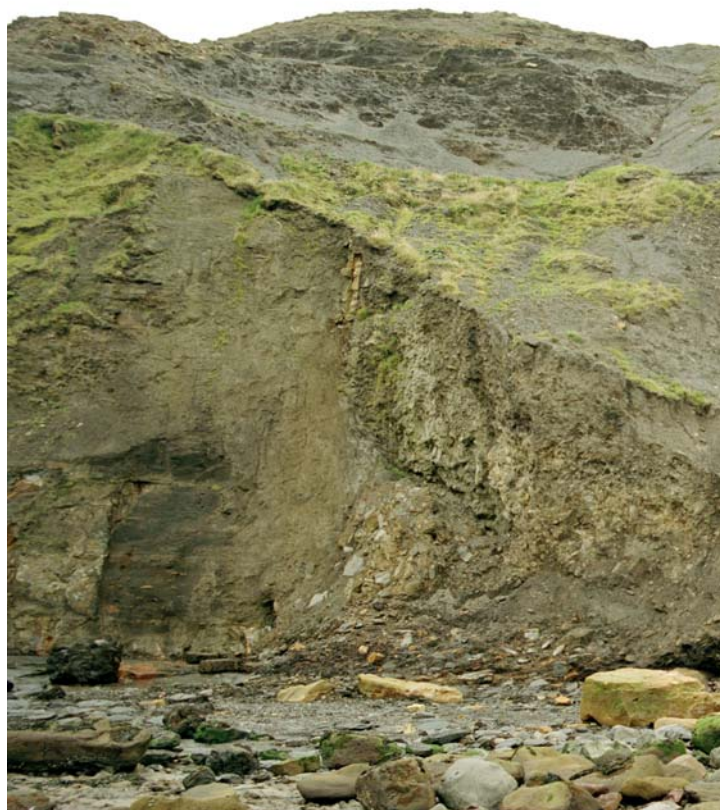
Figure 47.
The possible side wall
of cistern 3 in the cliff
face at the edge of the
1829 landslip.
(NMR AA040244)

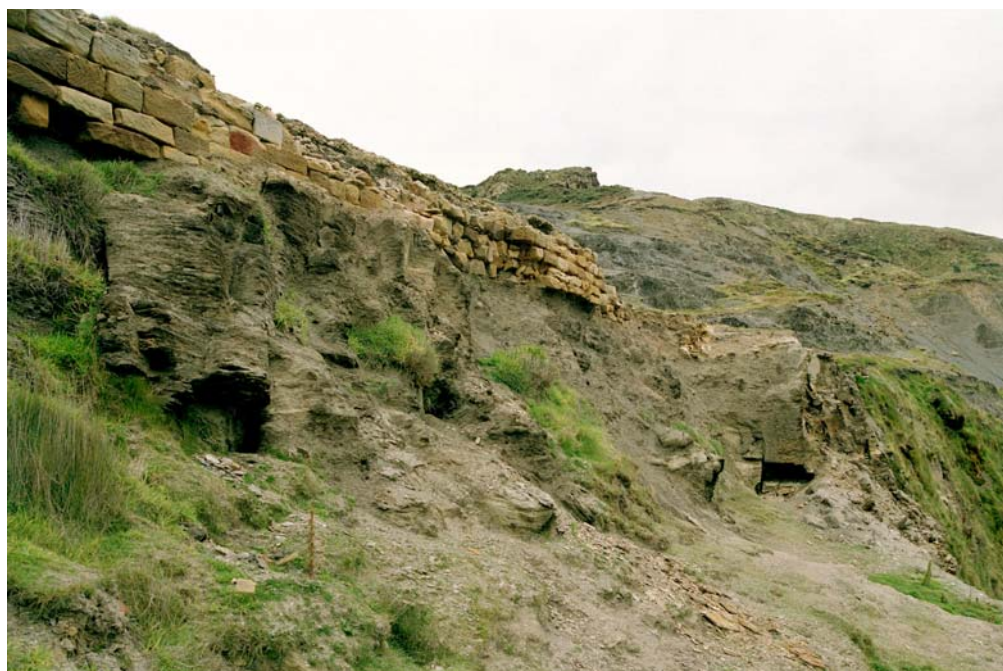
*Figure 48.
The collapsed ledge
at the edge of the
alum-house shelf.
Note the entrance to
mine 5 at right of
frame, and wall 3 (part
of the alum house)
along the top of the
rear edge of the ledge.
(NMR AA040229)*

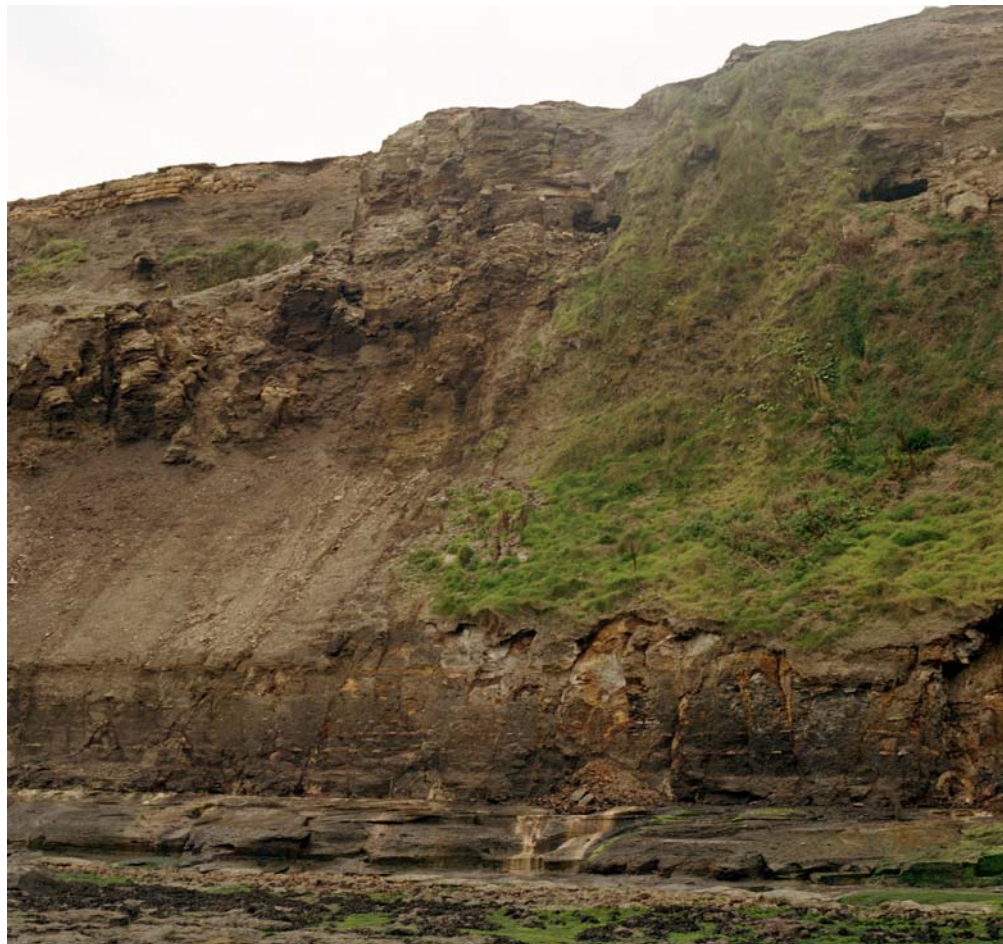
Figure 49.
Jet mines in the cliff
face south of alum
house 2.
(NMR AA040245)

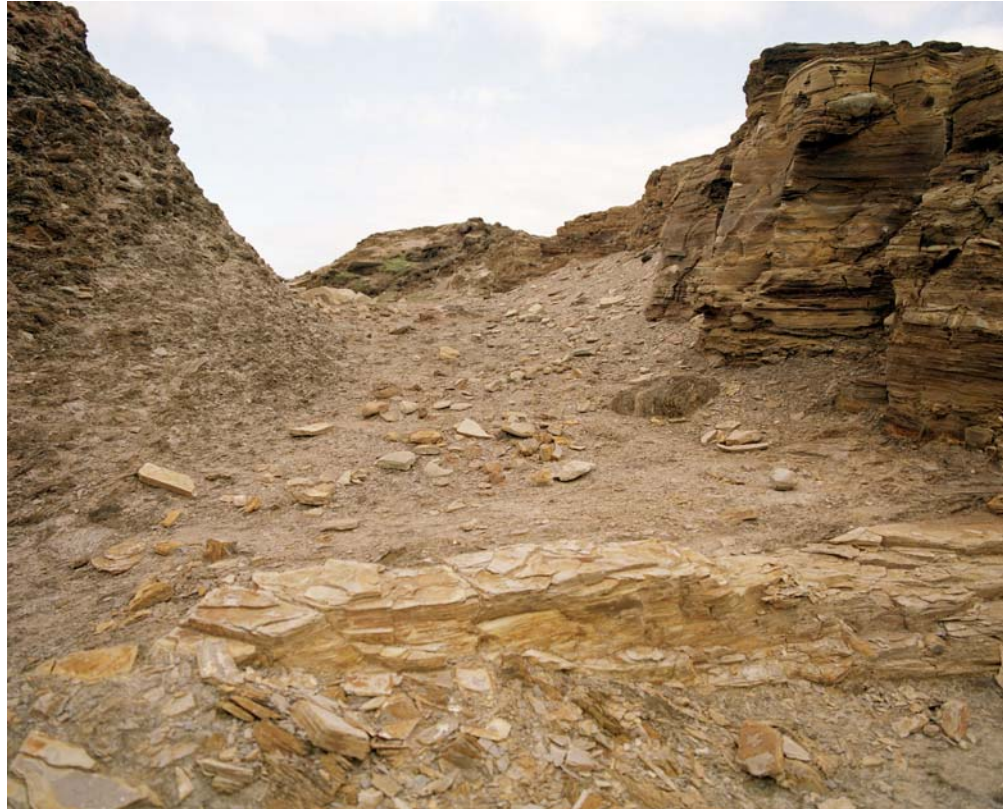
*Figure 50.
A de-roofed jet-mine
gallery on Kettleness
Point.
(NMR AA040255)*

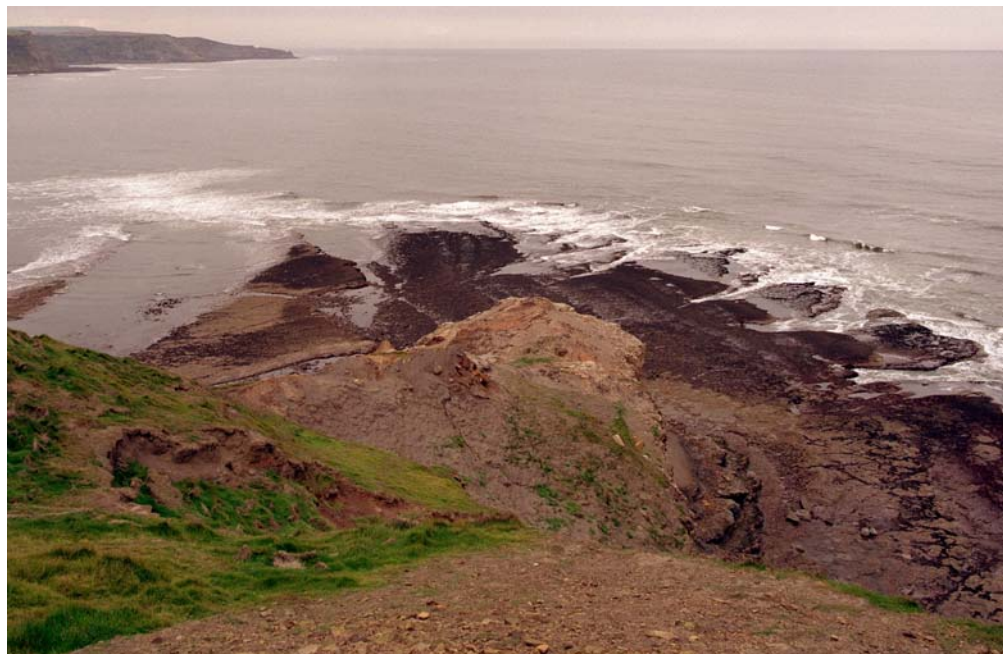
*Figure 51.
General view north
over Kettleness Point,
showing the difference
in ground level and the
evidence of red
(calcined) shale
overlying the de-
roofed jet mines.
(NMR AA040267)*

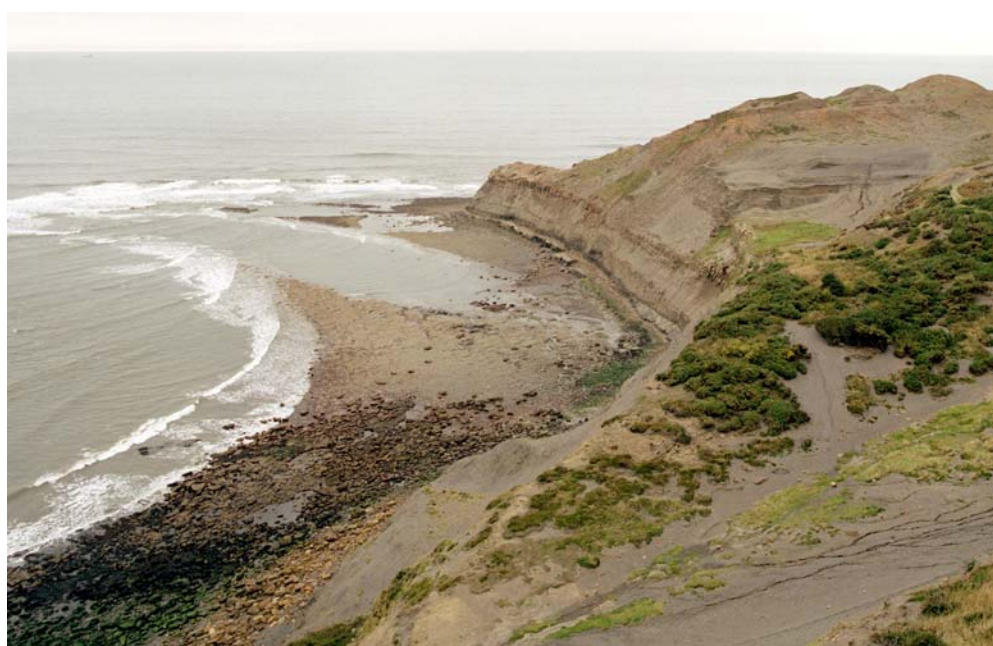
*Figure 52.
The ironstone quarry
in the floor of
Runswick Bay. The
western extent of the
quarry is highlighted
by the channel flooded
by the incoming tide;
note also the step at
the foot of the
sea cliffs.
(NMR AA040236)*

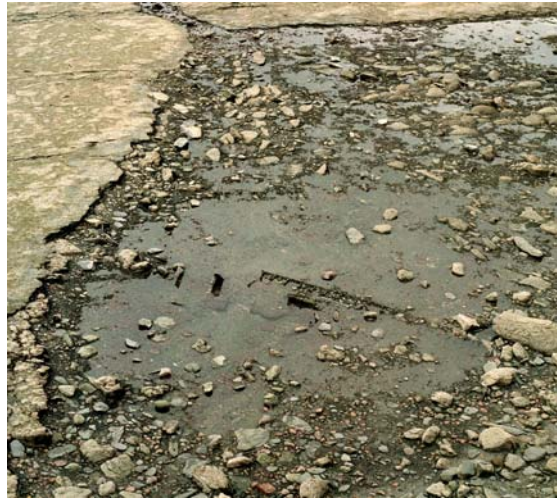
Figure 54.
Shipwreck 1 viewed
from Kettleness Point.
(NMR AA040254)

White Shoot below Lucky Dogs Point on the east side of the promontory at NZ 8372 1591 (Figs 2 and 11). Both wrecks are of ships with metal hulls. The former was not visible on the vertical aerial imagery and its scattered remains only observed during ground investigation (Fig 54), but the deck ribs and part of the keel of the latter were plotted from aerial photographs (Fig 55). Neither wreck was surveyed or investigated in detail on the ground.

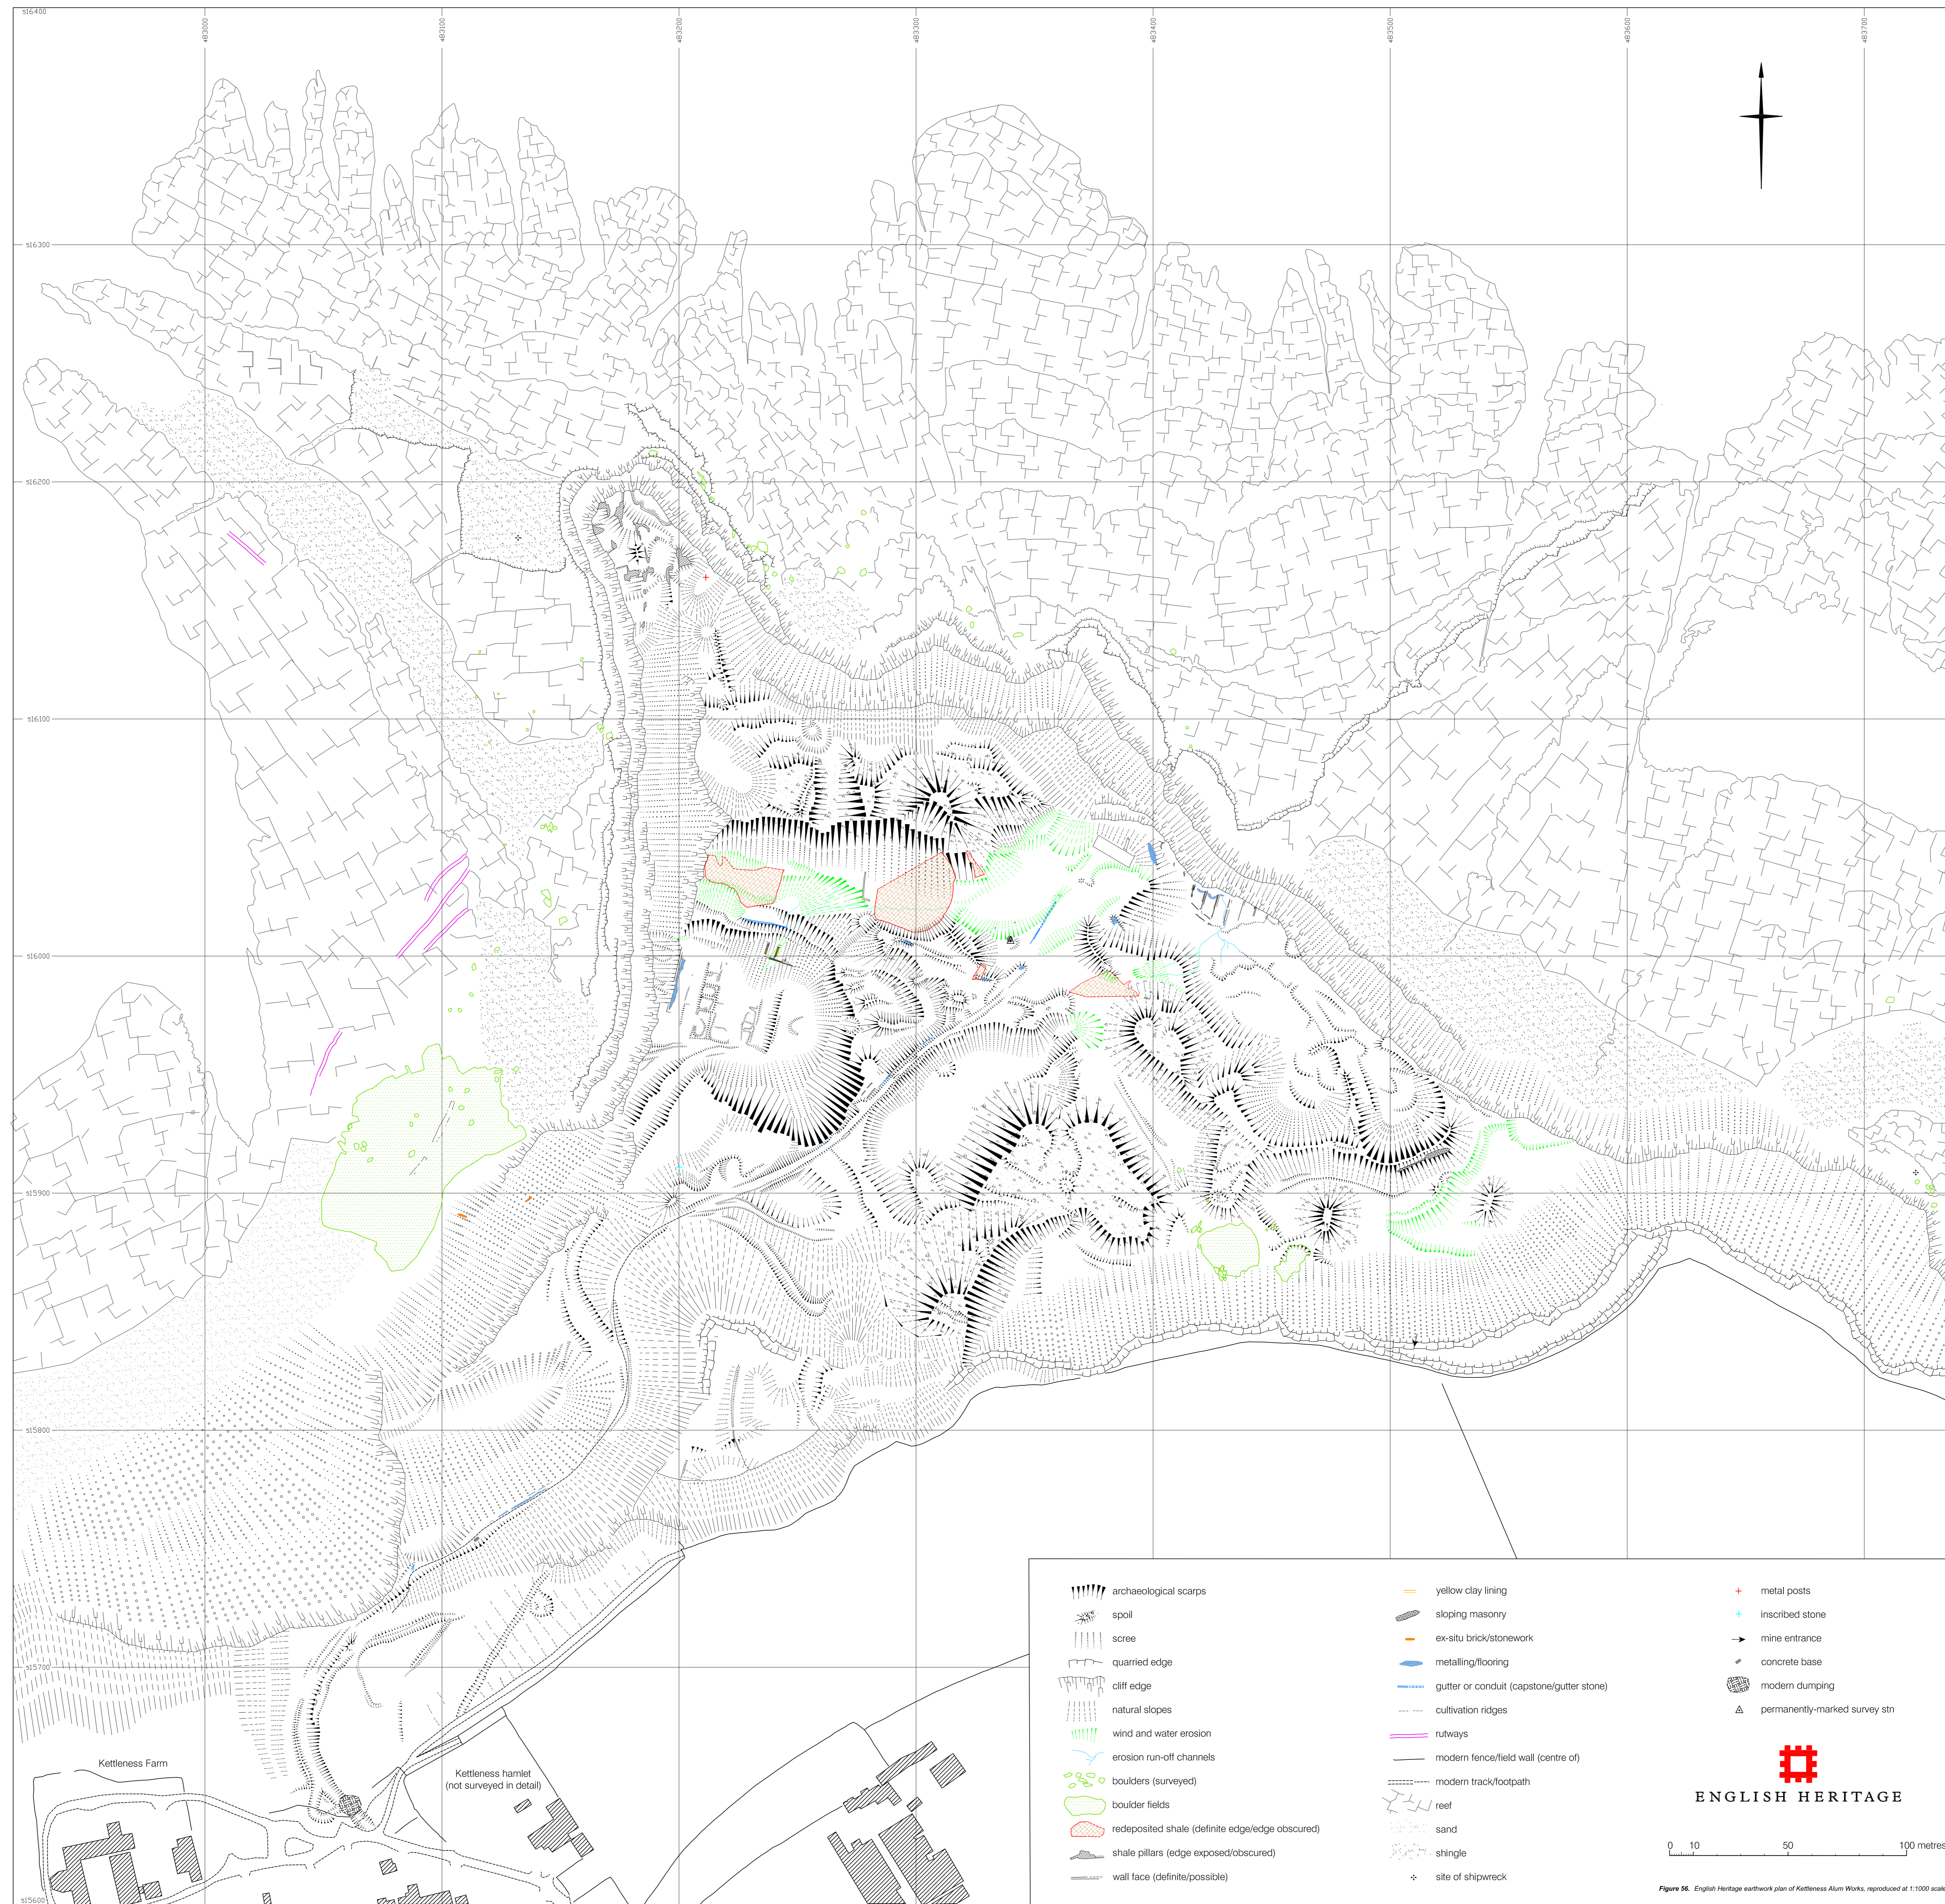
Figure 56. English Heritage earthwork plan of Kettleness Alum Works, reproduced at 1:1000 scale
