COCKHAM WOOD FORT Hoo St Werburgh, Kent

A 17th-century battery
for the defence of the
Medway and Chatham
Dockyard

SURVEY REPORT

**ARCHAEOLOGICAL INVESTIGATION REPORT SERIES 20/2002
ISSN 1478-7008**

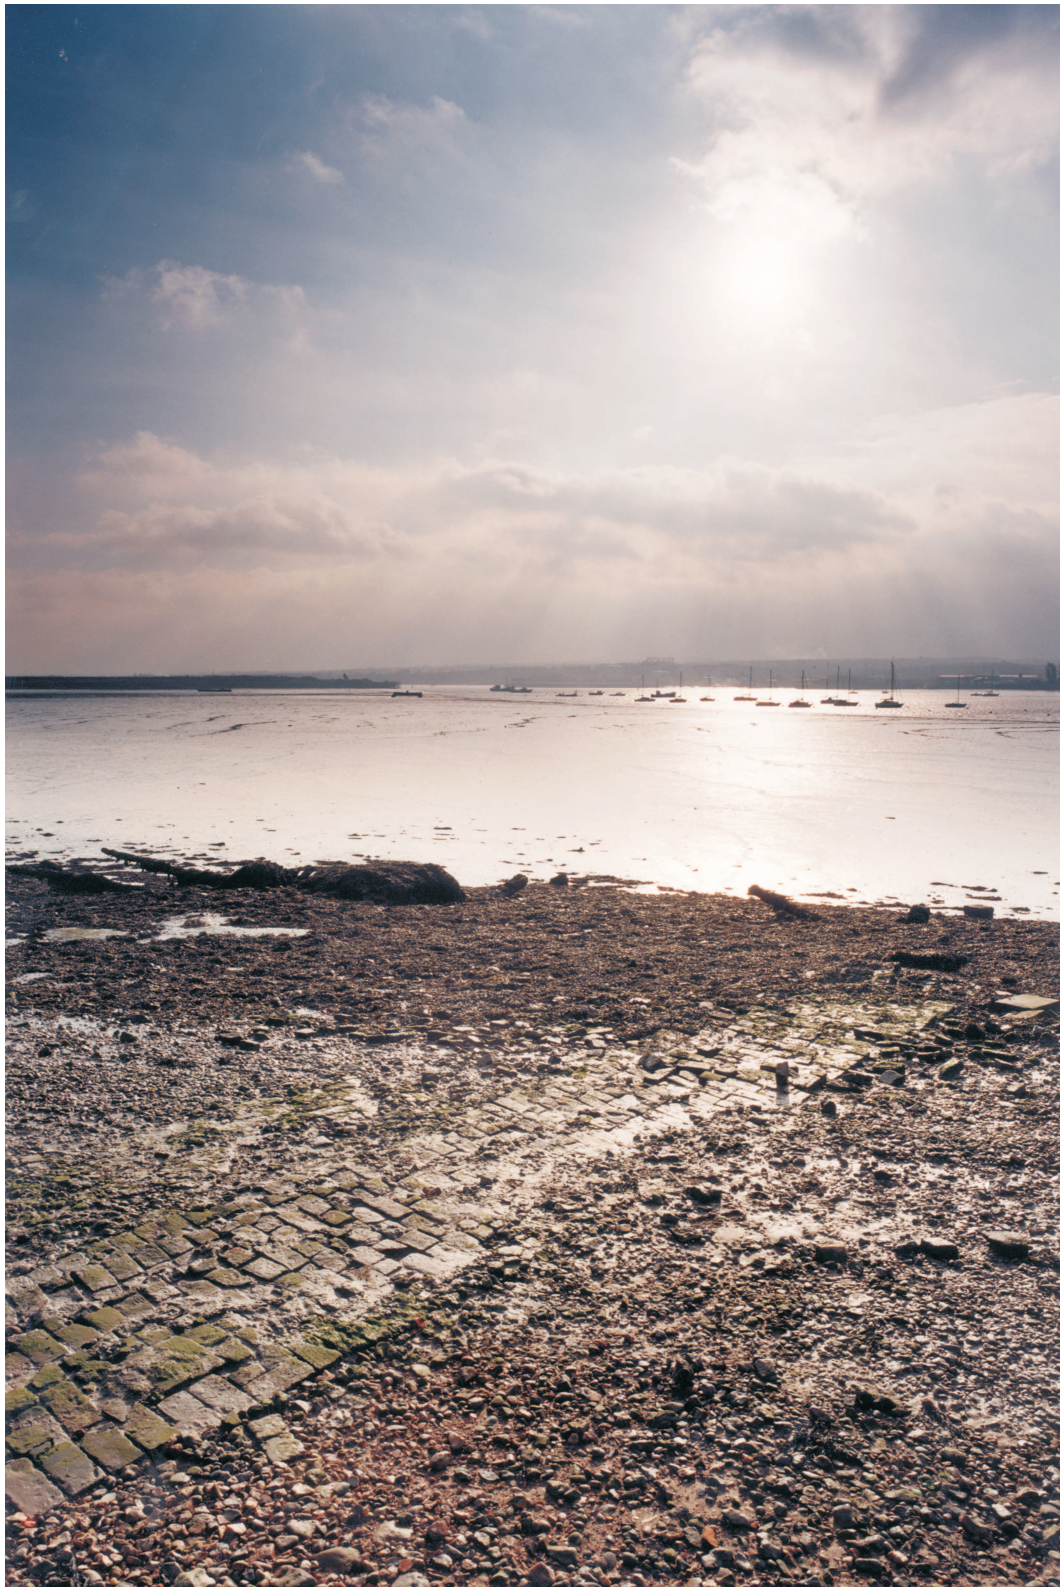
*The foundations of the east bastion of the lower
gun line, looking down river
(NMR: AA031331)*

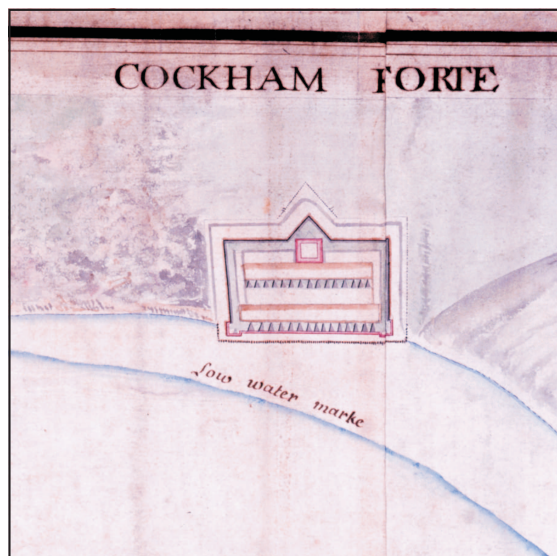
Figure 8
Cockham Wood Fort as represented on an early 18th century plan of the River Medway (PRO: MPH/1/76 part 2, by kind permission of the Public Record Office)

the base of the west ditch or the berm between the west ditch and rampart, as well as along the east side of the fort, each containing a central salient, probably represent palisades. A drain ran along the bottom of the gorge ditch, terminating in a small pond at its east end (PRO: MPH/1/703 part 6). This is the only accurate survey of the fort in the 18th century, despite its stylistic representation on several plans of the Medway (PRO: MPH/1/76 parts 1 & 2, MR/1.959; MPH/1/50; MPH/1/60; ADM /40/10; Fig 8).

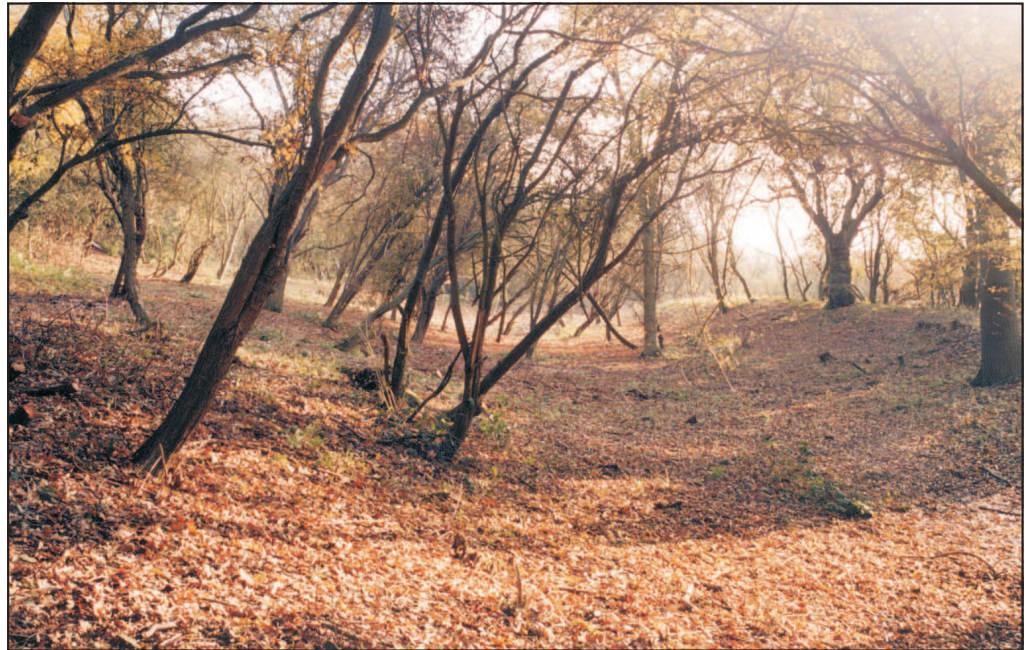
Figure 12
*The gorge ditch
from the west*
(NMR: AA031354)

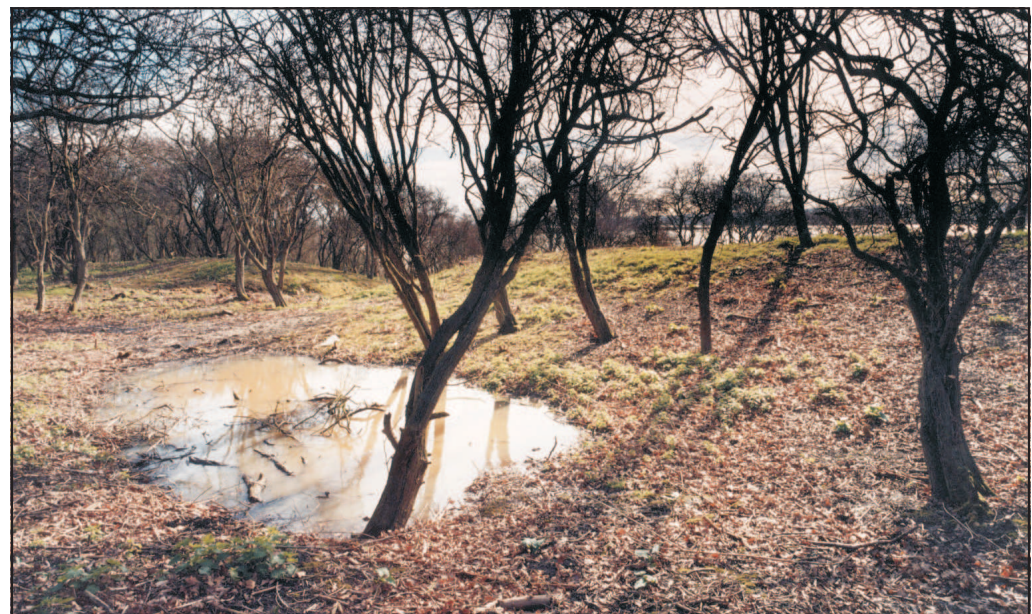
Figure 14
*The gorge rampart
from the north-west.
The water filled
depression is in the
ditch bottom
(NMR: AA031358)*

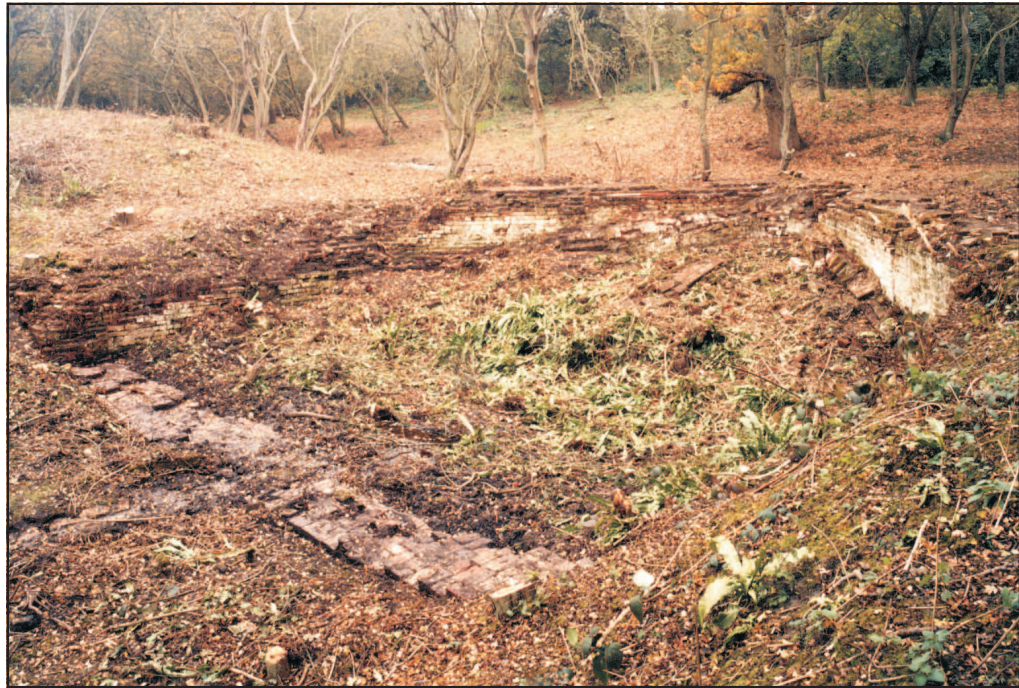
Figure 16
*The redoubt from
the south-east*
(NMR:
AA031356)

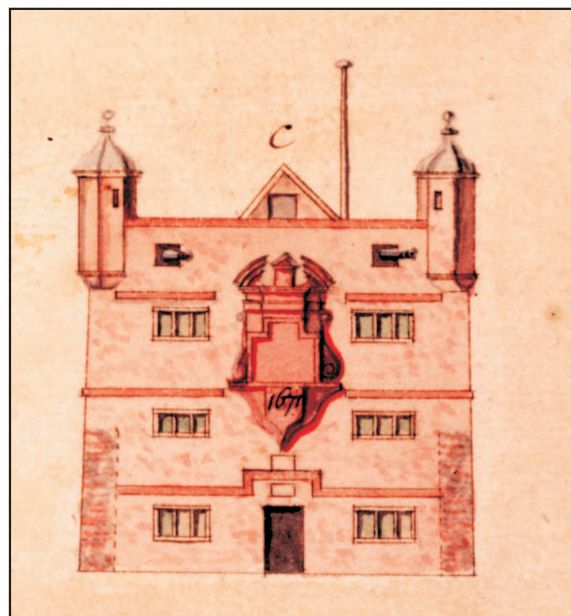
Figure 17
*Elevation of the
redoubt, dated 1698*
(BL: Kings 43, ff
35-36, by kind
permission of the
British Library)

An elevation of the redoubt, known as a blockhouse, appears with the 1698 plan of the fort (Fig 17). It had three stories totalling 10.4m high, entered at ground level from the interior of the fort. Above the entrance was an ornate coat of arms, inscribed with the completion date of 1671. Payments in 1672 include carving works, which may refer to this coat of arms (PRO: WO/49/218). In c1800 the redoubt was still standing to an extent that the inscription remained visible, but it was finally pulled down with the materials sold in the late 1830s (PRO: TS/21/26; RE Letter Books (Chatham) Sept 1842

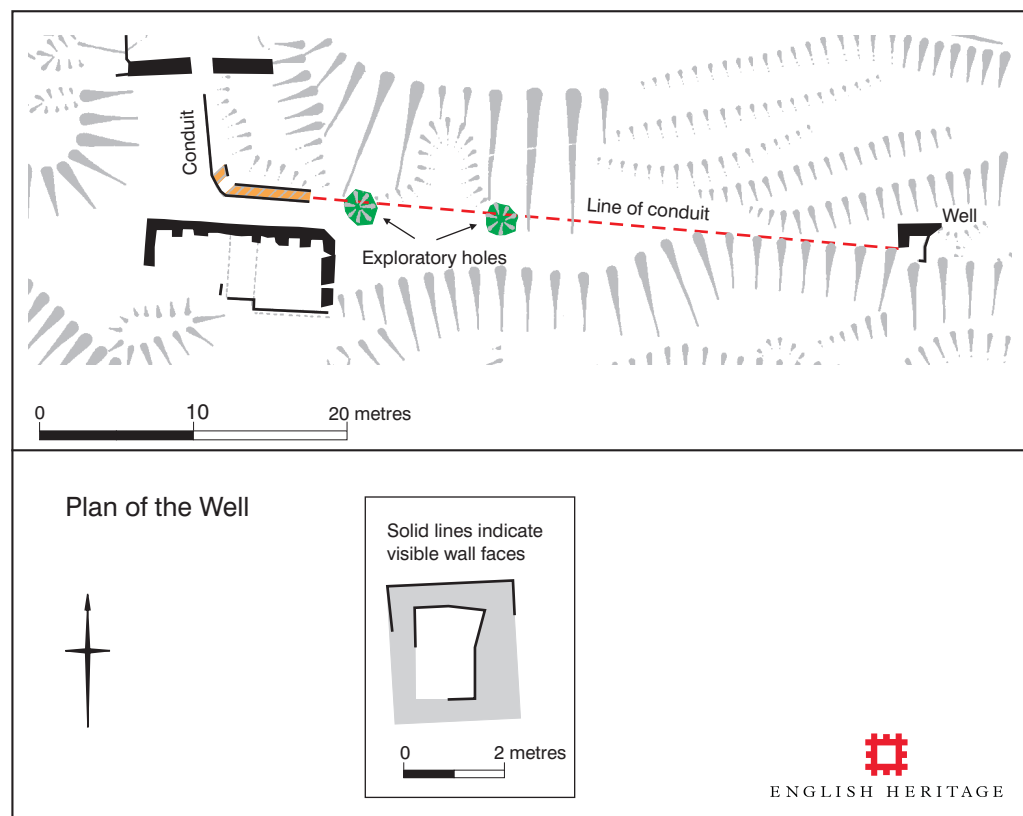
Figure 18
Plans showing the well and conduit

Linked to the well and carrying water to the redoubt was a brick-lined conduit. Part of this feature has been exposed south of the redoubt before turning east towards the well, with additional traces exposed in two exploratory holes at the base of the gorge rampart. The conduit is 0.7m wide, with a semi-circular vault and appears to have been 0.7m deep (Fig 21).

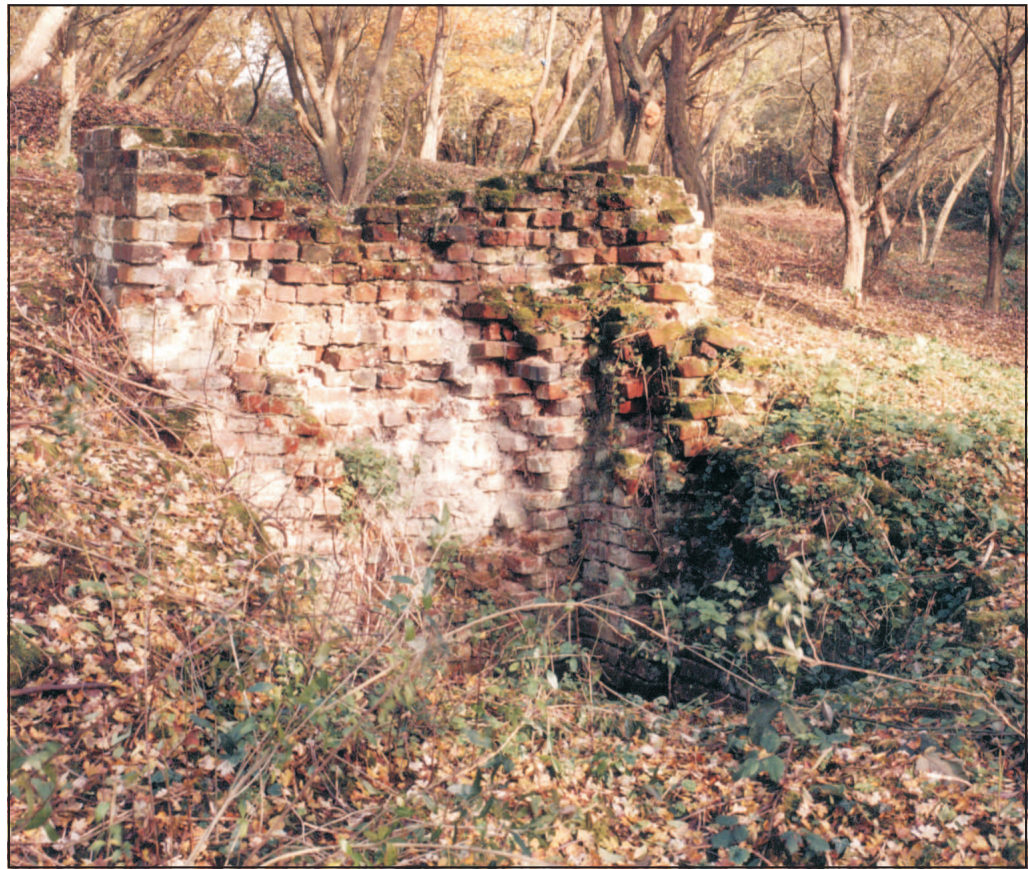
In the north-east angle of the fort, a small red brick-lined shaft is thought to be the top of the well that serviced the fort (Fig 19). It is roughly 3m square, the north wall surviving to a depth of 2.4m and a wall thickness of 0.7m. All the wall faces are bowing inwards under the pressure of the surrounding earth. It is likely that this is the well first mentioned in December 1670 (PRO: WO/51/52).

Figure 19
*The well from the
south-west*
(NMR: AA031352)

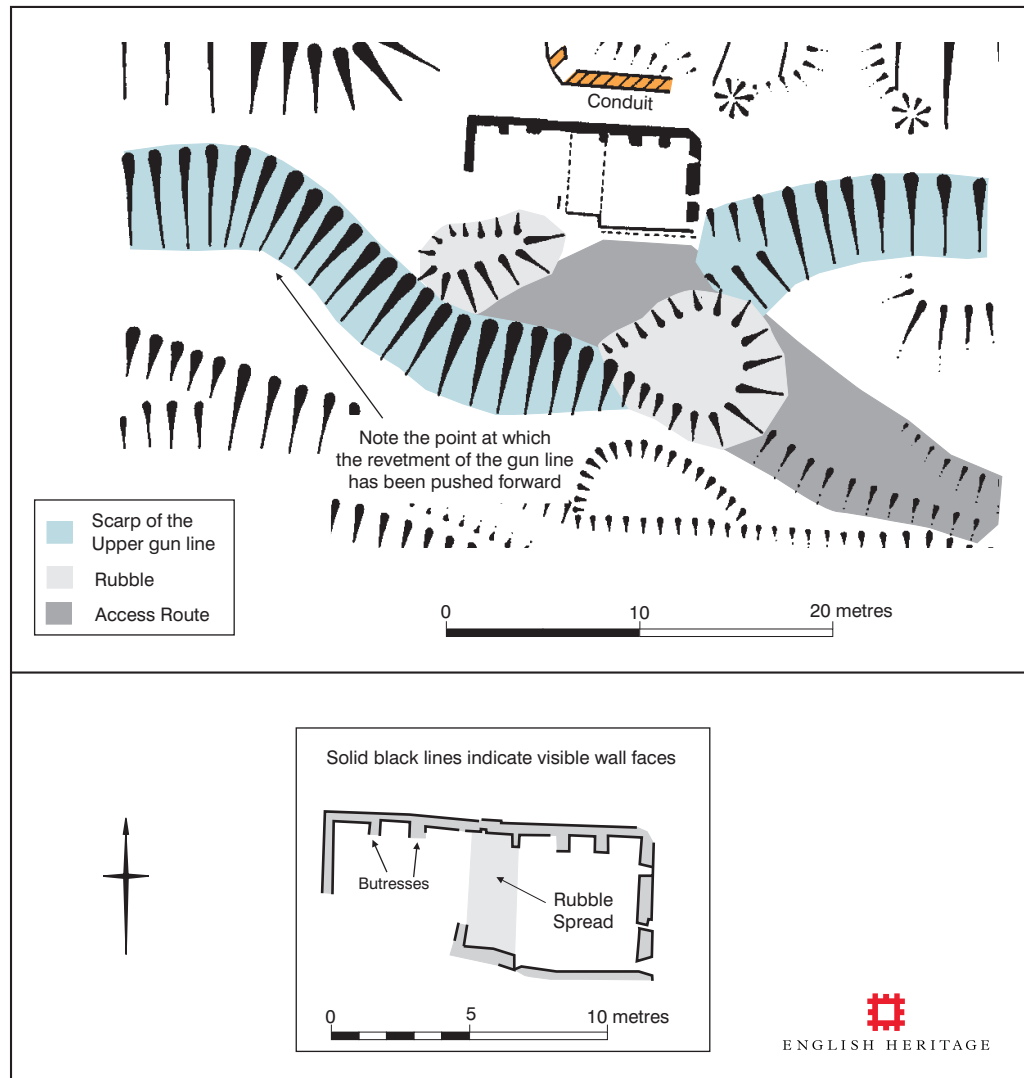
Figure 20
*Plan of the late
18th - century
gunner's house*

To the south of the redoubt and conduit, on the upper gun line, lie the remains of a second gunner's house, constructed in the 1790s, possibly from the materials of the original gunner's house (PRO: TS/21/26). In 1807 it was described as measuring 40 ft x 15 ft (12.3m x 4.6m) (RE Letter Books (Chatham) Sep 1805 – Sep 1807). An elevation of 1837 shows it had two stories, a pitched roof and chimney stacks on the gables. A doorway in the centre of the south face, gave onto two rooms separated by a central passage. The house was demolished late in the 1830s, following subsidence first noted in 1832 and which is likely to have been associated with the gradual collapse of the upper gun line (PRO: WO/44/141 and 143).

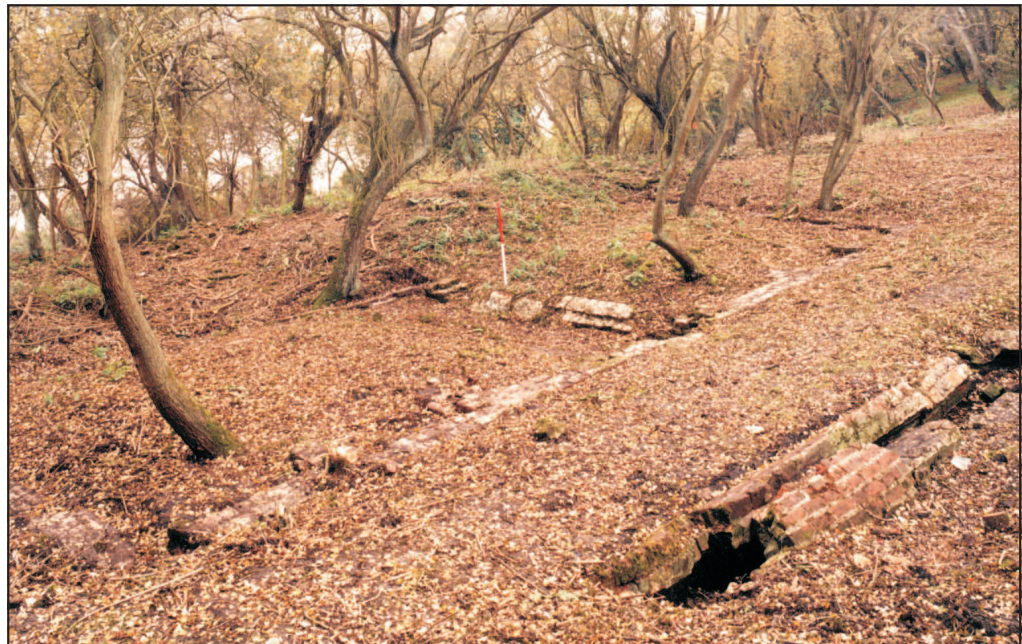
Figure 21
*The late 18th -
century gunner's
house from the
north-east. The
brick conduit lies to
the lower right*
(NMR: AA031357)

The house foundations survive, to a maximum height of 0.55m, in red brick some 0.43m thick. The whole north and east walls can be seen, together with sections of those on the south and west. Five '*buttresses*' each 0.5m square, abut the inside of the north wall and are likely to have been the supports for the floor joists. Few other details are visible, although there is some evidence of whitewash on the internal brickwork. A *rubble spread* 1.7m wide runs down the centre of the structure and is likely to represent the collapsed remains of the internal passage, of which a 0.75m length of wall face survives (Fig 21). It is possible to see where the upper gun-line was modified by the addition of material on the south to provide a larger platform for the house, as well as to enable a more gentle approach from the south. This is now largely obscured by two mounds of rubble.

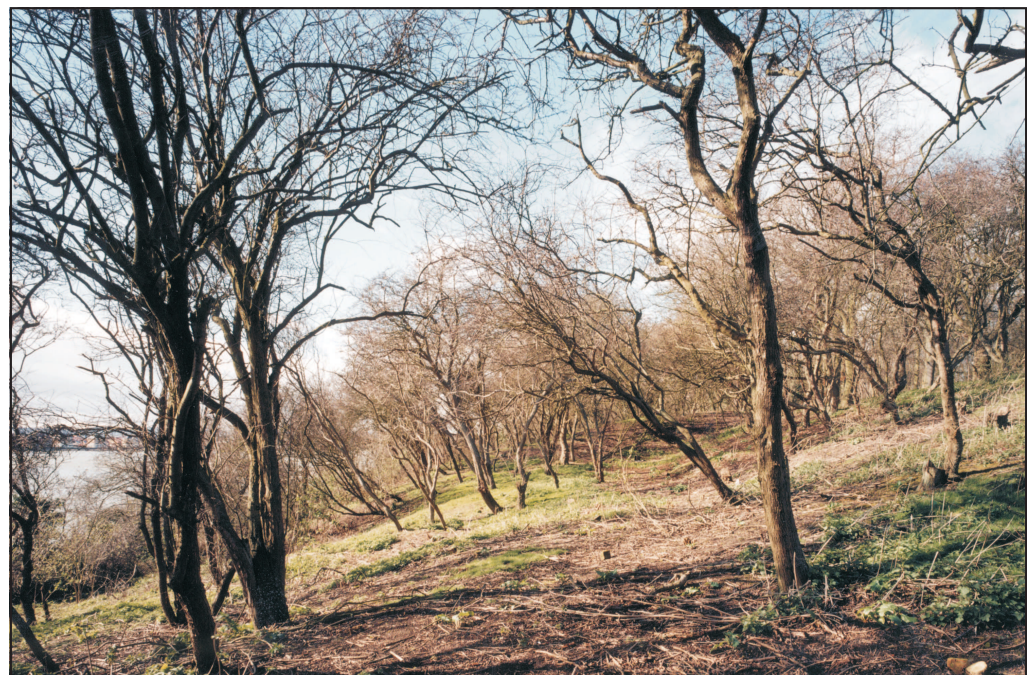
Figure 23
*The upper gun line
from the east,
showing (at centre)
the flat terreplein
(NMR:
AA031313)*

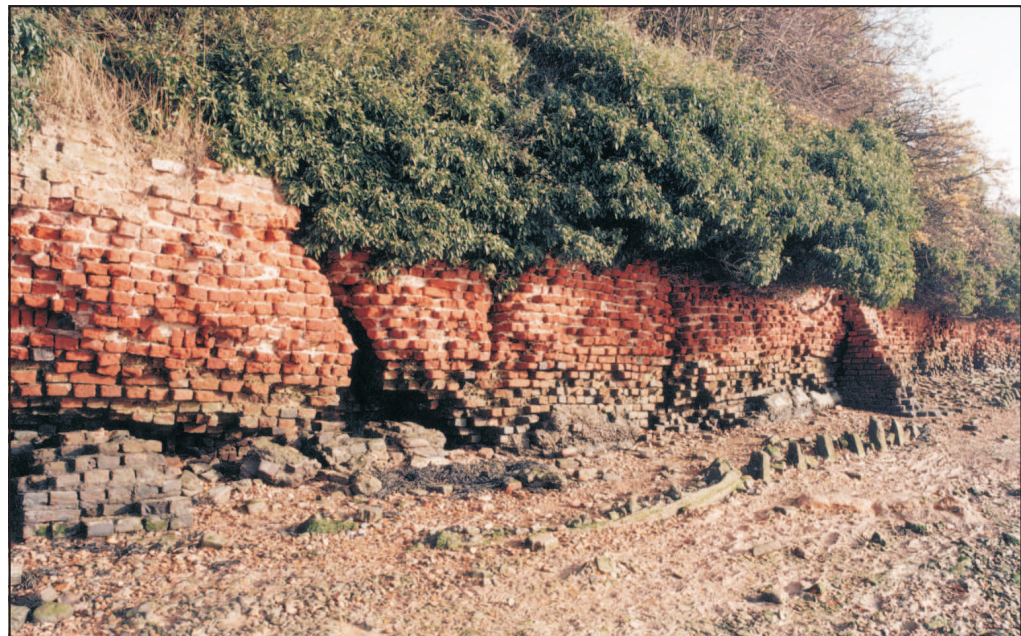
Figure 25
*The revetment wall
of the lower gun
line with the
timber remains of
the tidal defences
in front (NMR:
AA031343)*

Substantial parts of the lower gun line survive, albeit in a deteriorating condition. The red brick revetment, laid in English bond, can still be traced along much of the original frontage. Excluding the west bastion it stands to a maximum height of 2.3m, with no facing bricks surviving, though it is possible to see the back face of the revetment in a few places where areas of overlying soil have been removed. The east bastion is barely visible as a brick foundation at beach level; with the tide washing away much of the earth platform behind (frontispiece). The gun line did not front squarely onto the river for its entire length, as some 40m along the curtain from its western end, the line turns into the river. This has resulted in the location of the eastern corner some 16m further south than its western counterpart. This is confirmed by the 1742 plan and is presumably connected with both the line of fire and the course of the river. Several small buttresses, each c1.1m long by 0.6m wide, are placed at intervals along the line to provide extra support (Fig 25). Pebble concrete lying over the lower brick levels is a result of underpinning carried out at a later date, probably in the 20th century.

In the river mud some 2m south of the revetment wall of the lower gun line, and in a line projecting upstream from the corner of the west bastion, are the remains of timber piles and boarding, which survive to a maximum height of 0.2m (Fig 25). These are the remains of defences constructed to minimise the destructive effect of the tide on the brickwork of the lower gun line. It is possible that they are the small piles which were first recommended in a Royal Engineers perambulation report of 1853:

‘the brickwork which at present preserves the property from the inroads of the river is being daily undermined and it is recommended that small piles should be driven into the clay and ragstone filled in between them and the brickwork’ (RE Perambulation Reports, Aug 1853-Nov 1885).

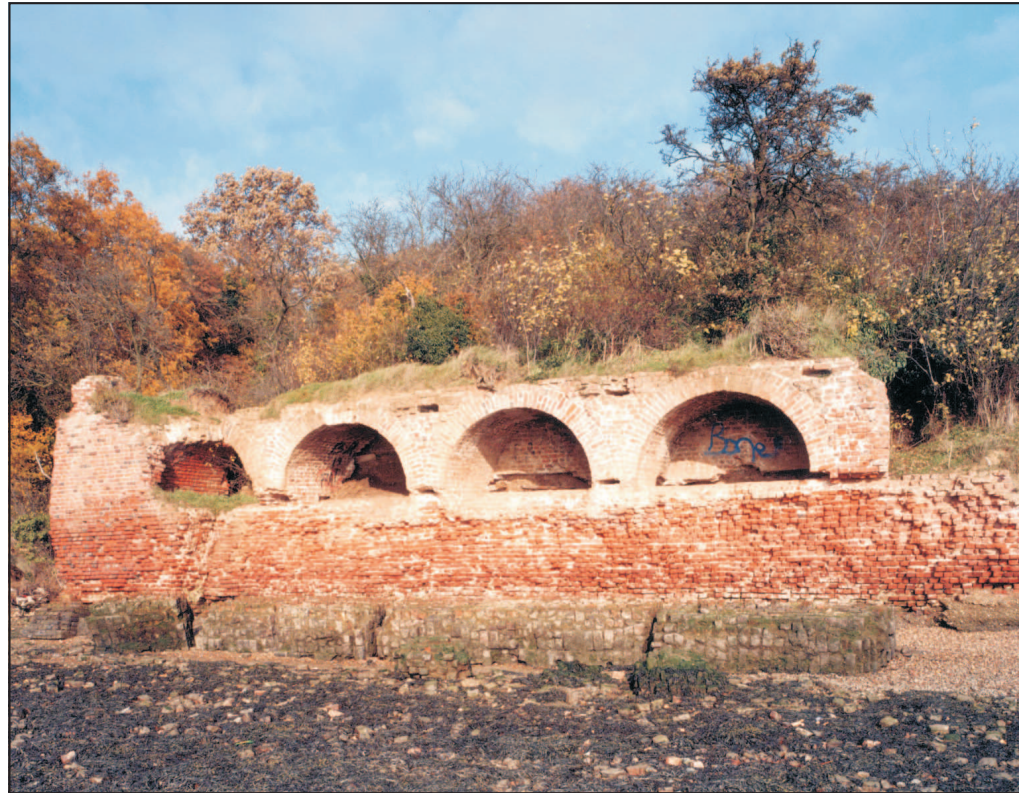
Figure 26
*The counterforts of
the west bastion*
(NMR:
AA031340)

The brickwork of the west bastion is comparatively well-preserved, standing some 5.5m high on its west side, as well as retaining some of the original facing bricks. Much of its front face has collapsed onto the beach, revealing four internal arched counterforts, which spring some 2m from the ground and to which the face of the wall had evidently been bonded (Fig 26).

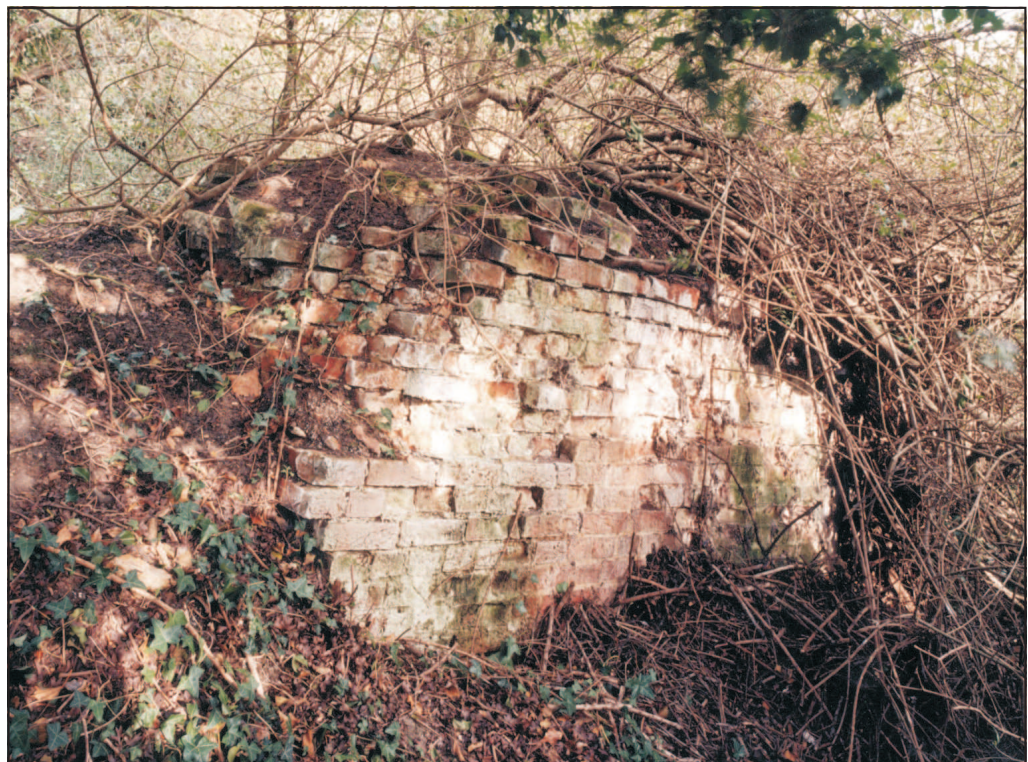
Behind the revetment, it is likely that much of the *terreplein* survives below ground, partly covered by eroded material from above, encouraged by the collapse of the rear revetment wall. An erosion scar at **a**, has revealed two in-situ flagstones from the gun floor of the west bastion, now covered by 0.8m of soil (Fig 27). A bank along the back of the revetment at **b**, is likely to be part of the rampart behind. Two sections of wall, at **c** and **d** are the remains of the rear revetment wall, although only **d** appears to be in-situ, suggesting a wall 1.3m thick that was whitewashed on its southern face (Fig 28).

Figure 28
*A section of the rear
revetment wall of
the lower gun line*
(NMR: AA031334)
