**FORT CLARENCE,
ROCHESTER, KENT**

A NAPOLEONIC GUN TOWER AND DEFENSIVE LINE

ARCHAEOLOGICAL INVESTIGATION REPORT SERIES 40/2002

Report by: Paul Pattison
Survey by: Paul Pattison, Moraig Brown, David McOmish and Cathy Tuck
Specialist report by: David Higgins
Drawings by: Louise Barker and Paul Pattison
Field photography by: Alun Bull

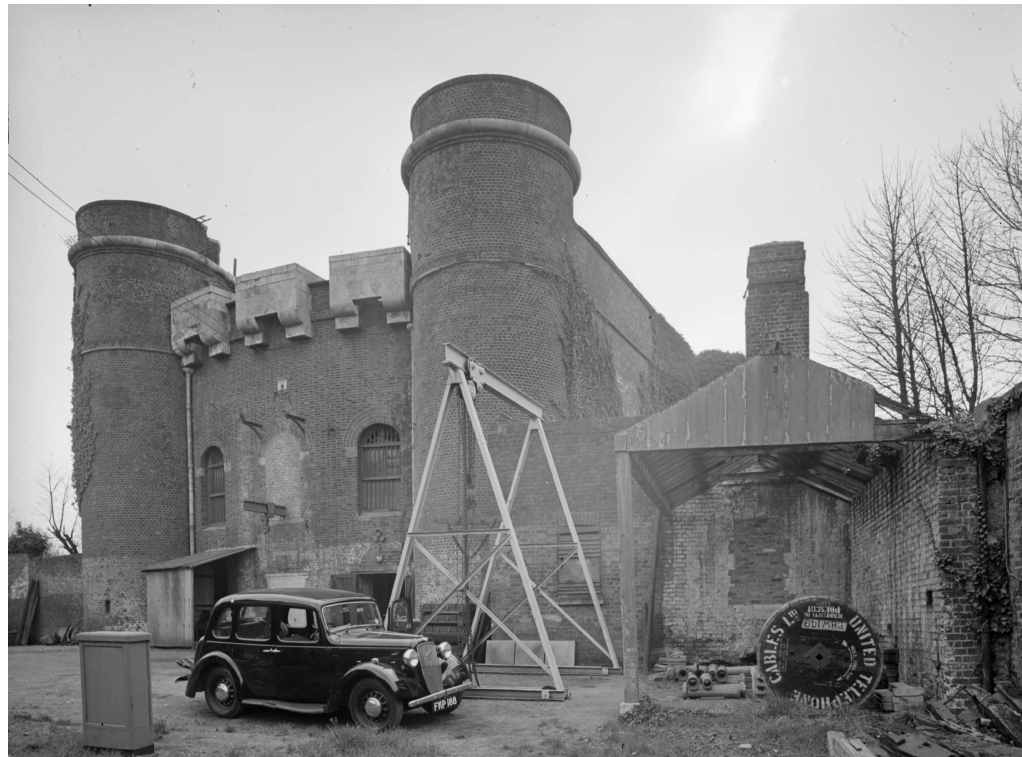
*A photograph of Clarence
Tower, taken from the
north-west in 1961
(©NMR: AA61/2555)*

This tower resembles a medieval keep, complete with machicolations, murder holes and twin turrets, in deliberate reflection of its older counterpart in the centre of Rochester (frontispiece, Fig 9). It sat astride the Line, with its east and west faces looking along and originally providing flanking artillery fire along the ditch, scarp and counterscarp. The roof formed a platform for longer range artillery defence.

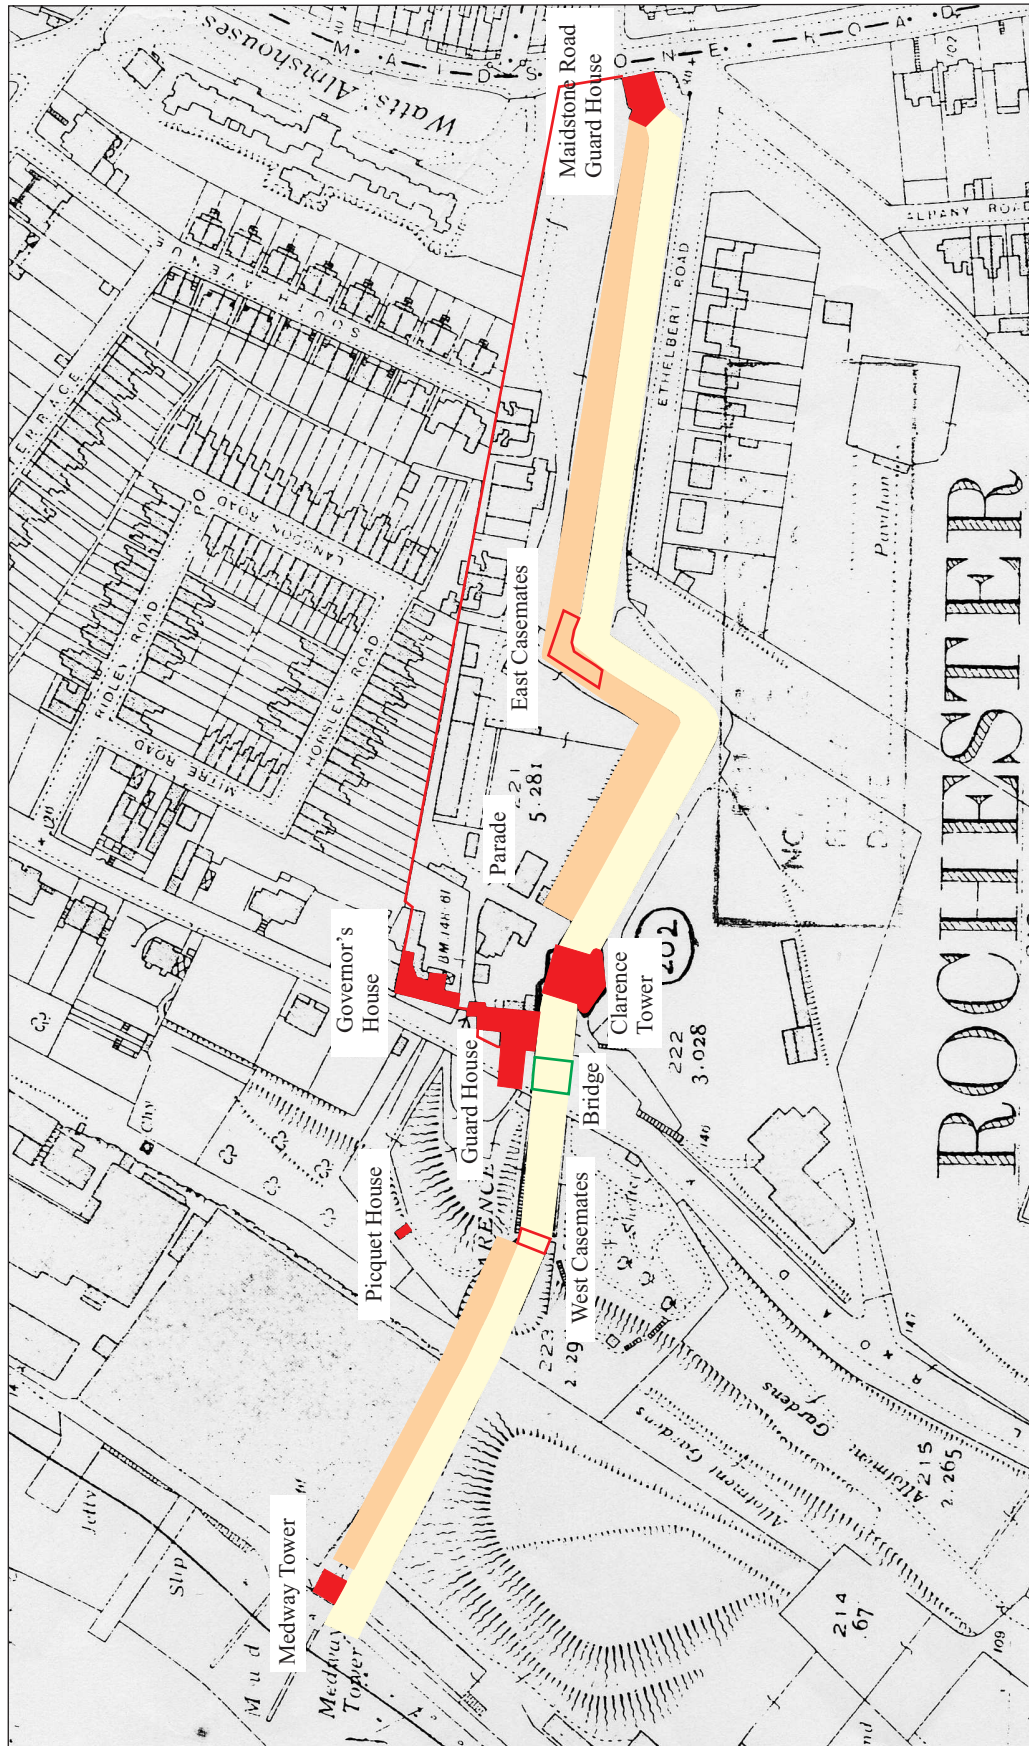
Figure 3

Plan showing the principal elements of the defences built at Fort Clarence, 1808-15. Sand = rampart; yellow = ditch; solid red = building above ground; outline red = building below ground; green = bridge across the Borstal to Rochester road (Reproduced by permission of the Director General of the Ordnance Survey)

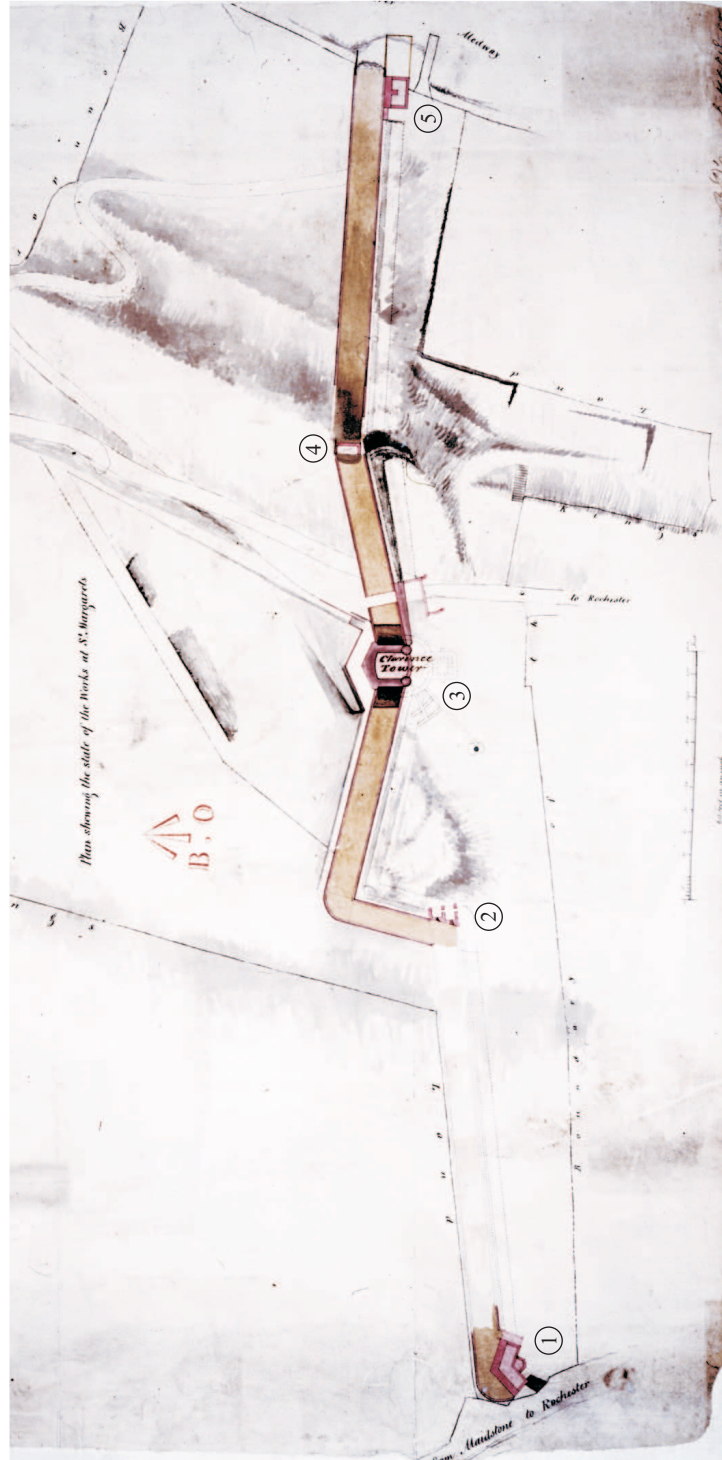
- ① Maidstone Road Guard House
- ② East Casemates
- ③ Clarence Tower
- ④ West Casemates
- ⑤ Medway Tower

Figure 4
A map of Fort Clarence, dated December 1811, showing progress to that date. Note the incomplete section of the Line between the East Casemates and the Maidstone Road Gatehouse. North is at the bottom of the page (PRO: MPH/1/585/6, © Public Record Office, by kind permission)

By November 1810, the earthworks of the Line were well advanced; a note on a section drawing of that date specified that the scarp and counterscarp between Clarence Tower and the Medway Tower should be revetted in 14-inch brickwork (PRO: Work/31/311). Nevertheless, the Line between the East Casemates and the Maidstone Road Guard House was unfinished at the end of 1811, and is shown as such on a plan of December 1811 and a section taken in January 1812 (Fig 4; PRO: MPH/1/585/6 ; Work/31/314). However, this part of the Line appears to have been finished by the October of 1812 (PRO: MPH/1/585/7).

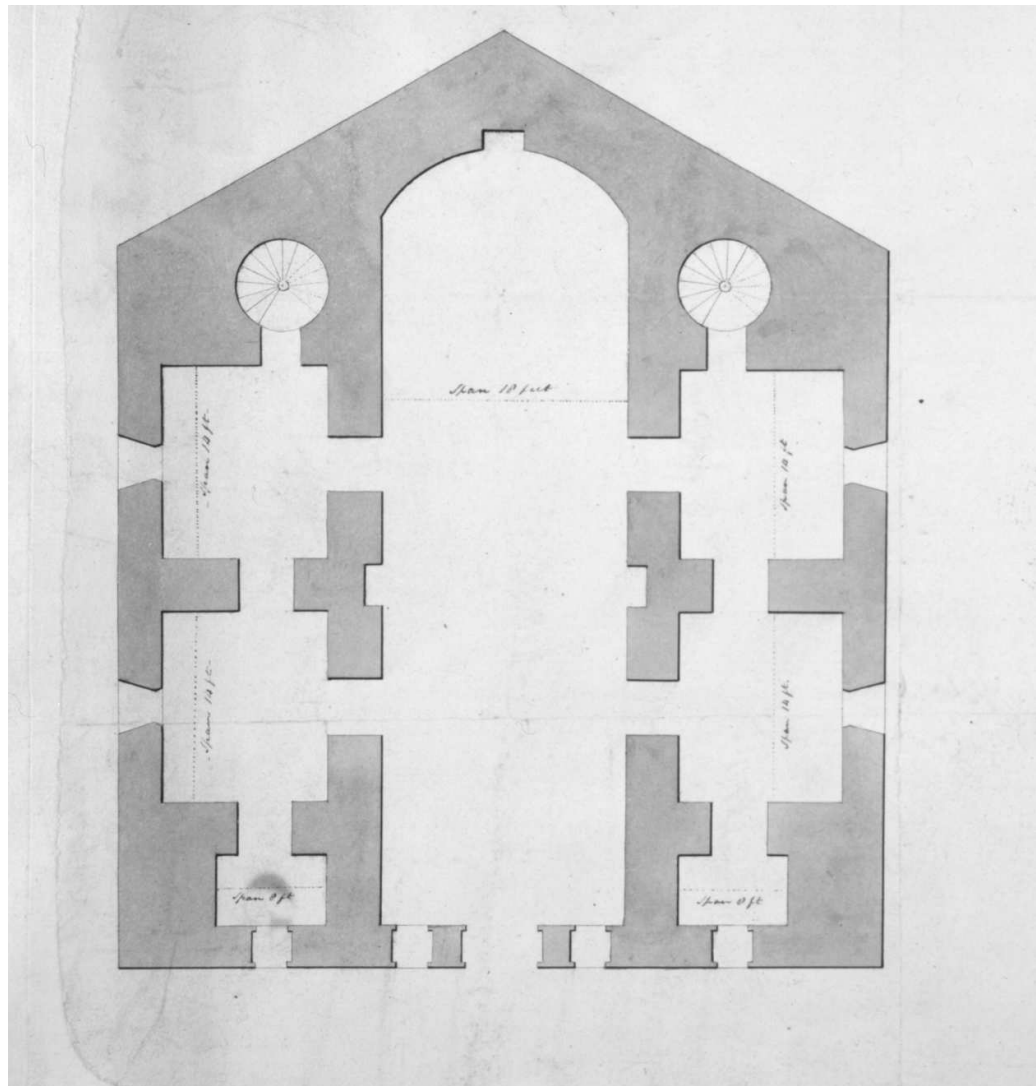
Figure 5
An early design for the plan of Clarence Tower, dating to 1809 (south is at the top of the drawing). Compare this with Figs 6, and 7, the latter showing the plan eventually adopted (extract of PRO: MPH/1/585/1 © The Public Record Office, by kind permission)

An early design for Clarence Tower was prepared by Lt Col D'Arcy - the CRE Chatham and officer in charge of the whole project - and attracted comment from Lt Col William

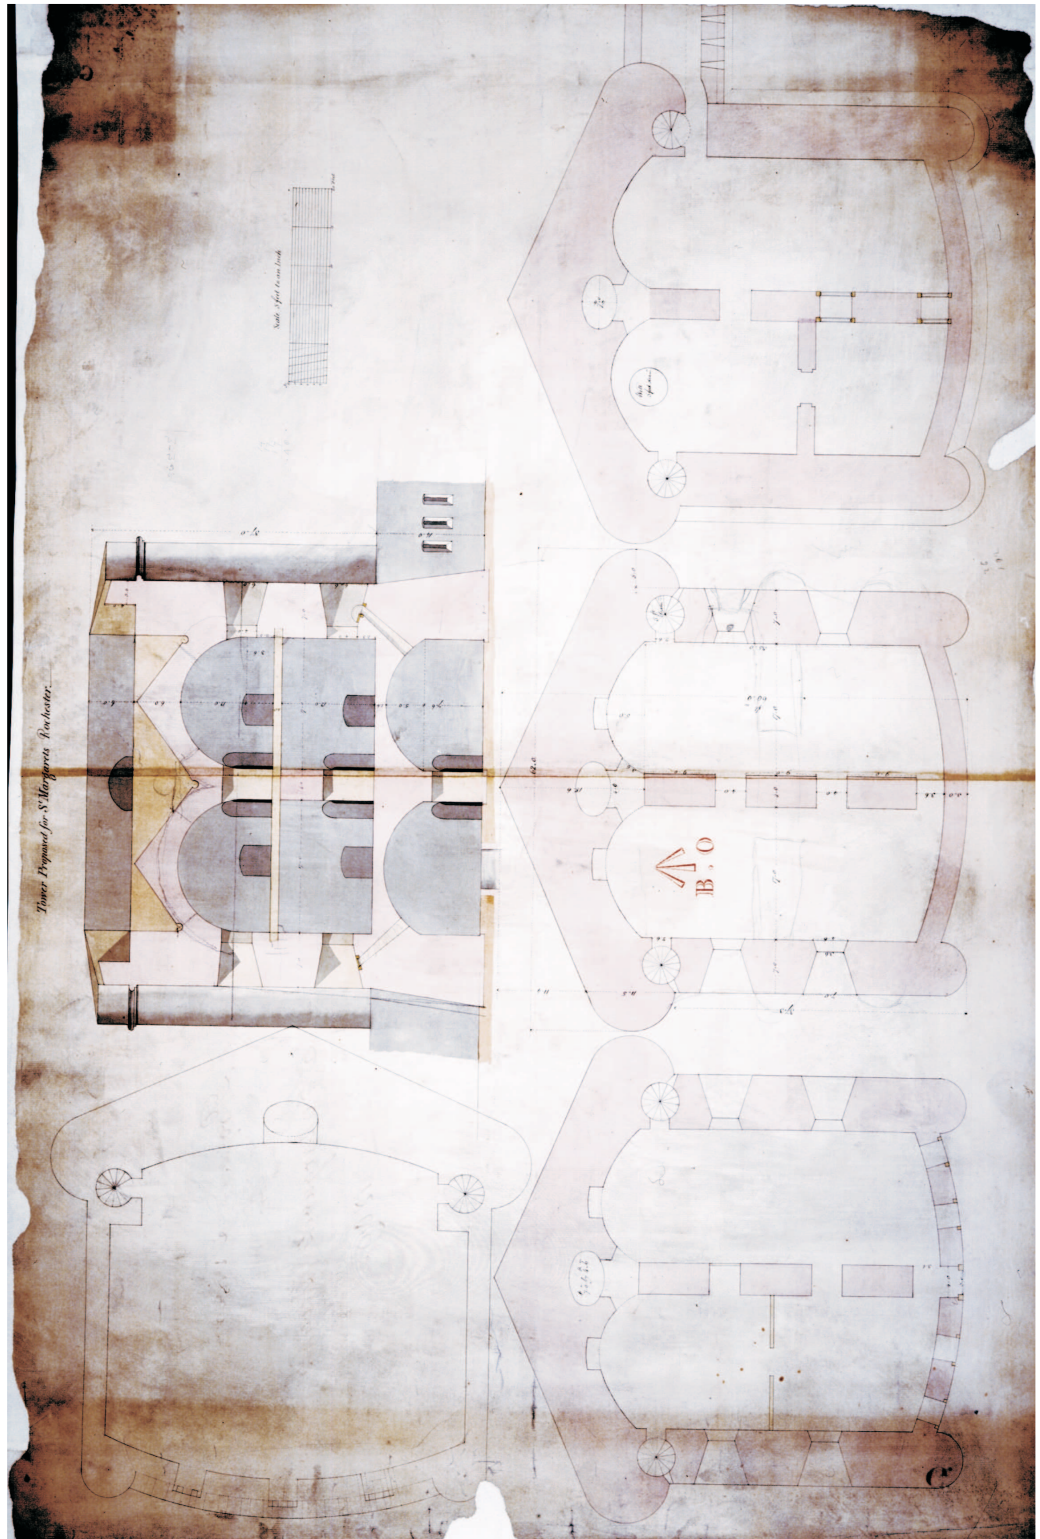
Figure 6
Plans and section dated 1809, showing the revised form of Clarence Tower proposed by Lt Col d'Arcy. It shows a structure very close to that subsequently built, with the exception of the newel stair positions. North is at the bottom of the page, the section is east (left) to west (right) (PRO: MPH/1/588/3 © The Public Record Office, by kind permission)

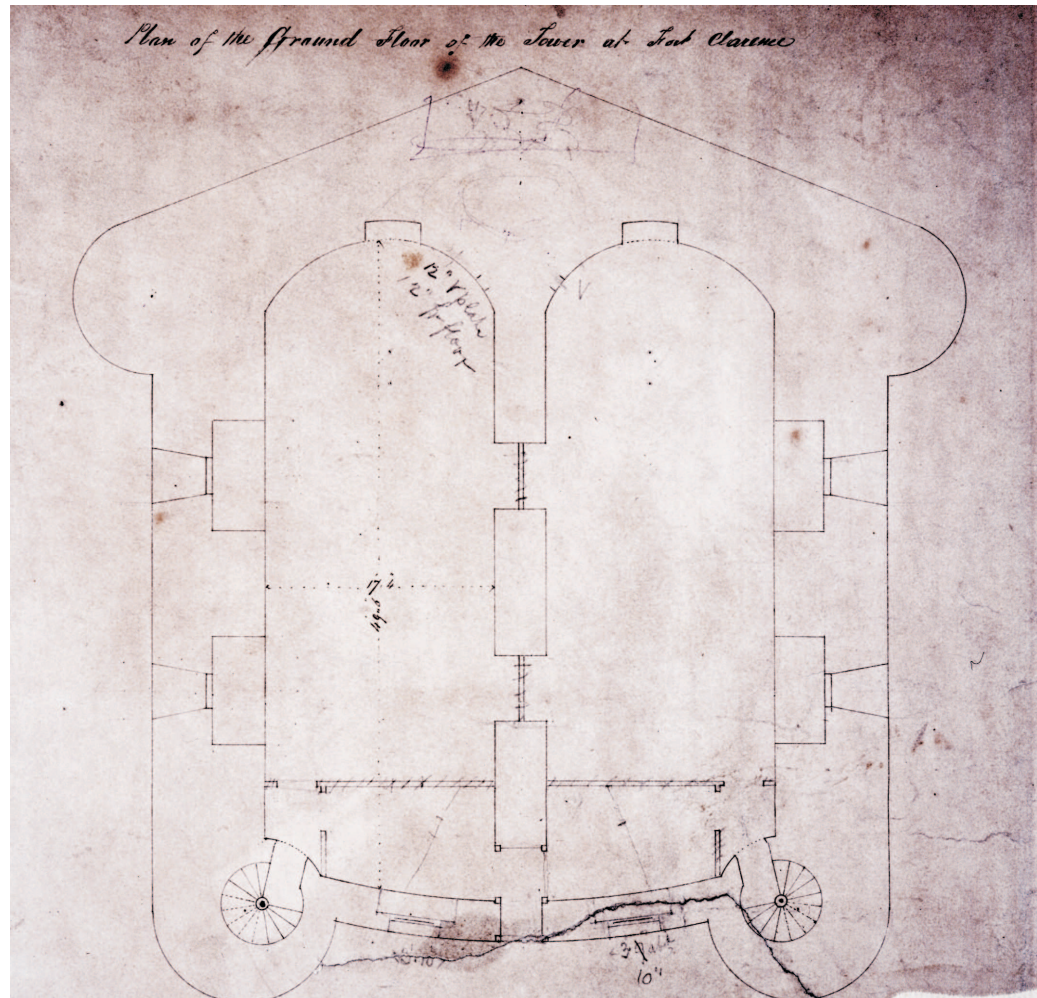
Figure 7
The ground floor plan of
Clarence Tower, as
finalised 1809-10. Note
the sketched position of
the ammunition lift as an
ellipse in the thick wall
of the south salient at
the top of the drawing
(PRO: Work/31/306 ©
The Public Record
Office, by kind
permission)

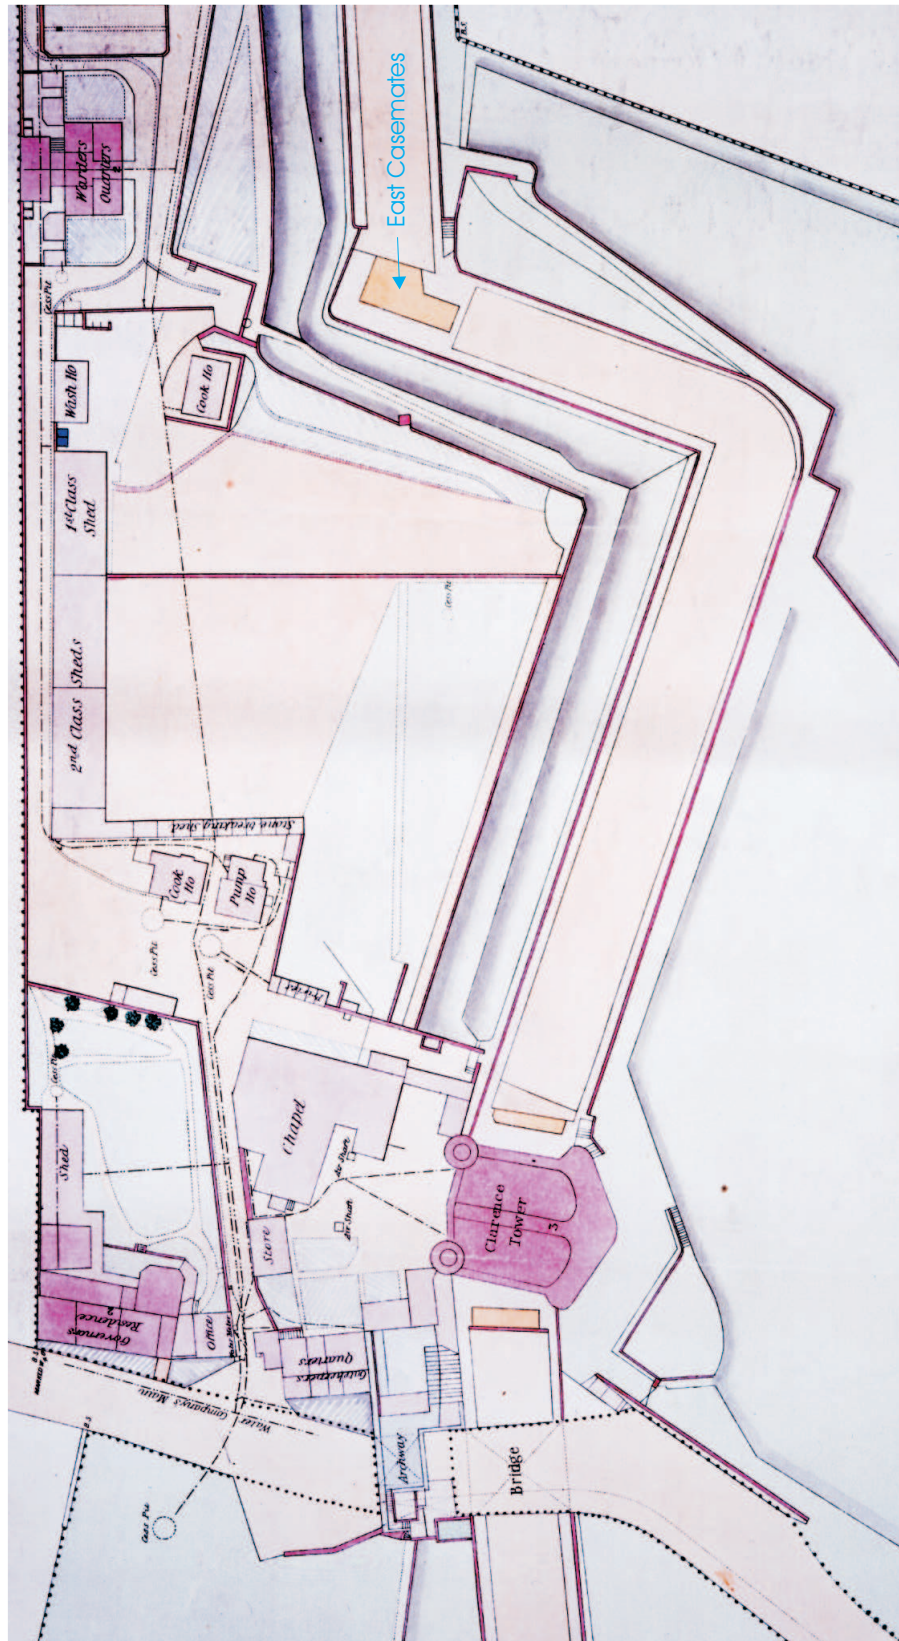
Figure 8
Fort Clarence Military Prison, extract from a plan of 1879, showing the proliferation of buildings which occurred from c 1845 to the north of Clarence Tower and the East Casemates. Text in blue is added by the author (PRO: WO/78/3194 © The Public Record Office, by kind permission)

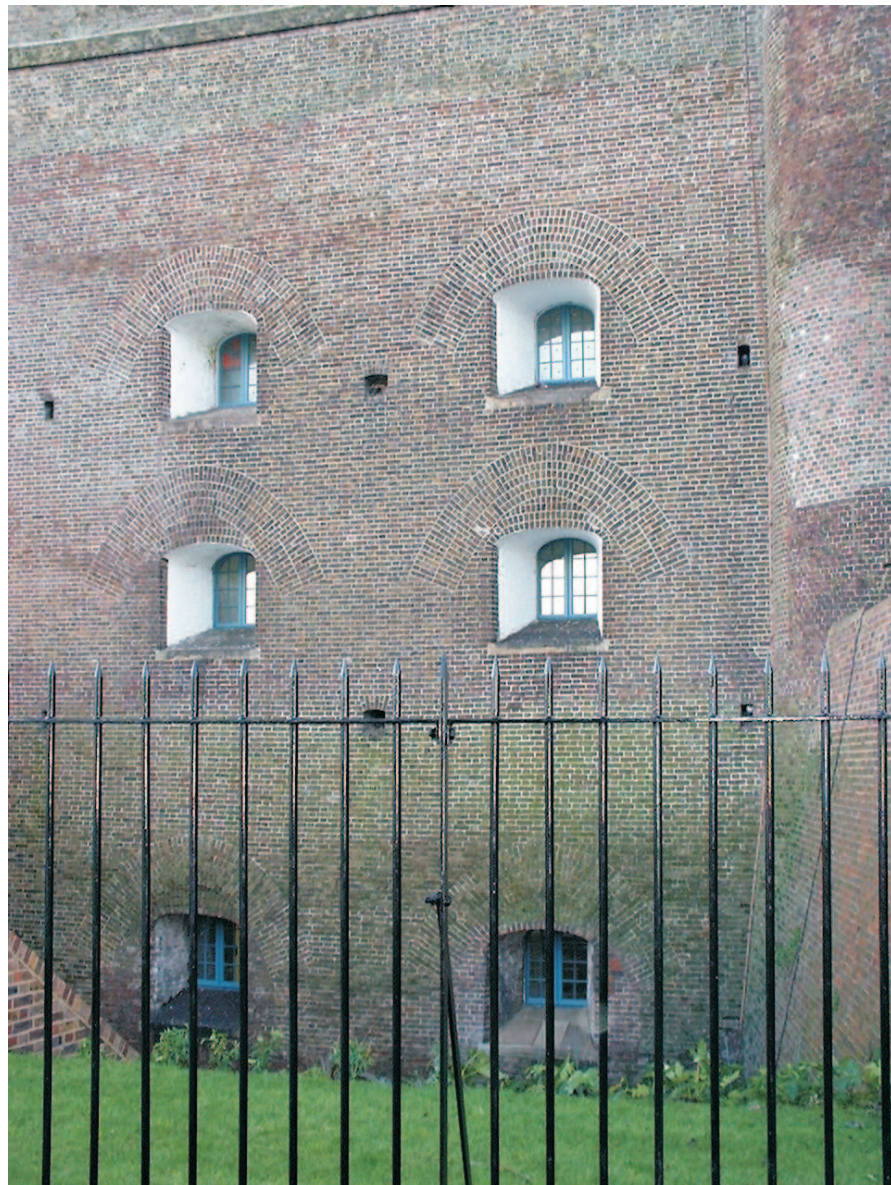
Figure 11
*Artillery embrasures in
the west elevation of
Clarence Tower, at first
floor, ground floor
(centre) and basement
levels, in December
2002(author)*

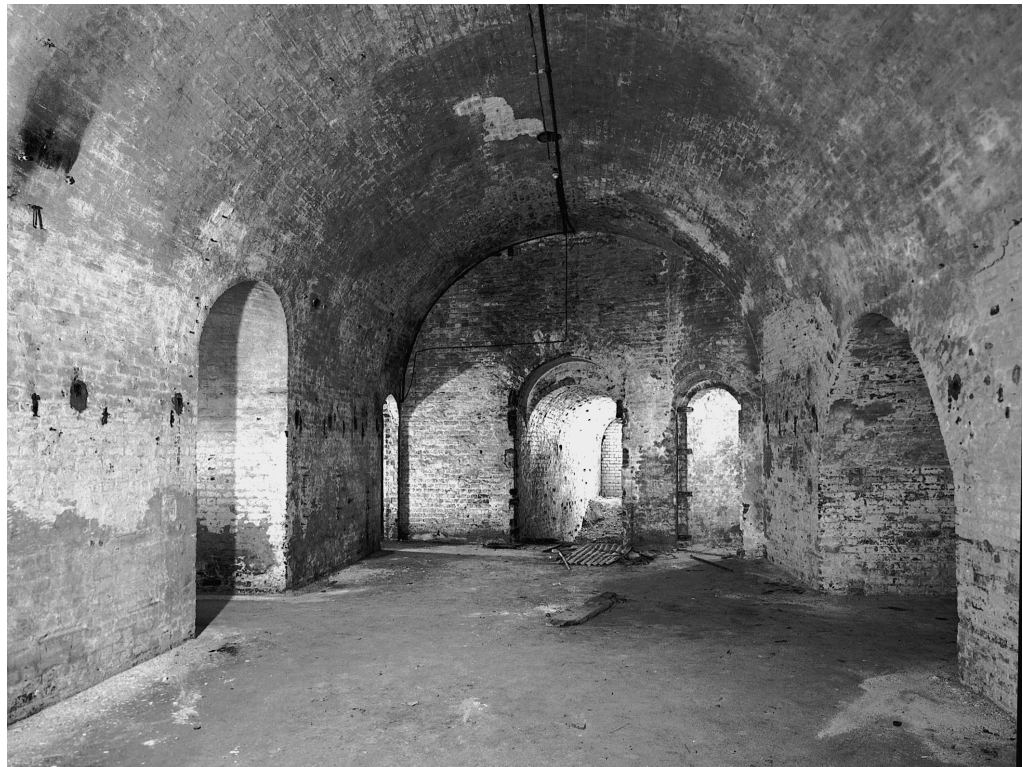
Figure 13
Clarence Tower,
basement level of the
east casemate, looking
north. The entrance at
centre rear of the photo
leads to the Main
Magazine, the one on
its right leads into the
NW turret (©NMR:
AA031464)

The basement casemates are mirror images, of essentially rectangular form with apsidal south walls, slightly curved north walls and semi-circular arched vaults (Fig 13). The floor is a concrete replacement of 20th-century date; the original was probably brick or stone flags. Four openings link the casemates through the party wall, here 2.75m (9ft) thick. All are original and each has a semi-circular arch of four orders. The southernmost is rebated for doors from the western casemate into the base of the ammunition shaft (see below), while the central two form short passages through the party wall, with rebates for doors on the central axis. The fourth and northernmost opening now links to a later

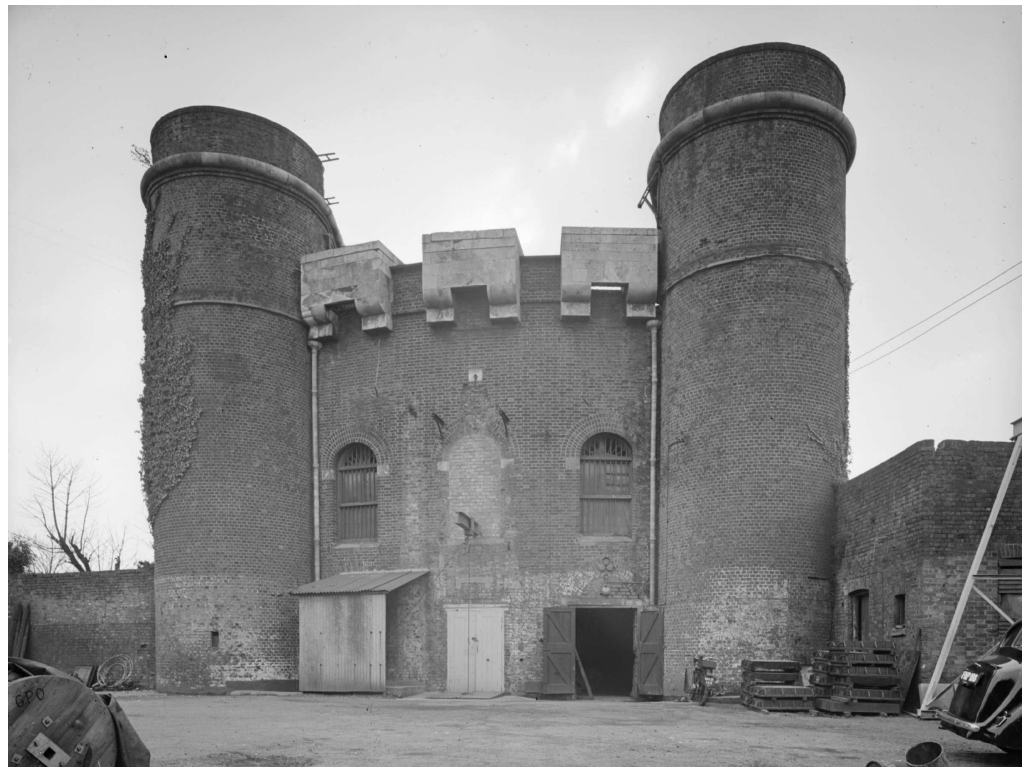
The north, entrance elevation of Clarence Tower in 1961. Note the RSJ projecting centrally at first floor level, with lifting gear linked to a winch in the shed below. This was for lifting heavy loads up and down from basement level via a vertical shaft, for which the trapdoors can just be seen at ground level
(© Crown copyright NMR: AA61/2554)

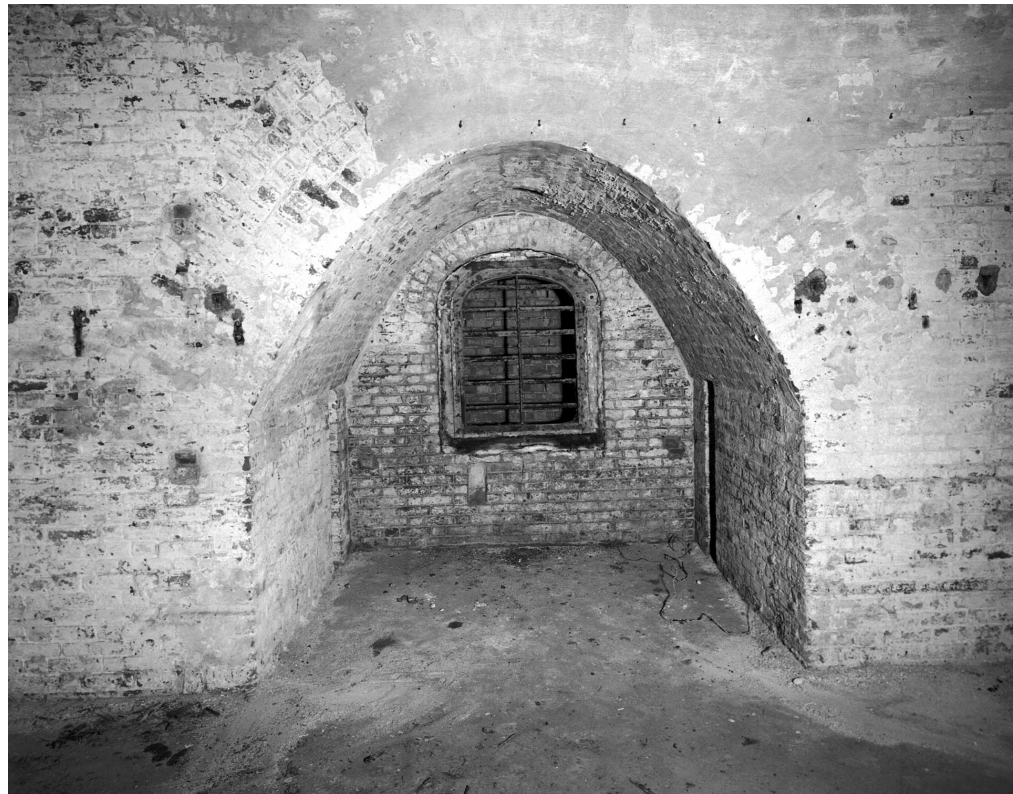
Figure 15
Clarence Tower;
artillery recess in the
basement west
casemate, with its
secondary barred frame
of asylum or prison
vintage (© NMR:
AA021155)

The embrasures are finished with segmental arches passing horizontally through the wall thickness, while the sides and sill are splayed outward and downward respectively to the exterior. The sill is of sandstone slabs. There are no traces of shutters to close the embrasures but the internal faces contained (or had contained) a timber frame of heavy scantling, 0.15m (6in) square, peg-jointed in four pieces. They are recessed and anchored into the brickwork in such a manner that they must be original. At some time, a secondary frame of slighter wooden strips was nailed and screwed into place, with grooves for the insertion of steel bars, no doubt when the site was in use as a lunatic asylum and prison. Additionally, there is evidence for the insertion of shelves across the back of all the recesses at arch and sill level. In the late 20th century, all of the embrasures were blocked with brickwork and render.

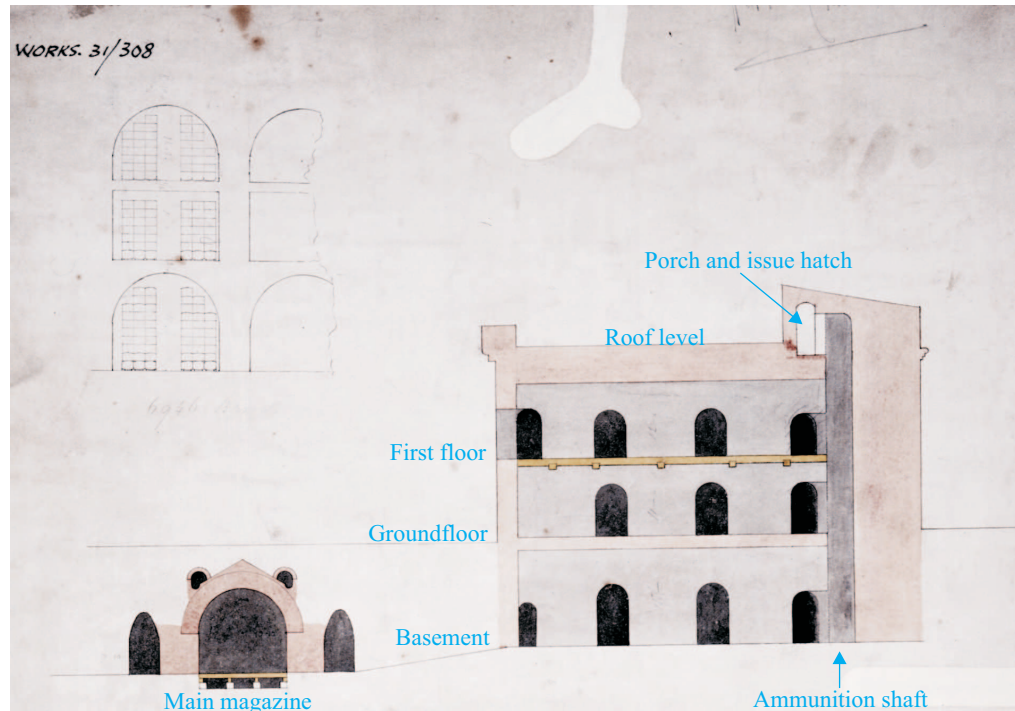
Figure 16
North-to south section through Clarence Tower, undated but c 1815 (north is on the left). Note the position of the ammunition shaft. Text in blue is added by the author (extract of PRO: Work/31/308 © The Public Record Office, by kind permission)

The shaft extends vertically from basement to roof, for lifting ammunition from the Main Magazine to all floors and also providing ventilation (Fig 16). It is a flattened circle in plan, with a diameter of 1.83m (7ft) east to west by 1.47m (4ft 10in), constructed entirely of brick headers. Rings of sockets in the brickwork just below ground, first and roof levels indicate the position of stout timber floors, originally pierced by trapdoors, through which ammunition and other supplies were hauled up. In the base of the shaft, an apsidal brick setting is of unknown purpose but probably secondary. On the roof, the top of the shaft pierces the sloping parapet in the centre of the south salient (see below).

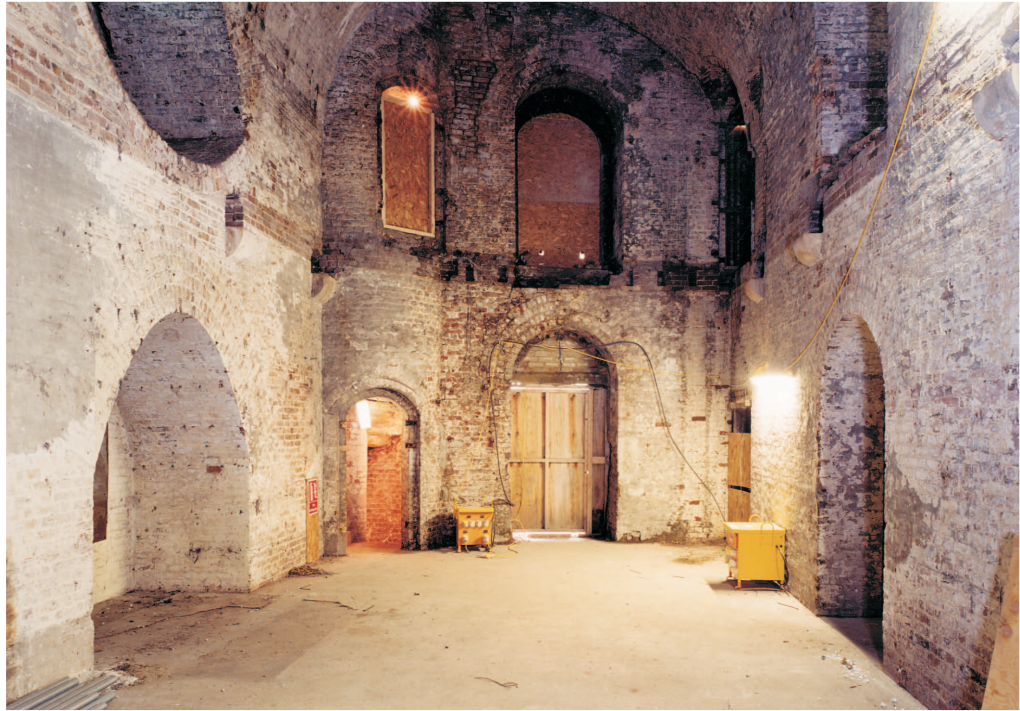
Figure 17
Clarence Tower, west casemate ground and first floor levels looking north. The timber floor structure has gone, leaving only the stone corbels from the tie beams. Note the different design of the artillery embrasures on the ground and first floors (at left) (© NMR:AA020022)

The party wall on this level is reduced in thickness to 1.23m (4ft ½in). To each side, a vaulted casemate, taller than those in the basement, contains both the ground and first floors (Figs 17-18). The floors at ground level are concrete replacements, while the first floor, a substantial timber structure, survives only in the eastern casemate.

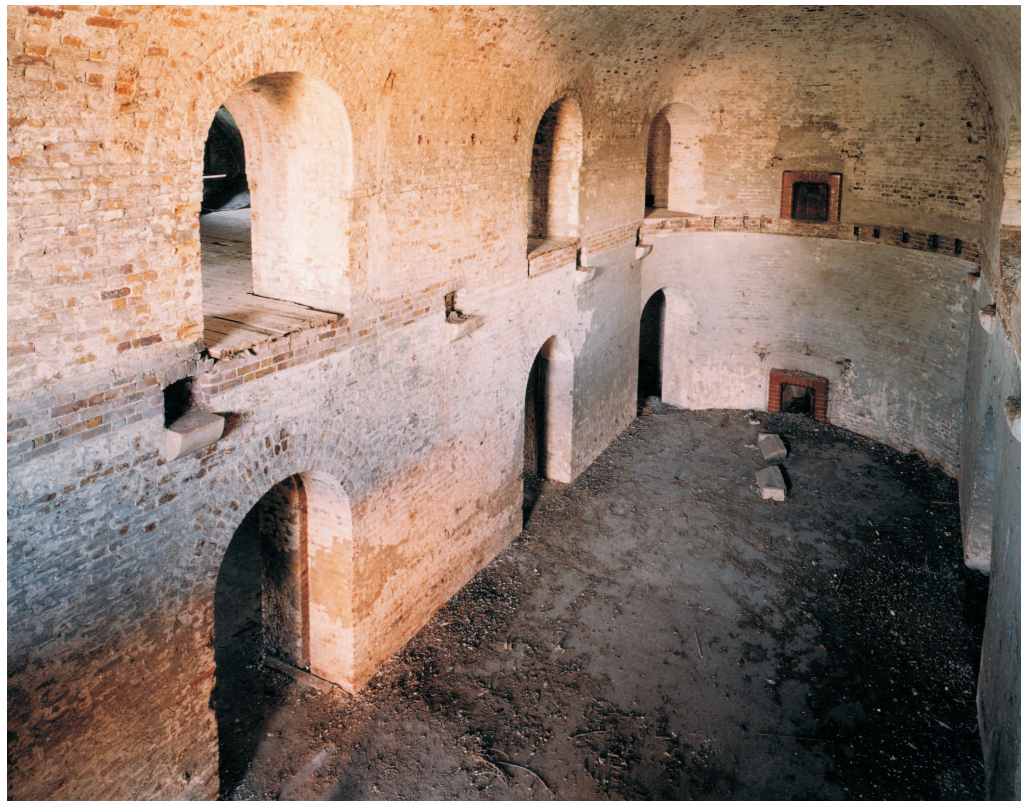
Figure 18
Clarence Tower, west casemate ground and first floor levels, looking south from the north-west turret. Shows the spine wall and the apsidal south wall with fireplaces on both levels (© NMR:AA021140)

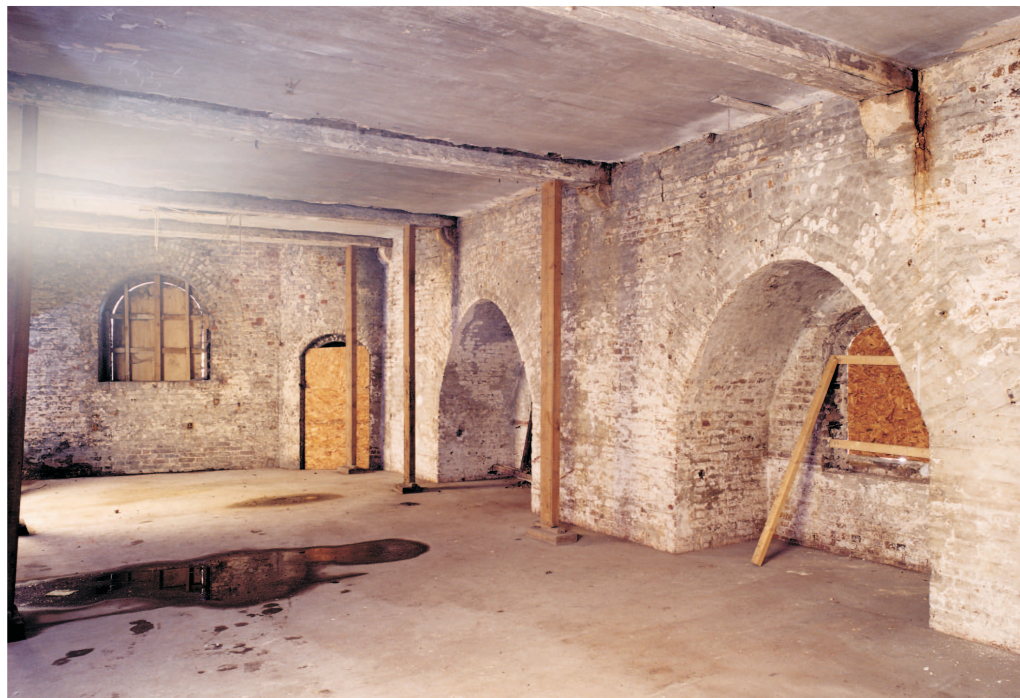
Figure 20
*The interior of
Clarence Tower, east
casemate, showing the
ground floor with
original ceiling,
artillery recesses
(right) and window in
north elevation (left) (©
NMR: AA020013)*

The artillery recesses in the outer walls are shallower than those in the basement, at 1.15m (3ft 9in), but otherwise identical (Fig 20). The sides of their embrasures contain opposing iron fittings, now broken but probably for holding back wooden shutters; a lead plug in each vault may have housed a bolt to secure a shutter in the closed position.

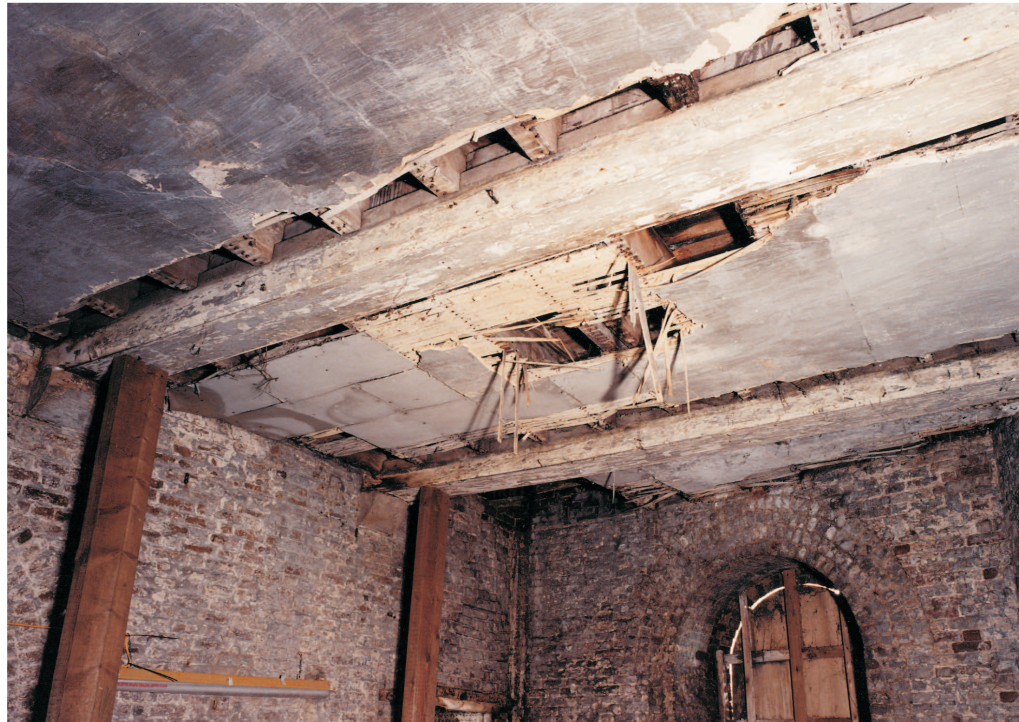
Figure 21
*Clarence Tower, detail
showing the structure of
the ceiling in the
ground floor east
casemate. The wooden
props at left are
modern (© NMR:
AA020015)*

corbels (Fig 23). The rebates are finished by single-order shallow segmental arches. Each tie beam, 0.28m (11 in) square, is clad with 5cm (2 in) planking which is chamfered and stopped at each end. Twelve joists, each 0.25m (10 in) deep and 0.09m (3½ in) wide run axially over the tie beams and are secured into the north and south walls in rebates 0.11m (4½ in) wide, 0.22m (9 in) high and 0.11m (4½ in) deep, with stone sills (Fig 21).

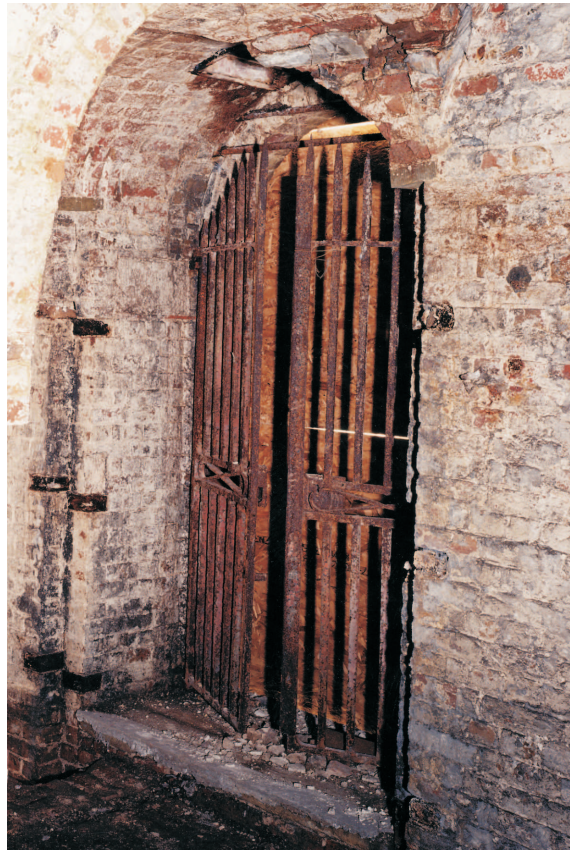
Figure 22
*Secondary phase iron
gates in the north
elevation of Clarence
Tower, guarding the
first floor entrance (©
NMR: AA020019)*

Each gate has seven square-sectioned uprights tapering at the top to plain points. These are secured at the base and near the top by horizontal bars; two more bars form a central panel infilled with a decorative cross and loop motif. The centre panel also supports, on the eastern gate, an external mortice lock. It is likely that the lock was moved from the

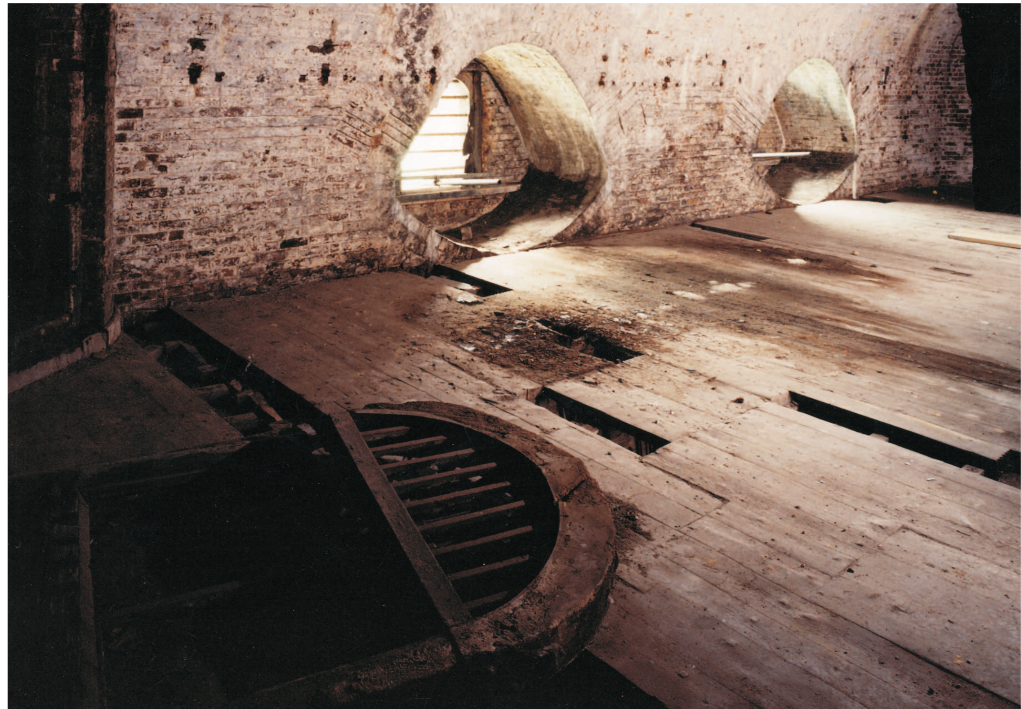
Figure 23
Clarence Tower; the first floor east casemate, showing the boards, window frame removed from the north elevation, and the ocular artillery embrasures in the east wall (© NMR: AA020009)

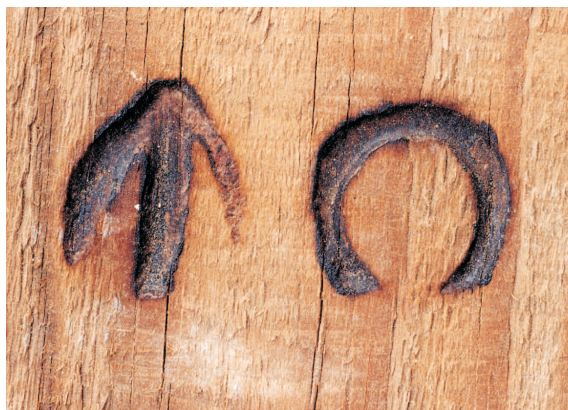
Figure 24
The Board of Ordnance symbol, as branded onto one of the first floor timbers in Clarence Tower. The symbols are each 3.5cms tall (© NMR: AA031469)

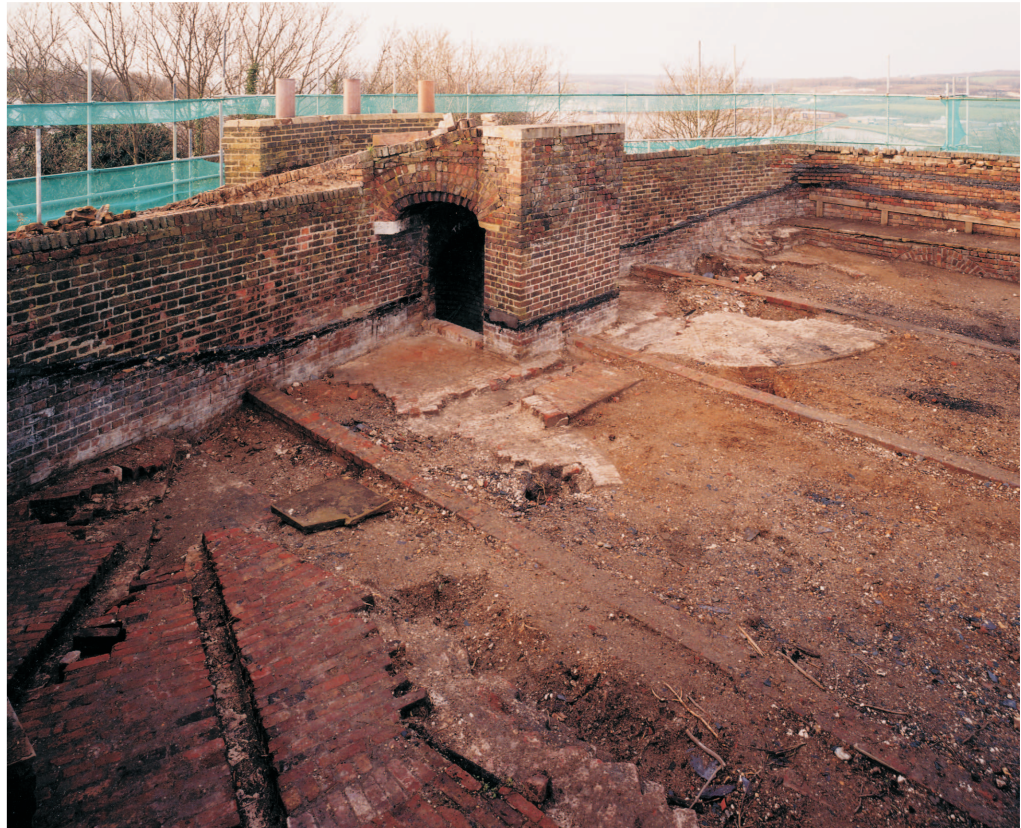
Figure 26
The southern end of the roof level on Clarence Tower, showing the porch to the ammunition shaft and the fragmentary original brick gun floor. Note also the three intrusive dwarf walls, built to support a temporary roof structure (© NMR: AA020032)

Before the present alterations began, the original roof level was covered by a temporary timber and felt roof installed during the Post Office ownership. This was built with its east and west sides sloping steeply inwards to a central section inclined very gently to the north for drainage. Upon removal, it was found to rest on three brick dwarf walls, aligned north to south, which had been cut into an original brick **gun floor** (Fig 26).

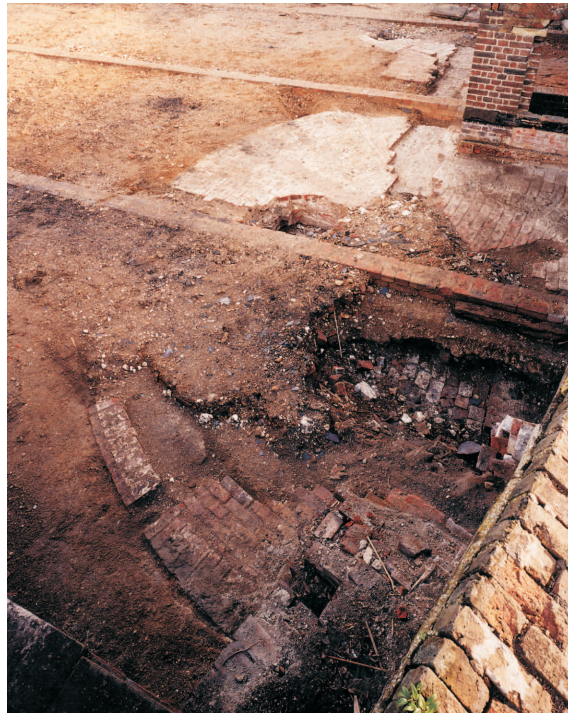
Figure 27
Clarence Tower; the south-western corner of the roof level, showing the emerging semi-circle of gun position no I, badly damaged by a broad trench cut for the insertion of a 20th-century dwarf wall for a later roof (© NMR: AA021135)

The position of **gun no I** is damaged by the later dwarf wall (Fig 27). It has only a very small patch of the top layer of paving but the site of the cross-shaped gun holdfast partially survives as a recess in layers two and three. Also apparent are two mortar scars

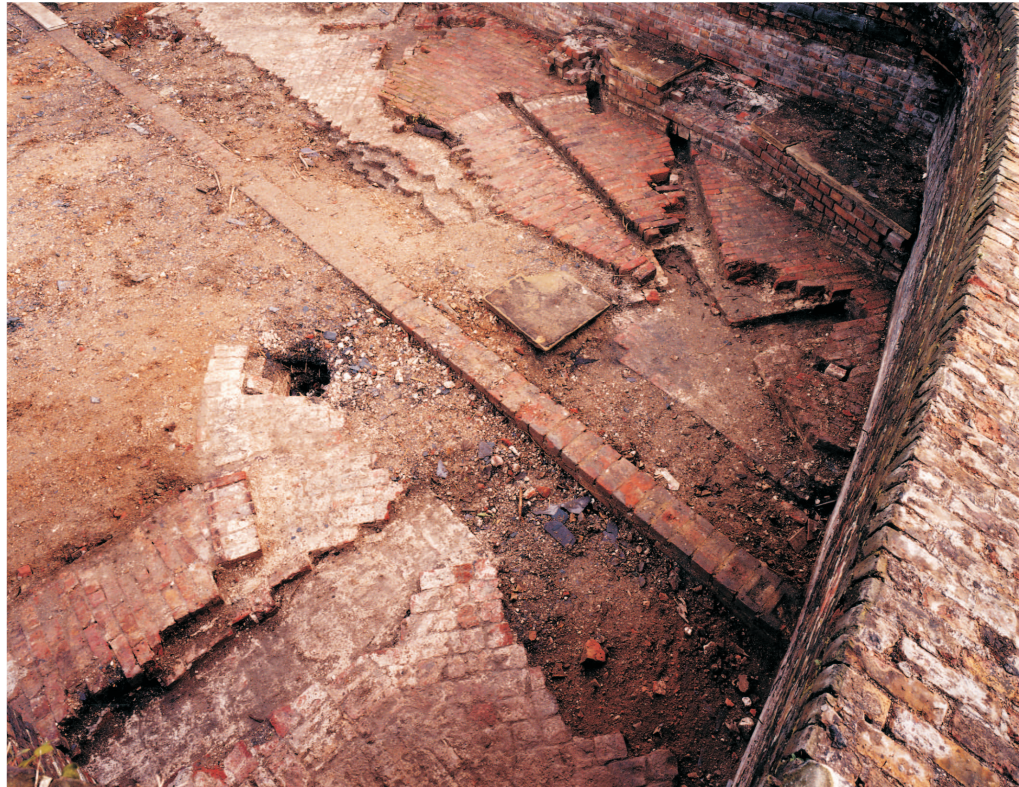
Clarence Tower; the south-eastern area of the roof, showing the position of gun no II, cut by a trench for the insertion of a 20th-century dwarf wall. The flagstone (at centre) covers the ventilator from the casemates below; to its right is the rebate for the holdfast and two radiating rebates for timbers which anchored the gun racers (© NMR: AA021137)

The site of **gun no II**, also damaged, is slightly better preserved and has identical arrangements (Fig 28). Also, a **ceramic ventilator** from the first floor casemates exits through the gun floor and was presumably originally covered by a grille flush with the brick surface. The survival of the top layer of paving indicates that the holdfast cross-timbers were
