**FORT CLARENCE,
ROCHESTER, KENT**

A NAPOLEONIC GUN TOWER AND DEFENSIVE LINE

ARCHAEOLOGICAL INVESTIGATION REPORT SERIES 40/2002

Report by: Paul Pattison
Survey by: Paul Pattison, Moraig Brown, David McOmish and Cathy Tuck
Specialist report by: David Higgins
Drawings by: Louise Barker and Paul Pattison
Field photography by: Alun Bull

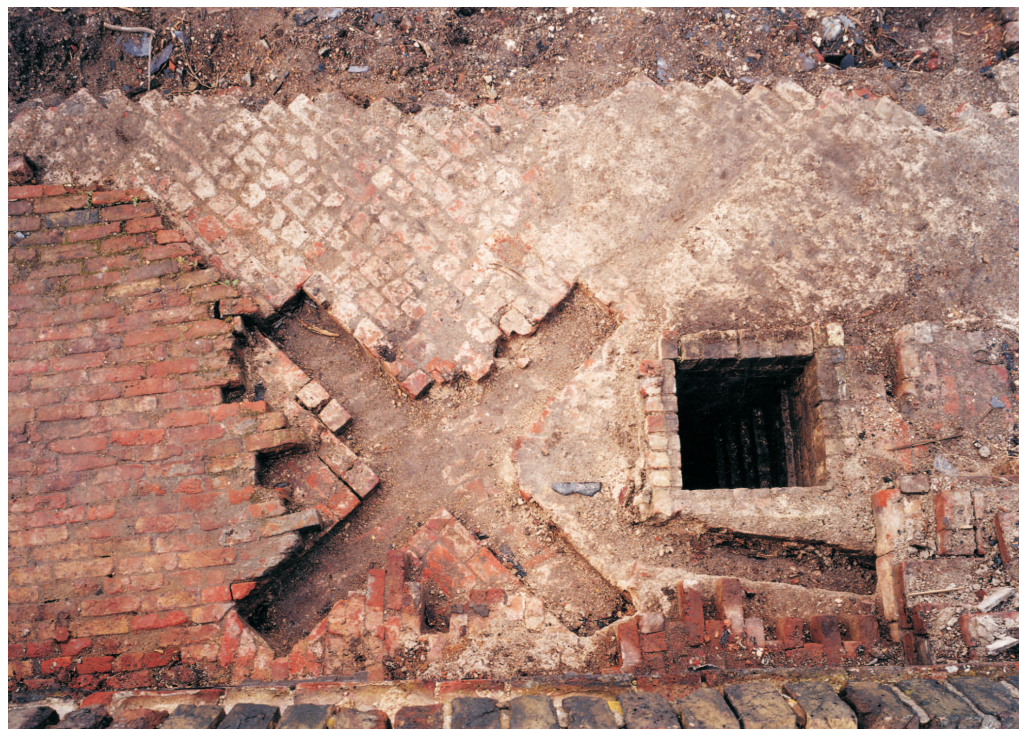
Figure 29

Clarence Tower; the eastern area of the roof, showing the cross-like rebate for the holdfast of gun no III, and the adjacent shaft to one of the roof cisterns (© NMR: AA021138)

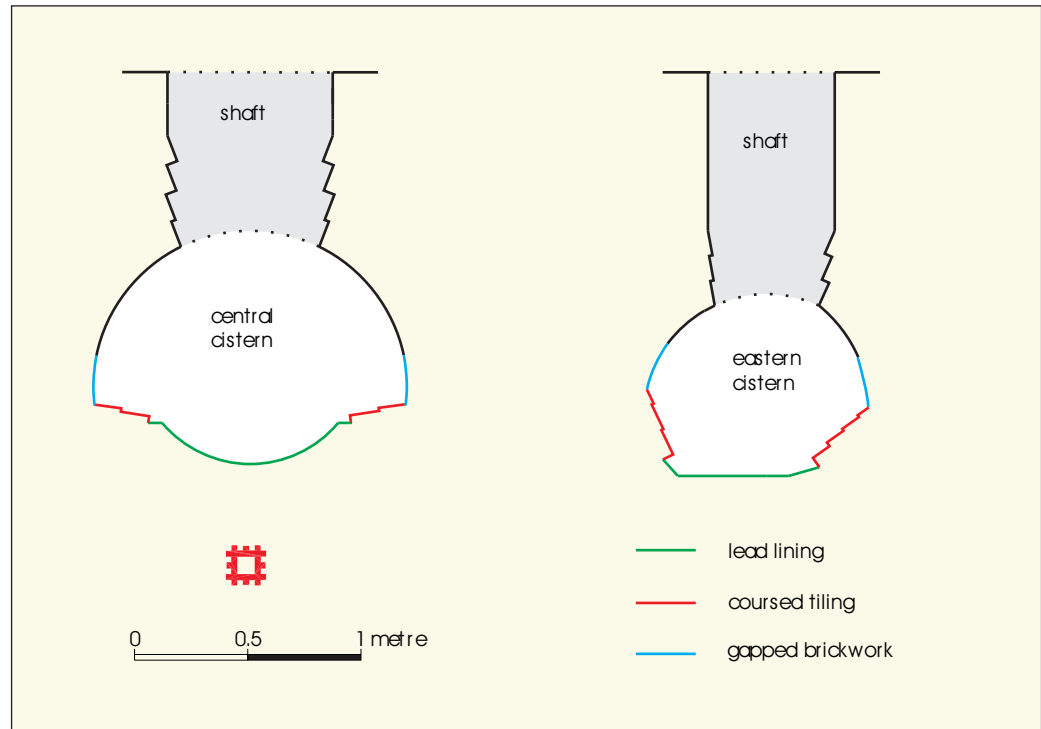
Figure 32
*Sections of the cisterns
built under the roof of
Clarence Tower*

The flanking cisterns are of identical construction but smaller at 0.98m (3ft 2½in) wide and 0.80m (2ft 6½in) high, with smaller shafts from the inspection holes (Fig 32). The vaults are slightly asymmetrical in section, with the outer edges ending at a higher level than the inner edges. Towards the north end, the western cistern was rebuilt with a shallower vault to accommodate the vertical foundation of the store room above, which afterwards formed one side of the cistern itself. Also, at its the north end, the vault ends and a small square drain leads from it around the north-west turret; staff from Swift Ltd informed me that this drain is carried in a spiral around and down the turret, and exit holes can be seen on the exterior brickwork. The south end of this cistern has a steeply sloping tiled face, partly obscured by a brick pillar carrying the services and communications from the casemates below.

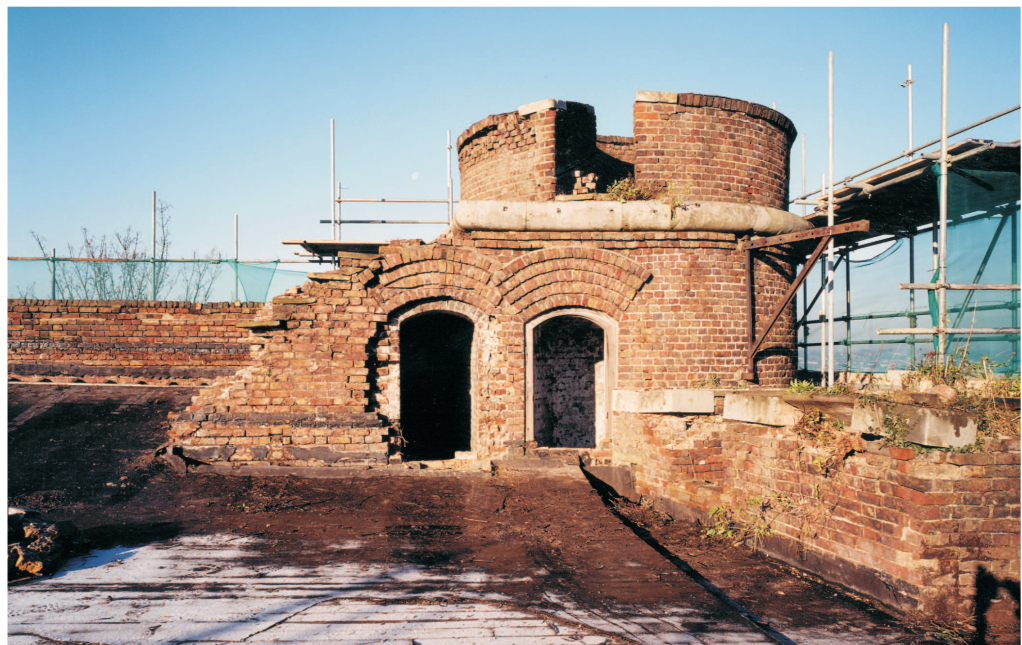
Figure 34
*Clarence Tower; the
NW turret. The
right-hand entrance is
to the newel stair, the
left-hand to the store
room (© NMR:
AA021108)*

independent stairs linked back to the infantry steps (Figs 34-6). At the top of each stair, the cordon is broadened to form a walkway and has sockets in its outer surface which formerly anchored a metal hand rail that terminated at the entrance to the observation position. Each entrance is a simple opening 0.86m (2ft 10in) wide at the exterior, tapering to 0.7m (2ft 3½in) inside; inner and outer faces are finished in Portland capstones. Each entrance emerges into the small circular observation space, 0.99m (3ft 3in) in diameter, with a stone flagged floor, protected by a parapet 1.47m (4ft 10in) tall internally, sloping to the exterior and covered by a protective layer of asphalt.

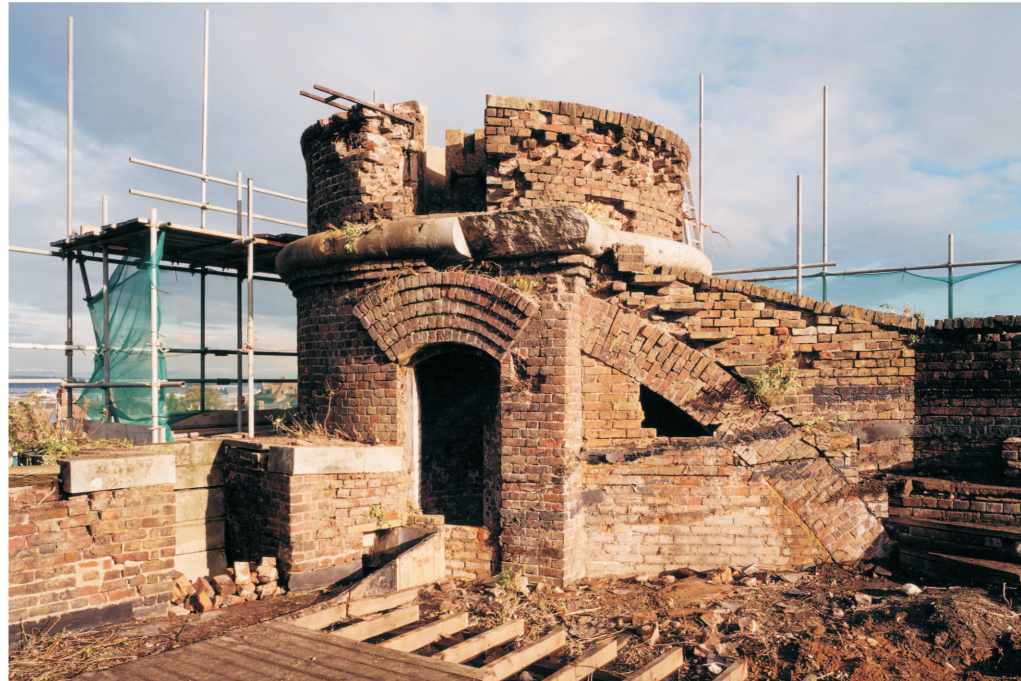
Figure 36
*Clarence Tower; the
NE turret. Note the
steps over the flying
buttress, ascending to
the observation
platform (© NMR:
AA020048)*

The interior of the observation position in the north-east turret is rendered and contains an inserted concrete pillar for a DRF instrument. This is 1.22m (4ft) high and 0.50m (1ft 7½in) square, with an iron supporting bracket for a telephone and recess in the rear face 0.13m (5in) square and 0.23m (9in) deep. The top of the pillar incorporates three circular recesses in a triangular pattern for mounting the instrument. This feature dates to the 20th century and would have been used during gunnery training.

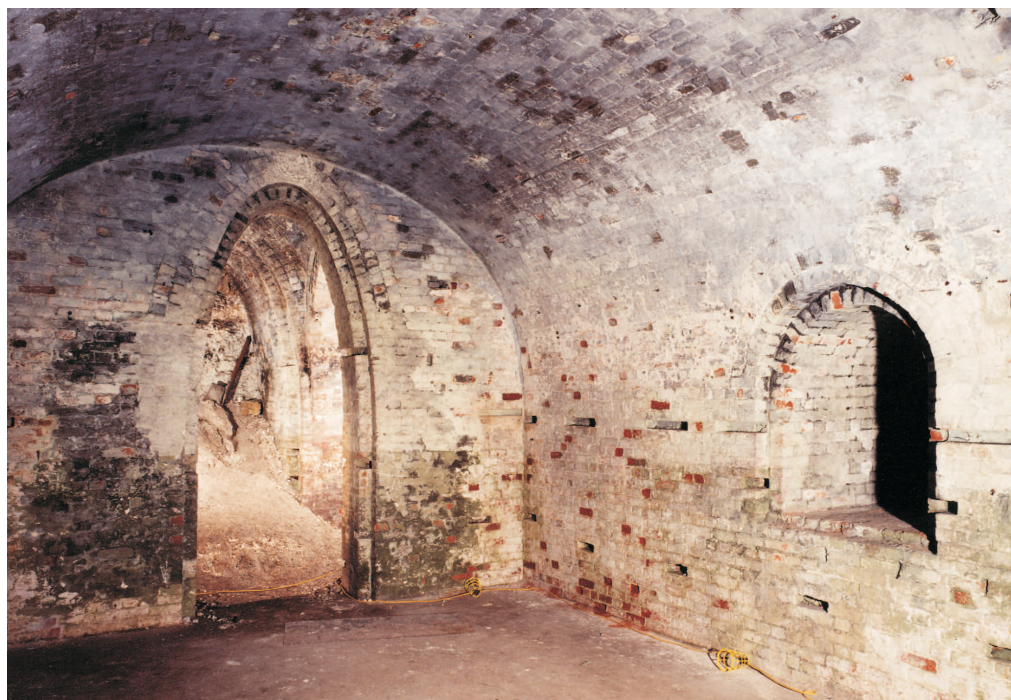
Figure 37
Clarence Tower; the main magazine, looking north-west. Note the parabolic entrance and the lighting recess (at right) (© NMR: AA020011)

The magazine is in red brick laid to English bond to a rectangular plan, measuring 6.7m (22ft) by 4.26m (14ft), with a semi-circular vault 3.42m (11ft 3in) tall (Fig 37). These dimensions tally with those given in returns dated 1821, 1830 and 1841 (PRO: WO/55/2458; 2543; 2920). The north and south walls are much thicker, at 1.9m (6ft 3in) than the east and west (end) walls, at 0.65m (2ft 1½in). Inside, the English bond brickwork has several coats of whitewash, with traces of a dark green paint - as in parts of the lighting passage - to a height of *c* 1.2m (4ft) above the concrete floor. The latter replaced an original suspended timber floor (Fig 38). There are opposing entrances from the lighting passage positioned centrally in the end walls, each with a parabolic arch of

The north wall is pierced by a large central lamp recess opening through to the lighting passage, with a flat sill 0.92m (3ft) wide and a semi-circular arched head, of three orders, 1.19m (3ft 11in) tall. The recess had timber frames at both ends, the rebates with identical arrangements for securing the joinery as the entrances, presumably with fixed glazing on the magazine side and doors opening into the lighting passage (Fig 37).

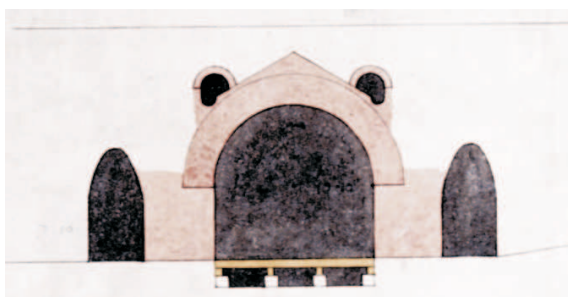
Figure 38
Clarence Tower; north-south section of the main magazine, showing the semi-circular vault, suspended timber floor and parabolic vaults of the lighting passage (PRO: Work/31/309 (extract)© The Public Record Office, by kind permission)

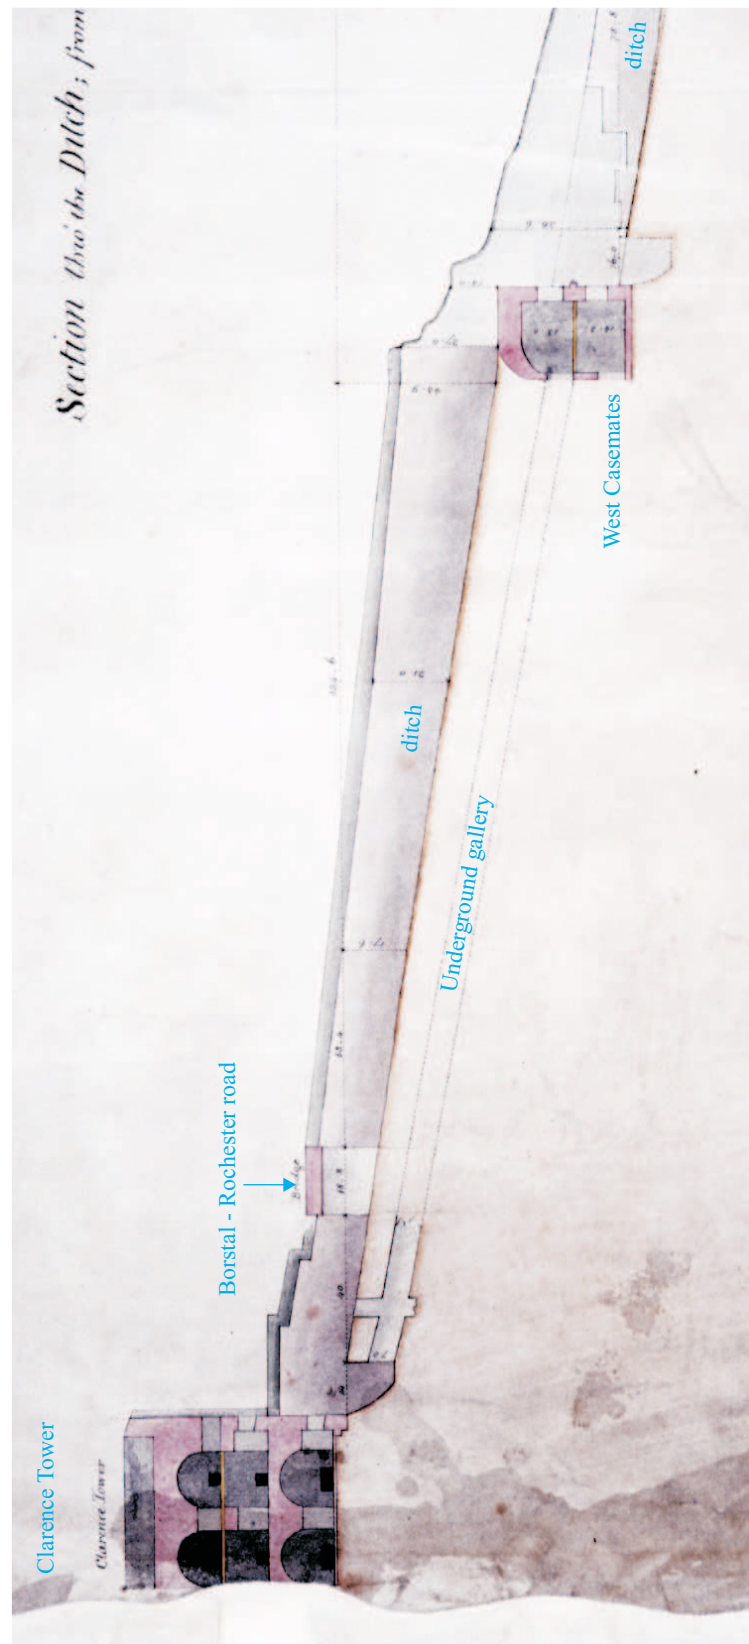
Figure 39
Section drawing of 1810 showing the Line between Clarence Tower and the West Casemates. Text in blue is added by the author (extract of PRO: Work/31/313 © The Public Record Office, by kind permission)

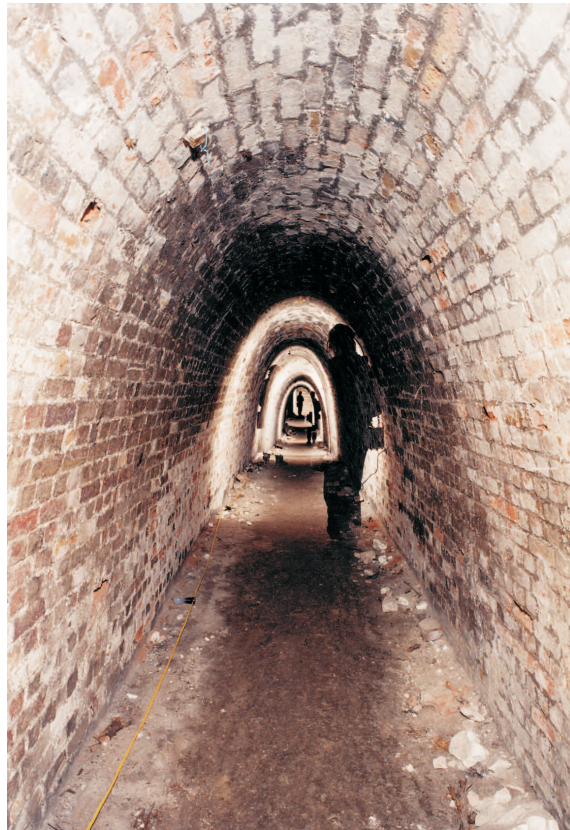
Figure 40
*The main gallery
connecting the West
Casemates with
Clarence Tower,
looking east (© NMR:
AA020017)*

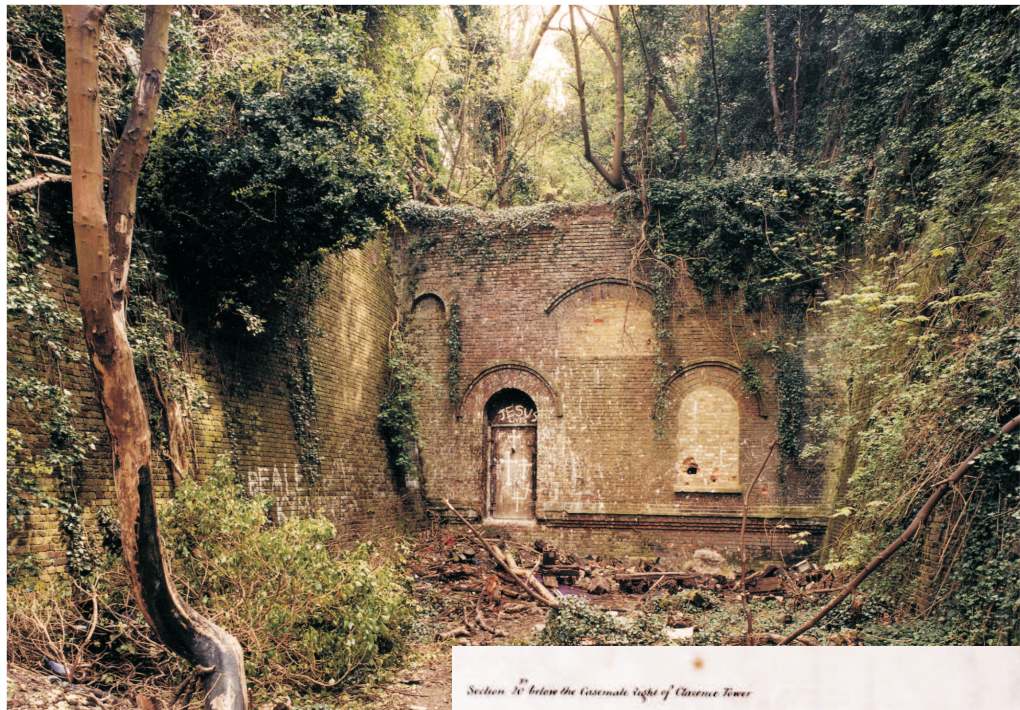
Figure 41

The photo shows the first floor elevation of the West Casemates looking east from the ditch of the Line: the ground floor is hidden by infilling of the ditch (© NMR: AA020024). The drawing shows the elevation in 1814, without the blind windows flanking the central high window of the first floor, one of which is visible in the photograph (PRO: Work/31/314 (extract) © The Public Record Office, by kind permission)

Clarence Tower defended the Line for half of its course towards the Medway. However, the steepness and angle of the natural slope dictated that both a substantial step and a change of angle was required in the ditch, leaving a potential blind stretch down to the river. Consequently, the West Casemates were constructed up against the step to cover the Line down to the Medway Tower (Fig 39). The result was a two-storied structure, constructed against a vertical cut in the natural chalk, with a drop ditch at its base. Today, the drop ditch and the main ditch have been infilled to such an extent that only the first floor of the West Casemates is visible; only the interior of the ground floor could be inspected (Fig 41-2).

windows; it also has a small expense magazine. This fenestration is almost but not quite that shown on a section drawing made in 1814 (Fig 41).

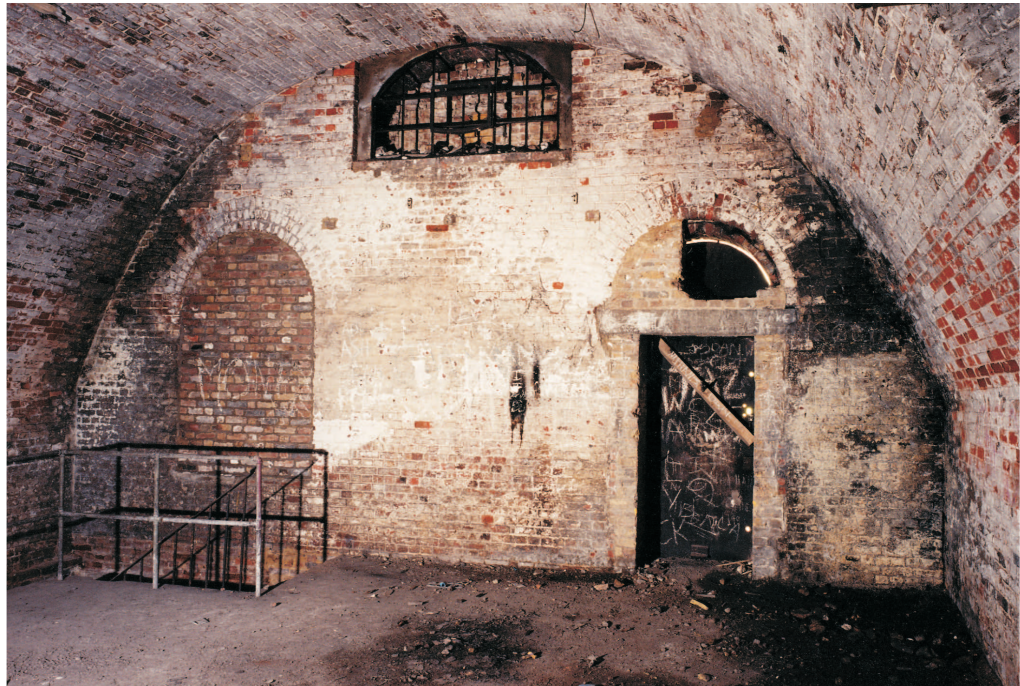
Figure 42
*The West Casemates,
interior at first floor
level showing windows
in the west wall (©
NMR: AA020006)*

The gallery emerges onto the first floor of the West Casemates through two entrances. There are steps down to the ground floor in the south-east corner. Although the first floor was probably defensible through two windows, it may have been more of an off-duty room than the ground floor, which has four musket loopholes in addition to identical

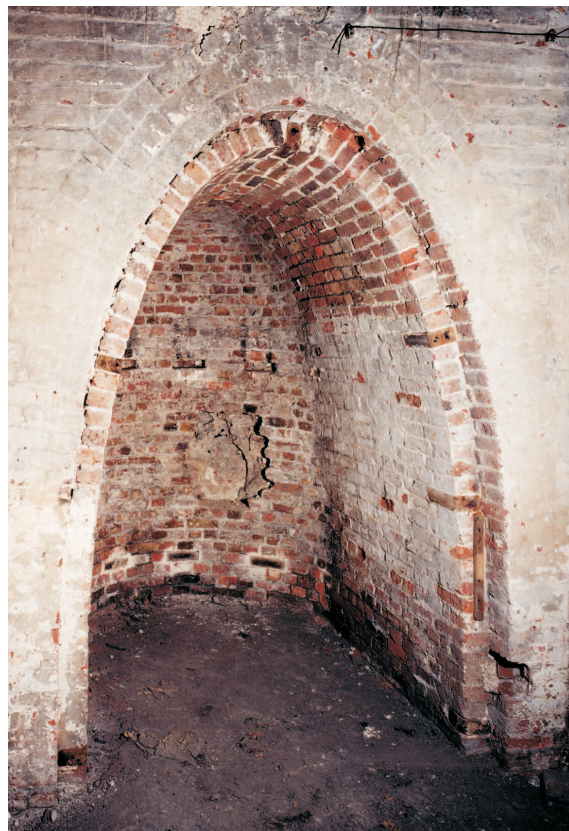
Figure 43
*The West Casemates,
ground floor; expense
magazine in the east
wall (© NMR:
AA020018)*

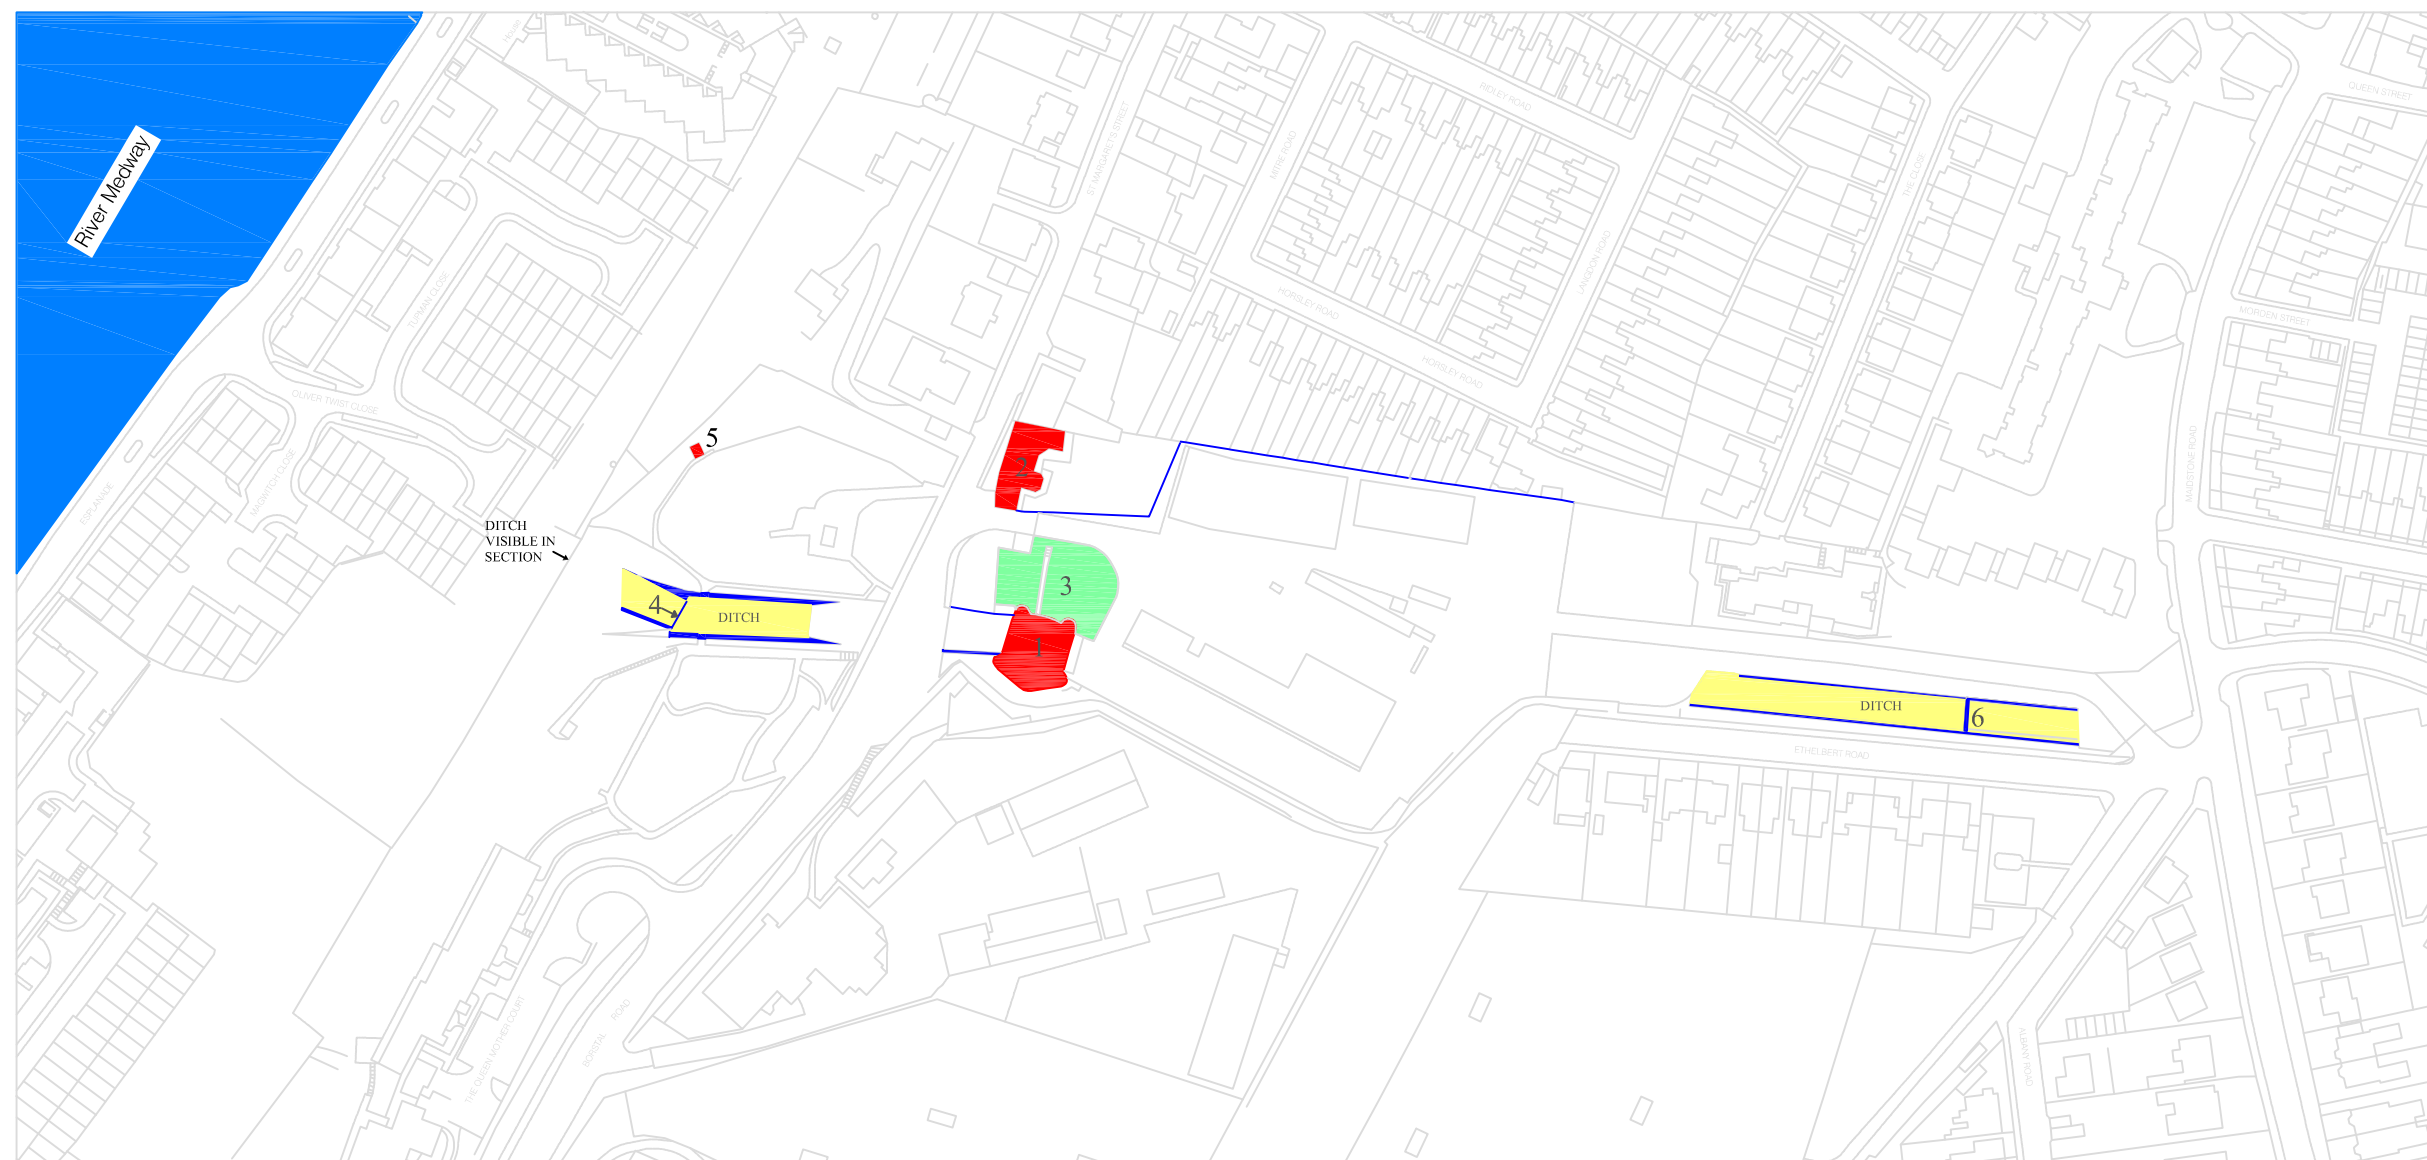
Figure 44
 Map showing the surviving visible elements of Fort Clarence:
 1 = Clarence Tower; 2 = The Governor's House; 3 = Earth bombproofing over the Main Magazine; 4 = West Casemates; 5 = Picquet House; 6 = Rifle butt
 Blue = ditch revetments and other fort walls; yellow = ditch bottom; green = earthwork; red = building
 (Reproduced by permission of the Director General of the Ordnance Survey)

A) The Line (Fig 44)

Another section of the Line can be seen in the woodland of Clarence Gardens west of Clarence Tower and the Rochester-Borstal Road. Although definition has been lost and a new slope created by infilling immediately west of the road, the ditch emerges with well-preserved revetments and continues up to and over the West Casemates. As at the Maidstone Road end, the rampart has been modified by landscaping. However, in the woodland there is the earthwork of the military path or road which wound its way down the hill from Clarence Tower to the Medway Tower, along with what is probably a the remains of a small brick piquet house on the brink of the artificial cliff. The woodland would merit further investigation to ascertain and record anything which survives of the scarping and terracing works undertaken by the Napoleonic engineers.

After the step down effected by the elevation of the West Casemates, the ditch revetments continue for another 20m on a new alignment, before truncation by an artificial cliff face at the east end of Oliver Twist Road; the ditch can be seen clearly in section at this point.

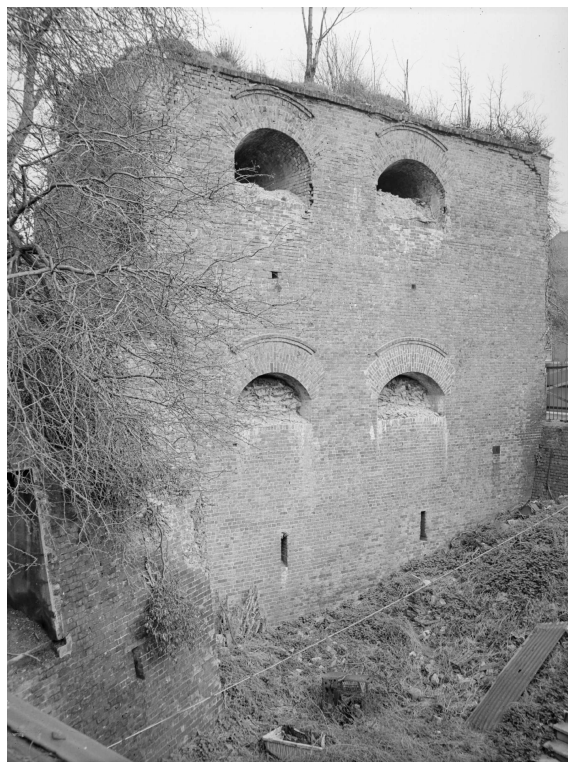
Figure 46
The Maidstone Road Guard House, south-west face of the salient, in 1961. The formidable nature of the gun complement facing along the Maidstone Road, only half of which is shown in this photograph, is immediately apparent
(© Crown copyright NMR: AA61/2536)

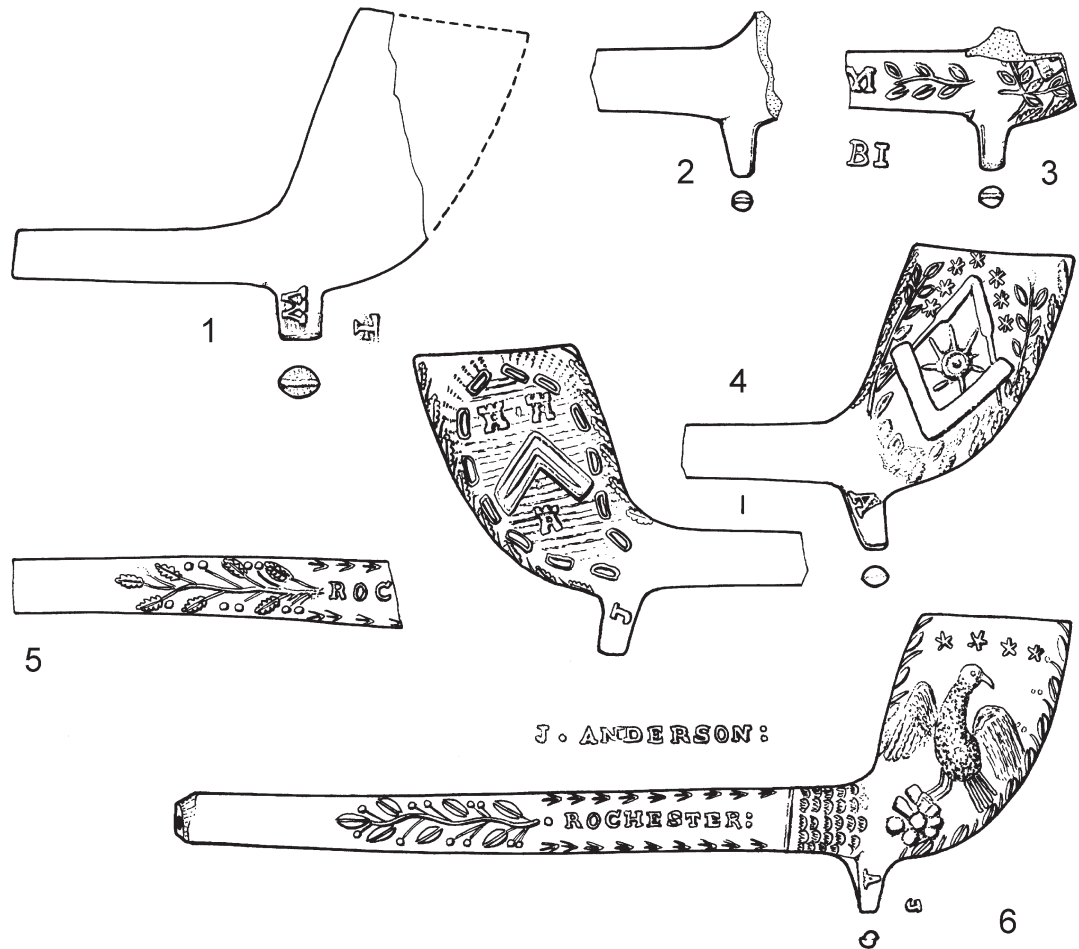
Figure 49

The three Type 27 bowls all have plain bowls and all three were produced in the same mould (Fig 49, 1). Although rather fragmentary, the bowl rims appear to have been lightly wiped, a finishing technique sometimes found at this period and not present on the other pipes from this site. The Christian name initial of the maker appears to have been altered in the mould at some point, leaving a rather indistinct symbol. The dominant letter now appears to be T, but with a bar extending from the upright that suggests it was previously an F. There are several known London area pipemakers with the initials TW at this period but none of them are very local to Rochester. The occurrence of three identical examples, however, suggests local manufacture and it may be that future documentary research will identify a maker with these initials in the area.

three instances the rounding is very slight, just forming a slight bevel at the broken edge. These fragments are all plain and have lengths of 70, 71 and 85mm. The 71mm long fragment is just opening into a bowl at its other end. Another plain fragment with a length of 51mm has a much more pronounced bevel, which extends almost half way across the broken end of the pipe. In the final two examples the broken end has first been smoothed and then a bevel added all around the edge. One of these is a plain stem with a length of 125mm and the other a J Anderson named stem with a length of 66mm (see composite drawing, Fig 49, 6).
