An Iron Age hillfort and its environs on Castle Hill, Alnham, Northumberland

SURVEY REPORT

Archaeological Investigation Report Series AI/2/2001

**NMR Nos: NT 91 SE 9, 17, 167,
344, 345 and 364
NGR: NT 9800 1094
SMR No: ND43**

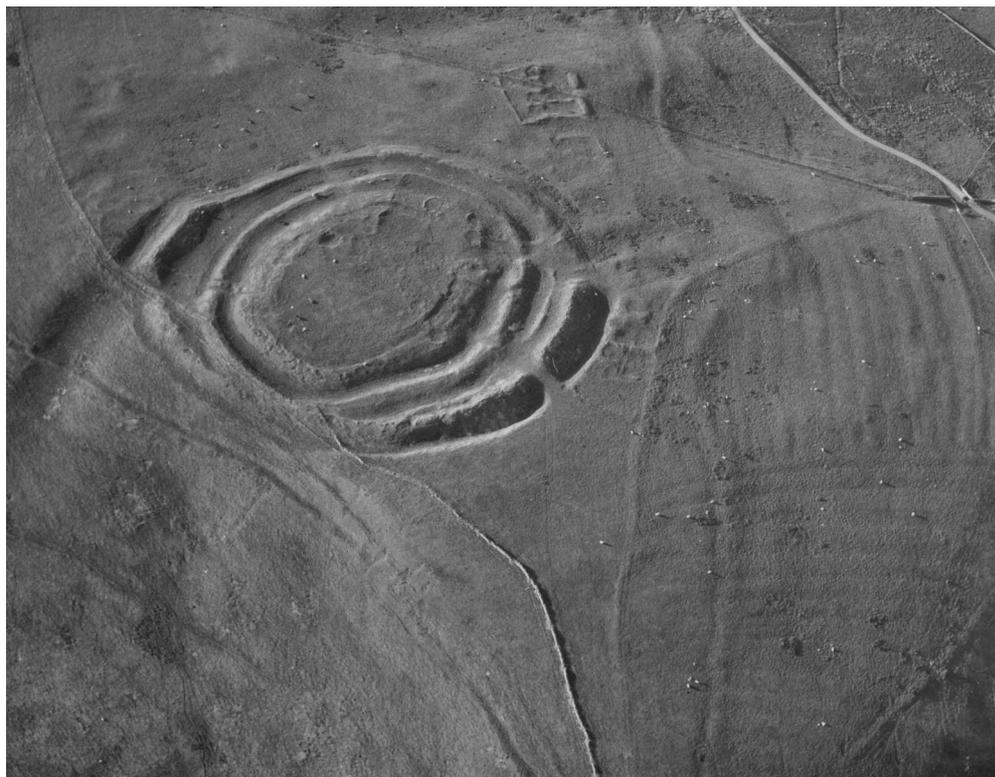
*Figure 3.
Aerial photograph of
the hillfort taken in
May 1997 (© Tim
Gates 1997)*

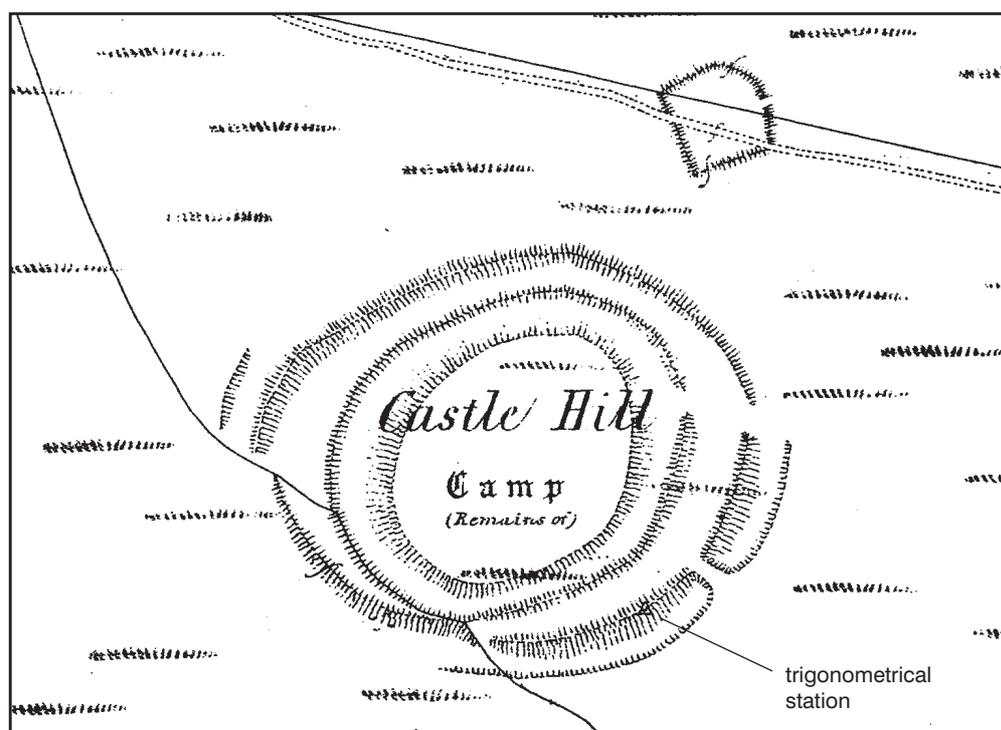
Figure 4.
Ordnance Survey
1:2500 scale plan of
the hillfort and its
environs surveyed in
1863 (Reproduced from
the 1864 Ordnance
Survey map)

The earliest surviving large-scale survey of the earthworks on Castle Hill was undertaken by the Ordnance Survey in 1863 and published at 1:2500 scale (Ordnance Survey 1864). The map shows the three lines of rampart, depicted in somewhat schematic fashion, and the outer ditch on the south-east and north-west sides (Figure 4). An Ordnance Survey trigonometrical station is depicted on the crest of the outer rampart on the south side of the fort and on the west side a field wall is shown crossing over the outer and middle defences. The only archaeological feature shown outside the hillfort is a rectangular embanked enclosure, the most northerly of a series on the east and north-east of the fort. This enclosure has three entrances depicted, two of which accommodate the track forming what was then the route between Alnham and Ewarty Shank, and is crossed by a field wall. The second edition map (published some thirty years later) adds nothing to the depiction of either the hillfort or the enclosure (Ordnance Survey 1897).

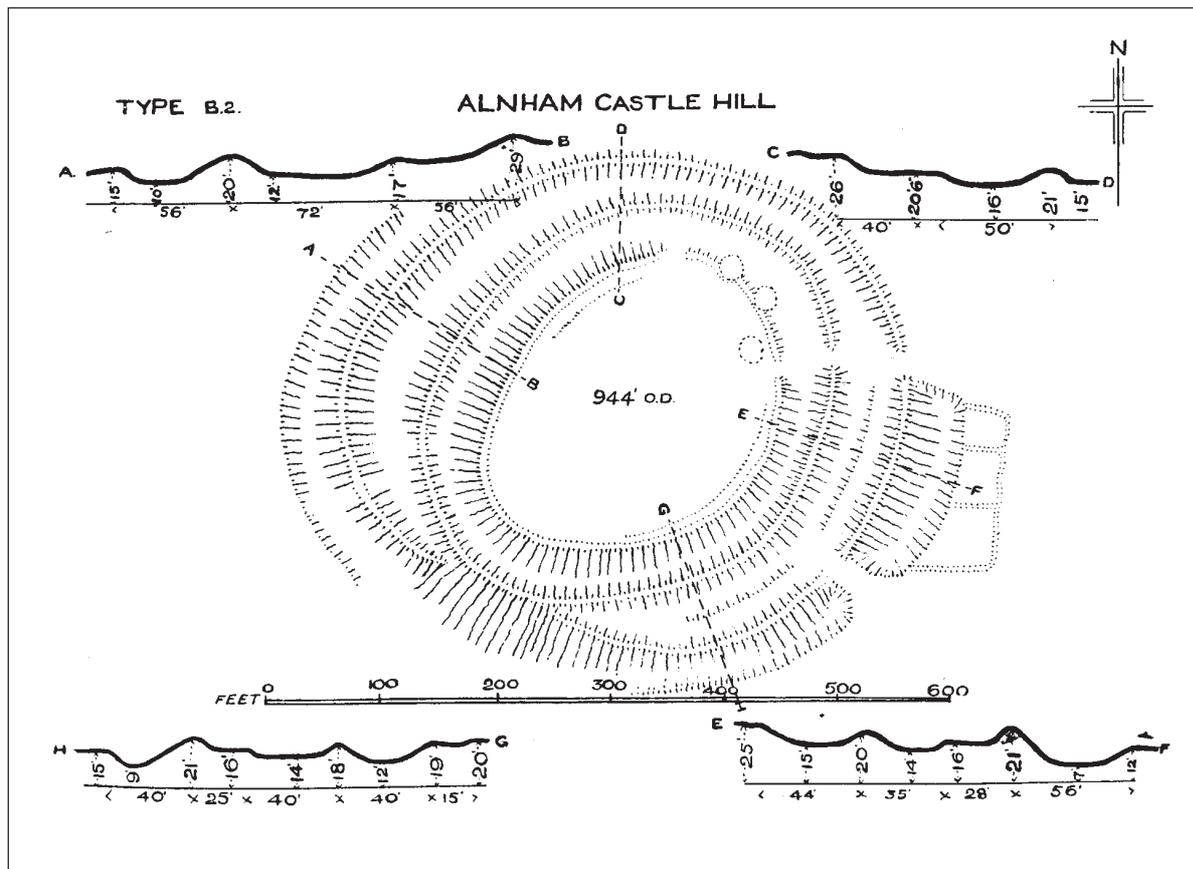
Figure 5. Plan of the hillfort published in 1935 (Hope Dodds 1935, Figure 15)

A further large scale survey of the hillfort was published with a brief description of the site in a volume of the Northumberland County History (Hope Dodds 1935, 34 and Figure 15). The description states only that the site belongs to a class of hillforts in the county, which are on high ground and are less dependent on natural slopes for protection. The accompanying plan shows more detail than the earlier Ordnance Survey maps (Figure 5). In addition to the ramparts and the outer ditch on the south-east and north-west sides, several minor earthwork features are shown including a discontinuous trench on the inside of the inner defences and a slight bank between the middle and outer defences on the east side of the fort. Three circular features are shown overlying the north-east arc of the inner defences and three rectilinear enclosures are shown immediately beyond the outer ditch on the east side.

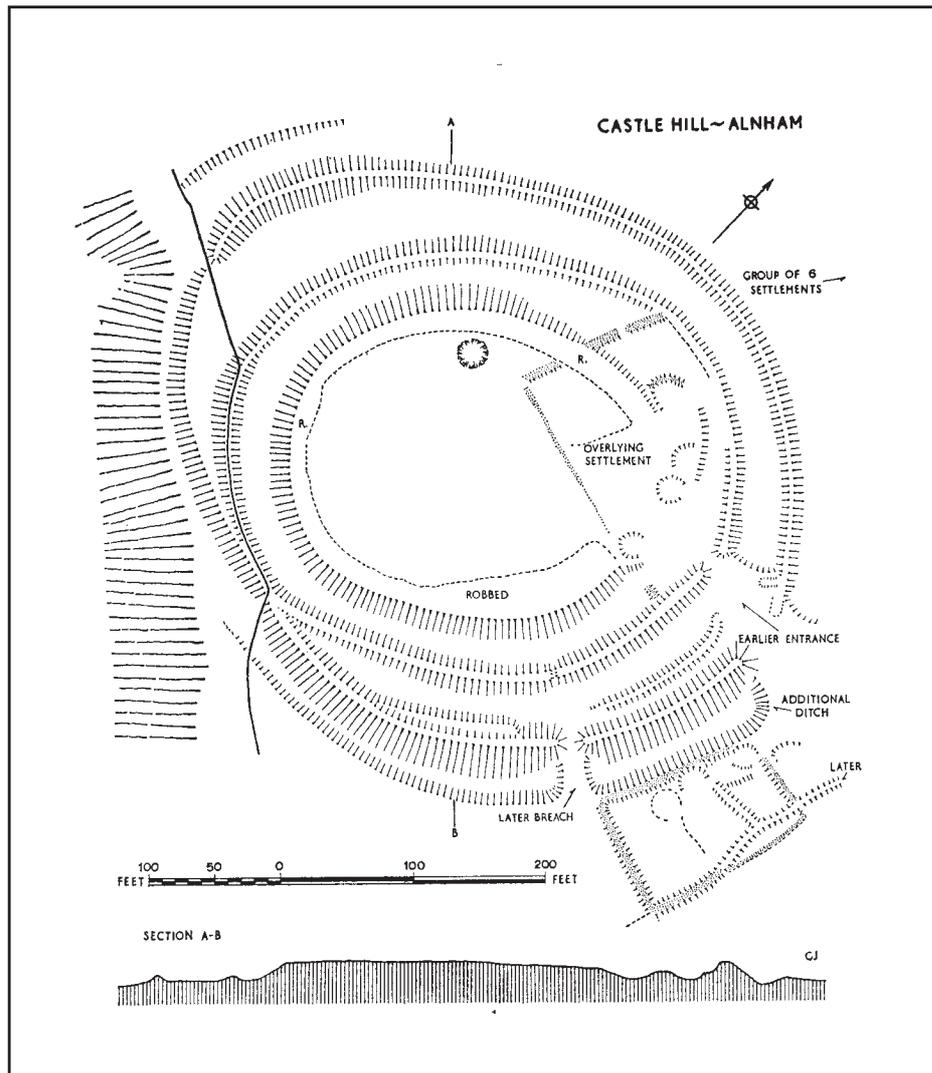
Figure 6.
Plan of the hillfort
and its environs
surveyed by Jobey
(Jobey 1965, 24)

George Jobey included Alnham in his overview of hillforts and settlements in Northumberland (Jobey 1965, 26 and Figure 1). His description of the site is rather concise but he implies that the fort may have originated as a univallate stone enclosure, the line of the enclosure wall picked out by a robber trench around the inside of the inner defences. On the accompanying plan, Jobey shows this trench as a far more continuous feature than was depicted on the 1935 survey noted above (Figure 6). He also states that “existing, though not necessarily primary multivallate defences, have received an additional rampart and ditch”. Presumably this means that he thought the inner and middle ramparts were added to the original stone enclosure and that the outer rampart and ditch were added later. The annotation on the accompanying plan conveys several other of Jobey’s ideas about the site. He labels the most southerly of the two possible entrances on the east side of the fort as a later breach, and identifies an area delineated by a bank and containing four semi-circular scoops on the north-east side of the inner hillfort defences as an overlying settlement. Where Hope-Dodds and Davies had recorded three enclosures against the outer ditch

on the south-east side of the hillfort, Jobey's plan shows just one large enclosure with a later bank overlying the east side and an offshoot creating an internal division. Jobey identified three semi-circular scoops in the interior of the enclosure and one on the outside.

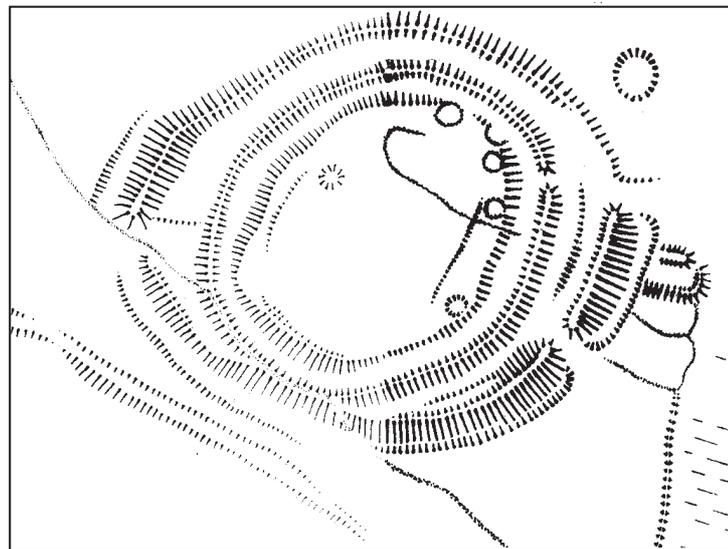
*Figure 7.
Plan of the hillfort
surveyed by the
RCHME, South-East
Cheviots Project in
1989. (scale 1:2500:
compiled from four
sheets NT 9710, NT
9810, NT 9711 and
NT 9811)*

In 1989, the site and its environs were surveyed at 1:2500 scale and reported on as part of the South East Cheviots Project, a multi-disciplinary landscape survey undertaken by the Royal Commission on the Historical Monuments of England (RCHME) between 1984 and 1989 (NMR No. NT 91 SE 9 – Authority 8). The plan produced as part of this survey depicts variations in the strength of the defences not clearly shown on earlier surveys, and the accompanying analysis of the earthworks supports the idea that the outer rampart is probably a later addition (Figure 7). However, contrary to Jobey, the two entrances on the east side of the fort were thought likely to be contemporary with it, and it was considered probable that there was an entrance on the west side leading into the wide gap between the outer and middle ramparts, as Davies had previously suggested. Five hut circles were identified in the interior of the hillfort; all except the most southerly equating with the four semi-circular scoops shown on Jobey's earlier plan. The 1989 survey also examined the wider landscape around the monument, providing the first description of many of the earthworks within the area of the present English Heritage survey. However, the rapid nature of the 1989 survey precluded any consideration of the evolution of the landscape around the hillfort based on a synthesis of the earthwork evidence. Finally, the analytical survey carried out by English Heritage in 2000, and the subject of this report, is the most thorough and extensive investigation of the hillfort and its environs to date. The documentary research undertaken as part of the survey was limited to a review of the secondary sources and readily available primary sources, particularly maps, plans and aerial photographs.

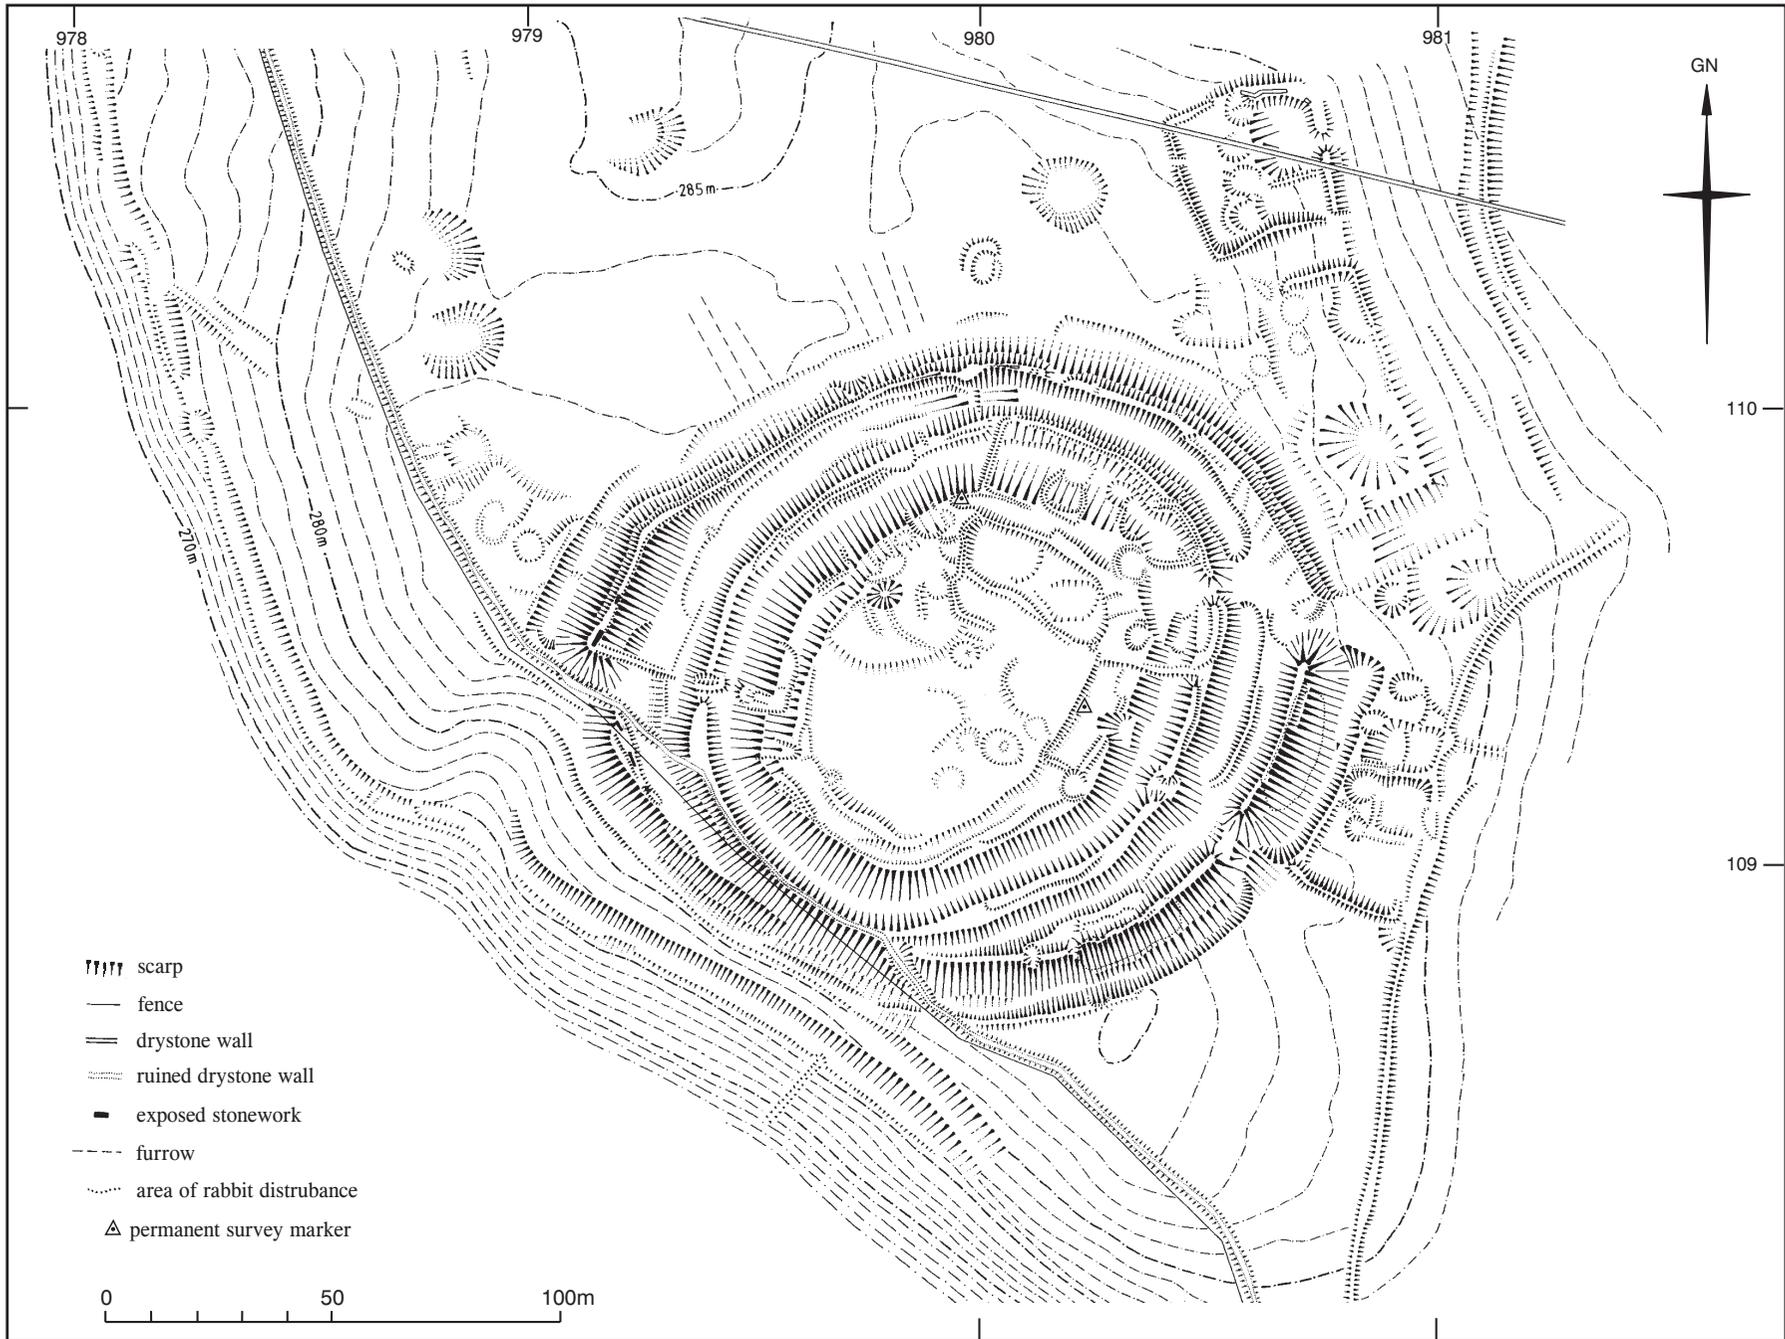
Figure 8. English Heritage plan of the hillfort and its immediate environs (reduced from 1:1000 scale original)

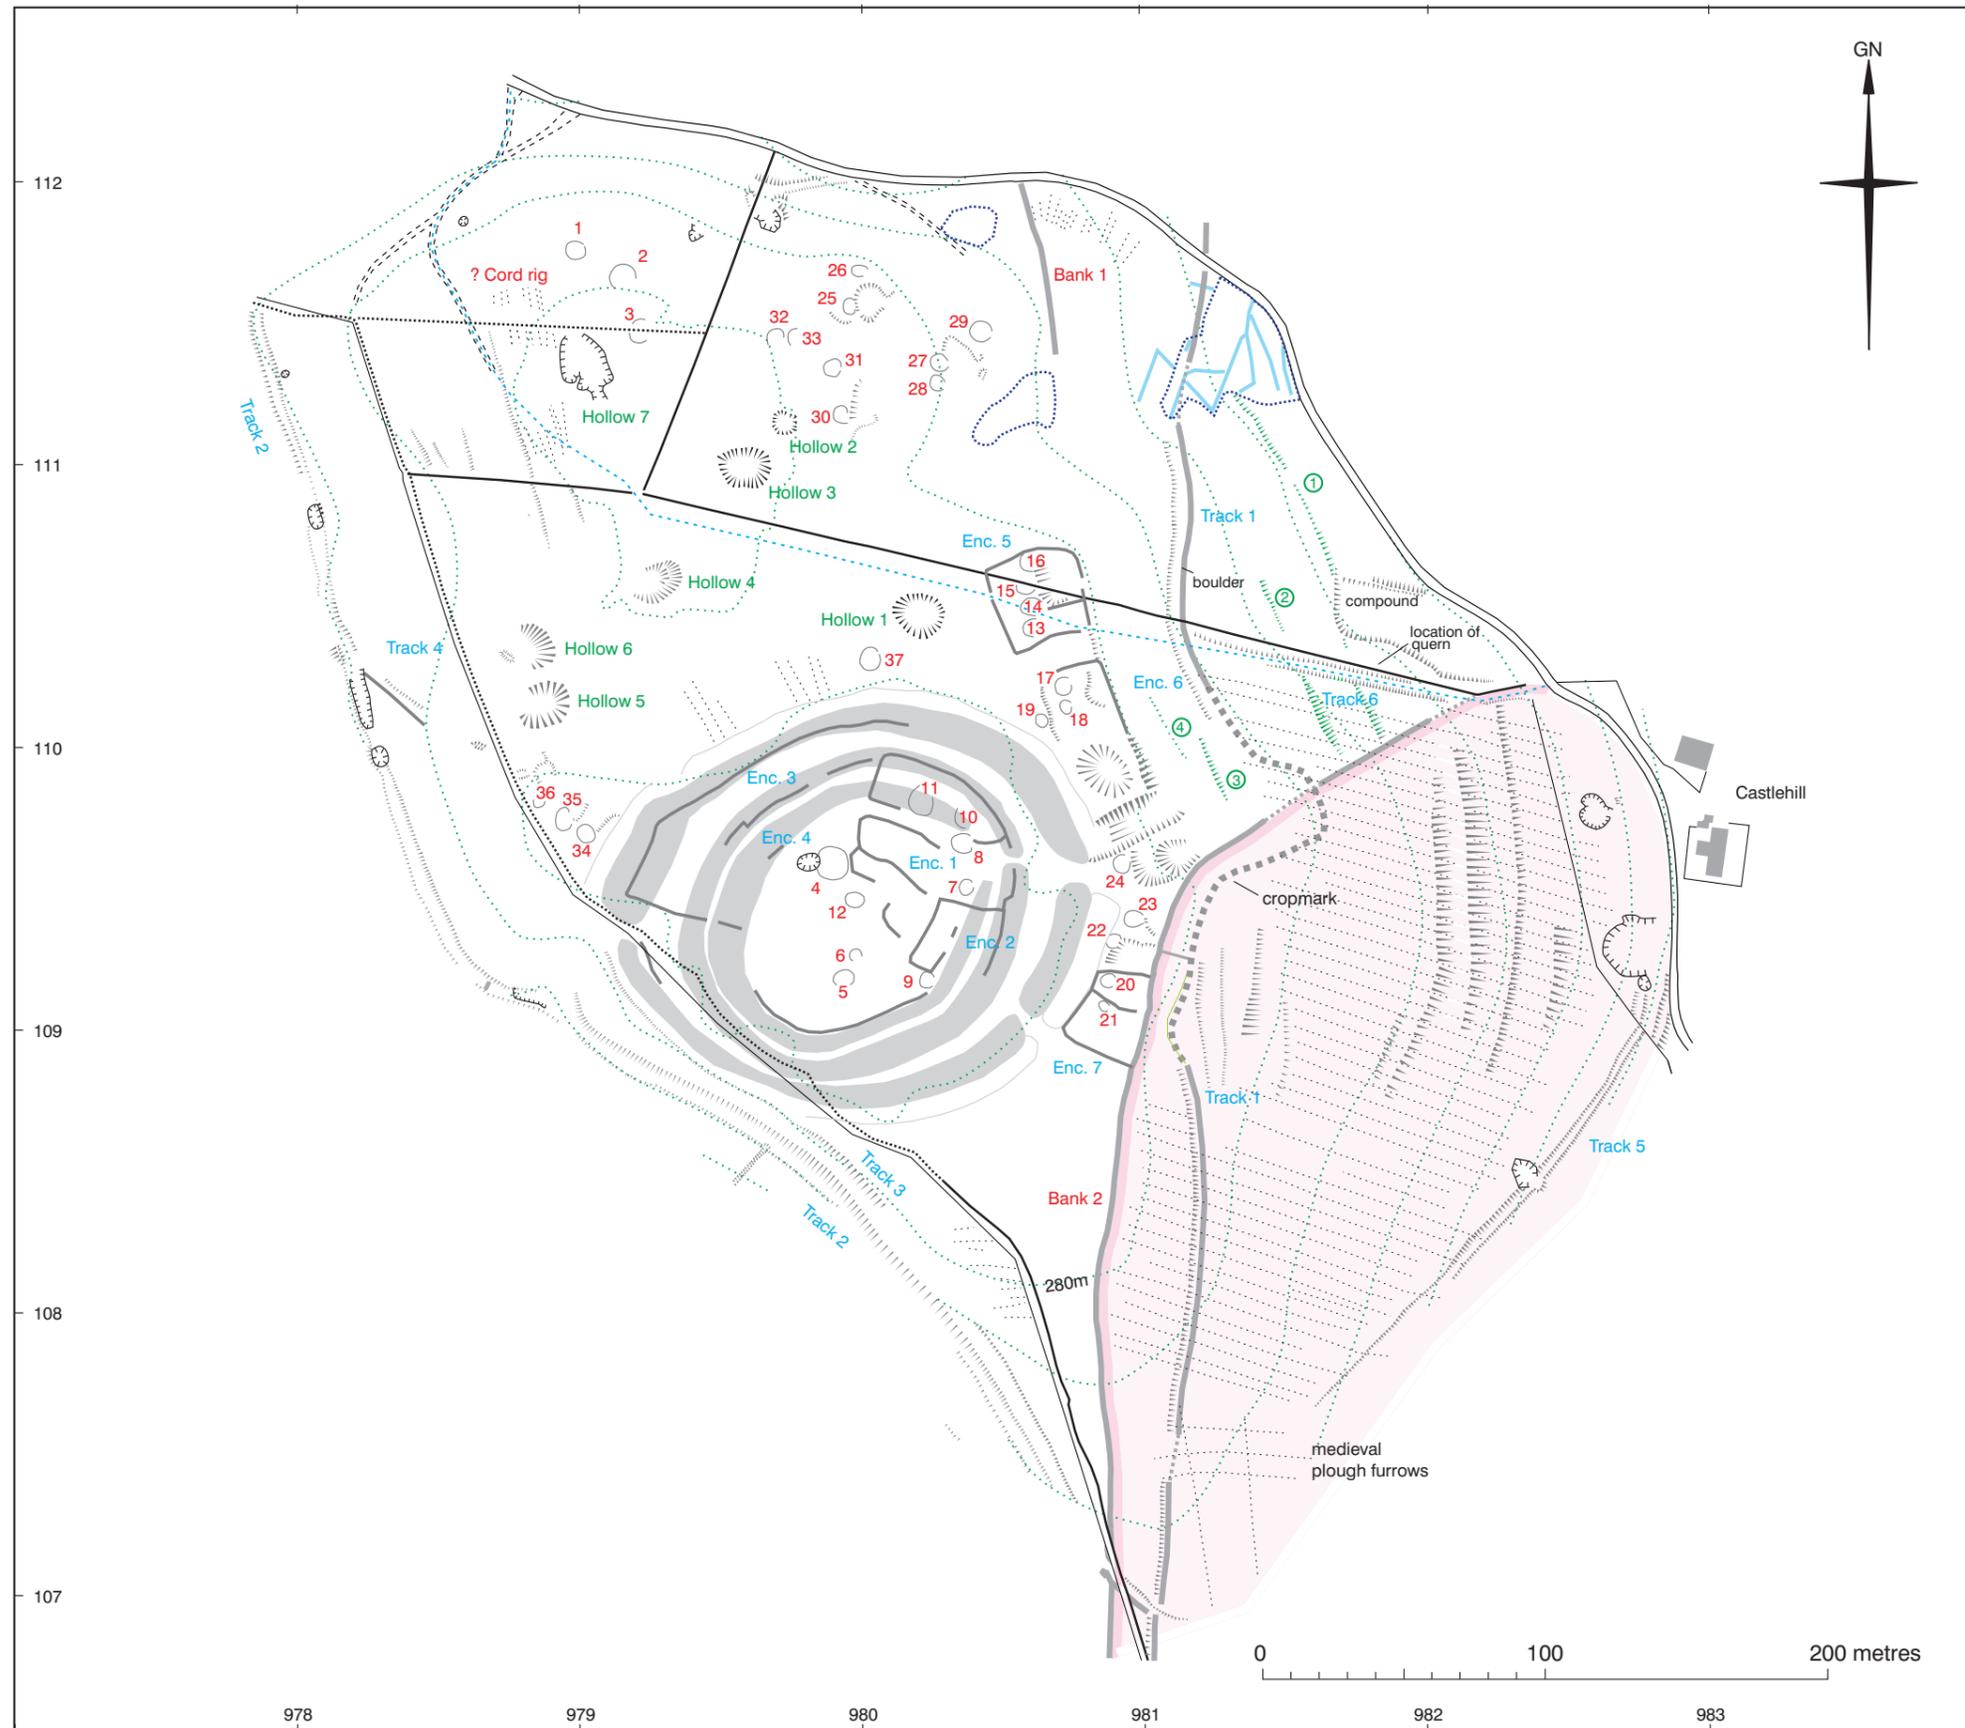
Figure 9. The landscape around the hillfort at 1:2500 scale showing features mentioned in the text

The earliest settlement on Castle Hill appears to be a group of three unenclosed, circular hut sites on the crest of the north-west slopes (Structures 1-3): similar groups of unenclosed hut sites have been dated to the Bronze Age and Early Iron Age in the Cheviots (Burgess 1984, 144). Close by is an area of possible 'cord-rig' cultivation, which will be described more fully later in this report; this is dated elsewhere in the north of England to the Iron Age, with possible origins in the late Bronze Age (Topping 1989). The hut sites are each defined by a curving outer bank, the best preserved being Structure 1 where the bank survives to a height of 0.3m and which has the slight remains of an external ditch no more than 1m wide and 0.1m deep. The bank defines a platform, 4.5m in diameter, which probably marks the site of a circular timber hut. A 1m wide break in the bank suggests the hut had an east-facing

entrance. Structure 2, 10m to the east, is defined by the curve of a discontinuous stony bank no more than 0.2m high. There is no clear sign of a levelled platform within the 7m diameter area defined by the bank, although it is likely that it contained a circular timber hut. Immediately to the east, the ground surface dips into an irregularly-shaped hollow up to 0.5m deep. This appears to be a natural feature and should not be confused with the artificial hollows representing livestock pens or yards found adjacent to several of the Romano-British hut sites to be discussed below. Structure 3 is 12m to the south of Structure 2 and is again defined by the curve of a discontinuous stony bank up to 0.2m high, which is divided by the collapsed remains of a post-medieval drystone wall. There is evidence of a slight external ditch up to 1.0m wide and 0.1m deep on the south-west side of the bank. The curvature of the bank indicates it enclosed a platform some 6.5m in diameter which probably would have been occupied by a circular timber hut. Immediately to the east is a further natural hollow up to 1.0m deep.

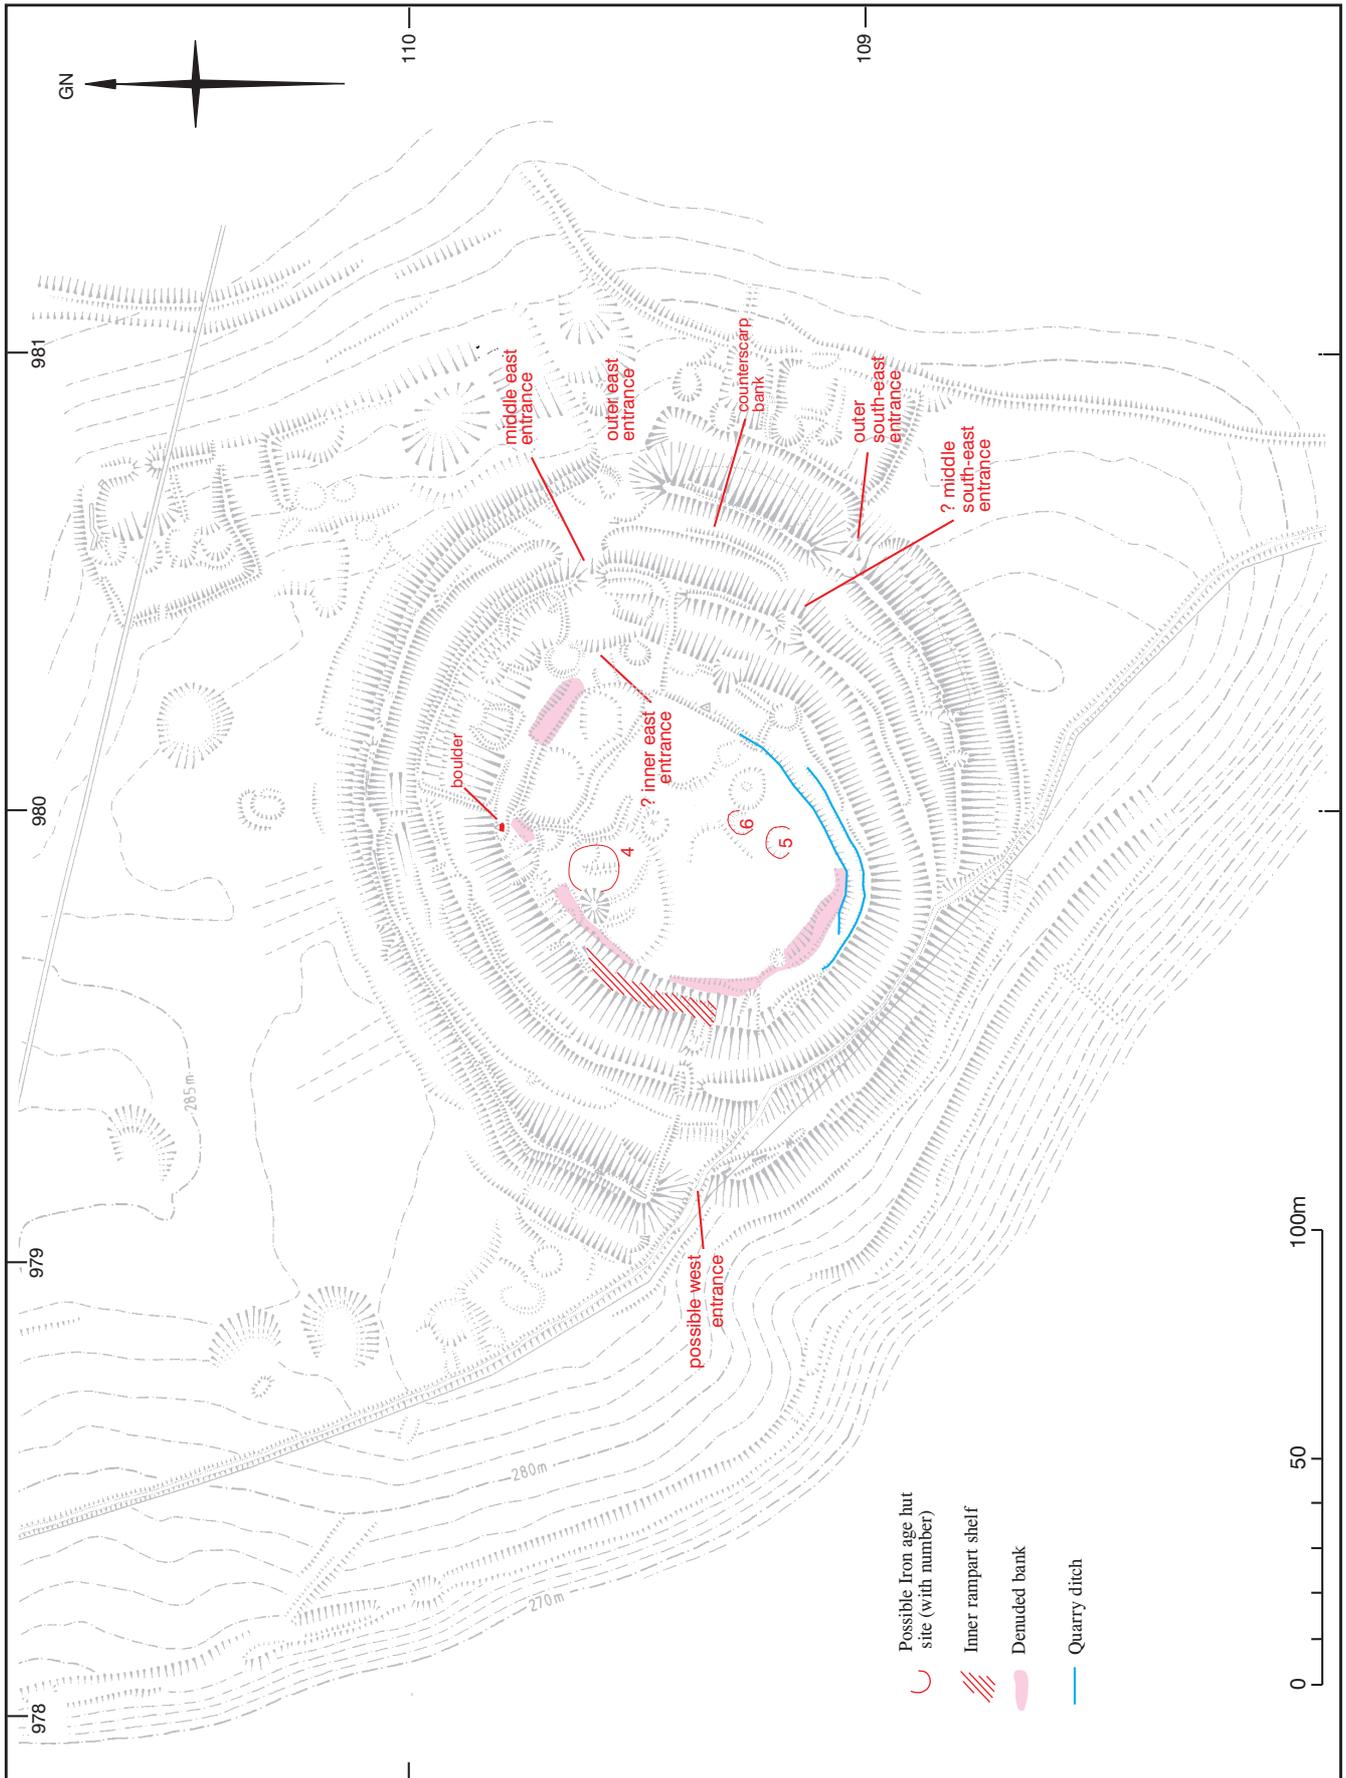
Figure 11. Plan of the hillfort showing possible pre-Roman features

At the west apex of the inner rampart there is a 5m wide terrace into the slope. This can be traced for 35m around to the north where it is cut by a series of shallow pits and scoops, one of which has exposed a block of andesite some 1.2m in length. The terrace may have been deliberately cut to exaggerate the strength of the hillfort defences when viewed from the north and west, by creating the impression that the inner rampart was in fact two. However, the field evidence suggests that this same effect could also have been created by the incorporation of the Phase 1 enclosure bank into the circuit as was discussed above. In either case, this terrace effect is most likely to be associated with the evolution of the bivallate Iron Age hillfort.

The field evidence suggests that the inner rampart, ditch, outer rampart (the middle rampart of the multivallate fort) and outer ditch were constructed as part of a single concept. The two ramparts are concentric around the summit of the hill, and

crucially, the inner rampart is set back far enough from the steep west side of the hill to allow the outer rampart to surmount the crest, suggesting the two were constructed at the same time.

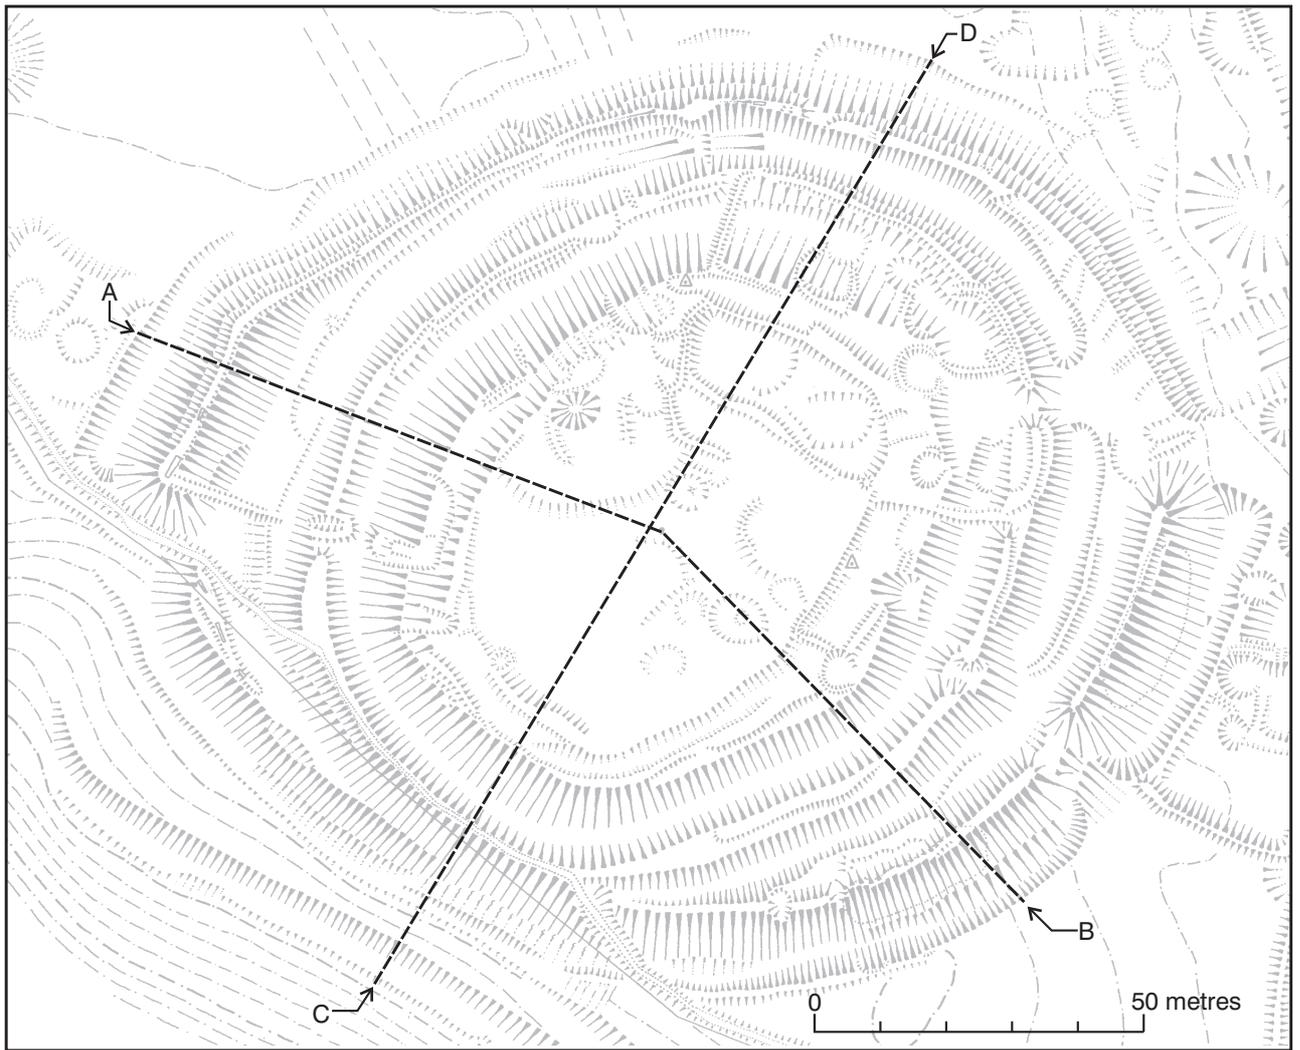
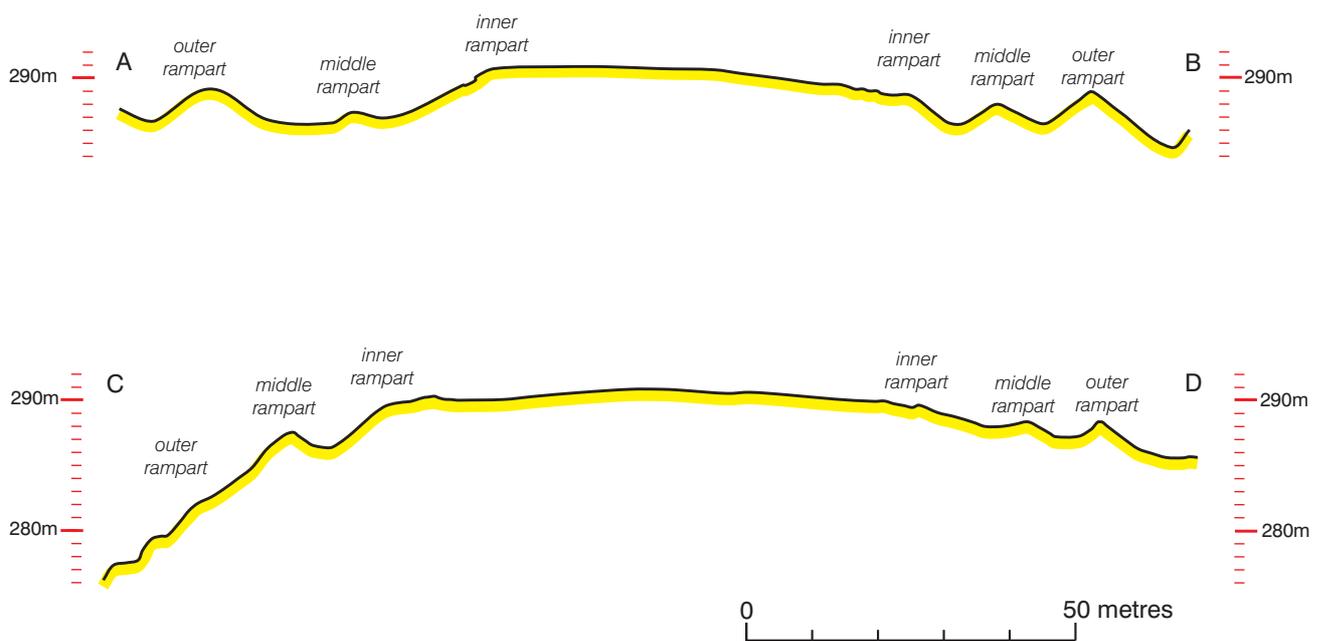
Figure 12. Profiles across the hillfort defences

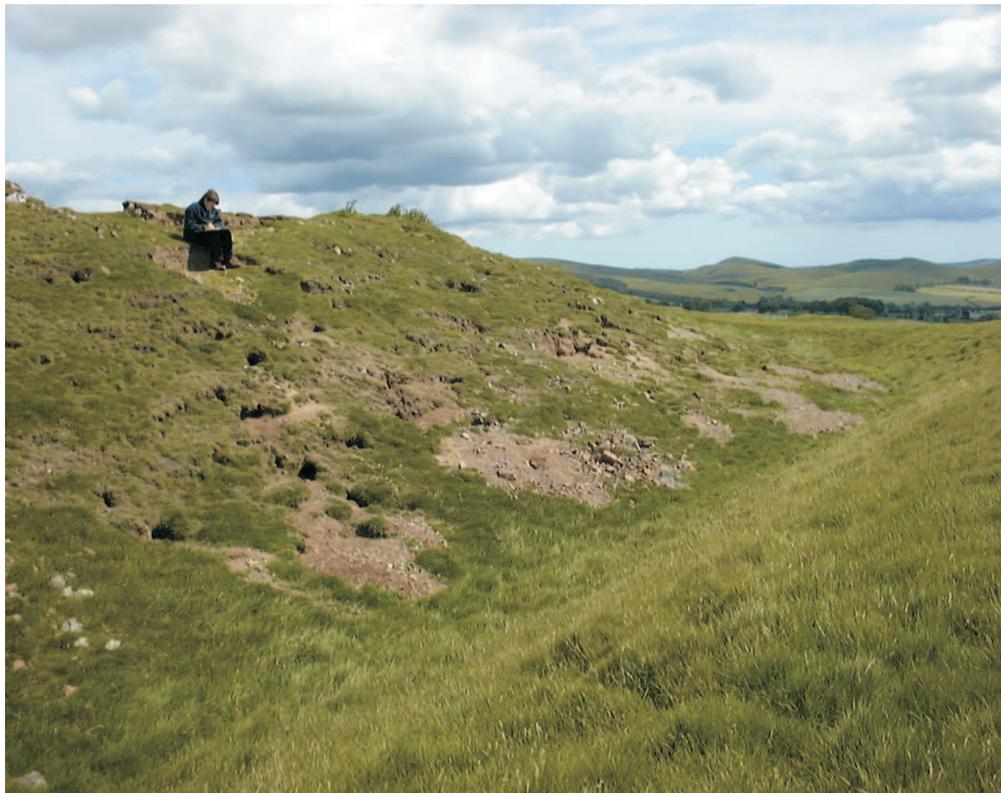
Figure 13. View looking north of the outer defences on the south-east of the hillfort

where rabbit burrows penetrate into the sides, suggesting that it is probably constructed from a simple dump of earth and stone (Figure 13). However, this is not certain as the core of the rampart was not exposed. The outer ditch is an imposing, steep-sided feature up to 5.0m wide and 1.5m deep with slight traces of a counterscarp bank and is in marked contrast to the much shallower ditches elsewhere around the Phase 3 outer rampart, and those of the preceding bivallate hillfort. Immediately to the north of the outer south-east entrance, a Romano-British settlement is situated on the outer edge of the ditch (Enclosure 7). The west side of the enclosure clearly respects the ditch and may re-use and redefine a section of the counterscarp bank. This is a firm indication that the ditch and consequently the enhanced section of the outer rampart pre-dates the Romano-British period, placing it securely it to the fourth and final phase of the hillfort defences.

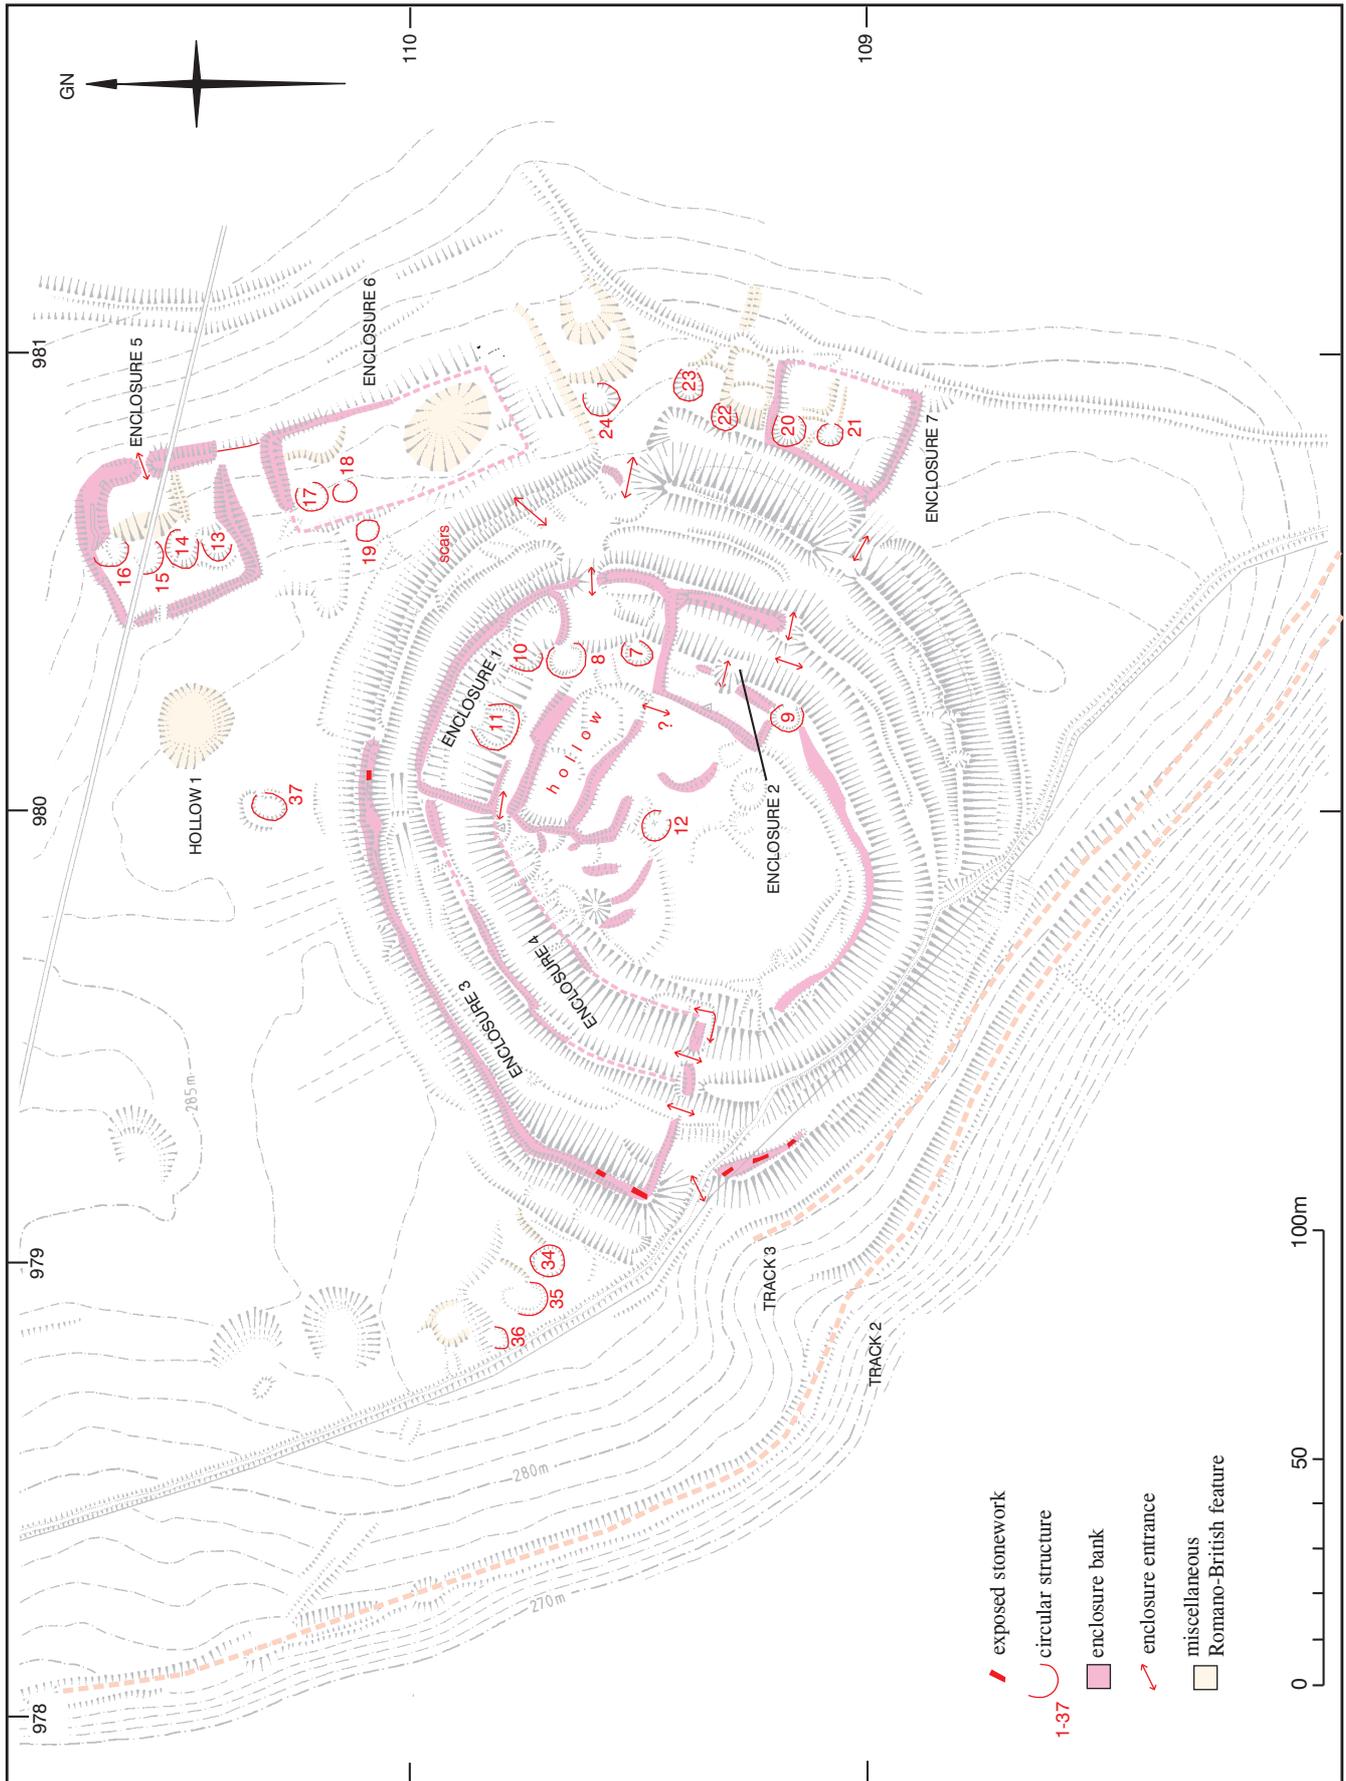
Figure 14. Plan of the hillfort showing Romano-British features

A series of discontinuous, low banks define four recognisable enclosures which overlie, and unambiguously post-date, the north half of the hillfort (Enclosures 1-4). Further isolated stretches of bank suggest there were originally several more enclosures. The banks were presumably surmounted by fences or hedges and are most likely the perimeters of livestock pens. Collectively, these enclosures occupy more than half the hillfort area, and point to a carefully organised complex for stock corralling and management. It is also possible that the more level areas inside the enclosures could have been cultivated although no evidence of this was observed.

Enclosure 1 is the only one of the four with definite evidence of occupation. It contains the sites of two probable huts and two possible circular huts or pens (Structures 7, 8, 10 and 11). The two probable hut sites (Structures 7 and 8) are defined by scooped platforms and external banks whilst the two other structures (Structures 10 and 11), also defined by curving banks, may be possible hut sites although it is equally possible that they may be later animal pens. Another probable circular hut site (Structure 9) is represented by a circular scoop immediately outside the south side of Enclosure 2, and a circular depression towards the centre of the hillfort may be a further possible hut site situated among a series of fragmentary enclosure banks not obviously part of the main complex of animal pens (Structure 12).
