An Iron Age hillfort and its environs on Castle Hill, Alnham, Northumberland

SURVEY REPORT

Archaeological Investigation Report Series AI/2/2001

**NMR Nos: NT 91 SE 9, 17, 167,
344, 345 and 364
NGR: NT 9800 1094
SMR No: ND43**

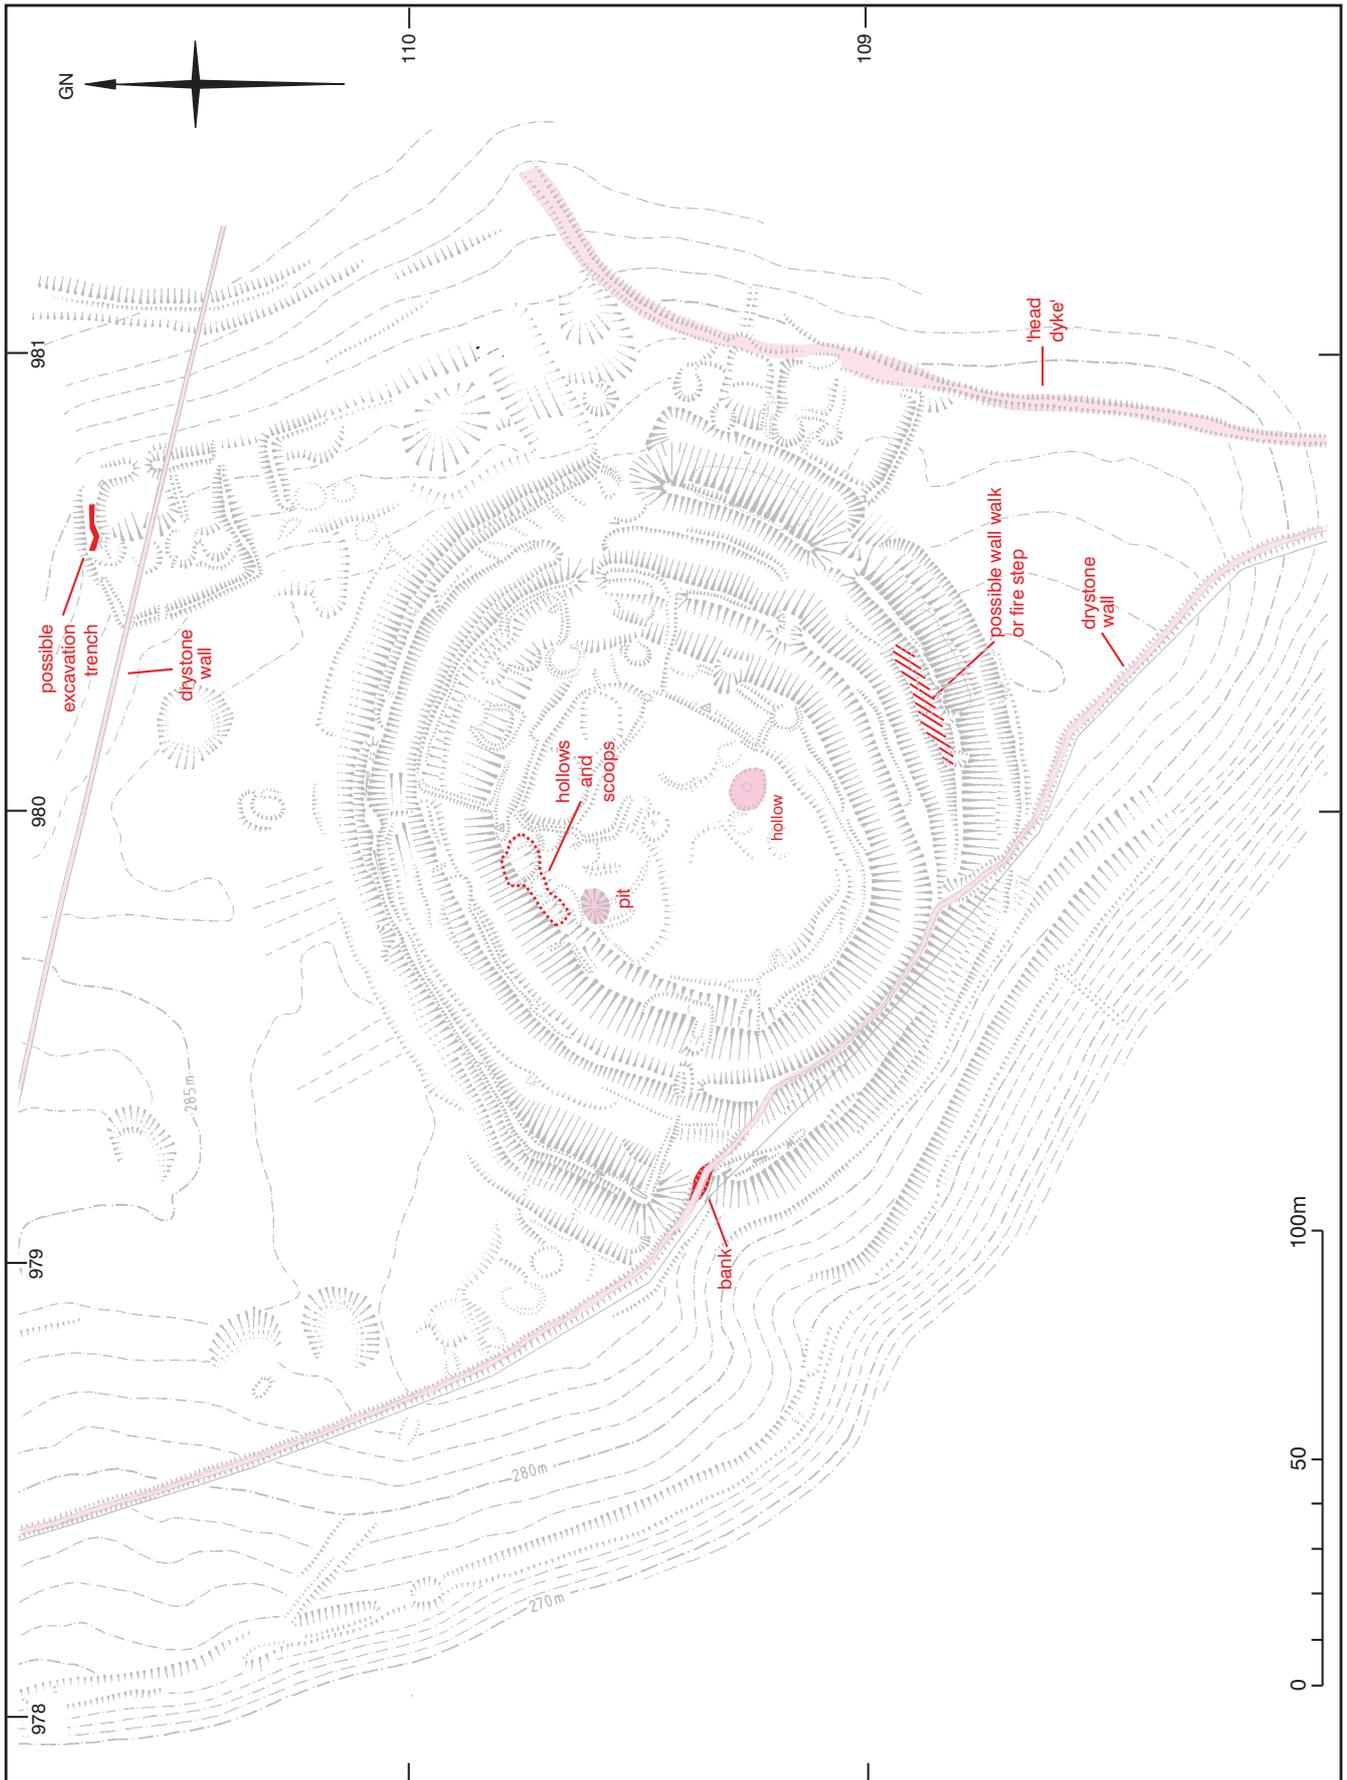
Figure 15. Plan of the hillfort showing post-Roman features

There is no evidence that the site was occupied after the abandonment of the enclosures and as a result the earthworks have only suffered minor modification and disturbance. The most visible change to the hillfort defences is on the south of the fort where a platform has been cut into the inner face of the outer rampart, as was described earlier in the report. On the west side of the hillfort, the middle and outer ramparts are overlain by a collapsed drystone wall which is depicted on the earliest Ordnance Survey map of the site (Ordnance Survey 1864) when it was presumably still functioning as a boundary. The date of the wall is unknown, but there is no evidence that it dates back into the medieval period since at this time a bank further to the east appears to have been the main land boundary (see below section 4.3.2). Some of the stone in the wall may have come from the hillfort ramparts and the overlying Romano-British enclosure banks although there is no evidence of extensive or systematic robbing on the site. More likely is that the majority of the stone for this, and other field walls on Castle Hill, was supplied by the various quarries and pits recorded in the area. The north apex of the middle rampart is pitted with several hollows and scoops which might also be localised quarrying of surface stone for building field walls and therefore relatively recent in date. One of the hollows contains a large andesite boulder some 1.2m in length but it is impossible to say if this rock is in-situ. No evidence was found for the Ordnance Survey trigonometrical station shown on the first and second edition Ordnance Survey maps on the crest of the outer rampart on the south-west side of the hillfort (Ordnance Survey 1864 and 1897).

In the interior of the hillfort, the main area of disturbance is a steep-sided oval pit some 1.5m deep, located on the north-west side. There are several short stretches of bank on the north and east sides of the pit which may be upcast. Its purpose is unknown, although it has been suggested as a pond (NMR No. NT 91 SE 9 – Authority 8). However, its depth and steep sides would seem to argue against its use by livestock and there is no sign of any wearing around its perimeter caused by the trampling of animals. Alternatively, it may be a quarry pit, but again this seems unlikely as there is no obvious reason why anyone should have gone to the considerable effort to extract stone from this depth. There is no firm evidence to establish the date of the feature, though judging by the sharpness of its profile it is unlikely to be of any great antiquity. One clue may be that it does not appear on any of the published plans of the site until that published by Jobey in 1965 and presumably surveyed not long beforehand. It is possible therefore, that the pit dates to the thirty year period between this plan and the previous survey published by Hope Dodds (1935). However, this is not conclusive as the surveyor of Hope Dodd's plan and the Ordnance Survey may have thought the feature too minor to depict. On the south side of the interior is a circular hollow up to 0.2m deep and 8m in diameter with a 0.3m high mound at its centre, which is around 1.5m in diameter. This does not appear to be a hut platform and its purpose and date remain obscure.

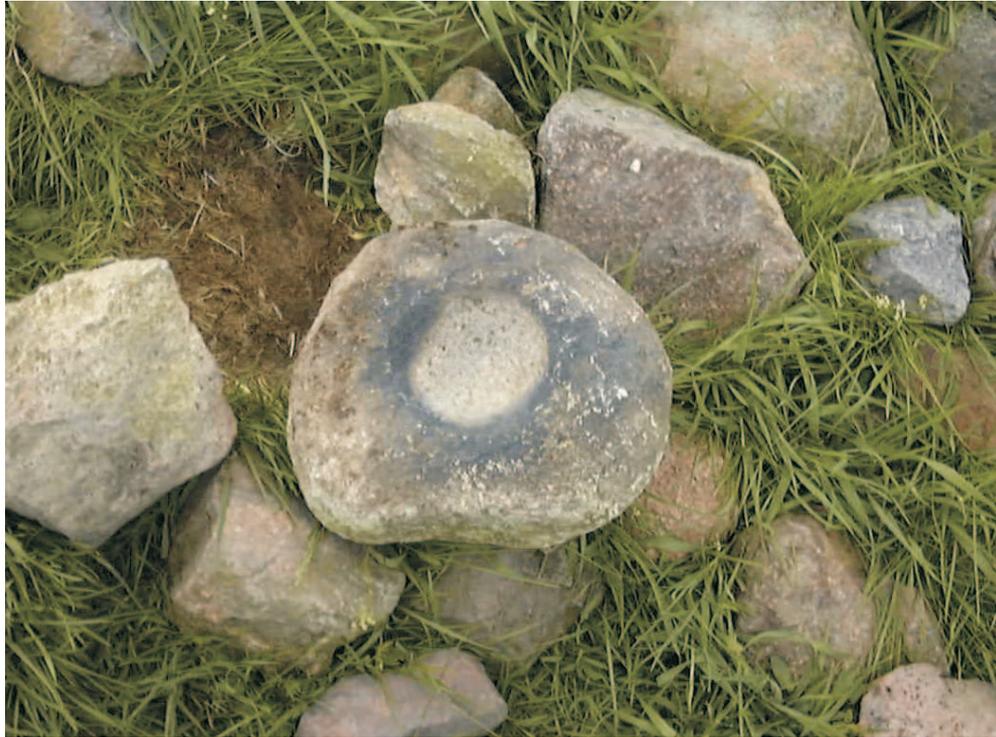
Figure 16. The quern discovered in a field boundary wall.

During the course of the survey a possible Iron Age or Romano-British quern stone was identified in tumble from the drystone wall immediately to the north of Track 6 (Figure 16). The quern, which would have been used for the hand-milling of cereal crops, has a 0.1m deep hollow some 0.2m in diameter carved into the surface of a small block of andesite. The quern was presumably gathered from close by during the course of building the wall and it is evidence that cereal crops were being cultivated in the Castle Hill area during the Iron Age or Romano-British period.

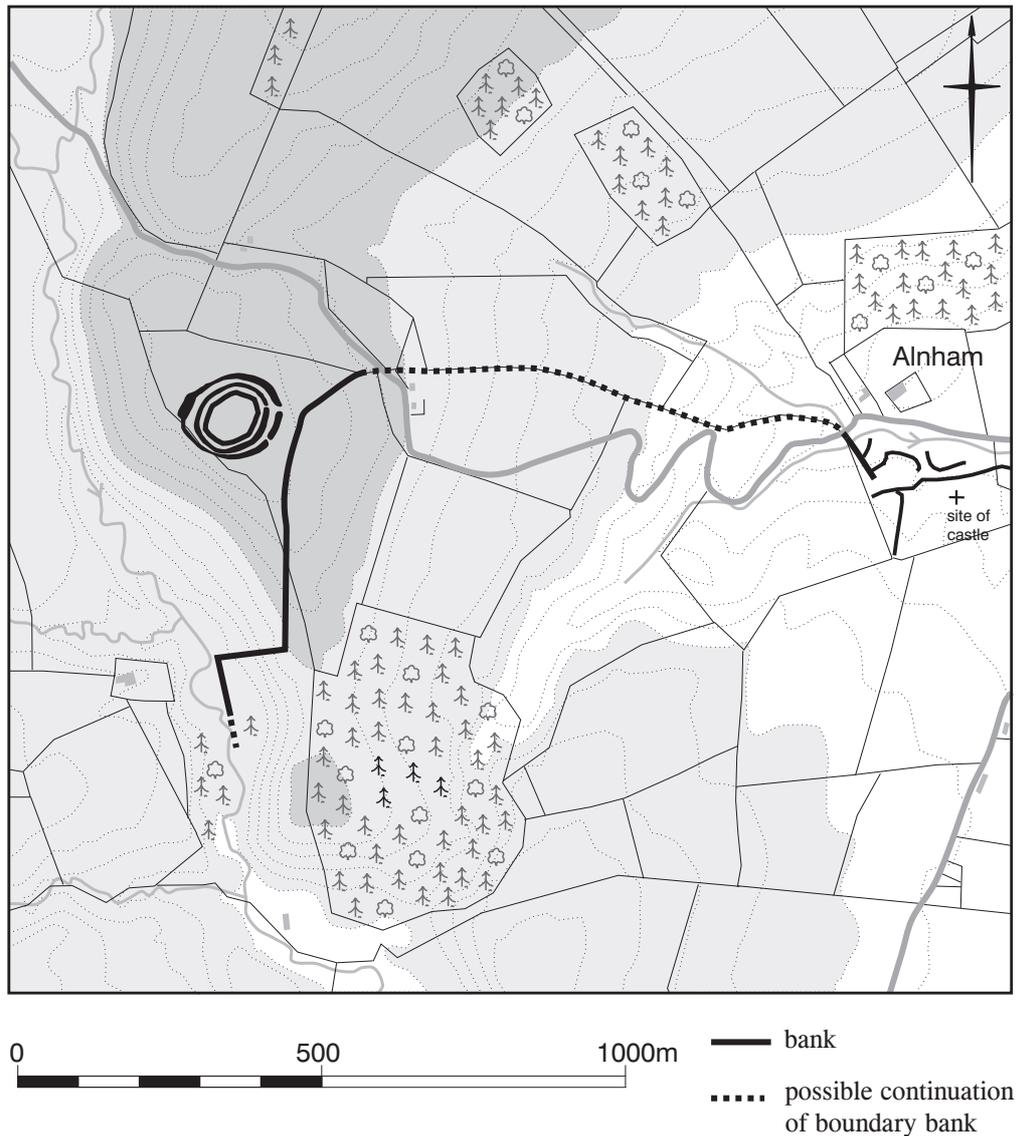
Figure 17. The suggested course of the medieval field boundary

The aerial photographs clearly show the medieval ridge and furrow bounded on the north and west by a bank which can be identified on the ground as an earthwork, which enters the survey area on the south after rising directly up the steep slope from the Spartley Burn (Bank 2). At the crest of the slope it is a prominent bank up to 0.6m high and is cut by the ditch marking the continuation of Track 2. Some 20m north of this point the bank fades to 0.2m in height and becomes much more spread. Here, slight ridges are visible west of the bank on the crest of the slope overlooking the Spartley Burn, suggesting that for a time at least, medieval ploughing crossed over one section of the established boundary. The bank continues up the hillside to the south-east corner of Enclosure 7, overrides the east side of the enclosure and then drops down the north-east face of the hill where it has been partially destroyed by improvement ploughing. It fades out some 15m short of the drystone wall on this side of the hill. However, it can be argued that the stretch of wall nearest to the road perpetuates the alignment of the bank, which is then picked out by the line of a second drystone wall on the opposite side of the road and continues outside the survey area to the village of Alnham (Figure 17). At the end of the stone wall the boundary emerges once again as a bank and leads up to the earthworks of the medieval castle.

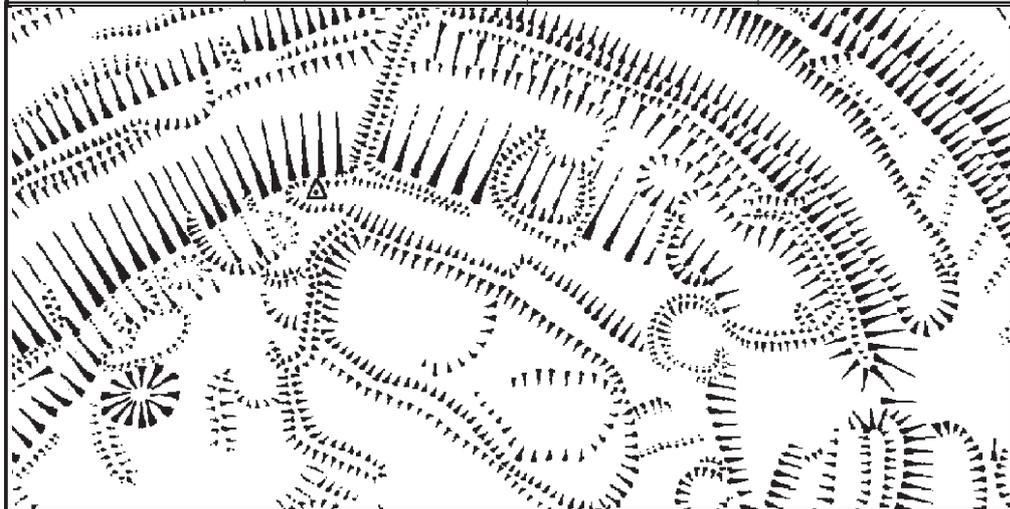
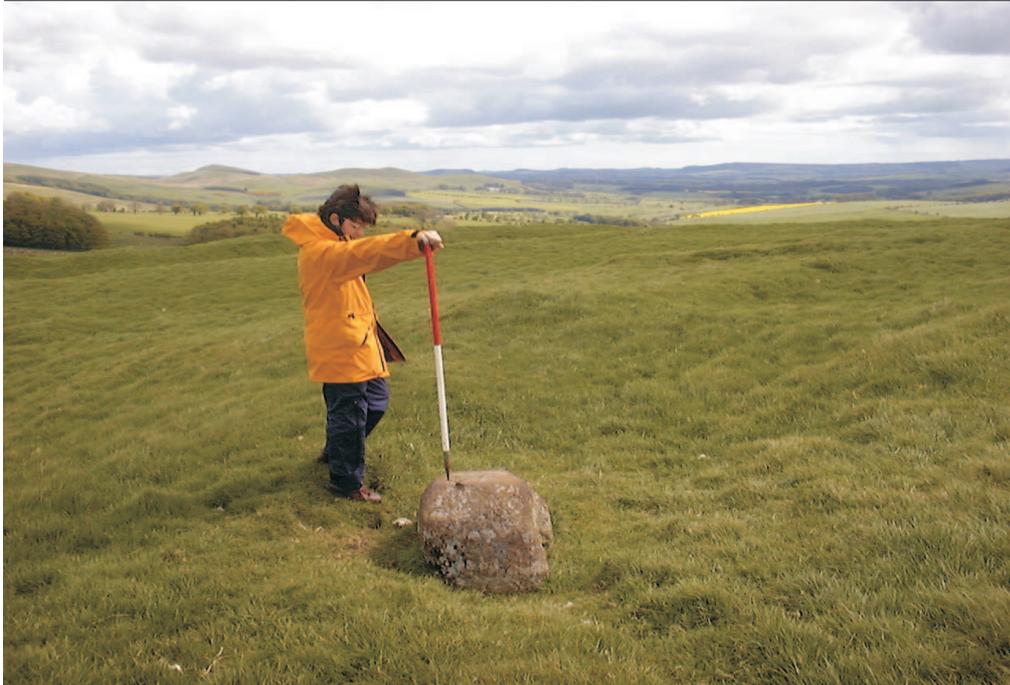
SITE NAME	Castle Hill, Alnham		
Station number	STN 1	Status	Permanent
Type of Mark	Brass rivet	NMR number	NT 91 SE 17
Date of Survey	May 2000	Sam number	Northumberland 43
Office of origin	York	RSM number	_____
Surveyor(s)	AL, TP, BT, MJ	Neg number	_____
Co-ordinate Scheme	Eastings	Northings	Height
OS National Grid	397995.777	610980.516	288.481

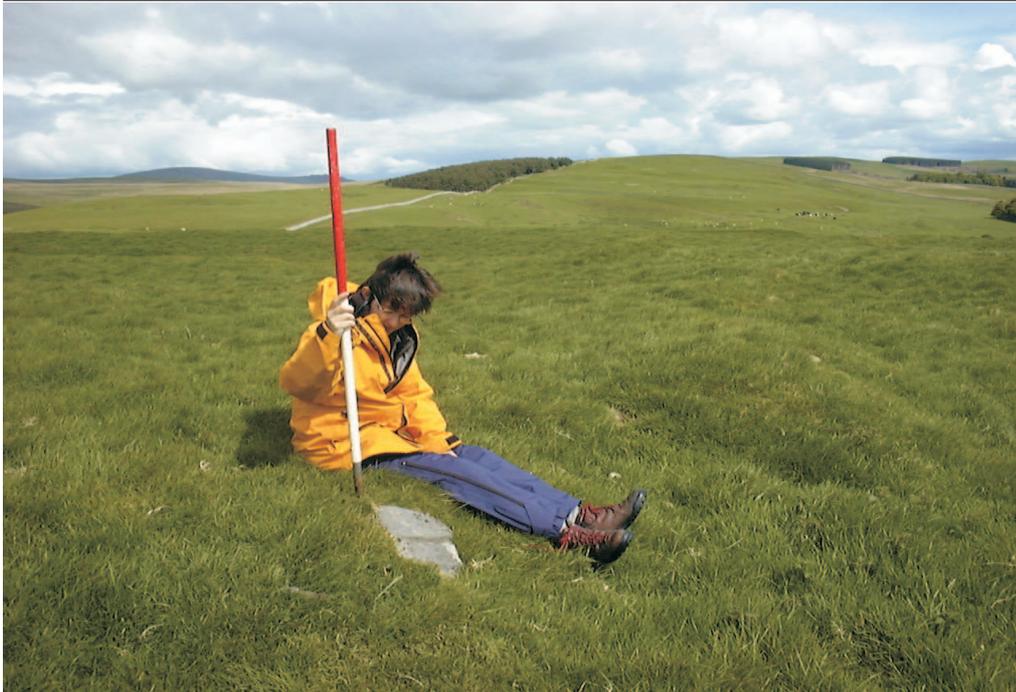
SITE NAME	Castle Hill, Alnham		
Station number	STN 2	Status	Permanent
Type of Mark	Brass rivet	NMR number	NT 91 SE 17
Date of Survey	May 2000	Sam number	Northumberland 43
Office of origin	York	RSM number	_____
Surveyor(s)	AL, TP, BT, MJ	Neg number	_____

Co-ordinate Scheme	Eastings	Northings	Height
OS National Grid	398022.379	610935.518	288.544
