The medieval and later landscape  
at Egglestone Abbey,  
Teesdale, County Durham

**SURVEY REPORT**

Archaeological Investigation Report Series AI/10/2001

**Archaeological Investigation Report Series AI/10/2001**

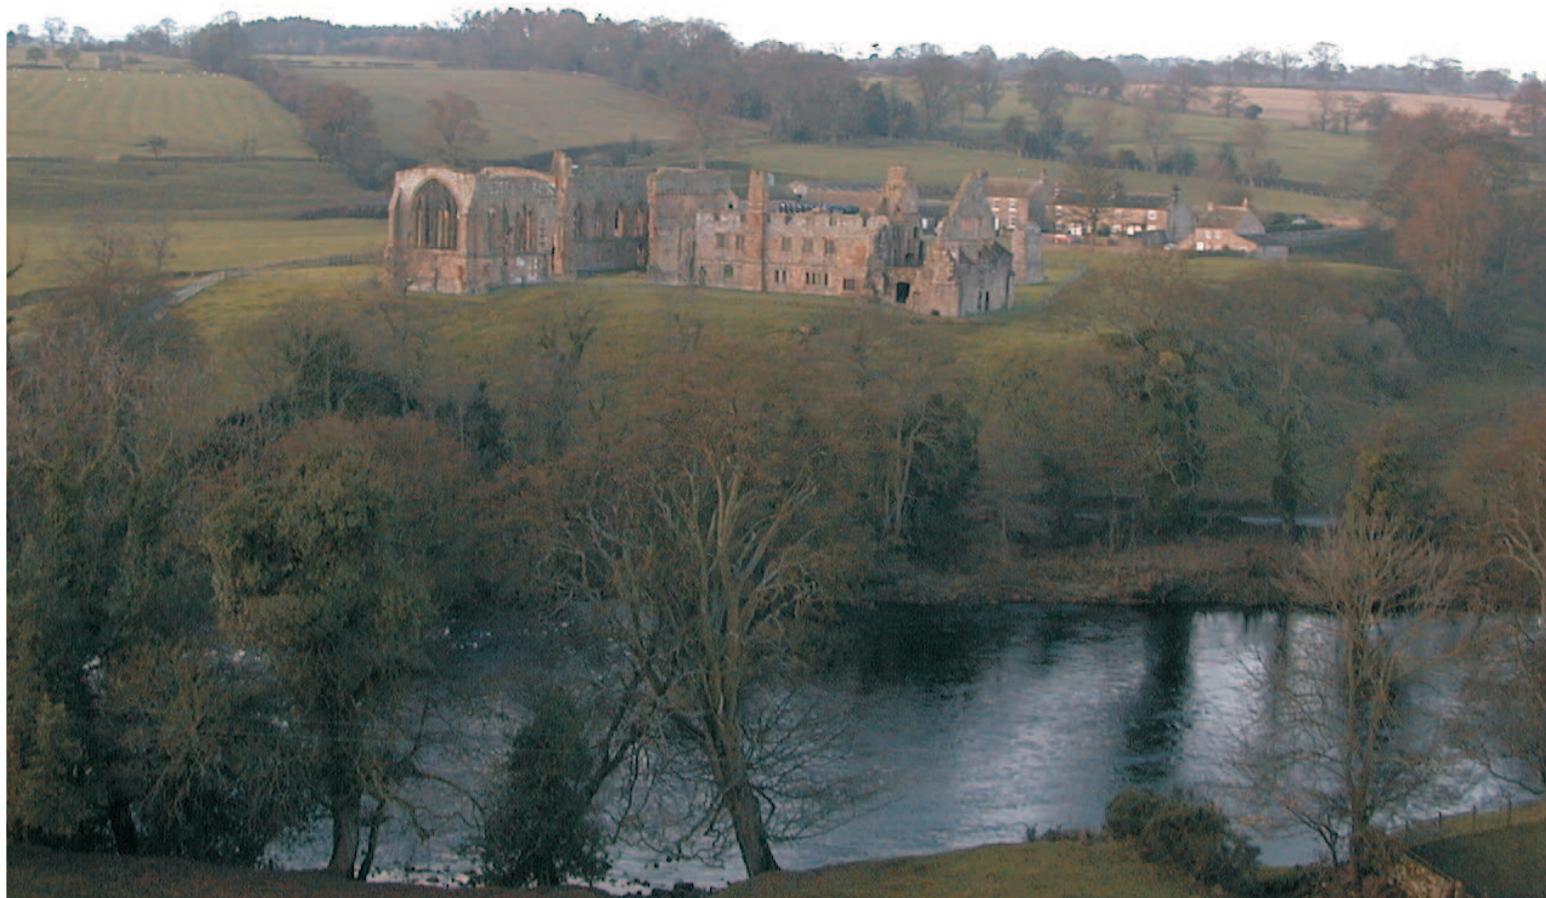
*Frontispiece. General view of Egglestone Abbey and the post-Dissolution house from the north-east (photographed by Christopher Dunn).*

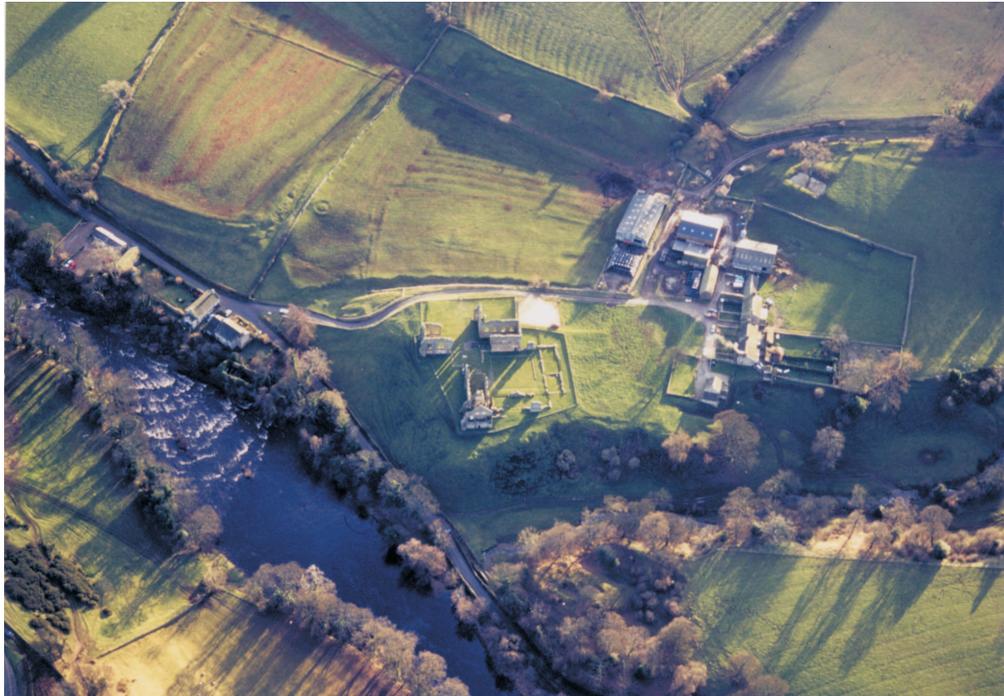
*Figure 2.  
Aerial view of  
Egglestone Abbey.*

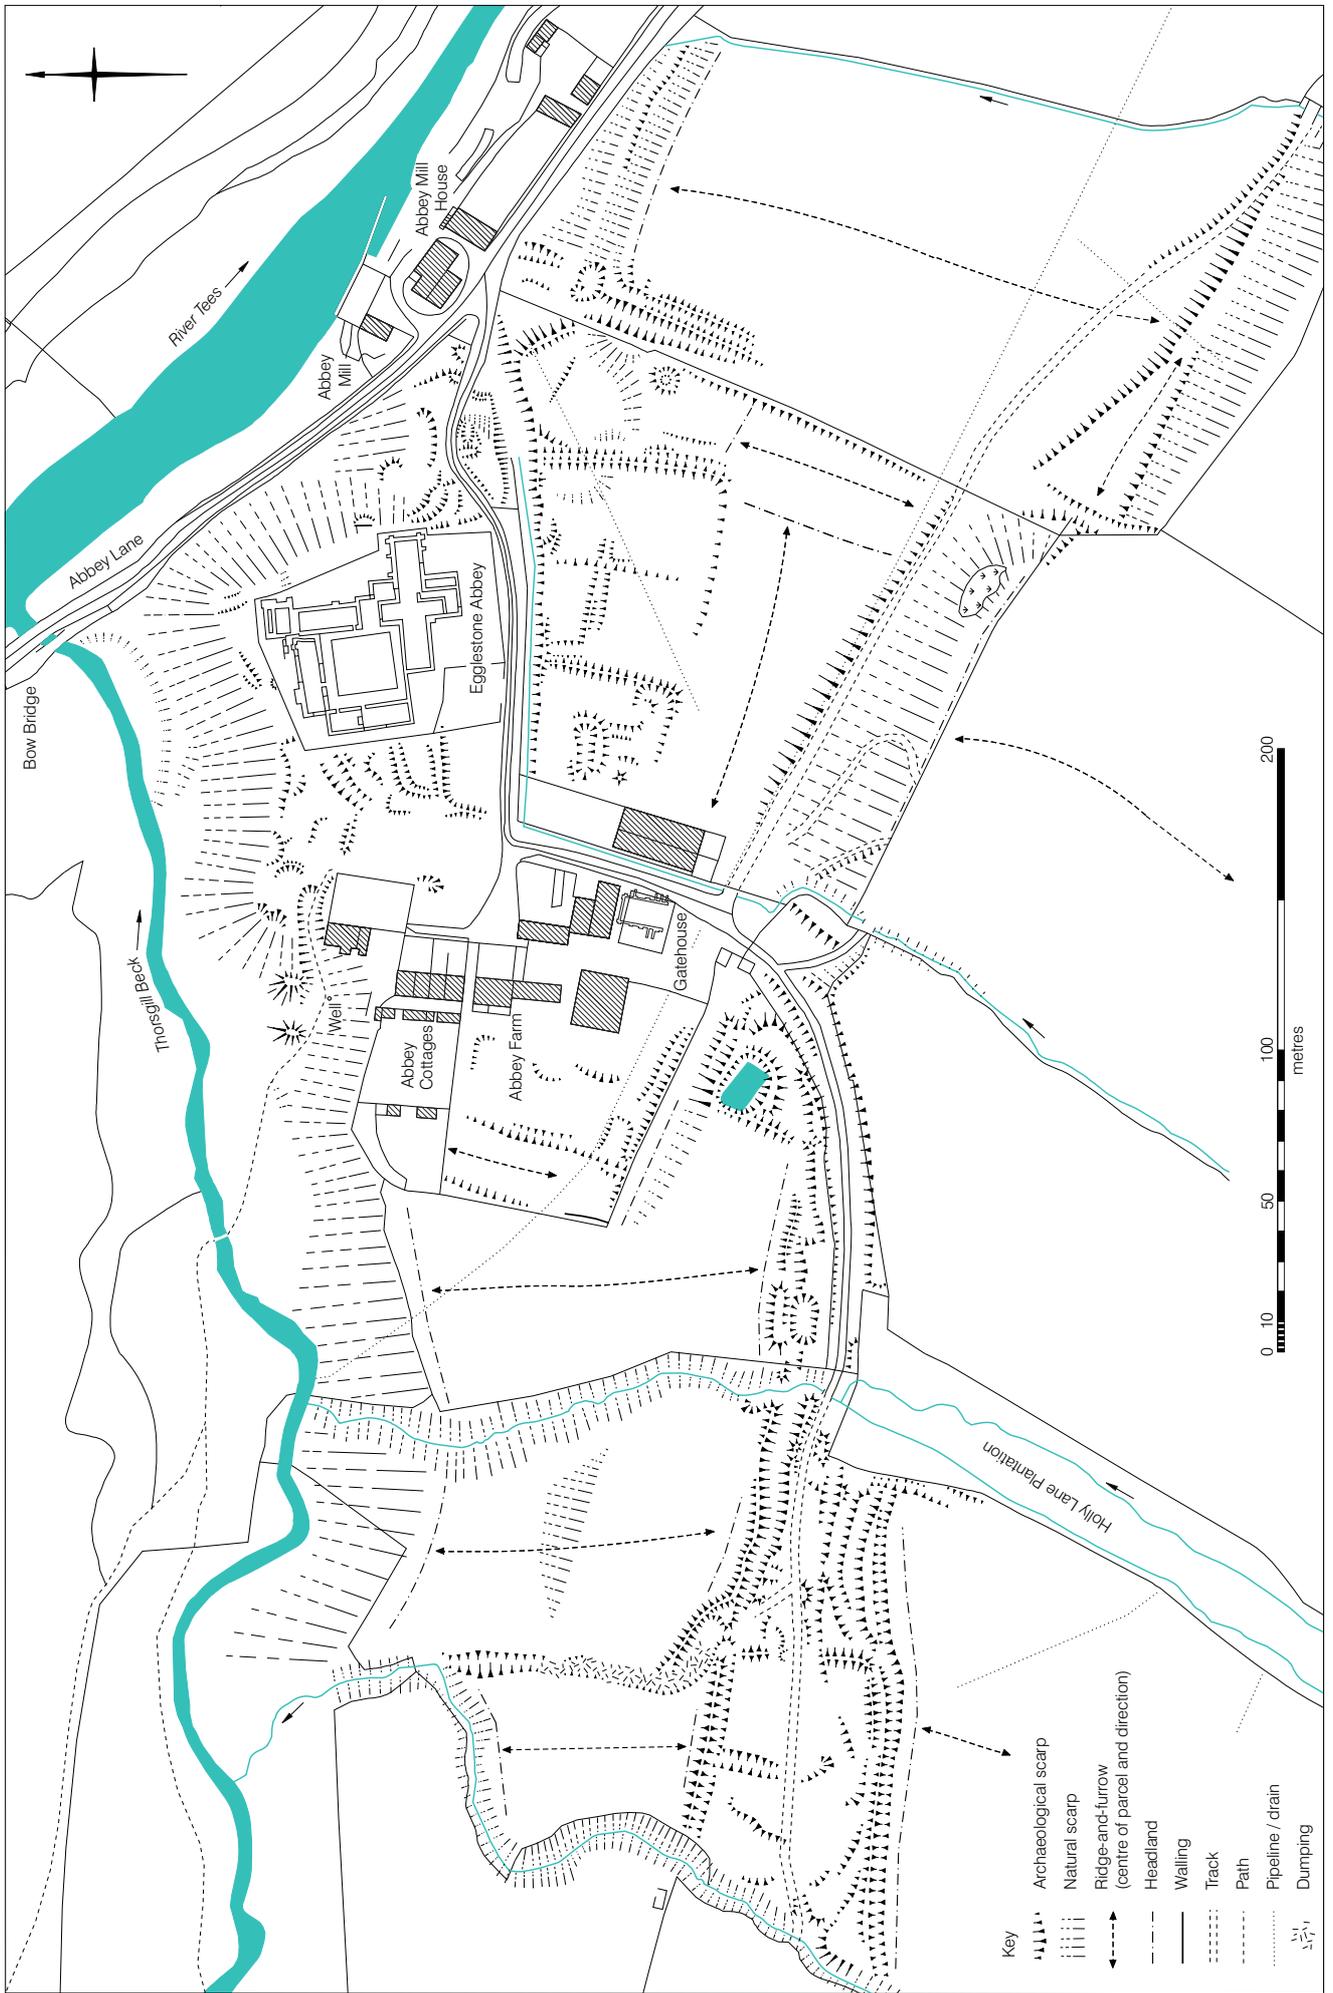
Figure 3. English Heritage earthwork plan of Egglestone Abbey and environs at 1:2500 scale (plan of gatehouse from Turnbull and Walsh (2000, Fig 1) with field boundaries, buildings etc. based on the OS 1:2500 mapping).

## **5. Description and interpretation of the earthworks and buildings (Fig 3)**

Earthworks occur in eight main areas that largely fall within existing fields and these divisions provide a convenient structure for the following account; these areas have been referenced 5.1 to 5.8. A final section (5.9) has also been added which contains a brief account of the domestic and farm buildings (Fig 4).

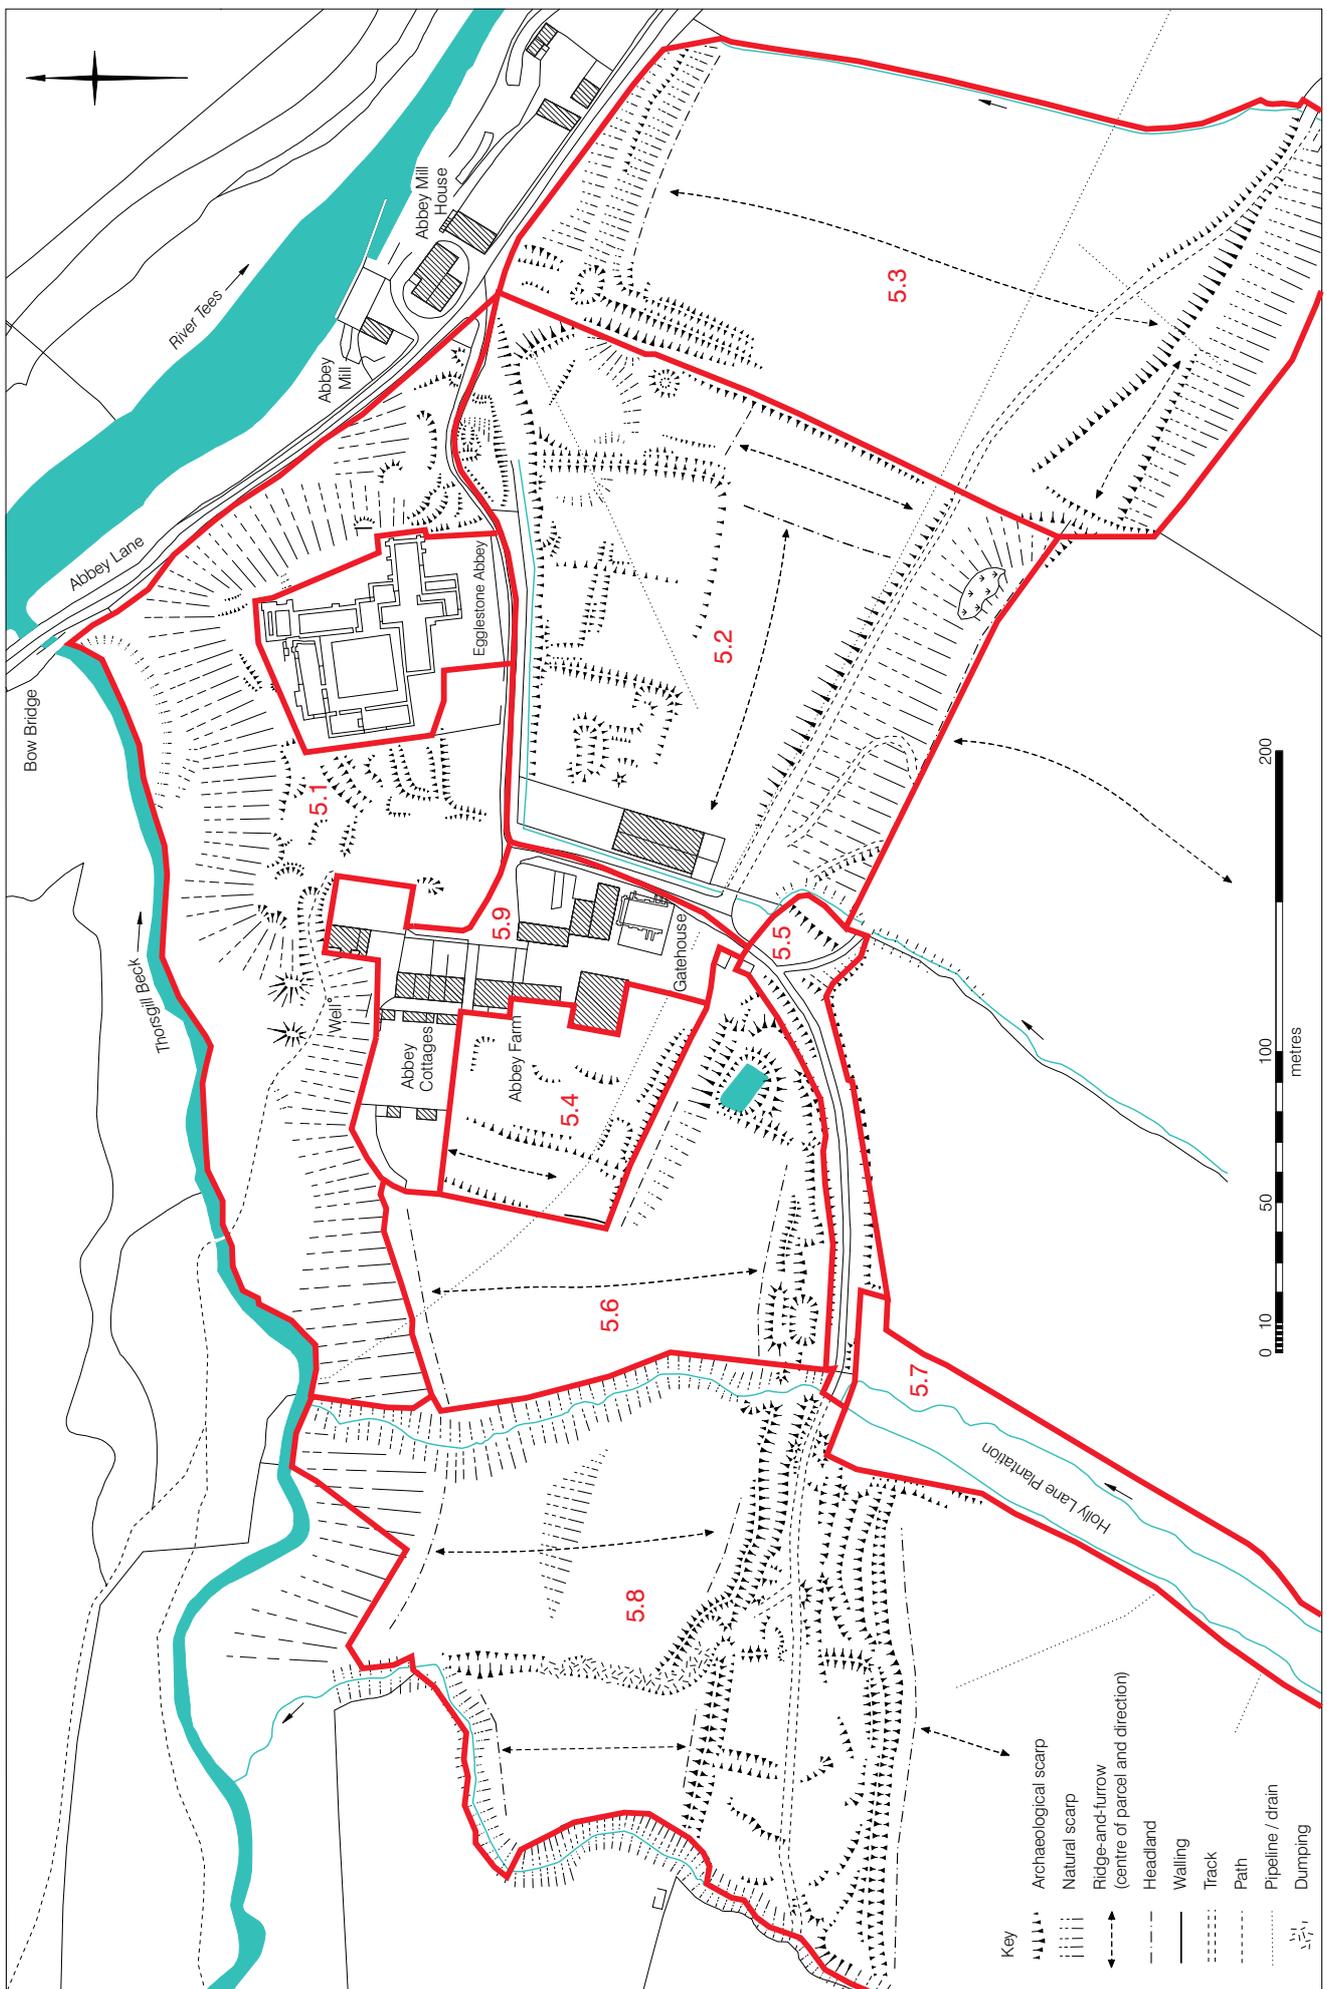
Figure 4. English Heritage earthwork plan of Egglestone Abbey and environs at 1:2500 scale showing the main areas of earthworks and buildings discussed in the report (plan of gatehouse from Tunbull and Walsh (2000, Fig 1) with field boundaries, buildings etc. based on the OS 1:2500 mapping).

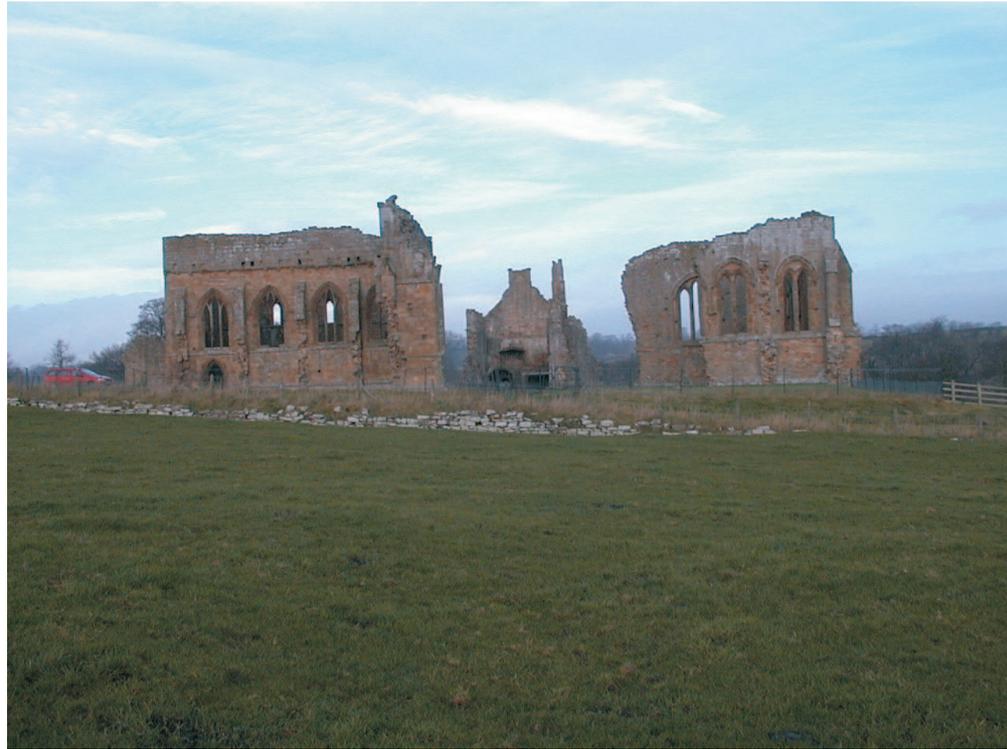
*Figure 6.  
The abbey church and  
inner (south) face of the  
north end of the east  
range viewed from the  
enclosures to the south.*

The enclosures are probably later in date than the abbey. Their orientation is not the same as the latter and they also appear to contain or overlies earlier features. One possibility is that they represent a series of garden compartments belonging to the post-Dissolution house. The good views of the surviving end gable of the house obtained from the northern parts of the central and eastern enclosures may not be fortuitous. It has been suggested that much of the central part of the abbey church - tower and crossing - was deliberately demolished soon after the Dissolution because it restricted the amount of light reaching the new mansion (Graham and Baillie Reynolds 1958, 13; Hodgson 1904, 155). It is also possible that the demolition took place to try and give some view of the house, and perhaps a romantic framing for it, from the gardens (Fig 6). Against this is the fact that the view may still have been

largely obscured until portions of the cloister arcade and north transept were removed a few years before Hodgson wrote his paper. The rectangular hollow situated immediately outside the eastern enclosure could also have been a garden feature. A second possibility is that the enclosures have an agricultural origin, perhaps they were paddocks and allotments for the labourers who were living in the house after it had ceased to function as a mansion. This might make them of relatively late date and could account for their orientation being different to that of the abbey. A twentieth century pipe trench crosses the enclosures almost diagonally and is visible as a very slight linear feature with a straight course; it misses the western enclosure.

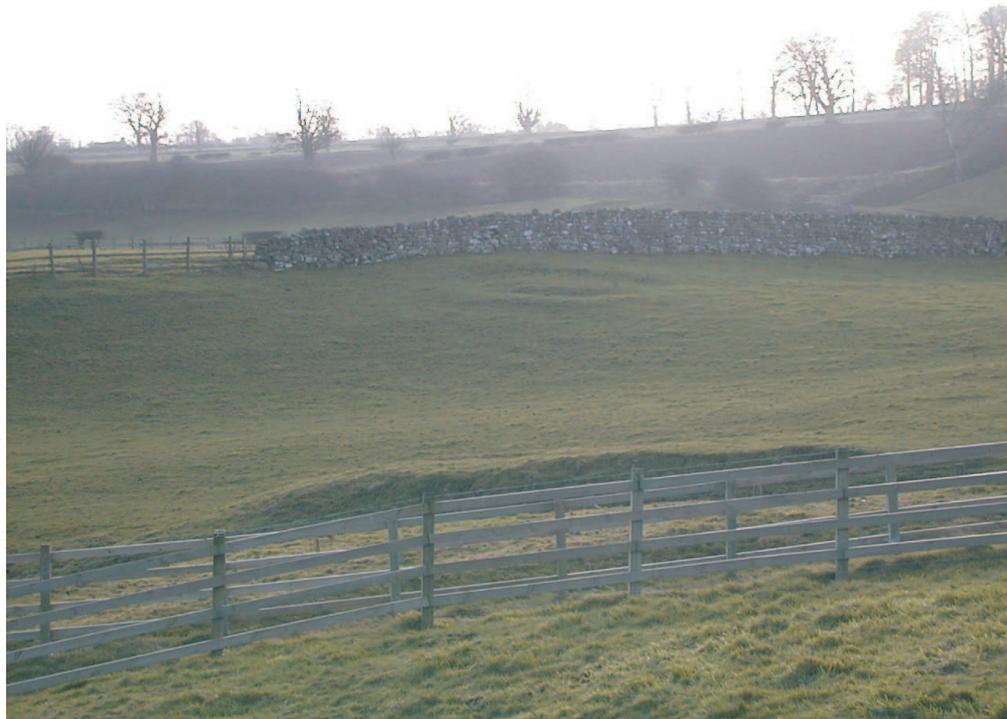
It is located at approximately NZ 0632 1502 and has been terraced into the upper part of a natural slope (Fig 7). The mound is 5m in diameter with a fairly flat top that measures 3.7m across; it stands 0.3m high above the ditch, which surrounds it. The outer side of the ditch is 0.6m high on the east where the natural slope has been cut. On the north-west the ditch becomes a ledge with a marked front scarp where material has been pushed out. The overall width of the monument is 10m.

*Figure 7.  
The small circular  
mound viewed from the  
abbey ruins to the  
north-west.*

The RCHME identified this earthwork in 1992 as a possible stack stand. It could, however, possibly be the remnants of a demolished dovecote (of unknown date) whose foundations have been robbed. Dovecotes were not uncommon in Teesdale and extant examples include the dovecote north of St. Lawrence's chapel, Barforth Hall, Barforth and also the one south of Gainford Hall, Gainford (English Heritage 1999, 11). There was also once a dovecote (NMR Number: SE 18 NW 330) above the ruined Premonstratensian abbey at Coverham, North Yorkshire. Alternatively it could be a garden feature such as the site of a gazebo. A scarp, whose route is parallel to the wall that forms the east boundary of the field, fades out close to this earthwork on the south. It is probably unrelated and is either an earlier course of the wall or a later plough scarp.

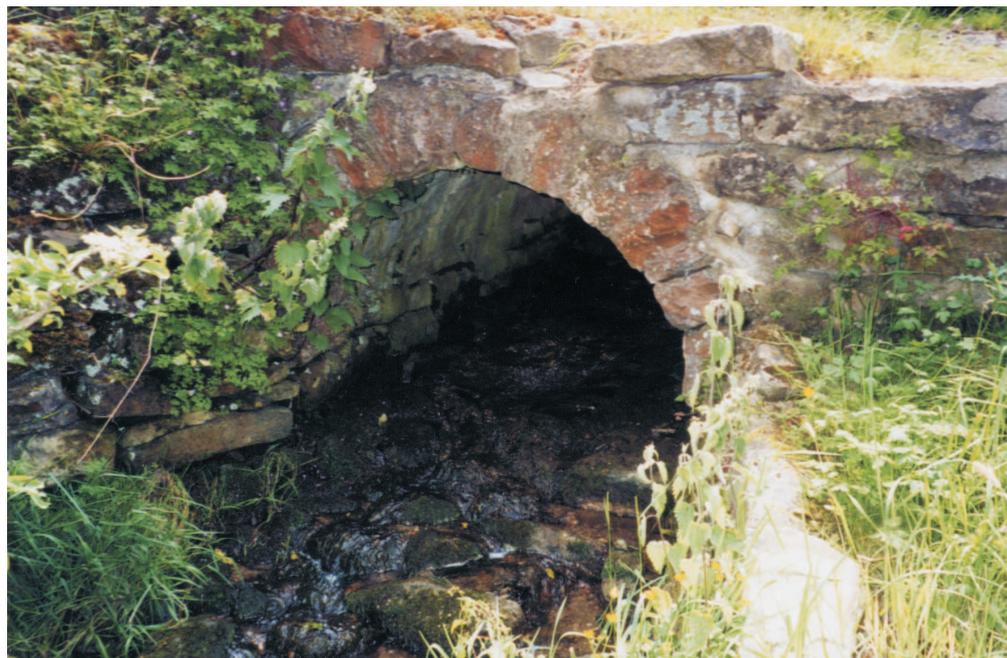
*Figure 8.  
The bridge crossing  
the stream south  
of the farmstead.*

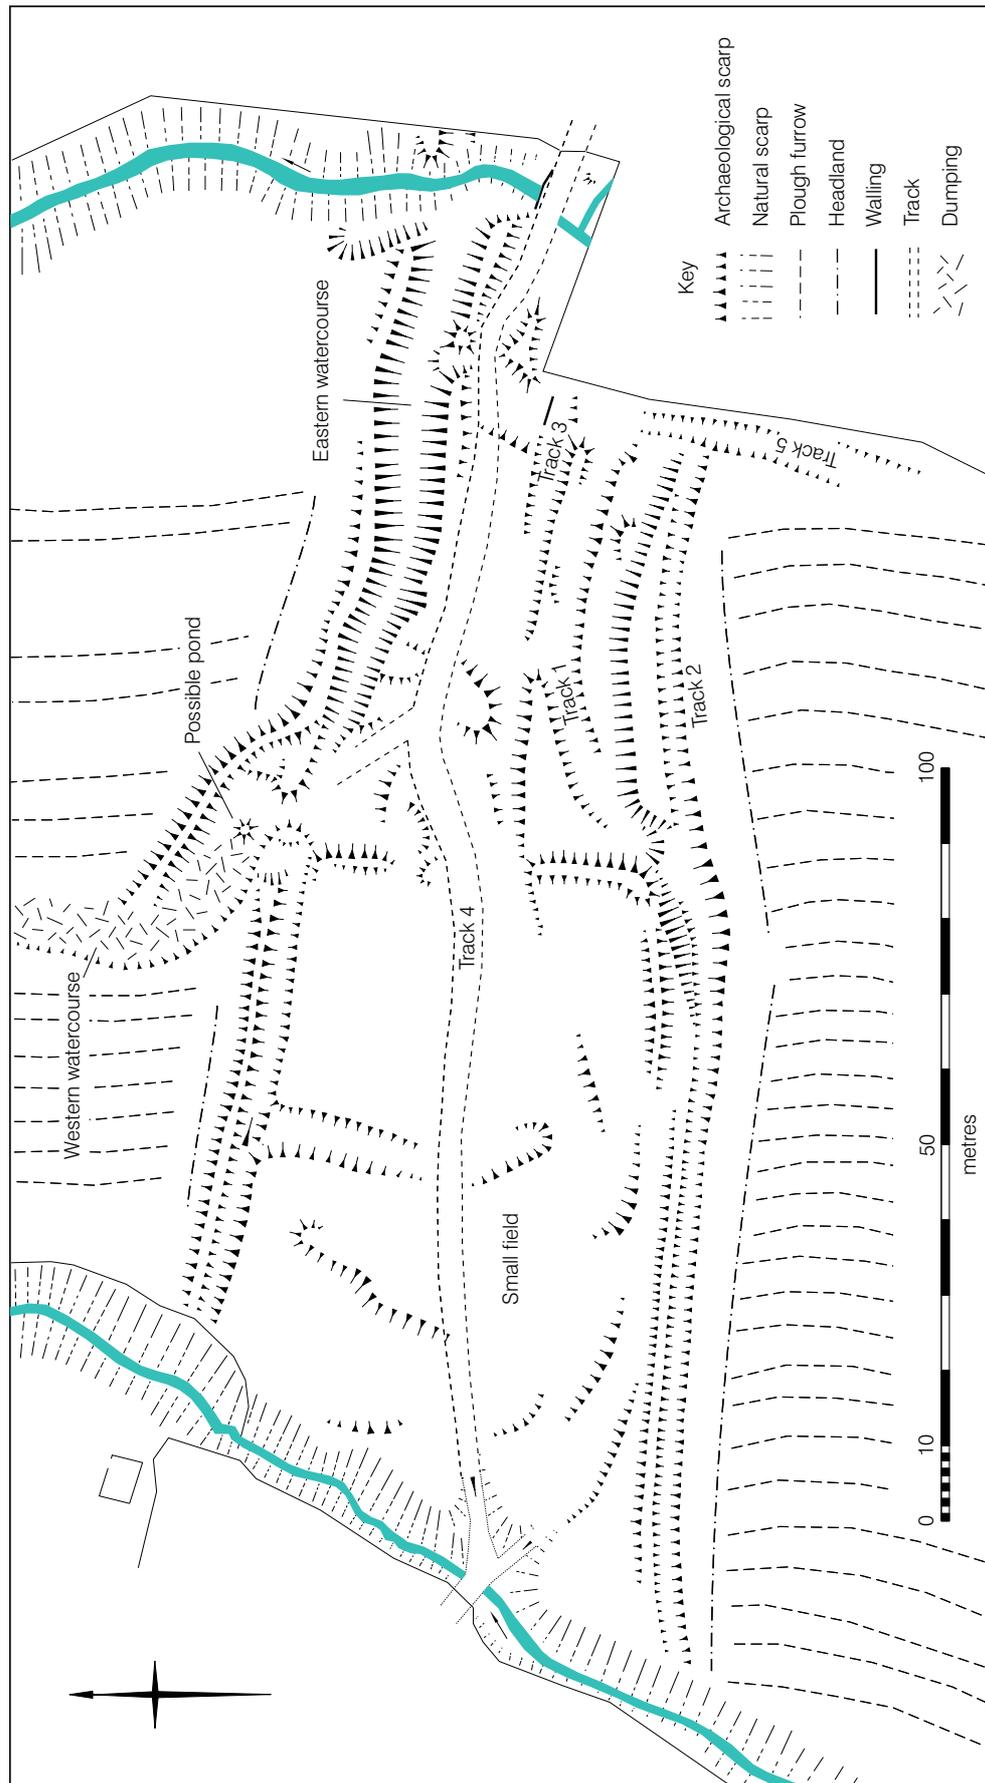
Figure 9. Annotated 1:1000 scale window showing the principle areas of earthworks in the field situated west and south-west of Holly Lane Plantation.

The remnants of at least four tracks cross the field in an east to west direction. The latest is the present tractor track (Track 4), which continues the course westwards of the farm track described above in Section 5.5.2. It enters the field on the east - just beyond the northern end of Holly Lane Plantation - and crosses on a causeway the stream that flows northwards from the plantation. The north side of the causeway is revetted to a height of 0.65m with boulders and crudely coursed rubble. The stones do not resemble, certainly in the muddy conditions that pertained at the time of the survey, the voussoirs of a small bridge as was suggested by Turnbull and Walsh (2000). The track crosses the remnants of the small field (section 5.8.2 below) whose site had clearly long since ceased to have any significance.

Returning to the eastern end of these earthworks, the earliest track appears to have been succeeded by the southernmost member of this group (Track 2) that lies on the northern side of a plough headland. The space separating it from the earliest track is crossed by a prominent north-facing east to west scarp, 0.7m high, which could be a limit of earlier ploughing, perhaps contemporary with the earliest track. The second phase track also seems to respect the small field. It leads towards the latter's south-east corner, where it appears to overlie the earliest track at about NZ 0590 1495. From the field corner it continues for 100m in a westerly direction to NZ 0579 1495 along and immediately in front of the bank which forms the southern boundary of this field. Here it is ditch-like measuring 3m wide and up to 0.5m deep. A substantial plough headland, 5.5m across and about 0.5m high, follows the southern lip of this feature.

The third track (Track 3) lies between the earliest track and the present track. It is now in a very fragmentary condition. In one place this is because it is surmounted by a cattle feeding trough and the land around it has become a churned up quagmire. Its

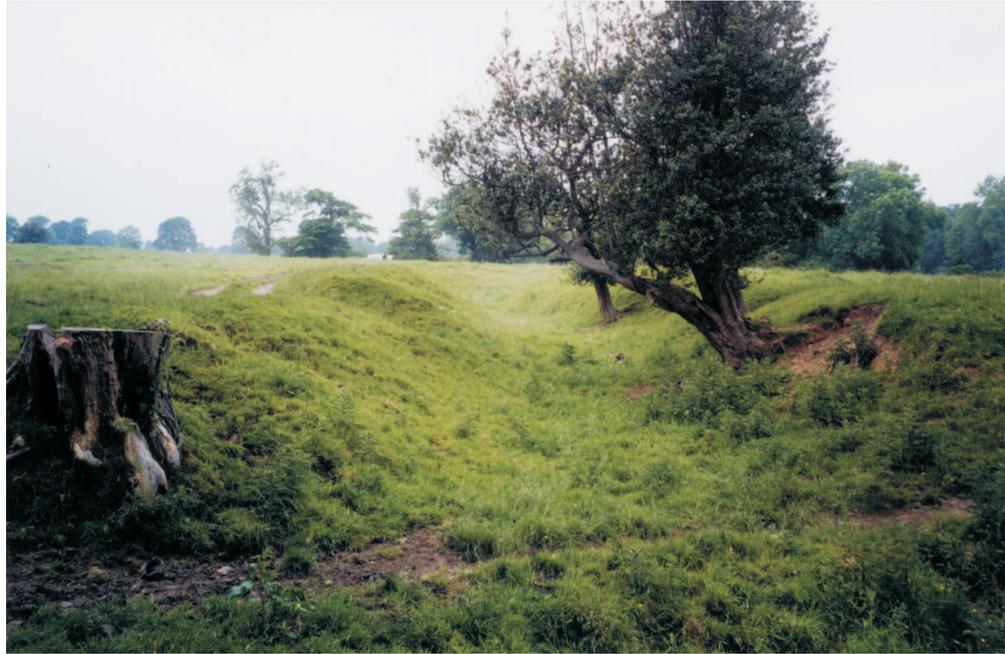
The eastern watercourse is of massive proportions and lies north of the present tractor track (Fig 10). It commences on the west bank of the stream, which follows the eastern boundary of the field, and extends along a slightly sinuous course for some 80m into the field in a westerly direction. The principal component is a ditch, about 10m wide at its eastern end but narrowing to 5m at the west and up to 1.9m deep, which is embanked on both sides. At its eastern end water seeps out of its base into the stream, suggesting that there may be the pipe of a later land drain buried in its bottom. The south face of the southern bank is 0.9m high; the bank does not extend

*Figure 10.  
The eastern  
watercourse  
looking west.*

for the full length of the ditch. The northern bank, which appears to be a former field boundary, is much lower with its north face only 0.3m high. Three old holly bushes - possibly the remnants of a hedge - are growing on it. To the west, the bank diverges from the ditch to partially enclose the possible pond. In this area it is about 0.5m high and may have been enhanced with spoil from the construction or subsequent cleaning out of the possible pond. The maximum width of the ditch and its attendant banks is 16m.

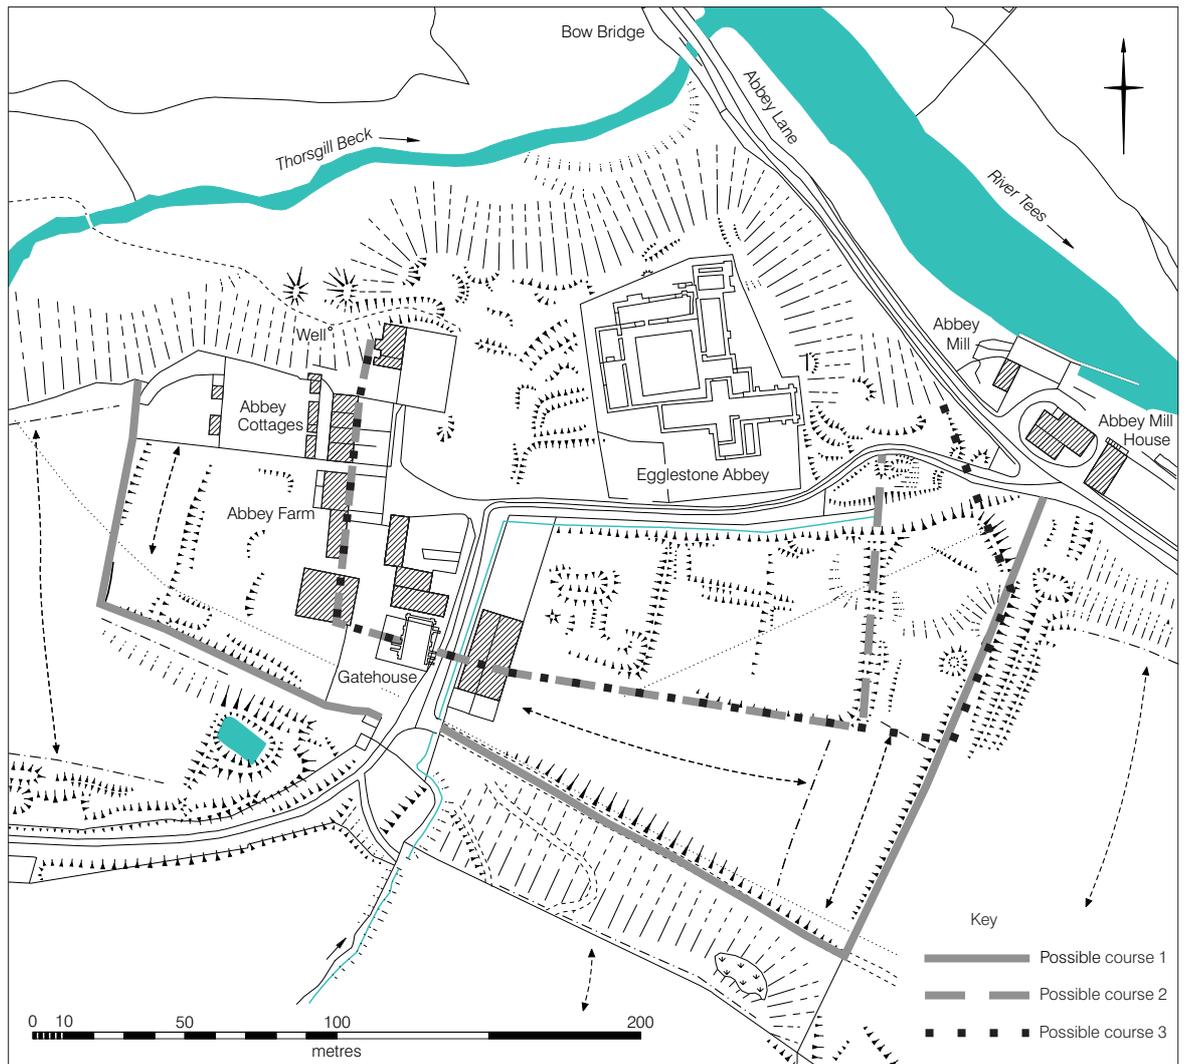
Figure 11. Possible locations for the precinct boundary to the west, south and east of the abbey (plan of gatehouse from Turnbull and Walsh (2000, Fig 1) with field boundaries, buildings etc. based on the OS 1:2500 mapping).

As a result of the survey two other possible locations have appeared, each apparently possessing equal validity and supporting Coppack's assertion that the precinct was small (Coppack 1990, 148). The first option (possible course 2) is for a very small precinct situated entirely on the terrace with the abbey church and claustral range occupying its north-east quadrant. Its boundaries on the south-east and south may have determined the limits in this area of the three enclosures in the field immediately south of the abbey (section 5.2.1 above). If this is correct it might account for at least one of the two banks that survive along part of the east side of the eastern enclosure; the exact course of the southern boundary may have been encroached upon by ridge-and-furrow. On the west the linear arrangement and alignment of the farmhouse and cottages may be a reflection of its former course in this area. The edge of the terrace could have been followed on the north and north-east.

In the second option (possible course 3) the western and much of the southern boundary is the same as in the first option except that this last boundary may have continued eastwards beyond the eastern enclosure. It could have changed direction to head north-north-east just inside the field south-east of Abbey Mill House. In this field it may survive as the stony scarp that defines the western side of a hollow-way near the western field boundary (section 5.3.1). Beyond the end of the hollow-way its former course towards the floodplain and the River Tees may be represented by the bank with the steep front scarp that crosses the north-east corner of the field lying immediately south of the abbey ruins (section 5.2.1 - the possible fourth enclosure). It is unclear if the northern boundary followed the edge of the terrace or the Thorsgill Beck. This slightly larger precinct would have provided the abbey with a more central position within the precinct and, on the east, would have skirted the industrial elements - Abbey Mill and Abbey Quarry (sections 1 and 2 above), which would have lain just outside it.
