# Roughton Gill Mine and Silver Gill Mine, Cumbria

## SURVEY REPORT

Archaeological Investigation report Series AI/8/2001

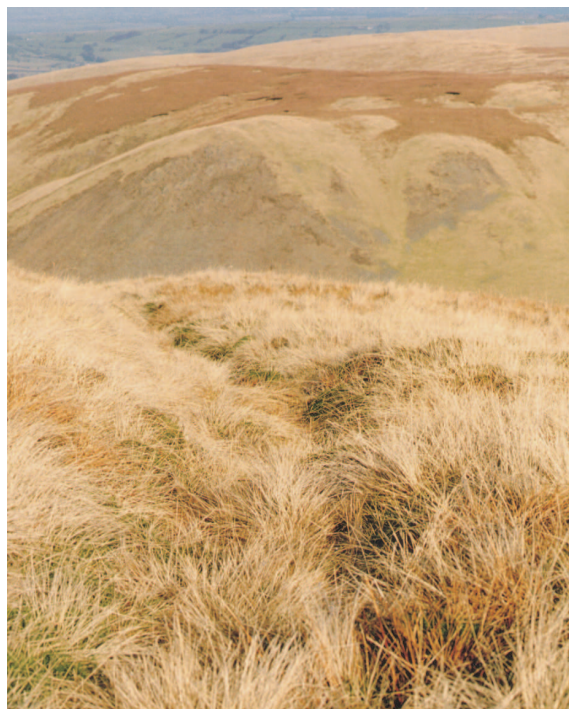
*Figure 6.  
Hush leat HL2 on  
Balliway Rigg  
viewed from the  
south  
(NMR/AA021986)*

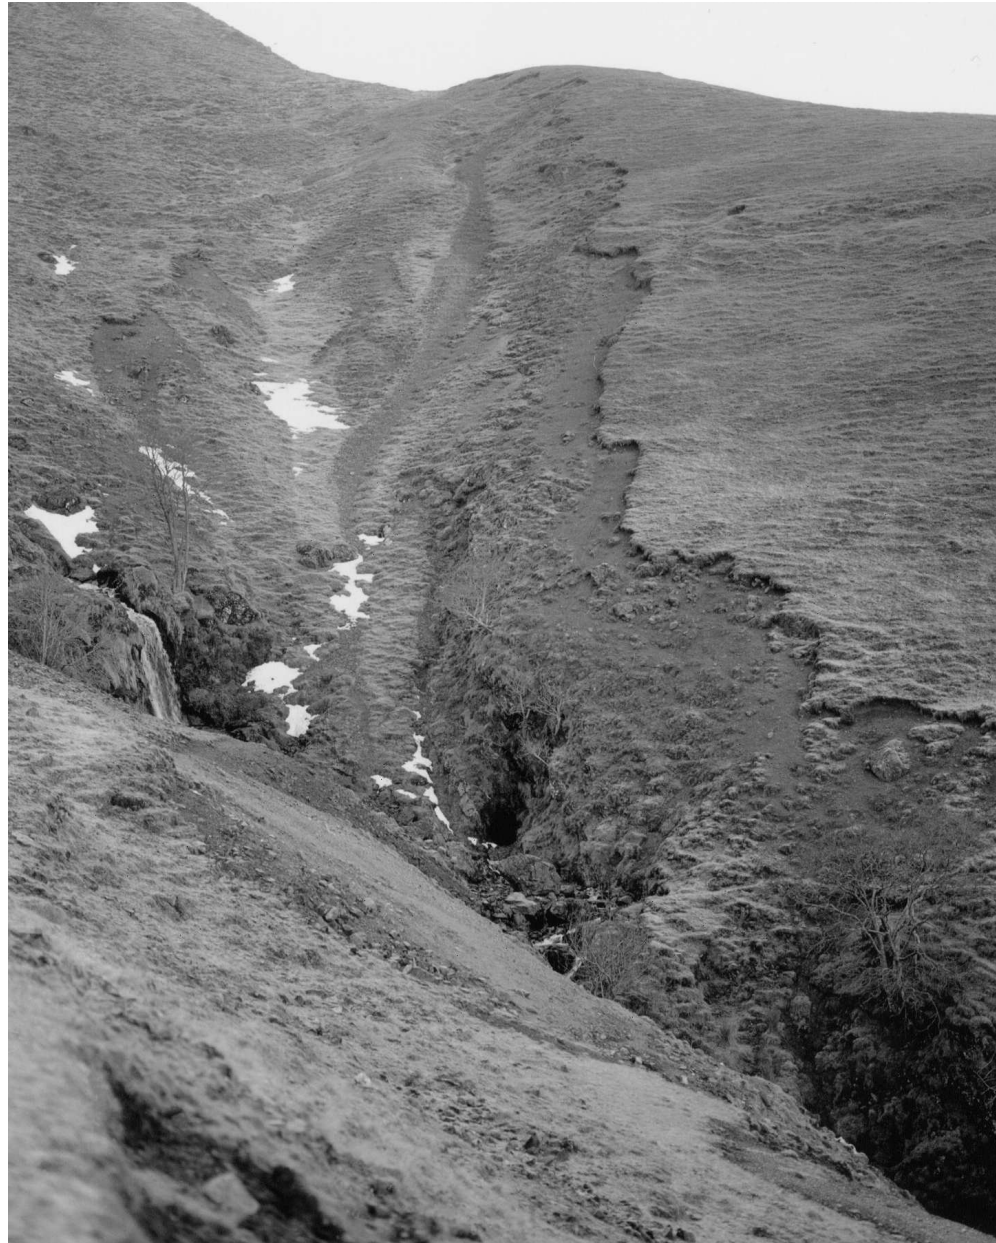
*Figure 8.  
Balliway Rigg  
from the east  
showing Blind  
Wastel and hushes  
H2, H3a and H3b  
(NMR/AA021993)*

below) and is as much as 25m wide (Fig 8). According to the British Geological Survey (1994), this lower part of H2 lies just south of the line of the Silver Gill mineral vein where exposed in the flank of Balliway Rigg by Roughton Gill.

The mine entrance is only slightly above the floor of the gill (*c* 445.7m AOD), cut into a vertical rock-face right on the northern edge of hush H3b where the latter meets the beck (Fig 8). A small stream issues from the mouth, which is currently open, although since the mine is not shown on the OS 25" survey of 1863 (Fig 5), there is the likelihood that it has been periodically blocked in the past. The mine was probably reached along tracks T5 and T6 which connected it respectively to the floor of the Dale Beck valley and to the miners' lodging house AS1 (sections 6.2.3 and 6.2.6 below).

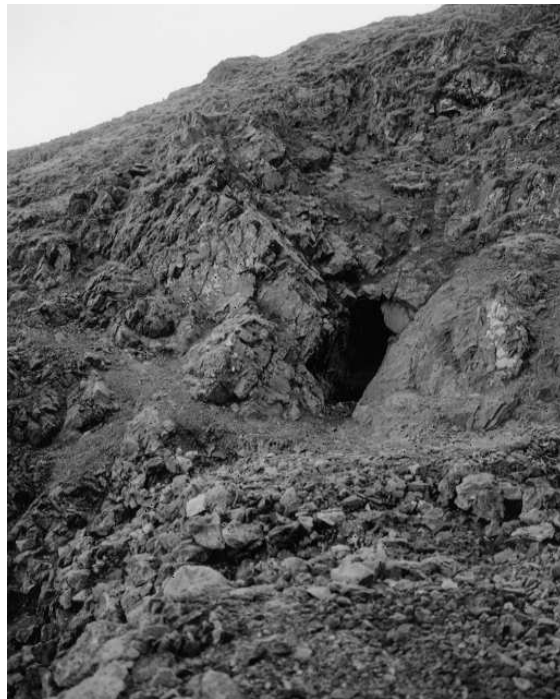
*Figure 9.*  
*Entrance to the*  
*16th-century*  
*Emanuel Adit in*  
*Silver Gill*  
*(NMR/AA021976)*

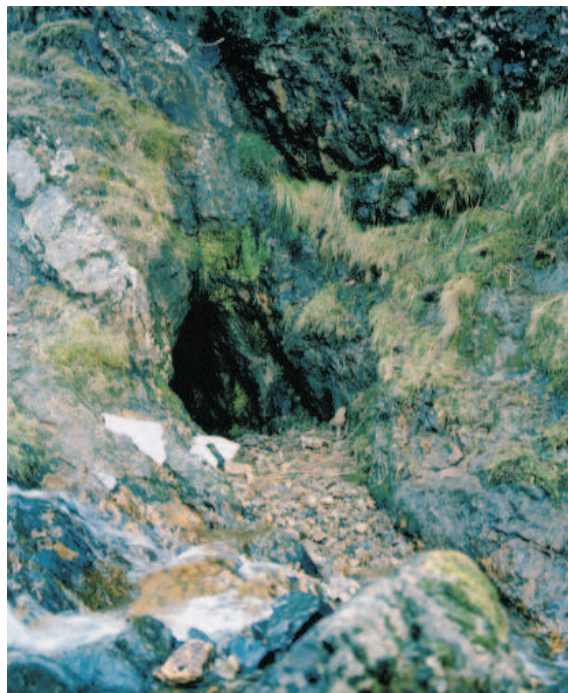
Figure 10.  
Entrance to the  
16th-century Blind  
Wastel in  
Roughton Gill  
(NMR/AA021992)

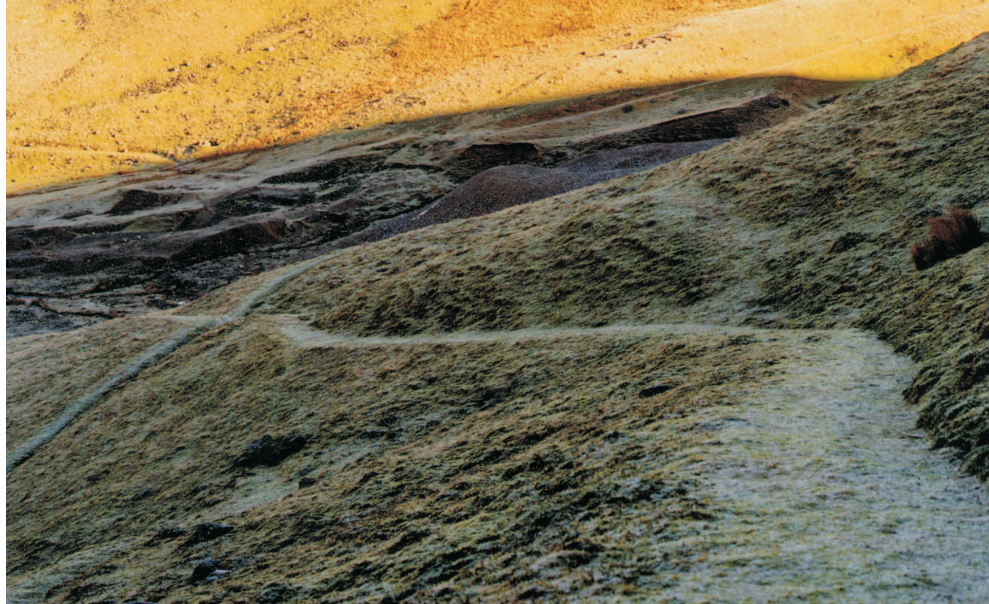
*Figure 11.  
View north-east  
down track T1 on  
Balliway Rigg,  
with leat L8 at left  
of frame  
(NMR/AA021974)*

The primary route to the early mines is T1 (Fig 11), which climbs the spine of Balliway Rigg from the floor of the Dale Beck valley. The initial part of the ascent from the valley floor has been destroyed by later access in phase 5 to the Roughton Gill 60-fathom mine complex along T16, and only survives on the ground south of T16a (Fig 27). A short distance beyond this point, the course of T1 drops down off the watershed onto the western flank of the hill in order to proceed in the general direction of Emanuel Adit. T3 branches off at NY 30066 34308 and heads towards New Adit (Fig 16). Up until this junction, T1 is well-engineered and maintains a fairly constant width (averaging around 2m) and gradient (*c* 1:4 or 25%); after the split, both tracks narrow, but since they also become even steeper it is debatable how much this narrowing reflects their original form, and how much is due to 400 years of soil creep and erosion on the steep, upper slopes of Silver Gill. Neither track now survives much beyond H5, although short lengths re-emerge as narrow, rock-cut,

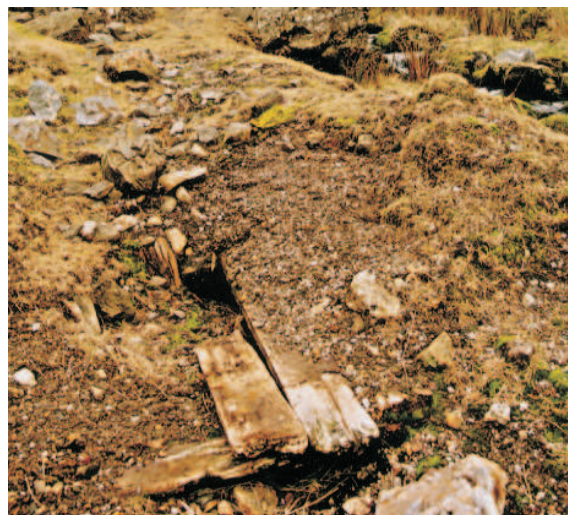
Figure 13. Exposed roof timbers in mine level ML6 in Todd Gill, viewed from the west (NMR/AA021950)

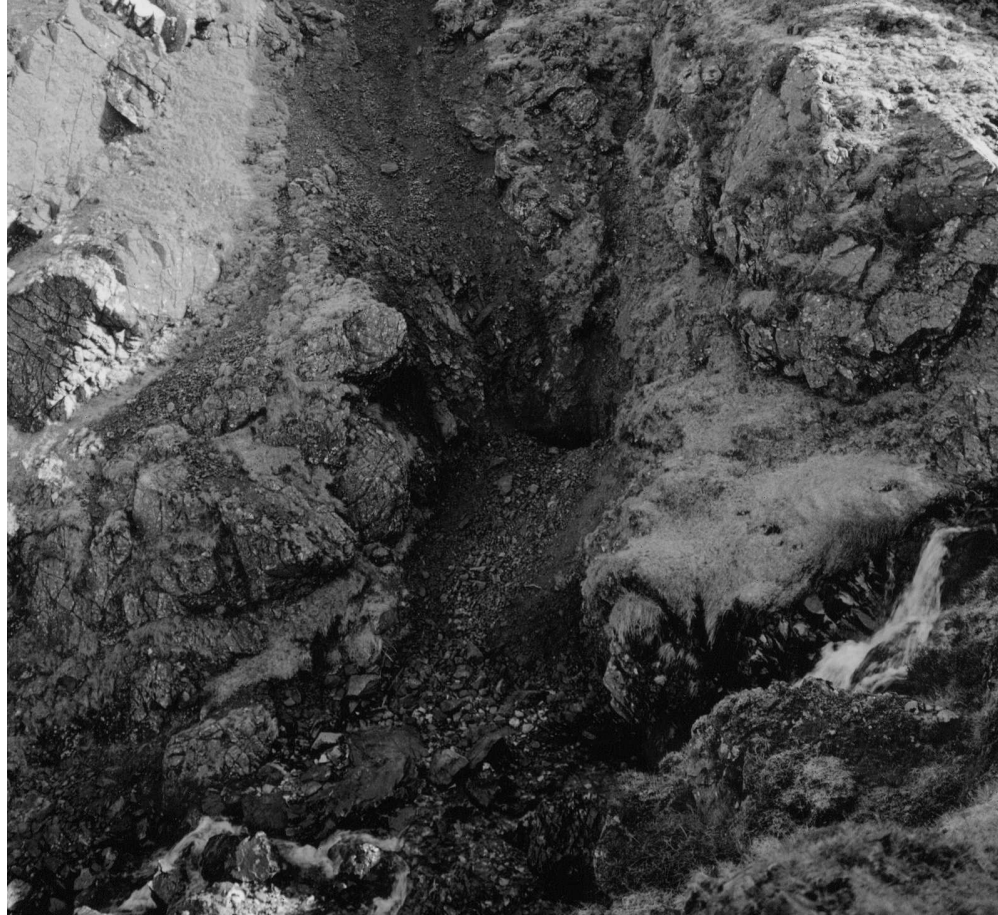
The mine lies at NY 30227 34124 at an altitude of *c* 498.5m AOD. The entrance, which has been cut into a near-vertical face of rock at the foot of the east bank of the gill, is currently blocked (Fig 15), but has been open in the recent past: a photograph taken in 1987 (Cooper and Stanley 1990, 55) shows a short, stone-revetted, passage way leading to the entrance, with part of a wooden tramway sleeper visible in its floor (tramway TR1, section 6.4.2 below). All that is visible now is the very top of the

*Figure 15.  
The blocked  
entrance to the  
Roughton Gill  
30-fathom  
cross-cut  
(NMR/AA021989)*

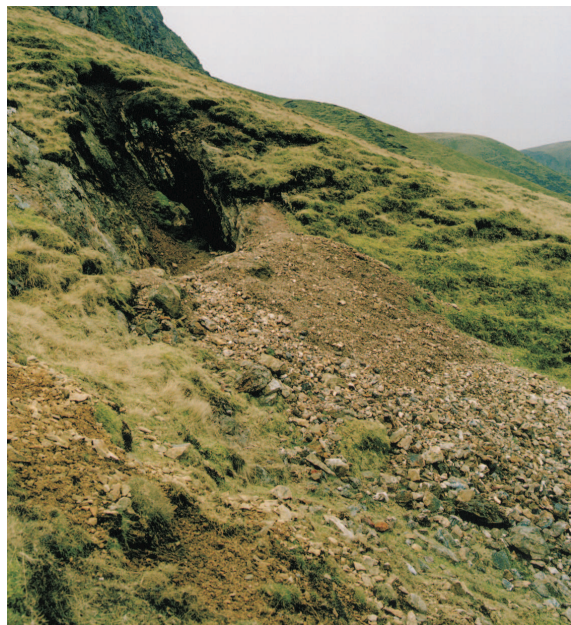
*Figure 17.  
Illicit mineral  
collecting at mine  
level ML12,  
viewed from the  
north-east  
(NMR/AA021962)*

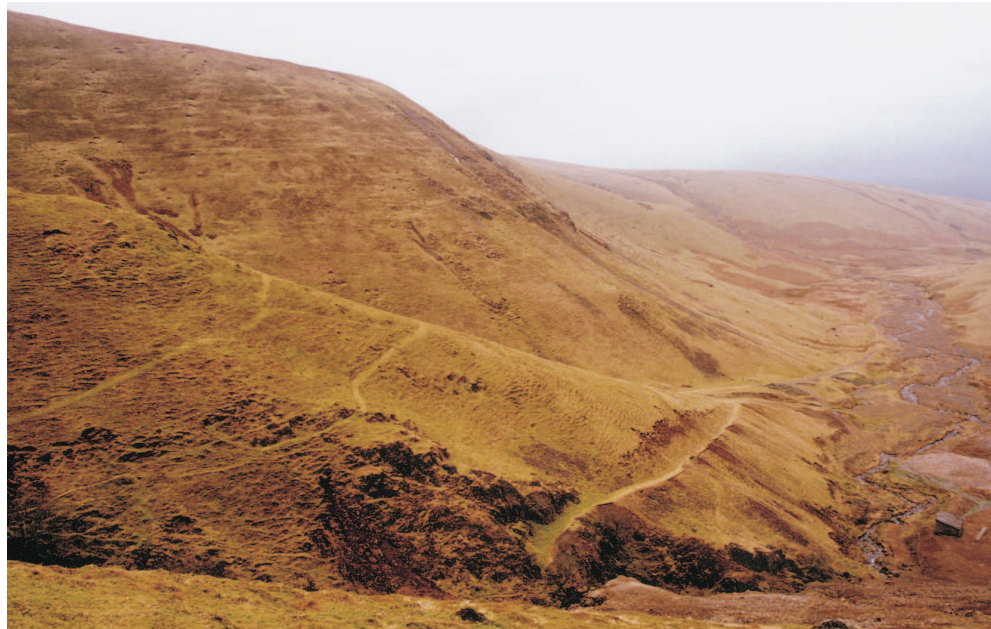
*Figure 20.  
Tracks T5, T17  
and T16 on  
Balliway Rigg  
viewed from  
beneath Iron Crag  
(NMR/AA021963)*

T17 runs across Balliway Rigg upslope of T16a (Fig 20). In width and form, it is identical to the earlier tracks on the hill and does not replicate the scale and degree of engineering apparent in T16/T16a. Its eastern end now dies out at NY 30202 34278 some 60m north of the Roughton Gill 60-fathom level (ML13), but as it is both aligned on, and at virtually the same altitude as, the mine entrance, it must have originally led to it. The reason for the missing section is very obvious on the ground: it has been carried away by an active area of sheet erosion which is slowly but progressively expanding from the northern edge of hush H3b along the foot of the gill (Fig 8). T17 leads away north and west around the contour of Balliway Rigg, and connects with T1 and T3 on the west side of the hill just above the Silver Gill 50-fathom cross-cut (Fig 16). This course suggests it was constructed specifically to connect the Roughton Gill 60-fathom level with mines in Silver Gill, particularly the 50-fathom (ML10), rather than simply provide an alternative to T16 down to the floor of the Dale Beck valley. No documentary references have been found to suggest that the Silver Gill mines were being worked in phase 5 when the 60-fathom level was first operational, whereas there are references to these mines being cleared out and re-opened at the start of phase 6. T17 should, therefore, date to phase 6, not phase 5.

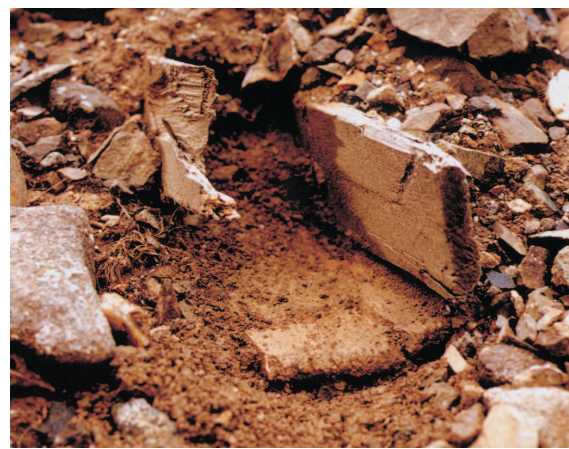
Figure 24.  
Detail of wooden  
launder-box  
buried in scree at  
mill complex MC4  
(NMR/AA021966)

Further timber structures are also visible below T16 where it doubles back to the west across Roughton Gill. These are mostly only the tops of posts and edges of planks, sometimes seemingly *in situ*, often eroded out and lying loose on the surface; but occasionally more striking remains can be discerned such as at NY 30255 34321 where the end of an *in situ* launder box of 0.13m internal cross-section is currently exposed (Fig 24). MC4 would have received its water from reservoir R2 (section 6.5.3

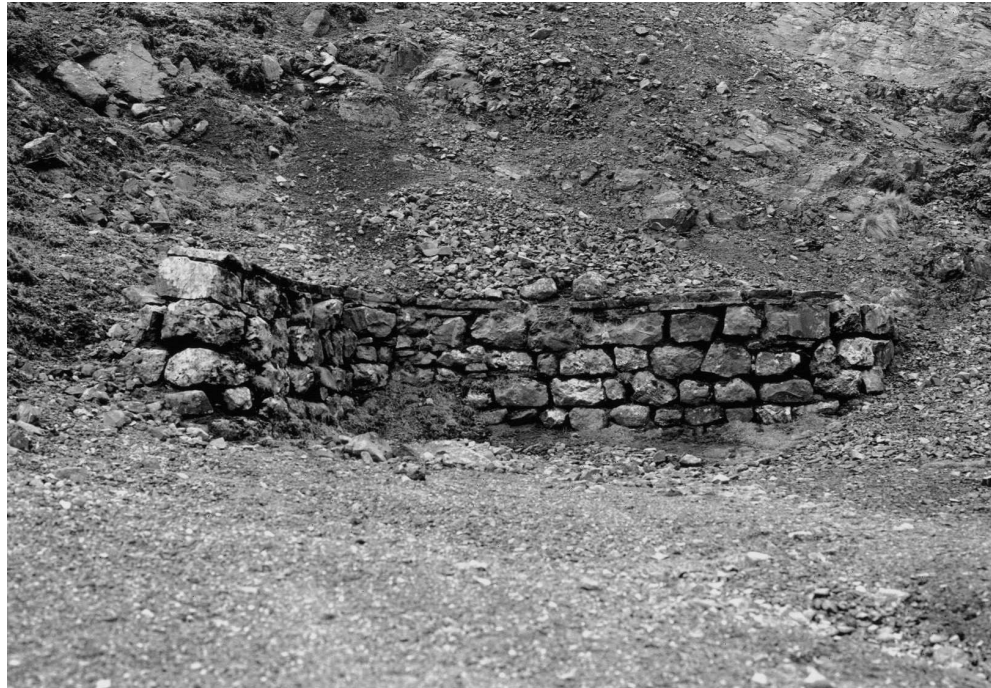
The mine entrance lies at NY 30247 34392 on the east side, and at the mouth, of Roughton Gill, just above the floor of the Dale Beck valley at an altitude of *c* 397m AOD. It is now blocked by a stone wall (Fig 25), built when the mine was purchased

*Figure 25.  
The blocked  
entrance to the  
Roughton Gill  
90-fathom  
cross-cut  
(NMR/AA021967)*

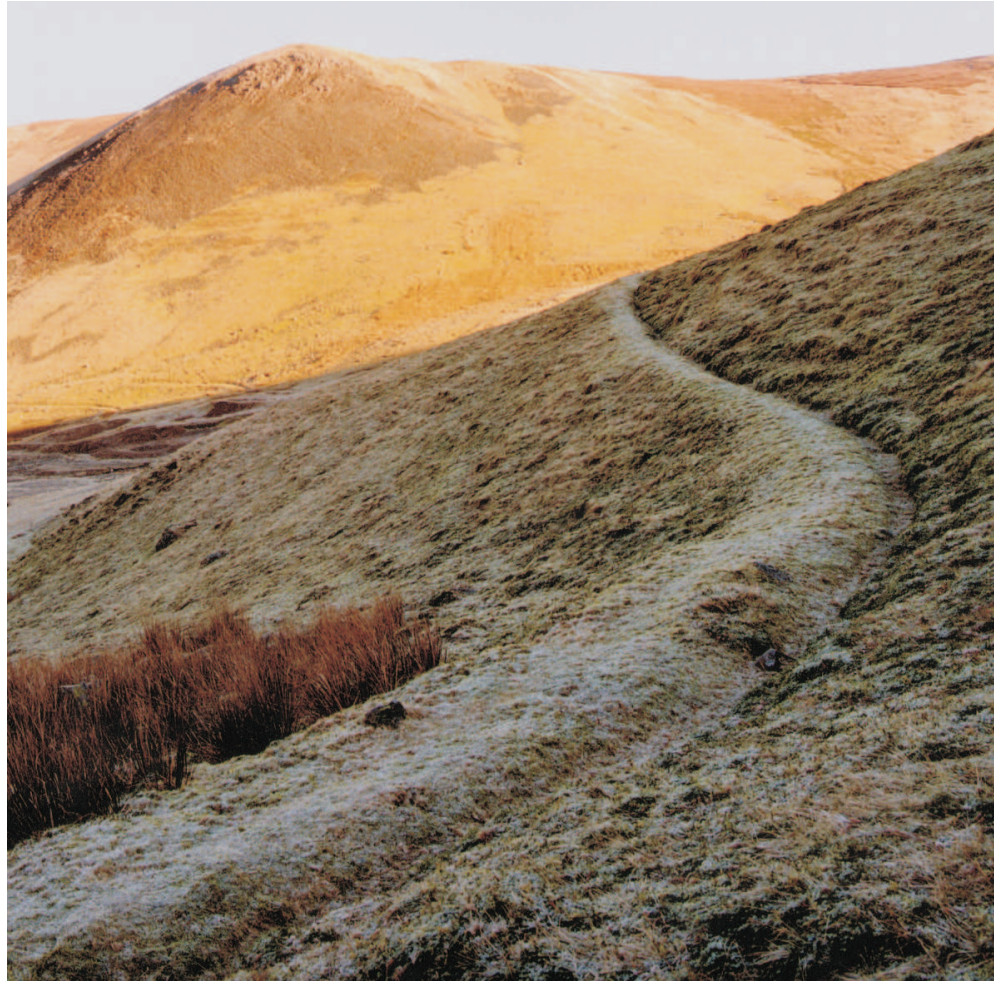
*Figure 29.  
Leat L8 on  
Balliway Rigg,  
viewed from  
the west  
(NMR/AA021973)*

L8 brought water to R3 from the beck in Silver Gill. Unlike L7, it largely followed the contours, and is consequently far better preserved. Water was presumably diverted into it via a weir in the beck somewhere below the waste dump associated with mine level ML10, but this need not have been a major construction: in any case it no longer survives. L8 now starts as an earthwork at NY 30085 34376, and can be followed across Balliway Rigg as an embanked earthen channel up to 0.4m wide and 0.1m deep falling at a very slight but steady gradient of *c* 1:60 or 1.67% (Fig 29) as far as track T16 to the east. It cuts both T1 and L2 *en route*, although the former may well have been bridged across it. It would also have had to have been carried across T16 on a wooden launder, although interestingly on the 1863 OS map (Fig 5) this is not shown, as if the leat was then (temporarily or permanently) disused. The leat resumes on the far side of T16 as a shallow earth-cut channel, but soon turns sharply east and drops straight down the contours for a short distance at a gradient close to 1:3. The map shows that it continued across Roughton Gill and passed behind the entrance to the 90-fathom level (ML14), but again this section would have had to be in a wooden launder – certainly across the gill, and in all probability across the steep scree slope above the mine as well since no earthwork channel would survive here for long in such an unstable environment. In the field, earth-cut channel now resumes at NY 30278 34418, and broadly follows the contour around to the far end of R3, although the final 75m falls at a steeper gradient close to 1:15 (7%). This final section, however, has now largely disappeared on the ground, infilled by alluvial deposits brought down by the active erosion torrent east of Iron Crag (Fig 26).

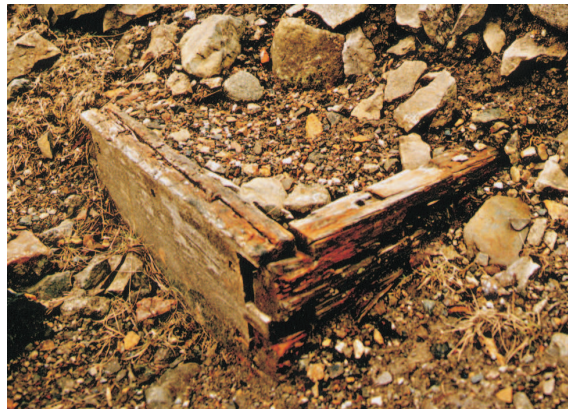
Figure 30.  
Wooden  
mortice-and-tenon  
frame exposed by  
erosion at mill  
complex MC5  
(NMR/AA021946)

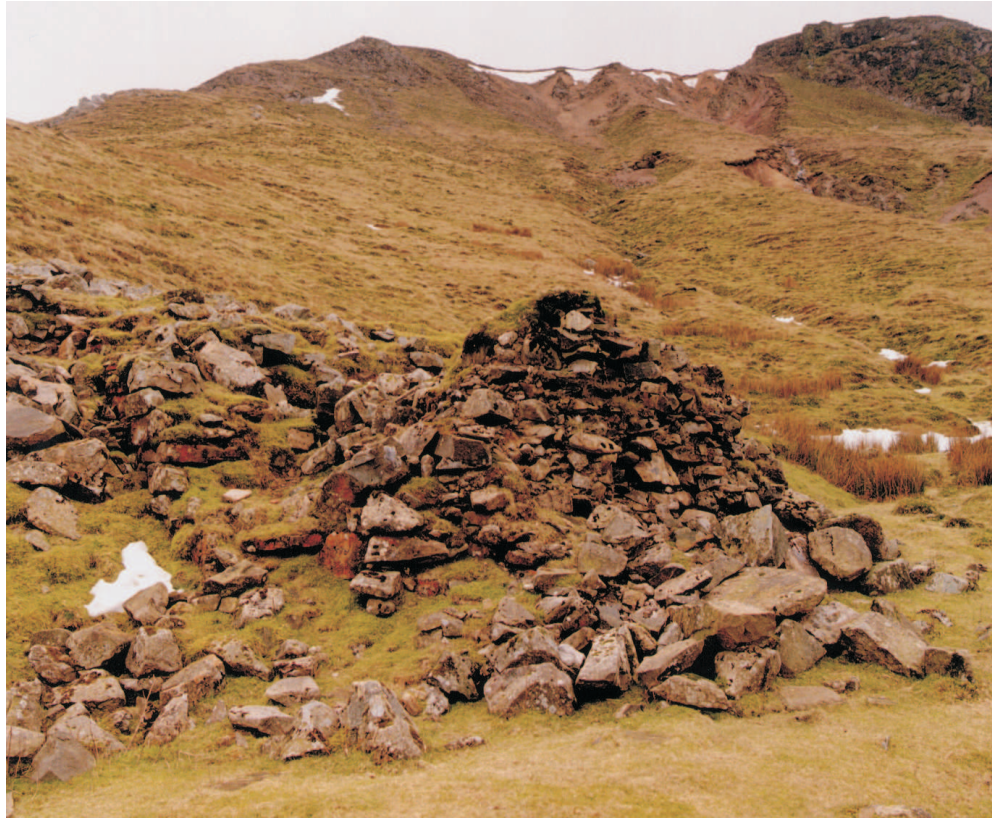
*Figure 33.  
Ruins of the  
Cornish engine  
house at Lainton's  
Shaft, viewed from  
the north  
(NMR/AA021957)*

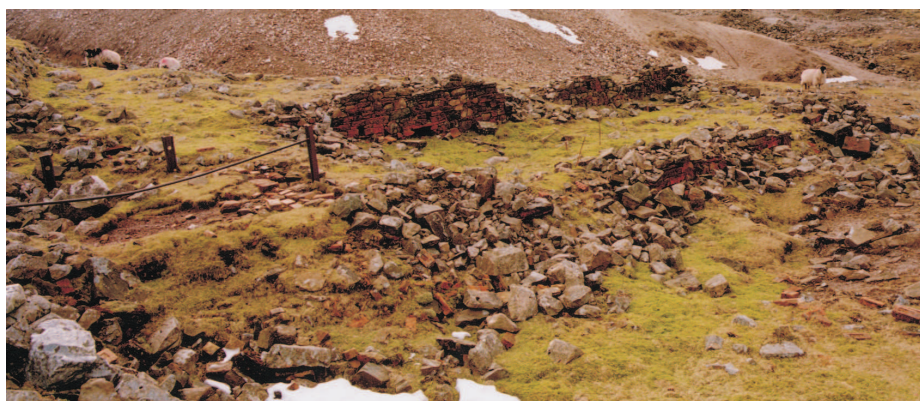
*Figure 37.  
The drying shed at  
the umber mill  
(MC6), viewed  
from the north  
(NMR/AA021952)*

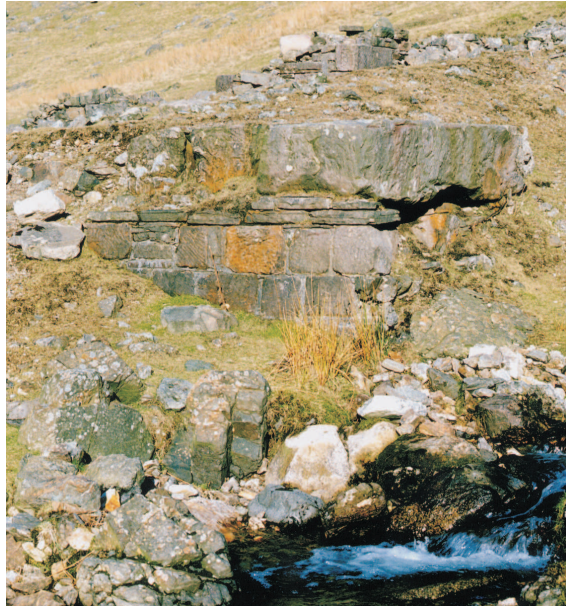
*Figure 39.  
Umber mill  
grindstone  
relocated to  
Caldbeck  
churchyard  
(NMR/AA022006)*

Until recently a broken grindstone stood close to the mill (Cooper and Stanley 1990, Fig 39), but has now been removed from site and erected in Caldbeck churchyard as a memorial to the long association between the Caldbeck area and lead mining. The identification of these ruins as those of the umber mill, however, means that the grindstone is likely to be a remnant of the umber trade, and probably has no direct connection with the lead industry.

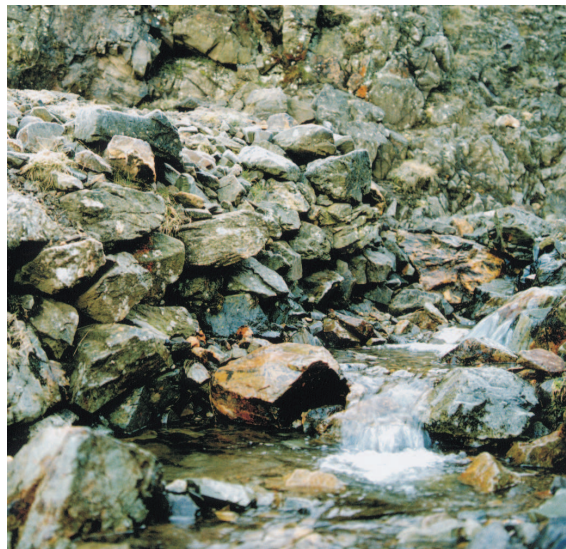
*Figure 40.  
Wall M1 in Silver  
Gill, viewed from  
the north-east  
(NMR/AA021975)*

M1 is a short length of drystone wall visible on the east side of Silver Gill at NY 29978 34213 (Fig 40). It revets a narrow terrace immediately above the beck, at an altitude of *c* 471m AOD. Its purpose and date are unknown, but it should indicate the presence nearby of a mining-related feature – perhaps a hand-dressing floor, or even a buried mine level. The possibility of the latter is discussed further in section 7.
