**THE WESTERN HEIGHTS,  
DOVER, KENT**

**THE DROP REDOUBT**

A 19TH-CENTURY ARTILLERY FORTIFICATION

ARCHAEOLOGICAL INVESTIGATION REPORT SERIES 24/2001

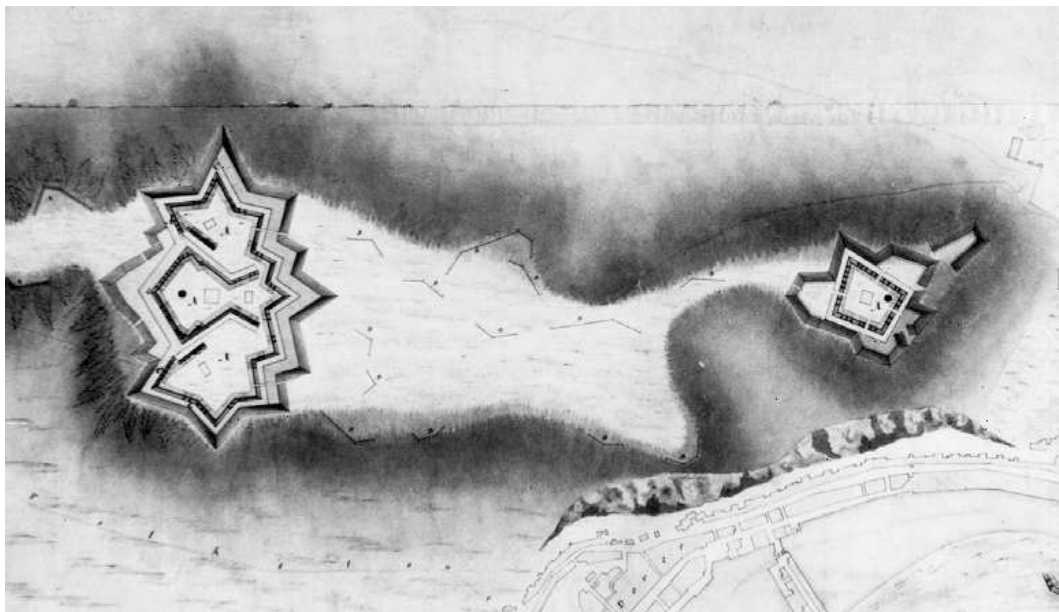
**Figure 2**  
*Extract from a plan of the 1780s, showing the fortifications planned by Page on the Western Heights. The fort on the right is on the site of the Drop Redoubt (PRO: MR/1/1345)*

It is of some importance to compare the older works shown on both plans of the 1780s with those of the new redoubt, first recorded on the plan of 1810 (Figs 2-4). The proportions and alignment of the north-west, south-west and south-east faces are identical on both plans, the only change being to the north-east, where two faces replace one, the new work being pentagonal. On this evidence it seems likely that between 1787 and 1804 some work had taken place to construct the eastern redoubt - even if it remained unfinished - and where practical the line of the old earthworks were reused in the new Drop Redoubt. Additionally,

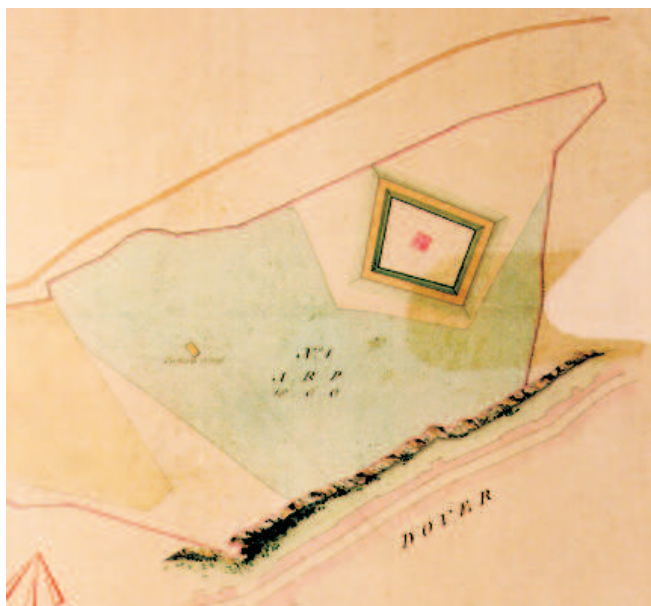
**Figure 3**  
*Lt Lewis Hay's plan of 1787, showing the 'Eastern Redoubt'* (extract from PRO: MPH/1/248/6)

*survey'*. This survey plan shows the four-sided eastern redoubt with a central guardhouse and notes that the ground had been broken; probably meaning that the outline of the redoubt had been roughly established (Fig 3). That the guardhouse was built is confirmed by its appearance on a land procurement plan of June 1804 (PRO: MFQ/1354/3B) and on plans of 1810 and 1811 (Figs 4 and 5). Its construction probably occurred after the resumption of

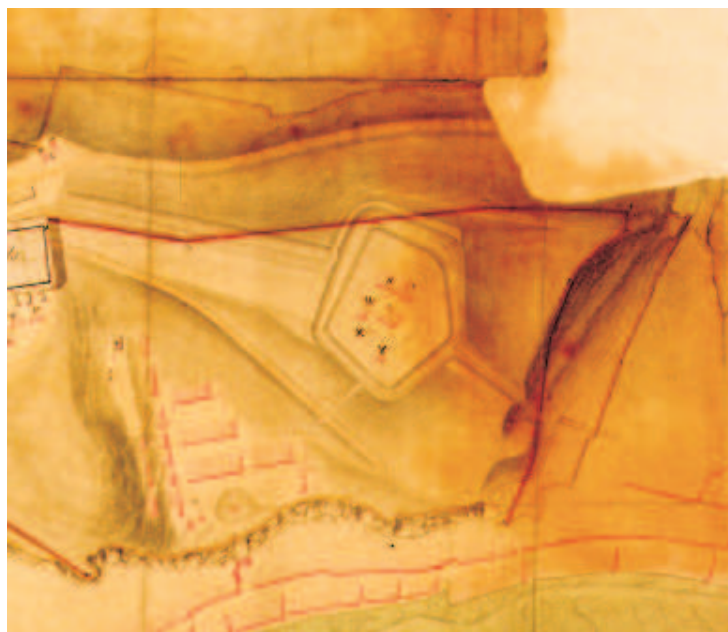
**Figure 4**  
*The Drop Redoubt in 1810* (extract from PRO: MR 1/1349)

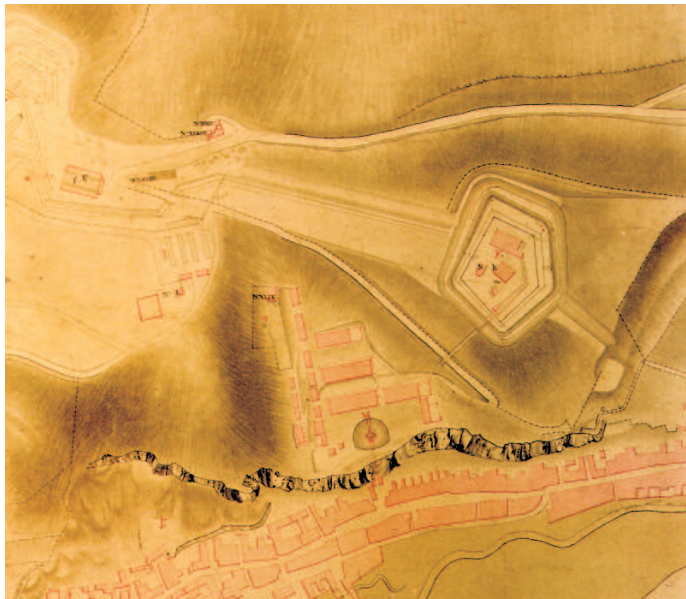
**Figure 5**  
*The Drop*  
*Redoubt in 1811*  
(extract from  
PRO: MPH/1/506)

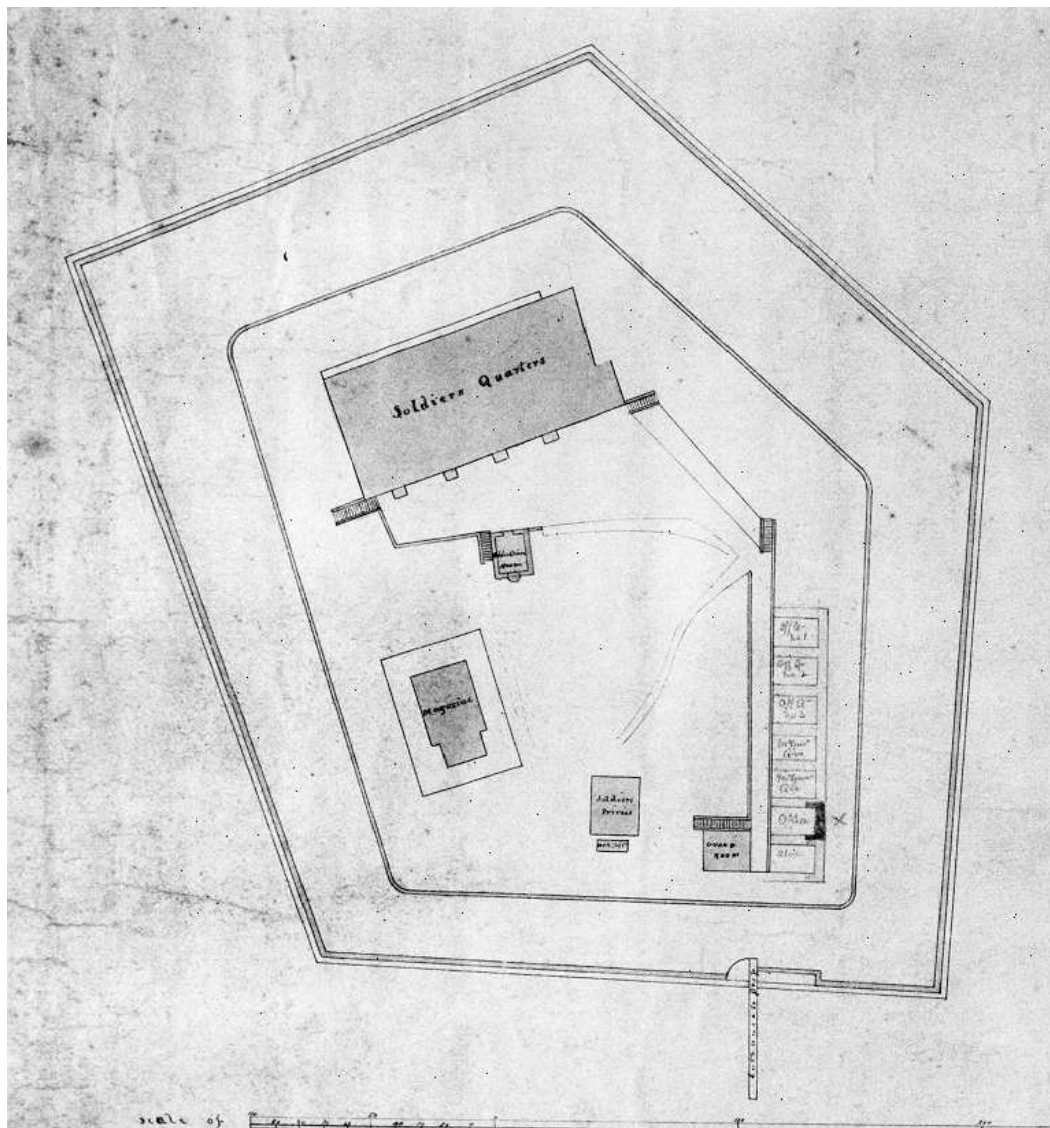
**Figure 6**  
*The Drop Redoubt in 1860, at the beginning of the remodelling and reflecting the work as left in 1815. Note the proposed new Officers' Quarters sketched onto the plan at right. The otherwise small number of internal buildings is apparent. Compare with Figure 7 (NMR: WD/2509)*

In 1860, alterations were proposed to a small Ablution Room, opposite the Soldiers' Quarters, which had been erected between 1844 and 1851 as a replacement for the wash house behind casemate 5 of the Soldiers' Quarters (Fig 6; PRO: WO/55/2751 plan 2; WO/55/2931 plan 2). The proposal was aborted in favour of a new range of three buildings, parallel to and facing the Soldiers' Quarters across the Parade Ground, for which proposal drawings were approved in 1861 (Figs 41 & 42). These comprised, in the centre, a single building in which were combined Ablutions, Latrines, Bath Room and Cook House and, on each side, Staff Sergeants' Quarters. The latter had been converted to Married Soldiers' Quarters by 1881 and remained in 1897, comprising two buildings of two identical units, in common with some of the Officers' Quarters (Fig 7; PRO: WO/78/2426/10; see above).

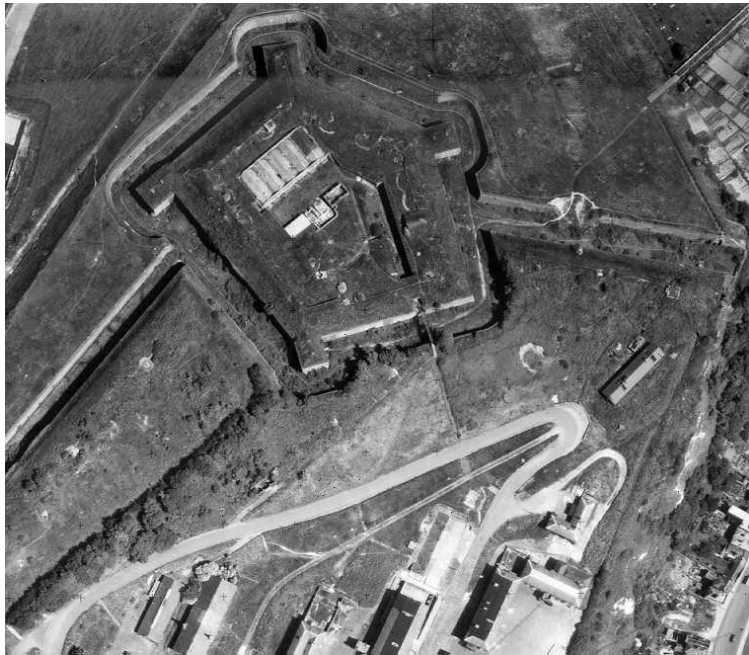
**Figure 8**  
An aerial photograph dated 1953 showing Drop Redoubt and part of Grand Shaft Barracks to the south (NMR: 3T79/613/F12/3325/119)

commando unit was based here. Several slit trenches and weapons pits cut into the rampart are of First or Second World War date. The North-East Line nearby was hit by a bomb (PRO: WO/192/45; NMR: HLA/373/982-3; Fig 8).

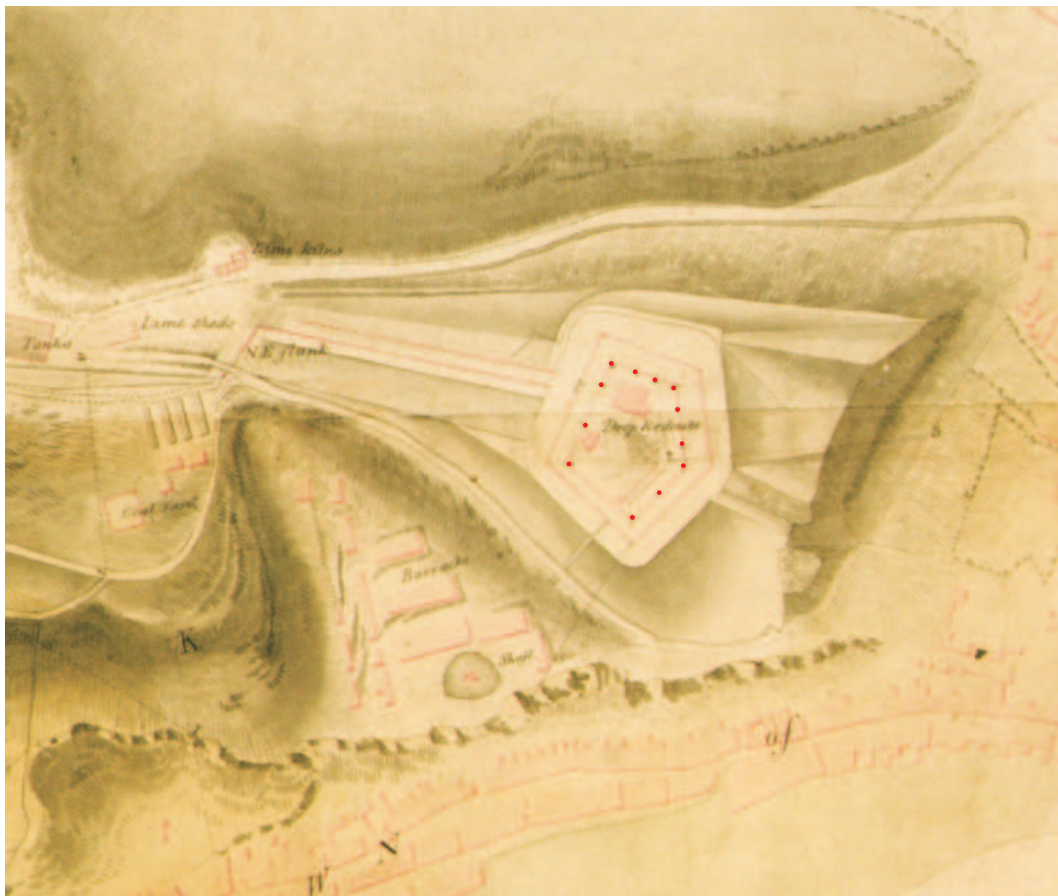
**Figure 11**  
*The Drop Redoubt in 1813, towards the end of the Napoleonic Wars. Note the gun positions, highlighted in red by the authors (extract from PRO: MR/1/1346)*

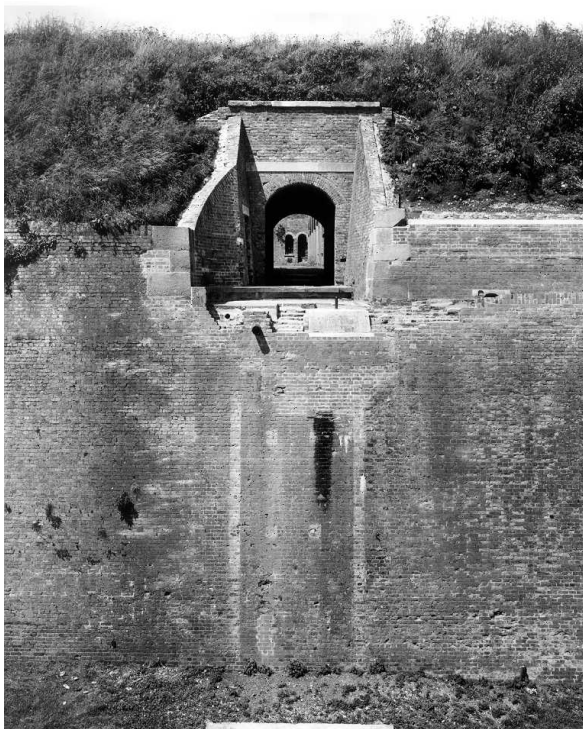
**Figure 12**  
*The main entrance:  
view across the  
ditch from the  
counterscarp. The  
recess for the swing  
bridge is visible on  
the right of the  
photograph at the  
top of the scarp  
revetment (NMR:  
BB99/15909)*

The redoubt was approached along a steep path from Drop Redoubt Road and the Grand Shaft Barracks. As completed in 1815, a wooden bridge of unknown form crossed the south ditch to an entrance passing through the rampart via a passage or tunnel. Although this bridge has not survived, the brick entrance and passage are relatively unaltered. Their fabric is characterised by the use of Portland stone for lintels and other details, and is distinguished from the 1860s work of the Officers' Quarters and Guard Room by structural breaks at the north end of the tunnel. In 1823, it was proposed to replace the wooden bridge with a new one and it may be that the surviving details are of that vintage (PRO: WO/55/780).

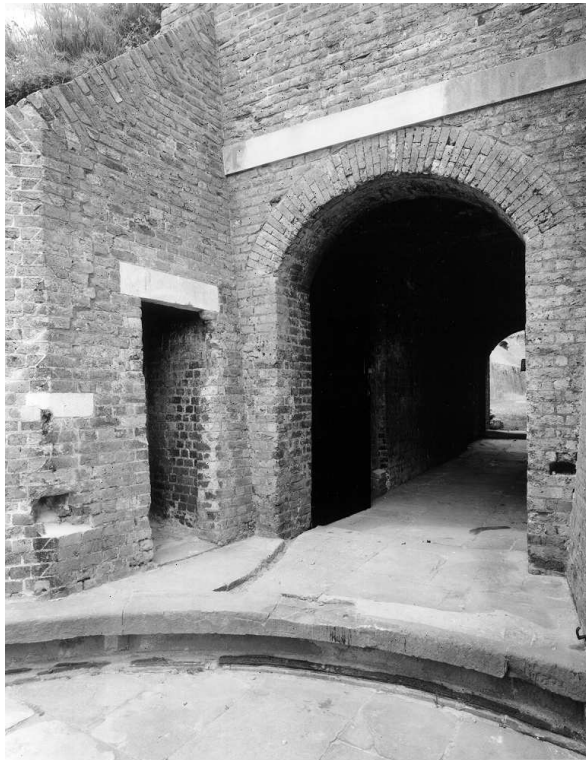
**Figure 13**  
*The main entrance, showing the sentry box, anchor block in the wall next to it and part of the curved runner for the swing bridge (NMR: BB99/15910)*

which may also have been counter-weighted at this end. The sandstone paving north of the racer stands above the level of the passage and may have been reset when the 1823 proposal was effected.

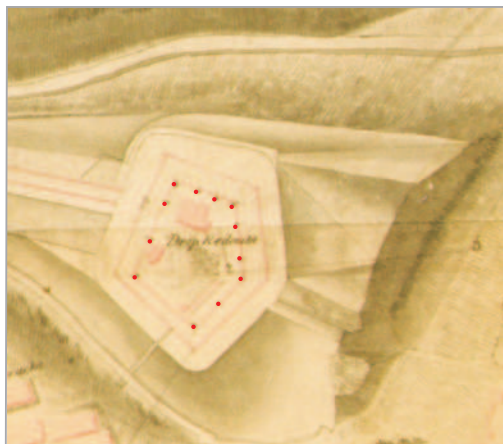
**Figure 14a**  
The Drop Redoubt  
in 1813, showing  
the terreplein gun  
positions, added in  
red by the authors  
(extract from PRO:  
MR/1/1346)

- **1804 - c1858.** In 1804 it was intended to provide twelve 24-pounder SB cannon on the *terreplein* and two carronades for the planned counterscarp gallery, and this is consistent with a later source which lists fourteen heavy guns, plus nine mortars in the redoubt in 1815 (Akers 1887, 62). The positions of the twelve *terreplein* guns are shown on the 1813 plan, arranged around the redoubt with a weighting towards the north (Fig 14a). The red

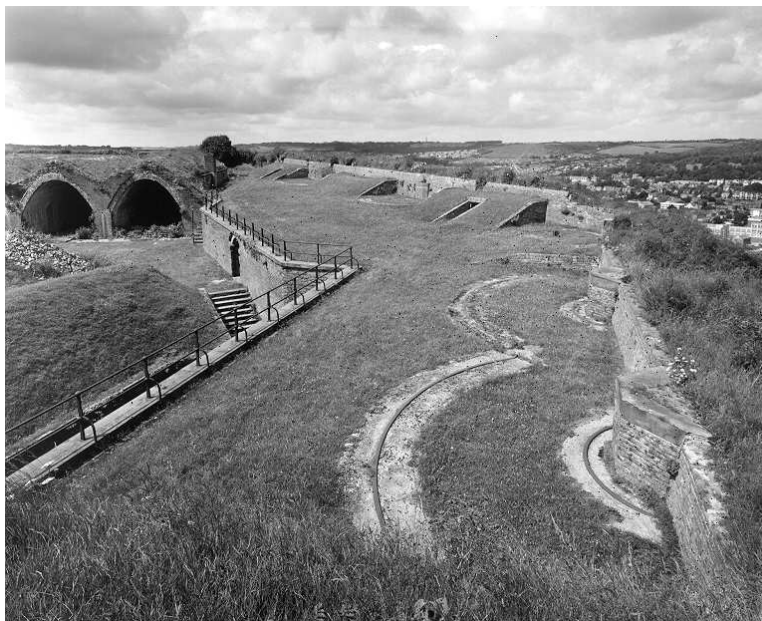
**Figure 15**  
*The terreplein along the eastern and north-eastern faces, showing the parapet, the gun emplacements and the racers for the traversing platforms (NMR: BB99/15925)*

The *terreplein* contains the remains of all eleven emplacements for guns on traversing platforms, positioned at intervals around the northern half of the redoubt (Fig 15).

The red brick early parapet survives to a height of 0.92m. It is capped by yellow stocks of the 1860s phase to a height of 1.85m and was broken at that time for the insertion of a brick pier at the centre of each emplacement. A pier is typically 1.25m high and capped by a block of millstone grit, 0.3m thick, to form the base of an embrasure. Each embrasure, let into the parapet to a width of 1.44m and height of 0.7m, is also strengthened by millstone grit quoins. The embrasures are cut through the earthwork of the rampart with outward splays enabling an arc of fire from each gun of around 70°, and angled downwards so that the guns could be depressed to rake the ground just outside the fort. The angles of fire were also arranged so that each gun could cross fire with its neighbour on the lip of the counterscarp.

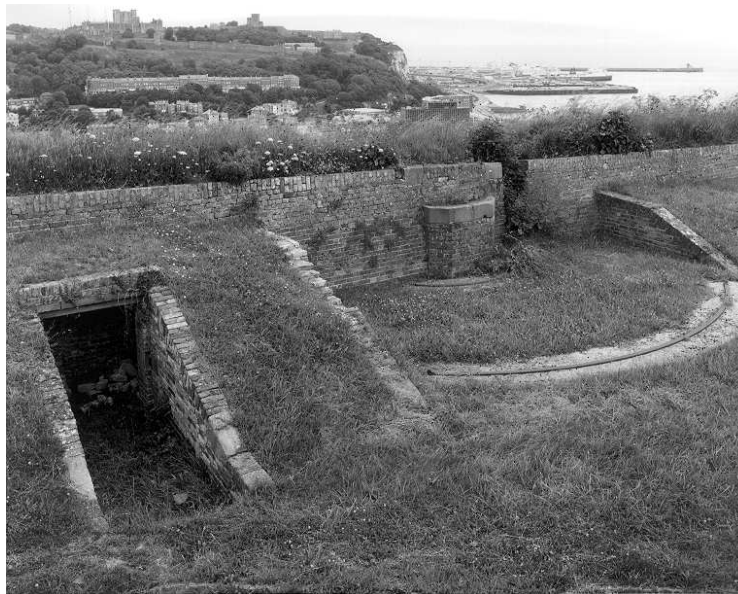
**Figure 16**  
*Emplacement no 5,*  
*on the north-east*  
*face of the*  
*terreplein, with its*  
*ready-use*  
*ammunition locker*  
(NMR:  
BB99/15927)

Between emplacements 3-11 are six ready use ammunition lockers; on the 1881 plan, they were annotated for shell storage (Figs 7 and 16). All are in yellow stock brick laid to English

bond with sandstone ceilings and floors; their condition varies, the best example being at **c**, between emplacements 5 and 6. Each locker, sunk 0.6m below the gun floor and covered by an earth bank, is approached along a short revetted passage, 3.0-3.4m long, with a drain along one side. There was a single outward-opening door, 1.1m wide by 1.6m high, with millstone grit lintels and sills. There are iron door hinges set into stone pads, and iron pins for locks on the opposite sides. Internally, each locker is roughly 1.8m wide, 1.2m deep and 1.6m high, though the depth varies according to the batter of the parapet against which they are built. The internal walls are whitewashed but there are no indications of shelves.

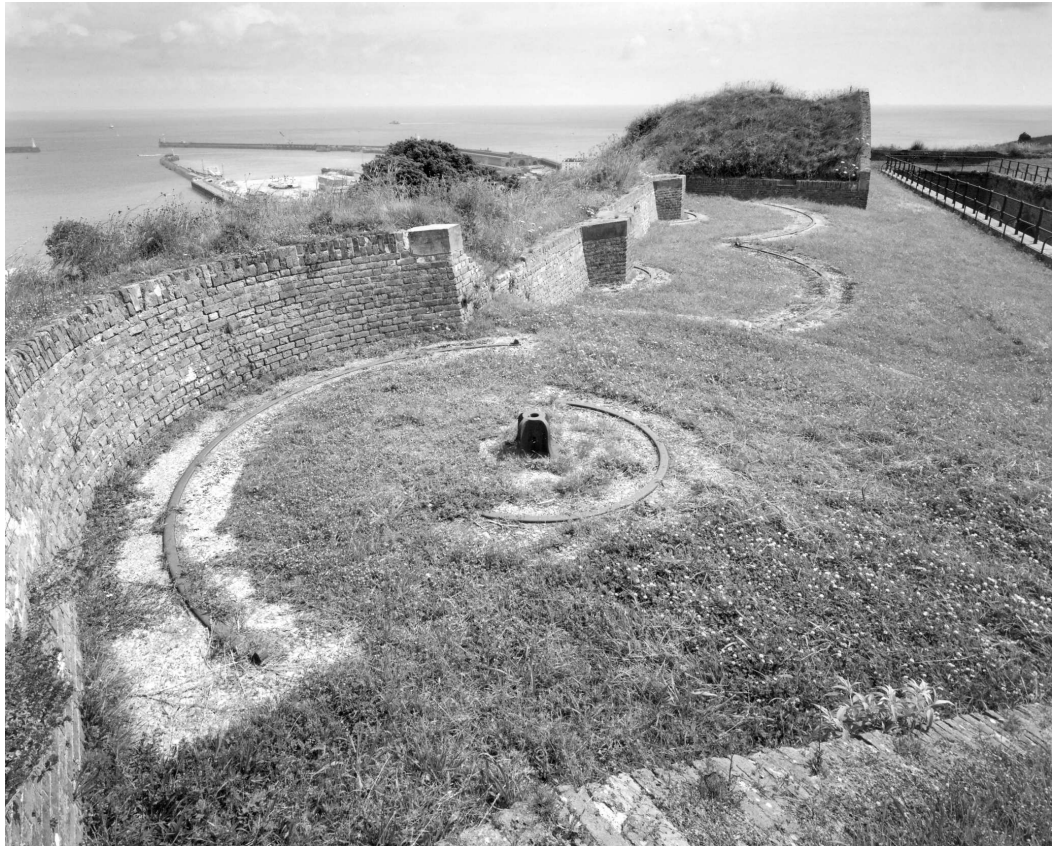
**Figure 17**  
*The east face of the terreplein, showing emplacement 3 with its 'C' pivot; emplacements 10 and 11 lie beyond (NMR: BB99/15924)*

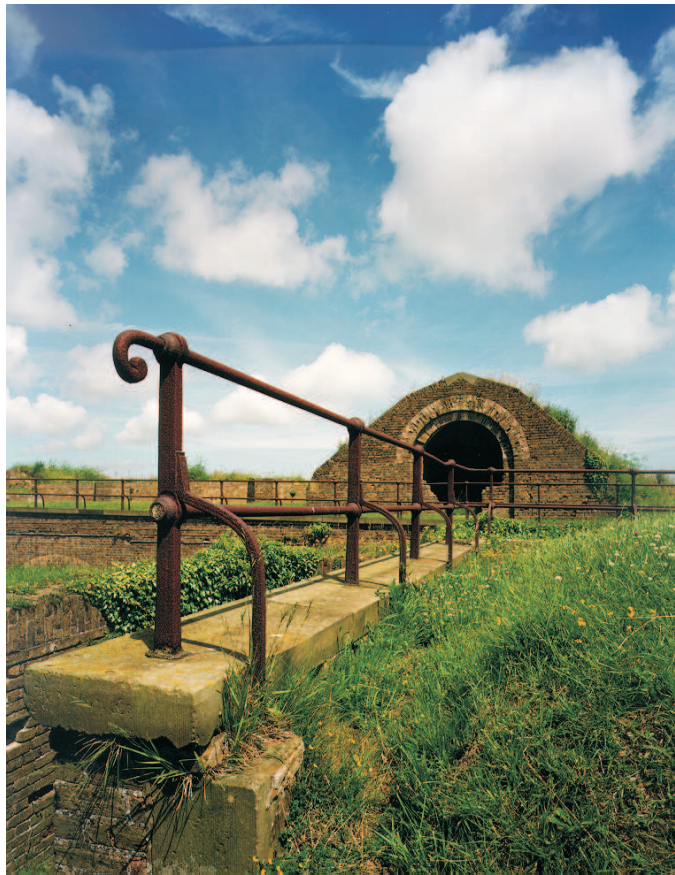
**Figure 18**  
*The side arms store,*  
*western elevation*  
(NMR:  
BB99/15922)

Midway along the eastern face, set in a traverse at a right angle to the *terreplein*, is a **side arms store**. It comprises a single vaulted room protected by an earthen mound which projects above the top of the rampart (Fig 18). The western elevation is formed into a canted gable of yellow stock brick, laid to English bond, containing the entrance which is finished in a round arch of buff brick. This brickwork detail, together with its position, built over the rampart, demonstrates that it dates to the 1858-67 phase (see similar detail on the Guard House, below). The entrance is slightly recessed, the doorway itself 1.2m wide but damaged so that no evidence of its height and frame details survive. Inside, there is a level flagstone floor and whitewashed walls rising to a brick barrel vault with a circular vent at the north

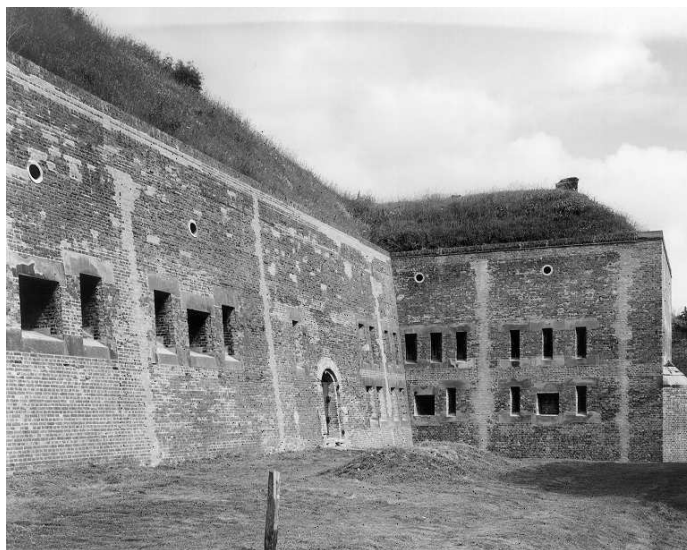
**Figure 20**  
*No 4 caponier with adjacent Sally Port and embrasures of gun rooms and musketry gallery (NMR: BB99/15890)*

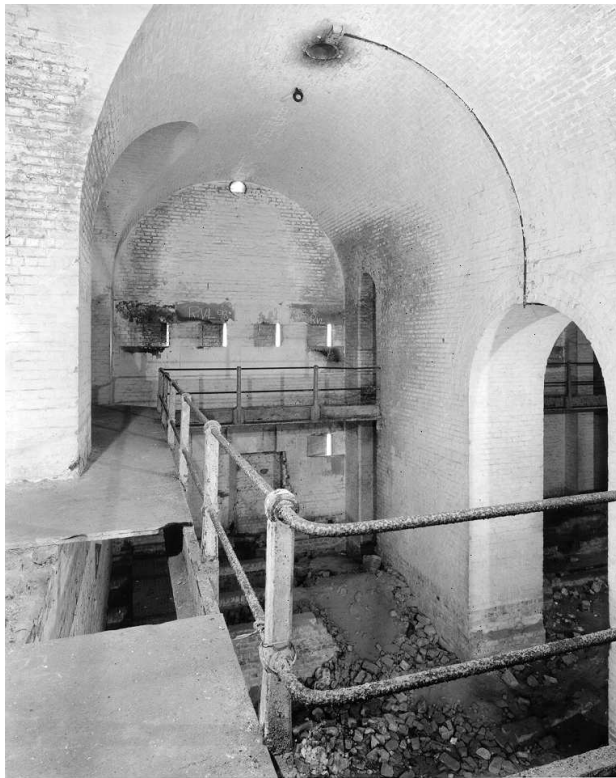
**Figure 22**  
*The interior of no 3 caponier, showing vaulting and first floor walkway (NMR: BB99/15904)*

The ground floors had suspended timber floors resting on dwarf-walls, though behind the carronade embrasures these gave way to solid brick or stone rectangular platforms to take the wear and tear caused by the recoil of these heavy weapons. The first floor comprises galleried walkways of slate slabs running parallel to the flank walls and set into the sides of the arches. The walkways are carried on wrought-iron 'I' section beams

and have cast handrail stanchions (Fig 22). The murder holes are accessible by slots in the slate floor, although as these have been sealed their exact form is not apparent.

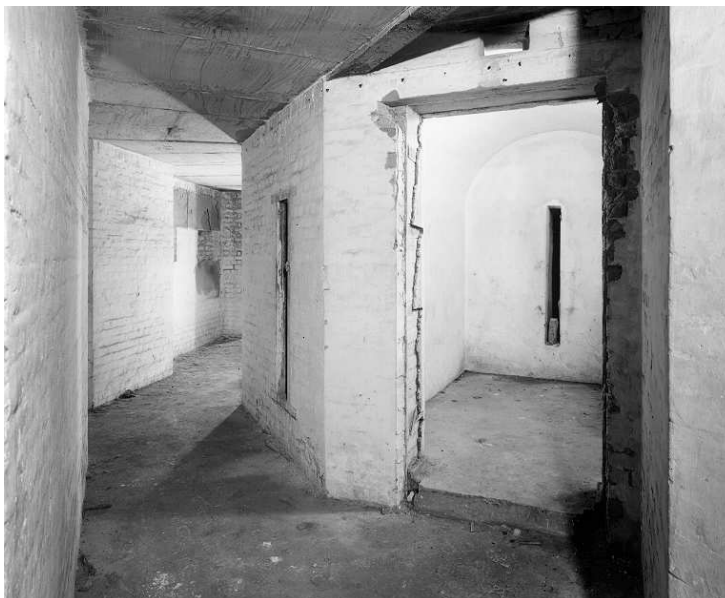
**Figure 23**  
*The western expense magazine (door to right) in no 3 caponier (NMR: BB99/15905)*

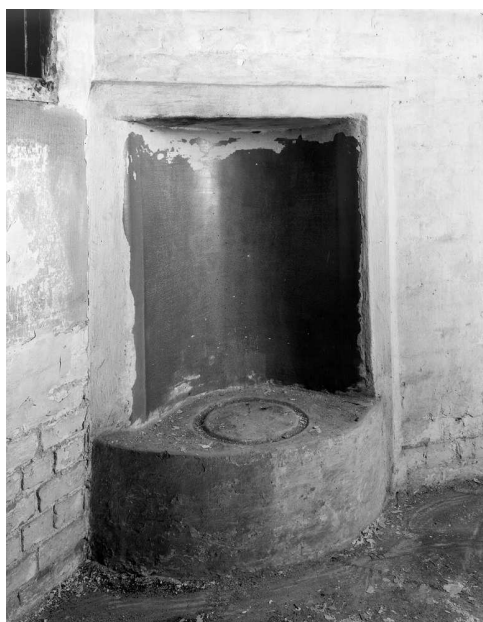
**Figure 24**  
Ceramic  
splash-back for a  
bucket latrine in no  
2 *caponier* (NMR:  
BB99/15900)

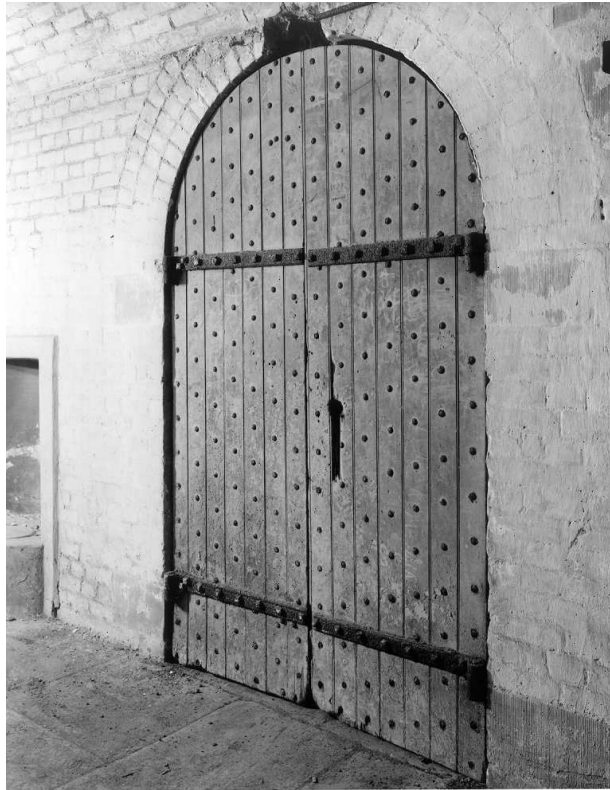
**Figure 25**  
*Heavy  
timber-iron-timber  
doors in no 2  
caponier, leading to  
the adjacent gun  
rooms (NMR:  
BB99/15899)*

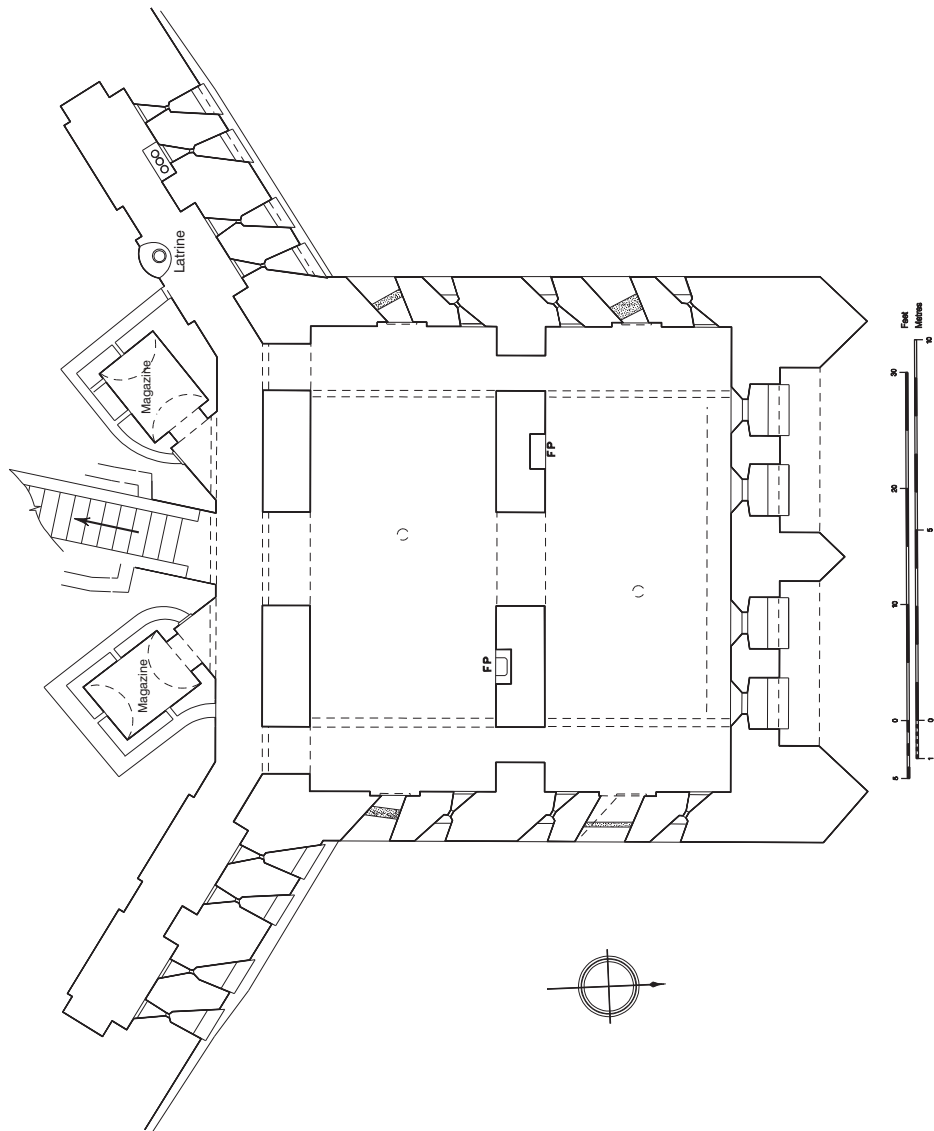
**Figure 26** *RCHME survey of no 3 caponier; ground floor plan at 1:200 scale*

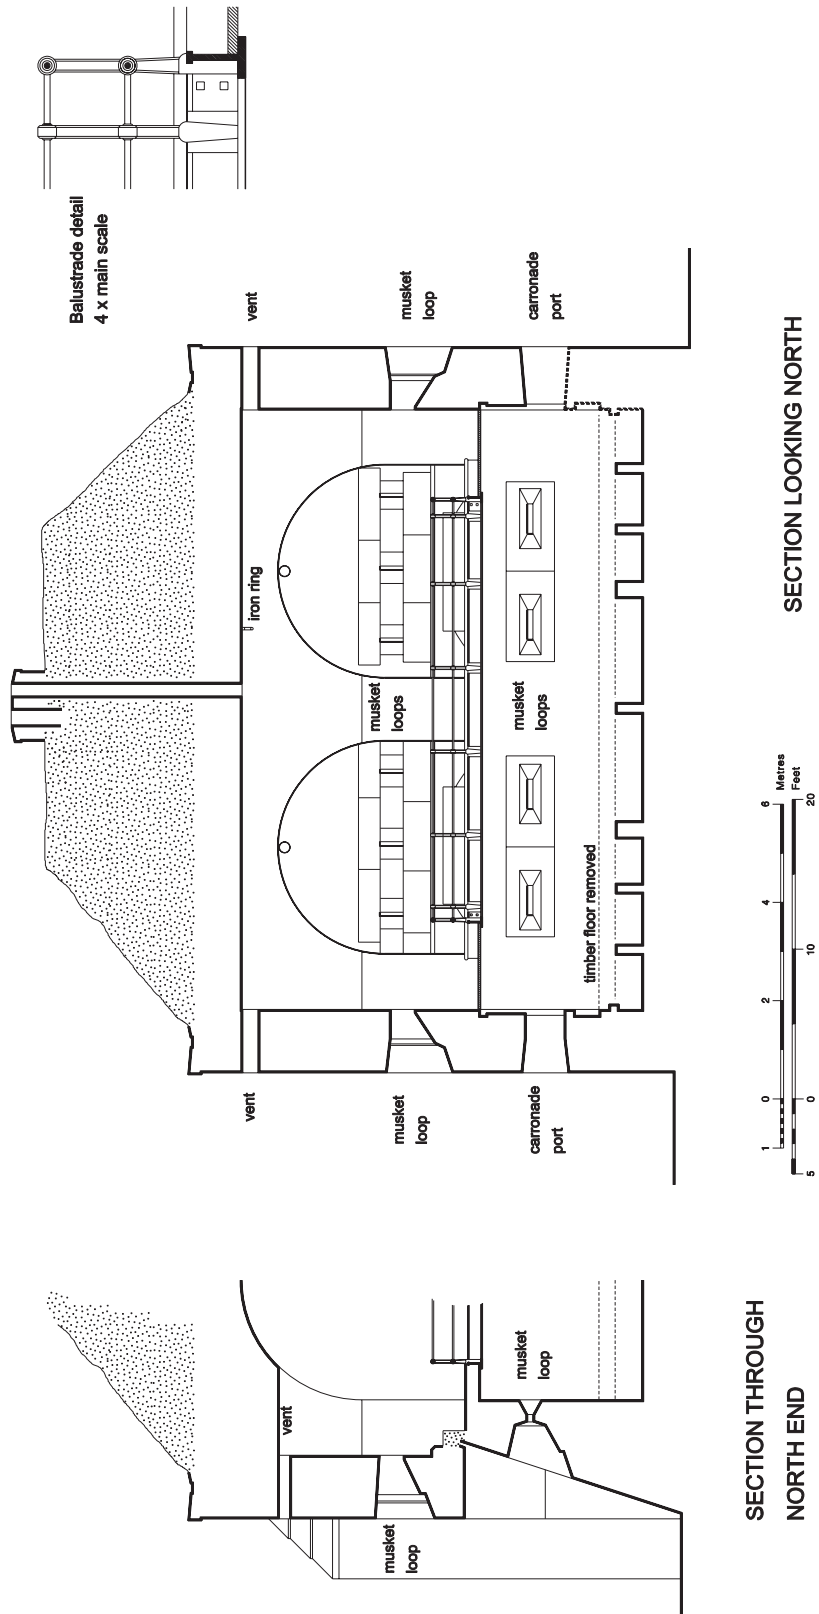
Figure 27 RCHME section through no. 3 caponier

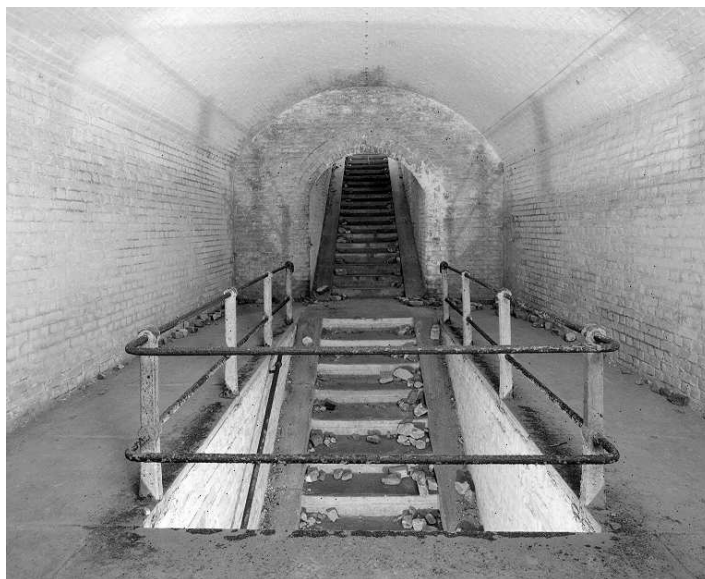
**Figure 28**  
The first floor landing at the entrance to no 3 *caponier*, with the base of the stair from the Soldiers' Quarters (NMR: BB99/15906)

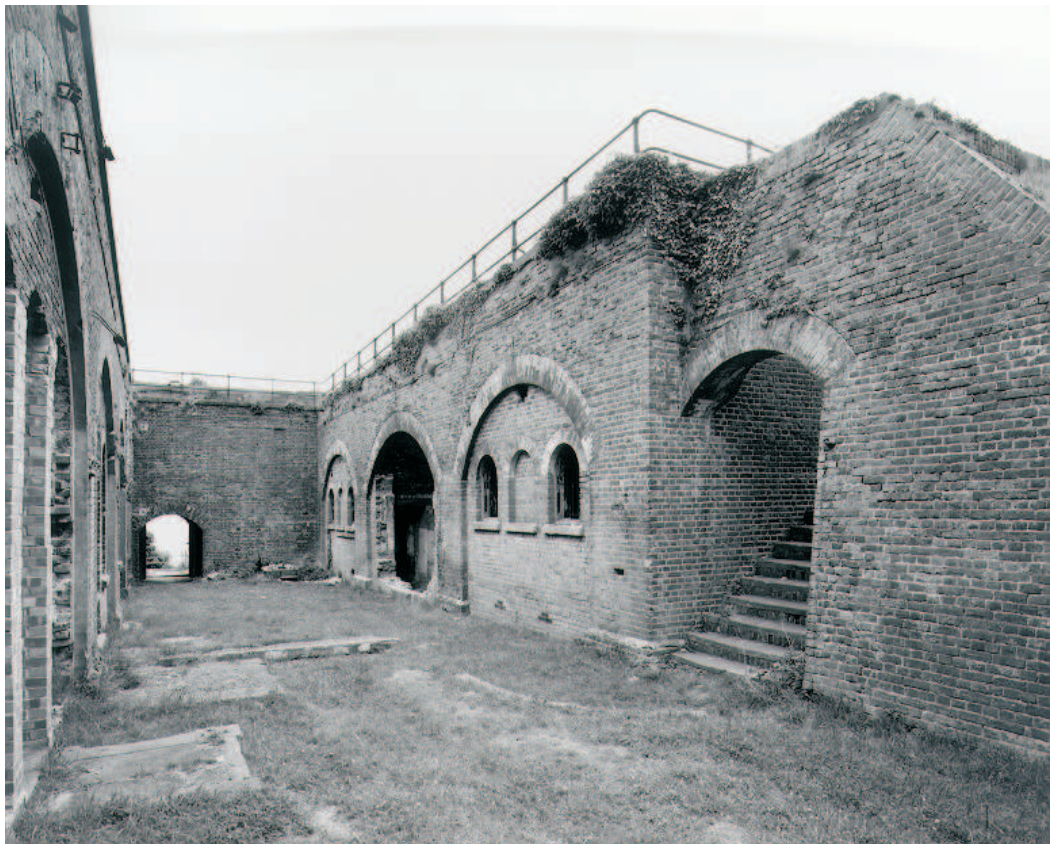
**Figure 30**  
*The Guard House  
range from the  
north-east (NMR:  
BB99/15911)*

- BB99/15911 Exterior. View showing the broken entrance to the Guard House and steps leading up to the covered way on the *terreplein*, from the north-east (B&W)

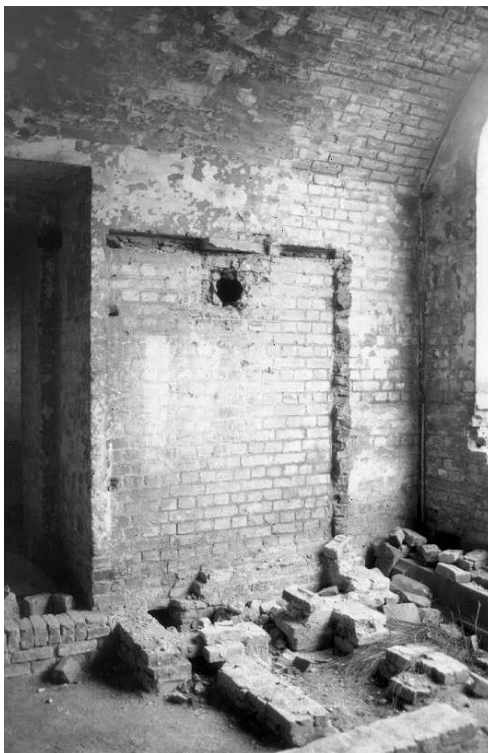
**Figure 31**  
*Remains of the stove and hot air cupboard in the Guard Room*  
(NMR: MF99/01348/16)

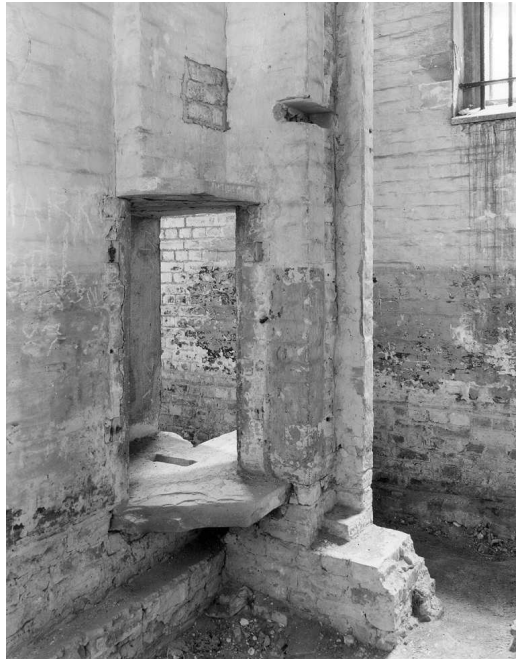
**Figure 32**  
*Setting for a rotating serving hatch built into the wall between the cells in the Guard House (NMR: BB99/15915)*

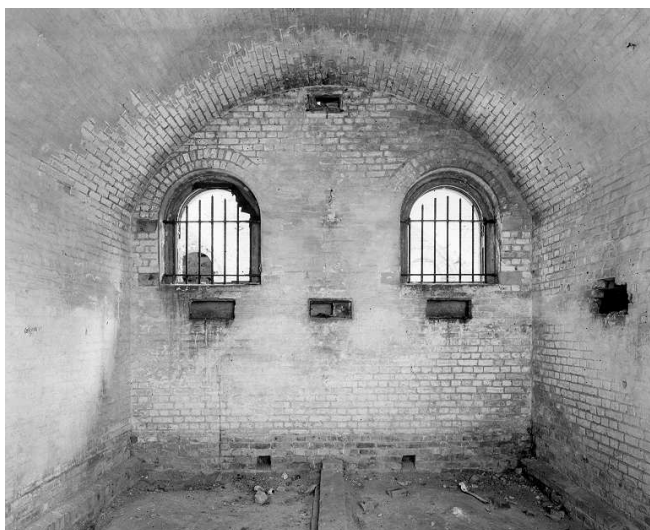
**Figure 33**  
*Interior of the Lock-Up in the Guard House (NMR: BB99/15913)*

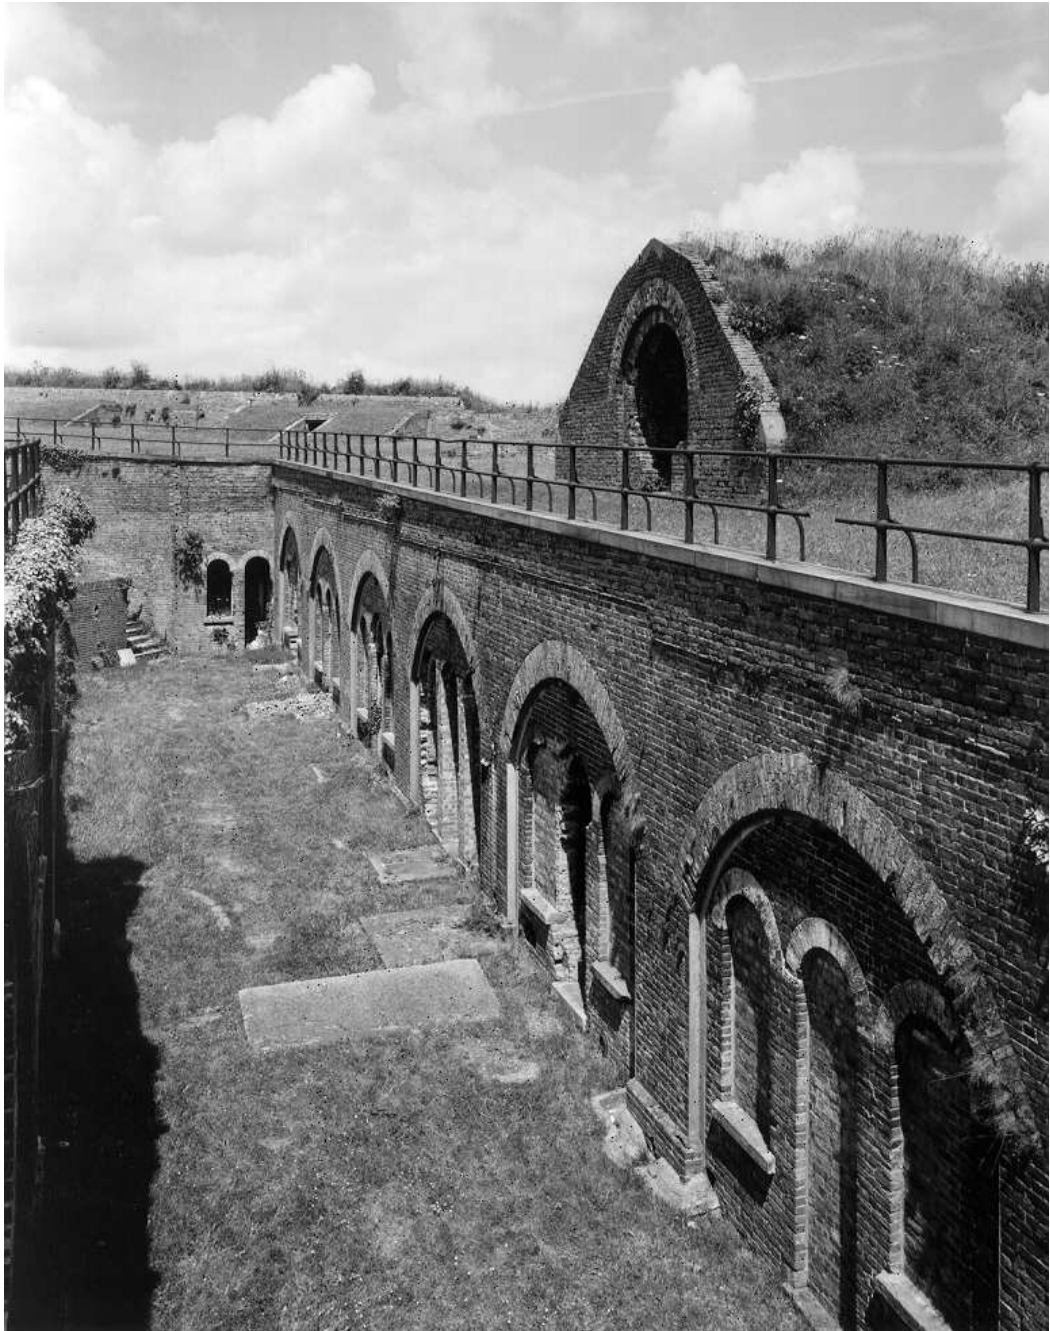
**Figure 34**  
*The Officers' Quarters: general view from the south, also showing the side arms store on the terreplein above*  
(NMR: BB99/15918)

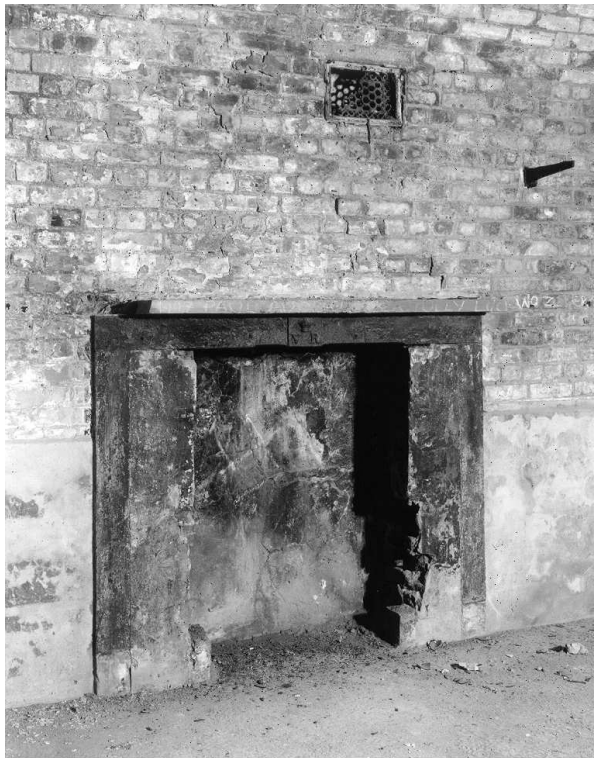
**Figure 35**  
A cast iron  
fireplace in the  
Officers' Quarters  
(NMR:  
BB99/15916)

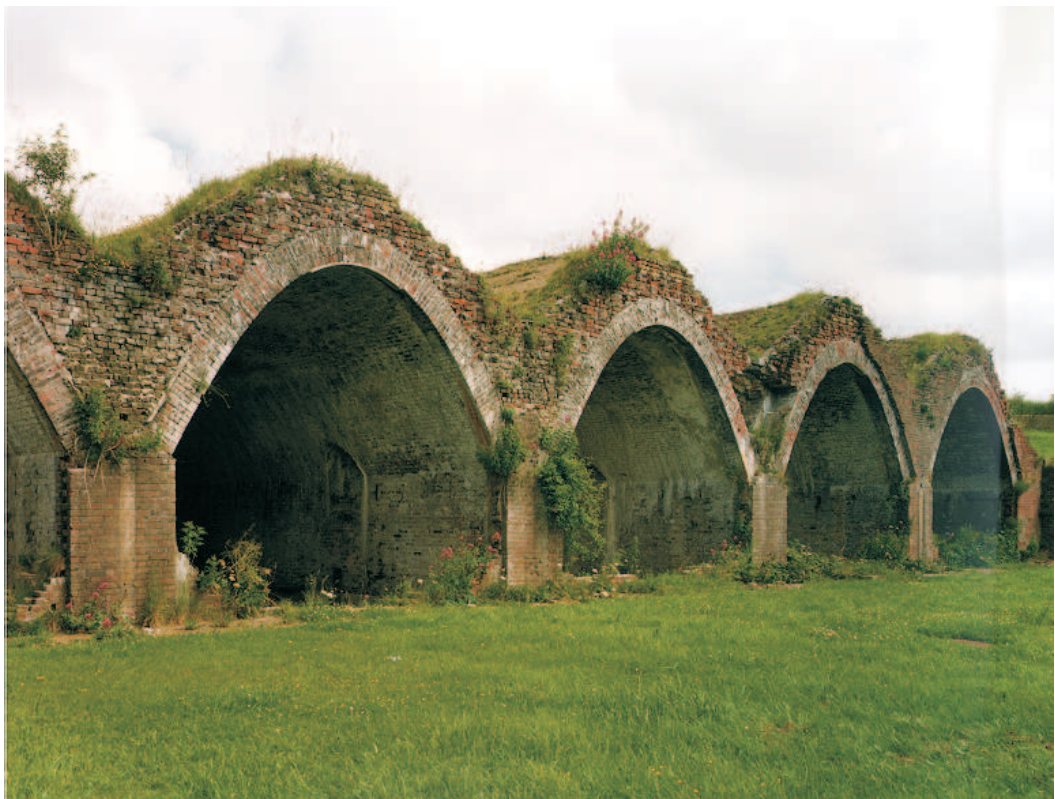
**Figure 37**  
*The Soldiers' Quarters: general view from the south*  
(NMR: BB99/15930)

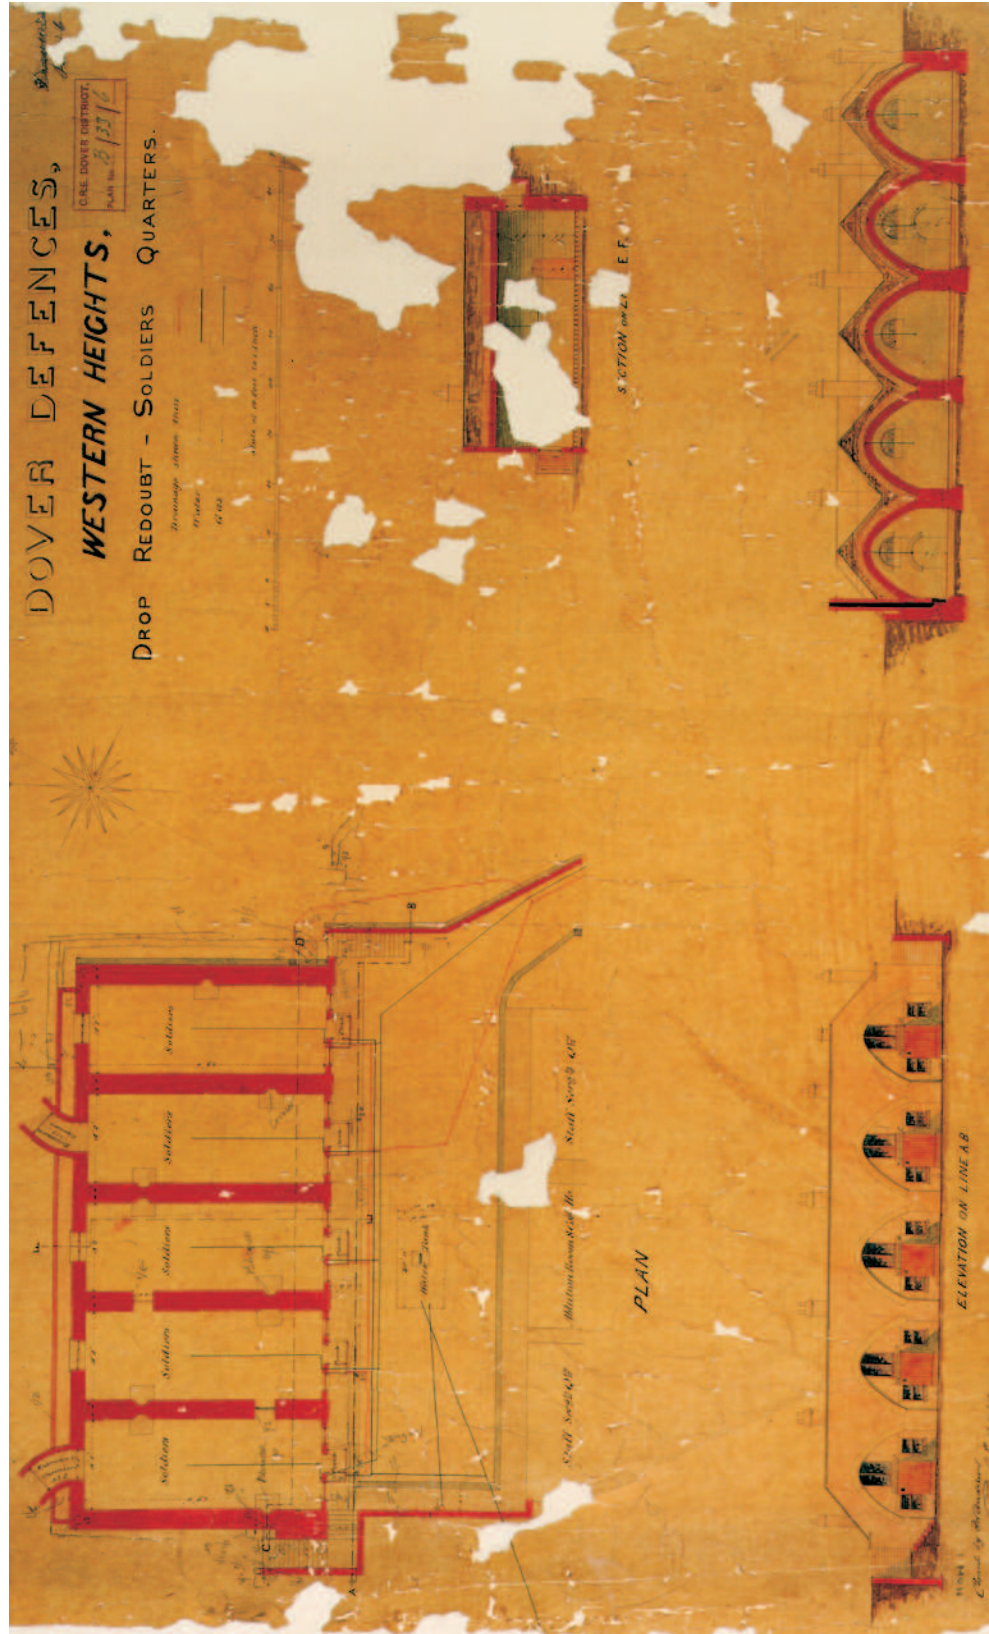
Figure 38 Record plans, elevations and sections of the Soldiers' Quarters, dated 1867 (NMR: WD/2516)

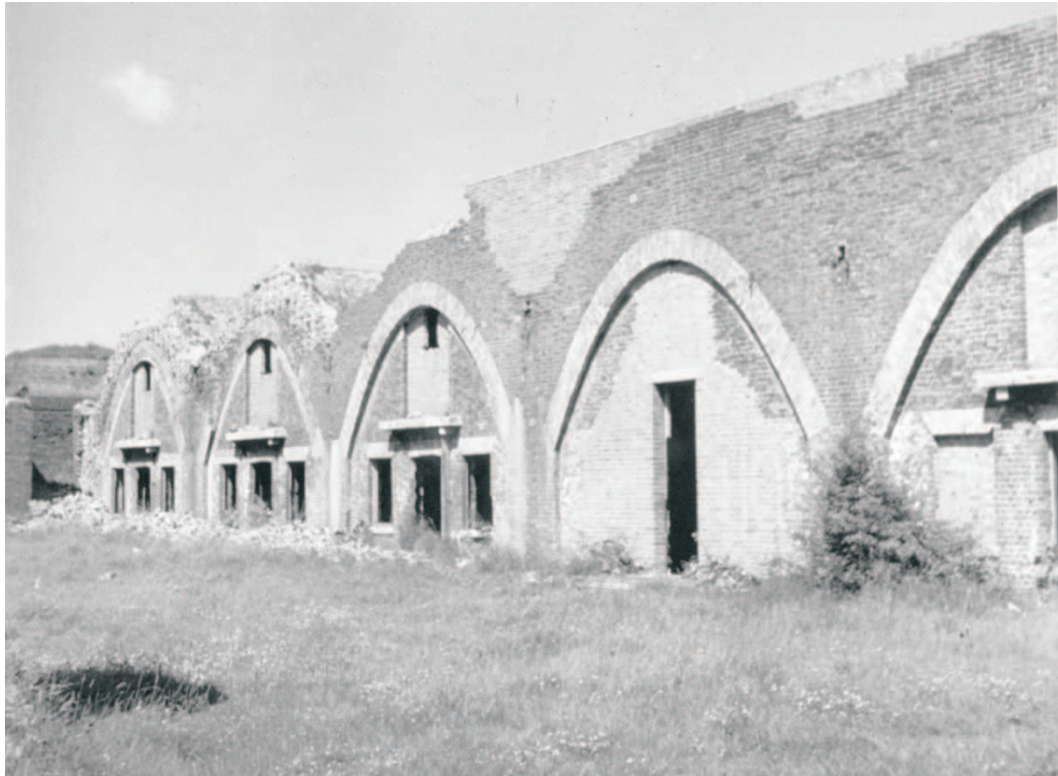
**Figure 39**  
*The Soldiers' Quarters prior to removal of the south elevation detail (Dover Museum: D07905; reproduced by kind permission of Dover Museum)*
