**THE WESTERN HEIGHTS,  
DOVER, KENT**

**THE DROP REDOUBT**

A 19TH-CENTURY ARTILLERY FORTIFICATION

ARCHAEOLOGICAL INVESTIGATION REPORT SERIES 24/2001

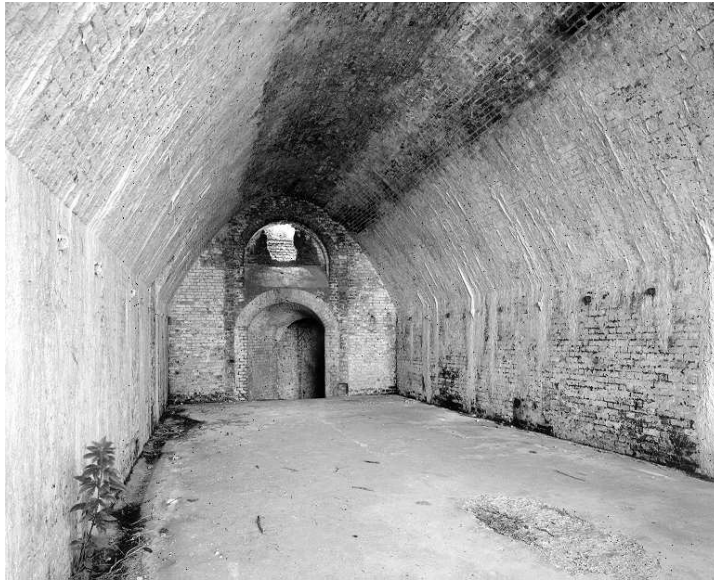
The interiors of the four long casemates form two mirror pairs (Fig 40). Each of the casemates have two fireplaces (now blocked) under a segmental arch. These are in a staggered arrangement, one on each long wall, giving back-to-back fireplaces on each party

**Figure 40**  
*The Soldiers' Quarters: interior detail of casemate 4 showing parabolic vault and entrance to gallery leading to no 3 caponier*  
(NMR: BB99/15931)

wall. The fireplaces drew air in from outside each of the buildings. Originally there were doorways with semicircular arches in the party walls, alternating with the fireplaces. Sub-vaults provide the necessary headroom for both fireplaces and internal doorways. Narrow slots, rising from floor level almost to the vault springing, with a stone lintel and three

stone anchor-blocks at intervals in the jambs, appear to be original features, but their function is unclear. Two are marked on the 1867 plan in casemate 1, and by this date do not appear to form part of either the water or the gas supply to the building. The original floors have been replaced by concrete.

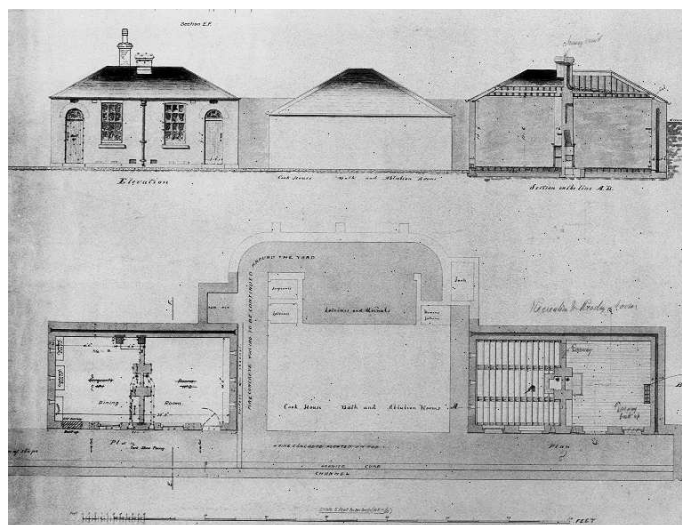
**Figure 42**  
Extract from an approved proposal drawing, dated 1861, showing a plan and elevation of the Staff Sergeants' Quarters (EH: WD/2508)

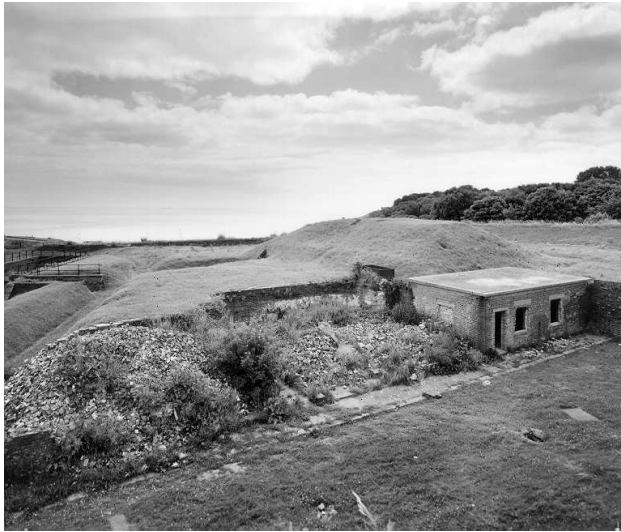
Today, the range is largely ruinous (Fig 43). However, one building stands at the western end, a rebuild of 20th-century date. It is built in yellow stock brick laid to English bond, with a flat concrete floor and roof, the latter supported on cross-axial metal beams. The single room, 8.97m by 4.48m internally, is entered

**Figure 43**  
Remains of the  
Ablutions building  
and adjacent Staff  
Sergeants'  
Quarters, with the  
20th-century  
shelter at extreme  
right (NMR:  
BB99/15932)

through a doorway in the northern wall, 0.98m wide by 2.17m high, with a stone sill and concrete lintel. Adjacent are two identical windows, each 1.05m wide by 1.33m high, with wooden frames, concrete lintels and tiled sills. A blocked doorway in the eastern wall has a concrete lintel. There are five circular vents in the roof, one of which was probably for a stove pipe. Two metal struts in the wall between the windows are

probably later insertions. It may have served as a **shelter** or communications room during the First and/or Second World Wars..

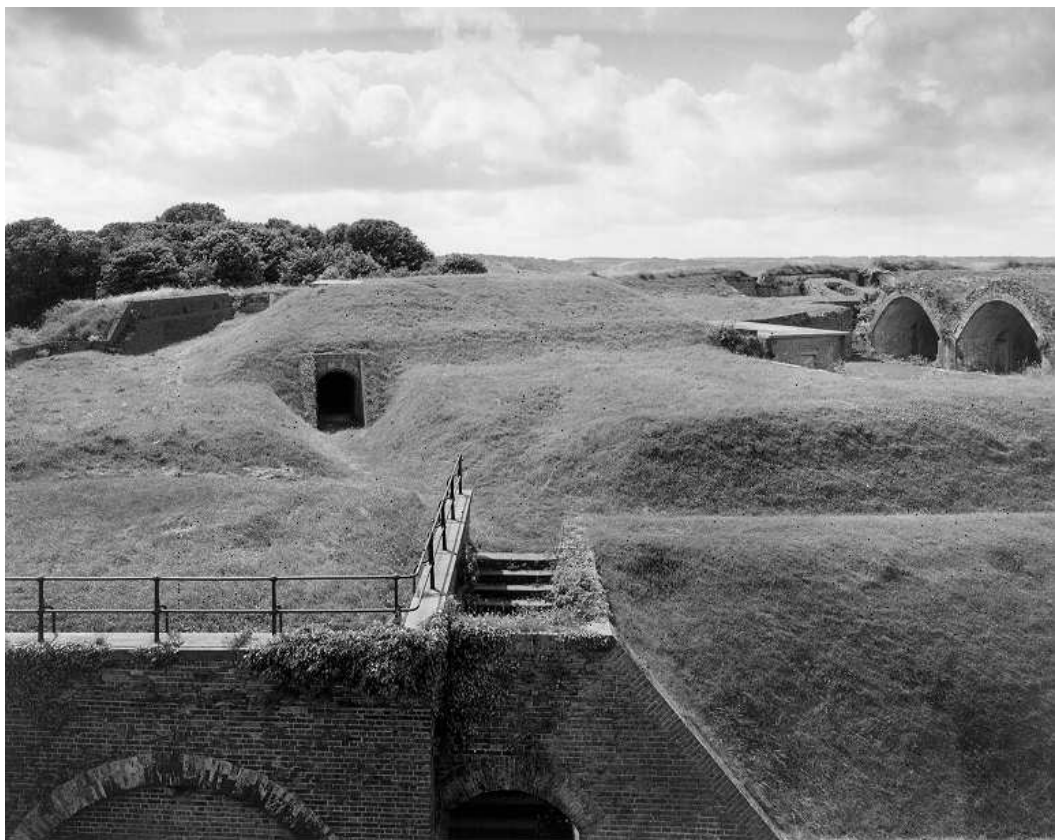
**Figure 45**  
*The Main Magazine mound and entrance, from the east (NMR: BB99/15934)*

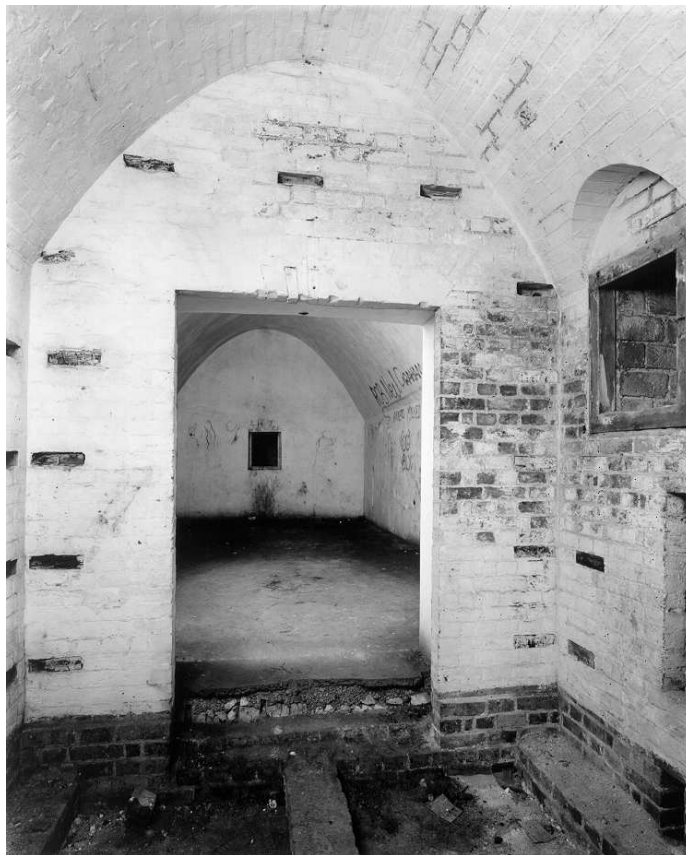
**Figure 46**  
*Interior of the Main Magazine, viewed through the shifting lobby (NMR: BB99/15939)*

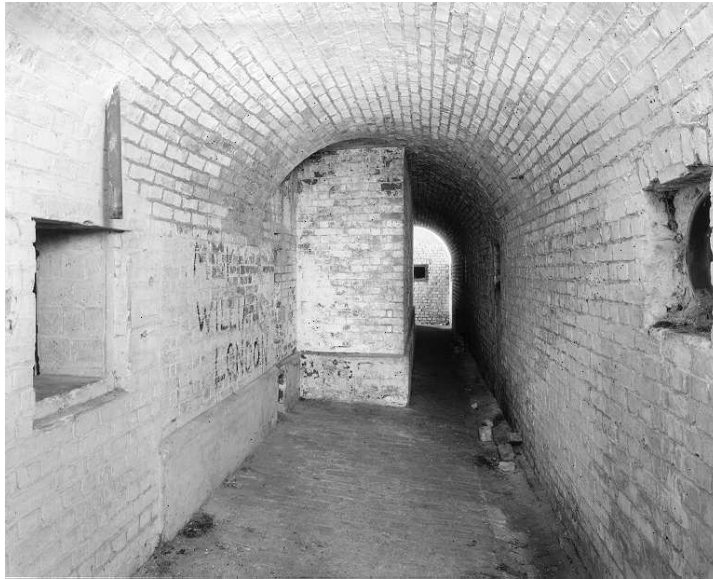
**Figure 47**  
*The magazine passage, with a lamp recess to left and a ceramic ventilation pipe to right (NMR: BB99/15938)*

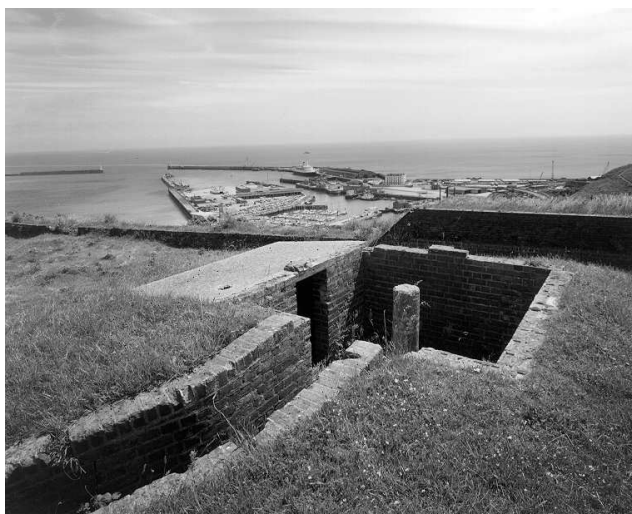
**Figure 48**  
*Second World War  
observation post on  
top of the Main  
Magazine (NMR:  
BB99/15943)*

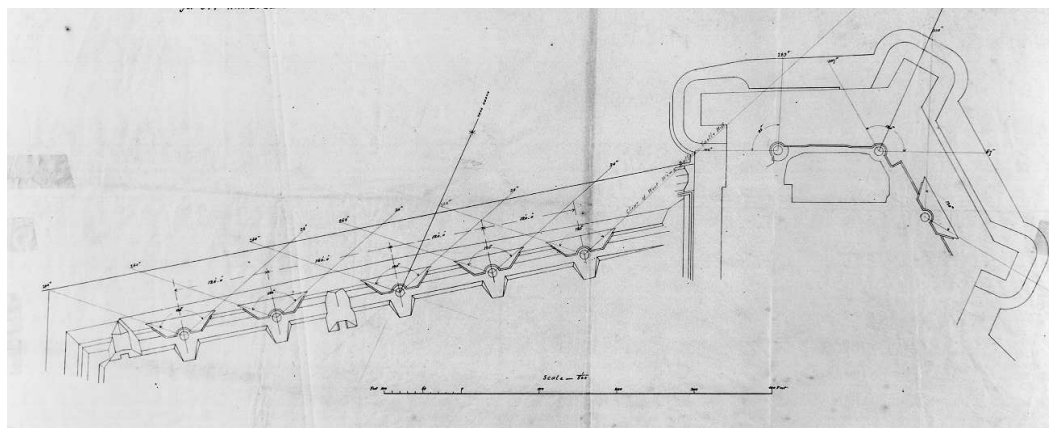
**Figure 50**  
Proposal plan for the installation of a new battery of 64-pdr RML guns at the Drop Redoubt, dated 1893 (NMR: WD/2512)

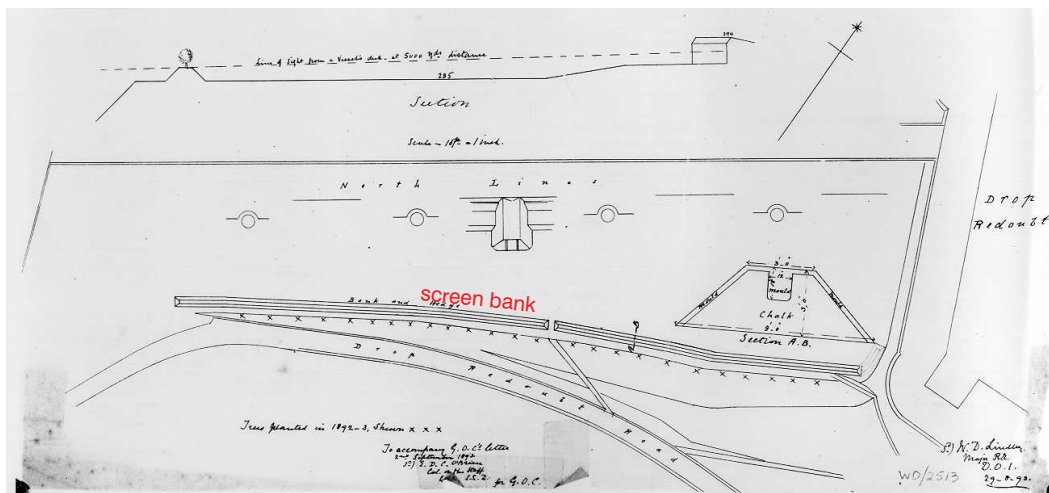
**Figure 51**  
Plan of the battery on the North Lines, dated 1893, showing proposed screen bank. Text in red is added by the authors (NMR: WD/2513)
