**Blue House Farm**  
North Fambridge, Essex

An archaeological survey  
of the grazing marshes

**SURVEY REPORT**

ARCHAEOLOGICAL INVESTIGATION REPORT SERIES 3/2000

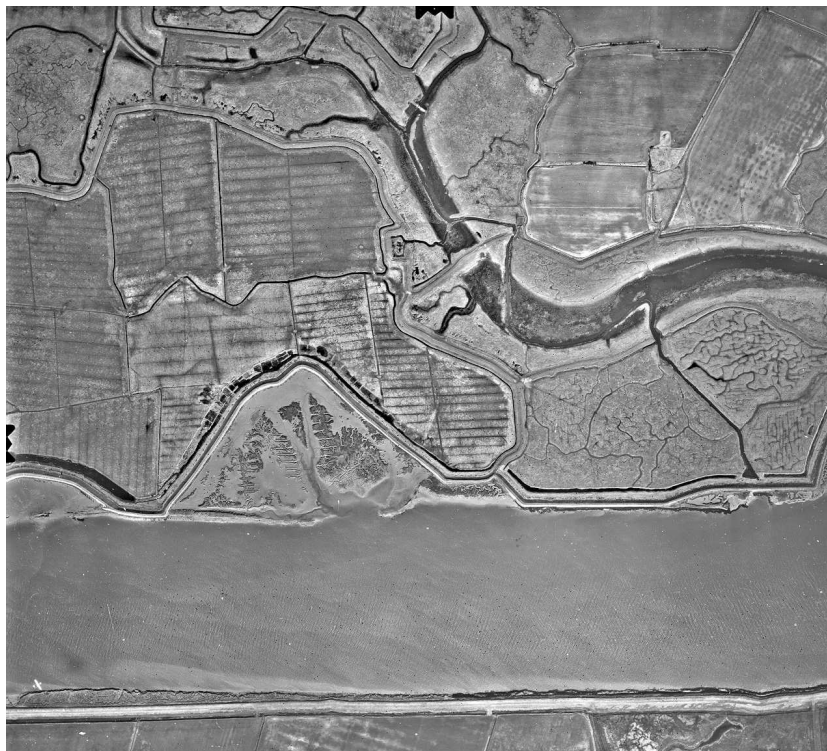
Figure 9:  
*The central and western part of the farm in 1970. Note the rectilinear drainage network in the fields to the left and the sinuous relict creek system in those to the right. The prominent indentations to the sea wall (lower left) are the result of rebuilding after the flood of 1897. Also visible is a rectangular 'enclosure' formed by an indentation to a counter wall adjacent to the fleet (upper centre)*(Extract from NMR: OS/70020/143)
