Force Crag Mine, Cumbria

SURVEY REPORT

Archaeological Investigation Report Series AI/1/1999

**FORCE CRAG MINE
ALLERDALE
CUMBRIA**

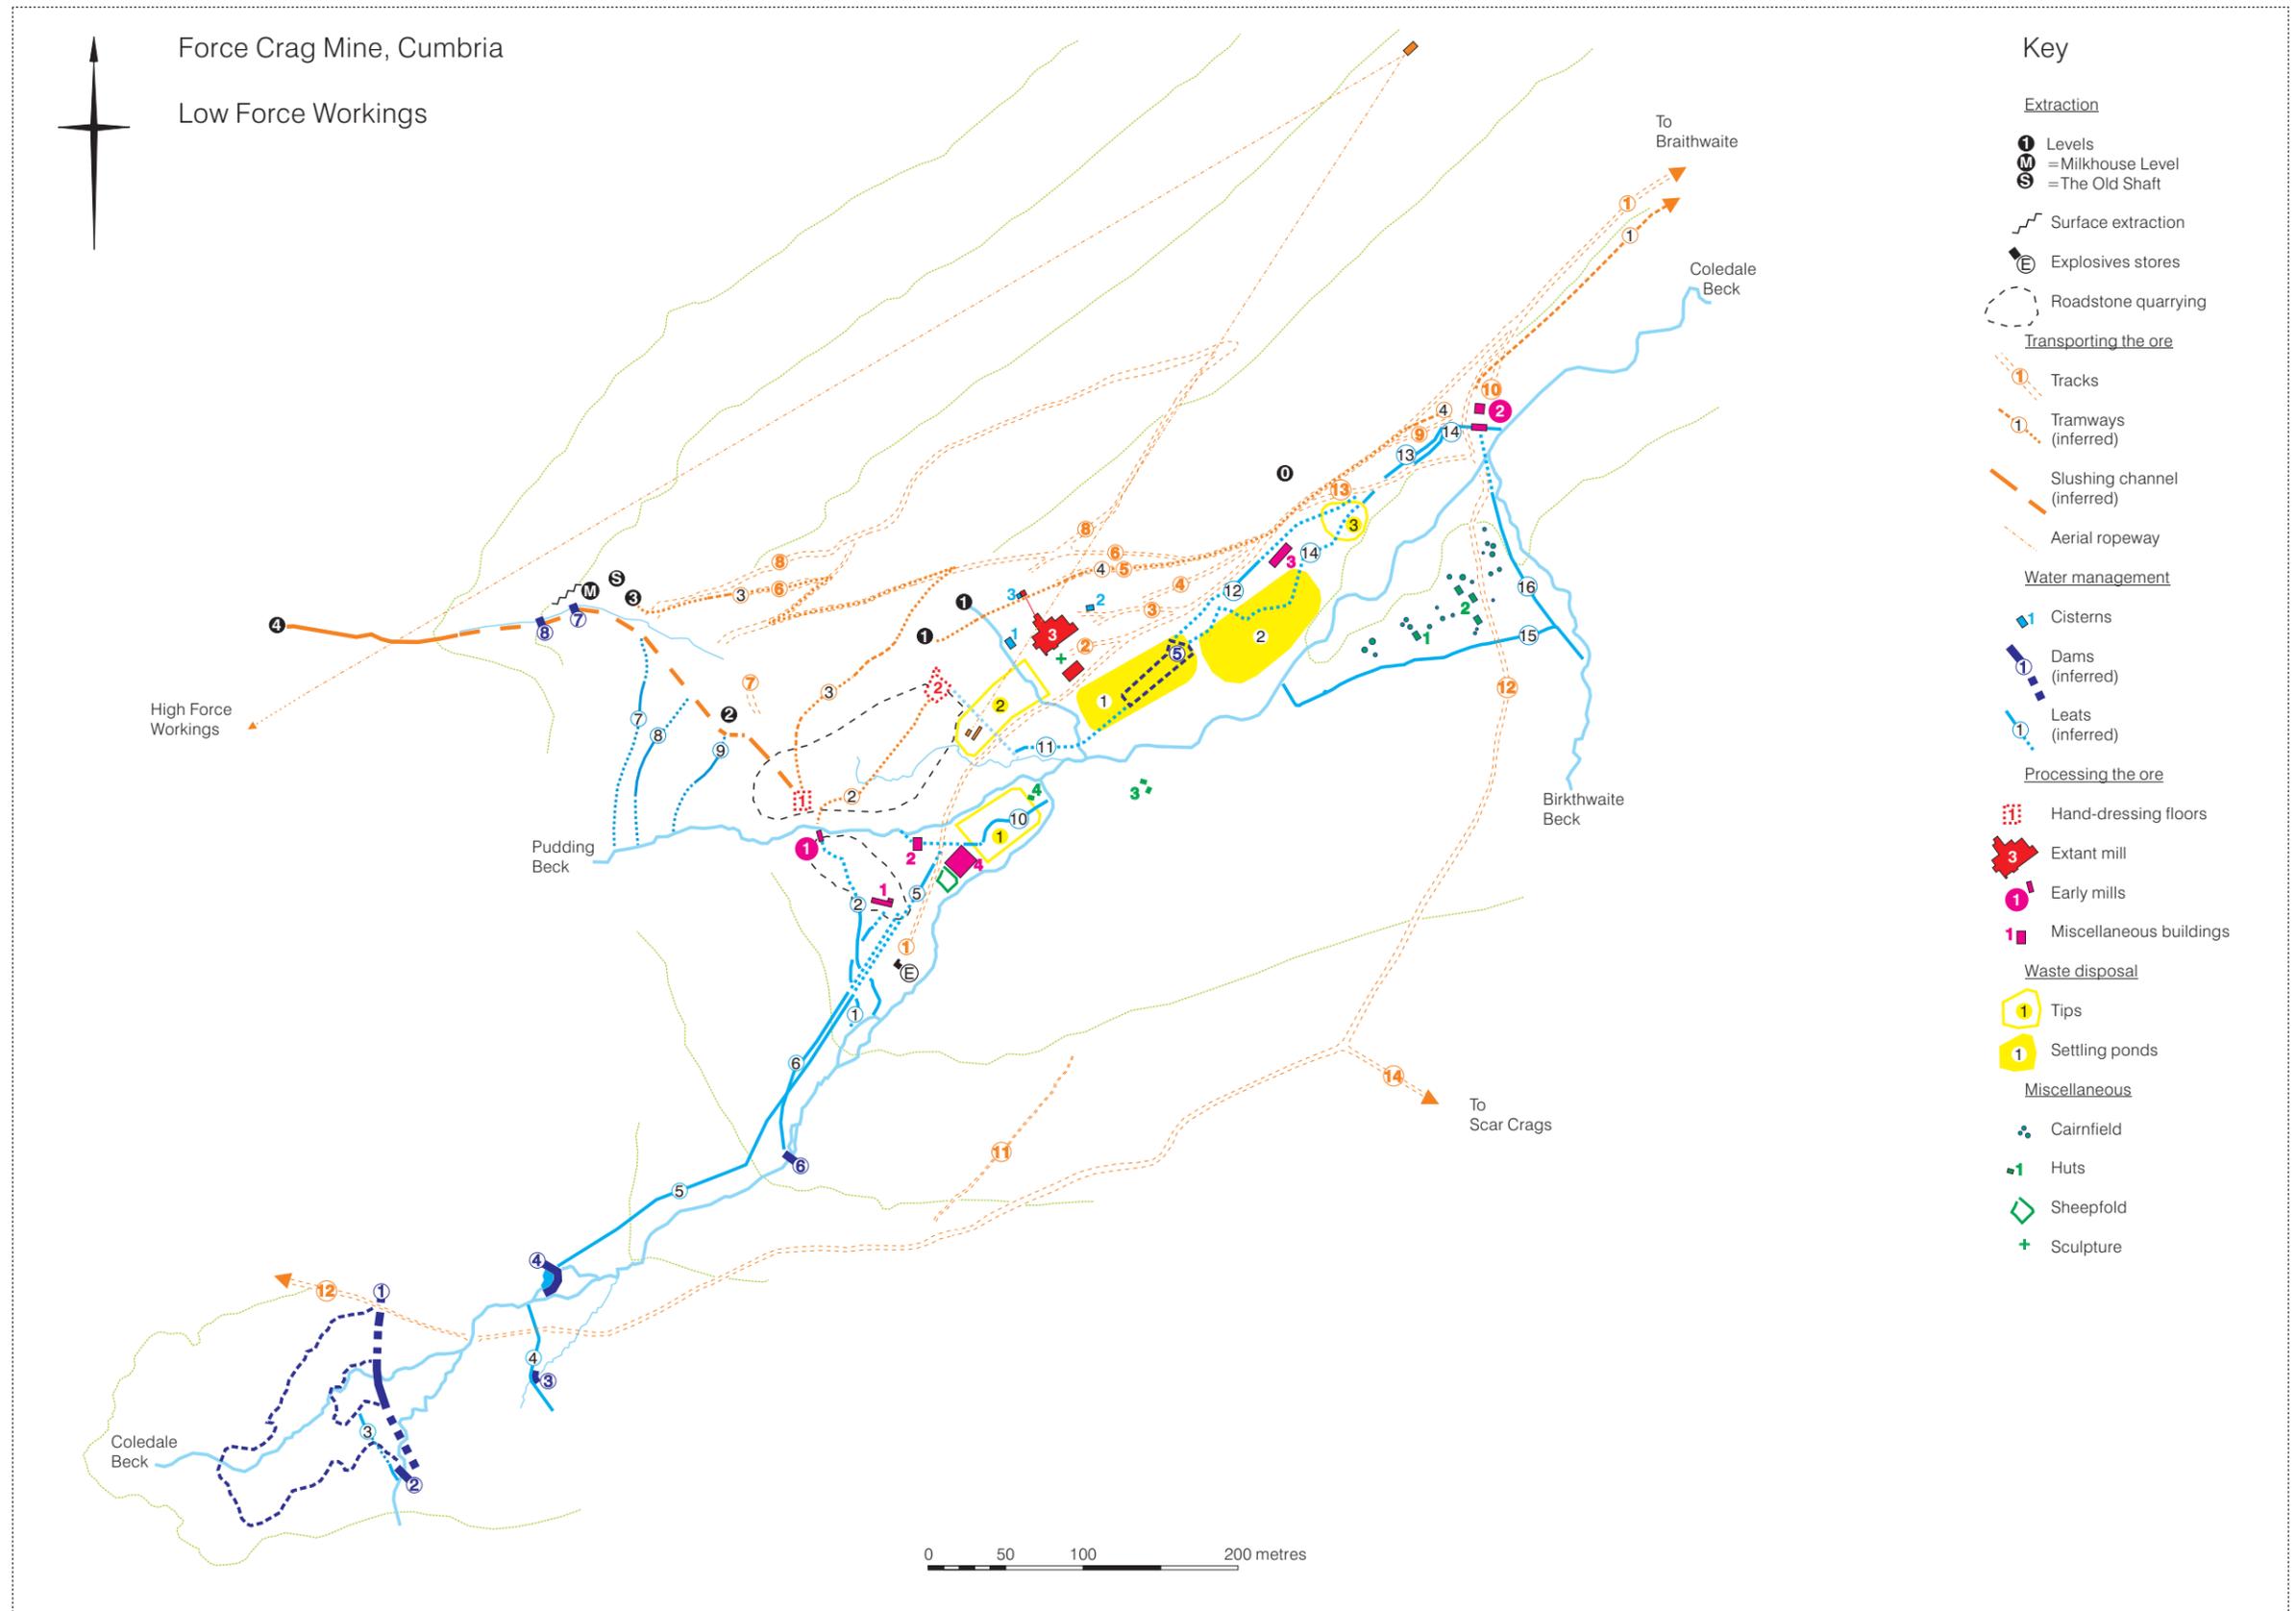
Figure 4. Schematic plan of the complex.

For an overview of the remains described in Section 5, see the schematic plan of the site (Figure 4). The surviving remains can be broken down into five categories which broadly correspond to activities that occurred in the sequence from the extraction of the minerals to their processing: extraction, transporting the ore, water management, processing the ore, and waste disposal.

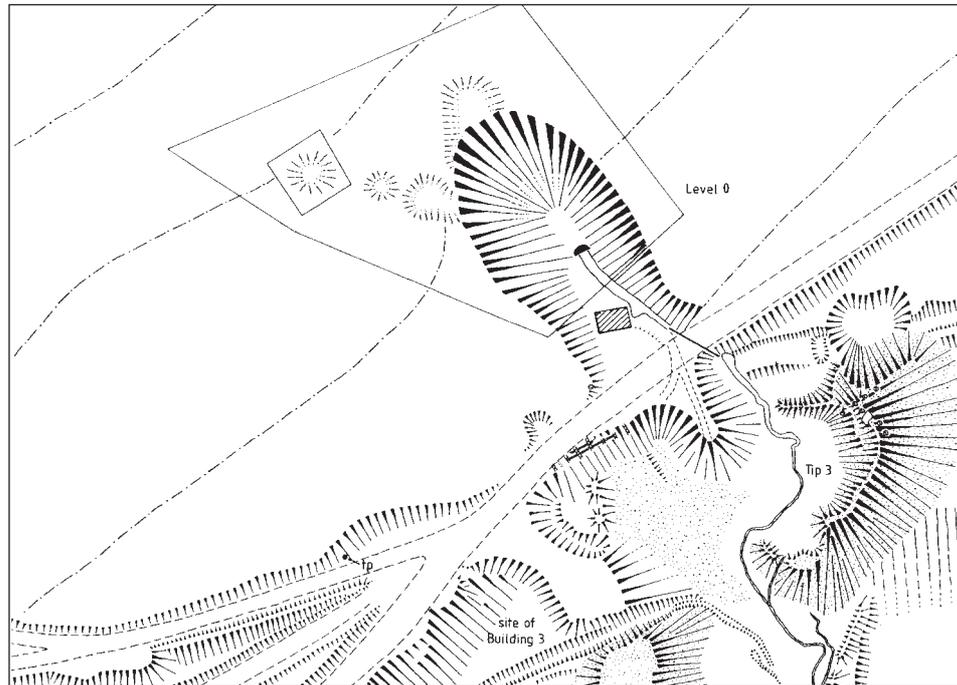
Figure 5a.
Extract from
survey reduced to
1:1000 scale
showing Level 0.

Level 0 is the lowest and most easterly of the adits of the Low Force Workings. The entrance lies adjacent to Track 1 at NGR NY 2012 2173, at an altitude of 257m above OD. It has been maintained and remains accessible. The portal, which is built of timber and corrugated iron, is in fairly good condition, although there have been some minor collapses into it. A sign overhead is now almost illegible, but reads 'DANGER - KEEP OUT'. The entrance lies towards the rear of a steep-sided cutting dug for a distance of 38m into the loose glacial overburden of the valley side, up to a maximum depth of 16m. Immediately upslope from the cutting, three deep sub-circular depressions mark the line of an underground collapse along the line of the adit, probably that which occurred in 1991. These are all unstable and have been fenced off for safety reasons.

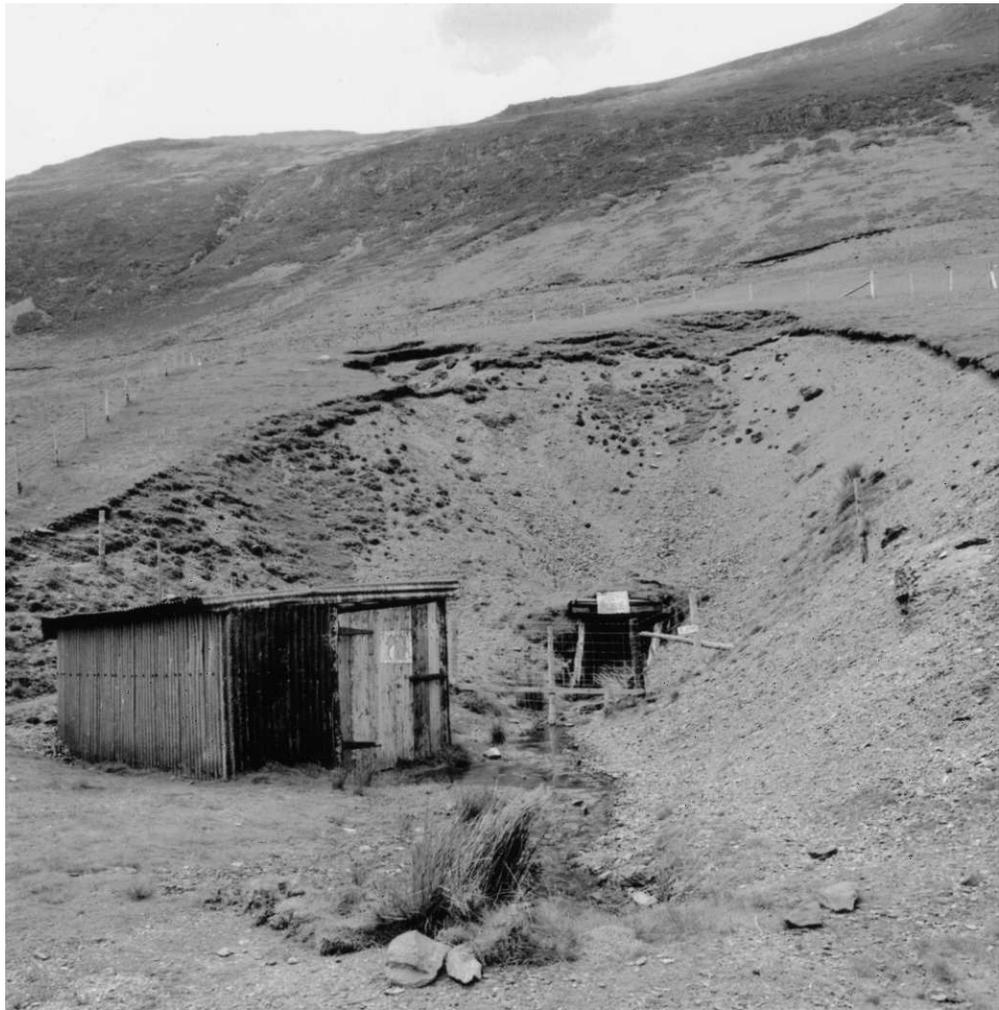
*Figure 5c.
Level 0 viewed from
the south-east (NMR
AA99/04047).*

A shed in the entrance to the cutting for the adit is built of timber and corrugated steel sheeting, and is in good condition. It, or a building of identical size, has stood there since at least 1960 (Cumbria CRO c). It is 5.0m long by 4.0m wide, with a broad doorway at its eastern end and a single window on its northern side. The tramway track seems to have run into the shed, indicating that the building housed the locomotive when it was not in use, presumably along with other equipment.

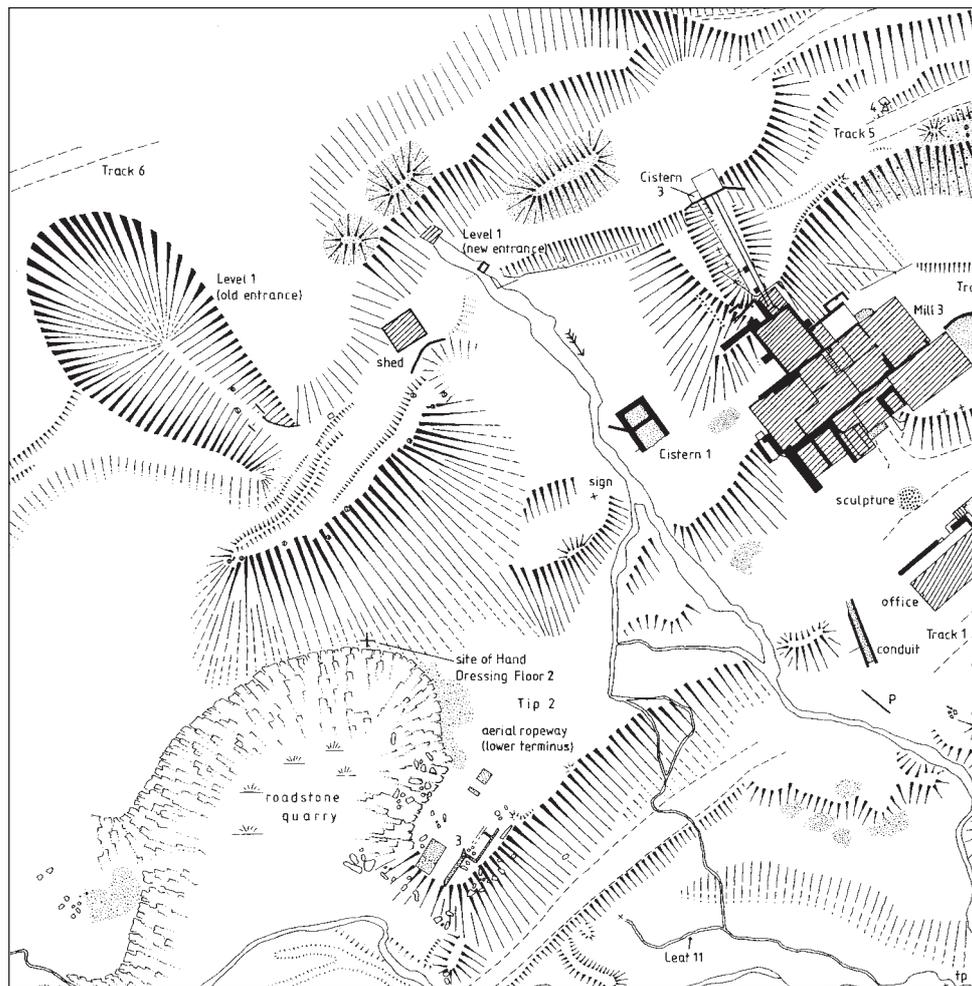
Figure 6a.
Extract from
survey reduced
to 1:1000 scale
showing Level 1.

The original entrance to Level 1 lies slightly higher than Mill 3 (the extant processing building) at NGR NY 1989 2163, at an altitude of 287m above OD. Access was originally gained from Track 5 and later from Track 6. The old entrance was dug into the loose material of the hillside, resulting in repeated slippage of scree and spoil

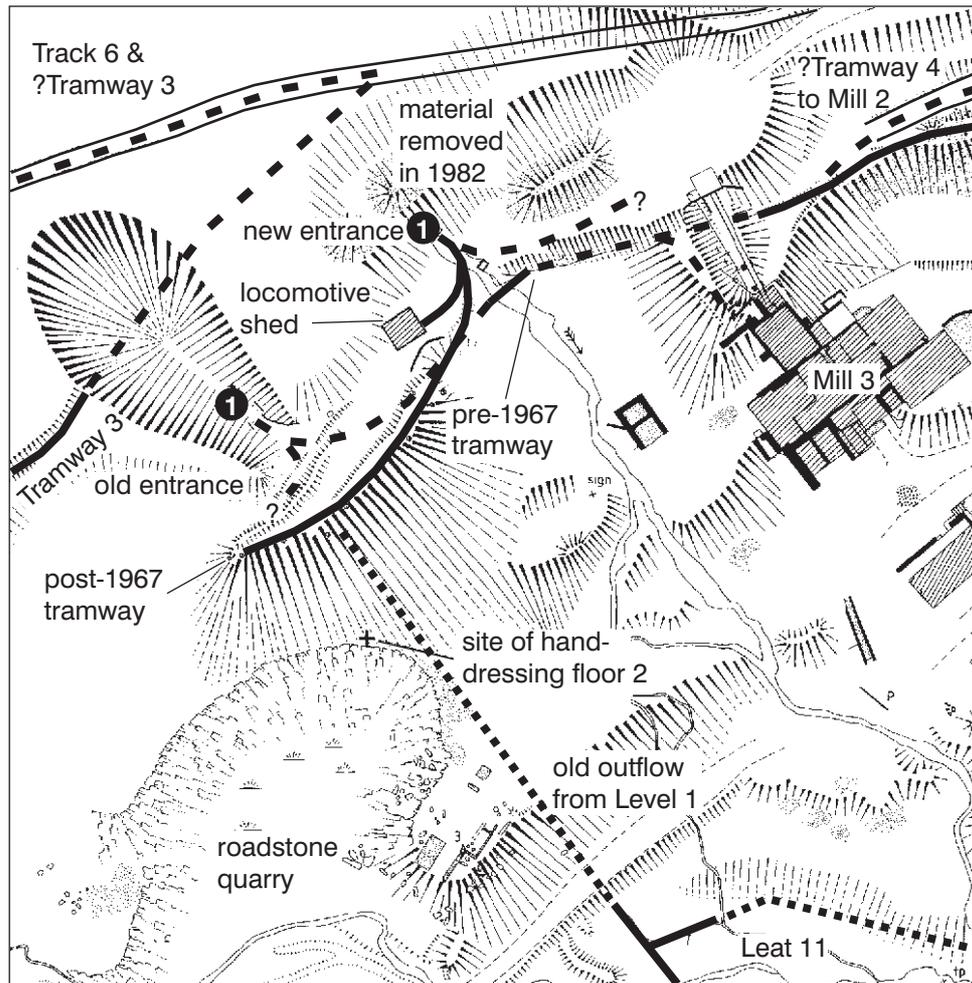
Figure 6b.
Annotated
extract from
survey reduced
to 1:1000 scale
showing Level 1.

from above, which caused it to be abandoned in 1967; it has subsequently become entirely blocked. Its position is now marked by a cutting c.2m wide at the base, which extends for nearly 20m into the hillside. The tops of two poorly preserved timber props protrude from the collapsed material. On either side of the entrance to the cutting, short lengths of crudely built dry stone walls, surviving to a maximum height of 0.5m, evidently served as revetments directly in front of the portal. A photograph of c.1916, taken by Mr J Hindmarch (reproduced in Tyler 1990, figure on page 40), indicates that these walls originally stood around 2m high. Another photograph, taken by Mr J Hodgkins shortly before 1967 (reproduced in Tyler 1990, figure on page 76), shows that the walls were in poor condition at that date and had been reinforced by timber hoarding (presumably when the entrance was cleared out in 1963).

Both photographs show tramways entering the adit, differing slightly from each other in form. The only trace of the earlier one that now survives in the immediate vicinity of the mine is a sleeper buried 1.2m below the top of the embankment that carried the tramway serving the later entrance. This has been exposed where the outflow from the new entrance has severely eroded the embankment. However, some 100m to the east of the old entrance lies a finger dump 2.5m high comprising coarse slate waste, with four poorly preserved vertical timber posts in a square

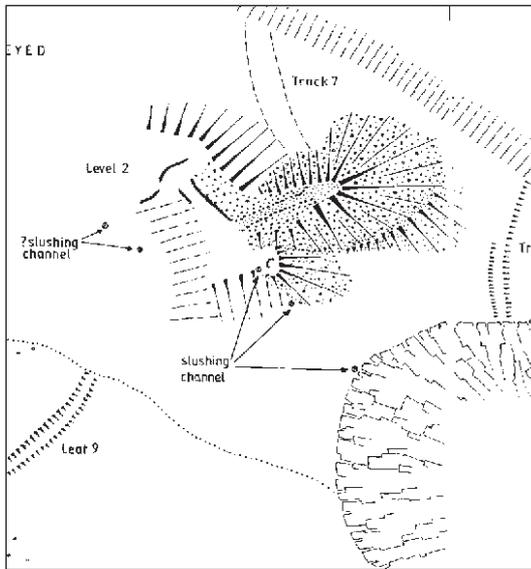
Figure 7a. Extract from survey reduced to 1:1000 scale showing Level 2.

The entrance to Level 2 lies at NGR NY 1976 2158, at an altitude of 331m above OD, with access gained via Tracks 6 and 7. Ore from Level 2 may have been transported down to Mill 1 along the Slushing Channel or Tramway 3. The entrance, which is cut into the loose material of the valley side, has been entirely blocked by the slippage of scree and spoil from above. The upper part of the portal, which is formed by a crudely built dry stone wall, protrudes from the slipped material and stands to a maximum height of 1.7m. On either side of the cutting

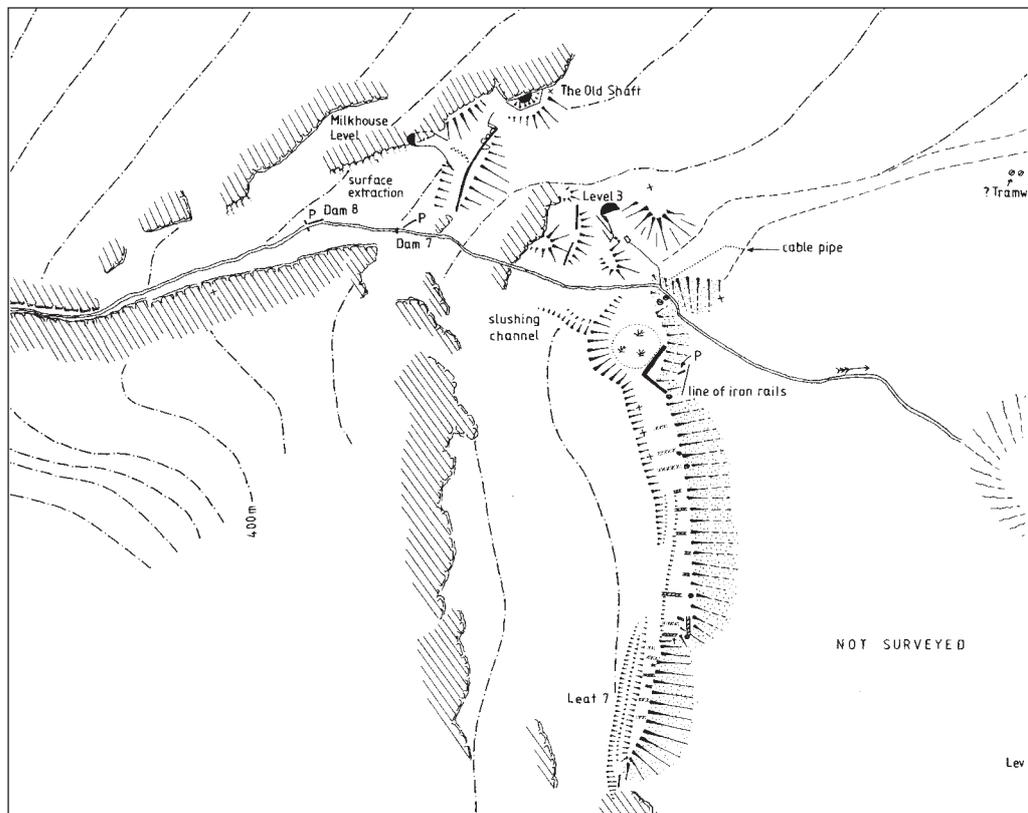
Figure 8a.
Extract from survey
reduced to 1:1000
scale showing Level 3,
The Old Shaft and The
Milkhouse Level.

The entrance to Level 3 lies at NGR NY 1970 2165, at an altitude of 358m above OD. Vehicular access would originally have been possible via Track 6, and later from Track 8. Some spoil and scree is heaped on either side of the entrance, but it may originally have been cut straight into solid rock at the point where the mineral vein was exposed on the surface, for there is only evidence for very low dry-stone

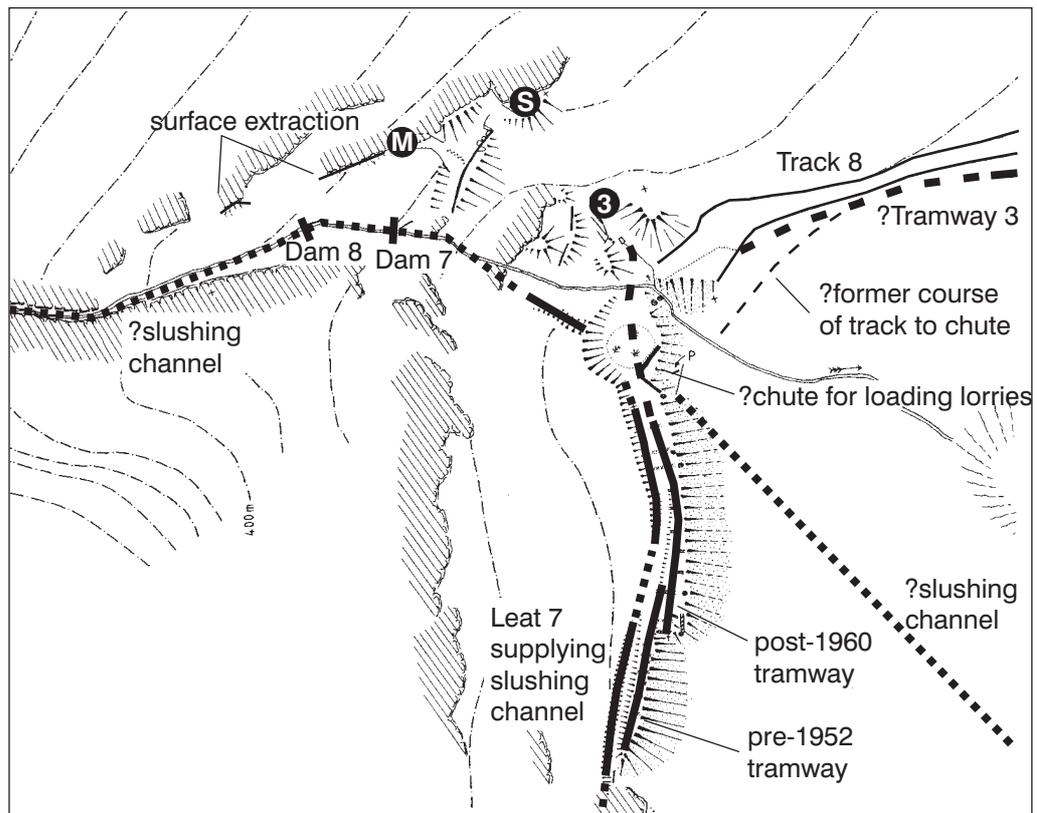
Figure 8b.
Annotated extract
from survey reduced
to 1:1000 scale
showing Level 3, The
Old Shaft and The
Milkhouse Level.

walls flanking the approach. The portal is constructed of timber uprights and roofed with corrugated iron supported by rails from the dismantled tramway. This probably represents repair work carried out in 1949. Although it has not recently been maintained, the entrance is partially open and still useable. The present opening is 1.5m wide and 1.0m high, but was evidently originally *c.* 1.5m high. Immediately outside the entrance a small wooden box sunk into the ground acts as a sump for a trickle of water which drains out of the adit through a plastic pipe. The noise of rushing water indicates that there is a much stronger flow underground, but this presumably continues down to Level 2 and from there to Level 1.

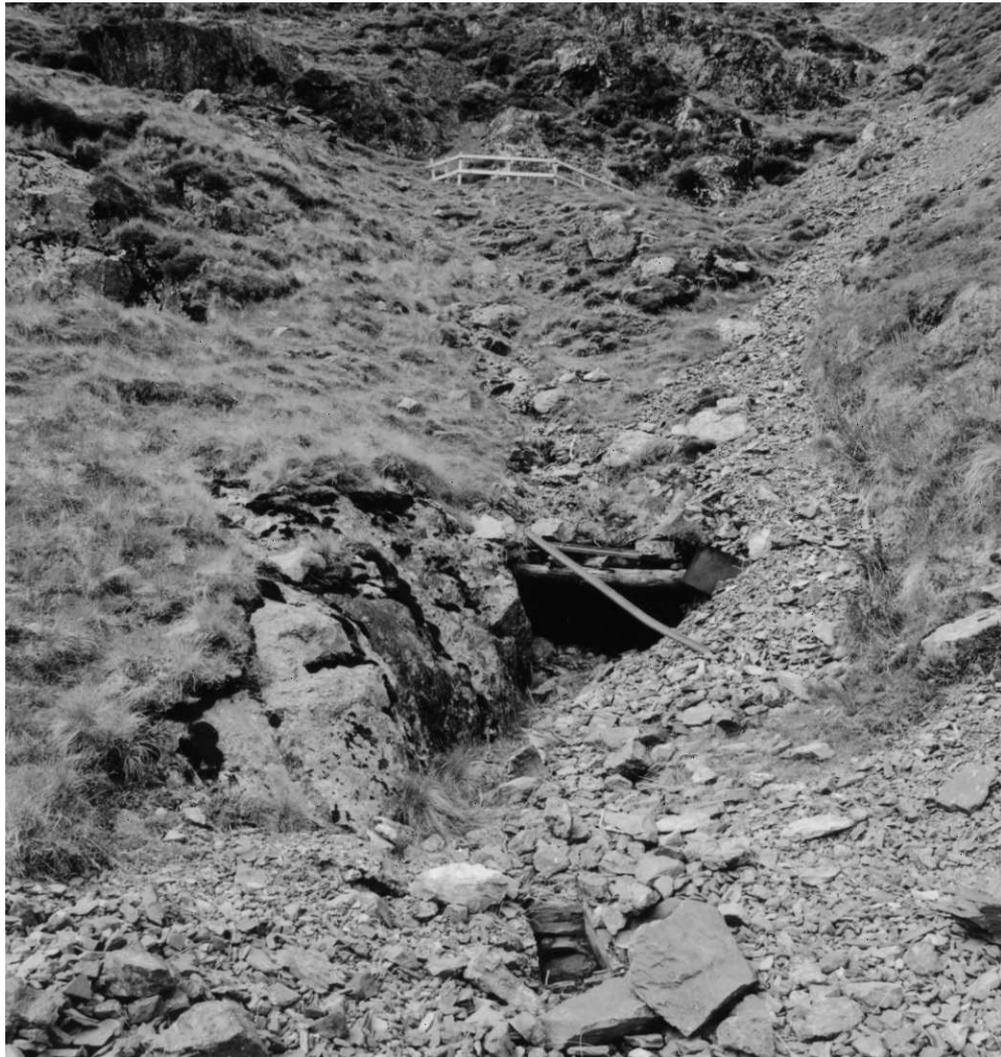
*Figure 8c.
Level 3, The Old
Shaft and The
Milkhouse Level
viewed from the
south-east (NMR
AA99/05404).*

Outside the entrance are the poorly preserved and partly buried remains of a rectangular or three-sided concrete structure interpreted as an ore chute or hopper. All that now survives is two walls describing an L-shape 3.9m wide by 4.6m long; the upper surfaces of the walls are flush with the ground and they descend for at least

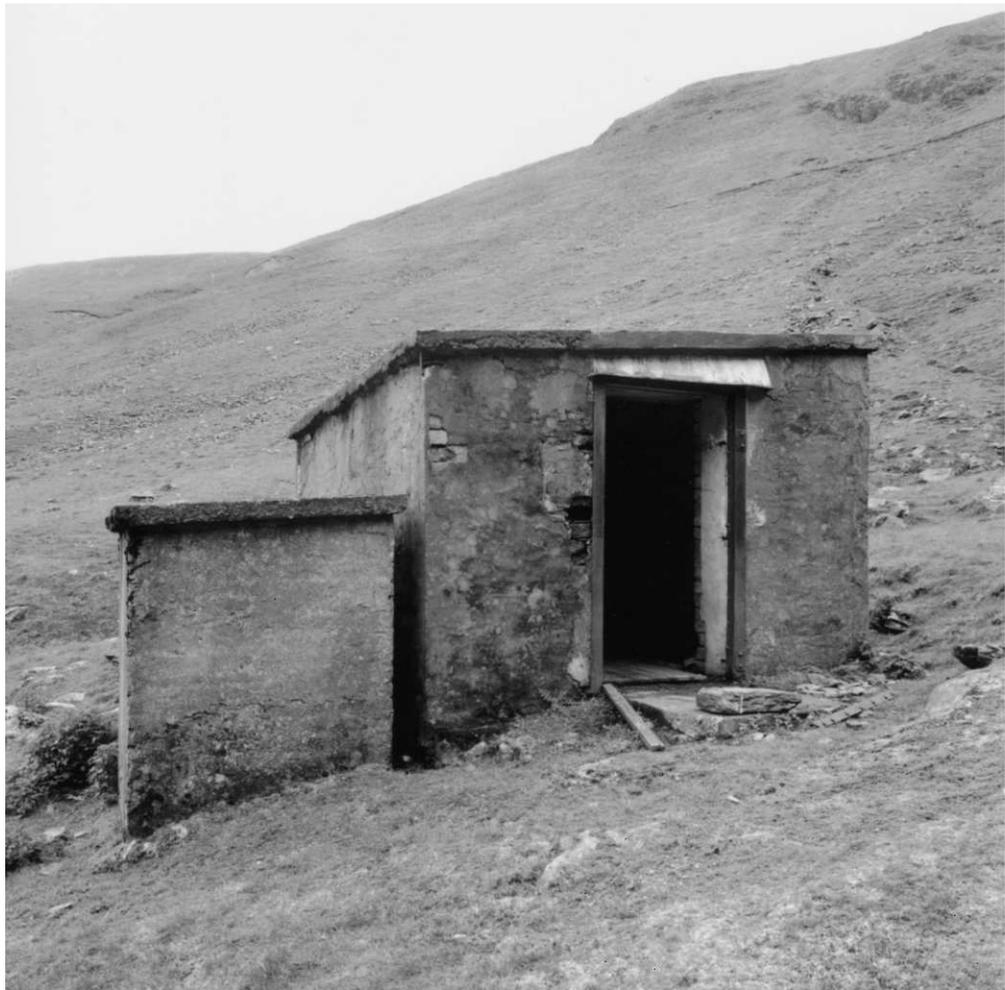
Figure 9b.
The explosives
stores viewed
from the
north-west (NMR
AA99/04038).

The First Edition map and the Second Edition 6-inch revision (Ordnance Survey 1862; 1900) both show a rectangular building that can confidently be interpreted as a gunpowder store, located at NGR NY 1987 2142. The site of the building, at the westernmost end of Track 1, is typically remote from the main areas of activity. The building

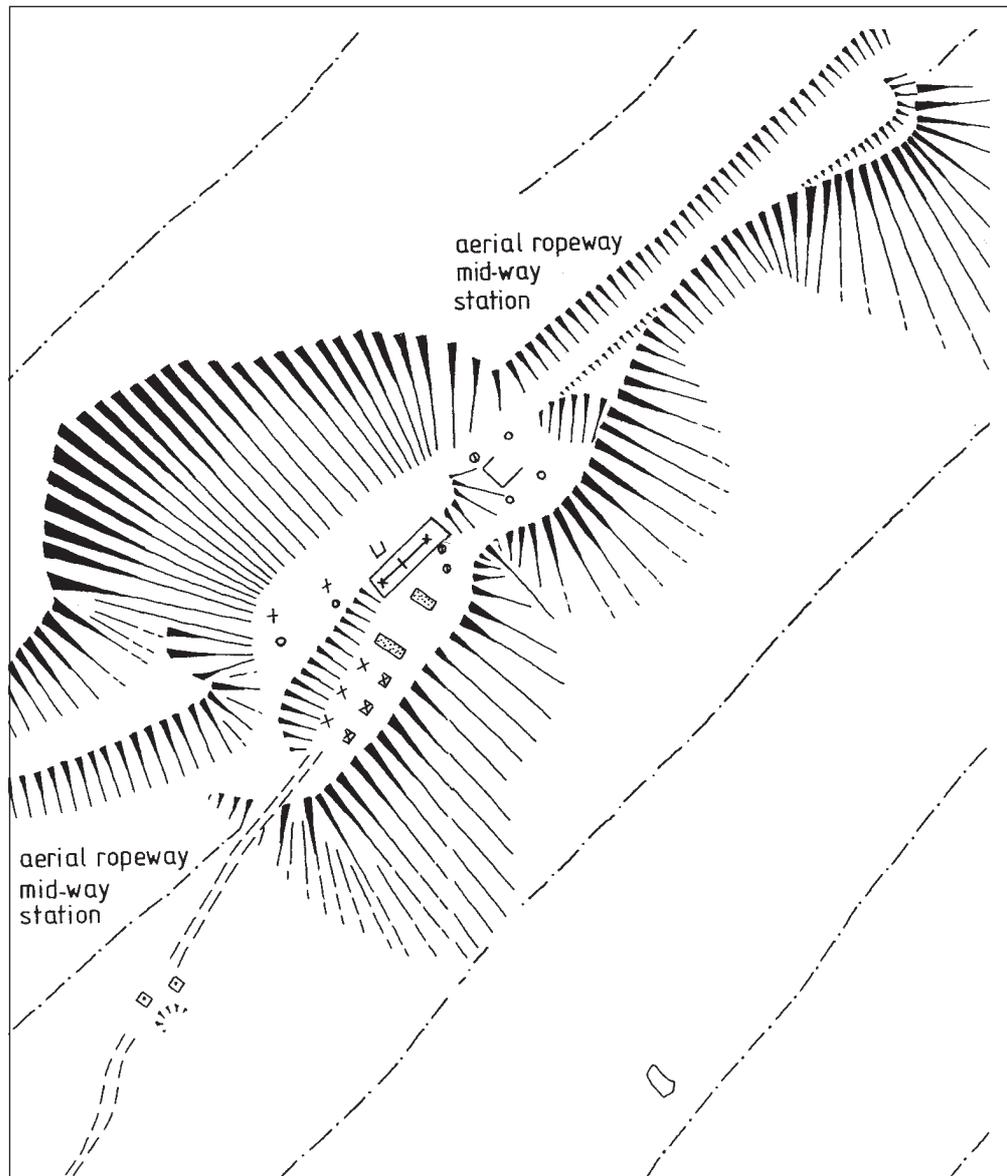
Figure 10a.
Extract from
survey showing
the mid-way
station of the
Aerial Ropeway.

Track 12 was too time-consuming to ensure a regular supply of ore to Mill 3 (Tyler 1990, 53-4). As a result, an aerial ropeway was constructed to transport material more efficiently, at an estimated cost of £10,000. According to Tyler's research, the company involved was the British Aerial Ropeway Company Limited, but all the fragments of the cast-iron wheel units noted during fieldwork are stamped 'Roe's Ropeways Ltd.'; the reason for this discrepancy is unclear. A date formed by slivers of slate pressed into the wet concrete of one of the pylon foundations probably records the completion date:

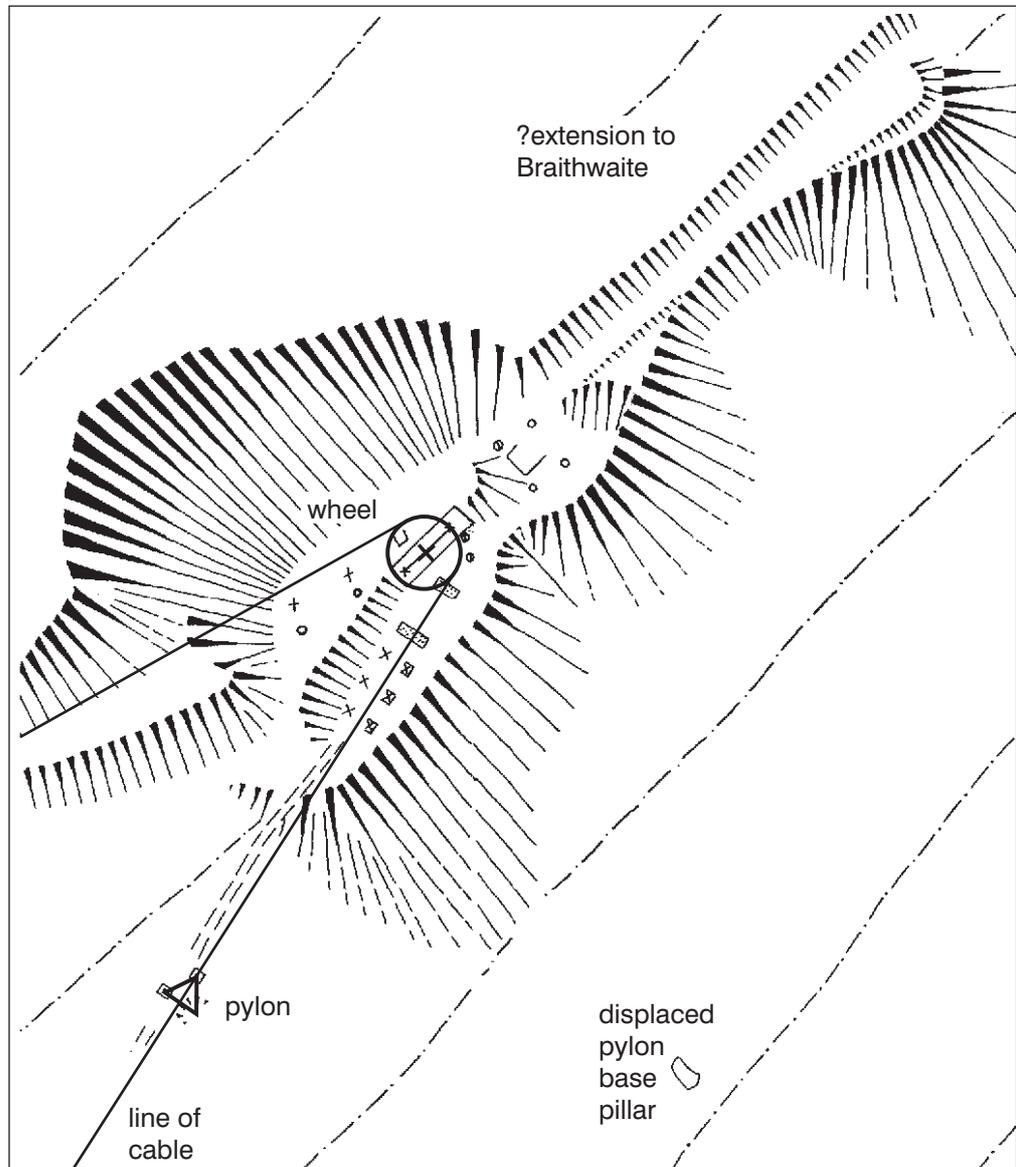
Figure 10b.
Annotated extract from
survey showing the
mid-way station of the
Aerial Ropeway.

The upper terminus at the High Force Workings, which lies outside the area of the English Heritage survey, is shown on photographs taken in the late 1960s or early 1970s (Tyler 1990, figures on page 60, 62 & 96). From there, the ropeway ran to the head of the gully above Level 3, passing over three pylons (*ibid.*, figure on page 57) before steepening in gradient and descending to a mid-way station. There, it turned an acute angle and descended through the upper wing of Mill 3, where the buckets were emptied automatically, and on to a lower terminus. The total length of the ropeway was around 1500m.

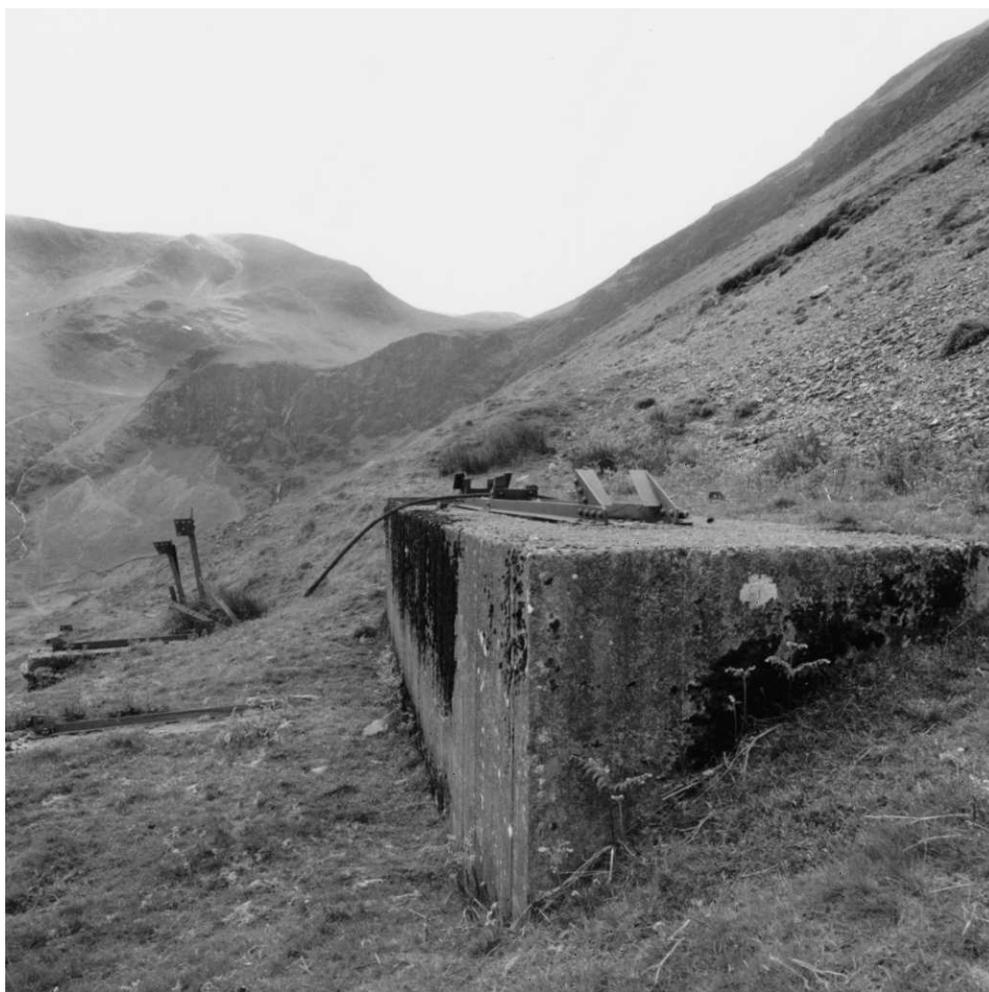
*Figure 10c.
The mid-way station
of the Aerial
Ropeway viewed
from the east (NMR
AA99/04034).*

The mid-way station is built on a level platform terraced into the loose glacial overburden of the hillside, at NGR NY 2020 2201 and an altitude of 341m above OD (see Figure 10). It has been erroneously marked on recent mapping as a disused mine (Ordnance Survey 1978). The key element of the mid-way station would have been a wheel *c.*4.8m in diameter, mounted horizontally at a height of *c.*2m above a concrete plinth, around which the ropeway cable would have turned through an angle of 328 degrees. The wheel itself no longer survives, but its position and size

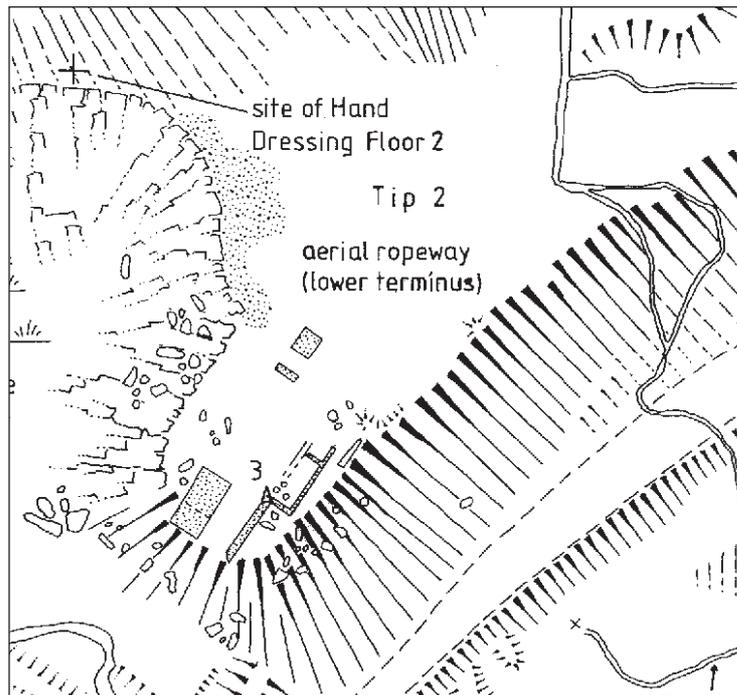
Figure 11a.
Extract from
survey showing
the lower
terminus of the
Aerial Ropeway.

Artifacts relating to the aerial ropeway are scattered widely around the mining complex, but not surprisingly there is a marked concentration in the area below its route. These include the wrought iron cradles and arms that carried the buckets, and fragments of the cast iron wheel units that carried the cable, which are stamped with

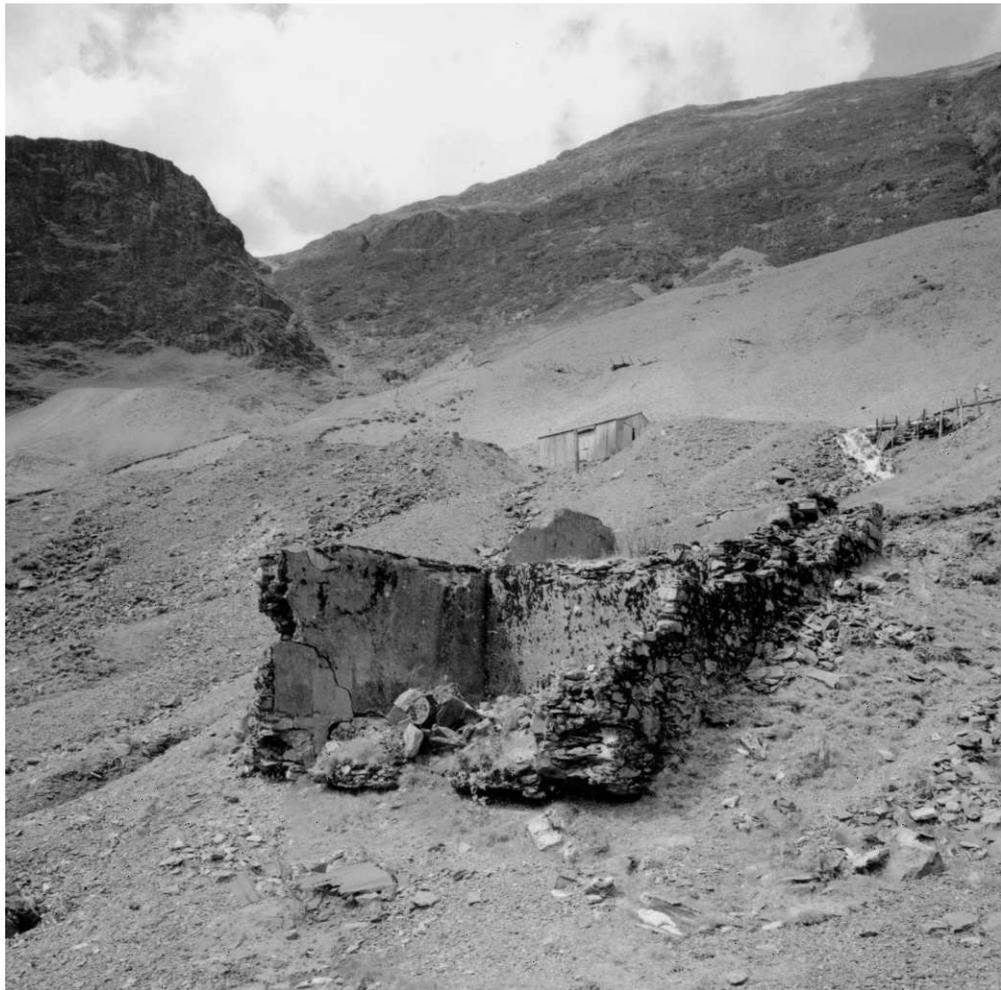
Figure 12.
Cistern 1 viewed
from the
south-east (NMR
AA99/04046).

At a later date, the sides of the cistern were raised by 0.9m and it was extended for 2.7m uphill, enlarging its cubic capacity to 32.94m³. The earlier overflow pipe was

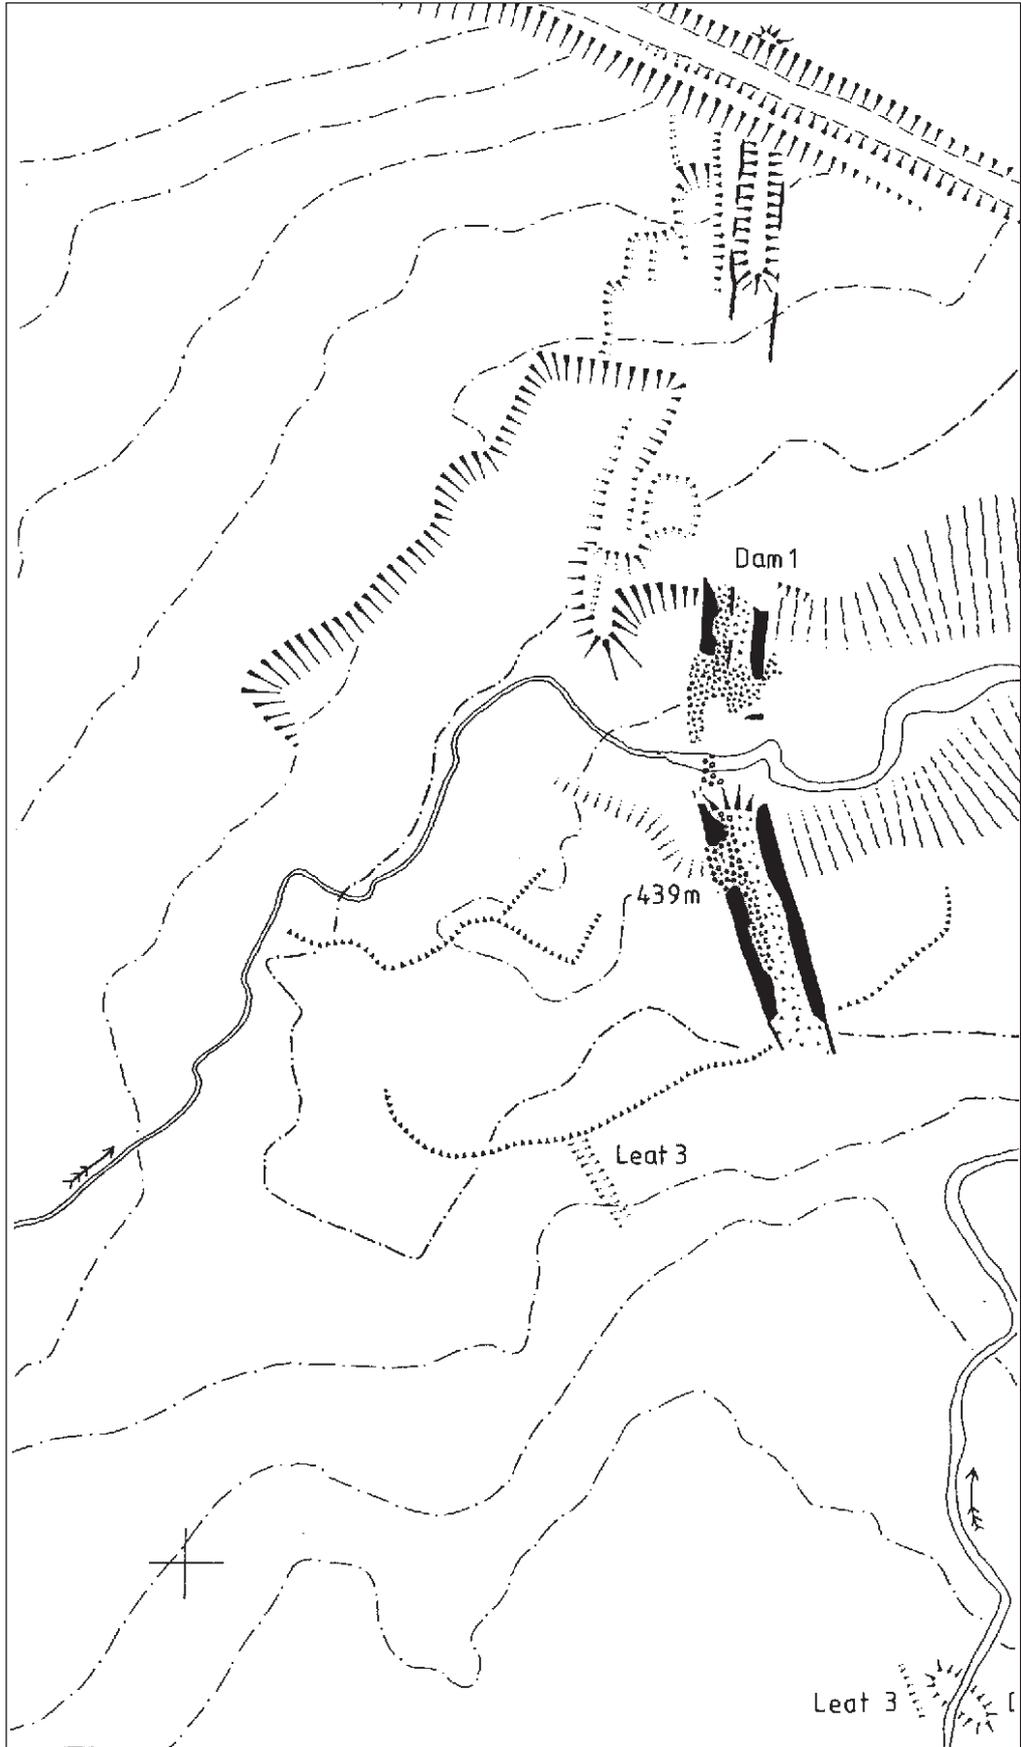
*Figure 13a.
Extract from
survey showing
Dam 1.*

Dam 1 spans the upper reaches of the Coledale Beck at NGR NY 1954 2115 (Figure 13a-c). It was built c.1839 to create a reservoir to supply the waterwheel of Mill 1 during summer droughts (Tyler 1990, 11). The reservoir is shown on the First Edition map surveyed in 1861 (Ordnance Survey 1862), from which it can be inferred that the dam was intact and probably in operation at that date. The dam was repaired in 1912 in order to supply the header pond formed by Dam 4, which in turn supplied the pelton waterwheel which provided power to the newly built Mill 3 (Tyler 1990, 35). There is no evidence that it would have been used after c.1922.

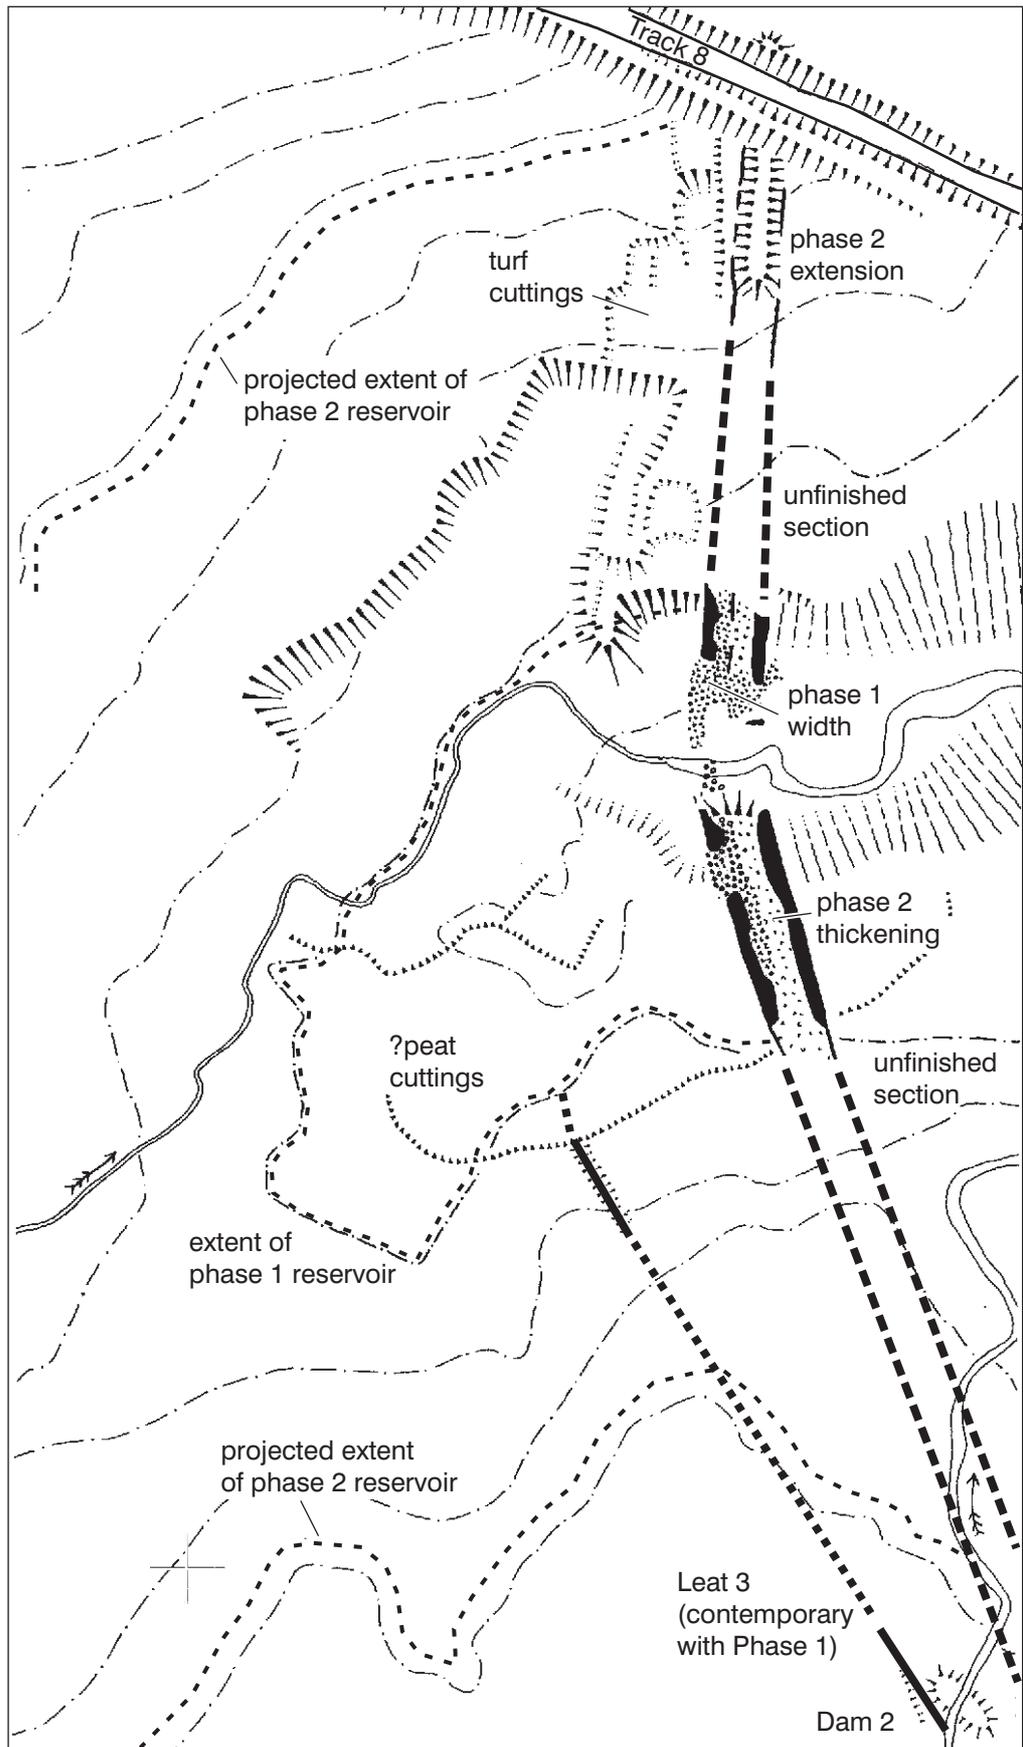
Figure 13b.
Annotated extract
from survey
showing Dam 1.

The dam is sited at the point where the natural rises on either side to the south and north are highest, rather than 30m further east where a much shorter barrier would have been required. The reservoir was not only fed by the Coledale Beck, but also by water from a tributary stream which was diverted along Leat 3. The dam now stands to a maximum height of 1.1m, but must have been considerably higher in the past. It appears to have been constructed in at least two phases, which may correspond to the work done in 1839 and 1912. The earlier phase matches the extent of the reservoir shown on the First Edition Map (Ordnance Survey 1862). It was built of turf and stone with battered revetment walls of roughly coursed slate blocks both front and back. It was approximately 25m long, 2m wide and must once have
