Force Crag Mine, Cumbria

SURVEY REPORT

Archaeological Investigation Report Series AI/1/1999

**FORCE CRAG MINE
ALLERDALE
CUMBRIA**

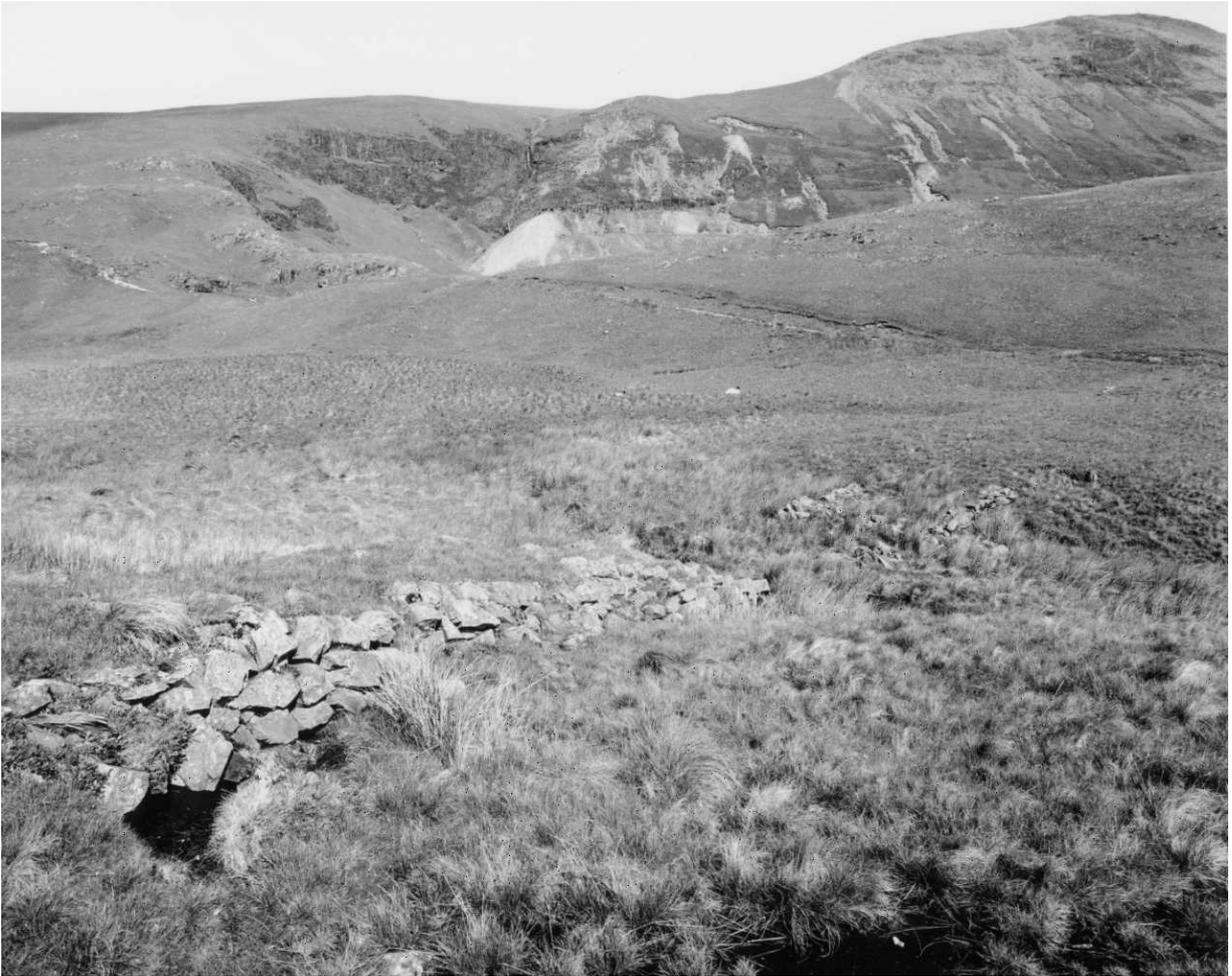
Figure 13c. Dam 1 viewed from the south-east (NMR AA99/04026).

Material to build the dam was evidently dug out in the immediate vicinity. Two different types of digging are evident. Firstly, there are shallow, precisely rectilinear cuttings no more than 0.2m deep which appear to have been dug to obtain turf, as noted above. Secondly, there are sheer-sided cuttings up to 0.8m deep, less regularly laid out, which seem to have been dug to obtain peat. Indeed, it is not entirely certain that these cuttings are contemporary with the construction of the dam, for while one on the northern side of the beck would appear to relate spatially to the shallow turf cuttings, one on the south seems to predate the dam. Equally, it is not impossible that several phases of activity are represented, or that peat was being dug at the same time, but for use as fuel rather than construction material.

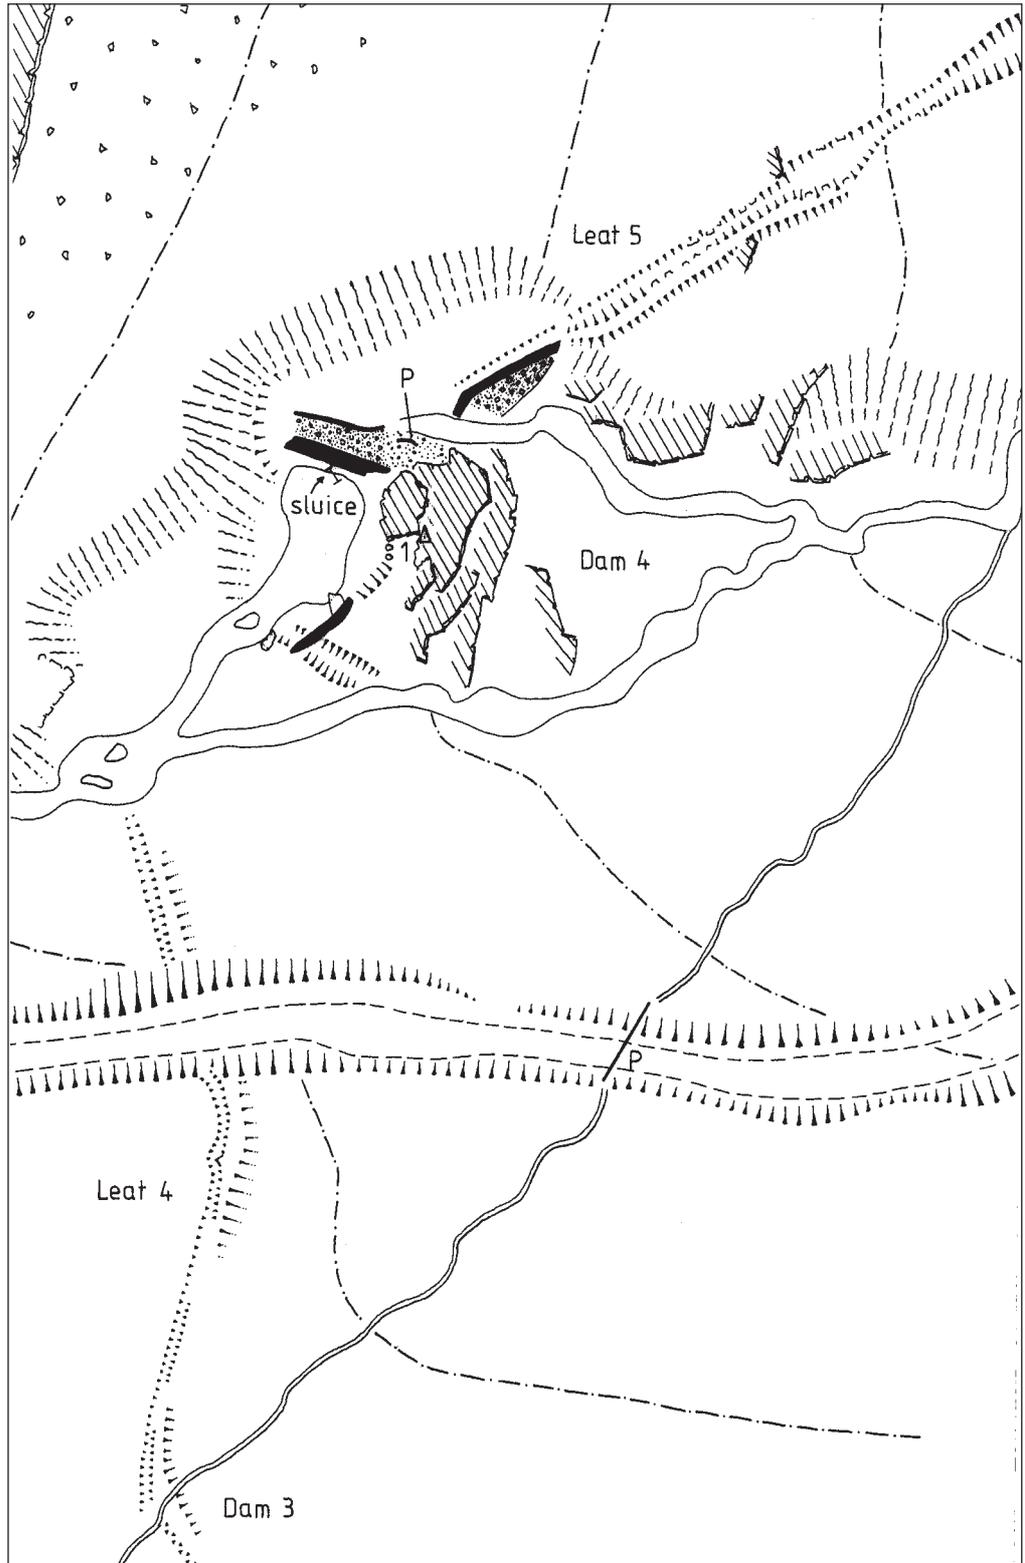
Figure 14a.
Extract from
survey showing
Dam 4.

Dam 4 spans the Coledale Beck at NGR 1965 2122 (Figure 14a-c). It was built in 1912 to form a header pond to supply the newly-installed pelton wheel via Leat 5 and may have been rebuilt in 1917 when the pipe ruptured (Tyler 1990, 35-7). It was disused by *c.*1922. The pond would normally have been supplied from the Coledale Beck, or from Dams 1 and 3 in times of drought.

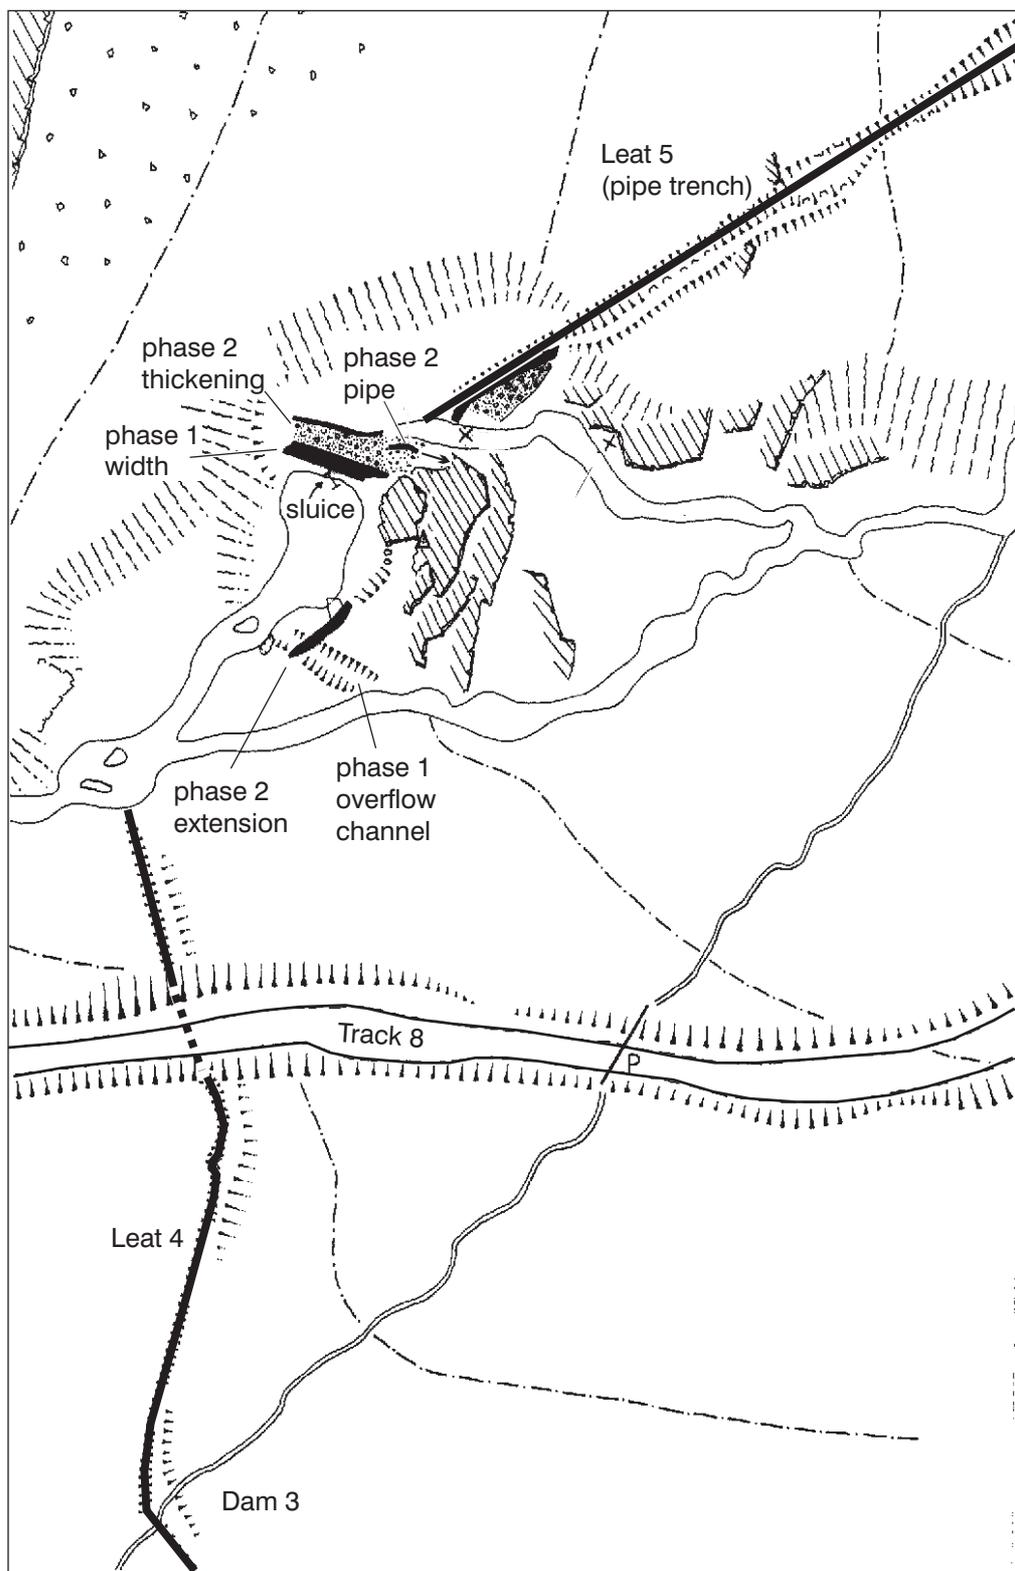
Figure 14b.
Annotated
extract from
survey showing
Dam 4.

The dam was evidently built in two phases, the earlier of which may correspond to either of the episodes of work mentioned above. The final modification seems to have been carried out at a later date. In the first phase, the dam comprised a wall 0.9m thick and 0.6m high, built of slate blocks mortared together and rendered over externally. The resulting pond would have covered a small area, approximately 11m long by 7m wide. This would have had the advantage of limiting the damage done by erosion,

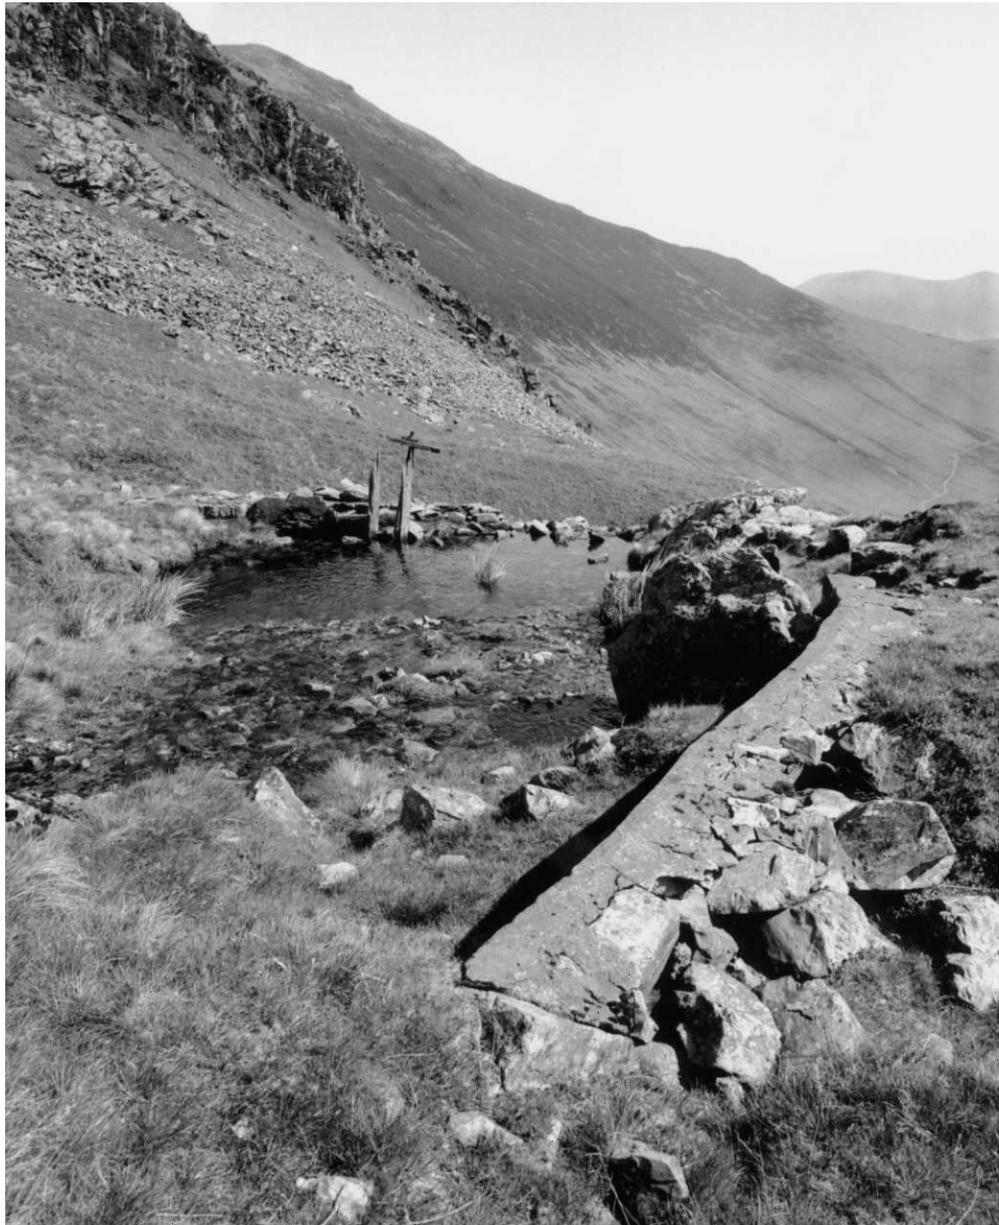
*Figure 14c.
Dam 4 viewed
from the
south-west (NMR
AA99/04036).*

In the second phase, the dam was raised using similar materials to a height of 1.2m and the downstream side of the highest section was reinforced with a lower drystone wall on average 2m thick. The dam was also extended for a few metres to the south, blocking the former overflow channel. The extant sluice, which is preserved in fairly good condition, is probably contemporary with this modification. A cast iron pipe from the sluice gate emerges from near the base of the section of dry-stone wall that reinforces the dam. Significantly, the bore of the pipe (28cms or 11 inches) is

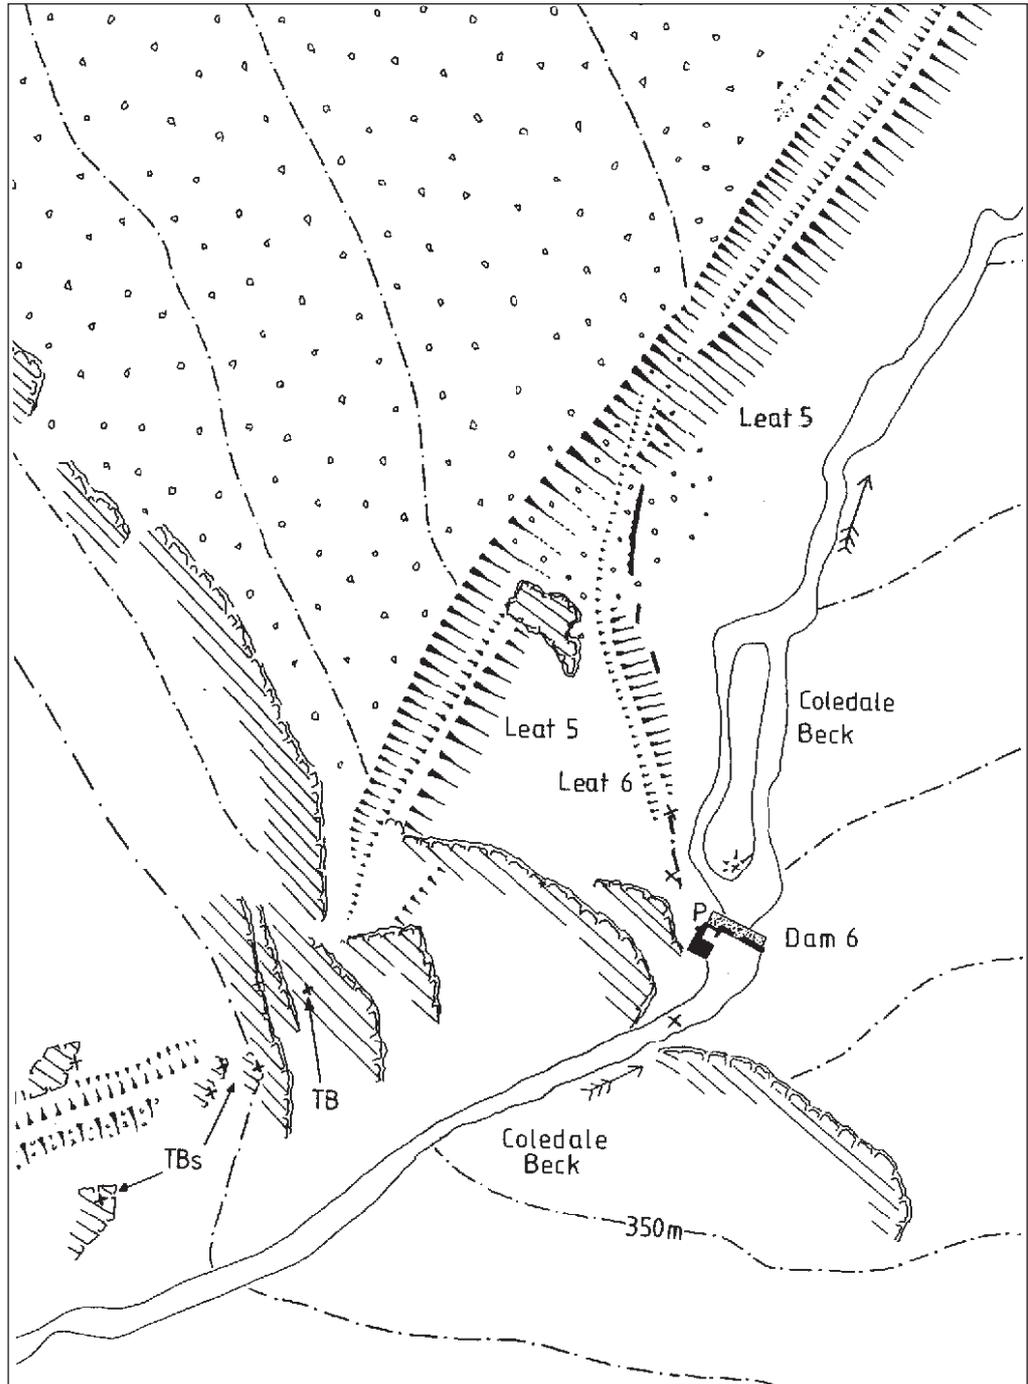
Figure 15a.
 Extract from
 survey showing
 Dam 6.

Dam 6 spans the Coledale Beck at NGR NY 1980 2129 (Figure 15a-c). It seems to have been built to create a head of water for a pipe, in a similar way to Dam 4, suggesting that it may have provided water to a pelton wheel. The date of its construction is uncertain, but the relationship of Leat 6 to Leat 5 and the roadstone quarry indicates that it was built after c.1922 and before 1961. The form and condition of the concrete, filter grill and pipes would suggest that the structure was built in the middle of the 20th Century, and the period between 1939 and 1947 is perhaps the most likely context for its construction.

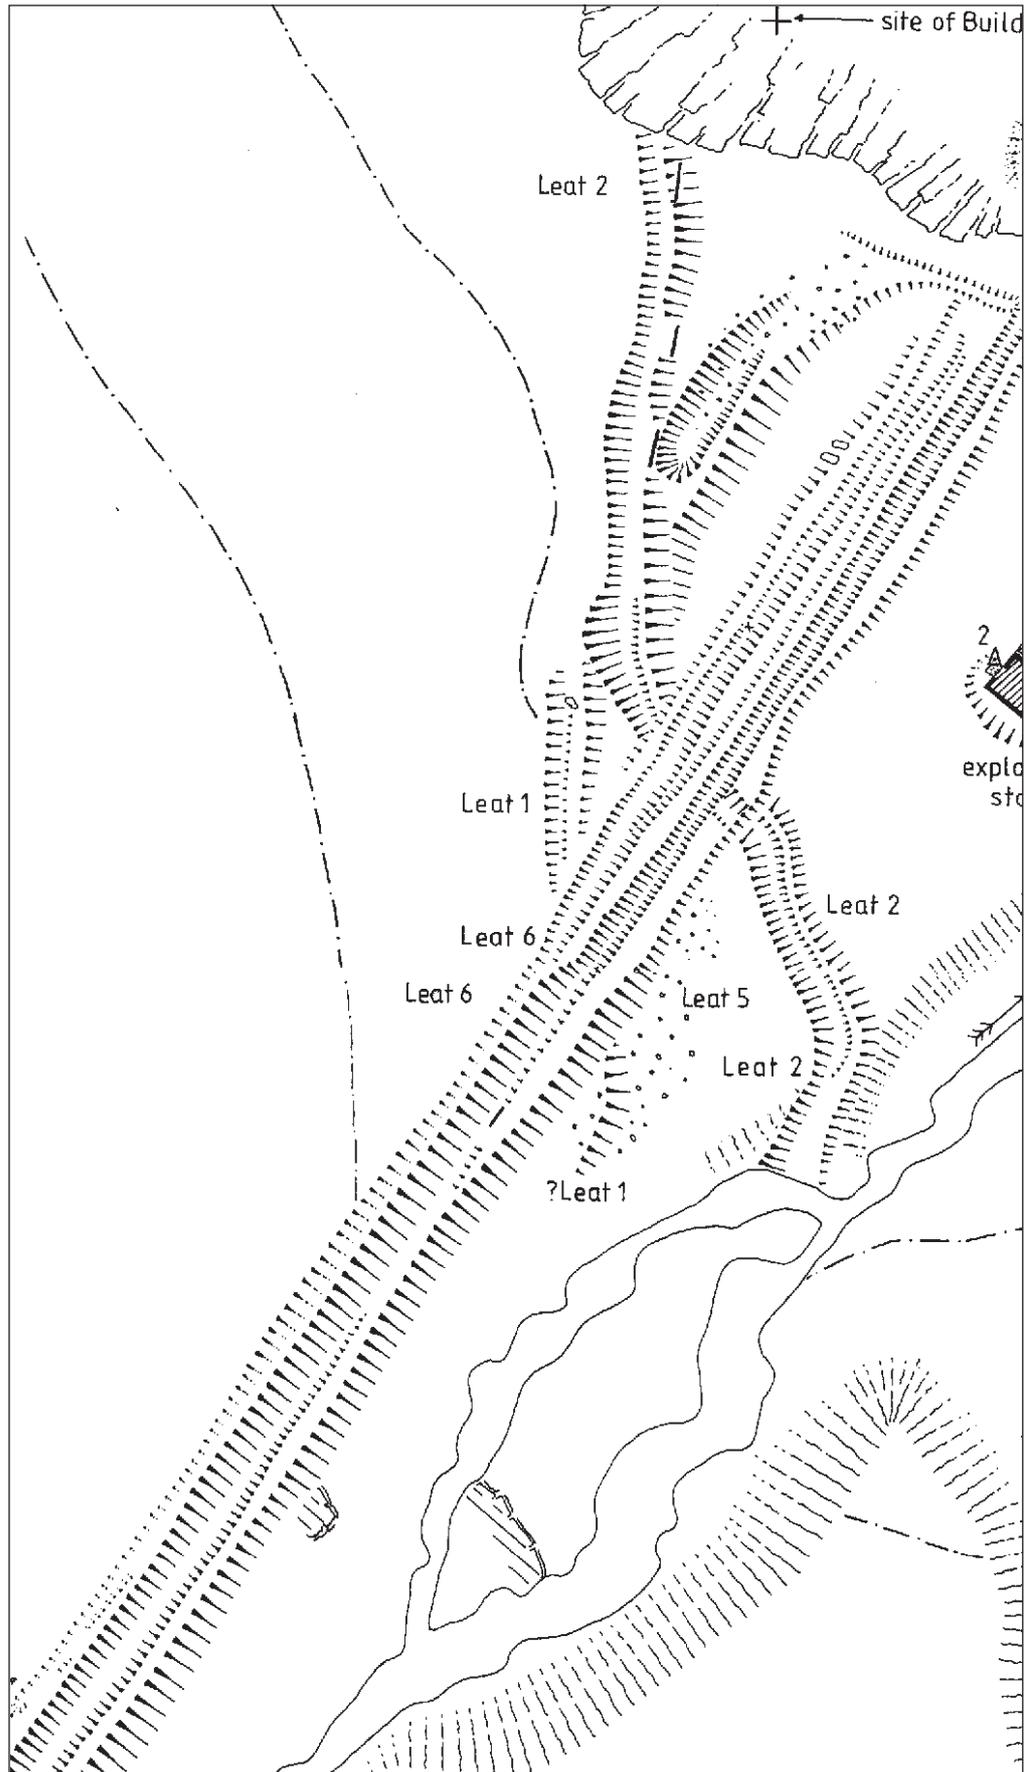
Figure 16a.
 Extract from
 survey showing
 Leats 1, 2, 5 and 6.

Leat 1 appears to predate Leat 2, which is known to have served Mill 1, making it is possibly the earliest artificial water course at Force Crag (see Figure 16a-b). However, the interpretation of the earthwork as a leat is open to some doubt. At NGR NY 1984 2142, a 15m stretch aligned from south to north is relatively well-preserved as a 0.5m wide channel of minimal depth, inclining unusually steeply across the contours. Further to the south, its course is overlain by Leat 5 and Leat 6, but there are slight indications that the underlying earthwork would have originated at the Coledale Beck. To the north, its course is cut by Leat 2, but it appears originally to have flowed into a slight rectangular depression cut into the hillside. This depression measures approximately 10m long by 3m wide, and is embanked on the downslope side to a height of 0.2m. In plan, the earthwork is suggestive of a wheel-pit, but the difference in height between the leat and the depression is not great, nor is the form of the

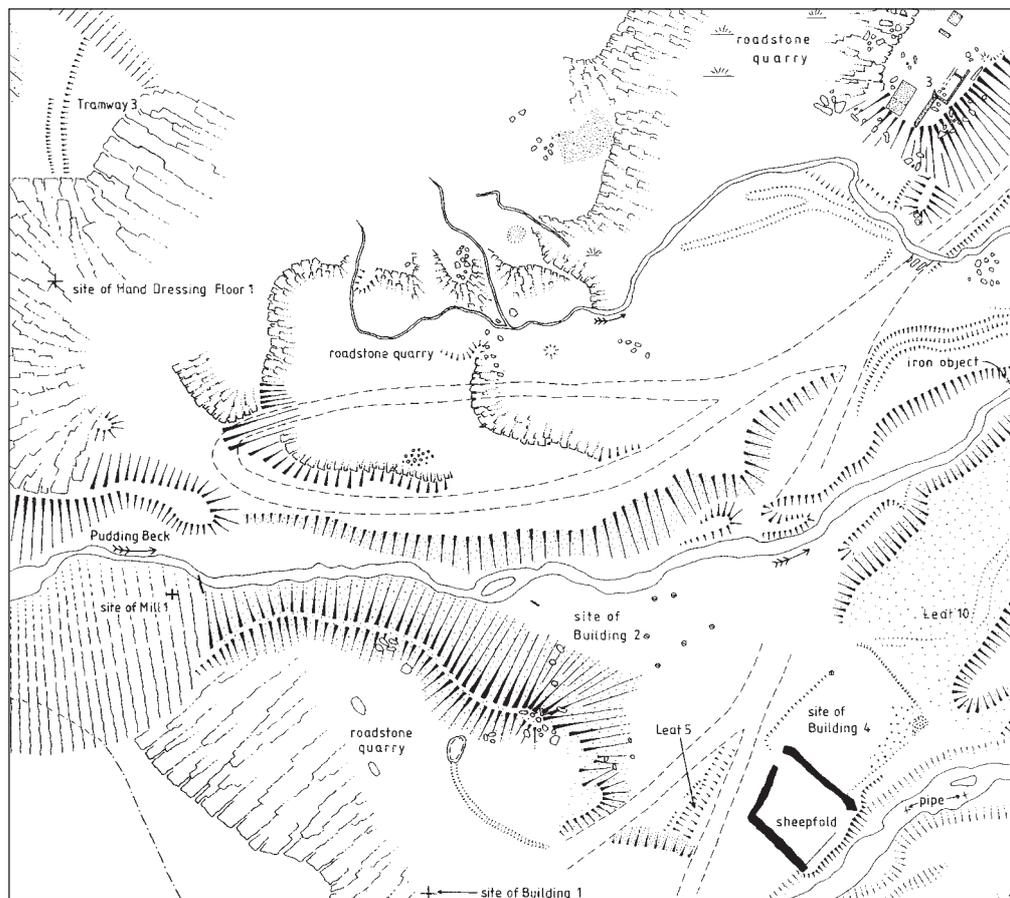
Figure 17a.
Extract from
survey reduced to
1:1000 scale
showing Mill 1.

The First Edition map surveyed in 1861 (Ordnance Survey 1862) depicts a rectangular feature which seems to represent a water wheel pit (possibly roofed over) on the southern bank of the Pudding Beck at the northern end of Leat 2, at NGR NY 1981 2150. However, the feature is not annotated as a water wheel, which may indicate that it was not in use at the time of the map-making. Tramway 2 is depicted as terminating adjacent to the feature, and the field remains of Tramway 3 and the Slushing Channel suggest that they also terminated at approximately the same point. Much of the surrounding area has been either destroyed by the roadstone quarrying that took place in 1961, or is now buried beneath the bank of spoil dumped around the edge of the quarry. However, what little is still visible on

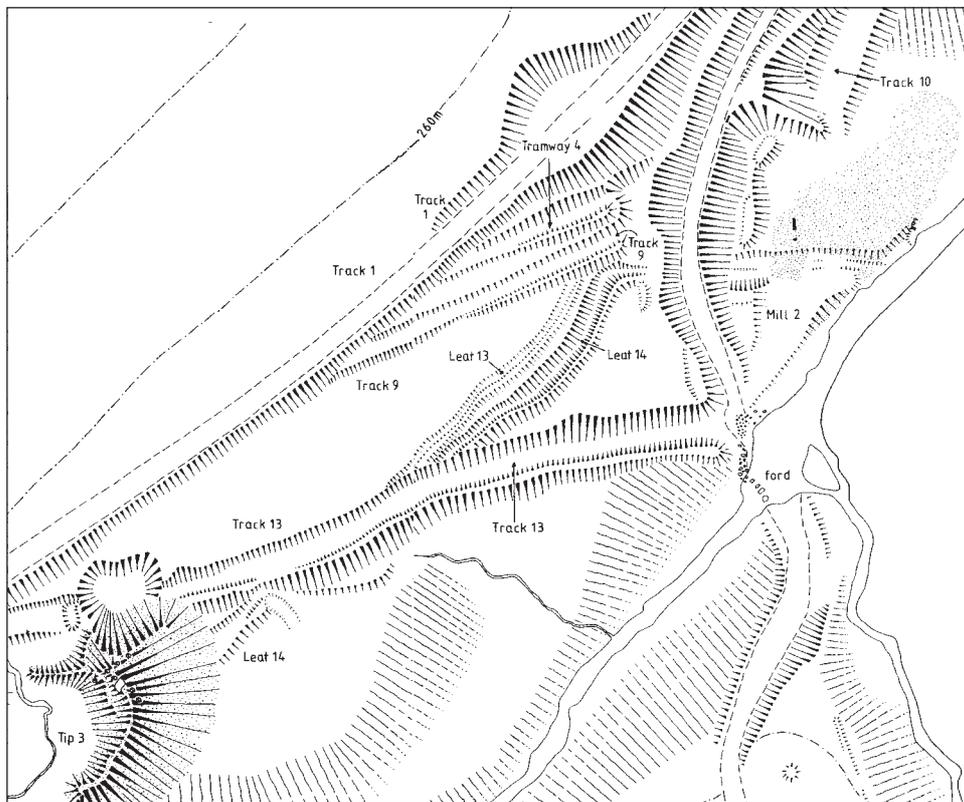
*Figure 18a.
Extract from
survey reduced to
1:1000 scale
showing Mill 2.*

On the raised area to the north of the wheel pit, a possible wall or foundation can be traced as a carefully laid line of squared stones 3.0m long, aligned at right angles to the wheel. This lies flush with the surface, which entirely comprises tailings from the mill. A square structure is depicted in approximately this position on the First Edition map, and seems to have been enlarged by 1881 (Ordnance Survey 1862; 1900). Two distinct mounds of material, now grassed over, lie on the surface of the raised area.

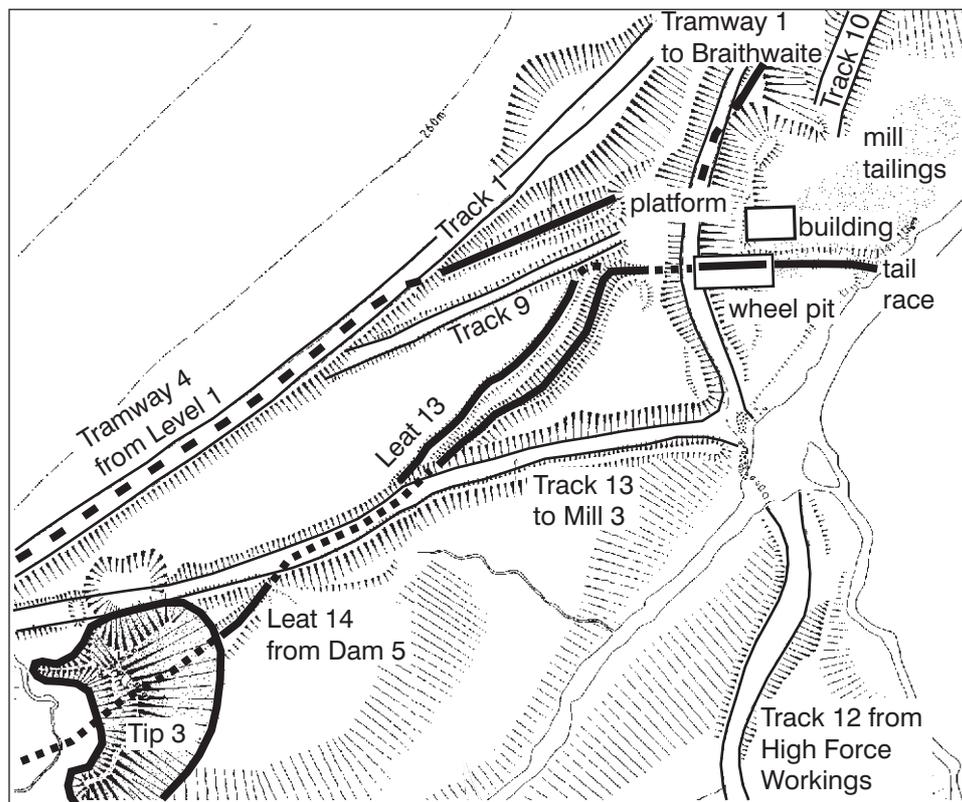
Figure 18b.
Annotated
extract from
survey reduced
to 1:1000 scale
showing Mill 2.

Above the wheel pit, the present course of Track 12 cuts through a level platform terraced into the natural slope. The First Edition map surveyed in 1861 indicates that the track originally terminated at the platform (Ordnance Survey 1862). Track 9 and Tramway 4 also terminate at this level area, which lies c.4m above the structure below. Ore would presumably have been tipped from here into the crusher.

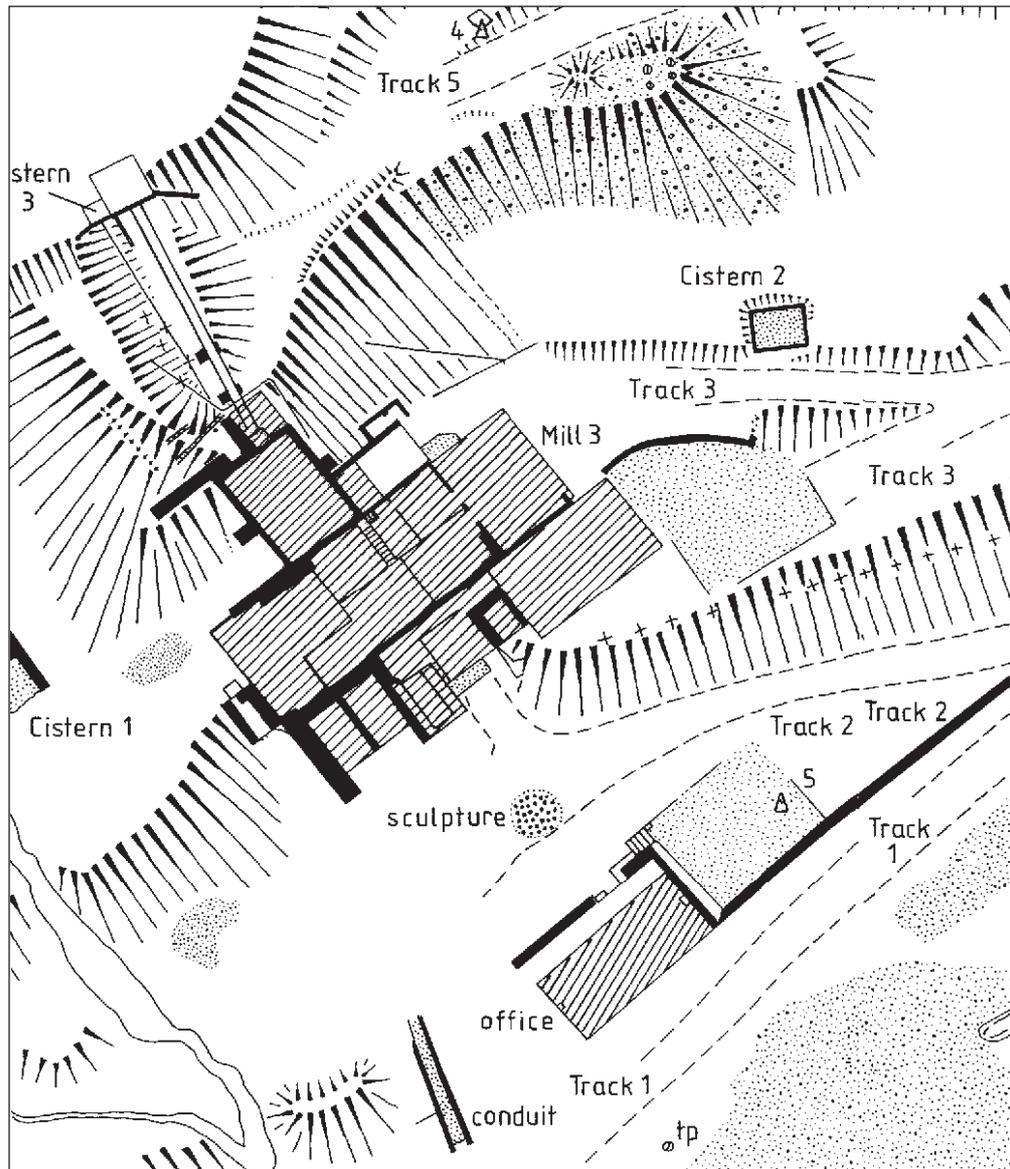
Figure 19a.
Extract from
survey showing
Mill 3.

Mill 3 is sited at NGR NY 1997 2163, some 50m south-east of Level 1 and 10m downslope from it. In addition to the survey at 1:500 scale that formed the basis of the field investigation, limited additional architectural recording was undertaken, comprising a photographic survey and analytical examination of the interior, and a measured survey at 1:100 scale of an elevation/section through the building (Figure 20). In conjunction with the documentary evidence, seven constructional phases can be identified (Figure 21), but it seems likely that the internal arrangements may have changed more frequently to accommodate new machinery. Scars resulting from the

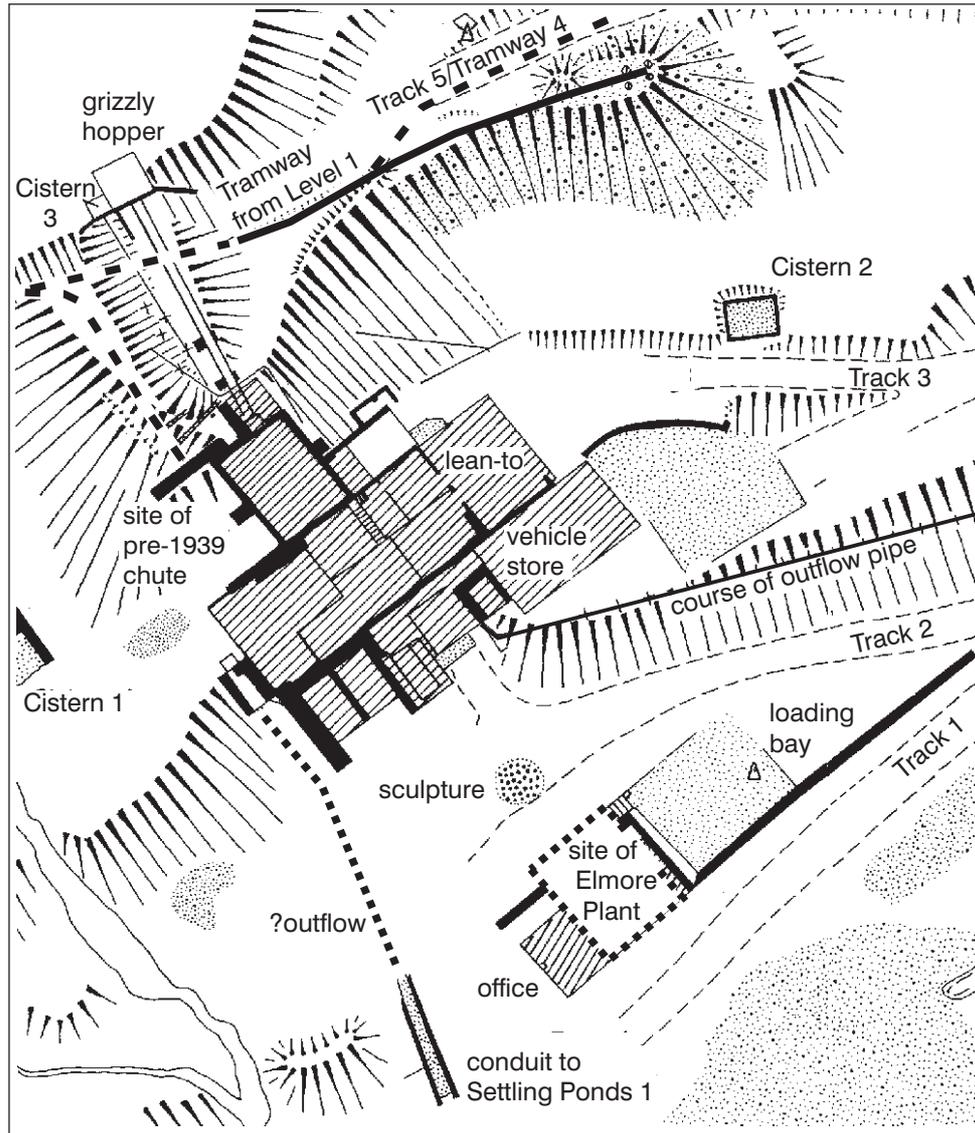
Figure 19b.
Annotated
extract from
survey showing
Mill 3.

The building completed in 1909 under the tenure of Cumberland Mines Limited seems to have comprised two rectangular ranges, each two storeys high, placed end to end and stepped down the natural slope. The masonry elements are constructed in roughly dressed slate blocks with quoins of orange/brown brick. The foundations and lintels are of concrete, the aggregate comprising tailings from the mill. Most of

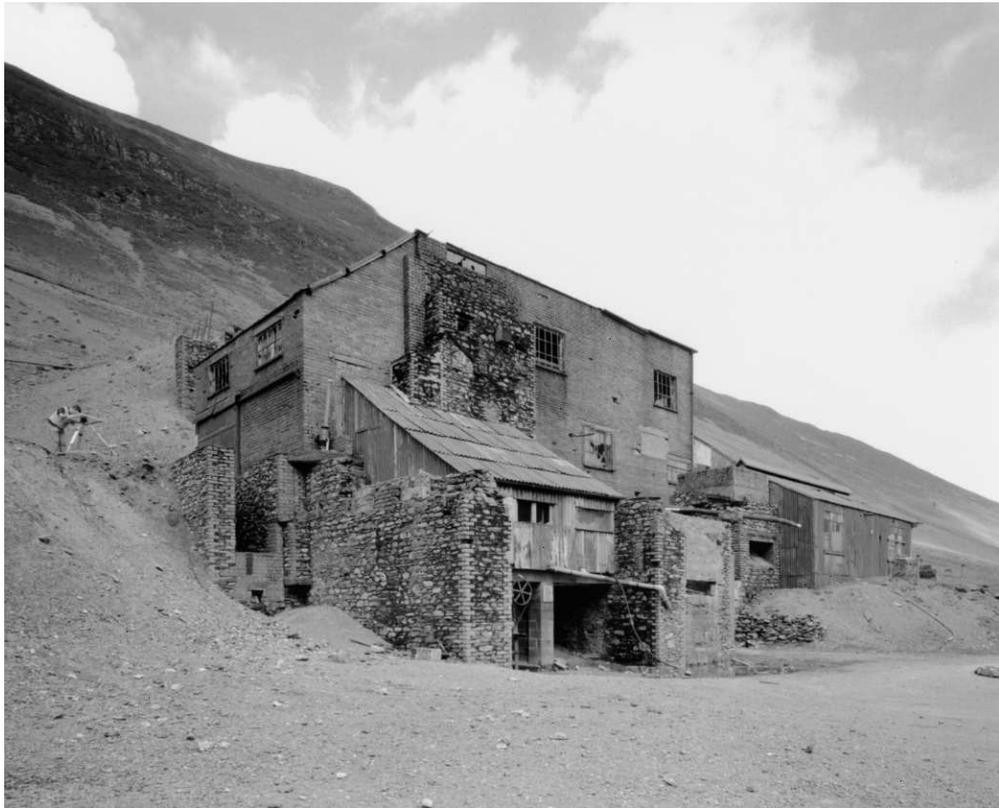
*Figure 19c.
Mill 3 viewed
from the
south-west
(NMR
AA99/04044).*

The upper range measured 6.0m wide by 9.0m long with its long axis aligned north-west to south-east, *ie* up and down the natural slope. Ore was fed into the room on the first floor at its upslope end, arriving via a steeply inclined timber chute which rested on the rear wall of the building and a taller free-standing pier. The chute no longer exists but the pier survives to its full height of at least 8m. Immediately behind the top of the pier, two horizontal timbers attached to vertical posts are partially buried in spoil and fairly well preserved, and it seems likely that some of the rest of the structure may survive beneath the surface. This structure may correspond to a timber gantry carrying a tramway from Level 1 out to the top end of the chute, which is shown on the photographs of c.1916. The floor of the room on the first storey was supported by massive beams, of which a number still survive, each 0.3m square. However, the photographs of c.1916 suggest that the superstructure was relatively lightly constructed of timber and corrugated iron, doubtless to reduce its weight. In the room on the first floor, the barren and oversize rock was presumably sorted by hand before being fed down to the crusher on the floor below. At ground-floor level the range was open on both sides, with massive walls at each end, which still survive. Vehicular access to the machinery would have been possible along Track 3. A door in the downslope wall (blocked in Phase 3 and re-opened subsequently) would have provided access into the lower range at first floor level.

The lower range was 6.0m square, and constructed in a similar way to the upper range. The floor of the room on the first storey was supported by massive beams, each 0.3m square. Although the original superstructure has been removed, the scar of the steeply pitched corrugated iron roof can be traced on the exterior of the end wall of the upper range. A line of circular timber studs, all sawn off just above floor level, appear to represent a remnant of the south-western wall. To the east of the main part of the lower range is another wall constructed in the same materials on the same alignment, which gives the building as a whole a T-shaped plan. This wall is much less massively

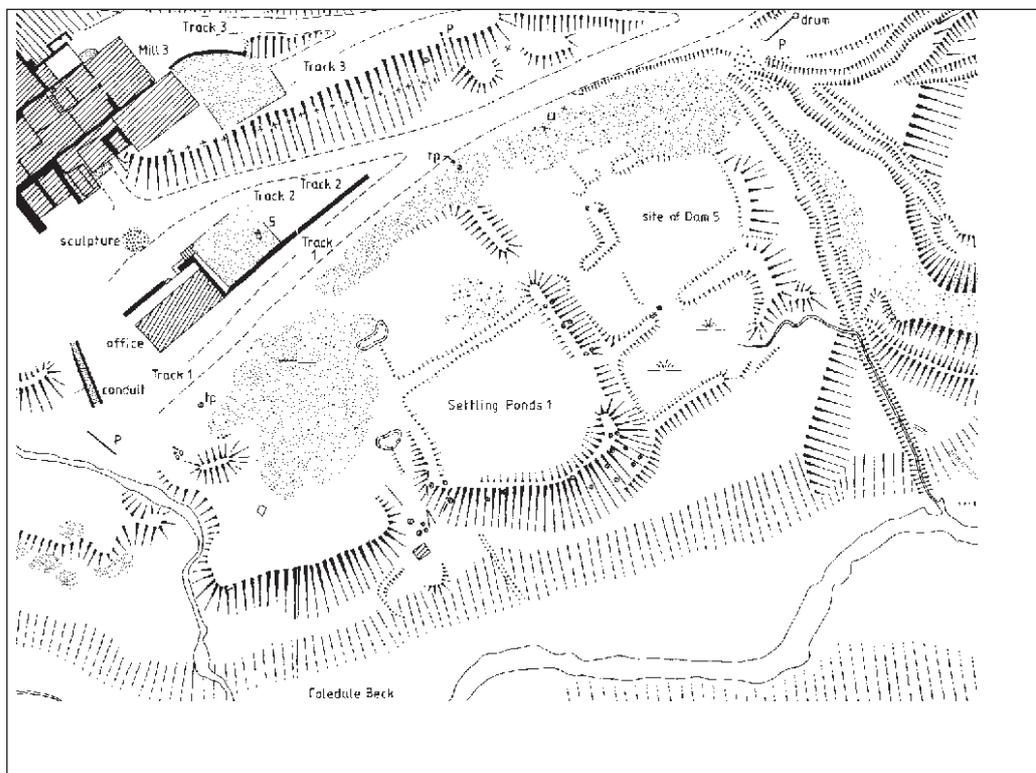
Figure 25a.
Extract from
survey reduced
to 1:1000 scale
showing Settling
Ponds 1.

400m² in extent, but one is L-shaped because its outline follows the plan of the pre-existing dam. The three ponds at the eastern end of the arrangement remain boggy and are now clogged with rushes. Some of the ponds were evidently interconnected by sluices; timbers that are probably the remnants of two wooden sluice gates survive. It is possible that the outflow from the easternmost pond was fed directly bank into the Coledale Beck. Alternatively, it may have been fed into a larger pond on the site of Settling Pond 2, and from there back into the Coledale Beck.

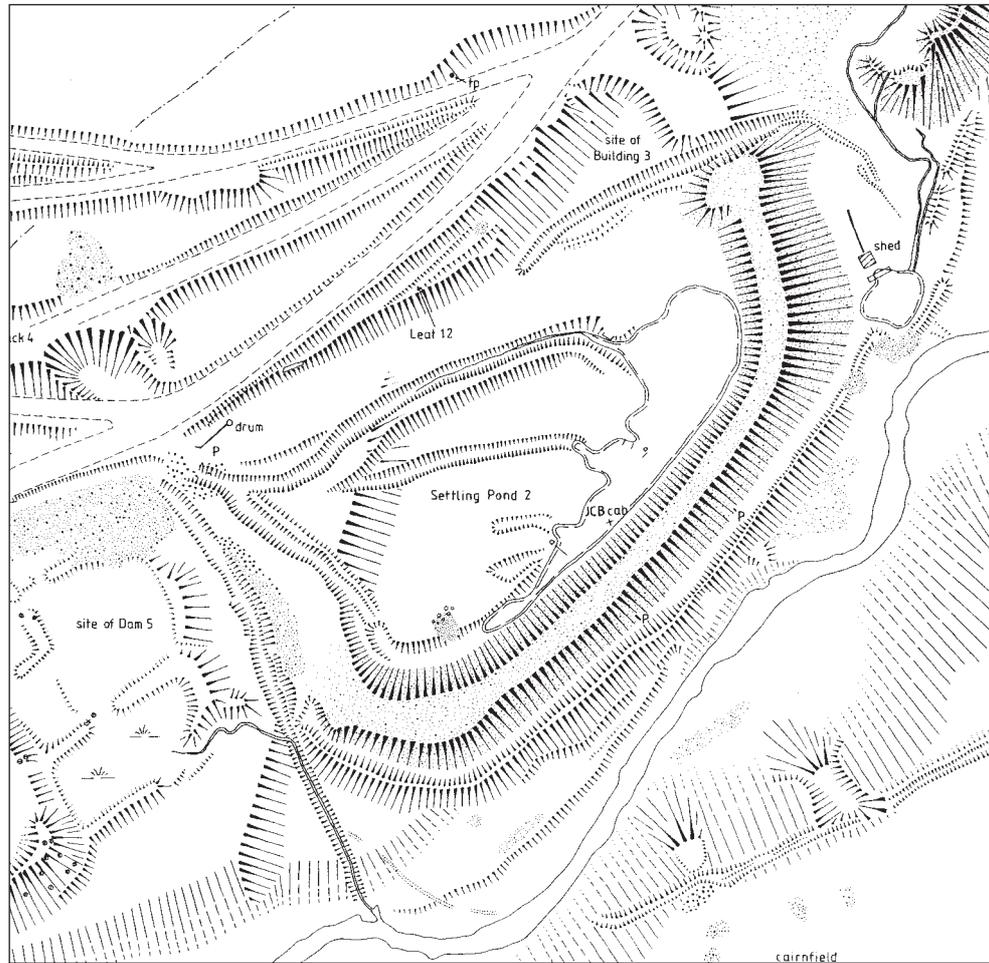
Figure 26a.
Extract from
survey plan
reduced to 1:1000
scale showing
Settling Pond 2.

Settling Pond 2, centred at NGR NY 2012 2164, appears to have originated as a large pond to the east of Settling Ponds 1, and indeed may have been contemporary with their construction (Figure 26a-b). It is unclear whether water was fed into the pond from Settling Ponds 1, or directly from a separate drainage channel that by-passed the other ponds. What may be a remnant of such a channel extends along the southern edge of Track 1. Sections through the sub-surface deposits are exposed in the northern bank of the Coledale Beck and both sides of a recut drainage ditch to the east

of Settling Ponds 1. In these sections, the thin natural topsoil is overlain by a layer of fairly clean yellow clay up to 8cms thick, which may have been deliberately laid across a large area to form an impermeable lining prior to the construction of the settling ponds. The clay may be a glacial deposit occurring naturally in the vicinity, since clay of similar appearance (though less clean) is visible below the topsoil in the sides of the cutting made for Level 0 and elsewhere. The pond itself then appears to have been formed by the construction of an earthen bank up to 0.9m high on the downslope side. An outward projection at the eastern end of the bank coincides with a small pool from which a rush-filled channel leads to the Coledale Beck, through which the outflow was apparently allowed to rejoin the stream. The pool was apparently deepened in a later phase of use.

During the most recent phases of the use of the mining complex, the earthen embankment that originally enclosed the settling pond was replaced by a more massive bank up to 2.5m high. This is formed entirely of fairly small slate fragments that appear to represent spoil from mining operations underground. Prior to the construction of the new bank, some topsoil and turf was evidently bulldozed onto the earlier earthen bank in order to create a broader depression at the rear of the new bank. A plan dated March 1972 depicts the new bank as a 'proposed extension' of the tip outside Level 0 (Cumbria CRO k). However, it seems unlikely that the plan was actually followed precisely, although the outcome was effectively the same. Instead
