Yeavinger Bell hillfort, Northumberland

SURVEY REPORT

Archaeological Investigation Report Series AI/24/1998

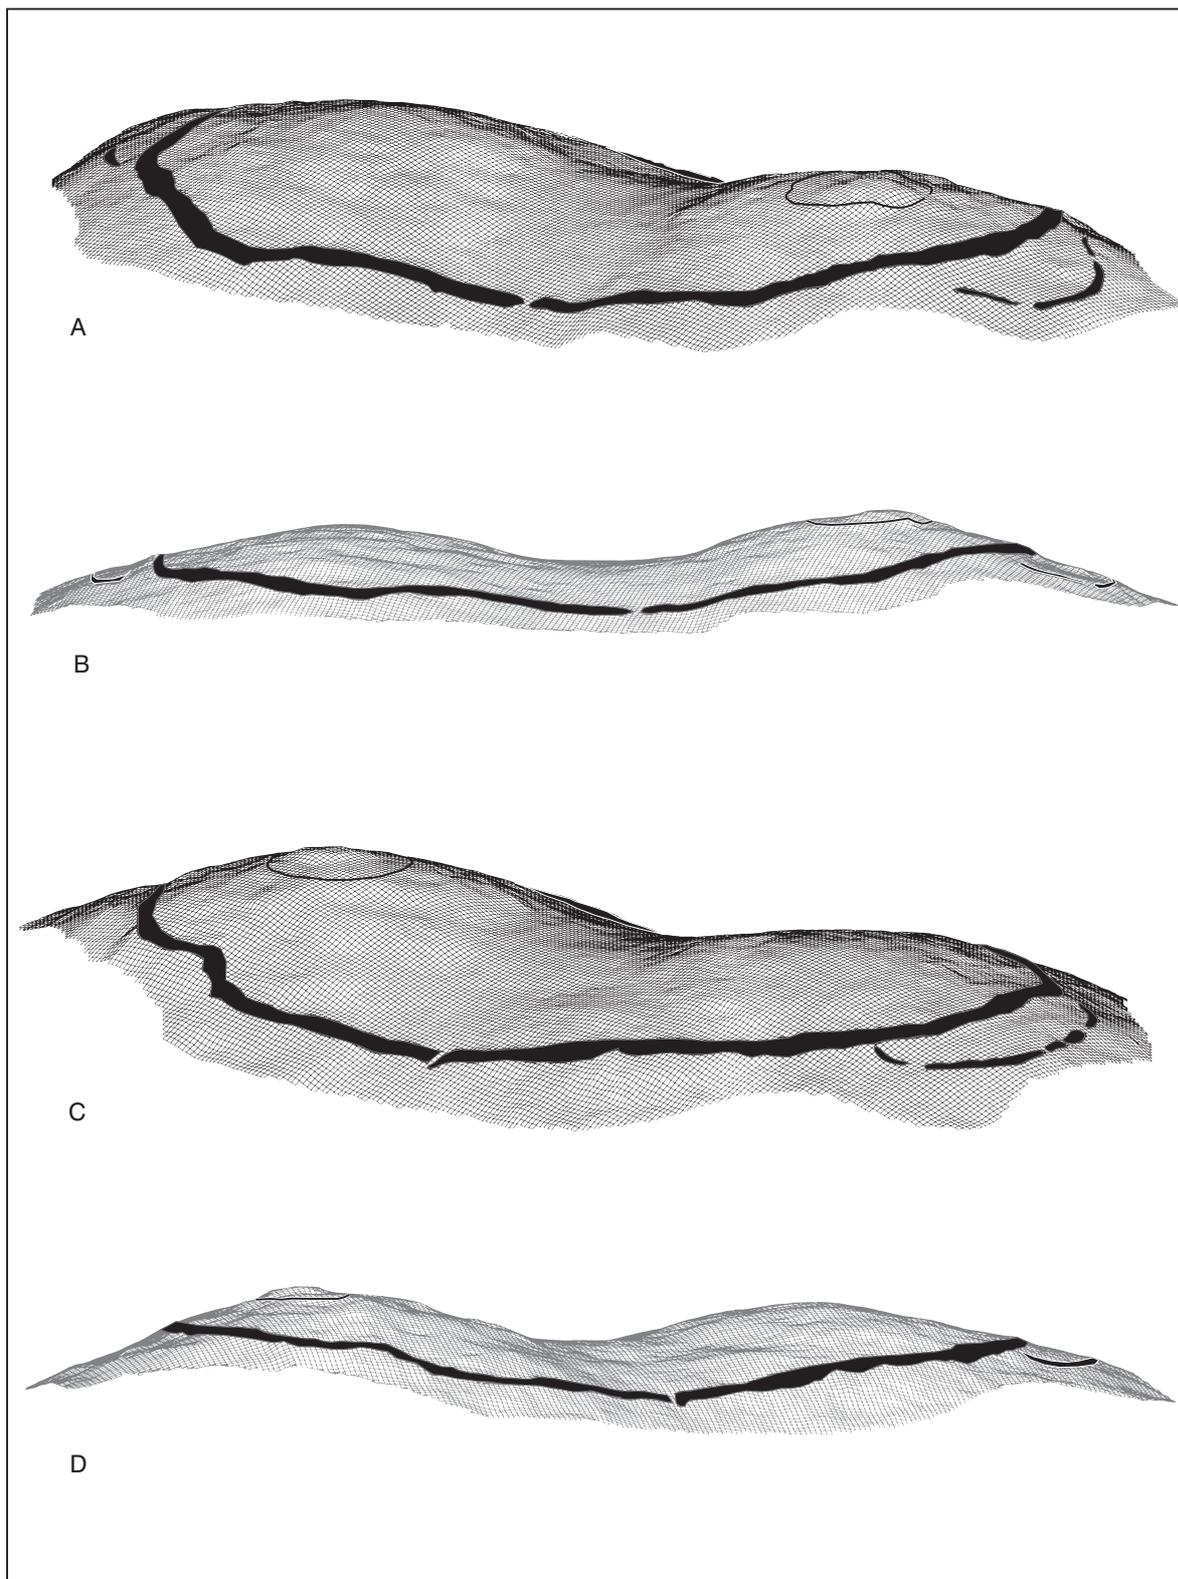
Figure 2. Terrain model of Yeavinger Bell viewed from: (A) the south-east at an elevation of 15 degrees; (B) the south at an elevation of 0 degrees; (C) the north-west at an elevation of 15 degrees; (D) the north at an elevation of 0 degrees

The hillfort entirely encloses the top of Yeavinger Bell (Figs. 2 and 3) which is formed by two opposing peaks of unequal height. The east summit dominates the hilltop, rising 4m higher than its neighbour to the west and 10m above the saddle which separates them. The crest of this saddle and the summit of the two peaks is the only level ground of any note in the hillfort. The north side of the hill falls away steeply for 300m down to the valley of the River Glen as does the west side, descending to the valley of a tributary stream. The east flank of the hill is as steep as on the north and west but the gradient is broken by a shoulder of relatively flat ground 50m below the hilltop. The south side has by far the gentlest descent dropping by less than 100m to the bottom of the 'U' shaped valley separating Yeavinger Bell from the interior of the Cheviot massif. The stream in the bottom of this valley is the closest source of fresh water to Yeavinger Bell and the slope down to it bears traces of having been cultivated since it is relatively free of surface stone and is crossed by several lynchets.

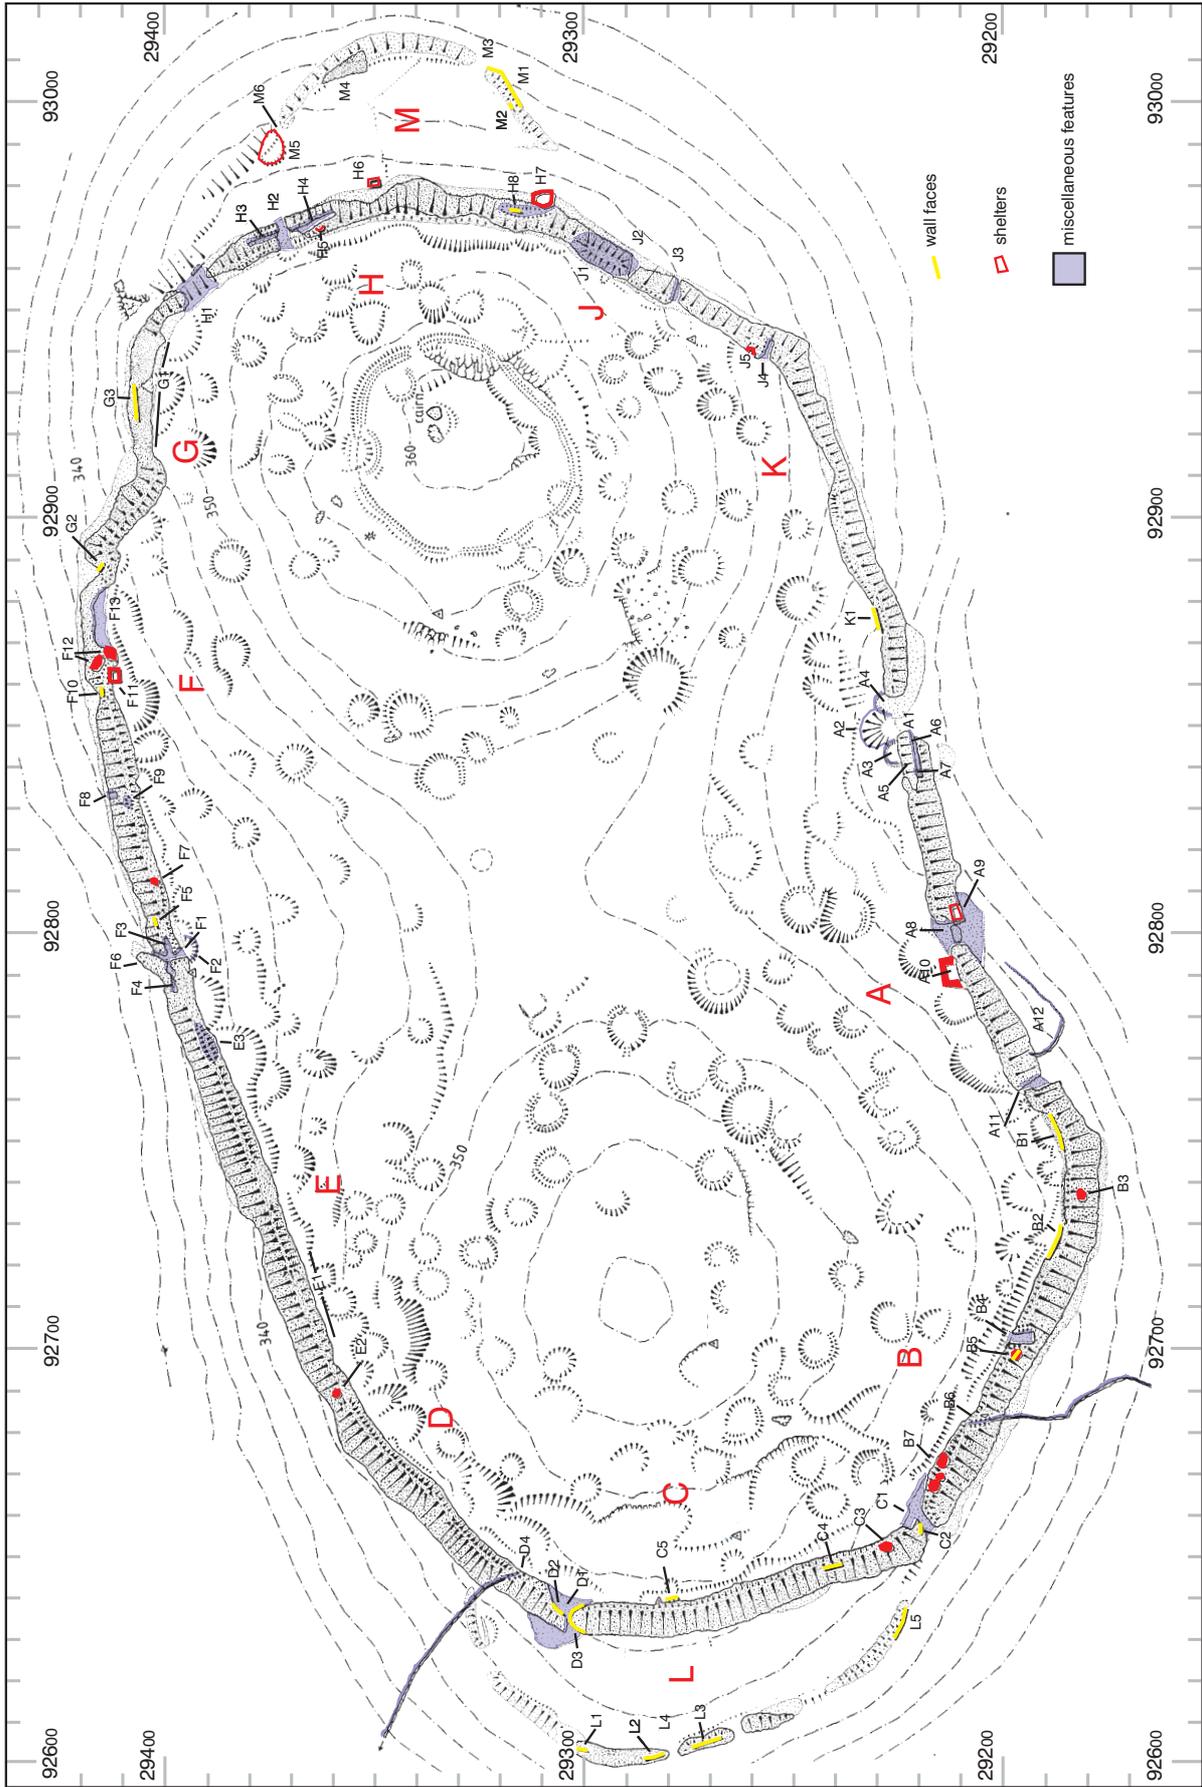
Figure 4. Features related to the perimeter of the hillfort and the two exterior enclosures

The bank is pierced by several gaps, most of which are probably quite recent although up to four have been claimed as original entrances (Tate 1862, 435-6). Other features associated with the bank clearly post-date the collapse of the fort wall and consist of a variety of small shelters and stretches of secondary walling. To assist in the detailed description of the enclosure bank and associated features, it has been divided into ten sections (A-H, J-K) and individual features within each section are numbered in sequence (eg A4, H7) and illustrated on Fig 4.

At A1 is the south entrance into the enclosure. It is 4m wide and stone free, suggesting it is contemporary with the fort wall and not a later entrance pushed through the collapsed bank. The earthfast boulders at the west side of the gap could be significant and represent one side of the original entrance passageway and the 0.6m deep hollow (A2) in the hillslope immediately to the rear could have been eroded by the passage of traffic. Flanking the west side of the entrance on the inside of the bank is a semi-circular, turf-covered bank 0.2m high (A3) in which several small stones are visible. This may be the guard chamber excavated by Tate in the 19th century (Tate 1862, 436) and it is mirrored by a semi-circular bulge on the opposite side of the entrance (A4) defined by a light scatter of stone rubble.

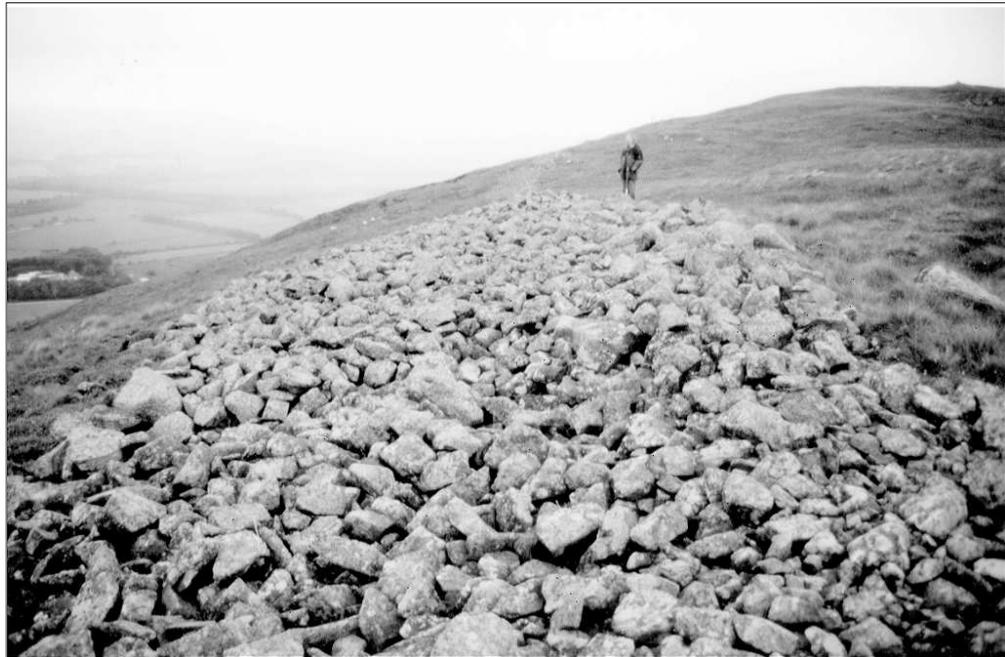
*Plate 1.
Part of the fort
bank on the
north-west,
(section E)
looking east*

In section F large stones re-appear in the make-up of the bank which attains a maximum height on the inside of 0.8m and 2.2m on the outside. There is an entrance into the enclosure at F1 which is a maximum of 2.4m wide, becoming narrower towards the exterior. The west side of the entrance is defined by several large earthfast

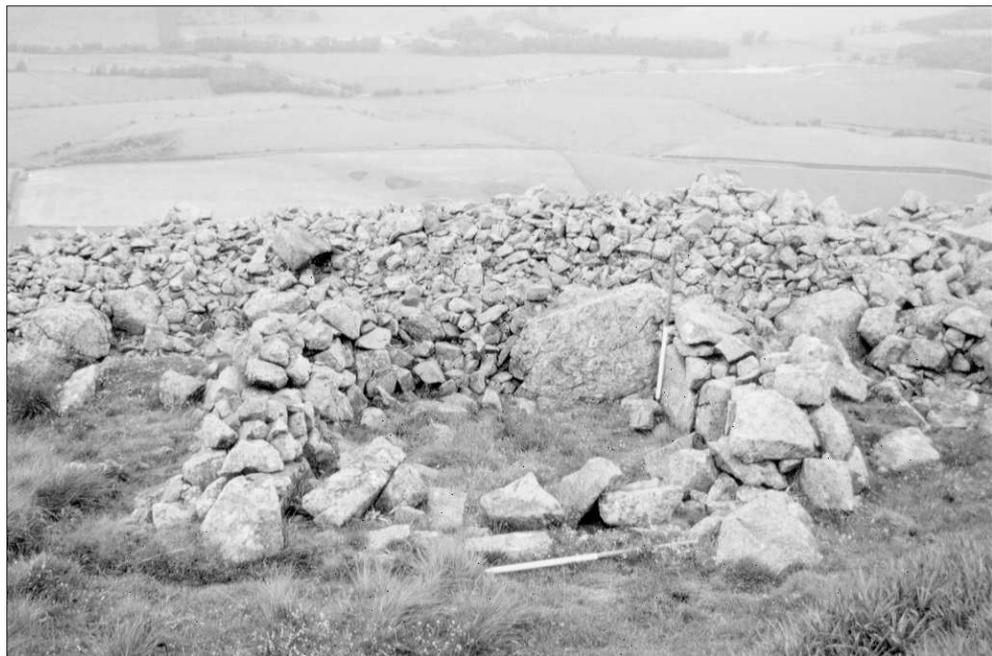
*Plate 2.
Recent shelter
(F11) on the
inside of the
north bank*

recent. The entrance to this structure was on the south-west whilst a large boulder about 0.8m high and 1.0m long in the north-east corner is probably a surviving part of the inside face of the fort wall. Bilberry growth at F13 obscures part of the enclosure bank.

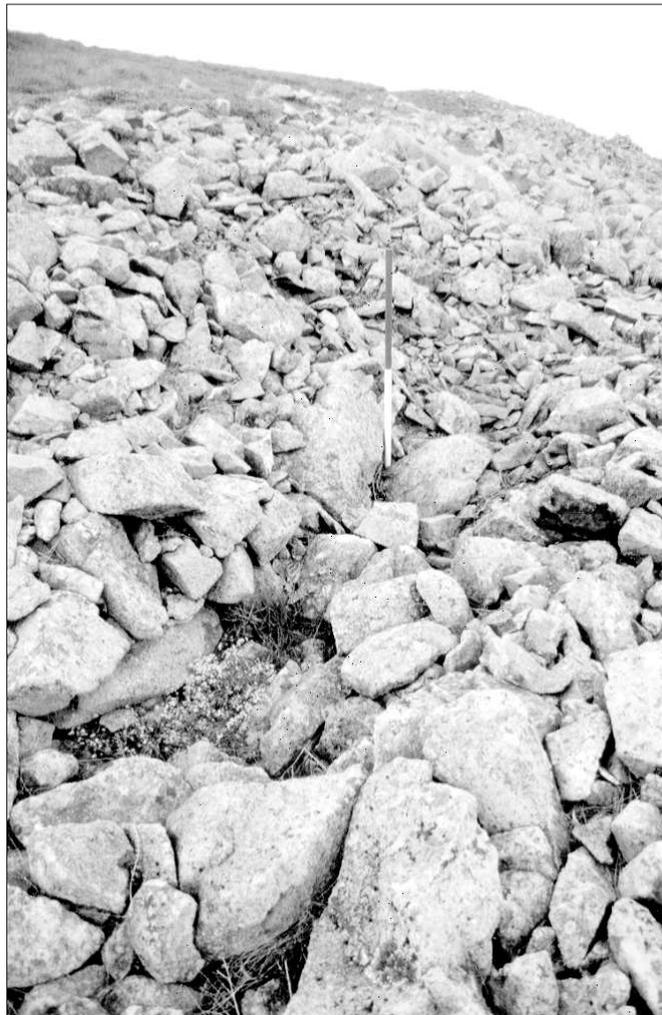
*Plate 3.
A section of the
exterior wall
face (H9) on the
east side of the
fort*

is no obvious sign of an entrance with this shelter. Nearby, stones have been cleared along the centre of the bank (H8), revealing a 0.7m high wall face composed mainly of large basal stones up to 0.8m in length (H9). The result of clearing around this wall face has left a linear hollow similar to those noted earlier at some of the openings through the bank (Plate 3). Like them, it probably indicates the site of an archaeological investigation.

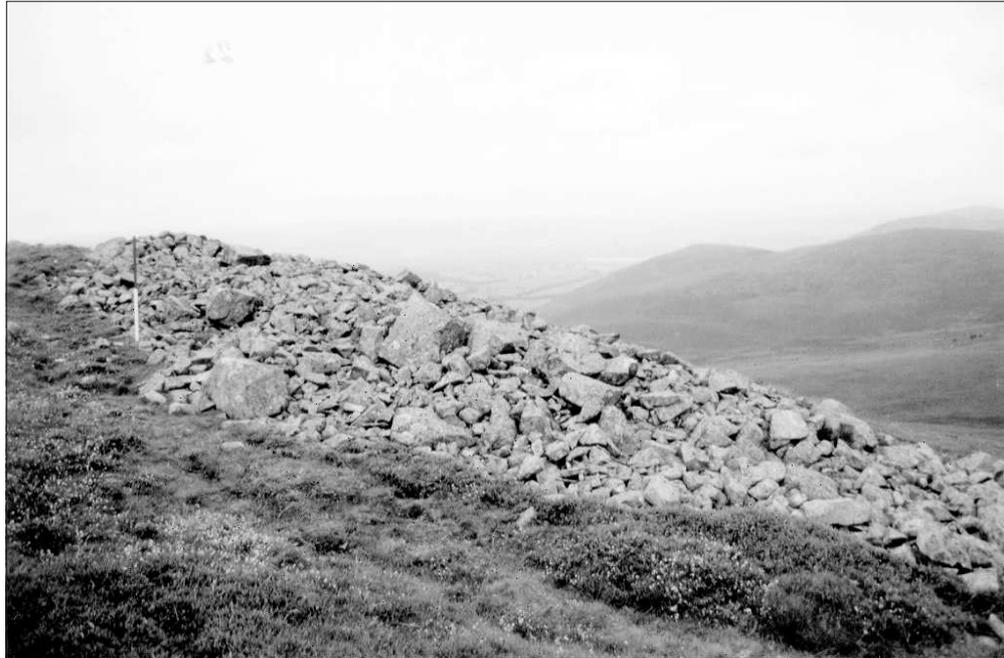
*Plate 4.
Part of the inside of
the fort bank on the
south-east (J1)*

In section J, the outside of the rampart is around 2m high and the inside 0.5m, though it rises to 0.8m at J1 which is the most upstanding stretch of bank on the south half of the circuit. The large boulders upwards of 0.5m across on the inside of this portion of bank have probably been displaced a short distance from the inner edge of the fort wall (Plate 4). At J2 and J3 vegetation growth obscures part of the bank but at J4, stones have been cleared to the sides and downslope to open up a cutting part way through the bank down to ground level. This could have been done to facilitate access into the interior or it is possible it is a further archaeological investigation into the construction of the bank. Nearby, on the inside of the bank, is a relatively recent, semi-circular shelter with tumbled walls up to 0.8m high (J5).

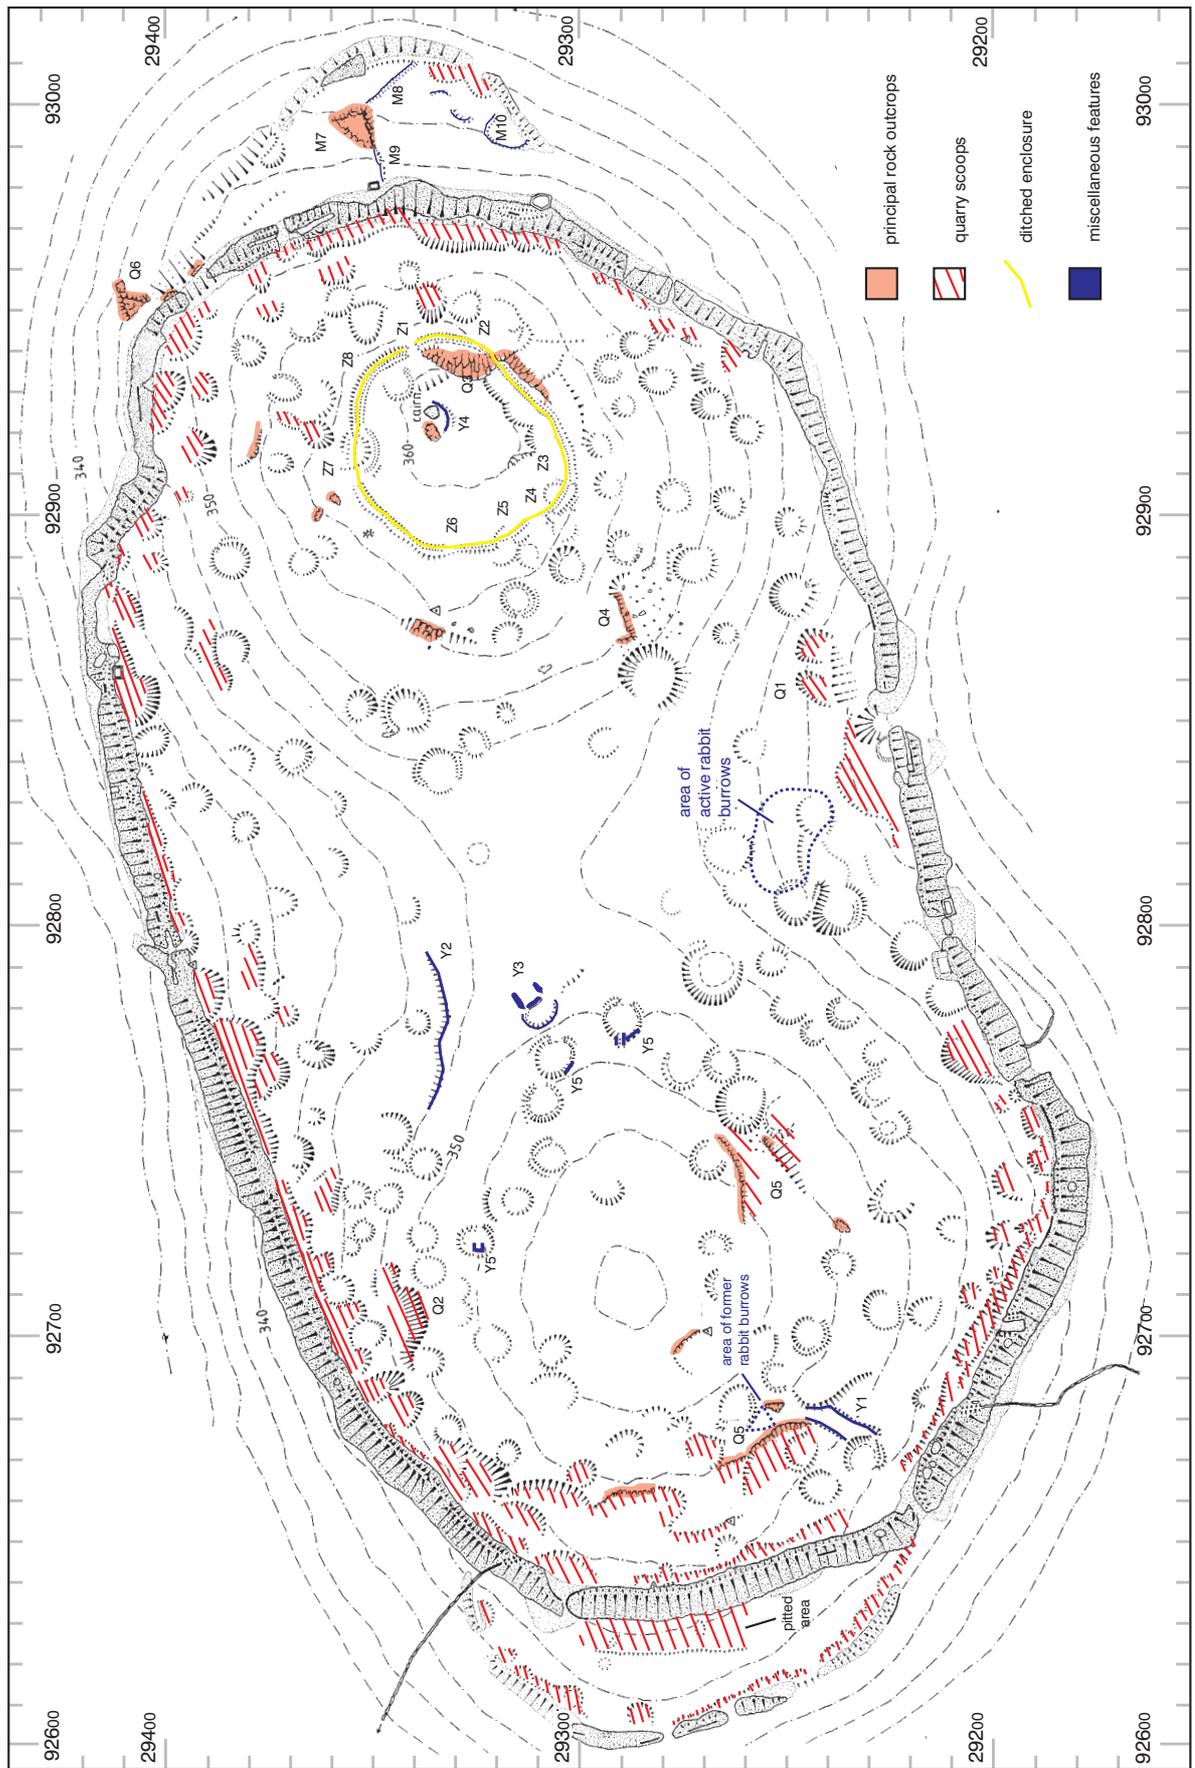
Figure 5. Features within the hillfort and the two exterior enclosures

On the immediate upslope side of the hillfort bank is an intermittent and irregular quarry ditch, achieving a maximum 30m width. It is evident around the majority of the circuit of the hillfort bank apart from a 60m section to the east of the southern entrance. The quarry ditch comprises a mixture of semi-circular scoops into the hillside and linear depressions running parallel with the line of the fort bank for which it must have provided the majority of the stone.

In places, notably the north and south sides of the west summit and on the east side of the east summit, this quarrying has carved a level shelf out of the rising ground at the rear of the bank. Other quarry scoops are evident further inside the enclosure and are

mostly between 0.3 and 1.0m deep, the most prominent being a pair of 2.0m deep cuts into the hillside just inside the south entrance (Q1) and a steep linear scarp 2.5m high on the north side of the west summit (Q2). All are likely to be associated with the construction of the fort. As will be described below, similar remains of quarry scoops and hollows were noted in the enclosure at the west end of the hillfort; less so in the enclosure at the east end.

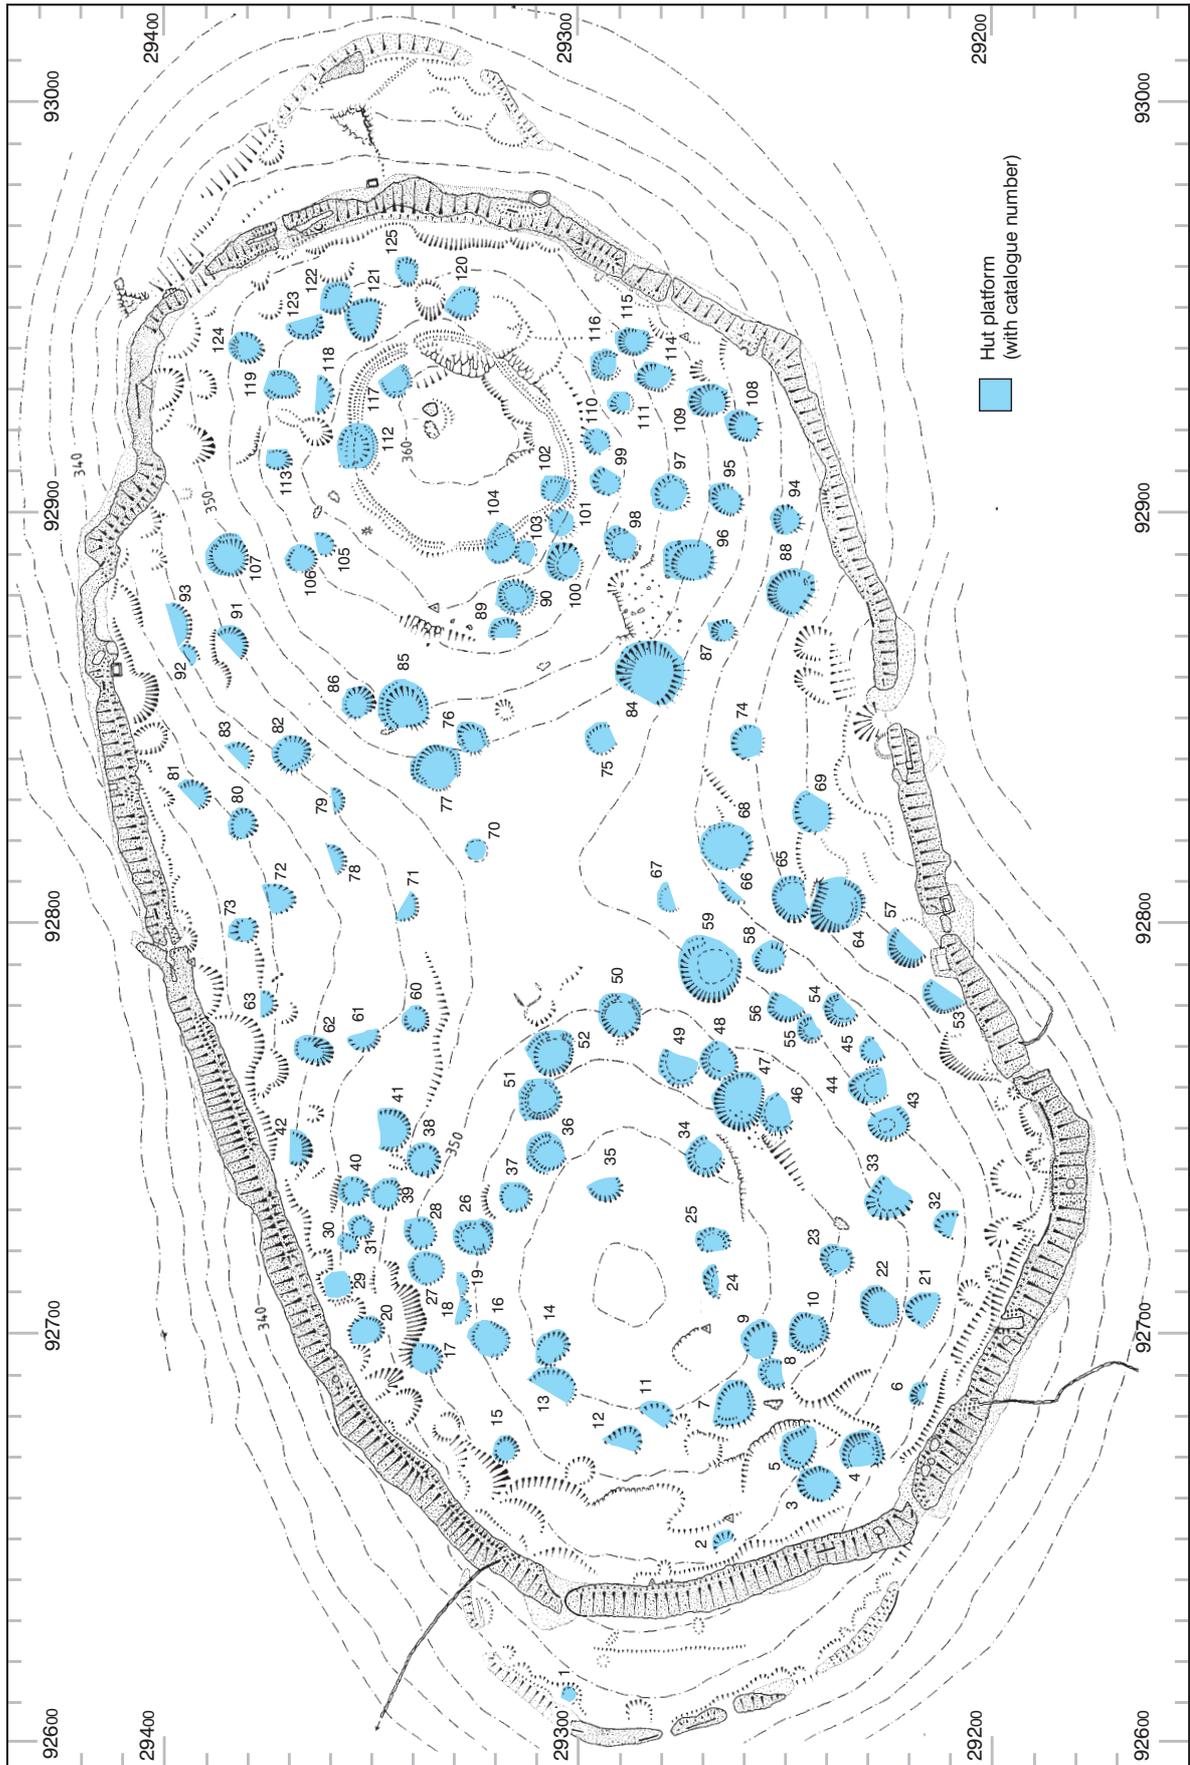
Figure 6. The hut platforms (for catalogue see Appendix 1)

A total of 125 hut sites were identified on the hilltop, all but one lying inside the main hillfort enclosure. This is likely to be a minimum figure as further examples without surface traces probably survive below ground, especially where level terrain obviated the need for any form of manufactured platform. It is also likely that there are more

huts among the quarry scoops around the inside of the fort than can be detected from surface evidence. The hut sites range in altitude from 339m (nos. 73 and 81) to 359.5m above OD (no. 117) and are mainly spread around the south and east sides of the hill. No trace was found of any huts occupying the crest of the two summits or on the top of the intervening saddle, apart from hut no. 70.

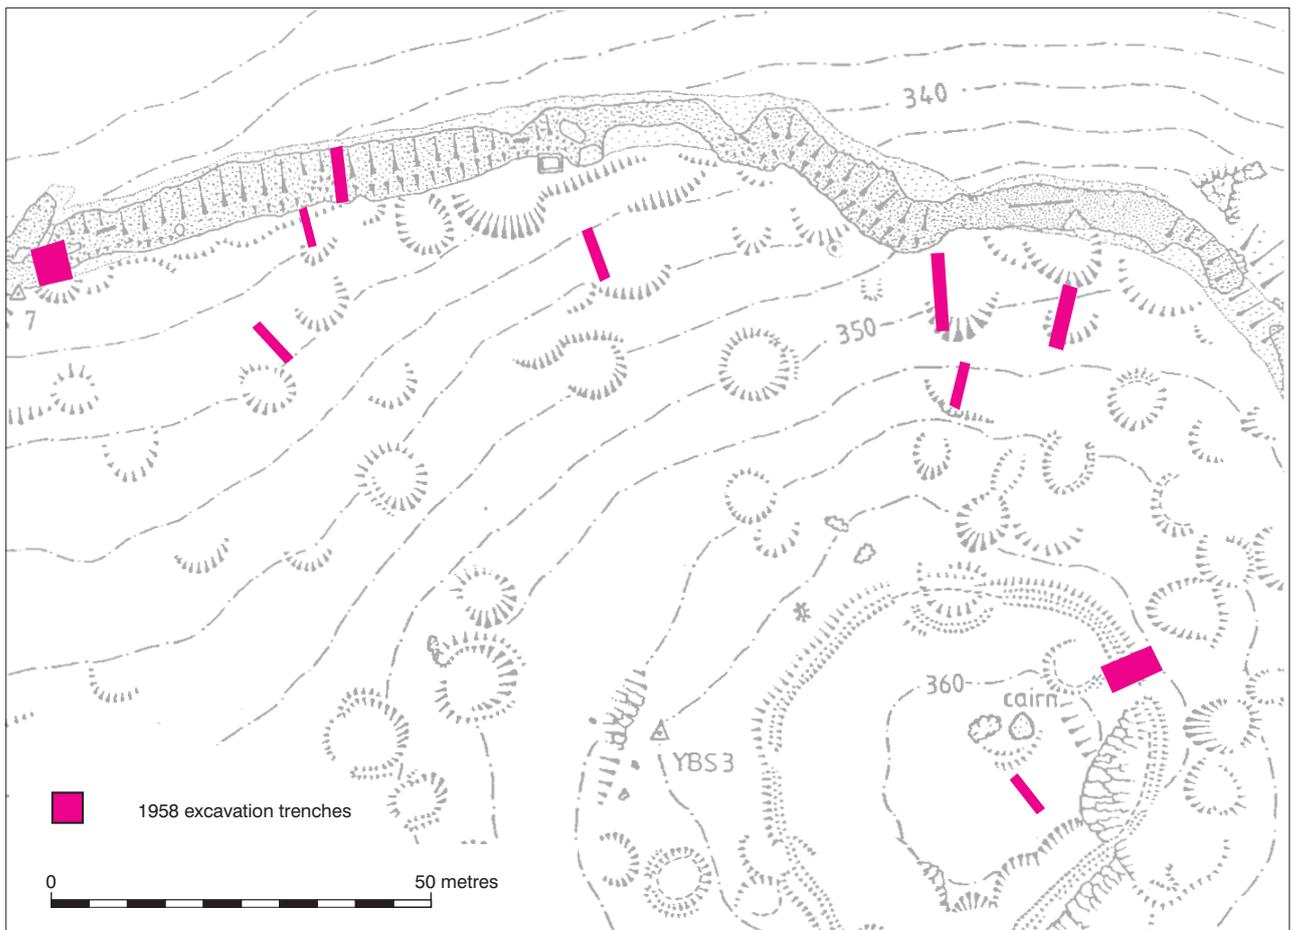
Figure 7. Location of Hope-Taylor's excavation trenches based on aerial photographic evidence (St Joseph 1958, XG46)

The aerial photographic evidence discussed earlier shows that Hope Taylor excavated around the north-east side of the east summit in the middle of July 1958. Apart from disturbance to the outside of the bank noted earlier, which occurs at a point where a trench shows up on several of the photographs (F8), there are no definite surface traces of Hope-Taylor's excavations visible on the inside of the fort. Their approximate position, accurate to within several metres, are shown plotted from the aerial photographs on Fig. 7.

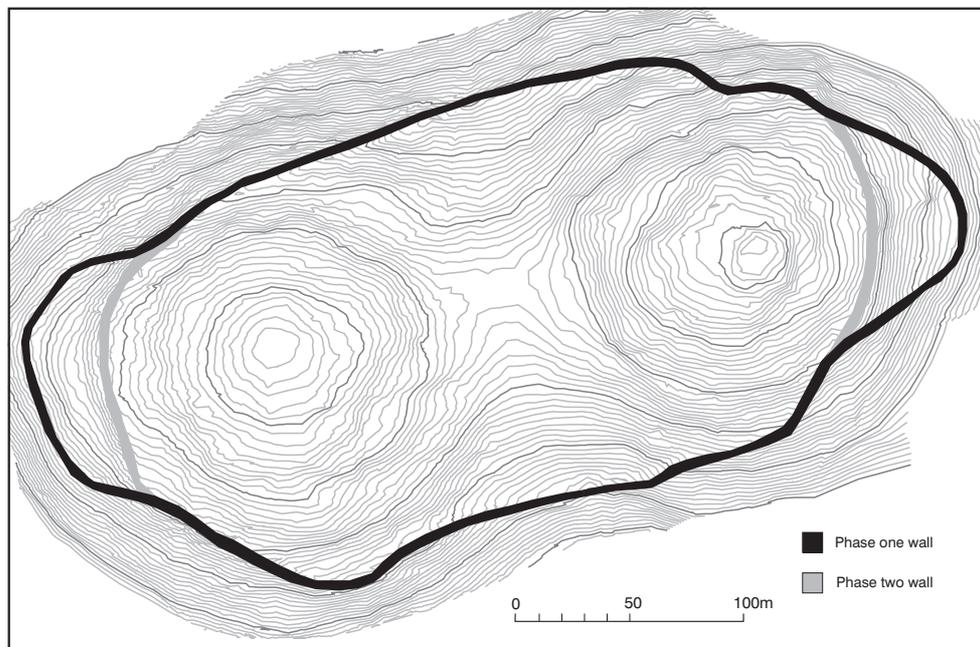
*Figure 8.
Plan of the
putative phase
one enclosure*

The field evidence therefore points to there being two episodes of enclosure around the summit of Yeavinger Bell, the second phase mirroring the layout of the first except for the re-alignment of the east and west ends (Fig. 8). The purpose of the first phase enclosure is assumed to be defensive, though this need not necessarily have been the case. It may be that moving the east and west ends of the fort higher up the sides of their respective summits in the second phase created a more defensible site which would also tie in with the putative rebuilding of the fort wall.

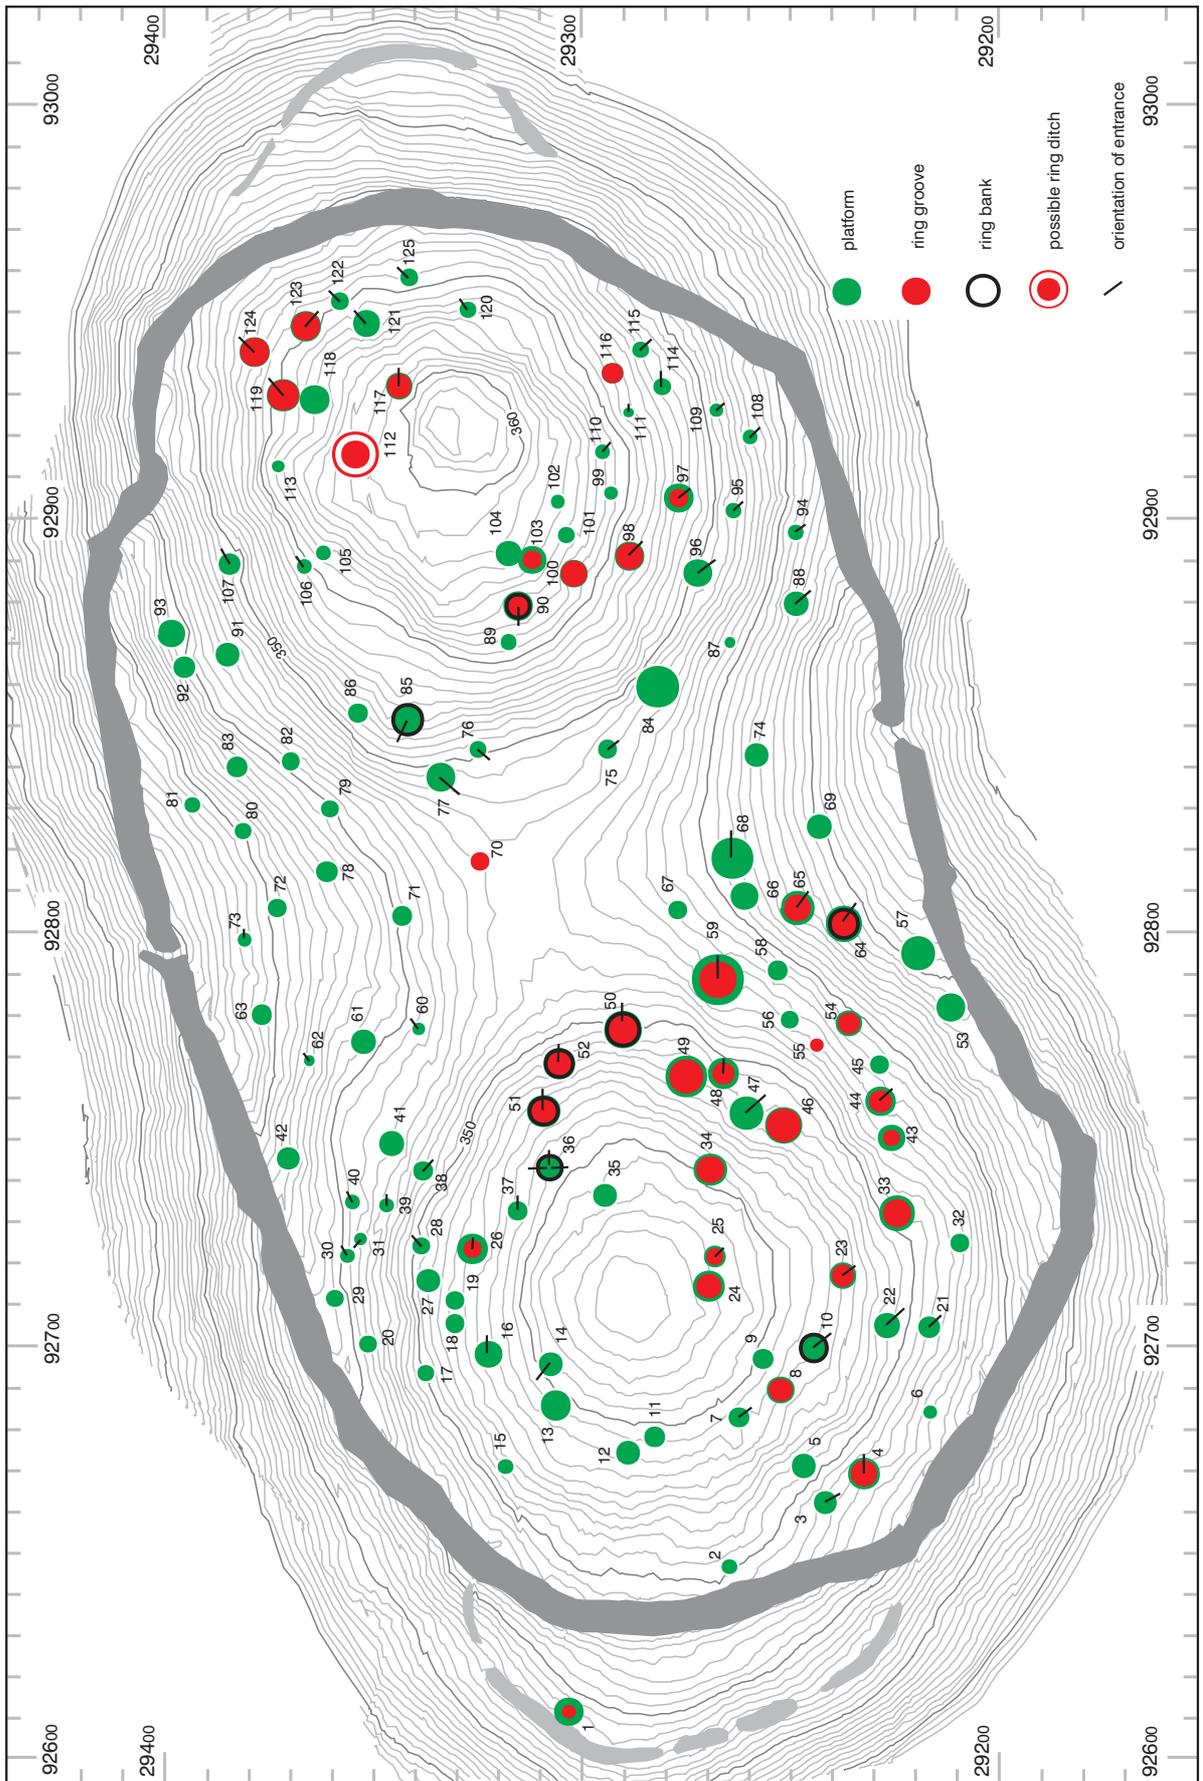
Figure 9. Plan showing the distribution of hut platforms

The survey has confirmed earlier accounts that the interior of the hillfort preserves the remains of around 130 possible hut platforms and it is evident from the field remains that a significant opportunity exists here to study a prehistoric hillfort community. Variations were noted in the density of occupation across the hillfort which might have important social or chronological implications (Fig. 9). For example, almost no hut platforms were recorded on either of the two summits, on the intervening saddle or in either of the two exterior enclosures. In contrast, most of the larger hut platforms and the ring-groove huts seem to cluster around the south and east flanks of the two summits.
