REPOSITORY WOODS,
WOOLWICH, GREATER LONDON
AN ARCHAEOLOGICAL SURVEY OF THE ROYAL
MILITARY REPOSITORY TRAINING GROUNDS
SURVEY REPORT

**REPOSITORY WOODS
WOOLWICH
GREATER LONDON**

**An Archaeological Survey of the Royal Military Repository
Training Grounds**

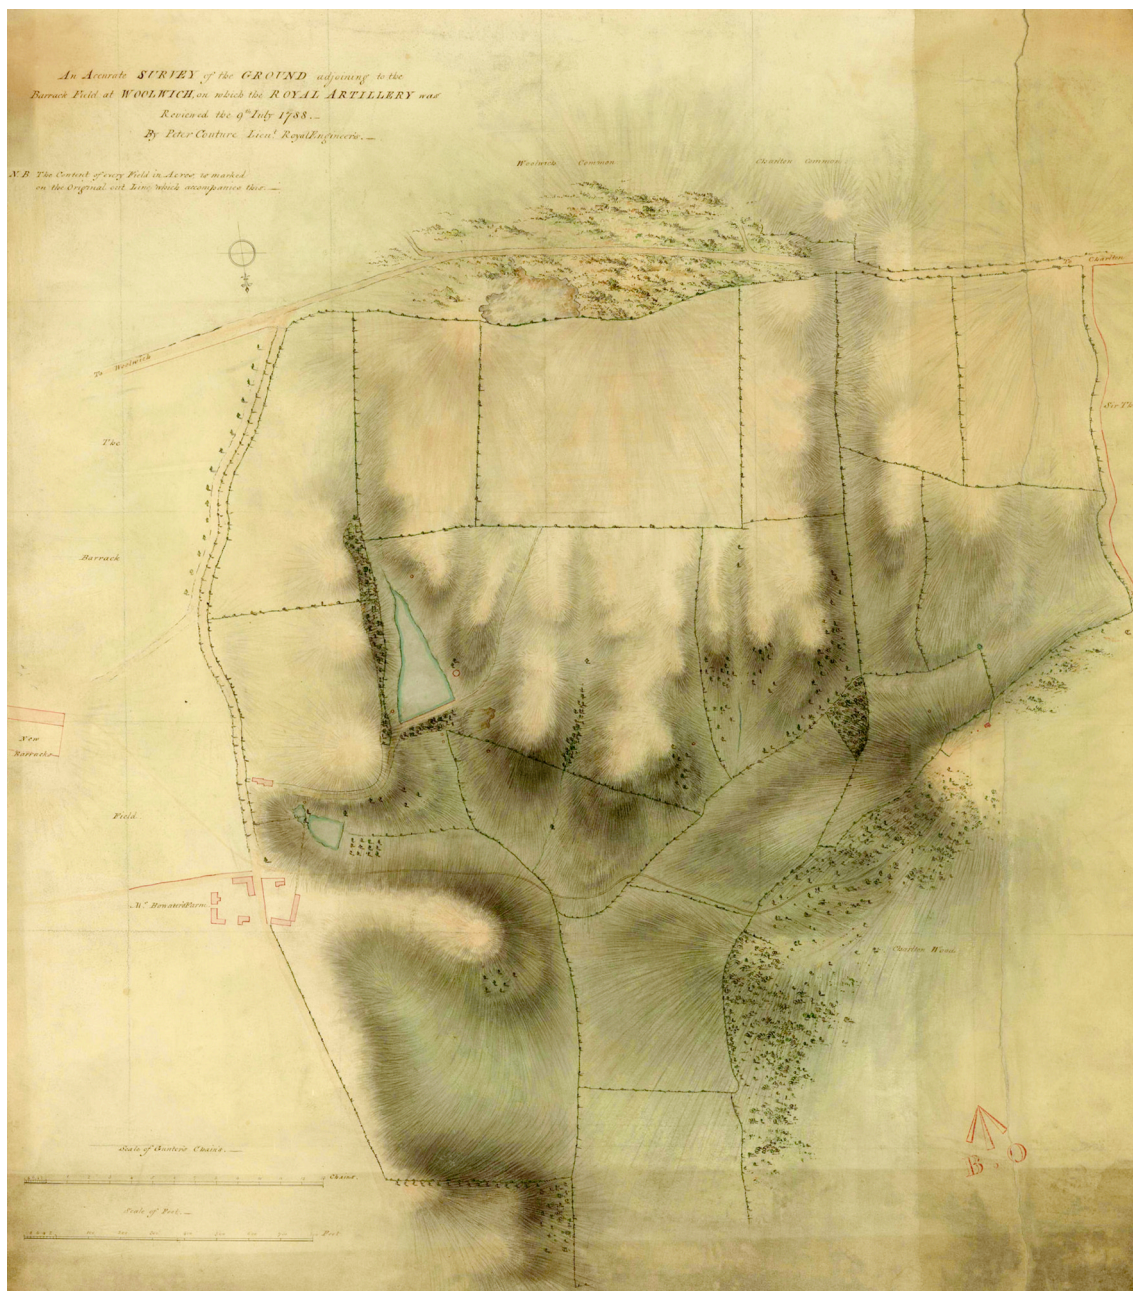
Figure 3: Map from circa 1788 showing the area that was later to become the site of the Royal Military Repository. NB North is to the bottom of the image. The National Archives: Public Record Office MPH 1/571 (1)

Despite suggestions that the Repository Grounds were formerly part of Bowater Park (Anon. 1913, 64) the 1788 map shows hedged fields, some of which contain light tree cover (TNA:PRO MPH 1/571). This suggests a mixed landscape of arable cultivation and pasture. The land may have been attached to 'Mr Bowater's Farm', which as mentioned above, is marked on the same plan. It is worth noting that the ponds shown on this 1788 plan are not those which were constructed and survive in the Repository,

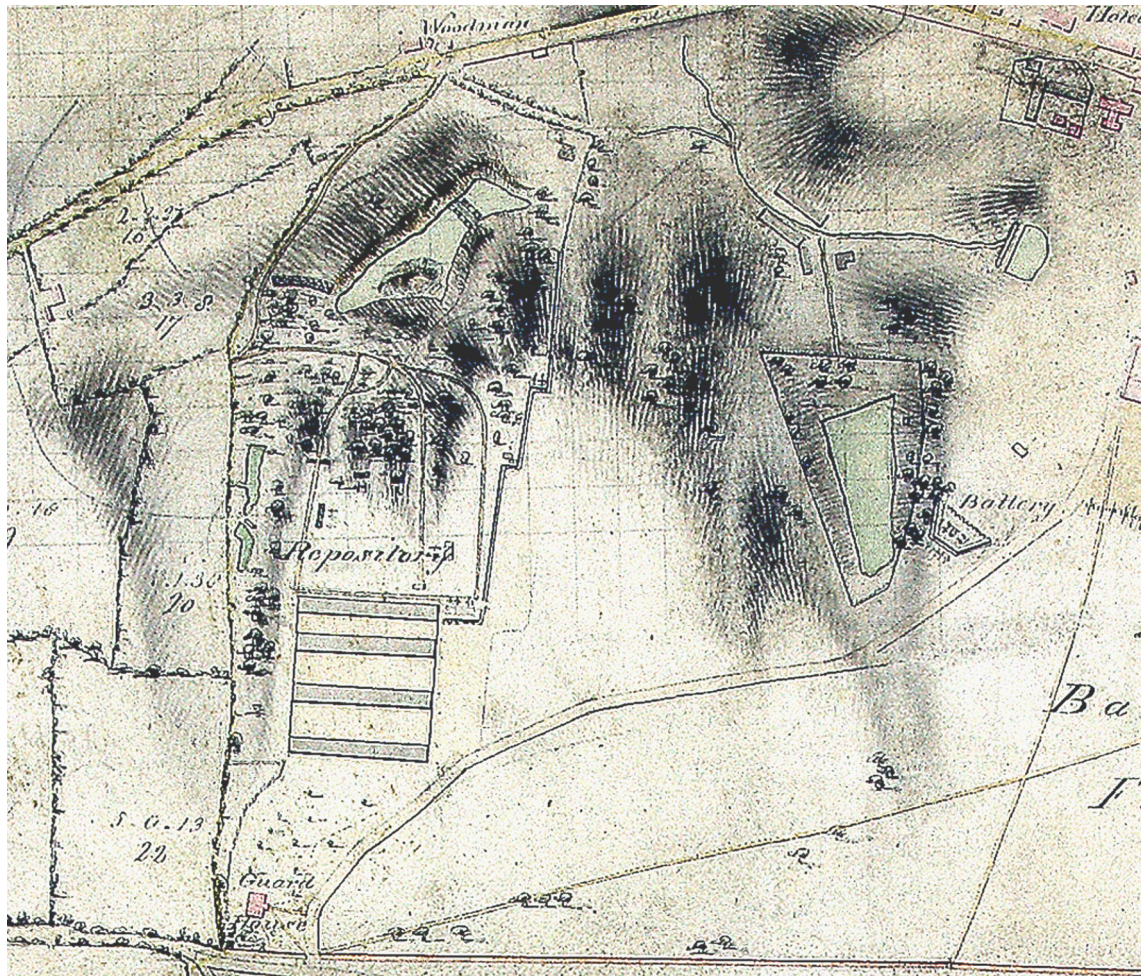
Figure 5: Map of 1808 showing the Royal Military Repository with sheds, guardhouse, stepped boundary, ponds, paths and what appear to be training batteries. The National Archives: Public Record Office MPH 1/189/4.

tracks around the grounds and features which may represent batteries or other artillery training structures (Figure 5), such as the earth and wood casemate construction shown on later photographs (RAHT Collection AL27/40-48; Figure 6) and the structures described as the 'West batteries' in later lists of the exercises (RAHT Collection MD 93).

Also noteworthy is the stepped boundary to the east of the Repository Grounds which is depicted differently to other boundaries on both the 1808 map (TNA:PRO MPH 1/189/4) and the map of 1810 (Greenwich History Centre). It is suggestive of an earlier fortified boundary pre-dating the later training fortification particularly as possible embrasures and artillery pieces are shown on certain faces in the same way as the earthworks created for the Repository exercises within the woodland are drawn. This is certainly a possibility as it seems that the idea of building practice fortifications has existed since the mid- 18th century (Anon. 1892, 3). However if this were the case there is no mention of a pre-existing structure in Congreve's letter asking for the practice fortification to be constructed (TNA:PRO WO 44/642) and it is likely to have been buried by later developments of the Rotunda compound. Unfortunately the boundary itself as it did not stretch as far as the less disturbed northern end of the later fortification.

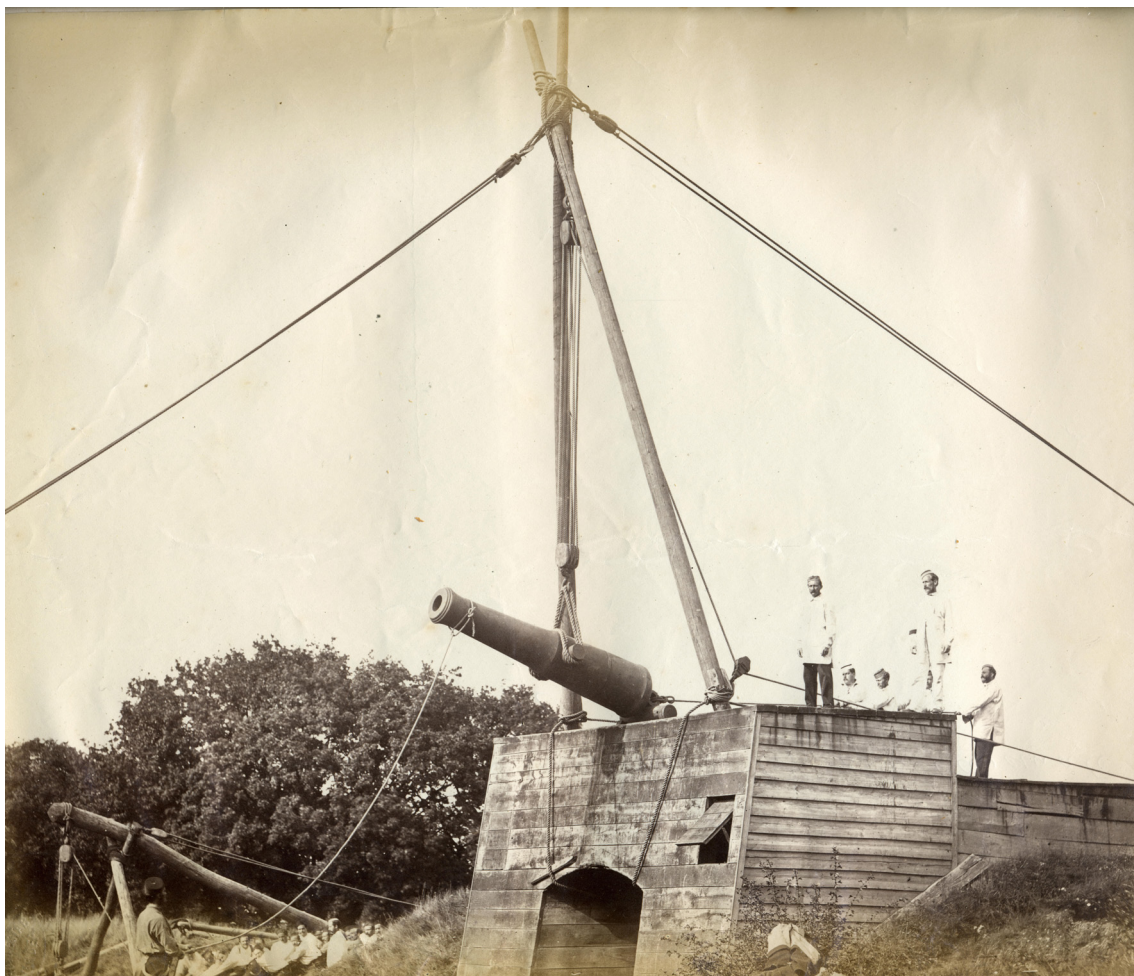
Figure 6: Earth and wood casemate probably located on the site of the 'dog kennels' in the modern Napier Line compound. The photograph is probably one of a series taken by John Spiller in 1858 to illustrate the Repository exercises. The same structure may be shown in this location on maps as early as 1808 and is depicted in detail on the Bayly map of 1867. Courtesy of the Royal Artillery Historical Trust (RAHT Collection AL27/42)

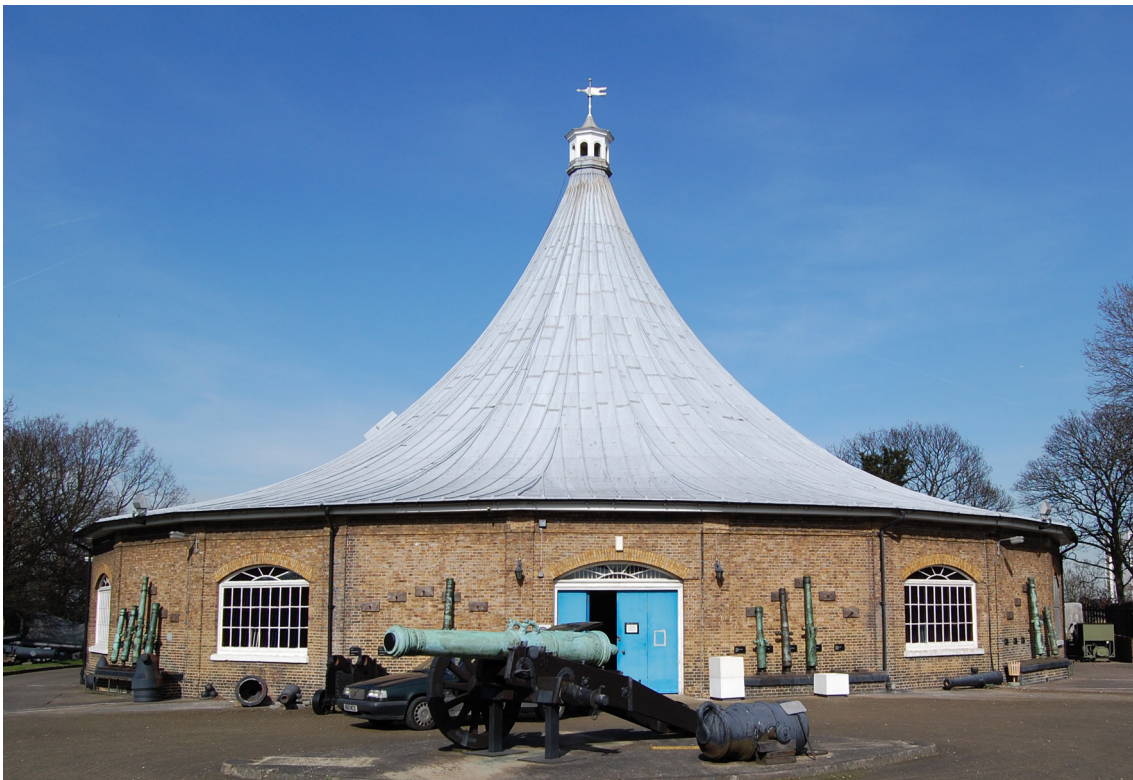
Figure 7: The Woolwich Rotunda from the south. Photograph: Sarah Newsome (5 March 2008) © English Heritage

By the end of 1818 when the dismantled building now known as the Rotunda arrived in Woolwich (Figure 7), a purpose-built military training landscape already existed to the west of the new barracks, where an agricultural landscape which had existed just 30 years previously. The Rotunda was originally constructed by the Prince Regent as a semi-permanent ballroom in the grounds of Carlton House in 1814 (Clarke 2007, 8) as part of the celebrations held there for the visit Allied Sovereigns after the defeat of Napoleon at the battle of Leipzig.

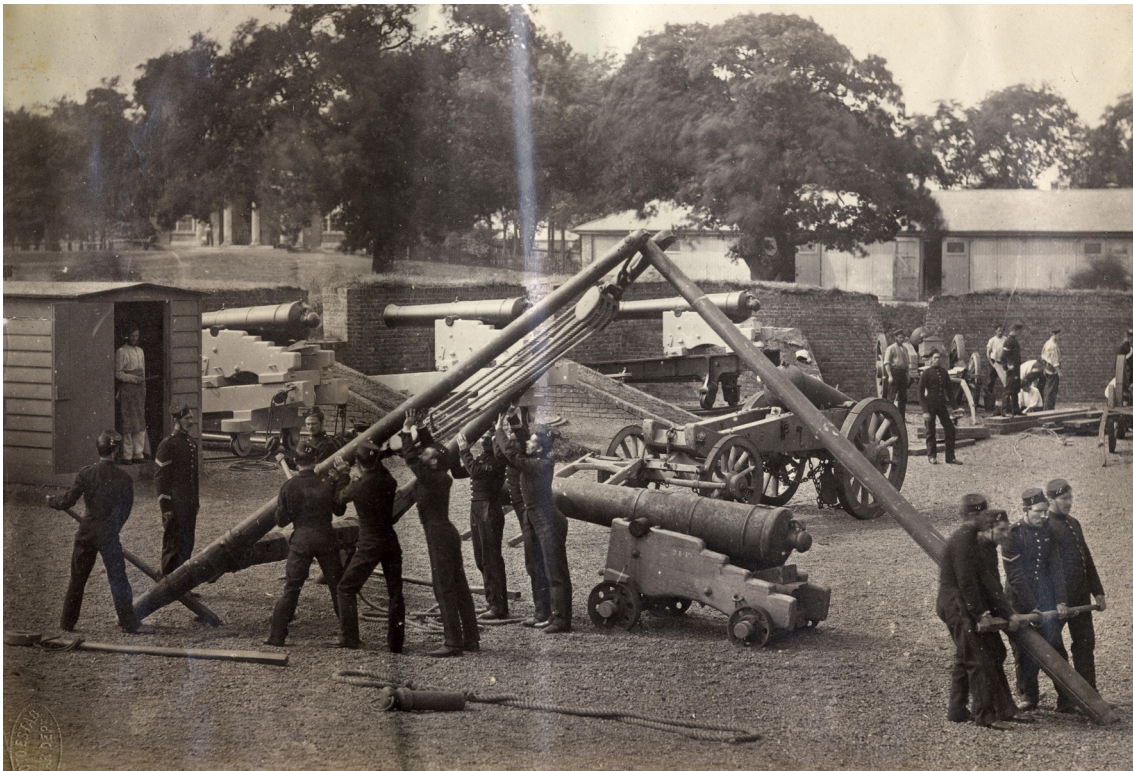
Figure 8: Cadets practising drill with a 'Triangle Gyn' in the southern-most bastion of the practice fortification. The photograph is probably one of a series taken by John Spiller in 1858 to illustrate the Repository exercises. Guns are visible mounted on fixed and travelling carriages and the buildings originally used as the gatehouse and for the horse artillery are visible in the background. Courtesy of the Royal Artillery Historical Trust (RAHT Collection AL27/26)

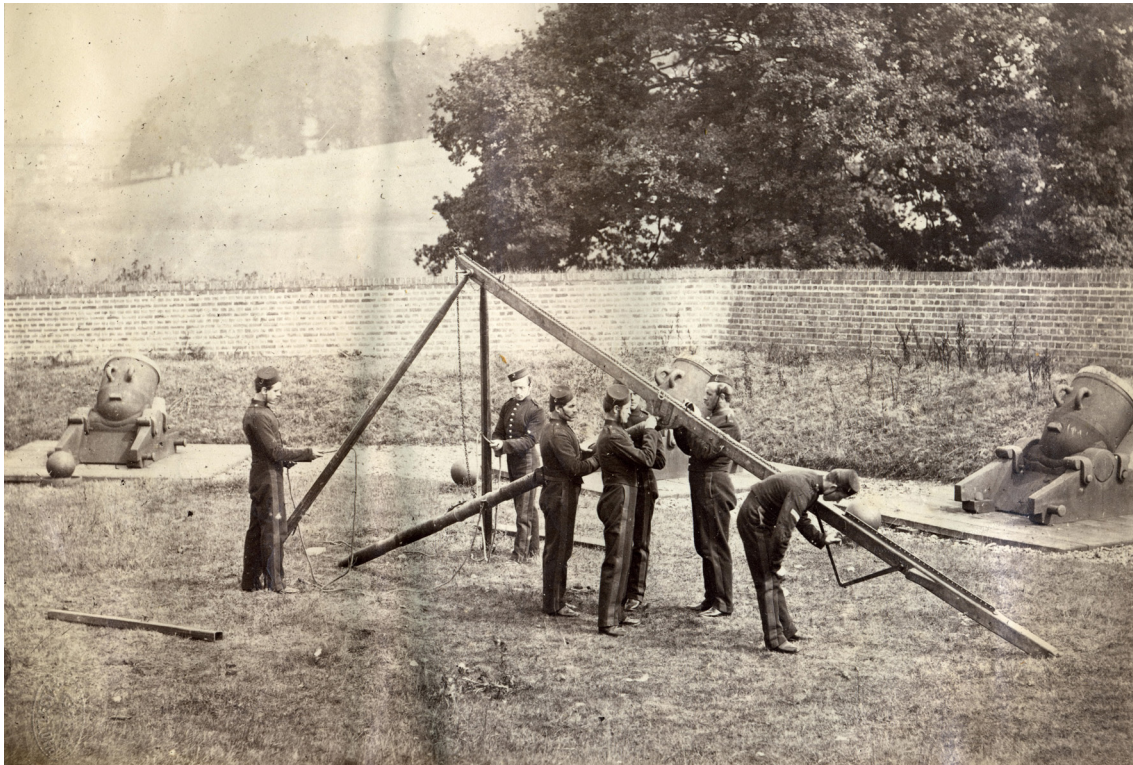
Figure 9: Cadets practising 'Rocket Drill' on a stretch of the practice fortification to the north of the Rotunda where no embrasures were built. Mortars can be seen located on hard-standings and the slopes of Green Hill can be seen in the background. The photograph was almost certainly taken by John Spiller as part of the series illustrating the Repository Exercises in 1858 (see RAHT Collection AL933 for more Spiller photographs). Courtesy of the Royal Artillery Historical trust (RAHT Collection AL27/34).

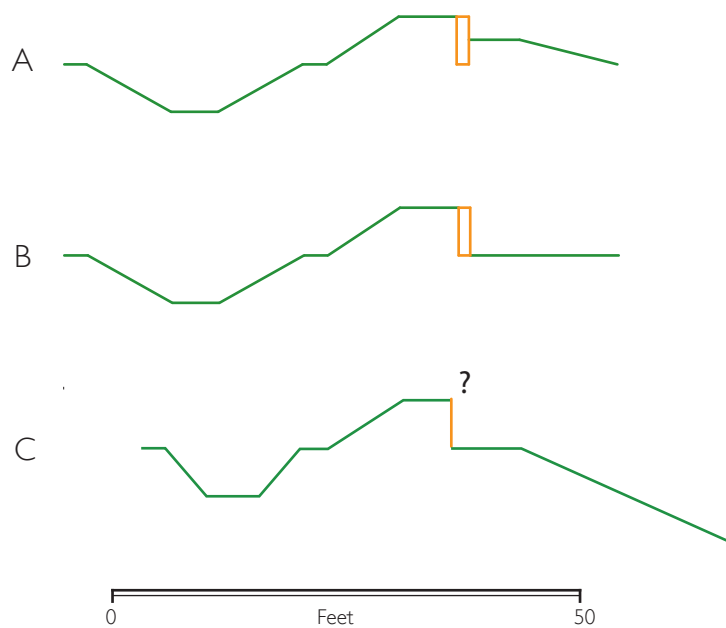
NB Profile interpreted from 19th century maps and photographs.
Depth of ditch not known.

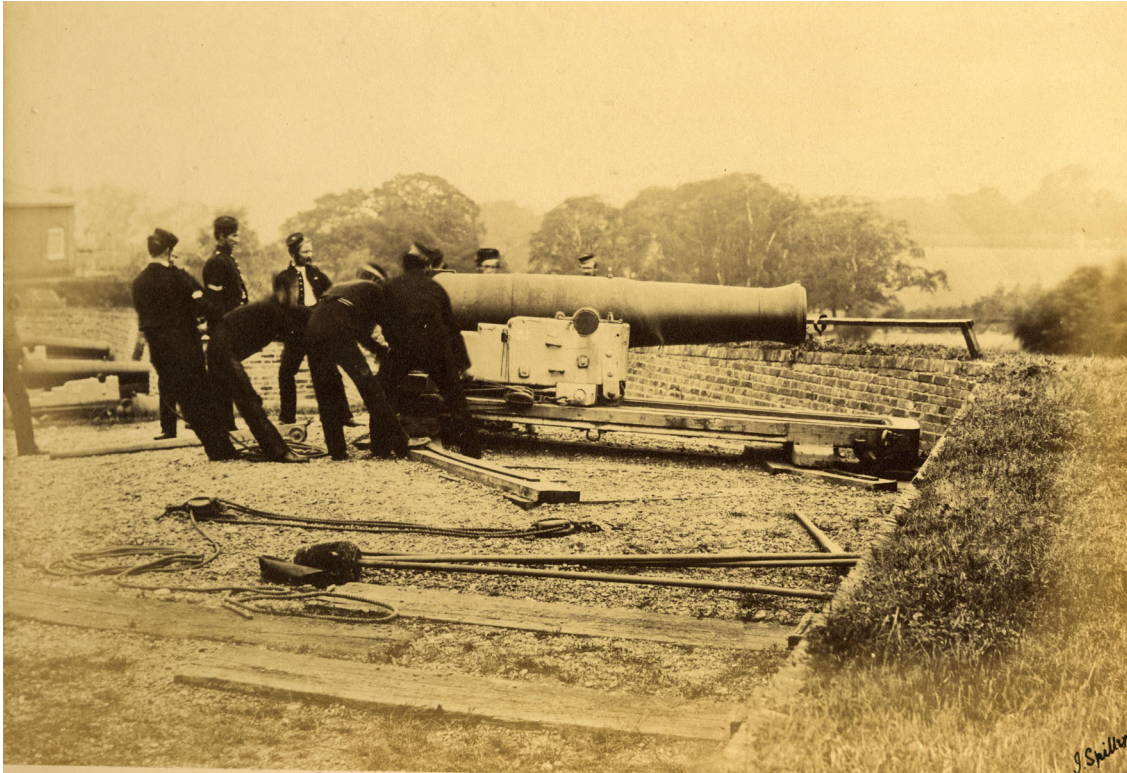
Figure 11: A photograph taken in 1858 by John Spiller showing a "10 inch gun 87 cwt on naval slide" positioned at the point of the Southern Bastion. The ground has been raised in this location in order to enable the gun to clear the parapet. The Rotunda is just visible to the left of the photograph. Courtesy of the Royal Artillery Historical Trust (RAHT Collection AL 933/15)

Photographs taken from 1858 onwards (held within the collections of the Royal Artillery Historical Trust – Albums 933, 27 and 112, Figures 8 and 9), along with the 1867 Bayly map (Figure 36A and B), show the internal faces of the fortification and the types of artillery mounted along the line in great detail. The various gun positions including hard standings without embrasures for mortars, hard standings with embrasures for guns on garrison carriages, arcs for guns on traversing carriages and positions at each apex of the two regular bastions which were for guns on traversing carriages but which, rather than having embrasures, were positioned to fire over the parapet (Figure 11).

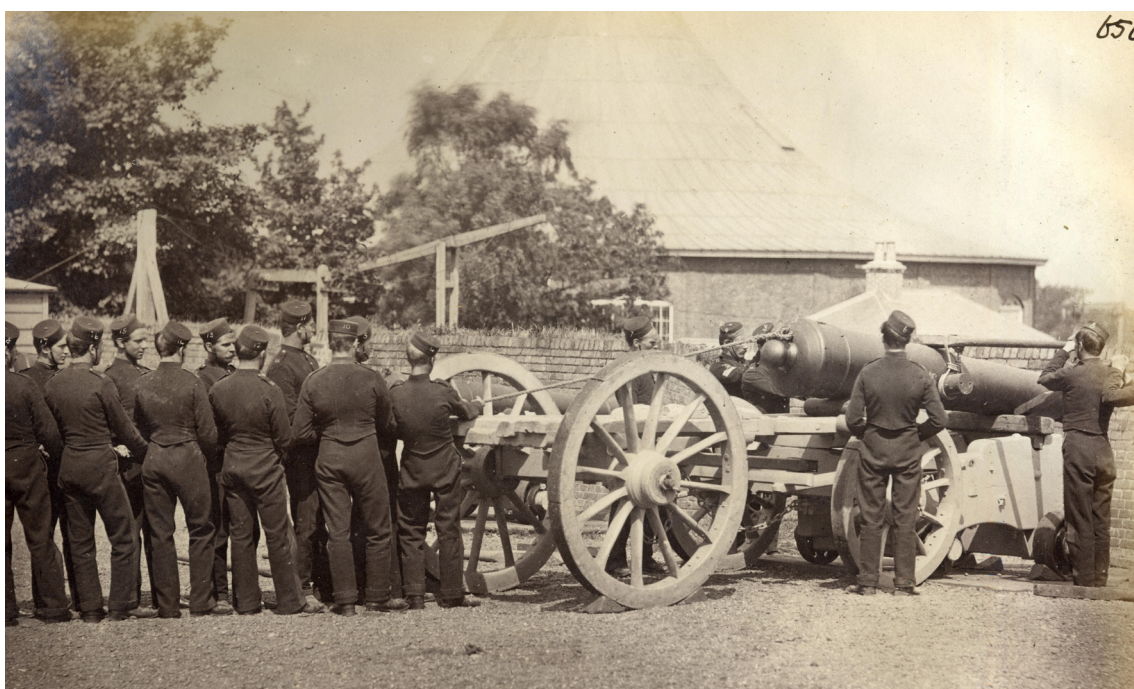
Figure 12: Cadets practising drill in the southernmost of the two bastions with the Rotunda visible in the background to the north. Courtesy of the Royal Artillery Historical Trust (RAHT Collection AL44/90).

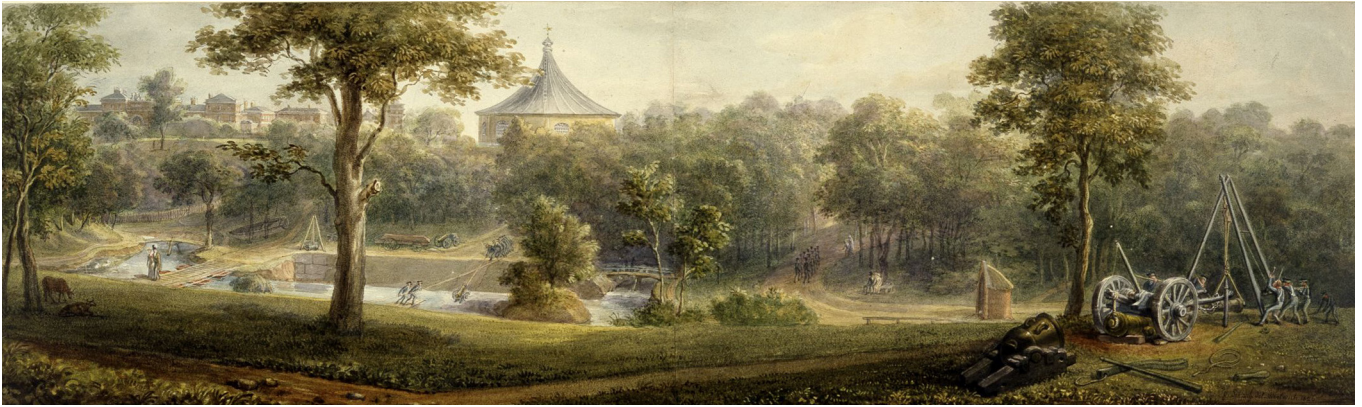
Figure 13: Watercolour by George Scharf, dating to 1826 demonstrating the dual roles of the Repository Grounds as training area and pleasure grounds. ANI92836001 © Trustees of the British Museum

The 1826 watercolour by George Scharf depicts some of these Repository exercises being carried out (Figure 13). Cadets can be seen in the process of mounting cannon, marching, and hauling an artillery piece across the large pond, an activity which apparently claimed the life of one cadet in 1830 (Anon. 1892, 91). The main bridge across the pond appears to be a pontoon-style construction whilst two smaller bridges are visible, one at the north-eastern corner of the largest pond where the modern dam/slucice is and one to the south-east corner over a channel carrying water into the pond.

As well as demonstrating how the Repository grounds were used for exercises, the 1826 watercolour by George Scharf also demonstrates the landscape's recreational role, as well as its use as grazing for cattle (Figure 13) – the Superintendent of the RMR also had

the right to cut hay in the grounds (TNA:PRO WO55/2864 1841) and a piggery was later constructed (Figure 36B). Couples sit on benches and stroll along paths; the one which leads up to the Rotunda may be that seen emerging on the Lucas 1820 view (RCIN/PLS: 701653). It is also worth noting the semi-circular summerhouse to the south of the main pond on the Scharf view, yet another indicator of the dual use of the Repository Grounds (Figures 13 and 16).

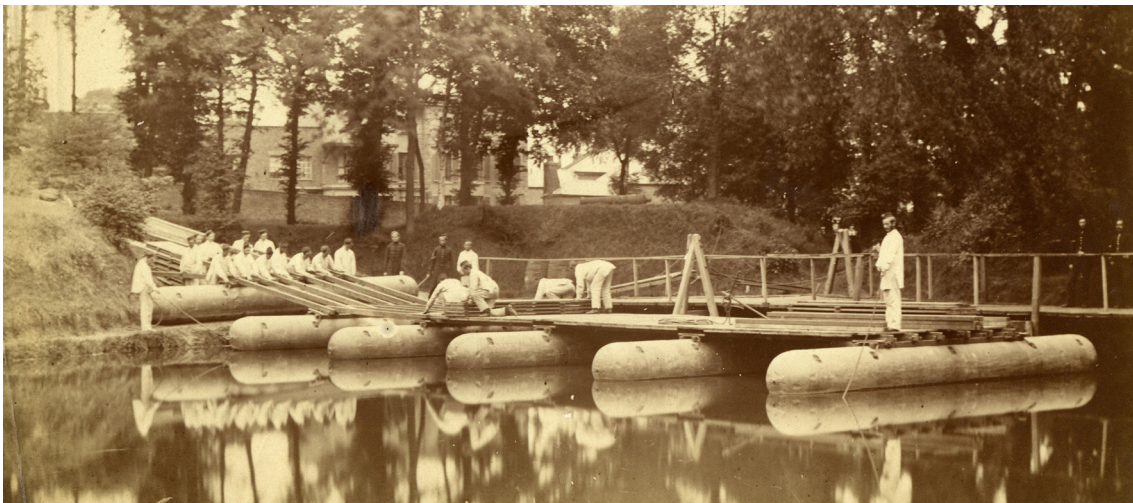
Figure 14: Cadets constructing a pontoon bridge across the north-western corner of the largest Repository pond circa 1858. A caption on a similar photograph, possibly taken at the same time, by Spiller described the components as 'Blanchard's cylindrical pontoons' (RAHT Collection AL28/12). The building marked 'Boat Store' on Bayly's 1867 map was located just out of shot to the left and houses located on Hillreach can be seen in the background. Courtesy of the Royal Artillery Historical Trust (RAHT Collection AL112 – no image number).

Photographs of various types of bridge construction were also taken by Spiller such as trestle, slot and pontoon bridges (RAHT Collection AL933 and Figures 14 and 16) and they were probably dismantled and reconstructed regularly, hence the need for the 'Bridge Store' marked on the 1867 Bayly map (Figure 36B). By 1839 a second bridge had been constructed and the pontoon style bridge shown on the Scharf watercolour removed by 1869 (NMR MD 96/124; Ordnance Survey 25 inch 1st edition 1869). The stone foundations of an earlier bridge or dam appear to be visible at the eastern side of the lake, though this may be the wharf shown on later photographs and maps, which was used for lowering gun with a 'crane formed of a 24 pounder on a travelling carriage' (RAHT Collection AL933/36).

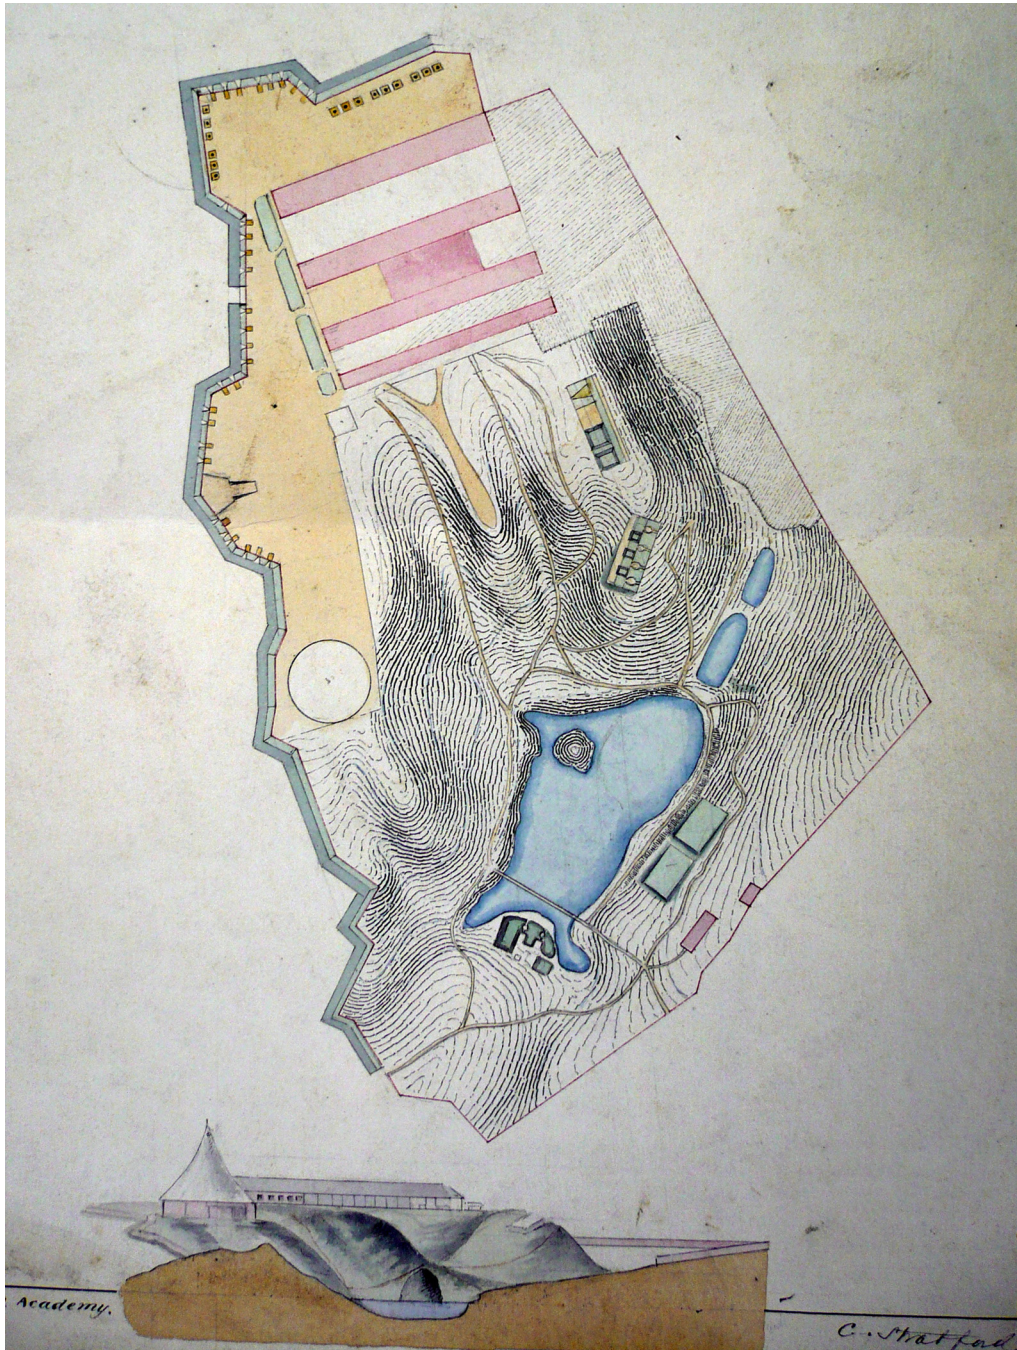
Figure 15: Undated map of the Royal Military Repository probably undertaken in the late 1840s or 1850s. The contours and profile depict the topography in great detail and the use of the 'Pocket Sextant' mentioned in the title suggests the area was used for surveying exercises. © English Heritage

demonstrated by the coloured map drawn 'by aid of the Pocket Sextant' by C. Stratford of the Royal Military Academy (Figure 15). Comparison with documentary and map evidence suggests that the undated sketch must have been executed between 1845, when the Dickerson memorial was erected, and 1861 (Skedd 2008, 18). It also seems that one of the ponds near the Repository was designated the 'Cadets' pond' for swimming in the mid-19th century (Guggisberg 1900, 93) though it is possible that this was one of the other ponds to the east of the Repository.

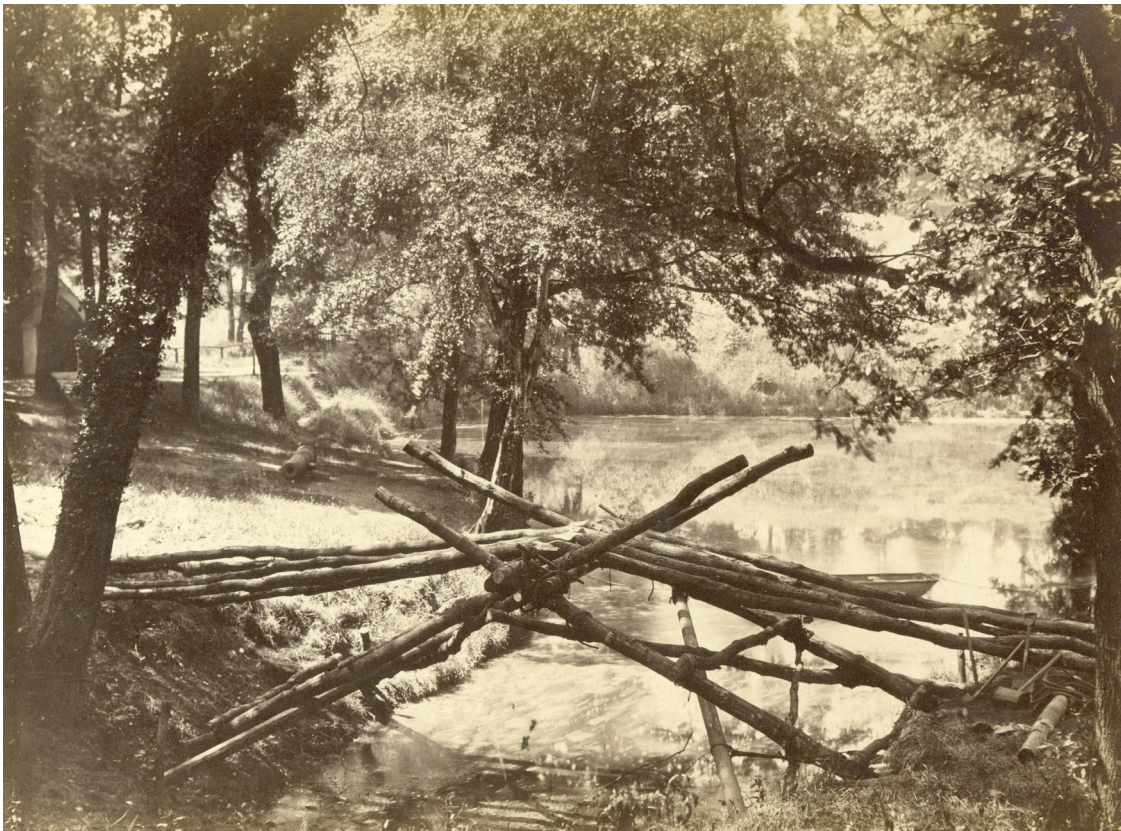
Figure 16: A picturesque view, looking west across the southern end of the largest Repository pond showing a temporary bridge in the foreground and the semi-circular summerhouse to the far left-hand side of the frame. The photograph was almost certainly taken by John Spiller in 1858. Courtesy of the Royal Artillery Historical Trust (RAHT Album AL112/23)

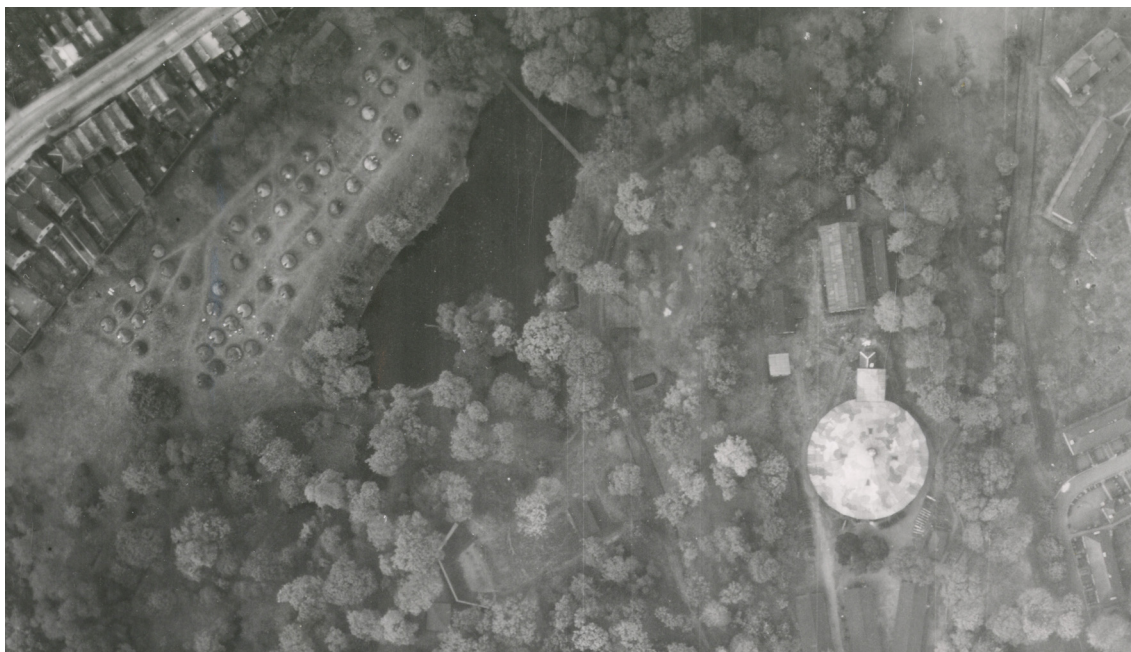
Figure 17: The Repository grounds in October 1945. A tented camp can be seen between the largest pond and Hillreach whilst to the east the Rotunda's camouflage paint scheme is visible. Storage huts can be seen between the pond and the Rotunda. RAF I06G/UK/916 6112 English Heritage (NMR) RAF Photography

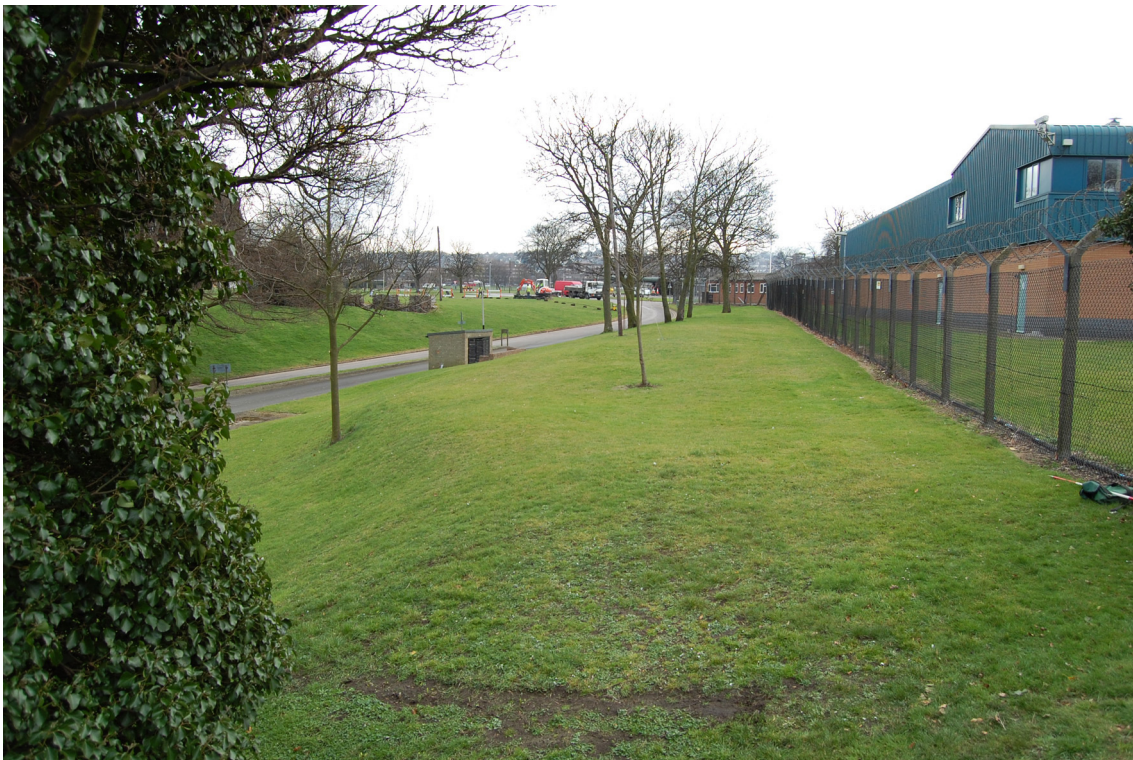
Figure 18: The earthwork platform which defines the remains of the northern-most bastion of the two original bastions, looking south towards Woolwich Common. Photograph: Sarah Newsome 2008 © English Heritage

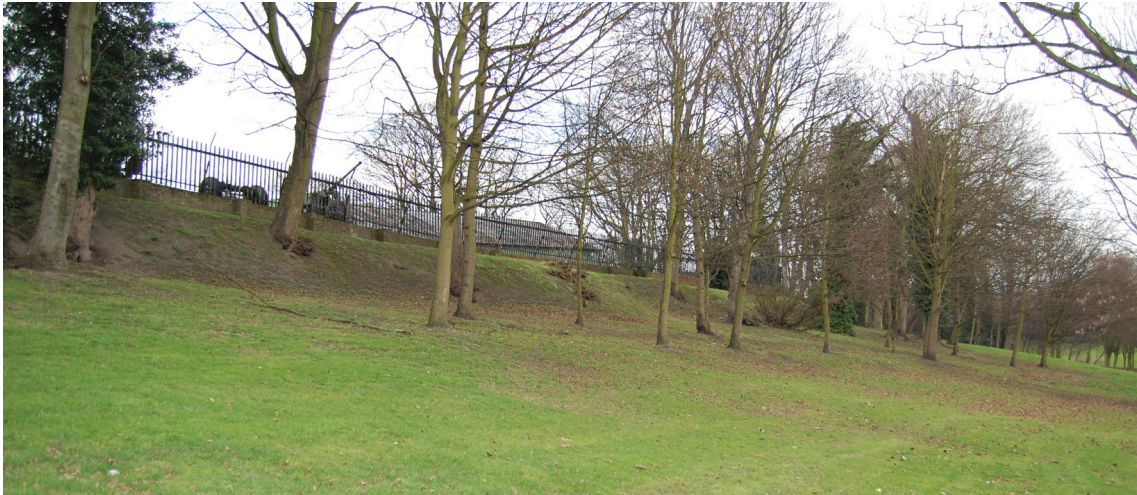
Figure 19: The eastern (external) face of the practice fortification north of the Rotunda. Photograph: Sarah Newsome 2008 © English Heritage

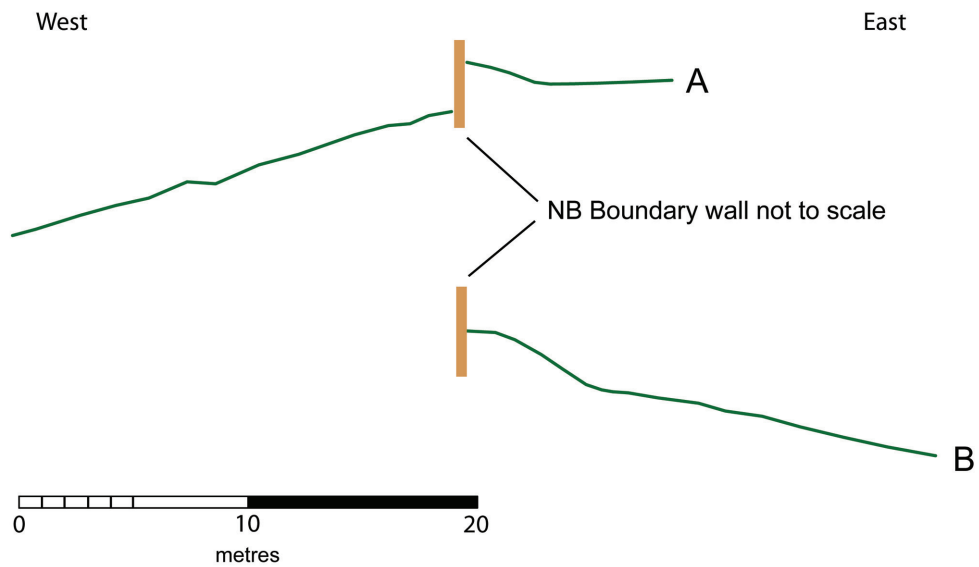
Figure 20: Profiles through fortification. See Figure 35 for profile locations.

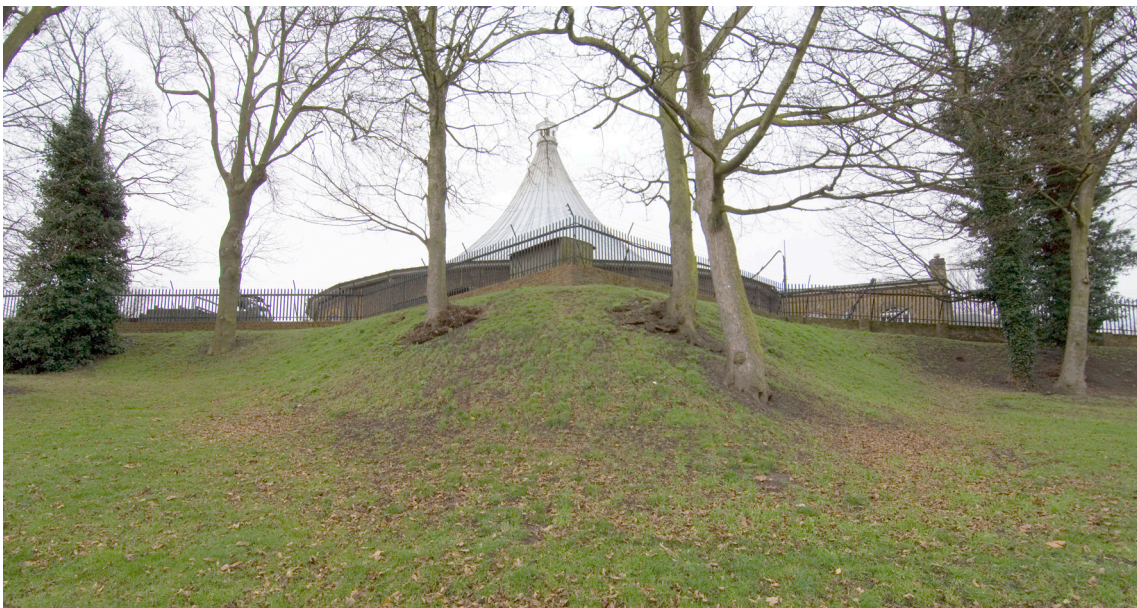
Figure 21: The Rotunda building from the east, framed by a large spur of the practice fortification. Photograph: Derek Kendall DP049765 © English Heritage

The earthwork is probably most substantial on the spur which is located immediately to the east of the Rotunda, framing the building and reaching a height of 5m, and this may be no coincidence though erosion in other areas must be considered (Figure 21). If the earthwork were constructed after the building was relocated here then this stretch of the line probably had more of an aesthetic than a practical training function.

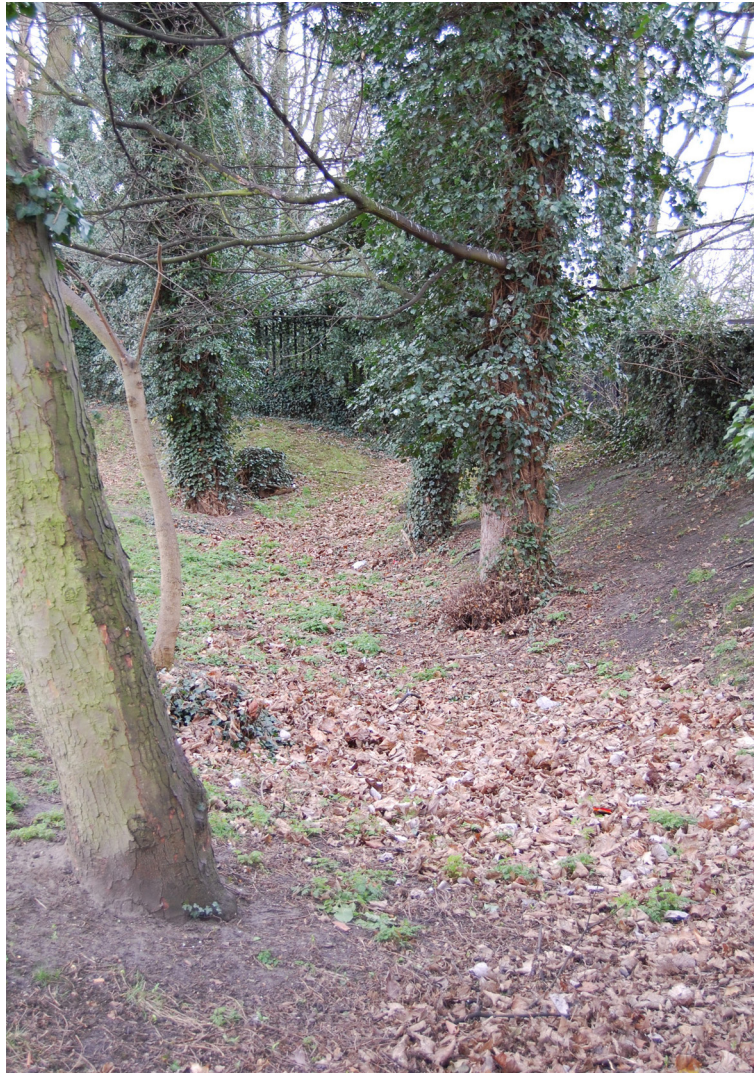
Figure 22: The slight remains of the ditch which is still visible at the northern end of the practice fortification. Photograph: Sarah Newsome 2008 © English Heritage

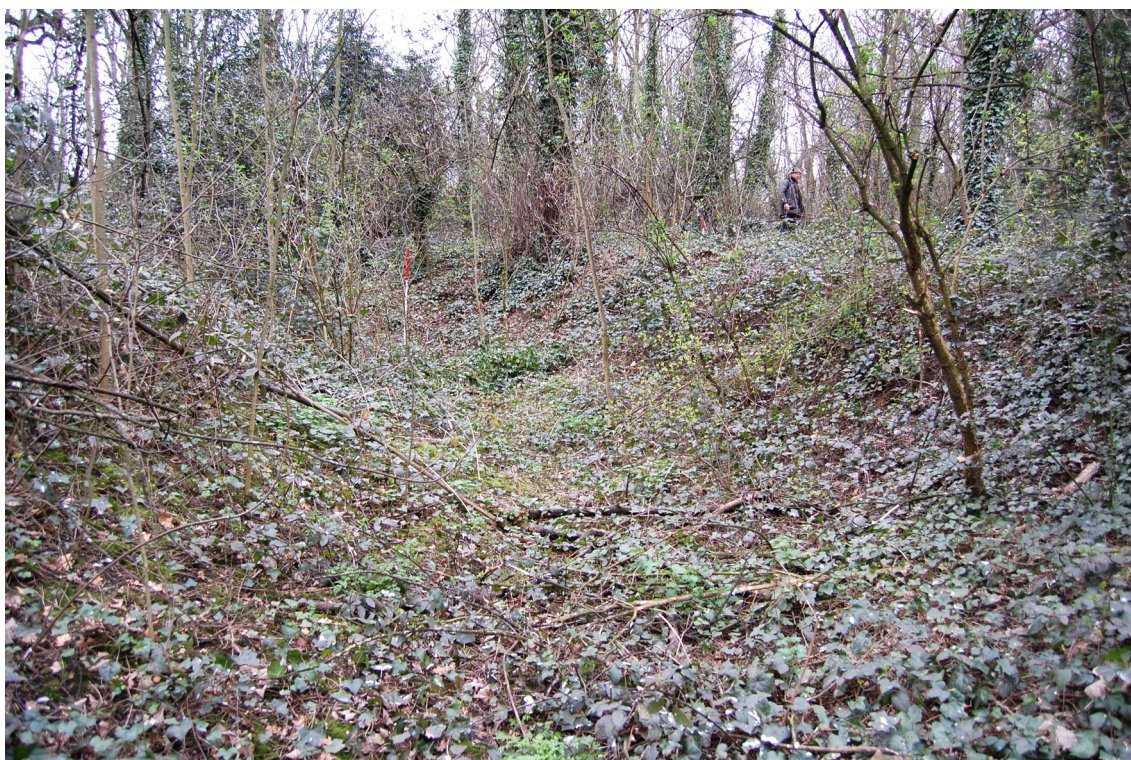
Figure 23: The 'Fieldwork near Summerhouse Pond' (RAHT Collection MD93) dating to the early 19th century located to the west of the middle pond, viewed from the west. The trench is shown on a map of 1808. NB Figure stood on northern bank for scale. Photograph: Sarah Newsome 2008 © English Heritage

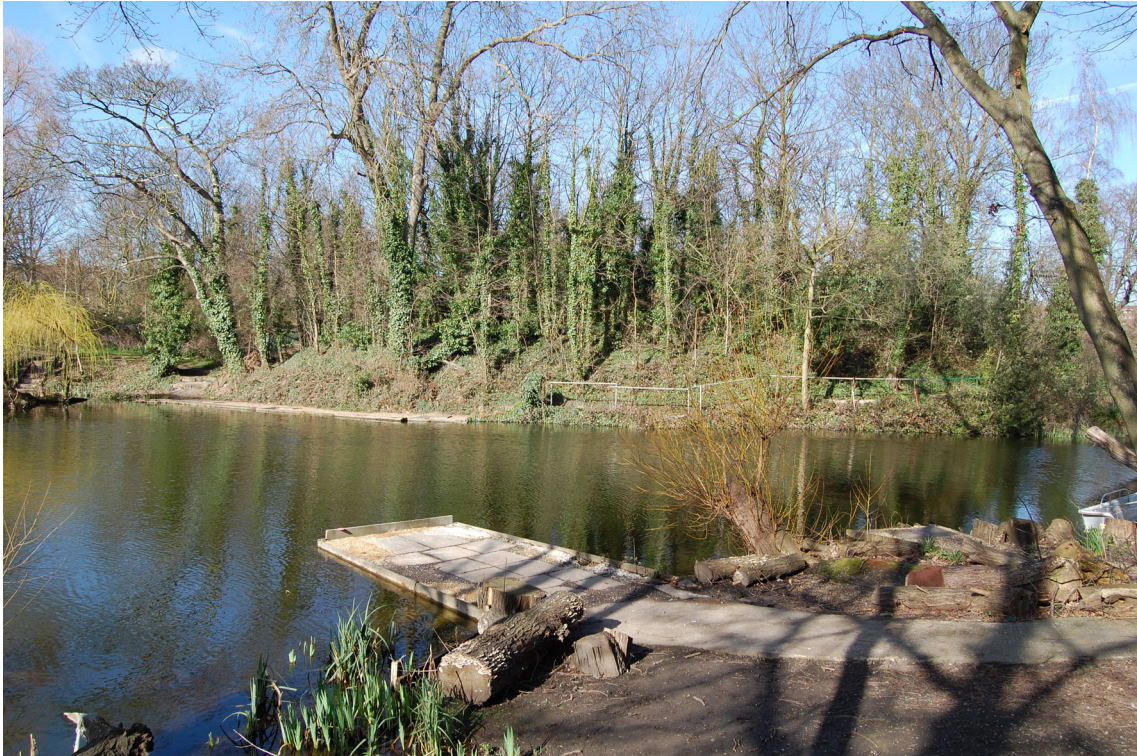
Figure 24: The heavily modified mound at the northern end of the largest pond. The material for this mound was probably excavated from the pond but the earthworks were part of the Repository training facilities and this supported by a Spiller photograph from 1858 (RAHT Collection AL933/33) which appears to show this mound being used to lower cannon down via a system of ropes and pulleys. Photograph: Sarah Newsome 2008 © English Heritage

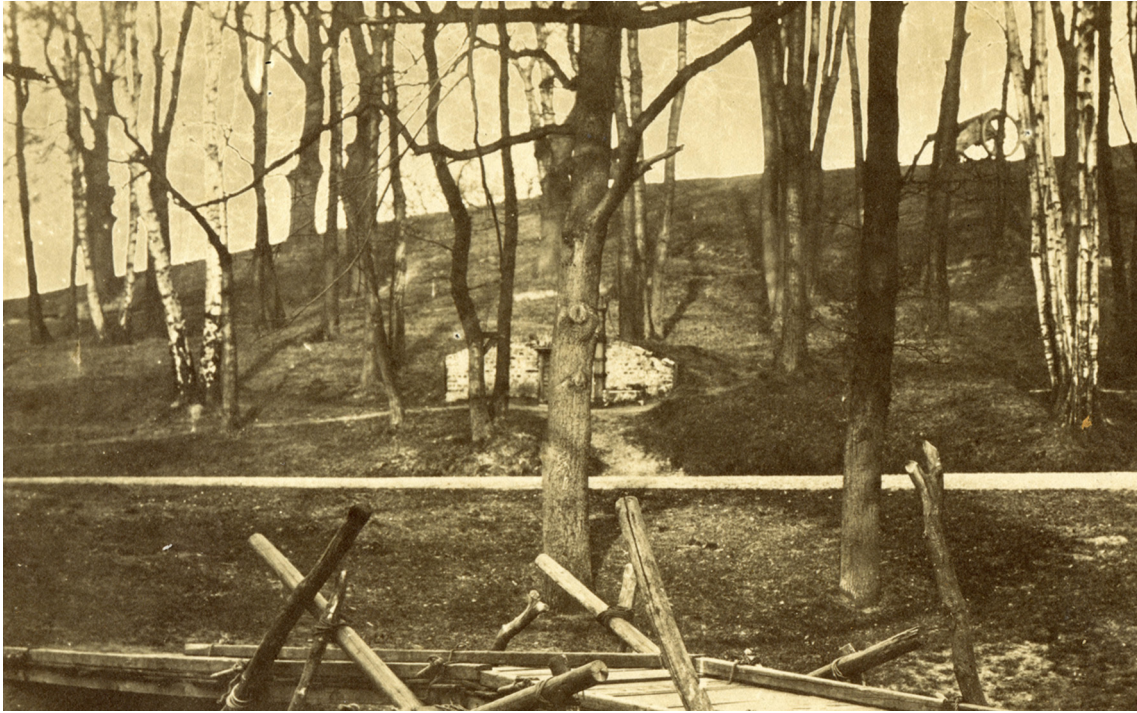
Figure 25: Brick-built structure, possibly protecting a spring source, whose foundations are still visible on the ground. Photograph circa 1858. Courtesy of the Royal Artillery Historical Trust (RAHT Album AL112 – no number)

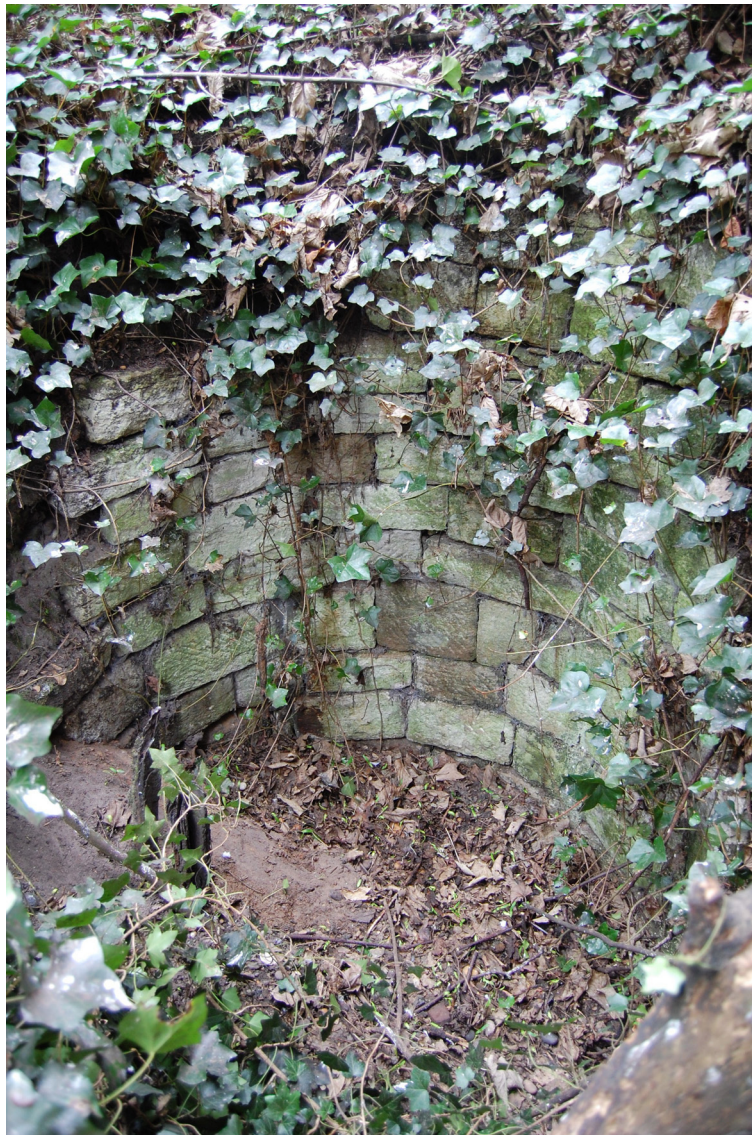
Figure 27: Dressed stone circular structure, probably related to 19th century drainage of the site, located at the southern end of the survey area. Photograph: Sarah Newsome 2008 © English Heritage
