REPOSITORY WOODS,
WOOLWICH, GREATER LONDON
AN ARCHAEOLOGICAL SURVEY OF THE ROYAL
MILITARY REPOSITORY TRAINING GROUNDS
SURVEY REPORT

**REPOSITORY WOODS
WOOLWICH
GREATER LONDON**

**An Archaeological Survey of the Royal Military Repository
Training Grounds**

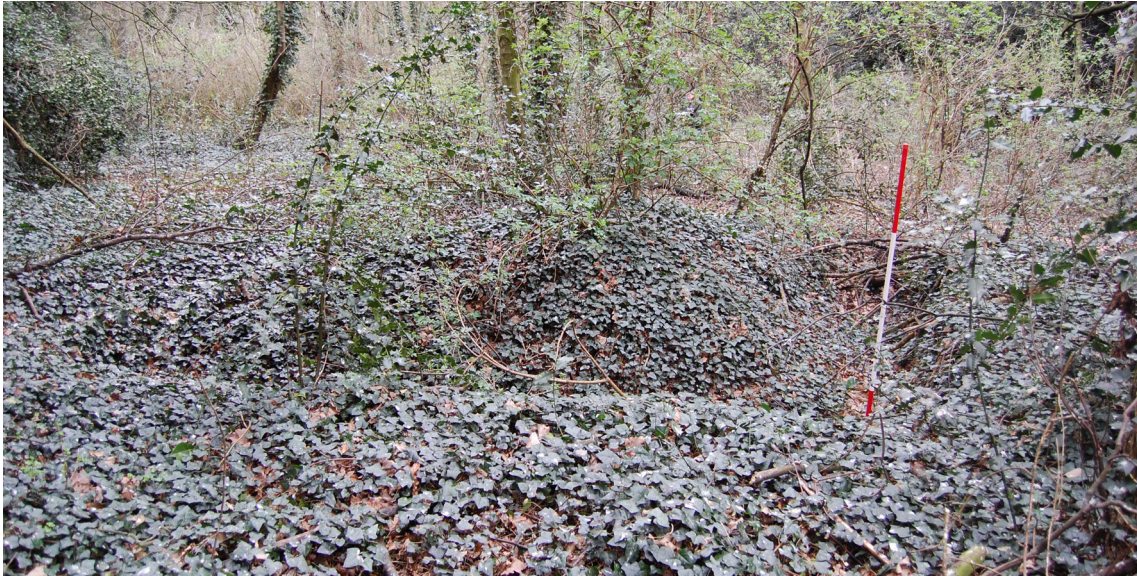
Figure 28: L-shaped trench located at the western side of the stream in the southern half of the survey area. The trench is probably mid-20th century in date. Photograph: Sarah Newsome 2008 © English Heritage

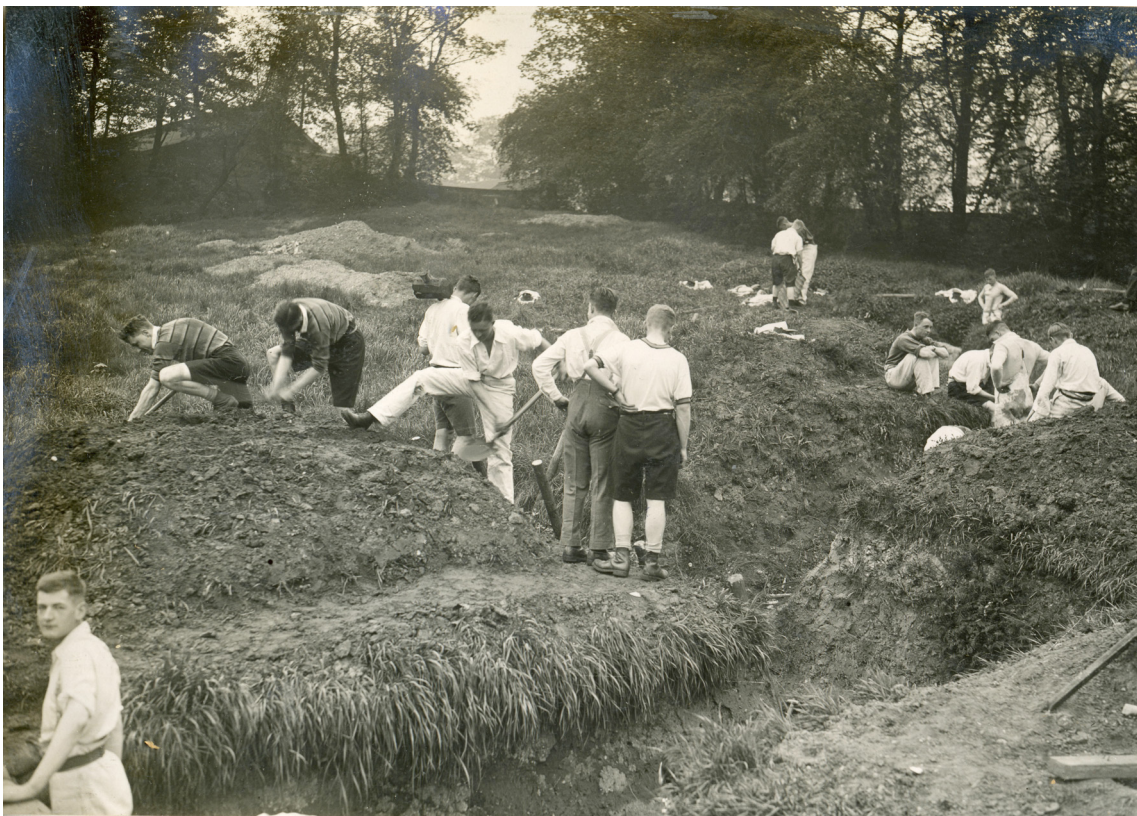
Figure 29: Cadets digging trenches in the Repository grounds at the western side of the small ponds some time in the early 20th century. Photograph taken looking north-west. Courtesy of the Royal Artillery Historical Trust (RAHT AL27/64)

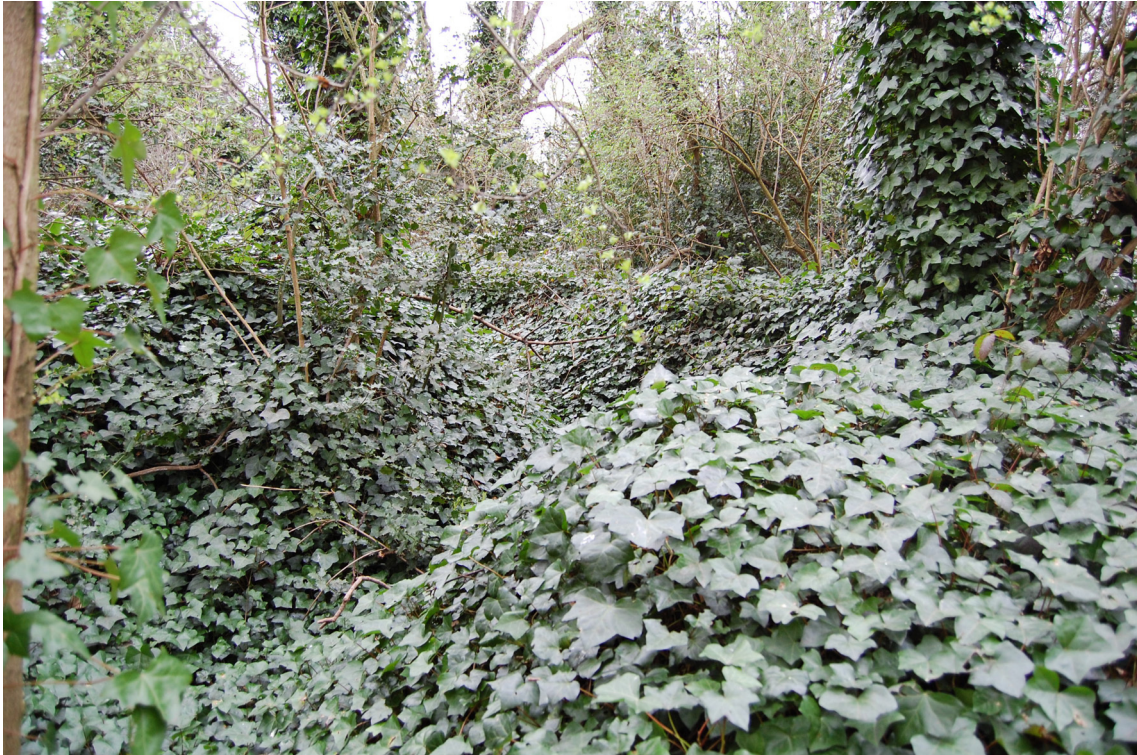
Figure 30: Zigzag trench which is still visible as an earthwork in the same general area as Figure 29. Photograph: Sarah Newsome 2008 © English Heritage

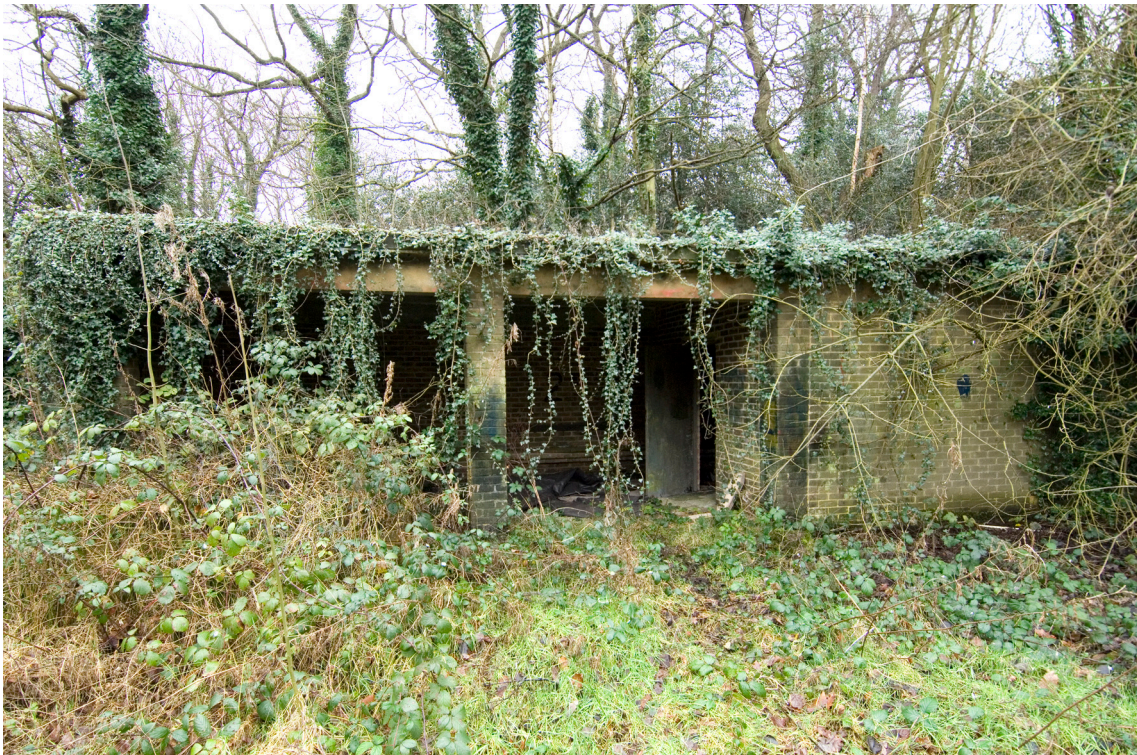
Figure 31: The rifle-range building viewed from the west. Photograph: Derek Kendall DP049806 © English Heritage

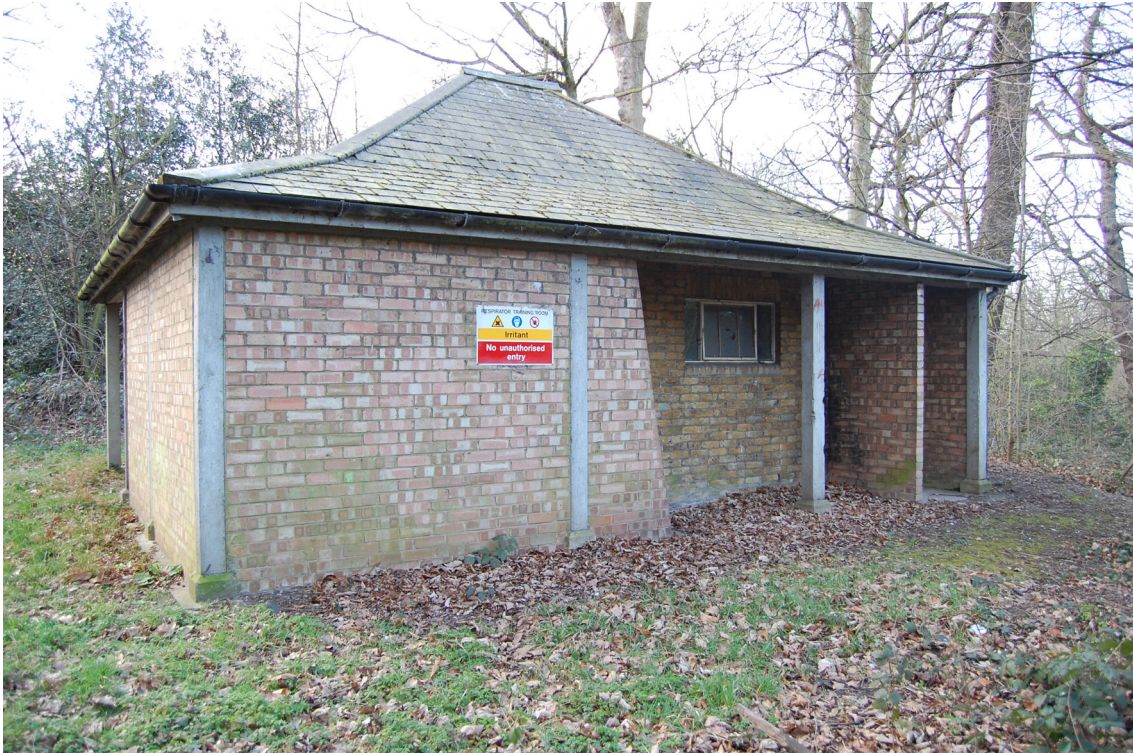
Figure 32: 20th century pavilion-type building now in use as a 'Respirator Training Room'.
Photograph: Sarah Newsome 2008 © English Heritage

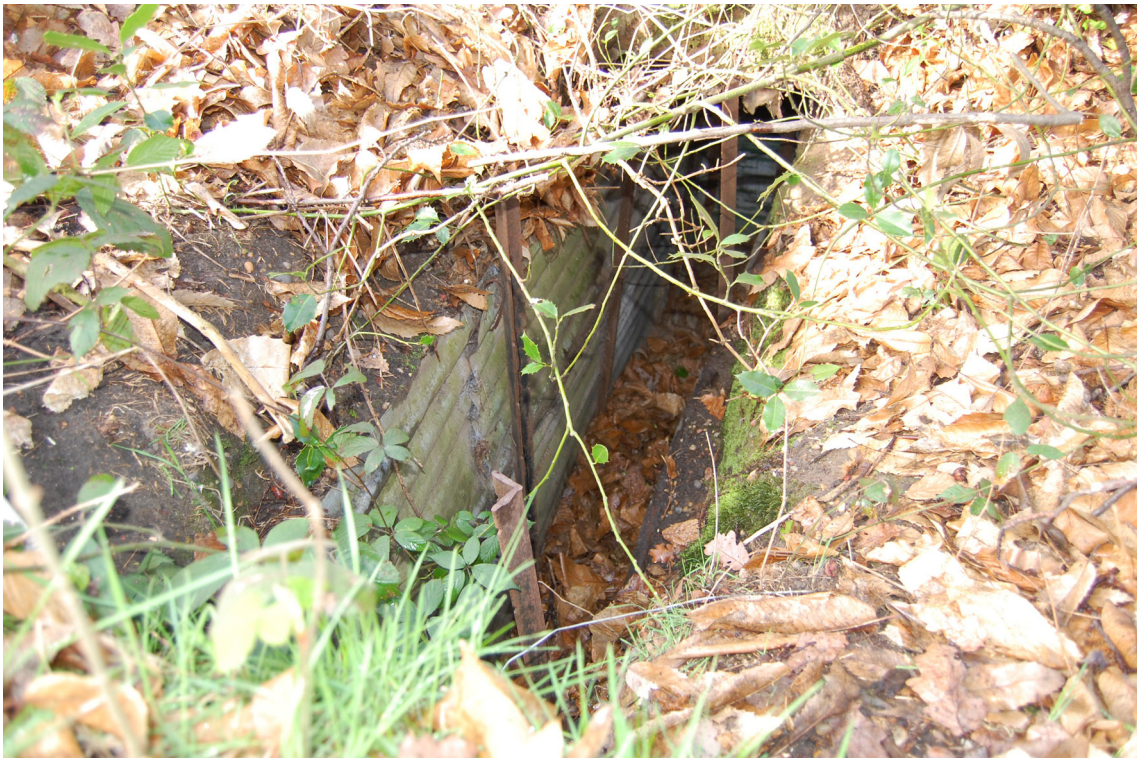
Figure 33: The entrance to the narrow buried trench which probably dates to the Second World War. Photograph: Sarah Newsome 2008 © English Heritage

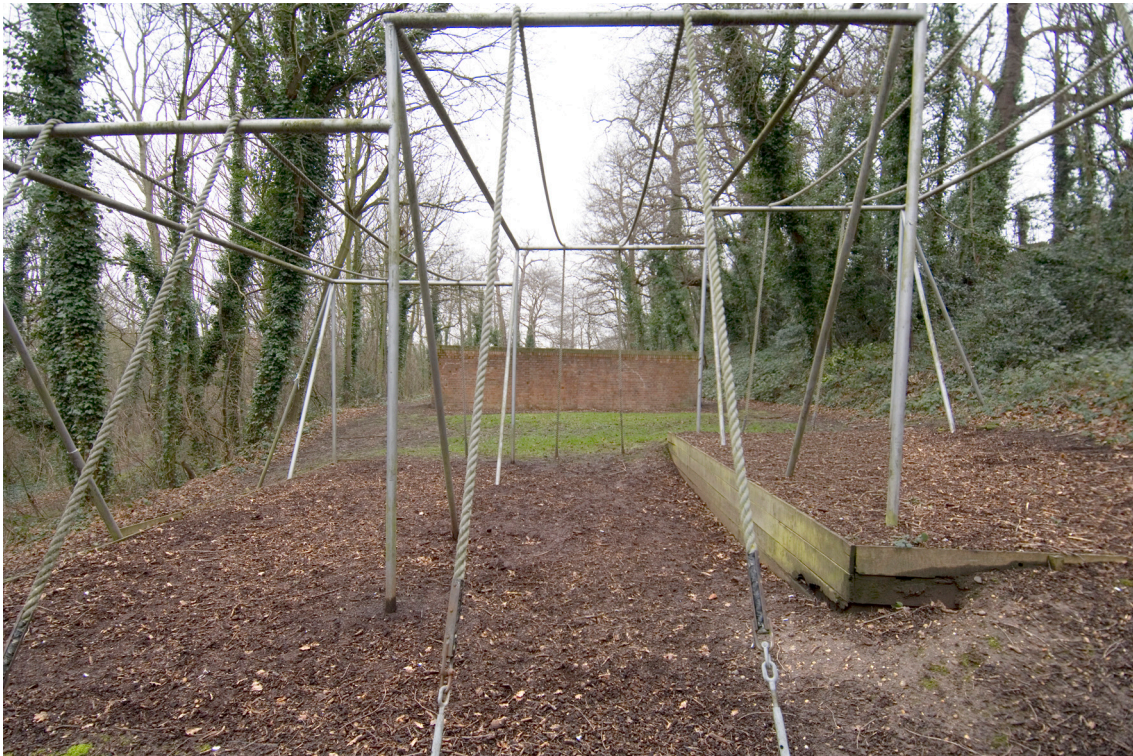
Figure 34: Modern assault course. Photograph: Derek Kendall DP049783 © English Heritage

Though all of the woodland has been used as a training facility throughout the 20th century, later activity appears to focus on two particular areas, the area of disturbed ground at the southern end of the survey area and the assault course (Figure 34) which is located on a man-made terrace on sloping ground between the largest pond and the Rotunda compound. The assault course consists of walls to scale, water traps and other obstacles and had been constructed by 1971 (MAL 71074/196 21-MAY-1971). In the area of disturbed ground at the southern end of the site various earthworks and structures are related to the continuing training of troops, perhaps for 'command task' training (Timbers 2008, 36). A concrete sewer pipe located to the west of the smaller ponds may also have been used for training purposes.

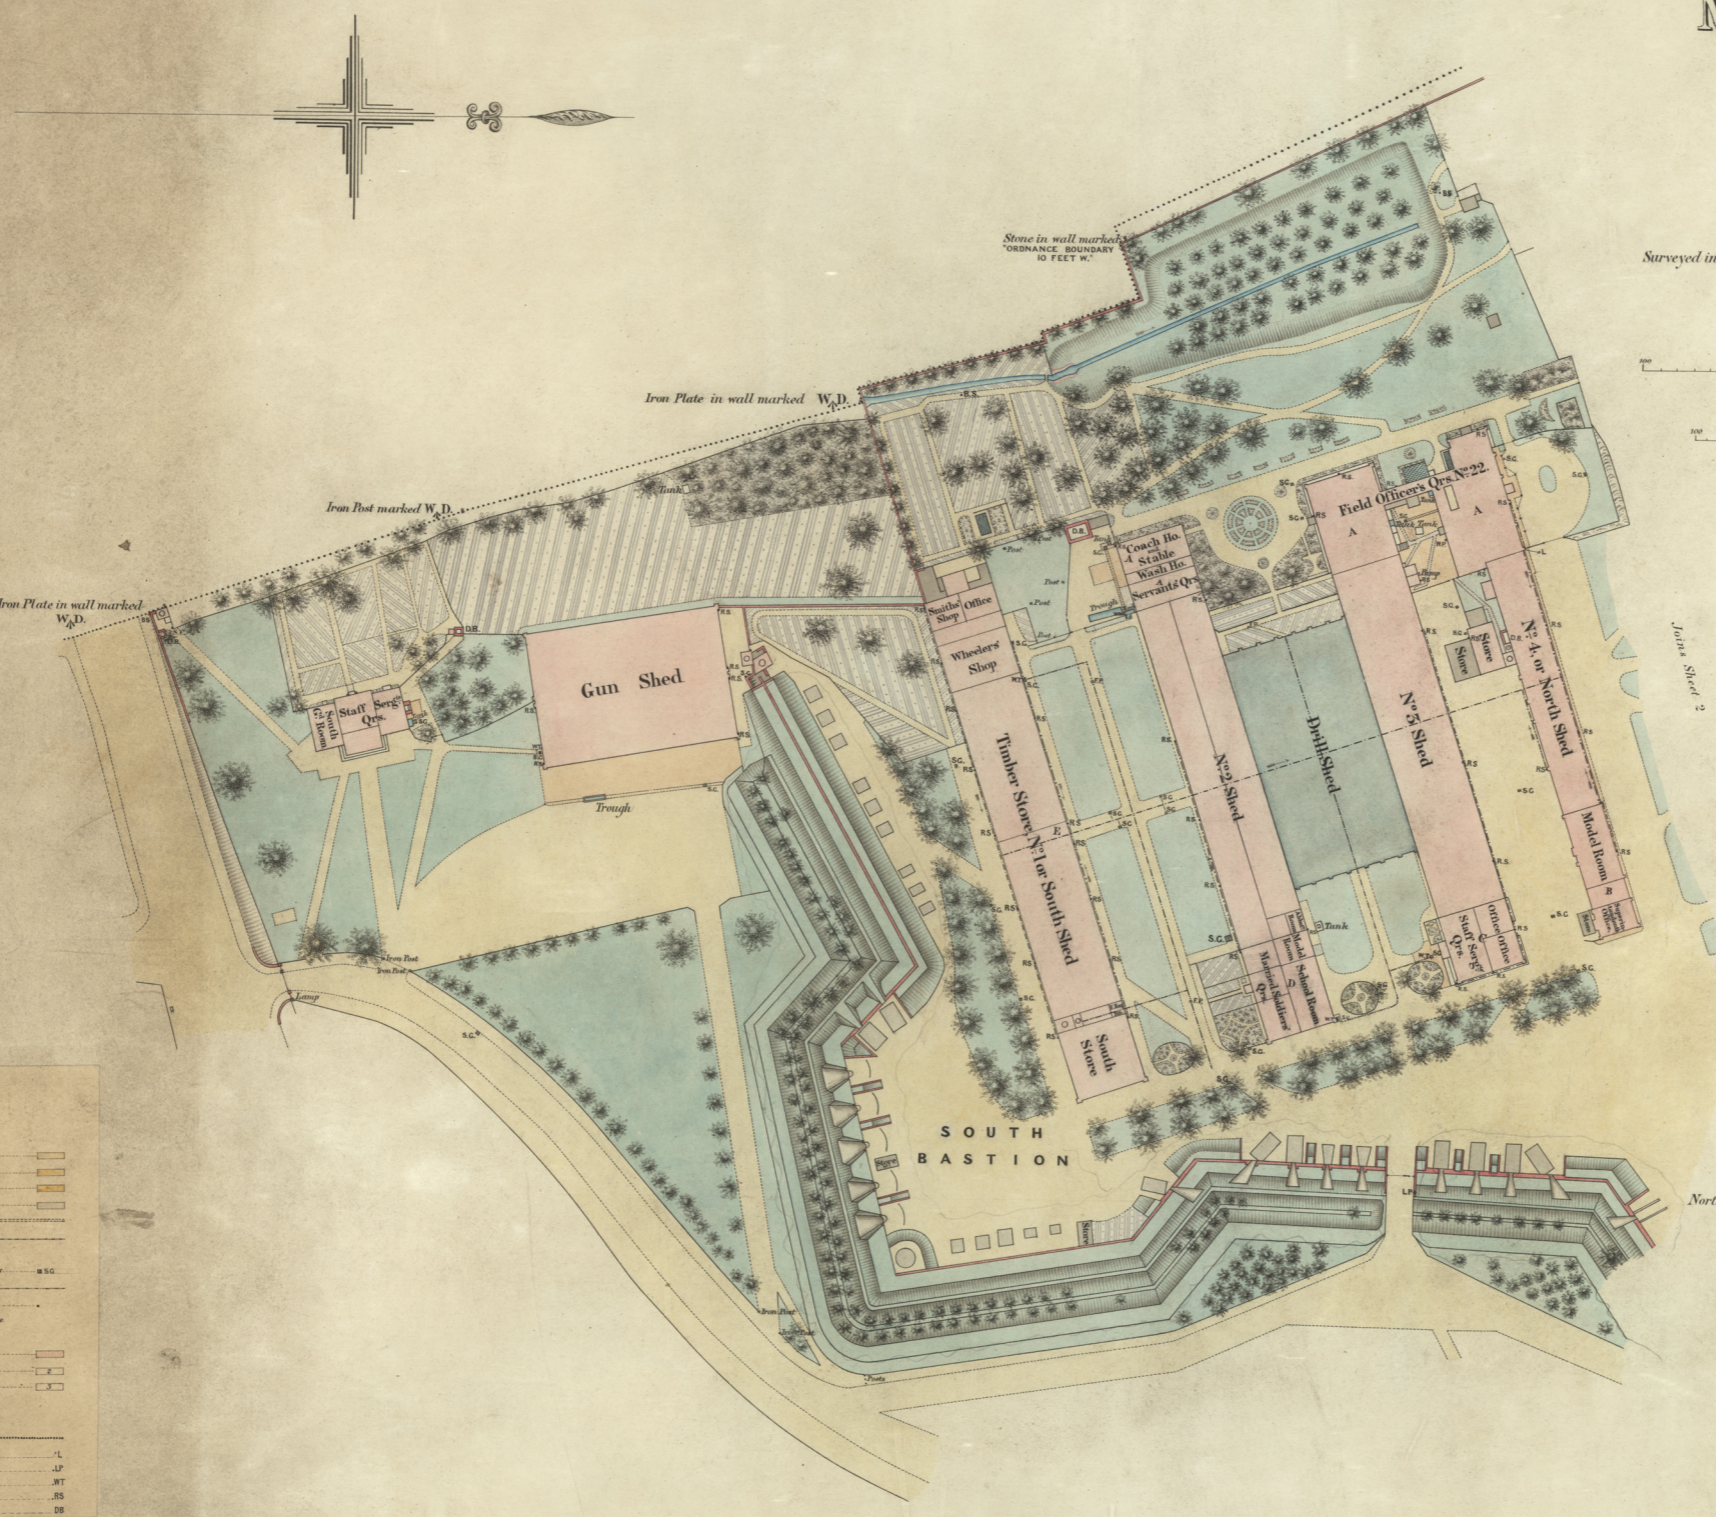
ROYAL MILITARY REPOSITORY, WOOLWICH.

Surveyed in 1867 under the direction of Lt. Col. Bayly R.E. Col. Sir H. James R.E. F.R.S. M.R.I.A. Superintendent of the Ordnance Surveys.

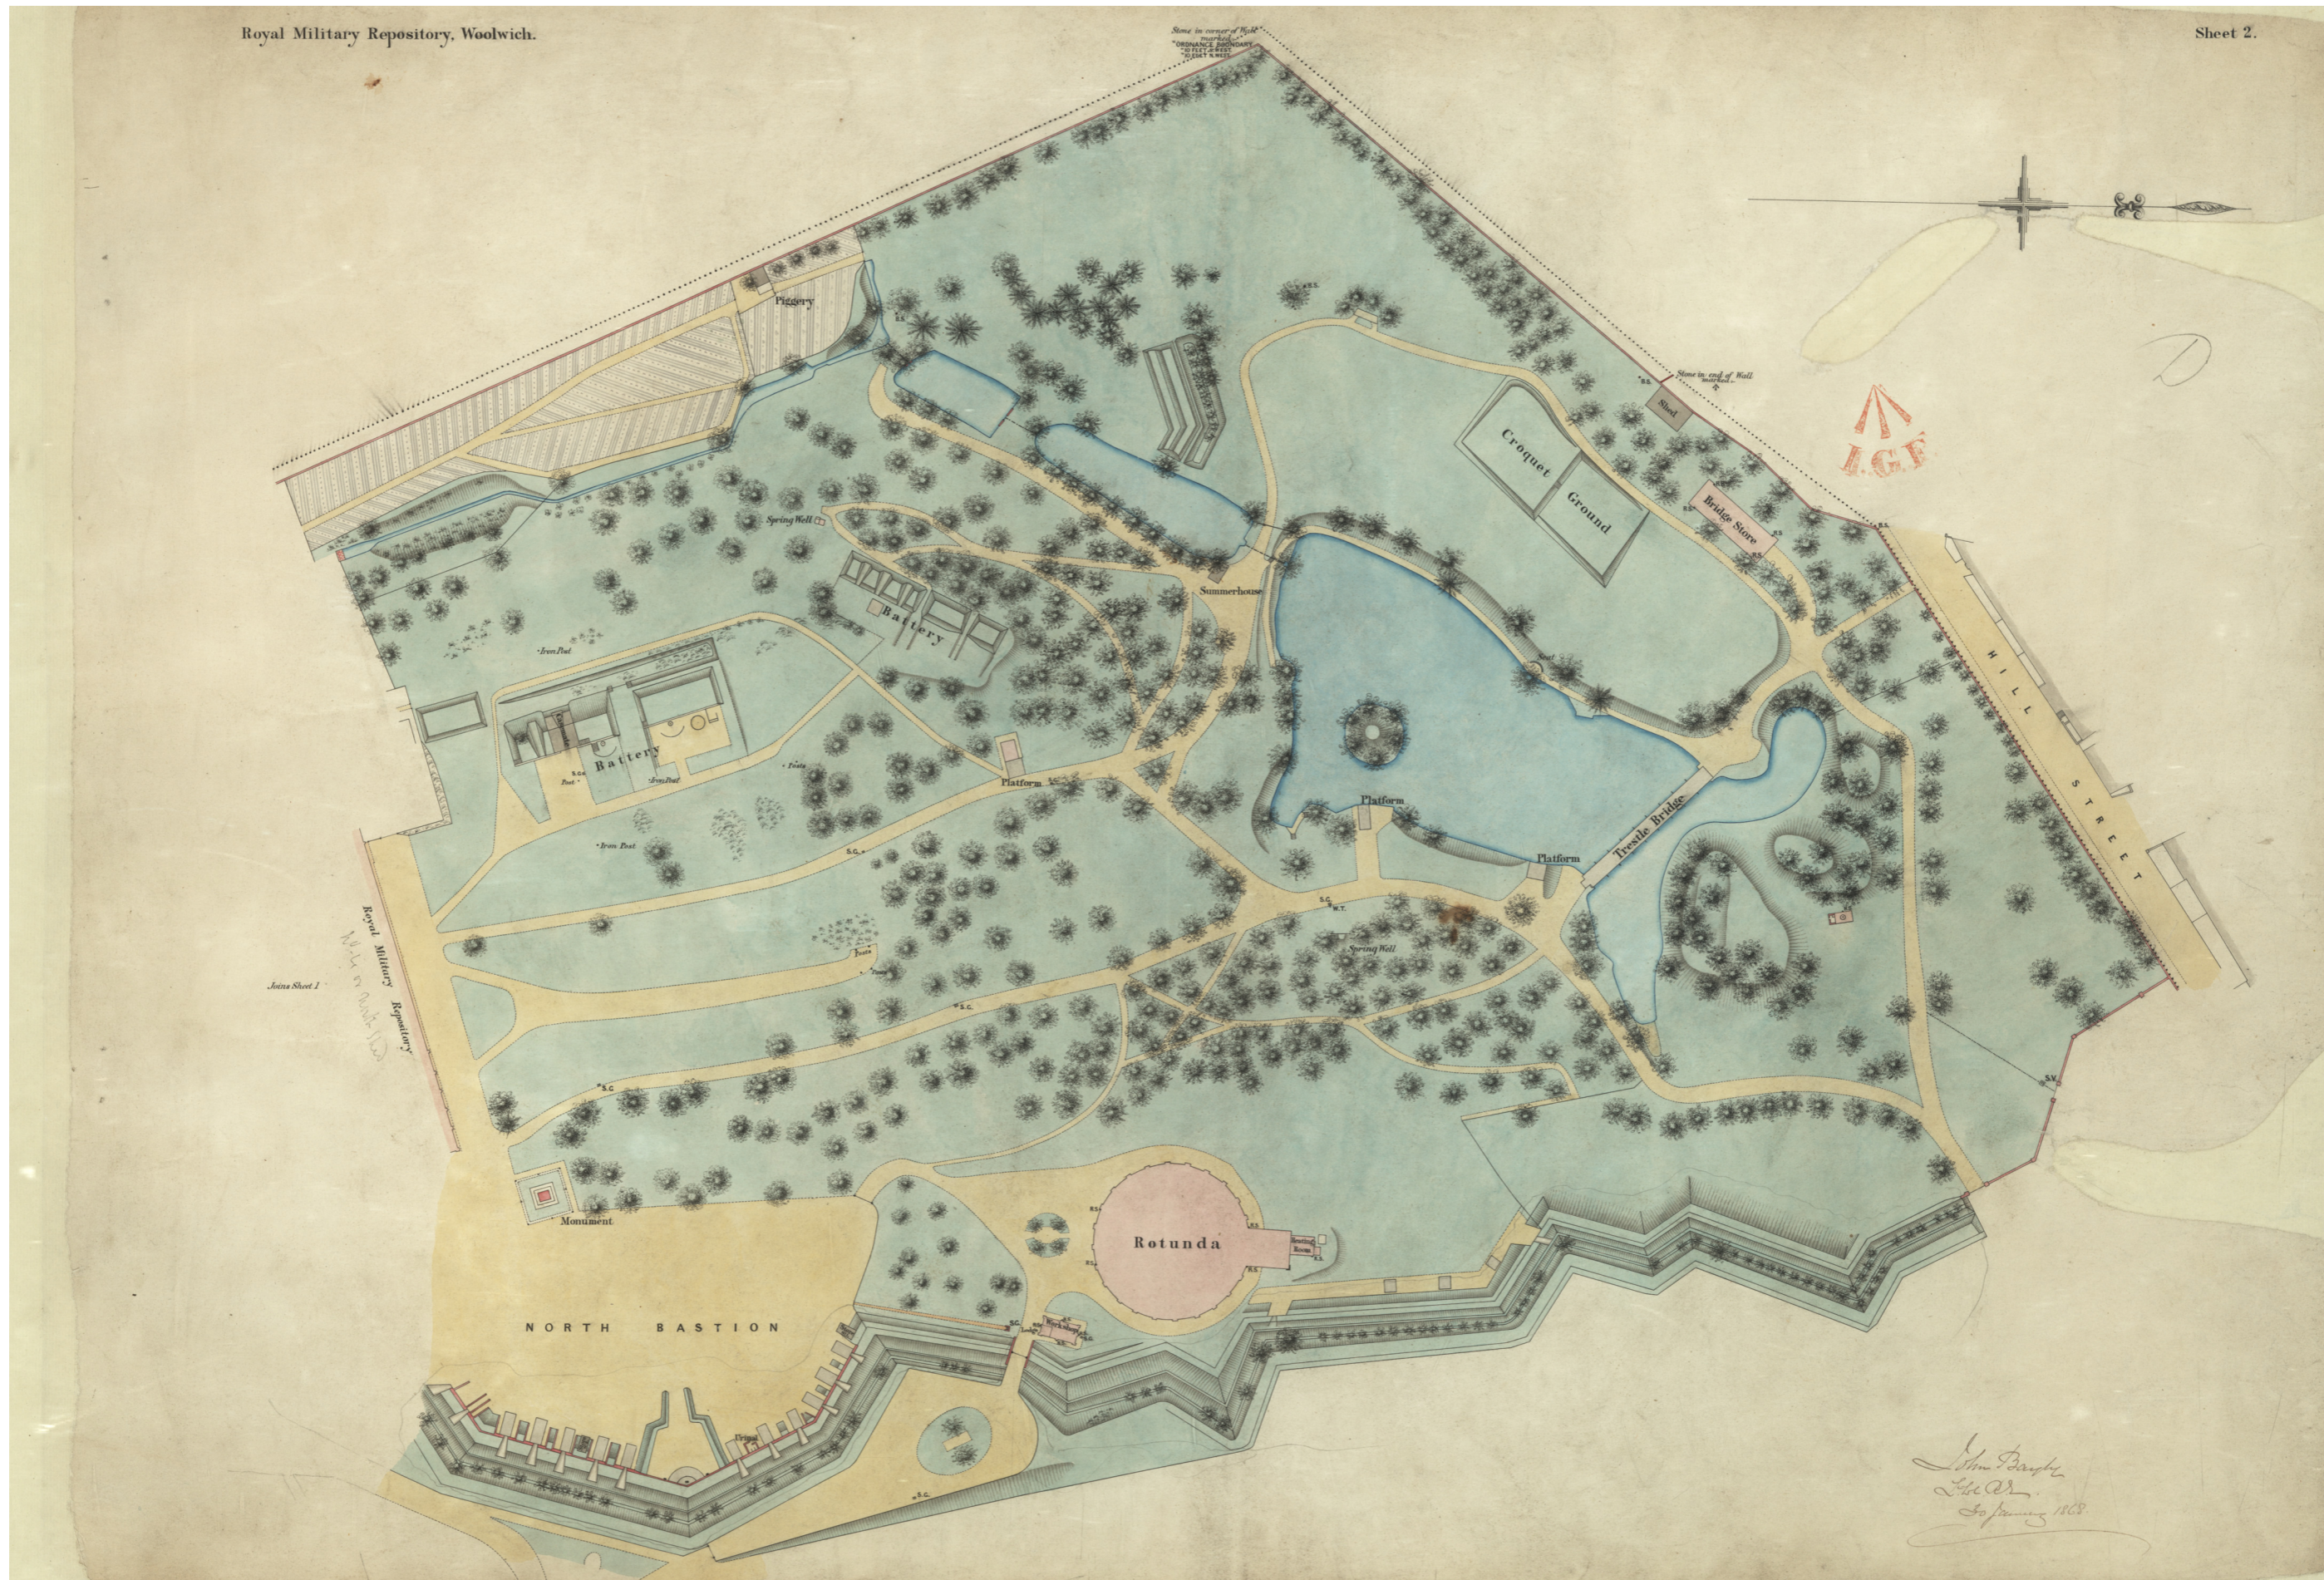
Figure 36B: 1867 survey by Lt. Col. Bayly and Col. Sir H James, Superintendent of the Ordnance Surveys, showing the northern section of the Royal Military Repository. NB North is to the right of the image.
 © The National Archives: Public Record Office MPH 1/362

It should also be noted that whilst the earthworks to the south-east of the respirator training room (below) are very much disturbed and partially buried by the dumping of rubble, some may relate to the training battery shown in this location on historic maps from the mid-1840s onwards and in great detail on the Bayly map of 1867 (Figure 36B).
