# COCKLE PARK TOWER, HEBRON, MORPETH, NORTHUMBERLAND TREE-RING ANALYSIS OF TIMBERS

SCIENTIFIC DATING REPORT

NGR: NZ 20089 91156

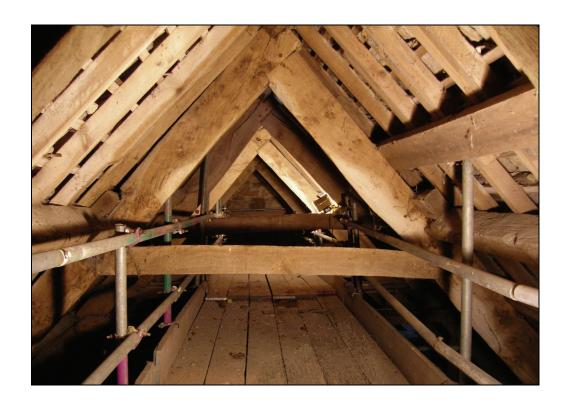
Figure 3: Cockle Park Tower; main range roof looking south (truss 3 in the foreground)

Within the main north-south range roof there are five principal-rafter trusses, with tiebeams, collars, and trenched purlins (Fig 3). At the north end of this range is a short cross—wing, extending out to the east. The roof here has a single truss of principal rafters and tiebeam (Fig 4).

Two of the samples from the main range roof (CKL-P03 and CKL-P04), both principal rafters from truss 3, have complete sapwood and the last-ring date of AD 1602, the felling date of the timbers represented. A further seven of the dated samples have the heartwood/sapwood boundary ring, the dates of which are broadly contemporary, varying by only nine years, and suggestive of a single felling. The average heartwood/sapwood boundary ring date is AD 1581, which allows an estimated felling date to be calculated for the timbers represented of AD 1602–21; this takes into consideration sample CKL-P13 having a last-measured ring date of AD 1601 with incomplete sapwood. This felling date range is consistent with these timbers also having been felled in AD 1602.

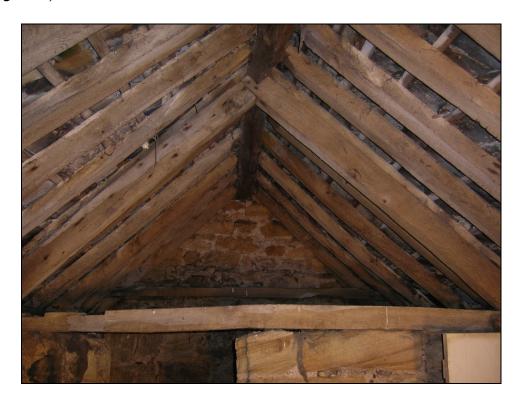
Figure 4: Cockle Park Tower; short cross-wing roof looking east (truss 1)

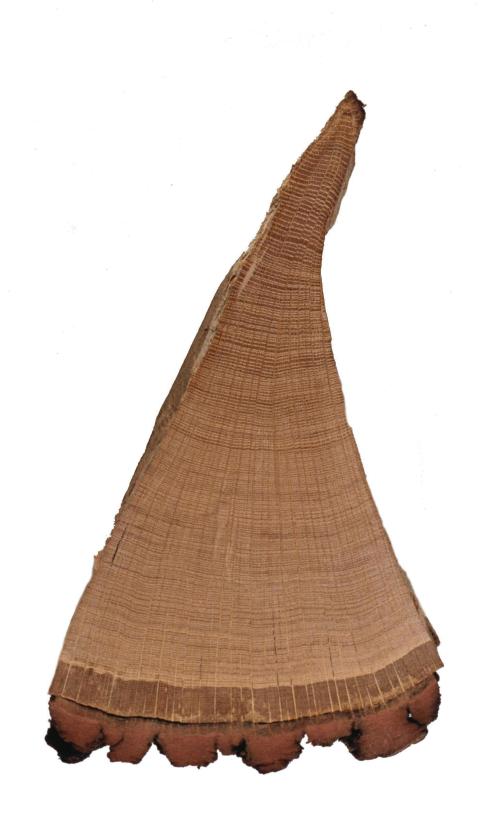
the last ring on the outside just inside the bark. The year of each ring can be determined by counting back from the outside ring, which Figure A1: A wedge of oak from a tree felled in 1976. It shows the annual growth rings, one for each year from the innermost ring to grew in 1976

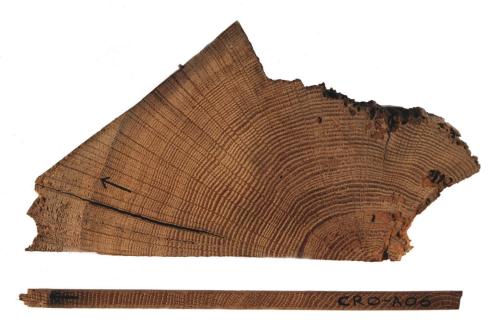
Figure A2: Cross-section of a rafter, showing sapwood rings in the left-hand corner, the arrow points to the heartwood/sapwood boundary (H/S); and a core with sapwood; again the arrow is pointing to the H/S. The core is about the size of a pencil

Quite often some, though not all, of the original outer rings are missing on a timber. The outer rings on an oak, called sapwood rings, are usually lighter than the inner rings, the heartwood, and so are relatively easy to identify. For example, sapwood can be seen in the corner of the rafter and at the outer end of the core in Figure A2, both indicated by arrows. More importantly for dendrochronology, the sapwood is relatively soft and so liable to insect attack and wear and tear. The builder, therefore, may remove some of the sapwood for precisely these reasons. Nevertheless, if at least some of the sapwood rings are left on a sample, we will know that not too many rings have been lost since felling so that the date of the last ring on the sample is only a few years before the date of the original last ring on the tree, and so to the date of felling.

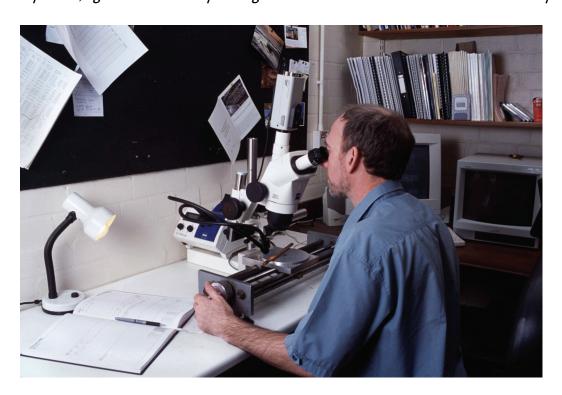
Figure A3: Measuring ring widths under a microscope. The microscope is fixed while the sample is on a moving platform. The total sequence of widths is measured twice to ensure that an error has not been made. This type of apparatus is needed to process a large number of samples on a regular basis

- 2. Measuring Ring Widths. Each core is sanded down with a belt sander using medium-grit paper and then finished by hand with flourgrade-grit paper. The rings are then clearly visible and differentiated from each other with a result very much like that shown in Figure A2. The core is then mounted on a movable table below a microscope and the ring-widths measured individually from the innermost ring to the outermost. The widths are automatically recorded in a computer file as they are measured (see Fig A3).

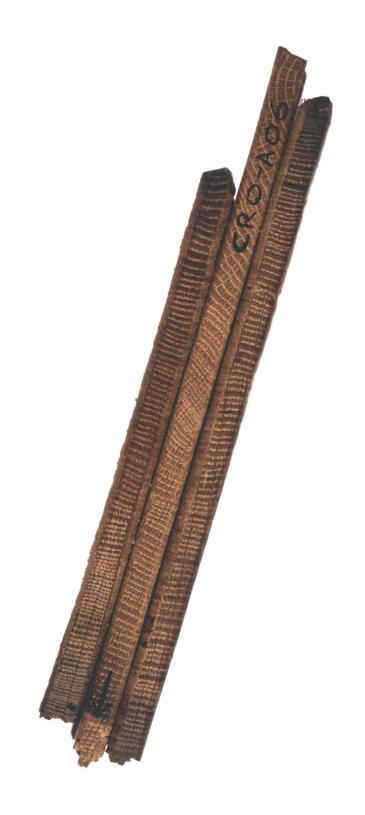
Figure A4: Three cores from timbers in a building. They come from trees growing at the same time. Notice that, although the sequences of widths look similar, they are not identical. This is typical
