# COCKERSAND ABBEY, THURNHAM, LANCASHIRE AN ANALYTICAL EARTHWORK SURVEY

NGR: SD 4270 5376

In 2008, English Heritage carried out an analytical survey of the earthwork remains of the Premonstratensian Abbey of St Mary-in-the-Marsh at Cockersand, Lancashire. The abbey, which originated as a hermitage in around 1180, occupies an outcrop of sandstone lying to the south of the broad mouth of the River Lune and stands only 4.8m above mean high tide level. By 2007, dilapidation of the standing remains and active coastal erosion had resulted in the site being assessed as at 'High Risk' in English Heritage's 'Heritage at Risk Register' for the North-West Region. Following this, English Heritage's Regional Advice and Grants Team provided grant-aid for urgent works to the standing Chapter House and requested the present survey of its environs.

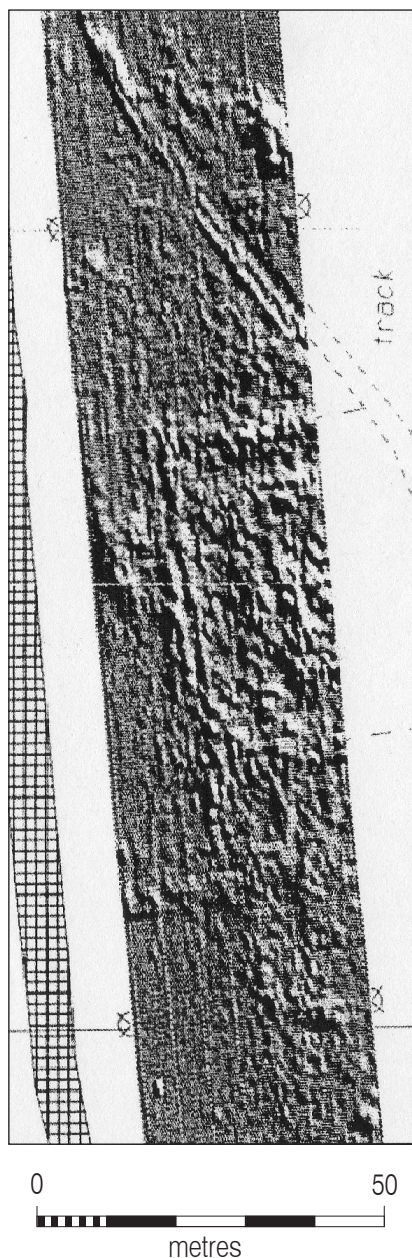
Figure 6. Geophysical survey plot of the western area of the abbey, produced in 1997 by Geoquest

In 1997 and 1999, the Environment Agency commissioned Babbie Group to undertake assessments of the coastal defences at Cockersand. As part of this work, in 1997, GeoQuest undertook a geophysical survey of a 30m by 280m transect in between the abbey ruins and sea wall revetment set 10m back from the sea cliff (Malim 2004, 10; Figure 6). This revealed a few additional details of the layout of this part of the site, with some walls detached from the main church and claustral area. The 2008 survey has shown that these are parts of the monastic precinct boundary to the north and to the south of the claustral range.

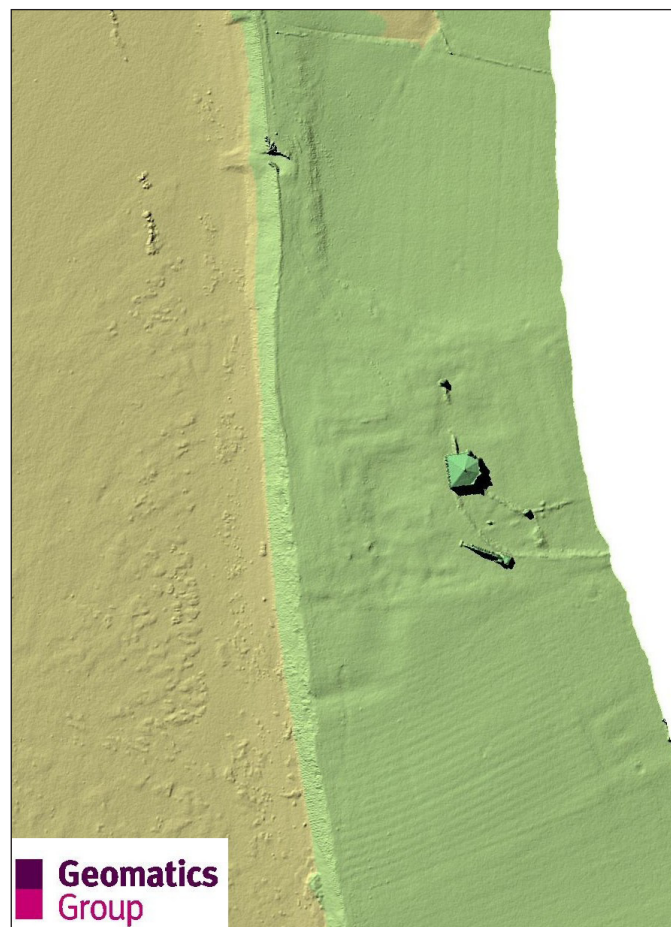
Figure 8. Lidar data highlighting the earthwork remains of Cockersand Abbey. Lidar data copyright Geomatics Group 2008

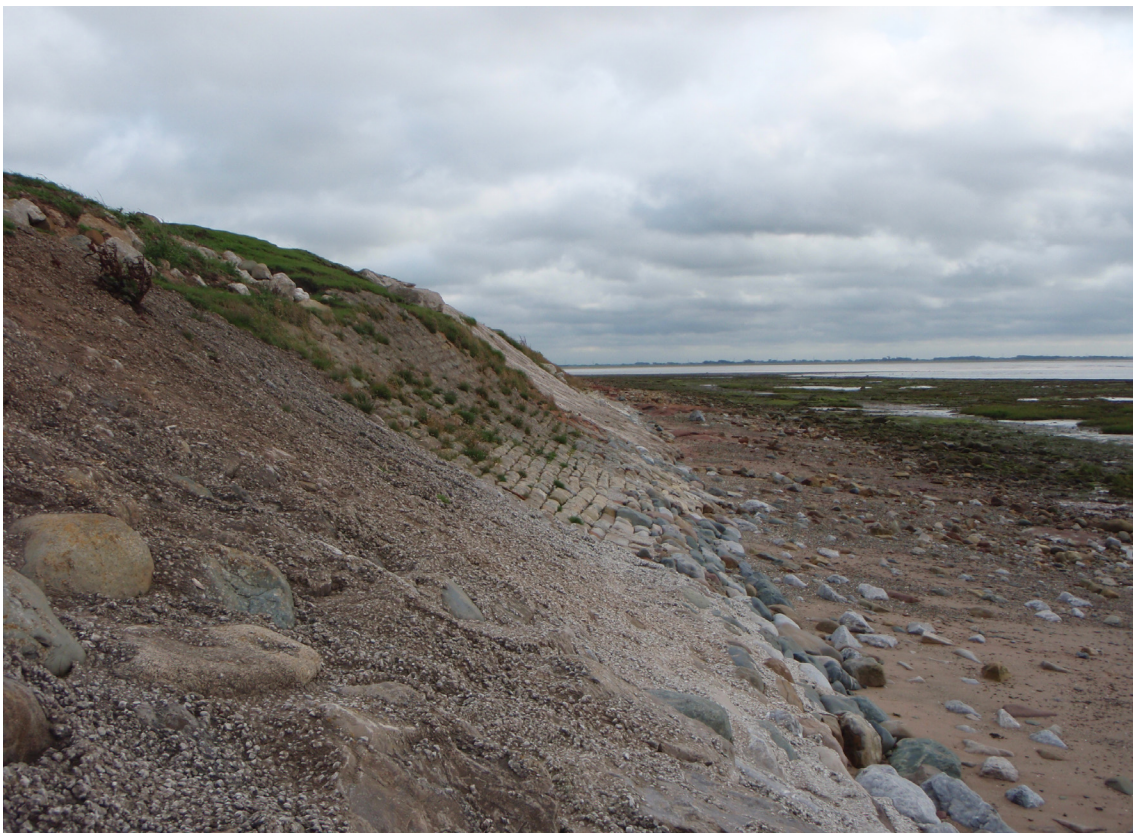
*Figure 10. View south along the sea wall showing areas of erosion at its base*

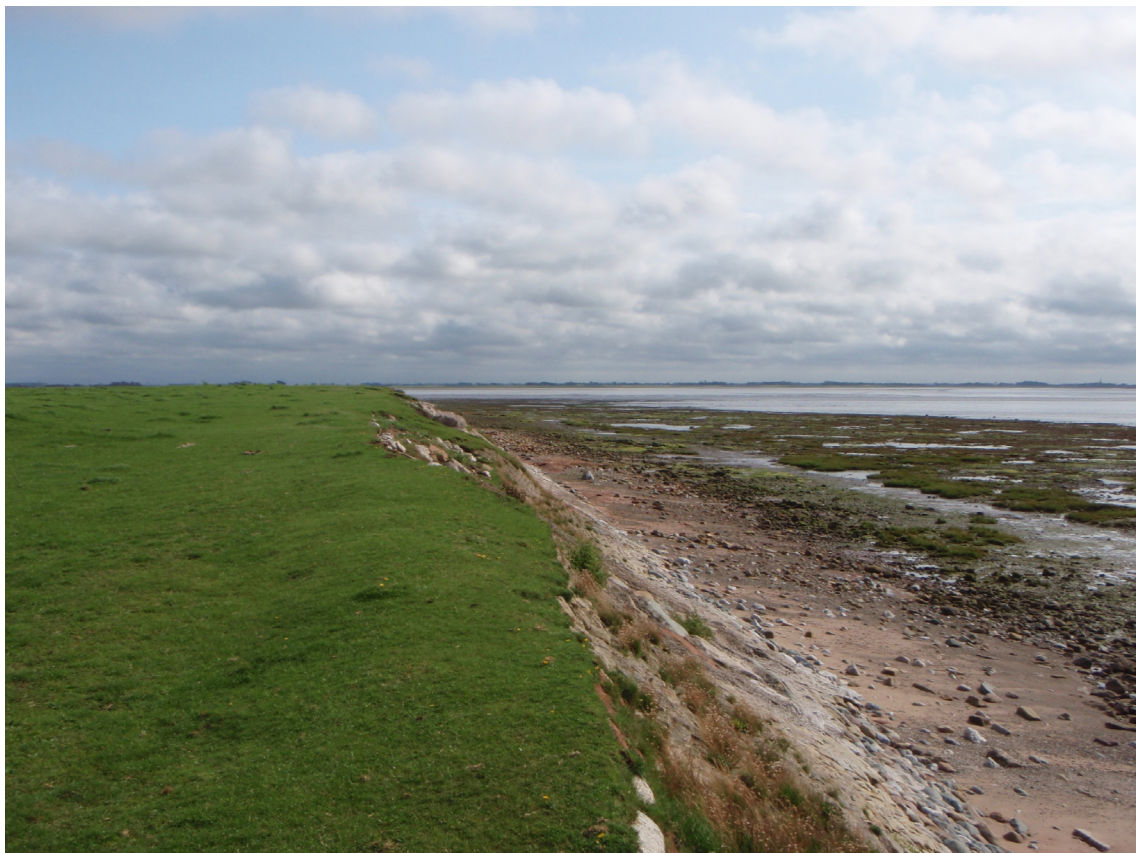
- A slight bank along the top of the sea cliff may relate to a relatively early enhancement of the sea defences (Figure 11). Alternatively, this may be a plough headland or field boundary, possibly related to medieval or post-medieval ploughing.

*Figure 11. View southwards along the facing wall of the sea cliff, showing landslips caused by wave action*

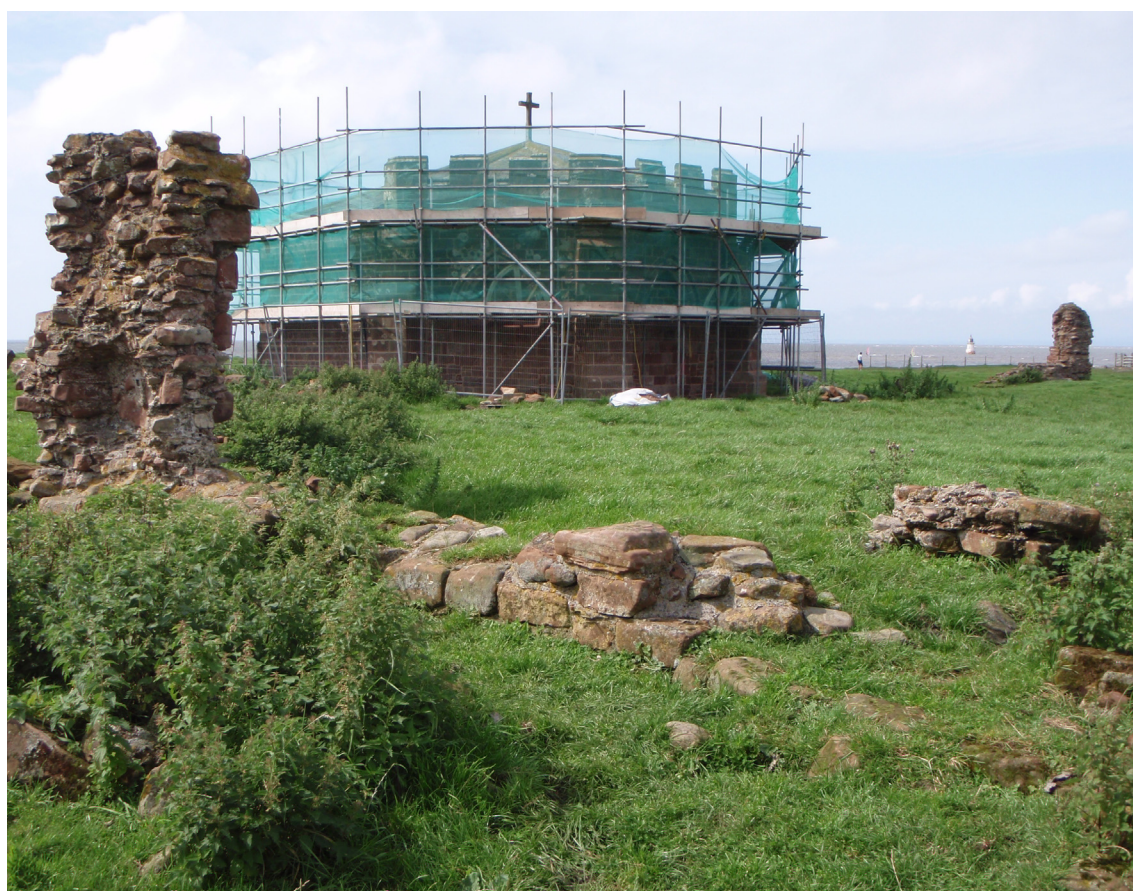
In 1750, the Dalton family repaired and converted the chapter house into a mausoleum; it fell into disuse as such in 1861 but has been maintained ever since (Figure 12).

Figure 12. View of remains around the chapter house, showing conservation work in progress

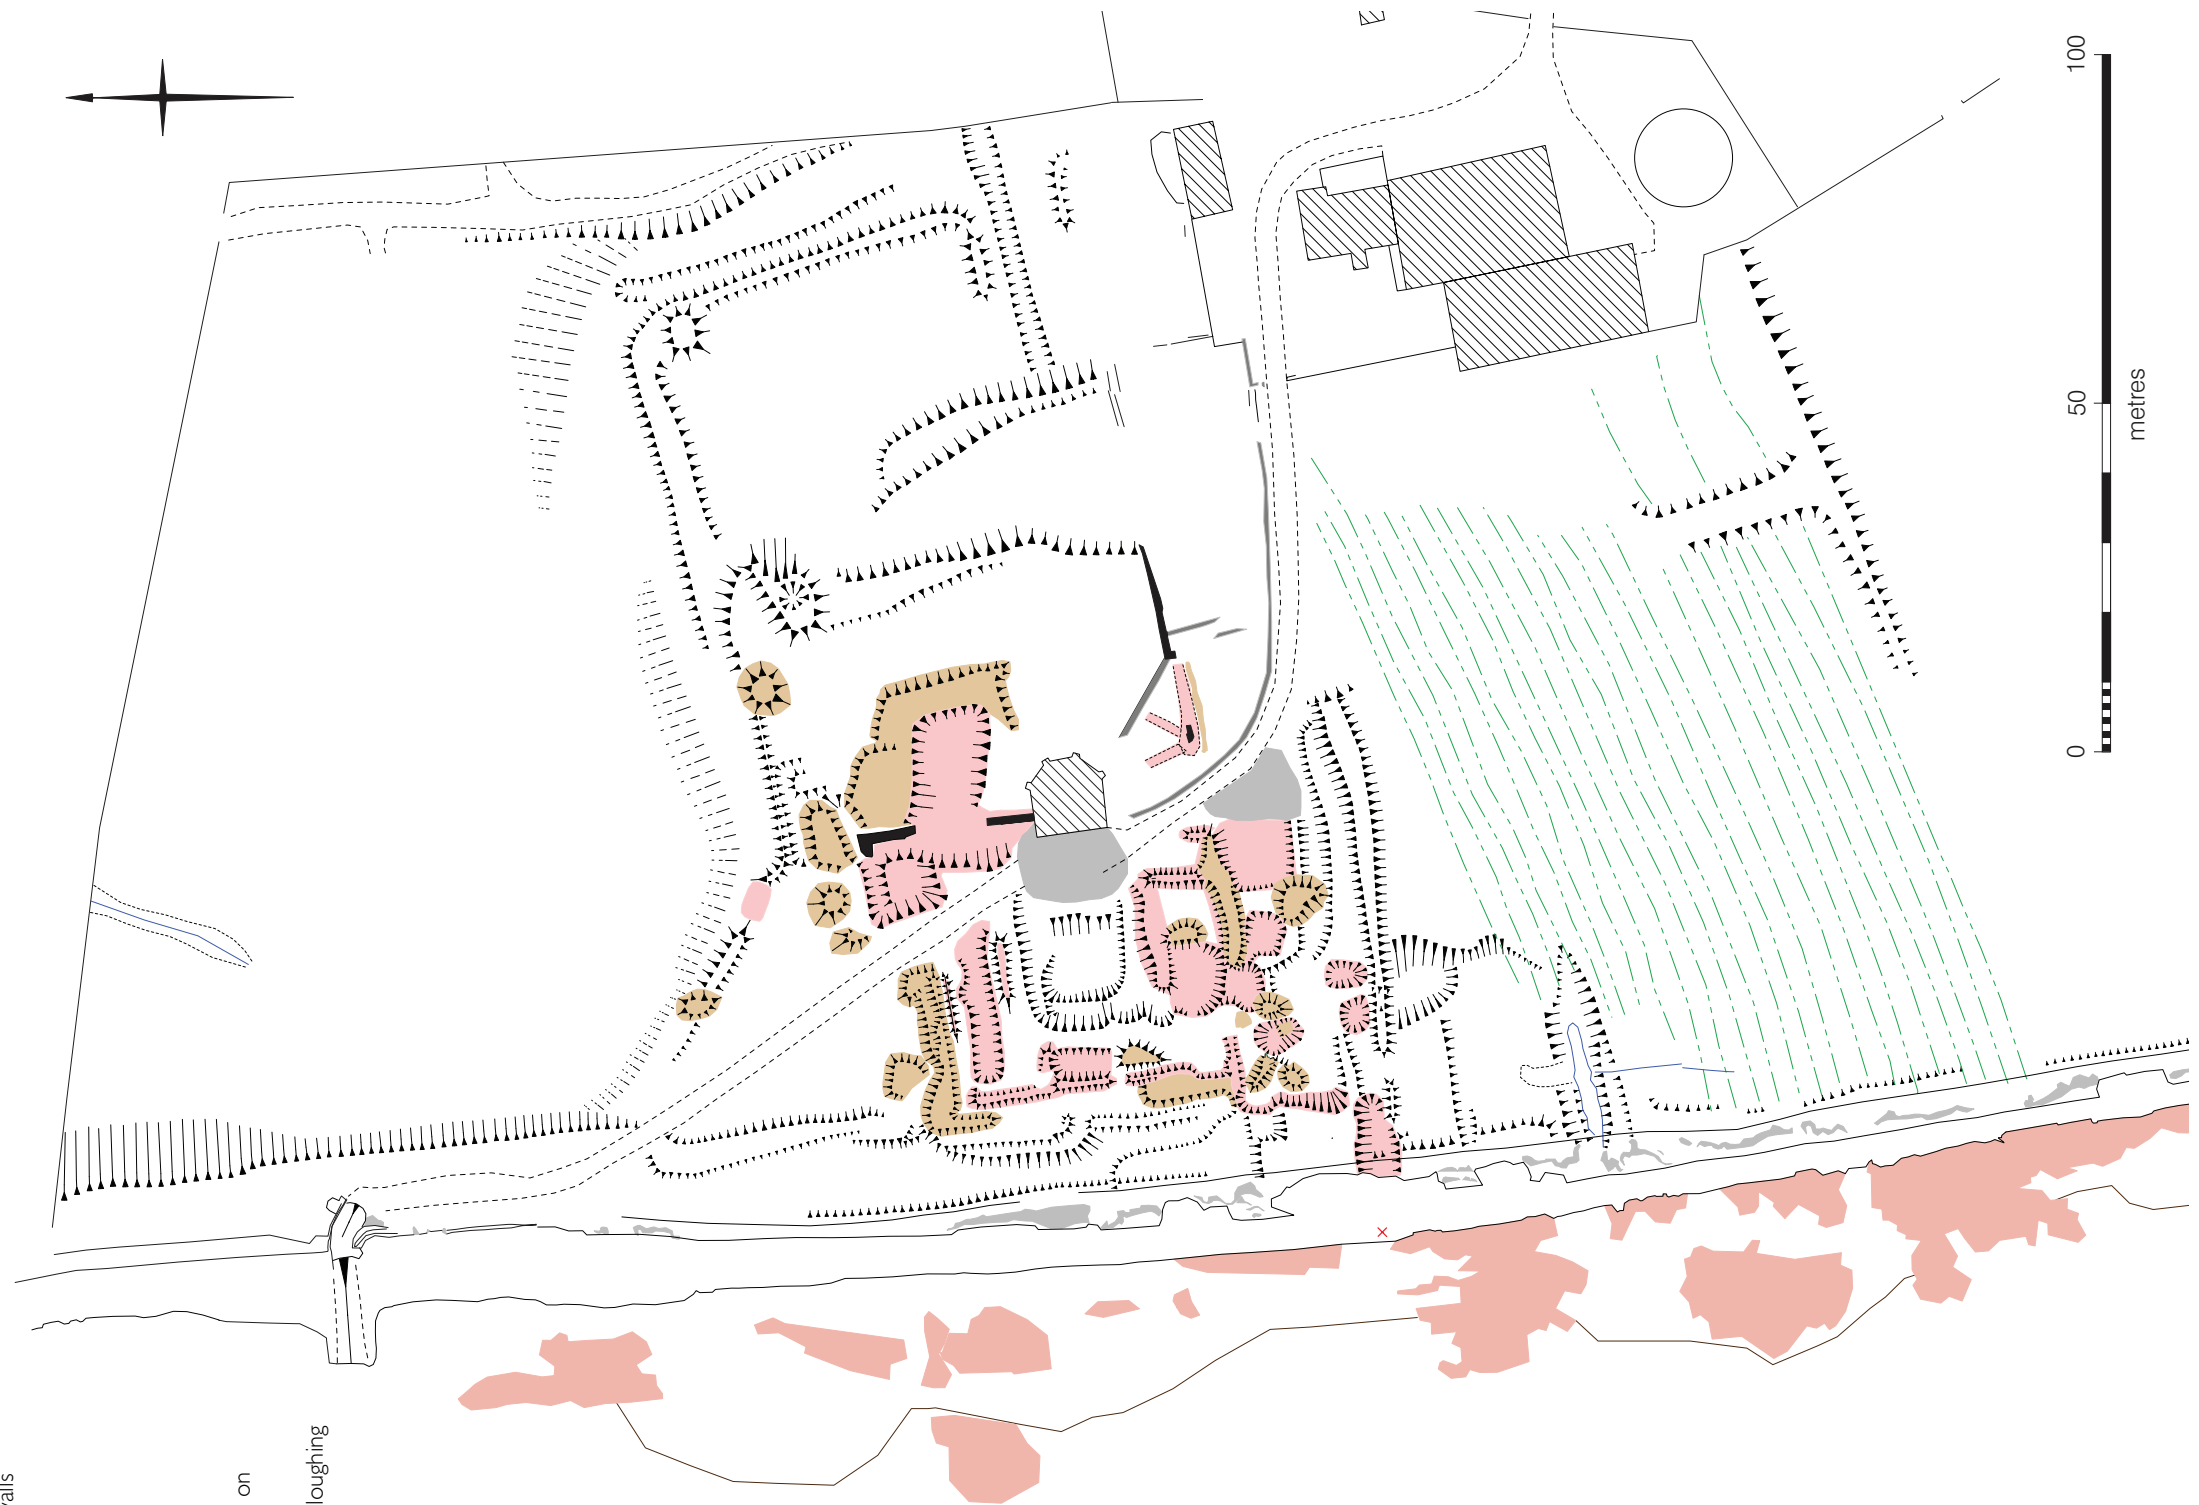
English Heritage's 2008 survey essentially confirms the plan of the conventual buildings as interpreted on the evidence of the excavations in the 1920s and Roper's 1886 survey (Figures 4 and 5), a plan which is fairly conventional (Swarbrick 1923). In these excavated areas, the main contribution of the new survey is to provide a definitive record of the state of the excavated remains and to provide, for the first time, a record of the undocumented distortions to the abbey earthworks caused by the 1920s investigations themselves, specifically the excavation trenches and the dumping of the resulting spoil (see Figures 9 and 15).

Figure 15 Hachured earthwork plan of  
Cockersand Abbey, Thurnham Lancashire
