Framlingham Castle, Suffolk

The Red House, formerly Framlingham Workhouse

Research Report Series 023-2016

**THE RED HOUSE
(FORMERLY FRAMLINGHAM WORKHOUSE)
FRAMLINGHAM CASTLE, SUFFOLK**

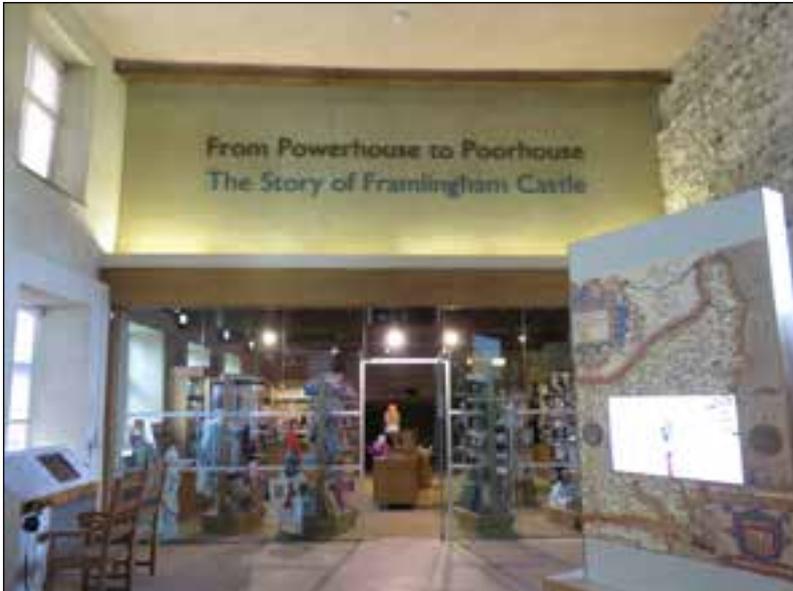
Fig. 2 The interior of the 1729 workhouse block (now shop and exhibition space), looking south. (© Historic England, K. Morrison)

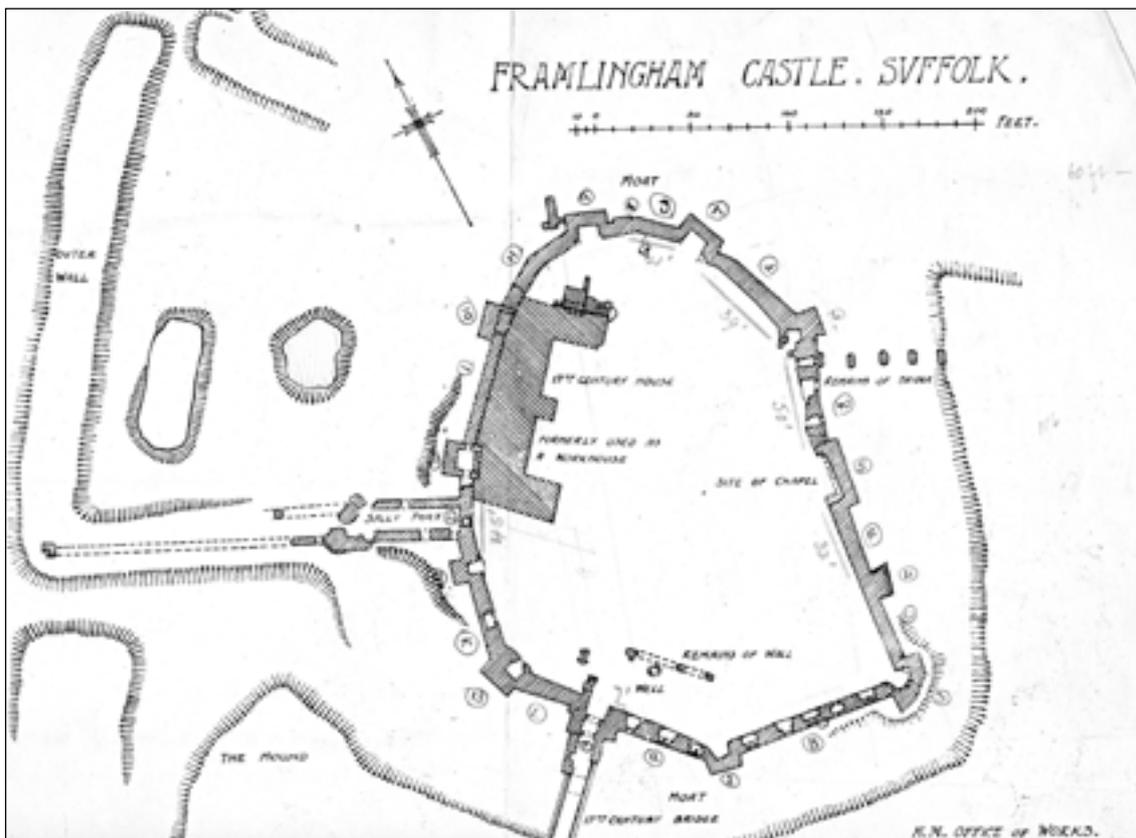
Fig. 3 A site plan of Framlingham Castle dated 1919, showing the location of the workhouse, comprising buildings of the late 16th century, 1664 and 1729. (TNA WORK 14/685)

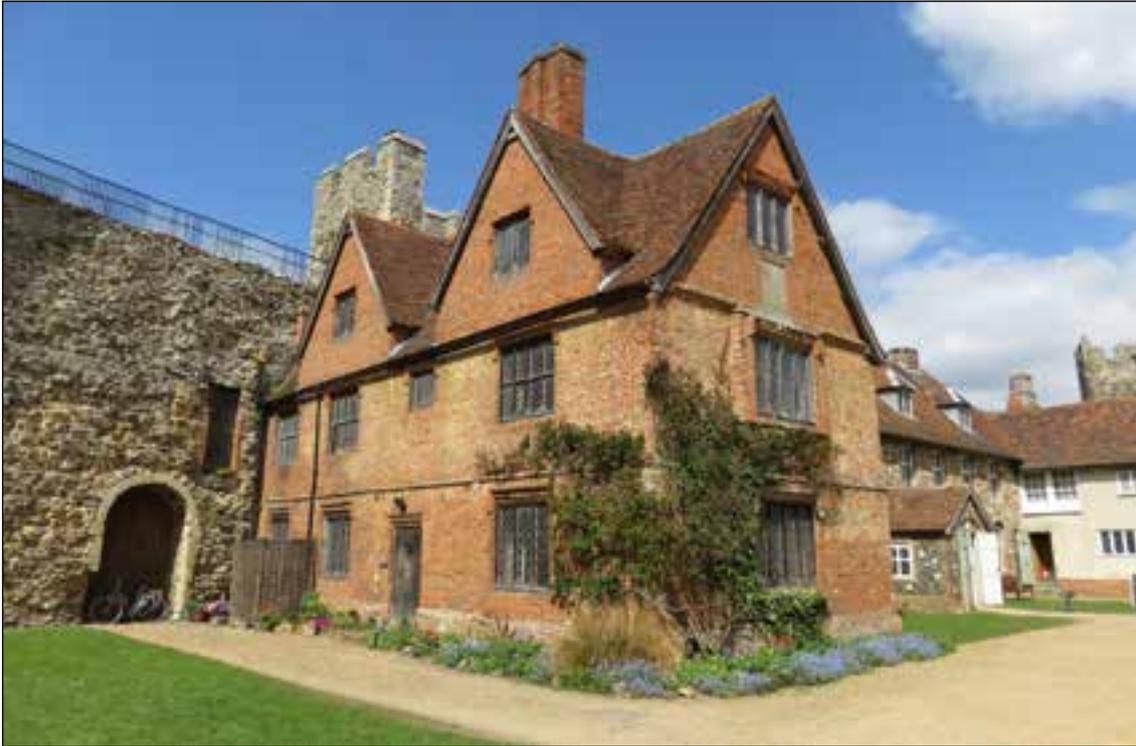
Fig. 4 The Red House, Framlingham Castle, from the south-east. The workhouse of 1729 lies to its rear (north). (© Historic England, K. Morrison)

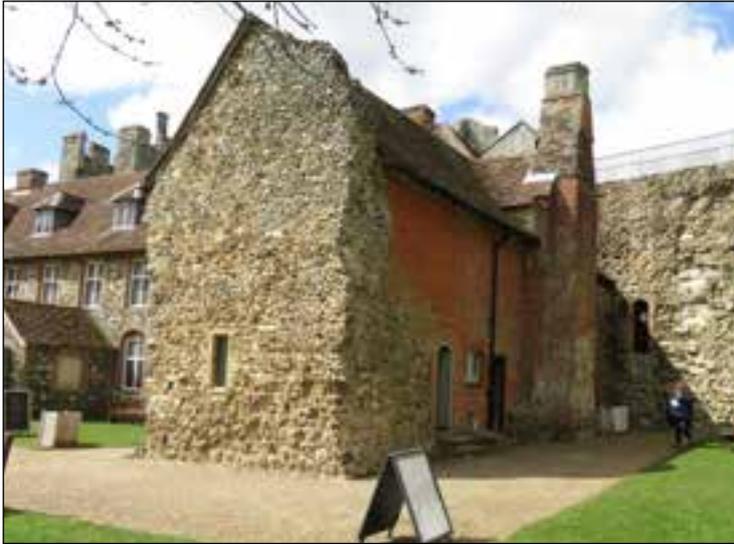
Fig. 5 The north range or White House, from the north-east. (© Historic England, K. Morrison)

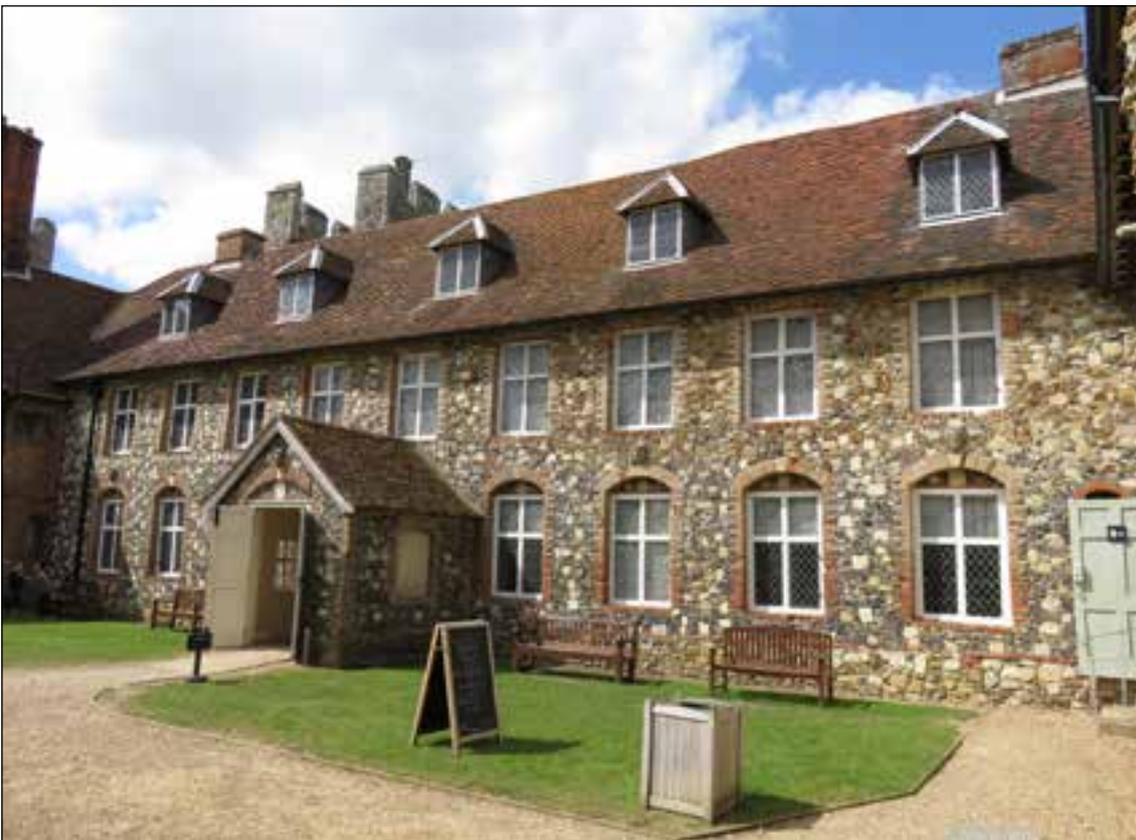
Fig. 6 The 1729 workhouse block, from the north-east. (© Historic England, K. Morrison)

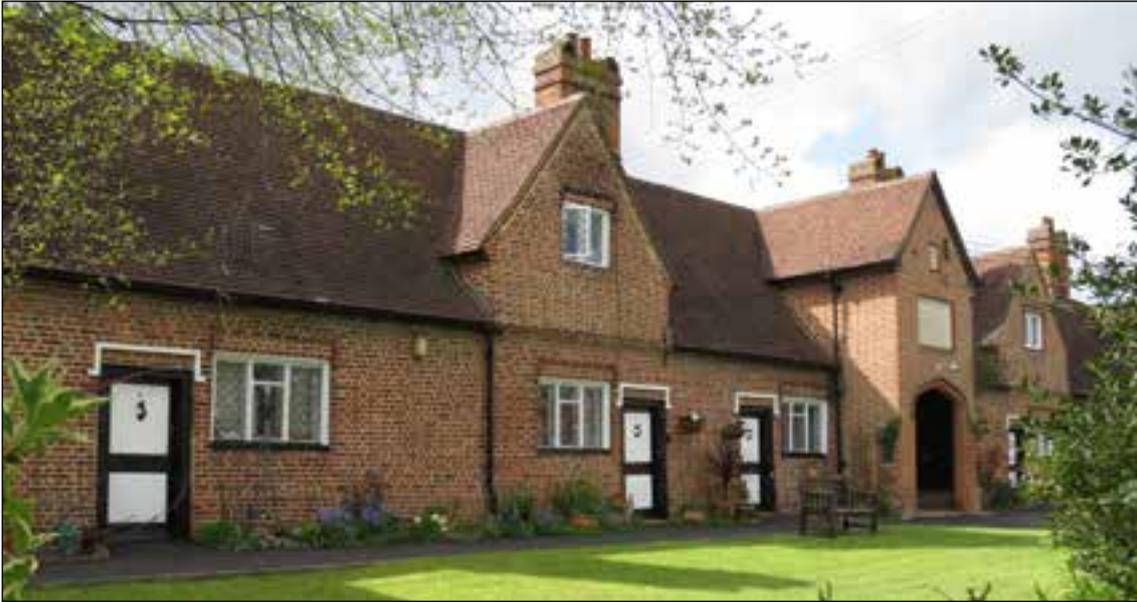
Fig. 9 The Hitcham almshouses, New Road, Framlingham. They were designed by Peter Mills and built in 1654. (© Historic England, K. Morrison)

The agreement of 1653/4 allowed the stipulations of the will to be fulfilled. Within a year, Pembroke Hall had built a row of 12 almshouses (Fig. 9) in New Road, Framlingham; these are dated 1654, and are now listed Grade II*.¹³ The contract

for the building was drawn up between Pembroke Hall and the Framlingham bricklayers Robert Goodwin, Robert Atkin, John Goodwin and William Spink, 'according to a plot already drawn and agreed on by Peter Mills of London surveyor'.¹⁴ Peter Mills (1598-1670) was an important architect, responsible for Thorpe Hall outside Peterborough (1653-56). He also designed the Hitcham Building (1659-61, Figs 10 and 11) on the south side of Ivy Court at Pembroke Hall in Cambridge, and may have had a hand in the design of the Red House in c.1664. Mills is known to have remained active almost until his death: he was one of the four surveyors appointed to supervise rebuilding after the Great Fire of London in 1666 (alongside Christopher Wren, Hugh May and Roger Pratt), and he designed buildings at Christ's Hospital in London in 1667-68.¹⁵

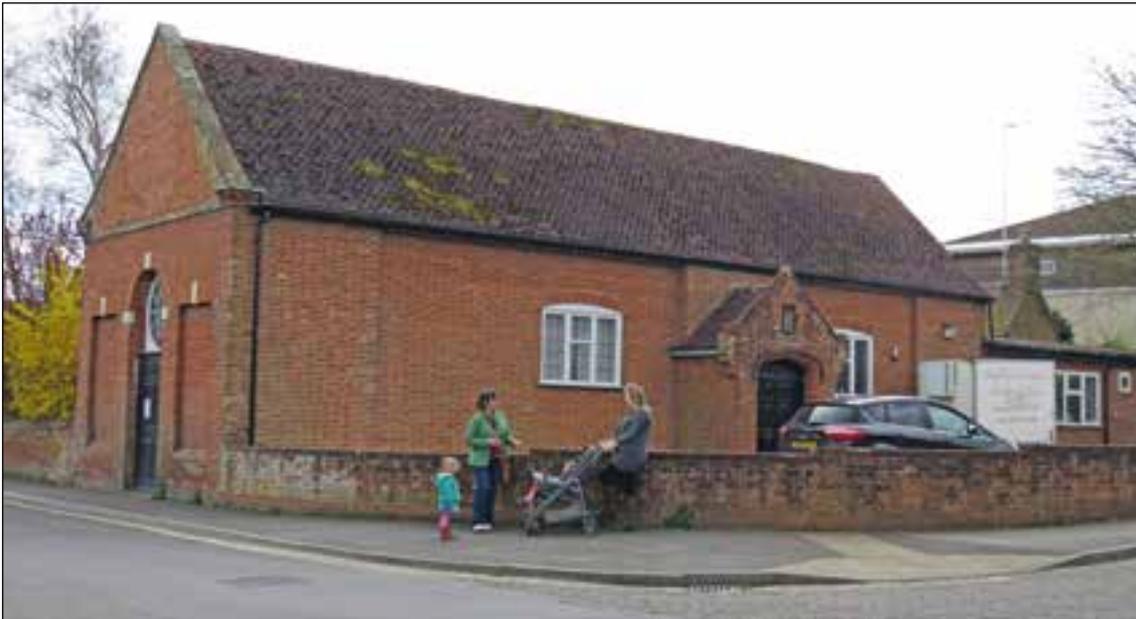
Fig. 12 The Free School, built to the north of Hitcham's almshouses in Framlingham in 1787-88. (© Historic England, K. Morrison)

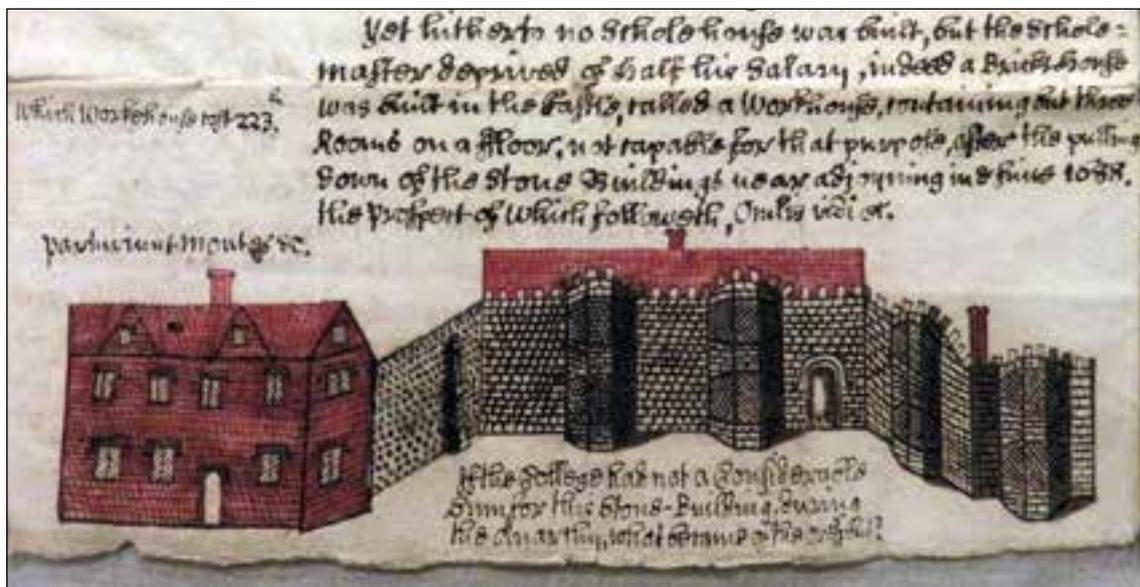
Fig. 13 Robert Hawes's drawing of the north range of Framlingham Castle, as it stood prior to its demolition in 1700, with the Red House to the left. From *Pembroke College N5*. (By permission of the Master and Fellows of Pembroke College, Cambridge.)

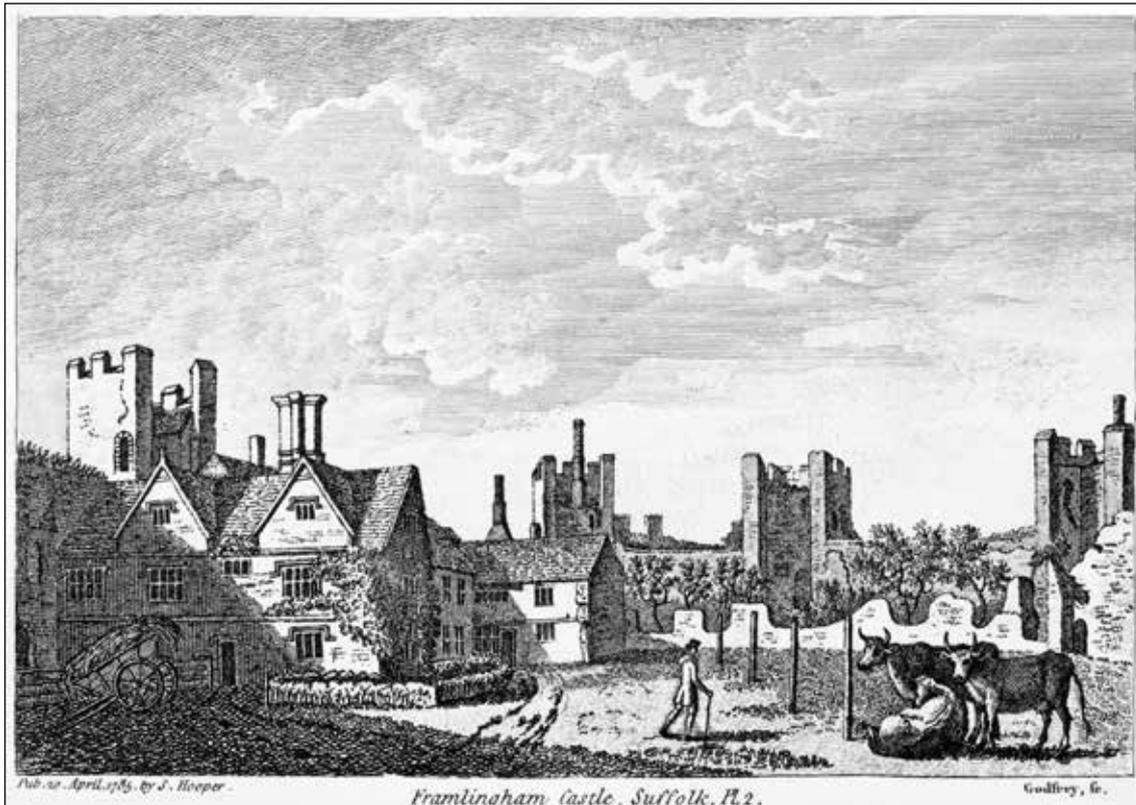
Fig. 15 An engraving by Samuel Hooper, showing Framlingham Castle after the demolition of most of the north range. Part of its rear wall was retained to enclose a garden on the north. Compare Fig. 13. (Historic England Archive)

The only known illustration of the north range of the castle was included by Robert Hawes in a critical account of Hitcham's Charity, written around 30 years after its demolition (see Fig. 13).⁴⁴ According to this sketch it stood two storeys high, was lit on the south by two canted bay windows with diamond-pane glazing, and had a red tile roof with a single stack. All that survived the demolition of 1700 was the west end of the range, today housing the bakehouse and, above it since 1984, the Lanman Museum (Fig. 14). In addition to these rooms, the lower part of the rear wall was retained to serve as a boundary around a garden occupying the northern part of the Inner Court: this area was leased in 1693 to John Browne.⁴⁵ The wall and trees beyond can be seen in early engravings of the castle, such as that by Samuel Hooper of 1785 (Fig. 15).

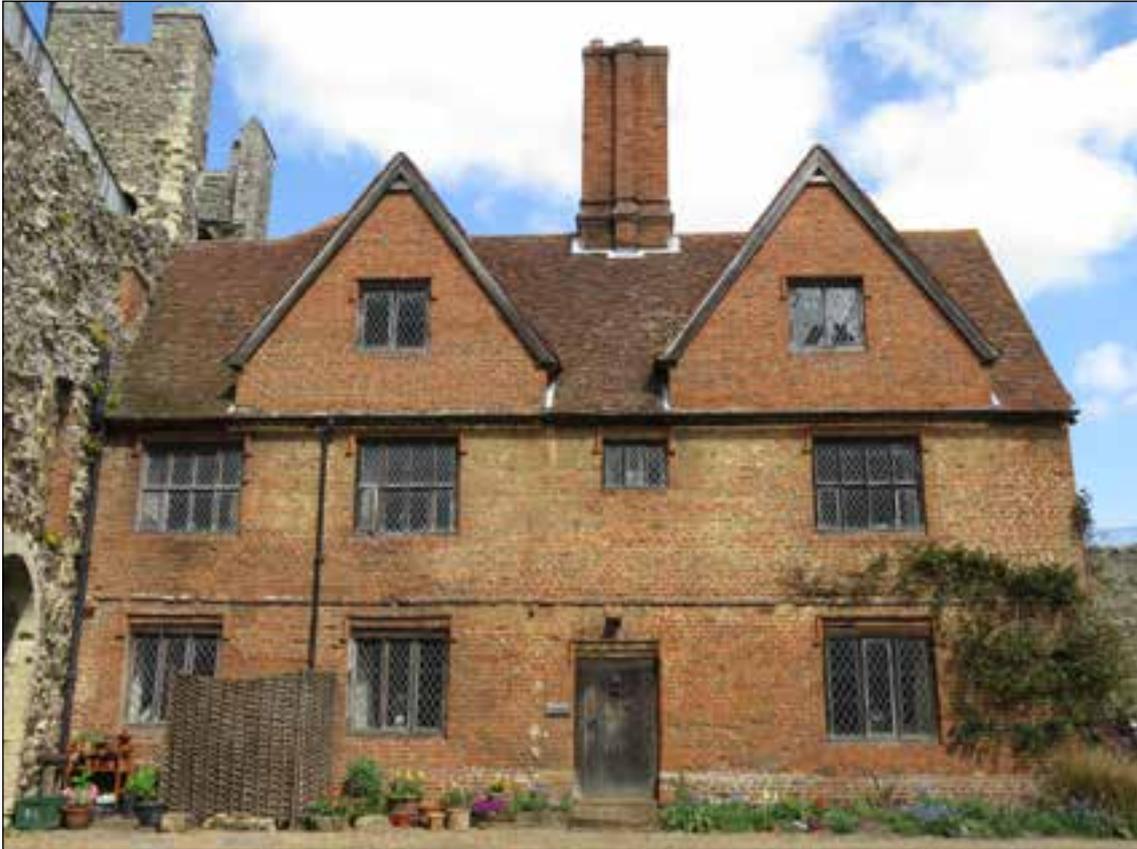
Fig. 16 The Red House from the south. (© Historic England, K. Morrison)

The completion of the Red House (Fig. 16) and the opening of the new workhouse building probably coincided with an agreement of 19 November 1664, drawn up between the Pembroke Trustees and John Kilbourne.⁵⁹ This confirms that the workhouse was being set up as a textile manufactory on a commercial basis. Kilbourne was to provide a sufficient stock of wool to employ 'three hundred poore people of fframlingham ... or more, if there be soe many in spinning'. Financial losses would be borne by Kilbourne, and he was also responsible for maintaining the quality of the work:

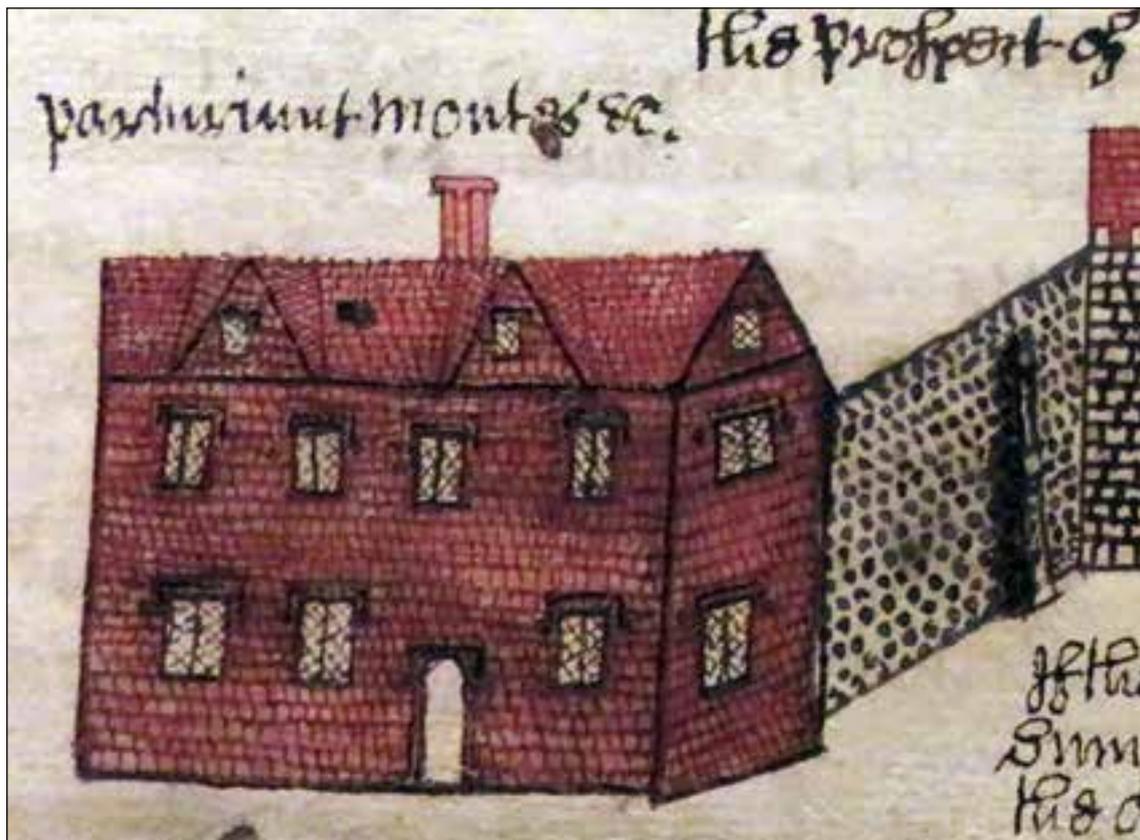
Fig. 17 A detail from Robert Hawes’s drawing of Framlingham Castle in c.1700, showing the Red House. From *Pembroke College N5*. (By permission of the Master and Fellows of Pembroke College, Cambridge.)

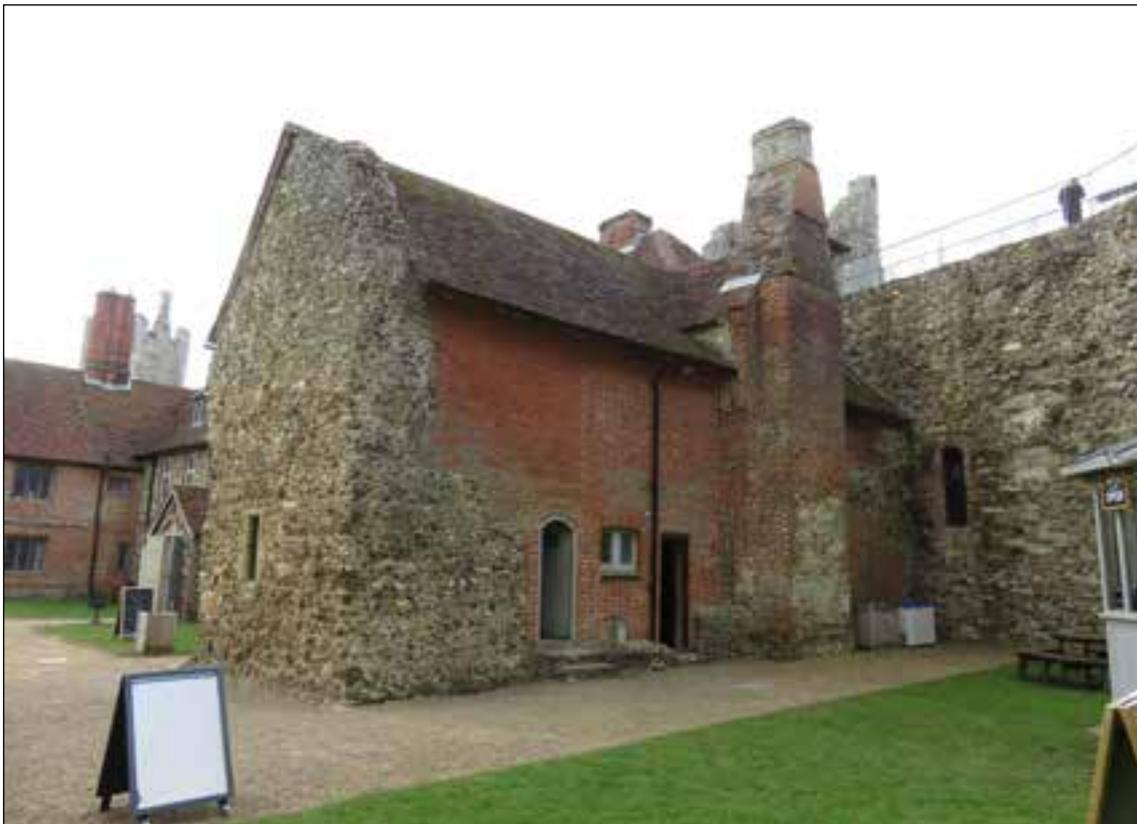
Fig. 18 The north range or White House, which contained the school chamber until 1722, viewed from the north-east. (© Historic England, K. Morrison)

Also, as has been noted, work was undertaken in the room under the school chamber (Figs 18 and 19) – Leverland’s former accommodation, with his stair removed. This was intended as a workroom for the workhouse children, but by 1704 it had been appropriated by the parish and was being used as a lodging for poor people – who Robert Hawes complained were being paid weekly in lieu of ‘Collection’ and were ‘ordered to be clad out of Sr Robt hitcham’s estate, with out the Approbation of the Trustees at a Generall Meeting’.⁸⁵ This area of the north range was still being used as the lodging of poor people in 1726, when a widow named Rachel Smith was allowed part of the room under the school chamber.⁸⁶

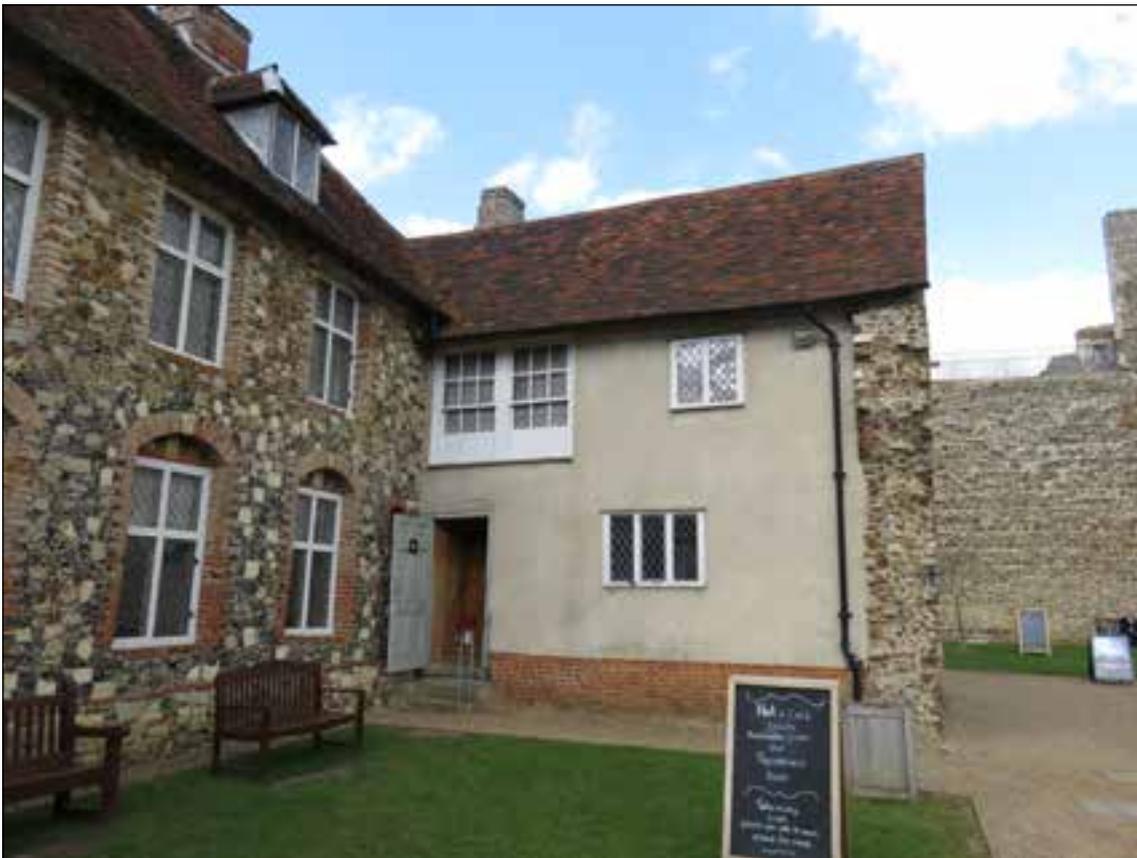
Fig. 19 The White House, viewed from from the south. (© Historic England, K. Morrison)

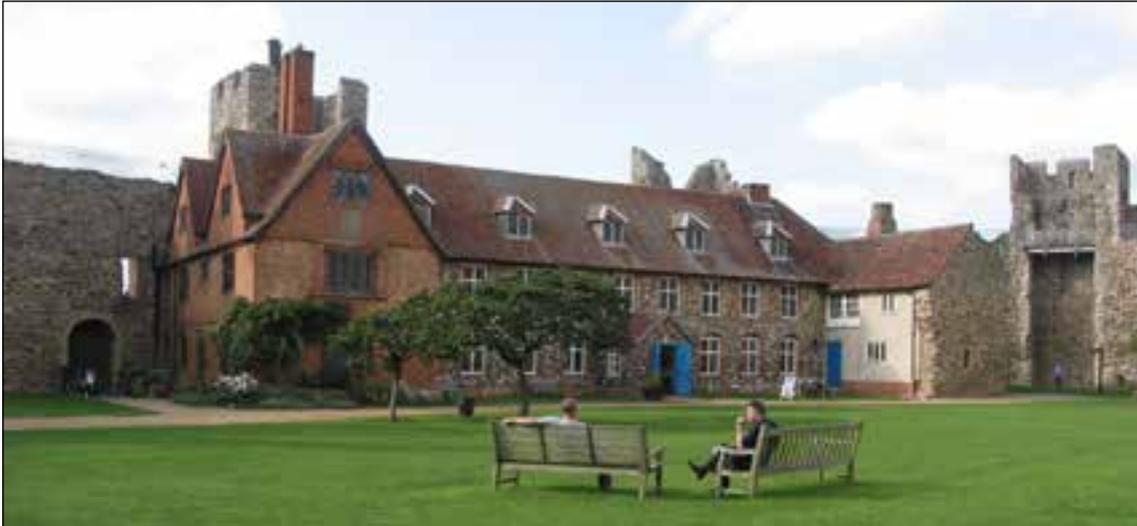
Fig. 20 The new workhouse was built between the Red House and the White House in 1729. Photographed in 2006. (© Historic England, K. Morrison)

The 1729 block adopted a straightforward rectangular plan and filled the space formerly occupied by the Great Hall of the castle, between the Red House and the remaining block of the north range or ‘White House’, a name first recorded in 1729.¹⁰³ Together with these two ranges – which as noted above did not form part of the new workhouse establishment from the outset – the complex assumed a U-plan.

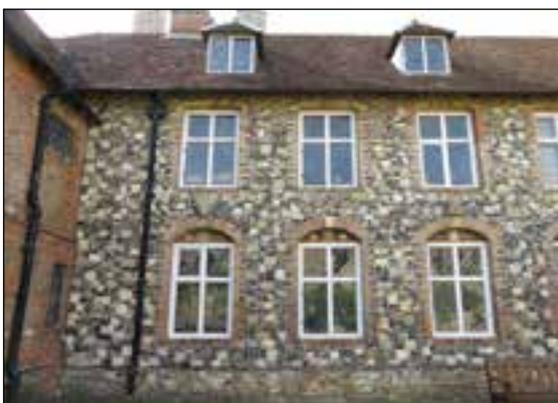
Fig. 21 The workhouse of 1729: the south end of the east elevation, abutting the Red House. (© Historic England, K. Morrison)

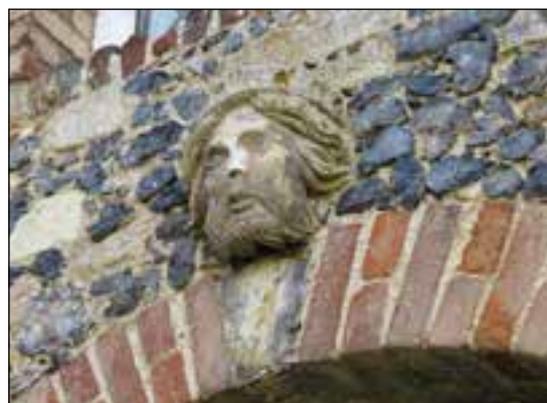
Fig. 22 One of several medieval heads decorating the façade of the 1729 workhouse. (© Historic England, K. Morrison)

Built of brick and flint, with a tile roof, the early 18th-century block stood two storeys high plus an attic lit by dormers (Fig. 21, and see Fig. 20). Medieval stone-carved heads (Fig. 22) were reset on the façade: ‘They have placed five old heads of Dukes and Dutchesses of Norfolk over ye windows wch were formerly taken out of ye Castle and preserv’d by Mr Hawes’.¹⁰⁴ In appearance, scale and plan, the building might be seen as a precursor of the 14 houses of industry or ‘hundred houses’ built throughout East Anglia between 1756 and 1785 (see Appendix).

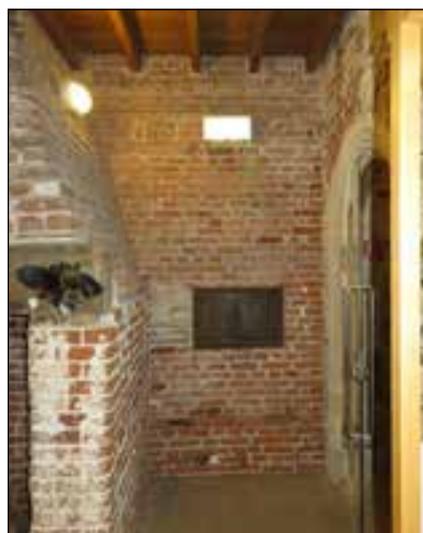
Fig. 23 The serving hatch in the wall between the 1729 workhouse and the Red House. (© Historic England, K. Morrison)

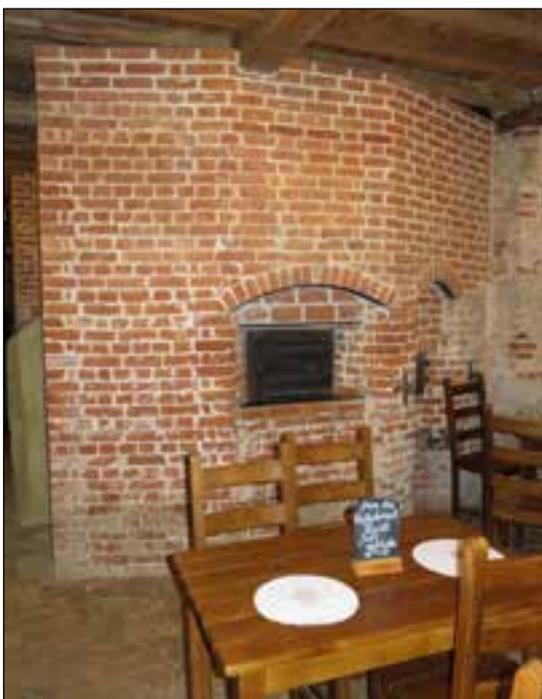
Fig. 24 (left) The bakehouse oven on the ground floor of the north range or White House. The south side of the oven has been cut away to create a corridor (compare Fig. 39). (© Historic England, K. Morrison)

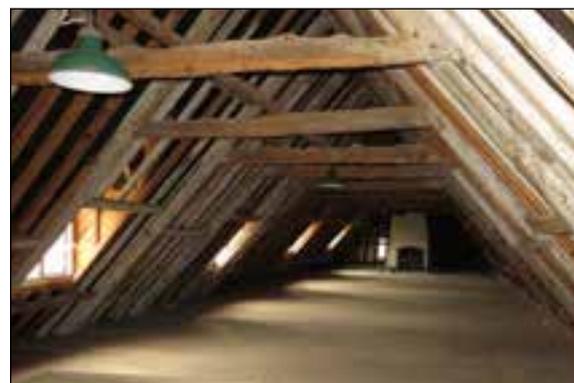
Fig. 25 (above) The attic of the 1729 workhouse block probably contained lodgings for inmates. (© Historic England, K. Morrison)

The 1806 inventory mentions 'Lodging Rooms' – containing items including 12 bedsteads, 26 coverlets, 40 sheets and 10 blankets – without revealing how many such rooms were contained within the building. Nevertheless, it can be assumed that they occupied the entirety of the first floor and attic (Fig. 25) of the 1729 block. The location of the Pest House is not known: the name 'Pest House' – and indeed its function, which was to isolate infectious cases from healthy inmates – suggests that this was a separate building rather than a room, but no such detached structures within the inner court survived into the 20th century.

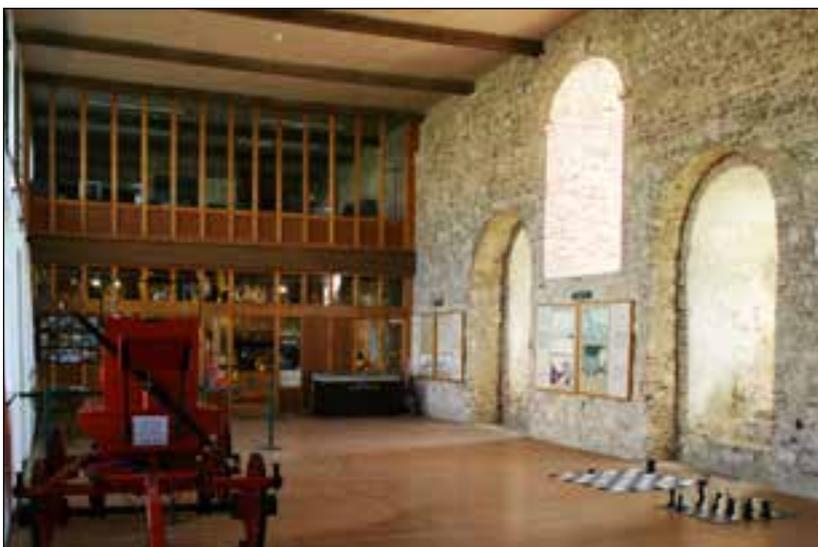
Fig. 26 The interior of the 1729 workhouse block, photographed around 2005, showing the arched window of uncertain date that might once have lit a central staircase. (© English Heritage, Properties Historians)

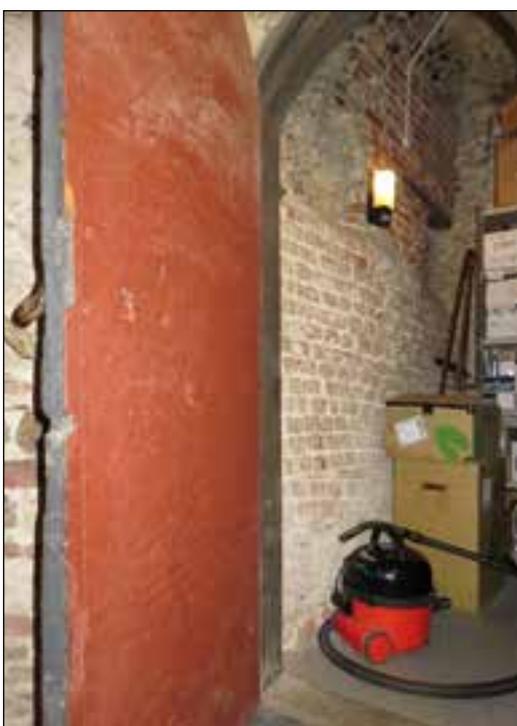
Fig. 27 The 'dungeon' or punishment cell at the bottom of the stair in the curtain wall, to the south-west of the 1729 workhouse block. (© Historic England, K. Morrison)

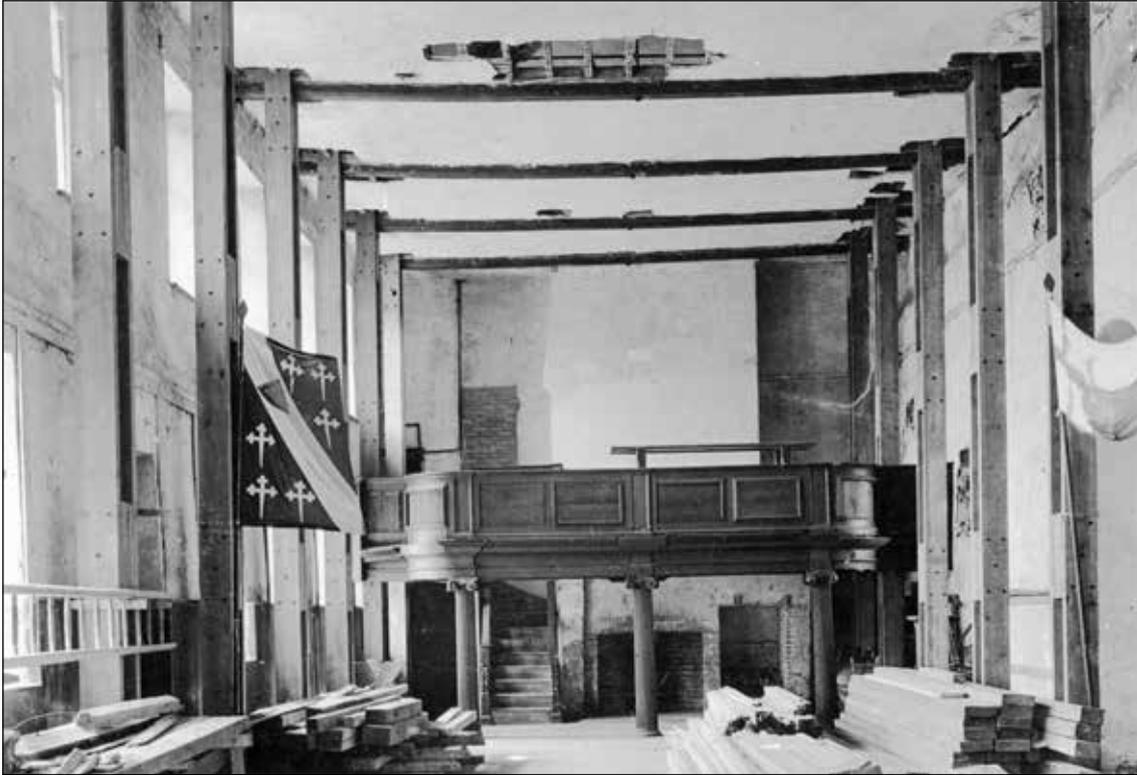
*Fig. 28 The Castle Hall, in a photograph of c.1930, showing the south gallery. Formerly the organ loft of the local parish church, this gallery was inserted here in c.1890. Note the two fireplaces.
(© Historic England Archive, AL0686/004/02)*

Meanwhile, as White's *Directory* of 1844 makes clear, the central workhouse block of 1729 had been retained by the parish and converted to a public hall (Fig. 28). It was called the 'New Town Hall' in January 1841, when the Framlingham Farmers' Club arranged a meeting there.¹³⁴ It was also known as the 'Castle Hall' – for instance, that was the name it was given in 1859, when the *Framlingham Weekly News* noted that the monthly sitting of the local county court was held in the building.¹³⁵ Court use of the 'Castle Hall' continued into the 1860s,¹³⁶ and the building may have been used for this purpose right up until the completion of the new Court House in Bridge Street in 1872. The hall was also used by local societies and clubs, for local events, and as a drill hall: the first such use was in December 1859, by the Framlingham Rifle Corps, founded earlier the same month.¹³⁷ In April 1860, there was report of a 'Target Ground' at the castle nearing completion.¹³⁸ The military use of the castle seems to have expanded over the years: in 1891, a James O'Neill, 'sergeant instructor', was living in the Red House, along with his Canadian wife Margaret and their children. A directory of 1892 provides further information, stating that O'Neill was 'drill instructor to the D Co 1st Battalion Suffolk Regiment'.¹³⁹ By the time the census was taken in 1901, O'Neill was retired but was still living in the Red House with his wife and 16-year-old son. Also within the castle complex was the parish fire station: this was present on the site by at least 1855, remaining until at least 1892, and occupied the projecting (east) part of the north range, as can be seen in surviving photographs (Fig. 29).¹⁴⁰

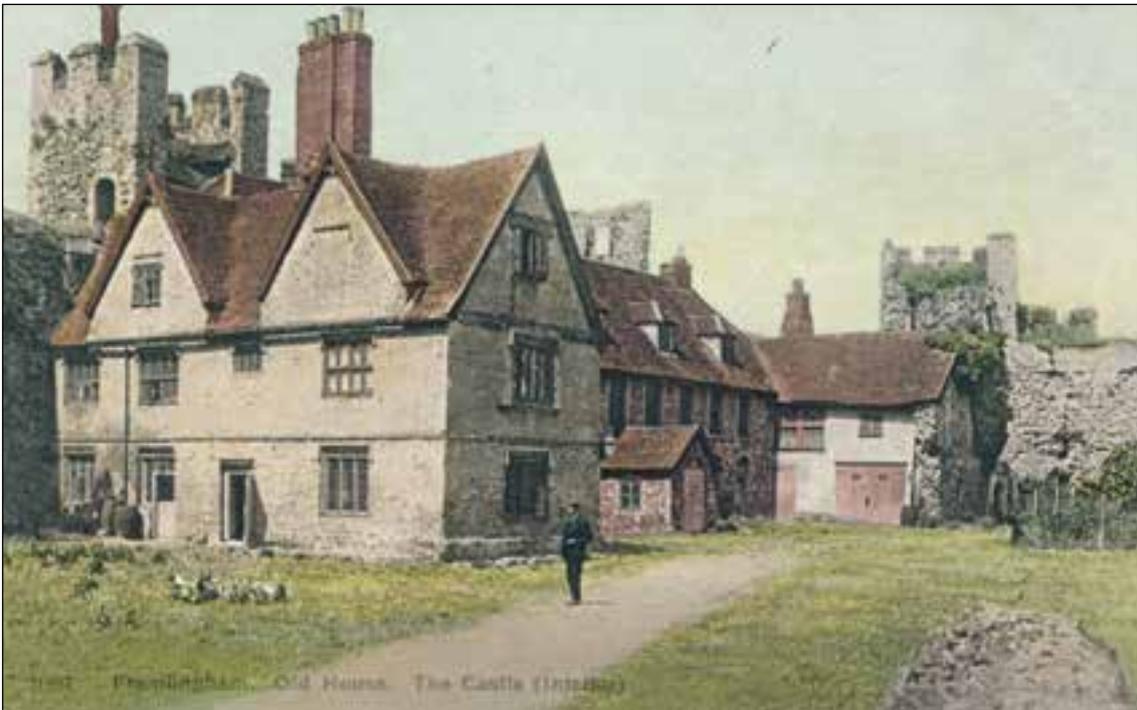
Fig. 29 A tinted postcard of c.1900 showing the former workhouse buildings. The double doors on the ground floor of the north range served Framlingham's Fire Engine House. This opening had been remodelled by 1930. (K. Morrison)

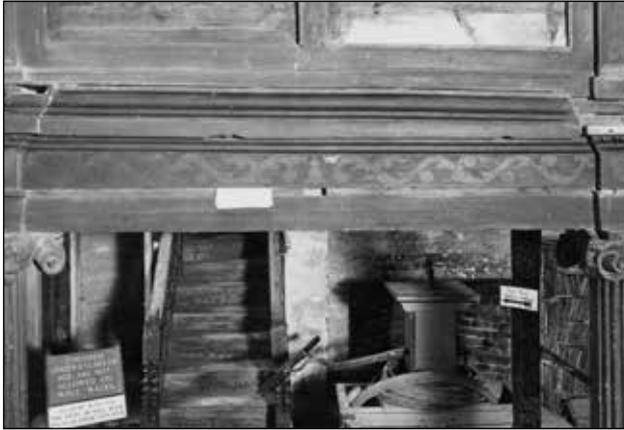
Fig. 30 (above) A detail of the south gallery and stair, c.1951. (© Historic England Archive, AL0686/018/01)

The gallery at the south end of the Castle Hall is known to have been replaced c.1890 (Figs 30 and 31, and see Fig. 28). White's directory of 1891-92 stated that: 'The appearance of the room has been lately much improved by the erection therein of the front of the west gallery removed from the church during its restoration'.¹⁴⁴ This refers to St Michael's Church in Framlingham, which was restored from 1889. This work involved the removal of the 17th- or 18th-century gallery, which had stood at the church's west end and carried its organ, built in 1674 for Pembroke College and presented to Framlingham in 1708.¹⁴⁵ The gallery's design had been criticised in print, and by the late 19th century it was probably viewed as disposable. The 1865 guidebook, for example, commented on the church's 'altar fittings and the gallery, which none can say are as they should have been, in accordance with the other portions of the building'.¹⁴⁶ A rare-surviving photograph of the historic interior of the Castle Hall around the 1930s shows the south gallery still in situ (see Fig. 28); it had been altered to fill the depth of the 1729 block, and was supported by three Ionic columns. The gallery area was reached by a staircase placed on the immediate east of the cut-back chimney stack. According to the photograph of the hall and another showing a close-up of the staircase itself (see Fig. 31), this had had turned balusters and probably dated from the early 18th century. It may have been reused from elsewhere within the 1729 block, or may have been removed from the church along with the gallery. It was not returned there, however, when in the 1960s the south gallery was removed from the Castle Hall and given back to St Michael's (see below).

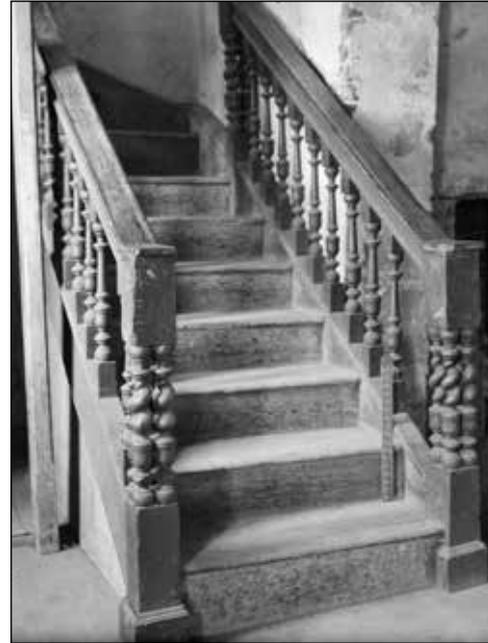
Fig. 31 (right) The south gallery stair, c.1930. (© Historic England Archive, AL0686/004/01)

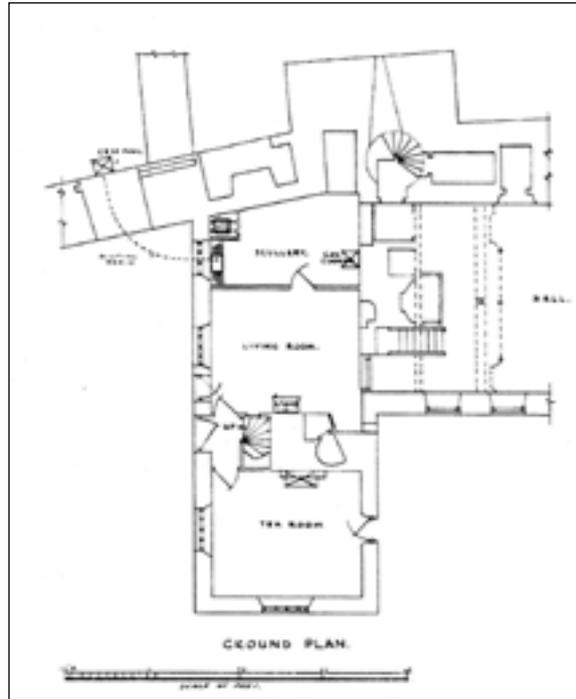
Fig. 32 A ground-floor plan of 1947 showing the Red House and the south area of the Castle Hall. Note the doorway between the Red House and the 1729 block, and also the gallery and stair which remained in situ until 1966. (© Historic England Archive, MP/FRC0071 crop)

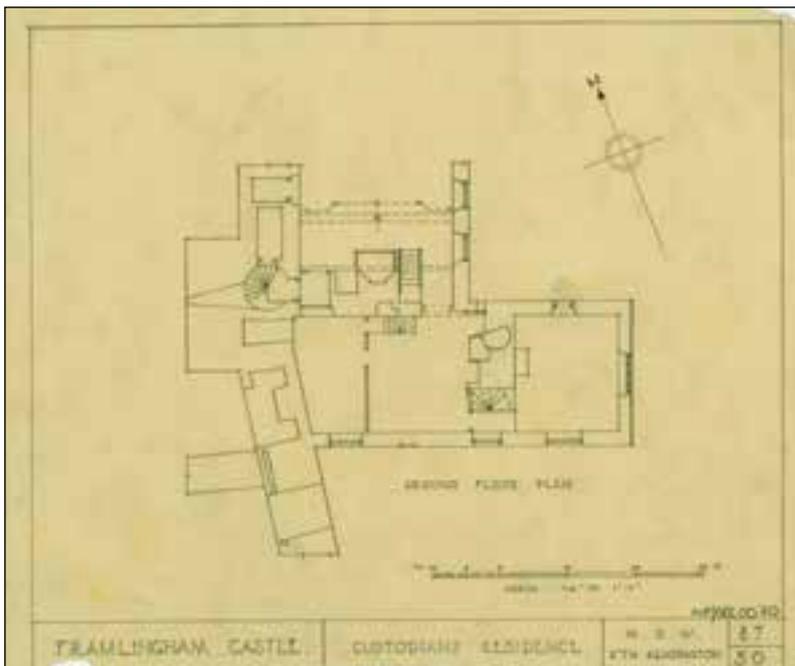
Fig. 33 A ground-floor plan of 1950, showing the Red House and the southern area of the Castle Hall. (© Historic England Archive, MP/FRC0070)

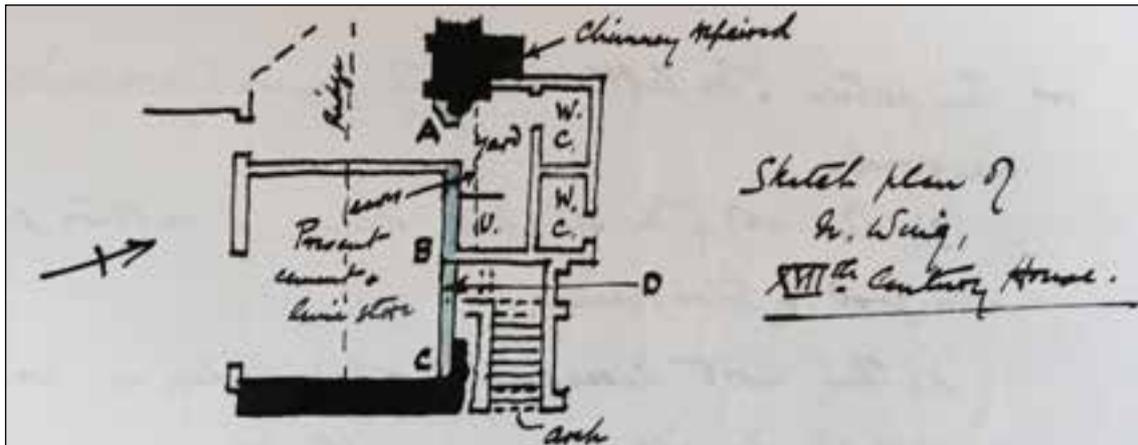
Fig. 35 (above) Sketch plan of the east end of the north range or White House, from a memorandum of 14 June 1916. (TNA WORK 14/685)

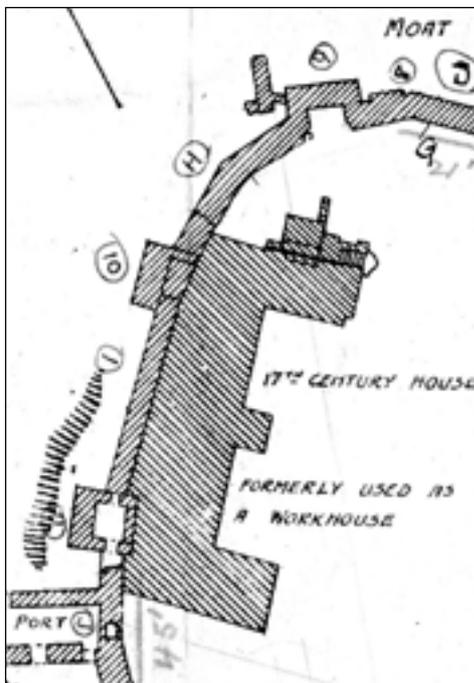
Fig. 36 (left) Detail of site plan of Framlingham Castle dated 1919, showing the outline of ancillary structures on the north side of the north range. (TNA WORK 14/685)

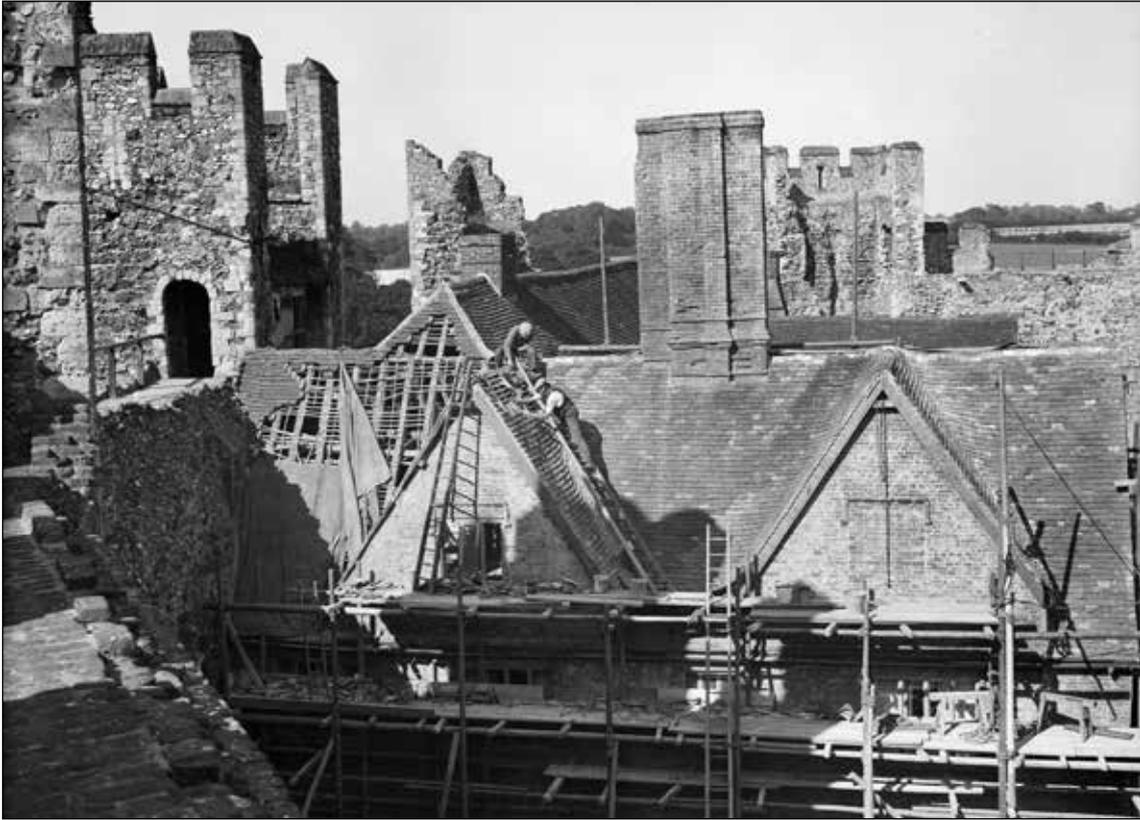
Fig. 37 Repairs to the roof of the Red House, 12 September 1933. (© Historic England Archive, OWS01/02/F01172)

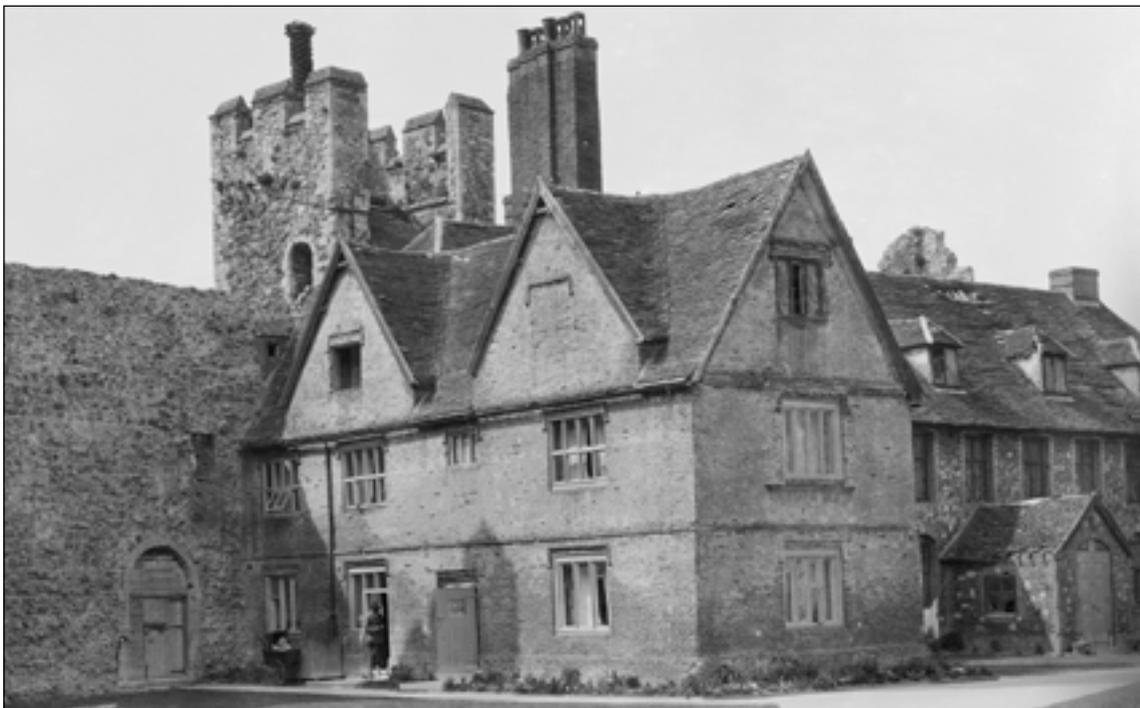
Fig. 38 A view of the workhouse buildings showing their state of disrepair around 1945 (detail). (© Historic England Archive, cc45/01193)
