Framlingham Castle, Suffolk

The Red House, formerly Framlingham Workhouse

Research Report Series 023-2016

**THE RED HOUSE
(FORMERLY FRAMLINGHAM WORKHOUSE)
FRAMLINGHAM CASTLE, SUFFOLK**

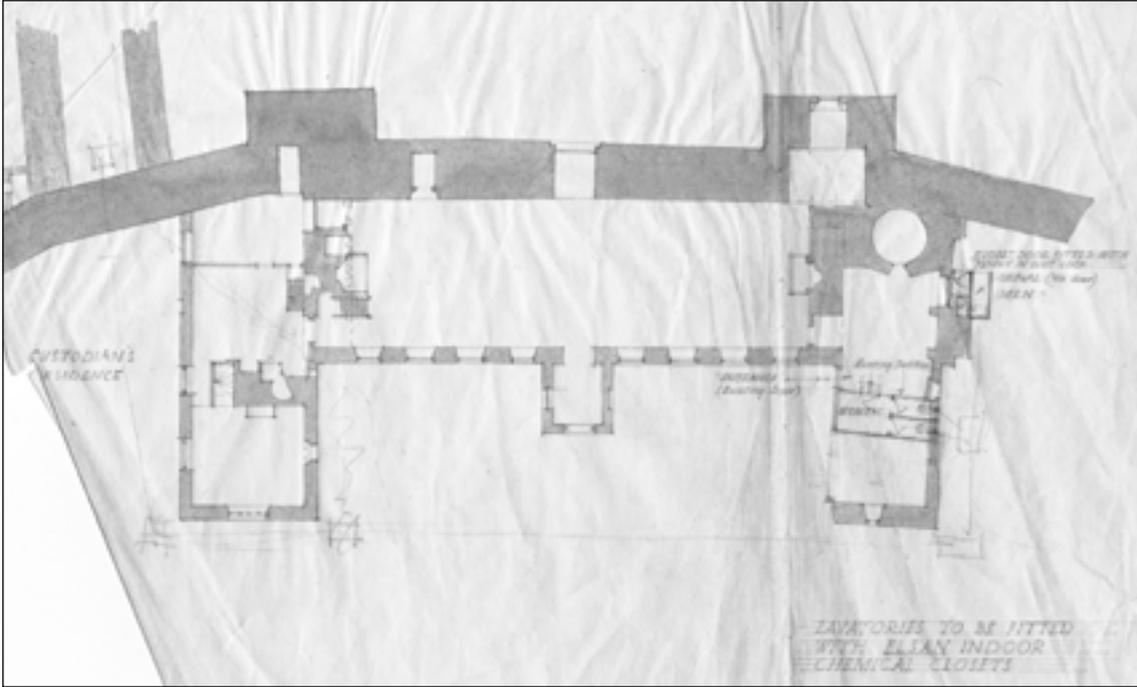
Fig. 39 A plan of c.1952, showing the former workhouse buildings (Red House, 1729 block, White House). North is to the right. (TNA WORK 14/685)

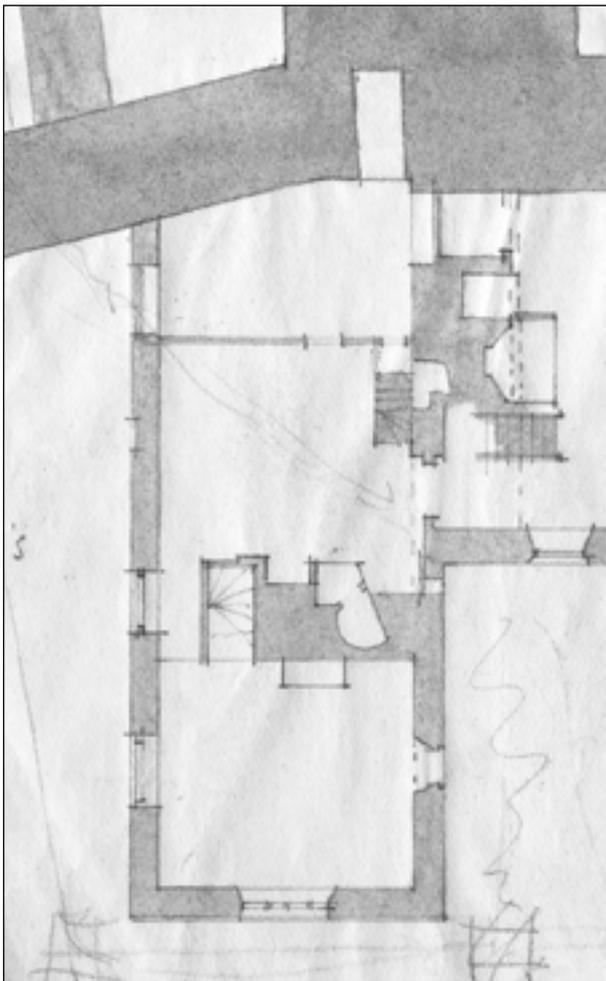
Fig. 40 Detail of the plan of c.1952, showing the stair and closet in the middle room of the 'Custodian's Residence' or Red House. Compare Fig. 54. (TNA WORK14/685)

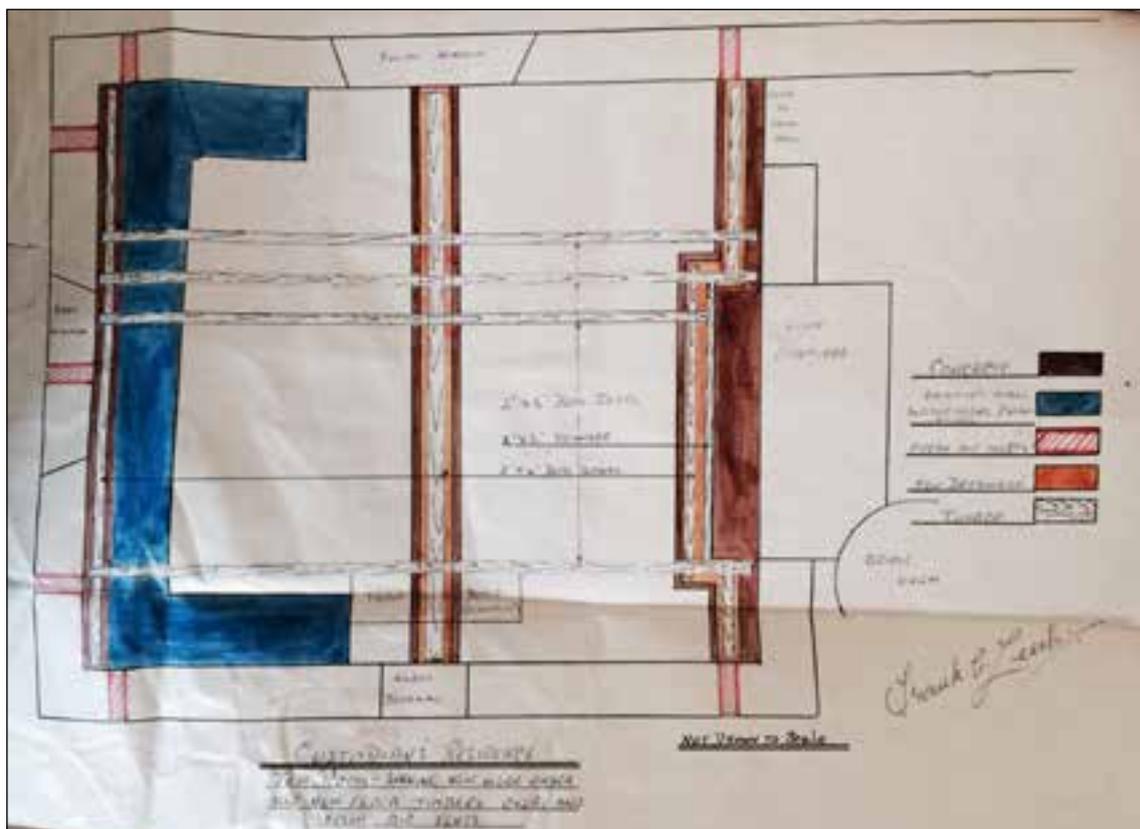
Fig. 41 Drawing of the floor of the Tea Room in the Red House (or 'Custodian's House'), 23 September 1955. The blue area represents footings of an earlier building, exposed during excavation. The white, orange and brown areas show new work being undertaken. (EH Registry File AM046227/004)

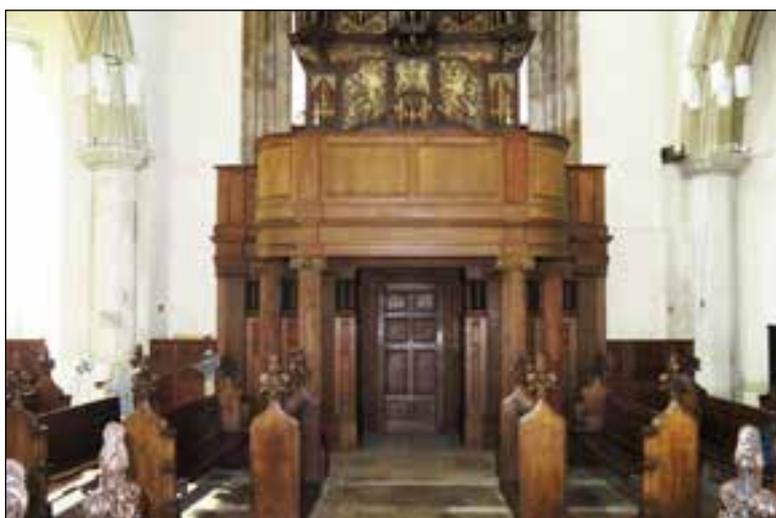
Fig. 42 The organ gallery of St Michael's Church, Framlingham. This was removed from the church and placed at the south end of the Castle Hall in c.1890 (see Fig. 28). It was taken down in 1966 and re-erected in the church in 1970. (© Historic England, K. Morrison)

In May 1964, the decision was taken – ‘after discussion’ – to remove the gallery at the south end of the hall, originally installed c.1890 (see above and Fig. 28), and to return it to St Michael’s Church (Fig. 42).¹⁸¹ Clearance of the gallery was carried out in late May or June that year,¹⁸² and the gallery was ‘reported collected by the vicar in 1965’.¹⁸³ It was reinstalled in the church in 1970 having been much restored and altered to re-fit the space; the organ placed atop the gallery was restored at the same

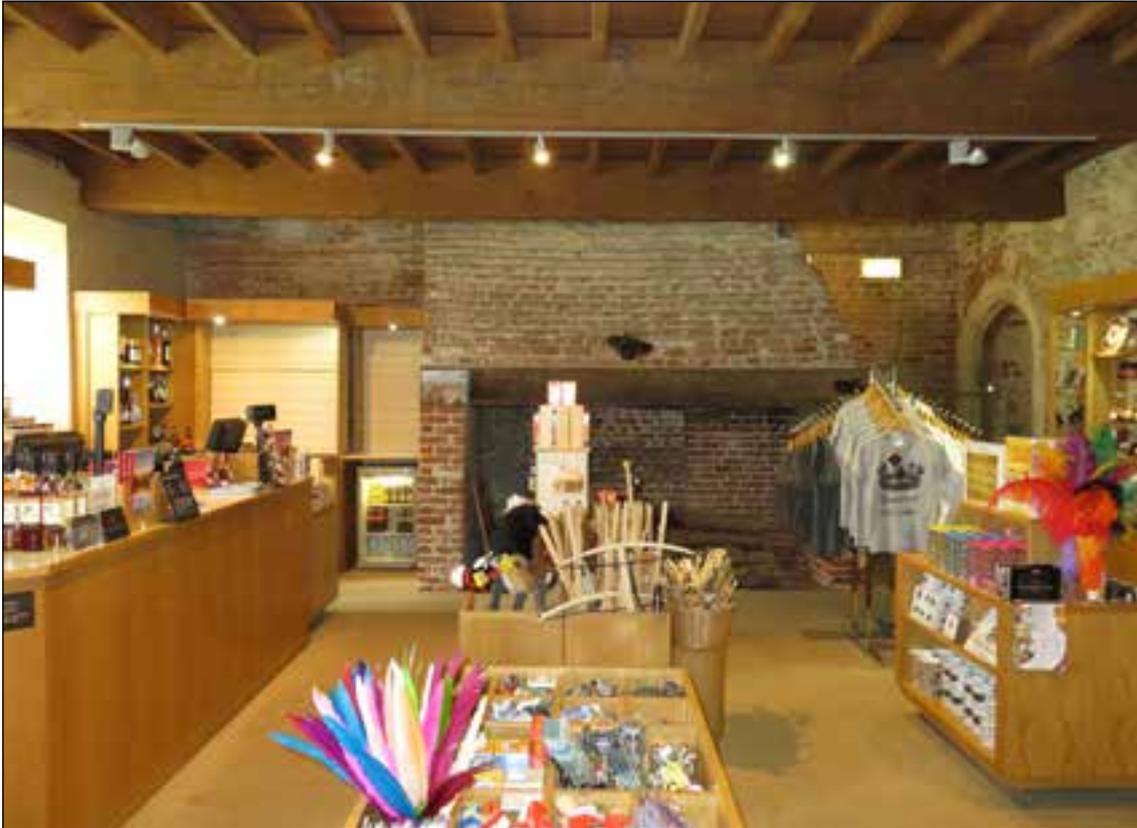
Fig. 43 The south end of the workhouse, showing the south stack. Note how the left (east) side was truncated to accommodate the gallery stair in the 19th century. (© Historic England, K. Morrison)

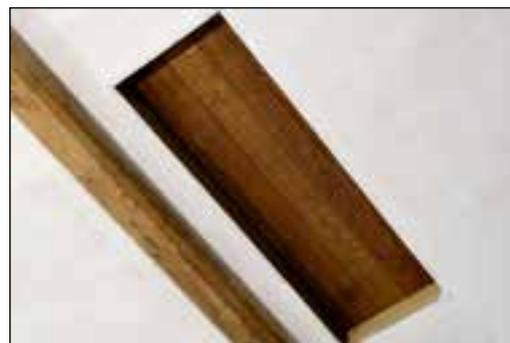
Fig. 44 The access hatch of 1965, which has been misidentified as a ‘coffin hatch’, photographed in 2008. (© Historic England Archive, DP066451)

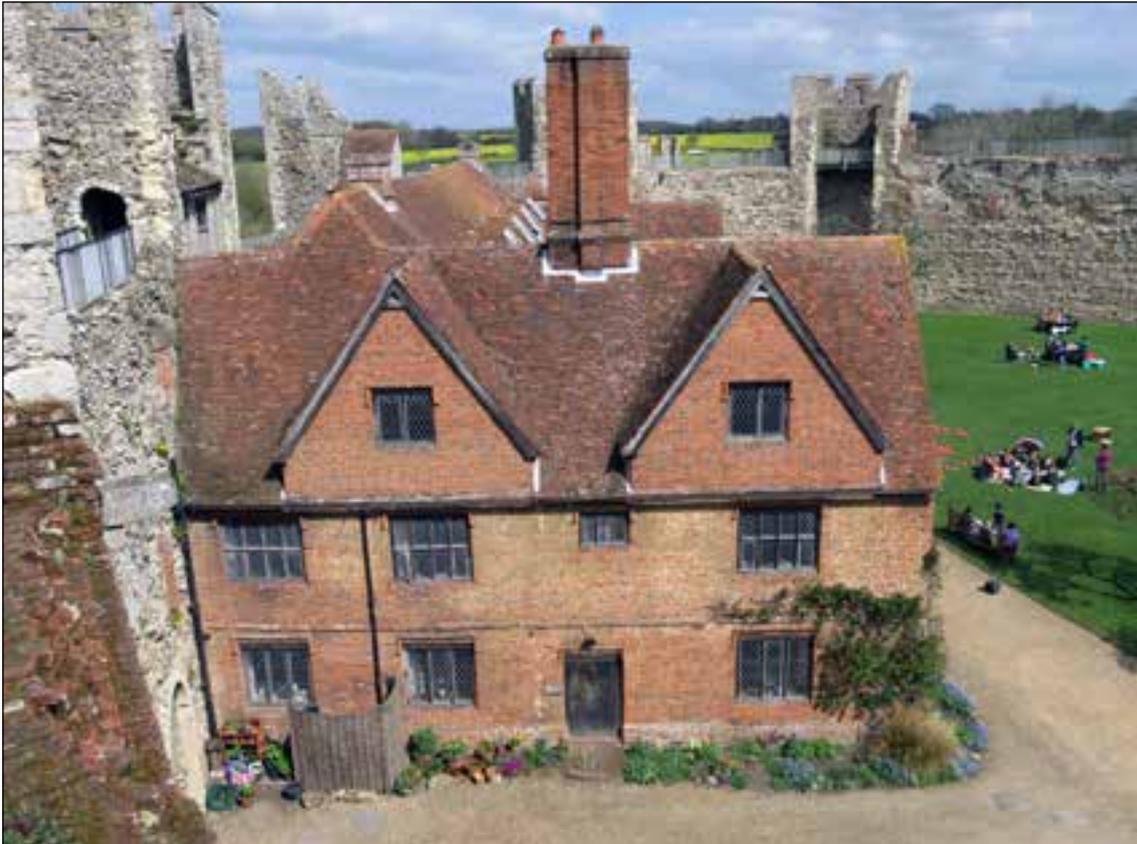
Fig. 45 The Red House from the south, photographed from the wall-walk. (© Historic England, K. Morrison)

The Red House (Fig. 45) is located within the Inner Court of Framlingham Castle. It was built against the west curtain wall, with the main entrance facing south towards the castle gatehouse and drawbridge. A cellar was found under the easternmost room during works in the 1950s, giving rise to the theory that the Red House was built on the site of an earlier building, said to be Tudor (see Fig. 41). This was probably a service wing of the Great Hall of the Castle.

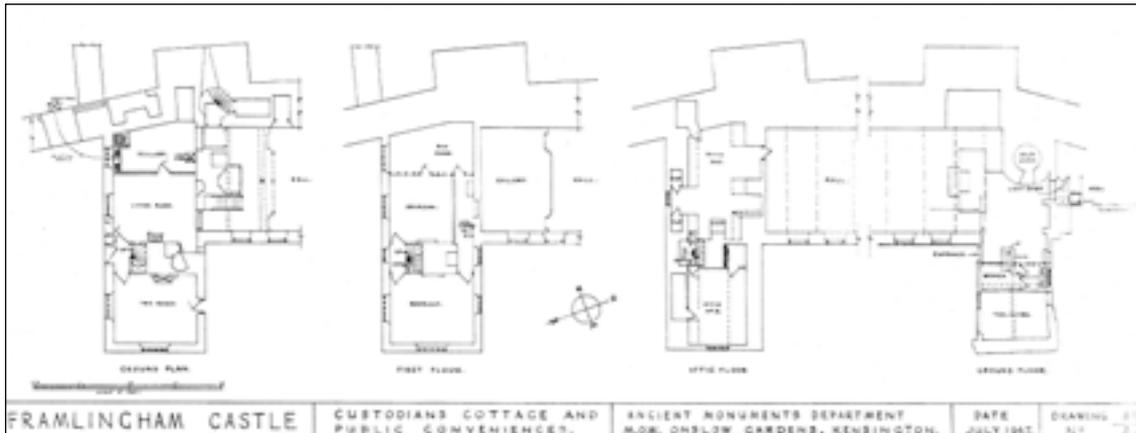
Fig. 46 Plans of all three floors of the Red House, dated July 1947. The plan to the right additionally shows most of the ground floor of the 1729 block and the north range (White House). (© Historic England Archive)

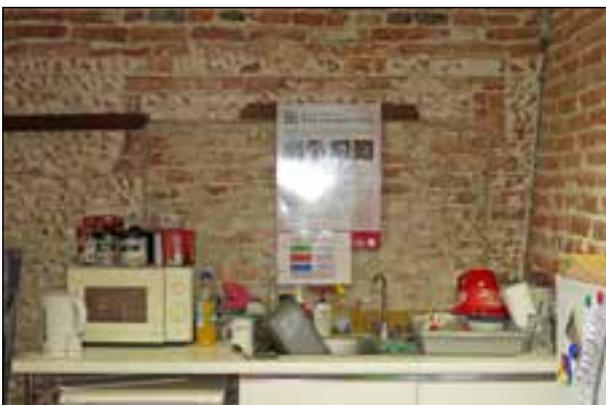
Fig. 47 Part of the north elevation of the Red House, showing a blocked window at first-floor level, viewed from the interior of the 1729 block (now office). (© Historic England, K. Morrison)

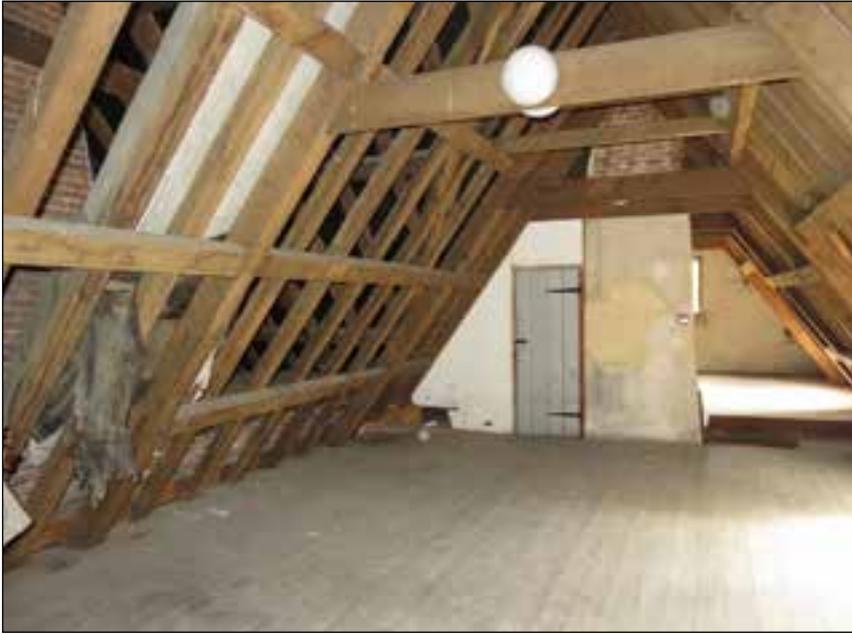
*Fig. 48 The attic and roof of the Red House, showing the stack from the west.
(© Historic England, K. Morrison)*

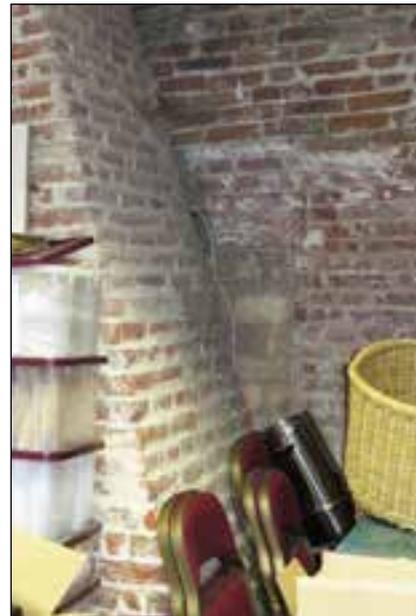
Fig. 49 A blocked first-floor window on the north elevation of the Red House, visible to the right of the 1729 chimney stack. (© Historic England, K. Morrison)

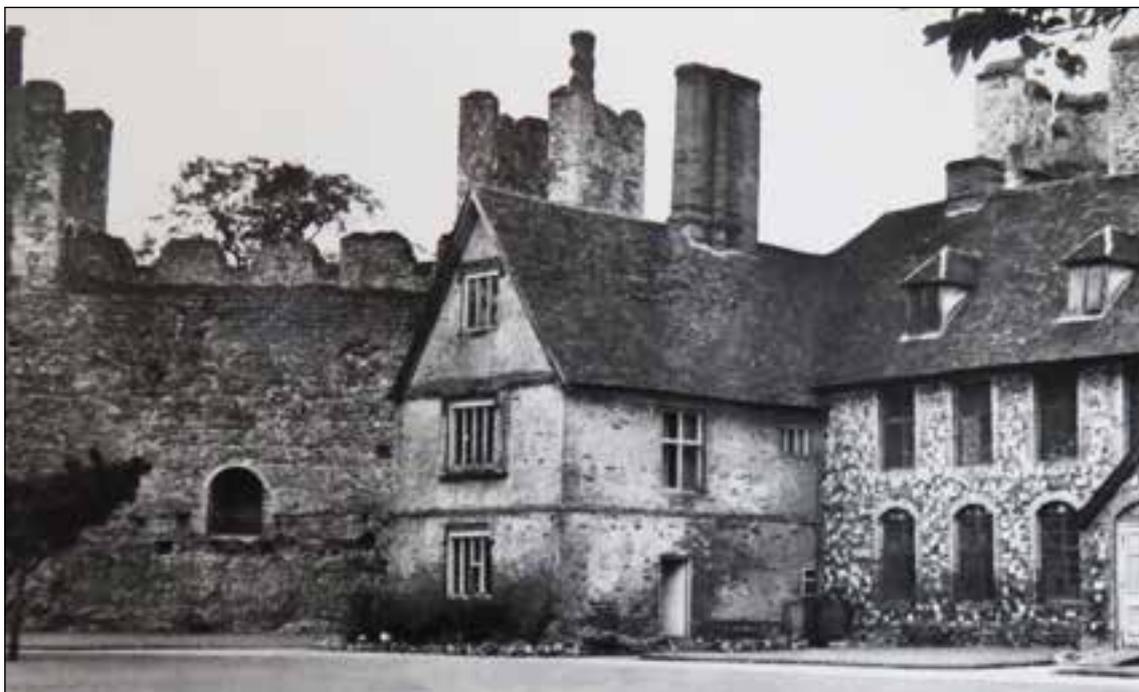
Fig. 50 Detail of a 20th-century postcard, showing the doorway on the north side of the Tea Room. It was replaced with a window in 1955 and the lower part blocked. (Diana Howard)

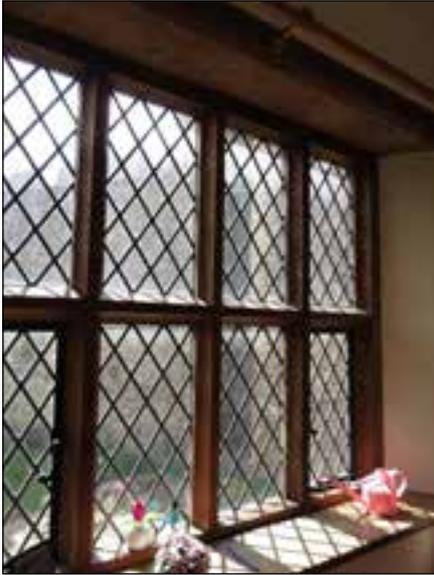
Fig. 51 Interior of a window to the sitting room. (© Historic England, K. Morrison)

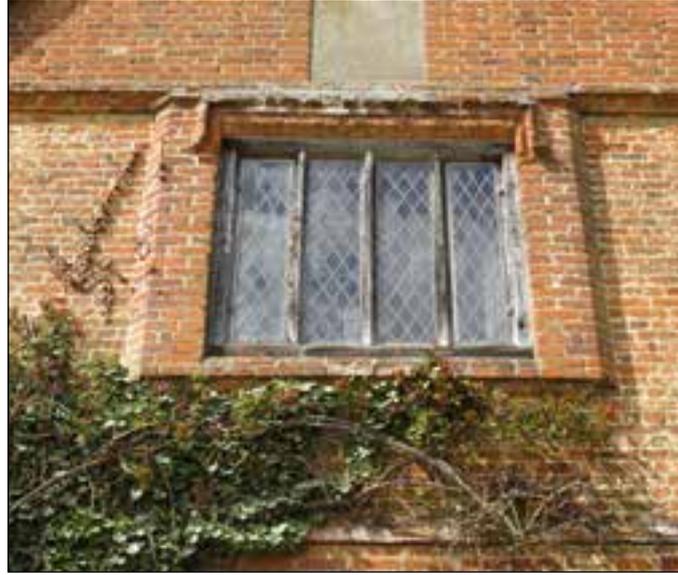
Fig. 52 Exterior of the salient window to the east bedroom. (© Historic England, K. Morrison)

replicas. The work of 1955-57 involved much replacement of timber window frames as well as reglazing, and this included a mixture of new and old oak. The windows have timber mullions and (on the first-floor south side only) transoms: all appear to have been renewed, or at the very least heavily repaired, but perhaps imitate the form of the originals. Some windows have internal ovolos (sitting room; kitchen), while the others have cavettos or, occasionally plain chamfers (Fig. 51). Most have plain chamfers externally. The windows to the first-floor lobbies are small and high. The first-floor east window (Fig. 52) is set within a projecting brick panel on a moulded course, suggestive of a shallow oriel.

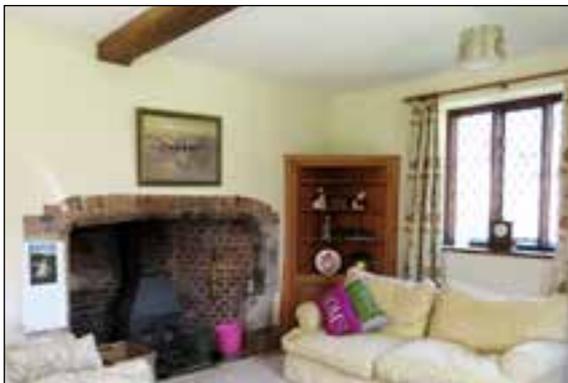
Fig. 53 The fire surround in the Red House's sitting room (east room). (© Historic England, K. Morrison)

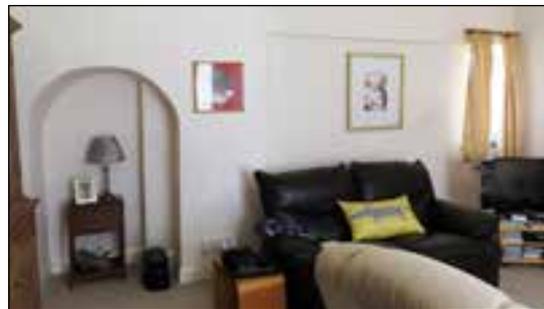
Fig. 54 The north wall of the living/dining room. The arched opening gave access to a closet/larder, and there was formerly a staircase in front of this (see Fig. 40). (© Historic England, K. Morrison)

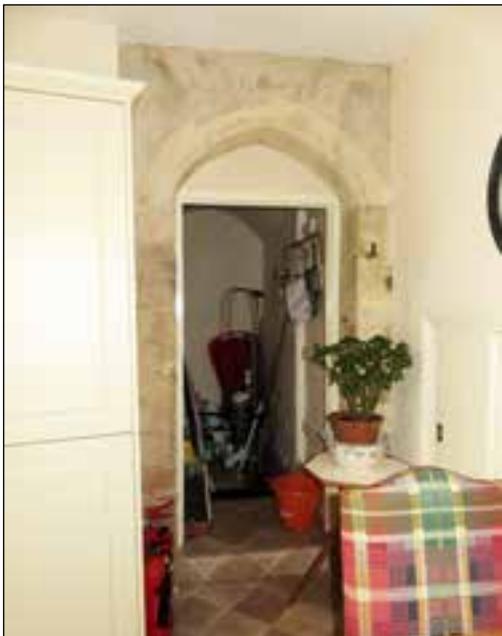
Fig. 55 (left) Doorway within the curtain wall, in the present kitchen (west room). Note the serving hatch just visible to the right (see also Fig. 23). (© Historic England, K. Morrison)

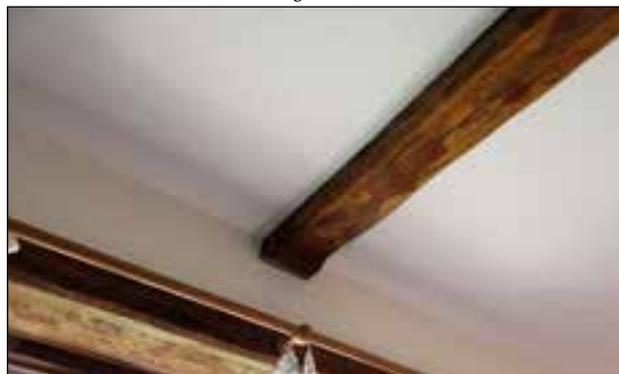
Fig. 56 (below) Detail of a repaired beam in the east bedroom. (© Historic England, K. Morrison)

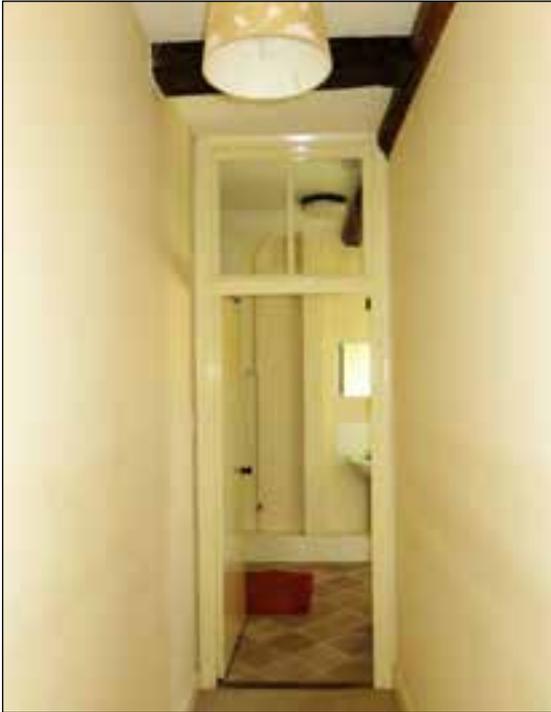
Fig. 57 The corridor to the bathroom, created in 1955. (© Historic England, K. Morrison)

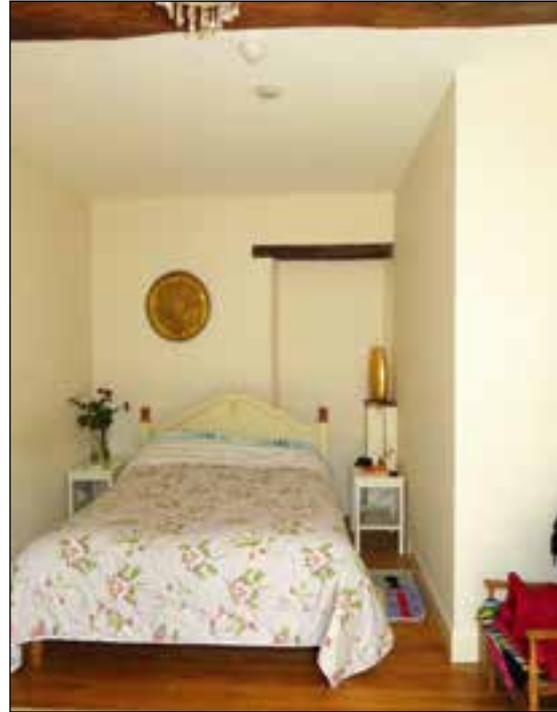
Fig. 58 The middle bedroom, showing the blocked doorway to the hall gallery. (© Historic England, K. Morrison)

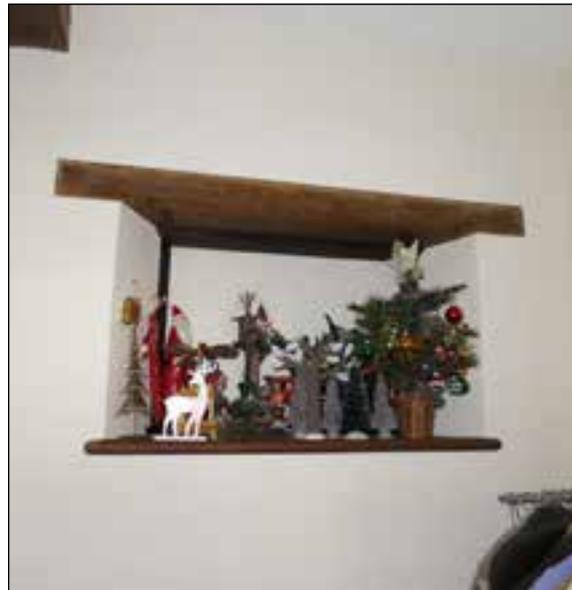
Fig. 59 Niche in the west bedroom, corresponding to a blocked window. (© Historic England, K. Morrison)

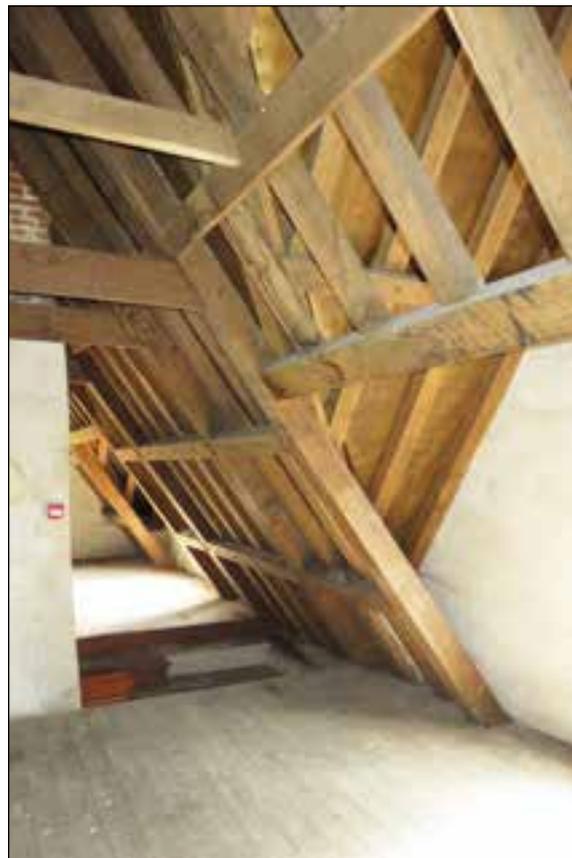
Fig. 60 The Red House roof, showing the hatch over the stair. (© Historic England, K. Morrison)

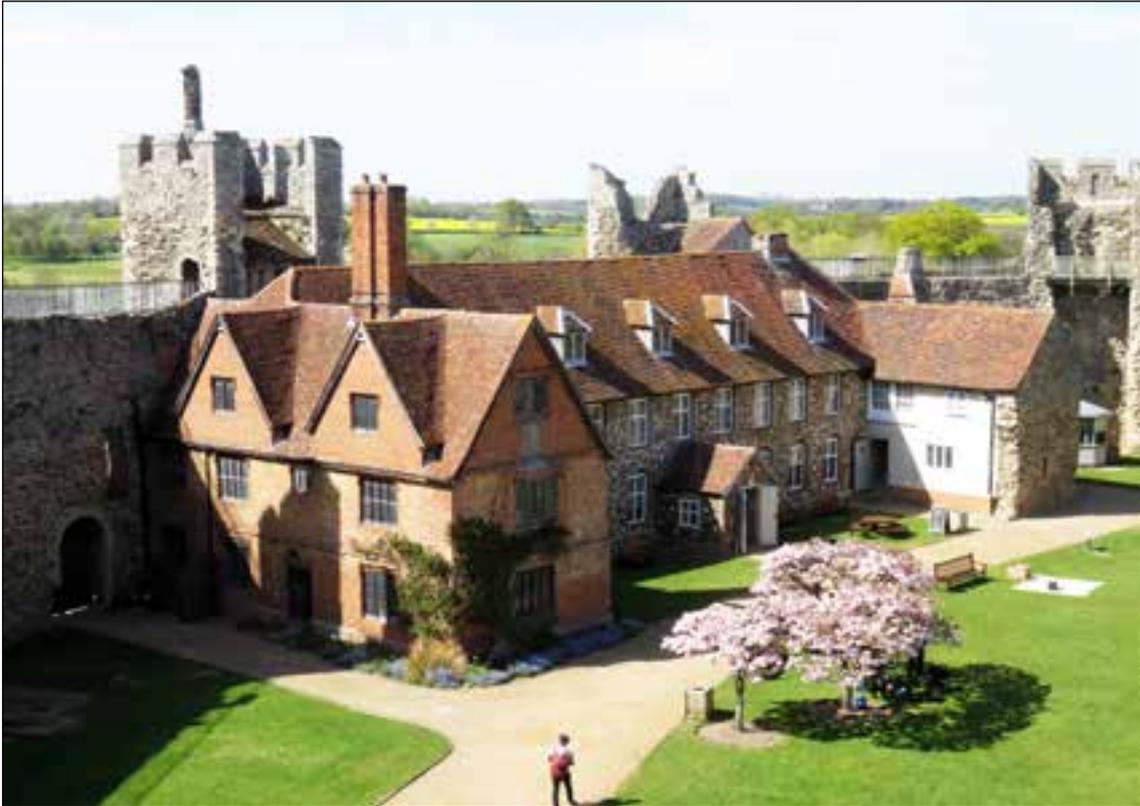
*Fig. 61 Framlingham Workhouse from the south-east, showing the Red House in context.
(© Historic England, K. Morrison)*

- The Red House (Fig. 61) was built in 1664 as a workhouse, not a poorhouse. It was not originally residential, but more of a domestic-style textile manufactory. It is crucial to establish the correct building type and the original functions of the building in order to assess its significance. Workhouses of this period are rare; poorhouses (generally cottages) more common.

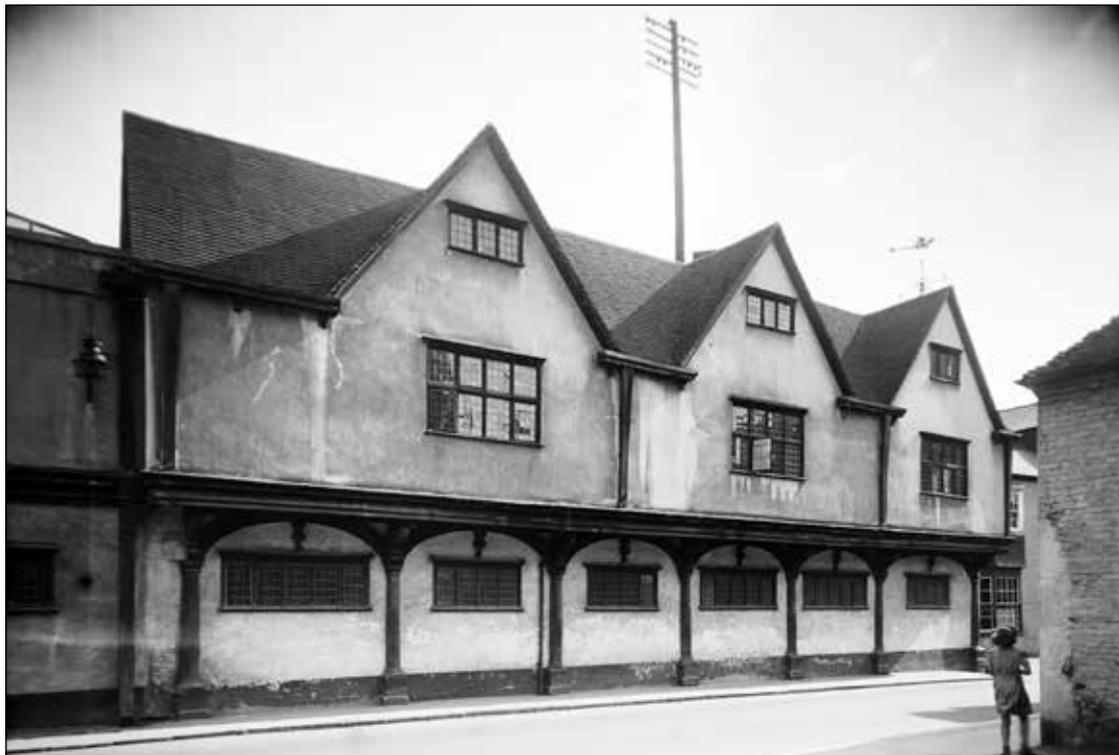
Fig. 62 Newbury Workhouse in Berkshire, completed in 1627. (© Historic England Archive, aa44/04194)

Newbury workhouse (Fig. 62) is probably the earliest purpose-built workhouse to survive in England, though it does not survive intact. Richard Emmes, a carpenter from Speenhamland, Berkshire, was appointed to build the workhouse in July 1626 and it was completed a year later. It comprised three new ranges around the north, east and south sides of a courtyard, with an old building to the west. It was essentially a woollen cloth factory, with a separate weaving shed, and a dye-house in the east range. Today only the south range survives: this was later known as the Cloth Hall and is now in use as a museum; the other blocks have been demolished. A timber-framed building with a jetty and large gables, it is listed Grade I.

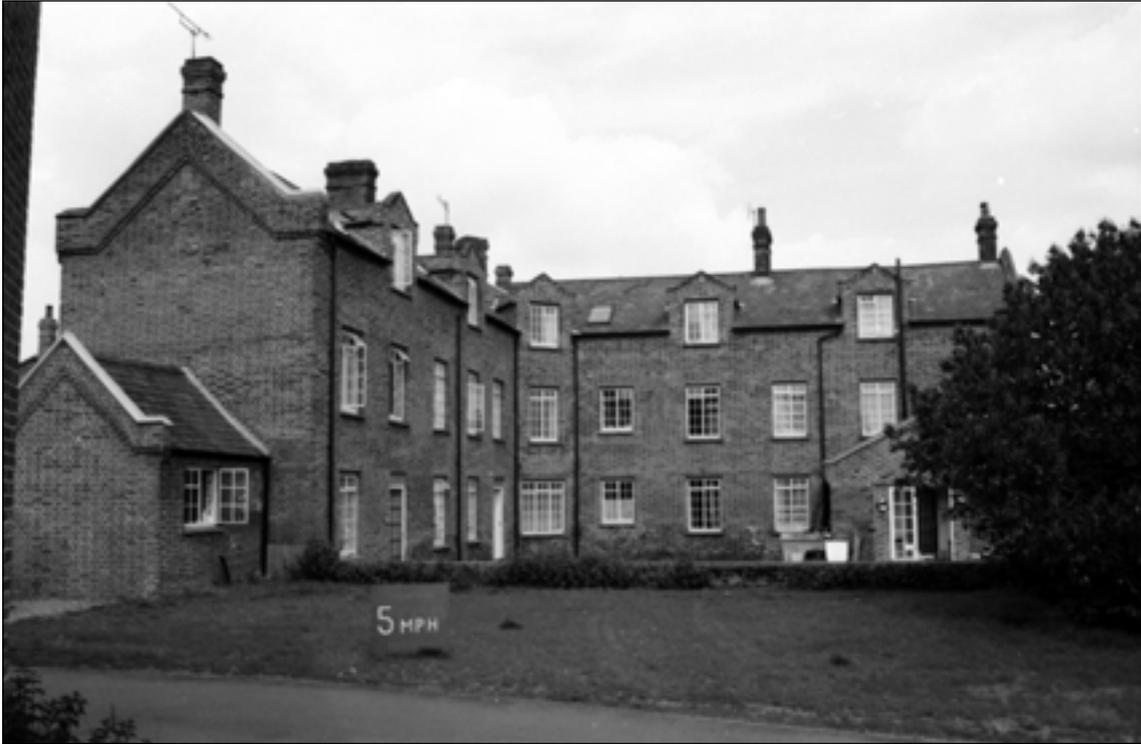
Fig. 63 Plomesgate Union Workhouse, Wickham Market, Suffolk, photographed in 1999. The workhouse opened in 1837. (© Historic England, K. Morrison)

classified and segregated – throughout the country. Framlingham was assigned to Plomesgate Union, which quickly decided to build a new workhouse at Wickham Market (Fig. 63). Once new workhouses opened, outdoor relief to the able-bodied ceased, as did attempts to make a profit from indoor pauper labour through spinning or shoemaking. One consequence of the New Poor Law which is seldom discussed is the fate of the many hundreds of parish workhouses and poorhouses that had to operate as union houses for a few years after 1834, and then were suddenly vacated.
