## CHAPTER 7: THE NORTH RANGE

### 1 Introduction

The north range constitutes the whole of the northern section of the house, comprising the ranges to the north sides of the main court, the service court and the back yard. The north façade (fig. 7.1) of this range faces onto Walnut Tree Court and contains the gate tower, which forms the main entrance to the house. This range was probably built in two phases for Guy Wolston in the second half of the 15<sup>th</sup> century. The Kitchen and the service range to the west probably formed part of the first phase of building and the remainder of the range was added when the house was expanded a few years later. The gardener's cottage beyond was added in the mid-18<sup>th</sup> century.

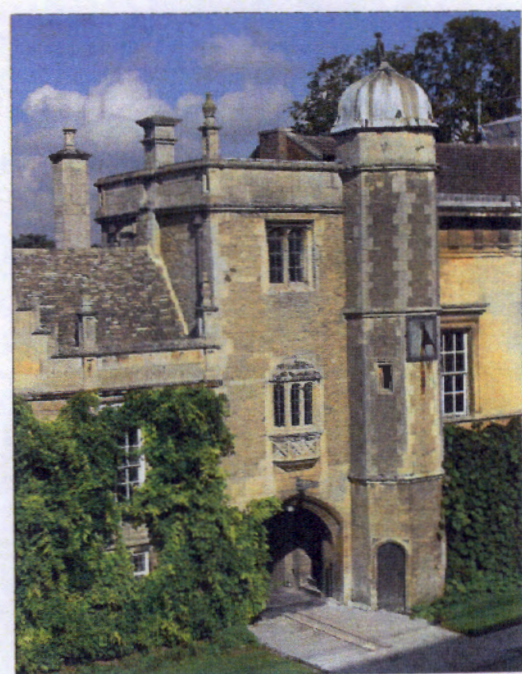
The three-storey gate tower and the octagonal staircase tower attached at its south-east corner were built in the late 15<sup>th</sup> century (fig. 7.4), and unlike most of the remainder of this range they survive largely intact both externally and internally, apart from their original battlements which were replaced in 1622-24.

*Figure 7.4 The south front of the Gate Tower. Pete Smith 2006*

The north (fig. 7.6) and south (fig. 7.4) façades of the gate tower have deeply moulded, pointed arches. The mouldings of the north arch are continuous, while those of the south arch die into the jambs. The flat plaster ceiling to this entrance passage is divided into six rectangular panels by moulded timber beams, each panel is then subdivided by similar diagonal beams into four triangular panels. Above the south archway is a canted oriel window with four four-centred lights, four lower panels with cross cusping and a stone roof. The details of this window, like the double chamfered sills, do not correspond with the details on the other gate tower windows, which may possibly suggest that it is a later insertion.

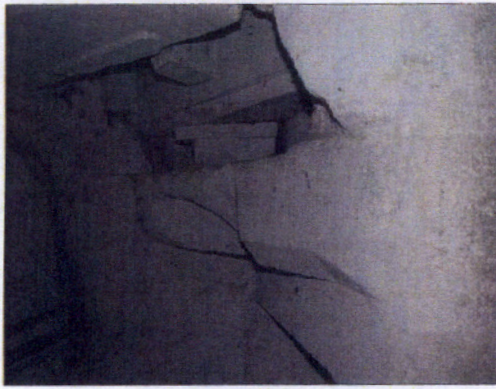
*Figure 7.5 The missing step on the spiral staircase in the Gate Tower.*

to accommodate changes in the access from the staircase to the ground and first floors and the doorways to these floors have also been altered - these changes of level are discussed in more detail below. Many of the upper stone steps are pierced for a bell rope, which once connected to a bell that hung in the dome above this stair tower. This is referred to in the 1629 inventory as 'A Bell and rope' in the Clocke Chamber,<sup>2</sup> in the 1705 inventory as 'On the top of the Stairs a Bell to Call the family dog',<sup>3</sup> whilst in the 1892 Sales Catalogue it is described rather more prosaically as 'the Bell Tower with alarm bell in case of fire'.<sup>4</sup>

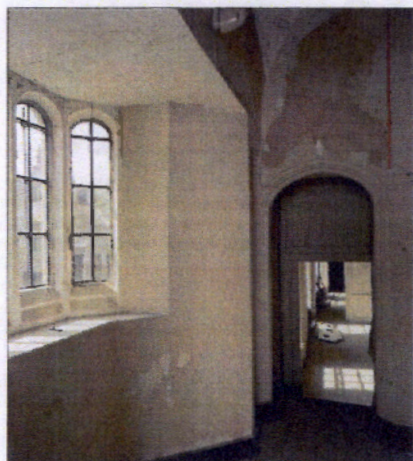
**Figure 7.8** The doorway on the first floor of the Gate Tower.

On the north side is a deeply set three-light window with four-centred lights and a hood mould. The first-floor chamber, known as the Canopy Room, retains its original stone cross-vault with plaster ceiling (fig.7.7). There are two surviving 15<sup>th</sup>-century stone doorways to east and west; both have chamfered and deeply moulded arches with four-centred heads on their inner faces (fig. 7.8).<sup>5</sup> Either side of the oriel window are projecting piers flanked by tall narrow recesses, these piers partly obscure the doorways and again might suggest that the oriel window was itself a later addition (see above). Above on both sides are single two-light windows with four-centred lights. These windows and the three-light mullion window on the floor below are set internally in deeply splayed surrounds with curved lintels and curved jambs hidden behind later shutters. The chamber on the top floor of the gate tower has a damaged late 15<sup>th</sup>-century stone fire surround with a cavetto-moulded arch with four-centred head and spandrel insets (fig. 7.9). The room is entered through a late 15<sup>th</sup>-century chamfered stone doorway with four-centred head. The floor is of gypsum plaster or lime ash over the solid stone vault below.

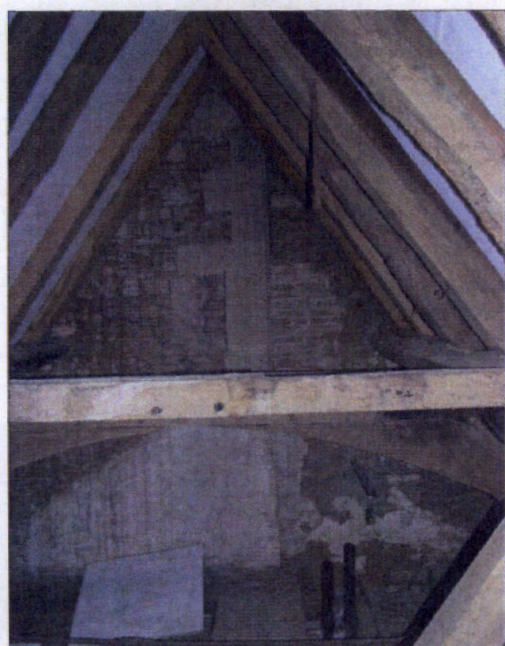
*Figure 7.13 The east roof gable of the North Lodging Block.*  
Pete Smith 2006

dividing wall between them is certainly thick enough to have once been an external wall. The roof of this range is in two sections, on either side of this masonry party wall (figs 7.13 and 7.14). Both sections appear to be late 15<sup>th</sup> century,<sup>7</sup> though dendrochronology has produced no dates for this roof. Each roof consists of two whole bays and two half bays, one at either end. The western roof has a ridge piece and both roofs have principals which are diminished in thickness above clasped purlins and un-cambered collars; there are arch-braces, and windbraces which in the west roof have a reverse curve. The slight differences in these roofs could be construed as further evidence that these two sections were built at slightly different dates. But a more likely explanation for the thinning of the southern wall at its west end is to make room for the bay window inserted at the north end of the hall range in 1622-24 (see Ch. 6). This window was certainly responsible for the narrower spacing of the later windows lighting the western room. On the inner faces of the end gable walls of both these roofs there are shallow triangular sections of painted plaster the scars of pitched ceilings whose apices were attached to the centre of the roof collars (figs 7.13 and 7.14). These unusual ceilings would not have been as impressive as the barrel-vaulted ceilings to the room over the parlour or the great chamber, but they do denote that these rooms were initially chambers of relatively high status. The west gable to the west room has a later rendered scar rising through the triangular ceiling scar, indicating that the original chimney stack, which has been removed, was sited on this wall (fig. 7.13). The now redundant stack is still in place on the ridge of the roof.

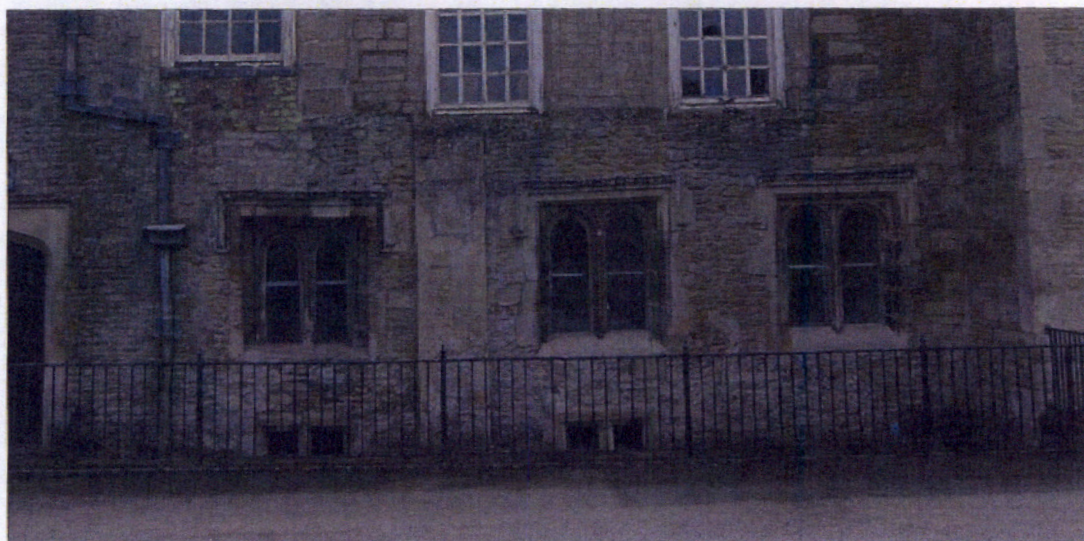
**Figure 7.16** *The north front of the former Housekeeper's Room and the Cellar.*

The original cellar constructed in the late 15<sup>th</sup> century may well have only occupied the northern section of the present cellars, and the section of pilaster visible on the exterior of the north wall suggests that this cellar was divided into two rooms. It was enlarged in the 1580s and again 1622-24 when its south wall was removed, and the two two-light chamfered mullion windows in the north wall were probably also inserted at this time (fig. 7.16). The former Housekeeper's Room above was probably also

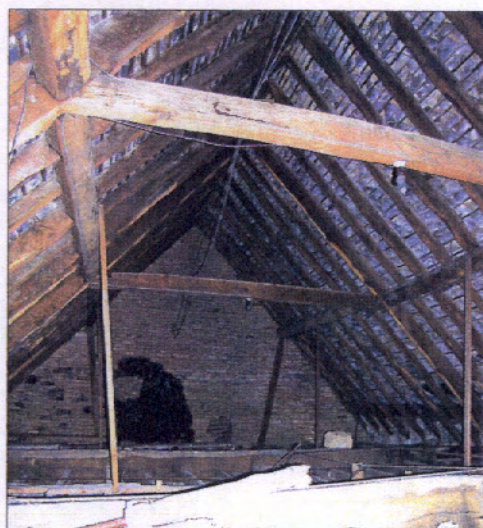
The Kitchen block to the west was completely rebuilt in the early 18<sup>th</sup> century, though this is probably the site of the smaller Kitchen built to serve the original house built for Guy Wolston. The smoke blackened scar of a former chimney stack is visible on the west gable showing the probable position of the original Kitchen stack (fig. 7.17).

**Figure 7.17** The Kitchen roof showing the smoke-blackened scar of the former chimney stack.

This stack, which has been removed externally, is clearly visible on various early 20<sup>th</sup>-century photographs of the north front (fig. 7.1).

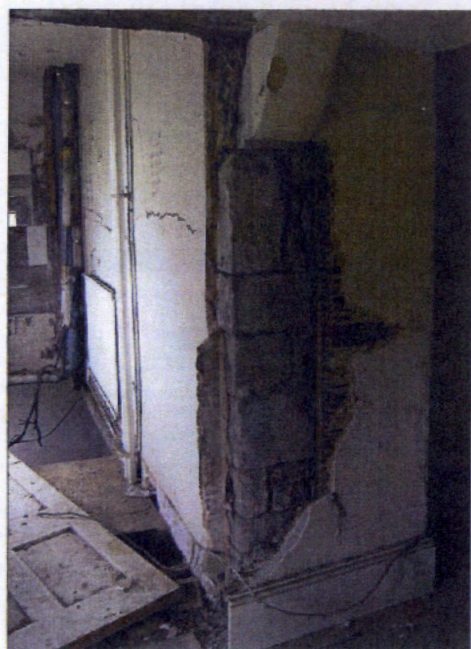
*Figure 7.18 The quoins exposed at the north-west corner of the Service Block.*  
*Pete Smith 2006*

At the northern end of the present first-floor corridor, which occupies part of the former Brewhouse, the quoins to the former north-west corner of this service range have been exposed (fig. 7.18). These quoins correspond with the evidence of the gable above, visible from the roof beyond. The west face of this gable (fig 7.19) has many surviving triangular coping blocks on the slopes of both pitches of the gable which clearly indicates that this was originally built as an external gable wall.<sup>8</sup> This wall therefore denotes the extent of this late 15<sup>th</sup>-century service range enclosing the service court, with an entrance gate or gateway between it and the west lodging range. The Rockingham Forest Map of c.1641 (see fig. 4.3) shows that the north range ended at this point,<sup>9</sup> and though this survey cannot always be relied upon in detail, the surviving physical evidence would seem to confirm that in this instance it is correct. This gable still retains the remains of a chimney stack within the roof, which heated the rooms at the western end of the service range.

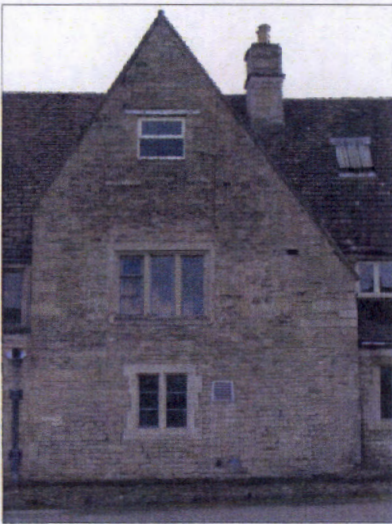
*Figure 7.21 The single gabled projection on the north front of the Service Block.*

This retains a single two-light mullion window on the first floor with round-headed lights which could be part of the original fenestration. On the north front the tall gabled projection to the east is irregular with a lower pitch to the west side (fig. 7.21). To the right the sill and part of the jambs of a single-light window can still be seen buried in the walling. This window might help to explain the reason for the irregular west side of this gable which appears to have been extended downwards at some time. It probably lit a stair or closet that was originally finished with a parapet. The lower walling of the further gabled projection to the west (fig. 7.22) has irregular banded rubble stone and a band of coping stones buried in the wall at first-floor level; perhaps this was part of the parapet to an original single-storey projection. The small two-light window with its

round-headed lights and incised spandrels, which appears to be late 15<sup>th</sup> century in date, would seem to confirm that the ground-floor section of this gabled projection was part of the original service range. The roofs to the service range were completely rebuilt in the early 19<sup>th</sup> century when the attics were added.

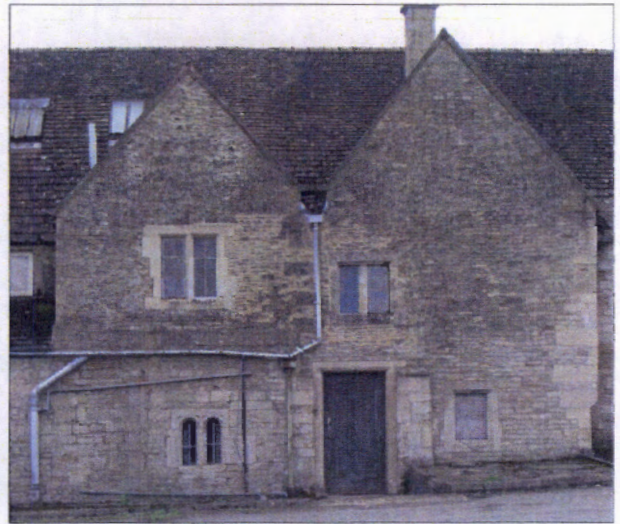
*Figure 7.22 The double gabled projection to the north front of the Service Block and the former Brewhouse.*

On the north front, at the eastern end of the former Brewhouse, is a projecting gabled wing (figs 7.22 and 7.39). The western corner of this gabled projection is corbelled out about a metre above ground level. In the angle between this projection and the north range there is an earlier projection with irregular quoins which was presumably the external chimney stack which served the Brewhouse.

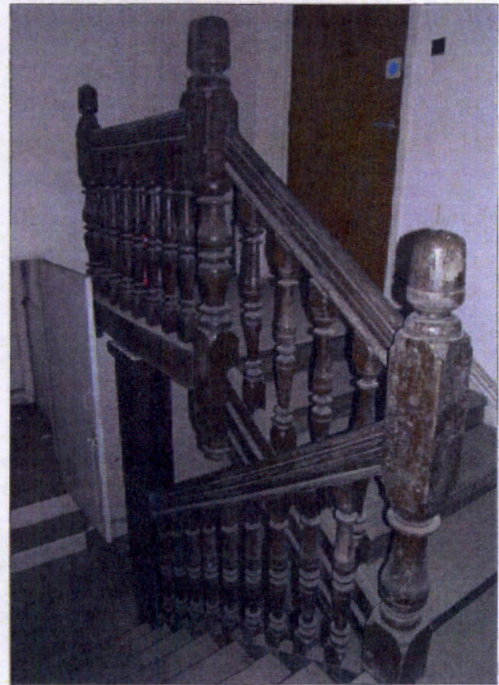
The Devil's Stair, or the Library Stair as it is sometimes known, at the eastern end of this range was inserted in 1622-24 to give direct access to the northern end of the Roof Walk from the Long Gallery and from the main courtyard, presumably via a now lost external doorway on the ground floor. It is constructed of oak, survives largely complete, though partially encased, and seemingly in its original position. It is a single flight return stair with bulbous turned newel posts and ball pendants, turned balusters, a moulded handrail and a continuous string with deeply chamfered mouldings (fig. 7.24). The ground-floor newel post has been encased with timber to form a continuous newel which rises to the first floor. Within the cupboard under the first flight of this stair the lowest section of the northern newel post can still be seen where it was never concealed by boxing.<sup>12</sup> This newel post is square with chamfered corners and hollowed panels to each face. The newel posts to each of the northern half-landings have been encased to form a continuous newel post, with staff mouldings, which rises up to support the cantilevered top landing. This might suggest that the square inner newel is continuous, but it is very different from the southern newel posts to this stair which are turned (see below), and it is perhaps more likely that sections of square newel were inserted between the original turned newels to support the cantilevered top landing. The fact that the inserted upper newel is considerably smaller than the boxing in does seem to confirm this interpretation. The handrails to the four main flights have also been encased in timber. The first-floor south newel post has had its finial removed and it has also been encased (fig. 7.25). During recent architectural investigation the top was temporarily removed from this encased newel post and the original newel post, shorn of its finial, could be clearly seen surviving within it.<sup>13</sup> On the top flight and landing the form of the original turned newel posts with their acorn finials, stumpy pendants and deeply moulded handrail can still be seen (fig. 7.24).

*Figure 7.24 The top flights of the Devil's Stair.*  
Pete Smith 2006

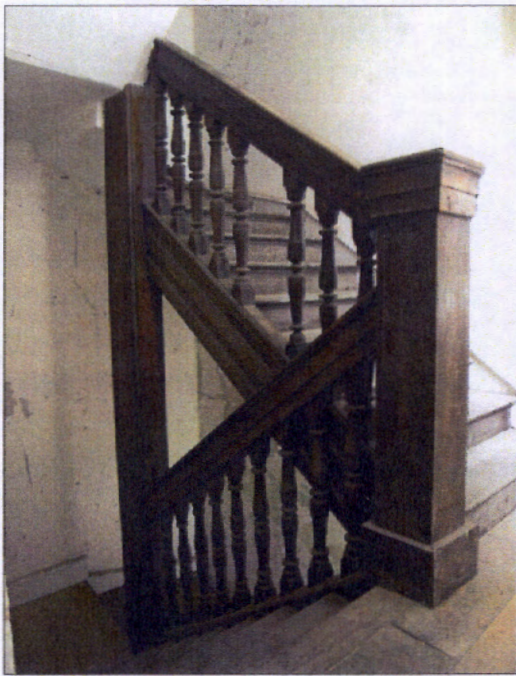
**Figure 7.25** *The middle flights of the Devil's Stair.*  
**Pete Smith 2006**

The width of the rectangular cage occupied by the staircase indicates the original width of this section of the north range which corresponds with the width of the gatehouse

and the range to the west.<sup>14</sup> Since there is no visible indication that the arrangement of the flights of this stair has been altered,<sup>15</sup> then the floor levels indicated by the position of the landings suggest that the present floor levels are roughly the same as they were in 1622-24. As we have seen the first-floor level corresponds with the first-floor level of the Long Gallery, and not with the section of the north range to the west of the gate tower, which is five steps lower. This strongly suggests that this whole section, which was constructed in the late 15<sup>th</sup> century, was rebuilt, or at least raised in 1622-24 so that the floor levels corresponded with the new east range and the gate tower.<sup>16</sup> The second-floor south landing level, which

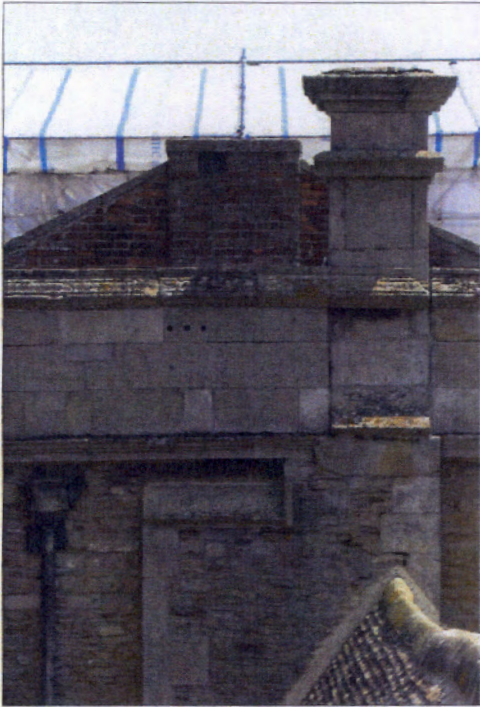
The west side of the gate tower retains a broad external chimney stack (see fig. 7.31), which is visible above the roofs of the west range. This stack has been altered, but it originally served the fireplaces in the west wall of the gate tower.

**Figure 7.31** The altered chimney stack on the west side of the Gate Tower.  
*Pete Smith 2006*

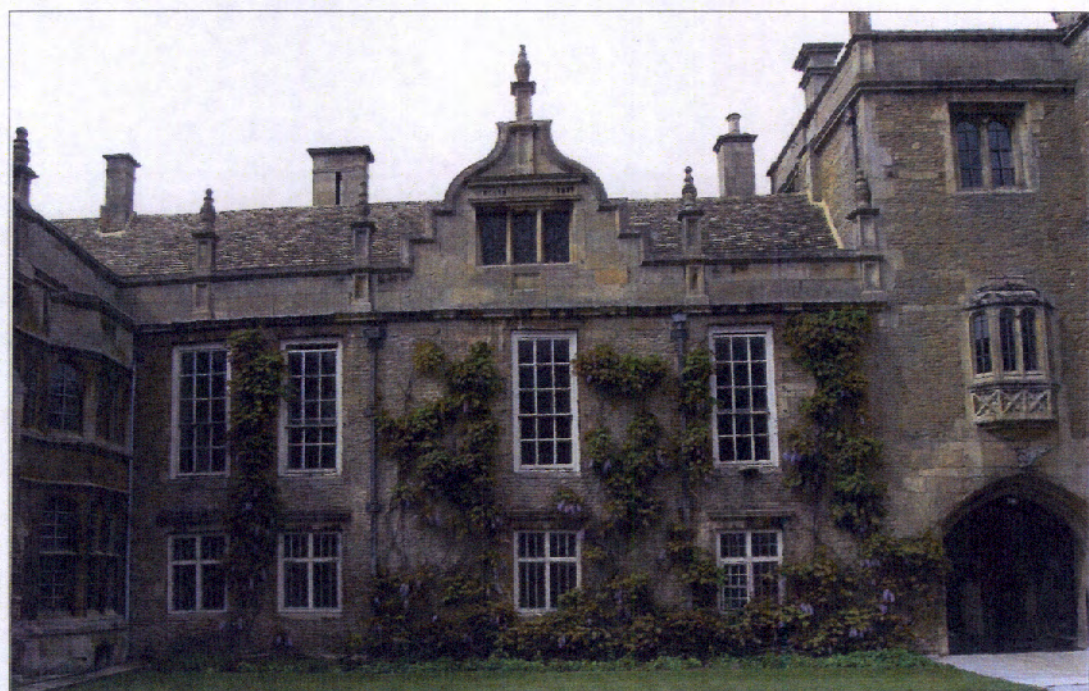
A parapet with dies and urn finials and an off-centre gable with a false three-light mullion window was added in 1622-24 to the south or courtyard façade of this section of the north range (fig. 7.32). The sash window immediately below the gable has a section of reused and inverted fluted lintel of a type found over many of the windows added in 1622-24. On the north front, immediately west of the gate tower, is a broad external chimney with regular quoins, which rises up to a single square ashlar stack

to the left; the sloping right section seems to have lost its matching square stack. This chimney was added in 1622-24 and it served the now blocked chimneypieces on the ground floor and first floor, replacing the stack on the west wall of the gate tower. As already noted the stack on the west wall of the gate tower was reduced to only a single flue serving the Canopy Room in 1622-24 (fig. 7.31). This means that the chimney pieces to the east rooms, originally on this east gable wall, were replaced at this time and that the external stack on the north wall was then introduced to replace them. Both the rooms on the first floor were accessed after 1622-24 from the hall range, via the new staircase inserted in the north-west bay window (see Ch. 6). To the west is a boldly projecting rectangular closet or garderobe block (fig. 7.12) topped with an ashlar parapet of 1622-24 with, behind, a tall double chimney stack of similar date. The two-light window was almost certainly inserted when this projecting block was regularised and given its parapet and finials in 1622-24, for it is sited centrally within this newly enlarged block. The room immediately to the west of the gate tower may be identified as the Porter's Lodge in the 1629 inventory,<sup>21</sup> with its former south doorway giving access to the main court.

Figure 7.32 The south front of the North Lodging Block.

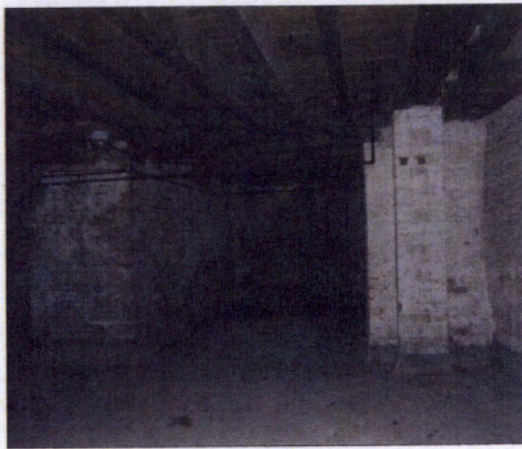
**Figure 7.33** *The Cellars.*  
Pete Smith 2006

original cellar was also removed except for a very broad section to the east which has large stone quoins (fig. 7.33). This surviving section of wall had to be retained to support the walls and roofs of the corner between the walls and roofs of the hall and north lodging ranges. It also supports an inserted chamfered beam, which has empty double mortises on both its north and south faces, which would once have contained joists.<sup>22</sup> This beam and most of the other timbers to this ceiling have had

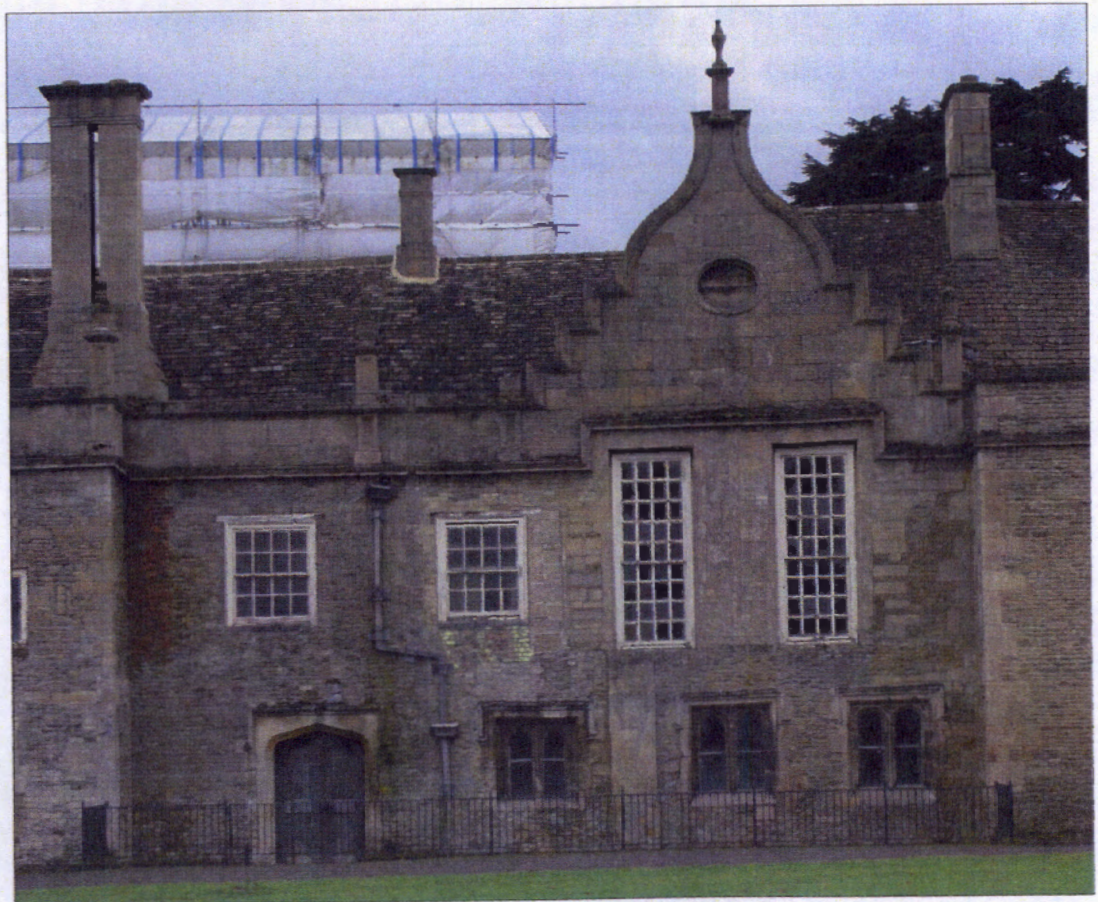
**Figure 7.34** *The north front of the Old Dining Room.*

The upper section of the north façade of this block was almost completely rebuilt in 1622-24 when the Old Dining Room (fig. 7.34) was created on the first floor.<sup>25</sup> The two very tall sash windows, which were inserted in 1716-17,<sup>26</sup> are set within the frames of the two broader mullion and transom windows that were inserted in 1622-24. The major mullion which divided these two former windows can still be clearly seen embedded in the ashlar stonework between these two sashes. Above the ashlar parapet with dies and urn finials, plus the broad curved and stepped gable with its moulded band and blind oval window which rises over these windows, are all part of these alterations. This new room originally occupied the whole space between the hall and the north wall.<sup>27</sup> Its collar purlin roof has upper collars to each truss and lower collars to all the pairs of rafters (fig.

This central section of the north range has a single façade to the north (see fig. 7.34), whilst the south side abuts directly onto the north end of the hall range (see Ch. 6). It consists of the Cellar, the former Housekeeper's Room above and the Old Dining Room at first-floor level.

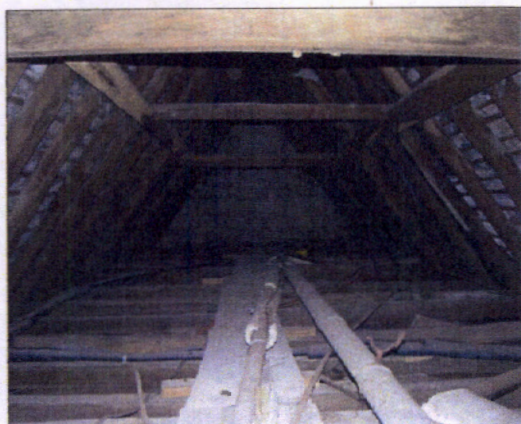
*Figure 7.35 The roof of the Old Dining Room. Pete Smith 2006*

the eaves level of the north gable so a barrel vaulted plaster ceiling must always have been a feature of this room. The plain plaster ceiling was introduced in the mid-18<sup>th</sup> century, probably replacing a far more decorative Jacobean style plaster ceiling. The fireplace (fig. 7.36), which is positioned awkwardly at the north end of the west wall, occupies its original site on the west wall of the former, late 15<sup>th</sup>-century, lodging chamber. The plaster overmantel is all that survives of the fireplace introduced as part of these 1622-24 alterations. It has a strapwork-enriched plinth with three grotesque lion-like heads in high relief from which rise three armless terms, two male and the central female, with Ionic capitals,

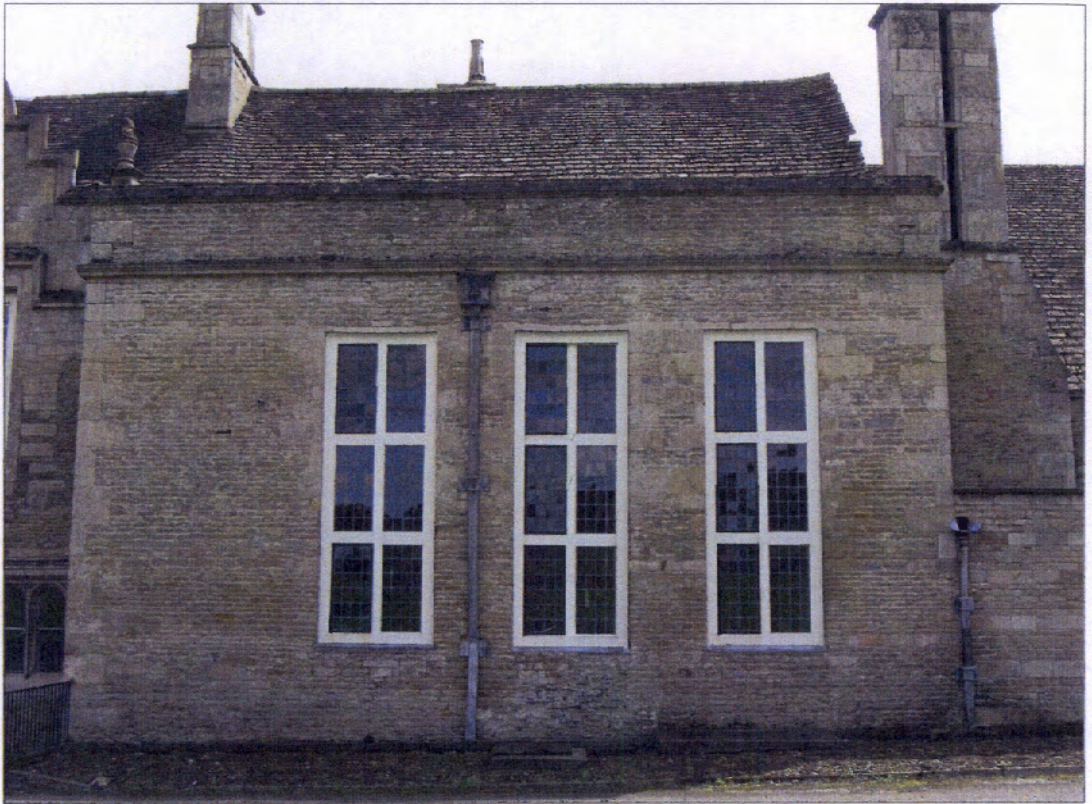
*Figure 7.38 The north front of the Kitchen.*

The present Kitchen was enlarged, or more likely completely rebuilt, for the 6<sup>th</sup> Earl. This Kitchen block projects forward from the north front (fig. 7.38), and its roof is higher and wider than the roofs of the ranges to the east and west. It is constructed of even and regularly coursed rubble stone with regular quoins and a plain rubble parapet. The results of the dendrochronology dating of the timbers of the Kitchen roof give felling dates of 1689 and 1703,<sup>32</sup> with two presumably re-used timbers which have felling dates of 1613 and 1639,<sup>33</sup> and this tallies exactly with the references in the 6<sup>th</sup> Earl's accounts for the period Lady Day 1704 to Michelmas 1705 which concern the Kitchen.<sup>34</sup> The first of these is to 'Laborors felling trees for kitchen' followed by 'Lime and Slate [...] for kitchen uses - £15', with others for 'Masons Worke...£42:3', 'for 10 oake boards - 10s', 'for 27 oake boards - £15:15:8', 'for 1000 of white bricks - £1:2:6' and 'for 48 new ridge tiles from Euston - 10s'. Followed by payments for 'Haire

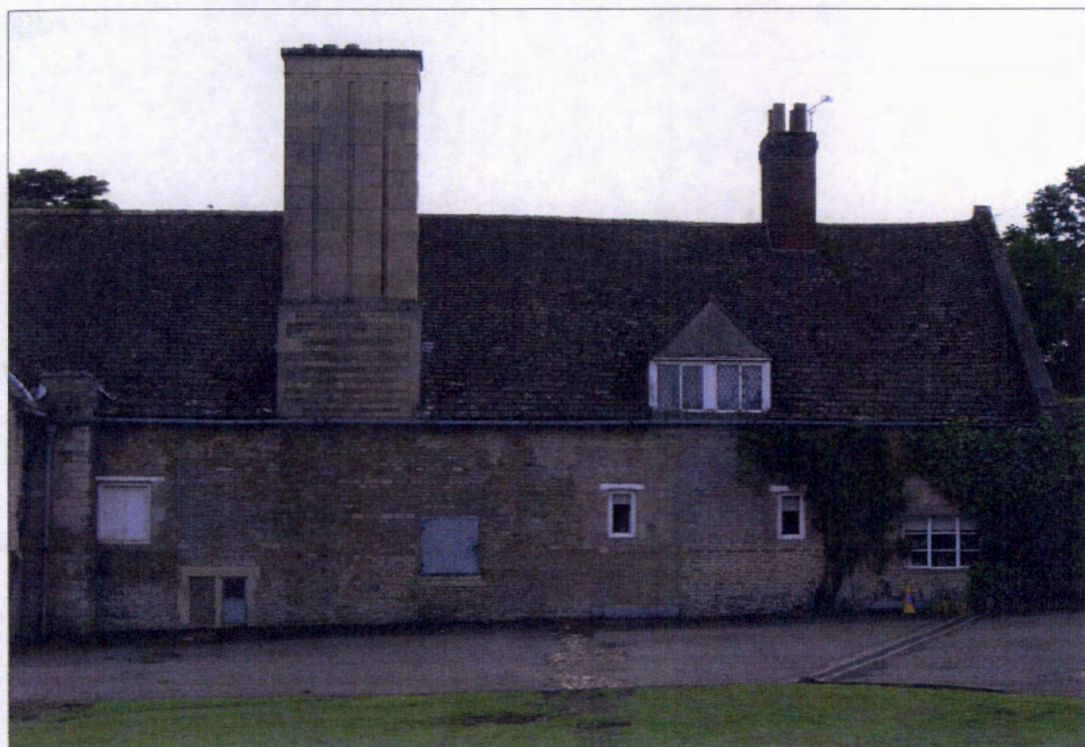
Figure 7.39 The north front of the former Brewhouse and cottage.

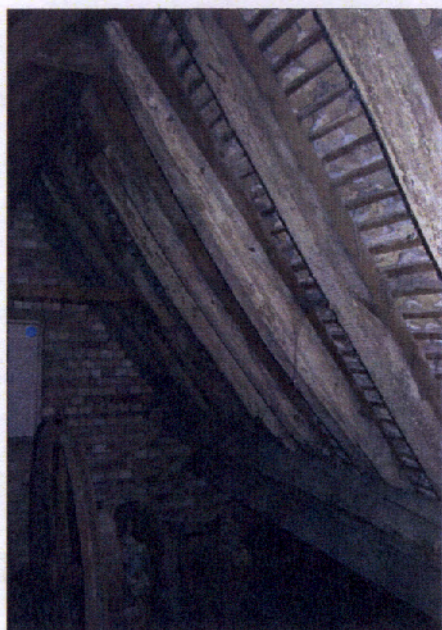
**Figure 7.40** *The roof of the former Brewhouse.*  
Pete Smith 2006

The former Brewhouse has a simple collar-purlin roof which was largely rebuilt and strengthened in the late 20<sup>th</sup> century (fig. 7.40). On the south pitch many of the rafters have been replaced whilst on the north many new rafters have been inserted to strengthen the originals. The surviving original timbers are painted or white-washed showing that the roof to the Brewhouse was open until the alterations of 1913. The surviving trusses each have collars with two struts which presumably linked to tie-beams, though these seem to have been removed when the new ceilings were inserted by Blomfield well above the eaves level. A single curved wind brace survives supporting the purlin on the north pitch of the roof, but there is no evidence that the roof had any other such braces.

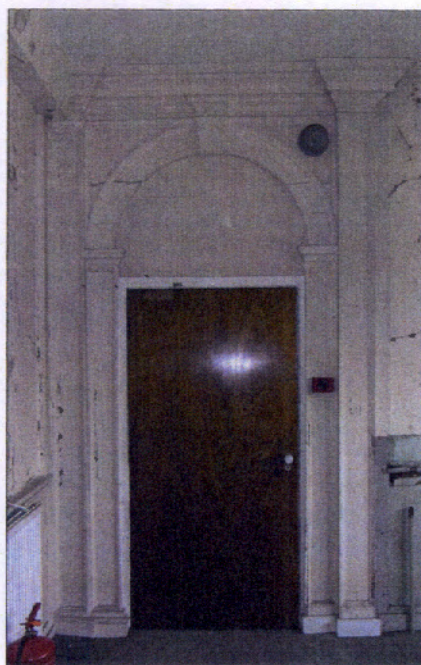
**Figure 7.41** The arched entrance to panelled rooms in the North Lodging Range.  
Pete Smith 2006

These rooms were accessed after 1622-24 from the hall range, via the staircase inserted then in the north-west bay window (see Ch. 6). This stair was altered at this time though the original balusters were reused.<sup>40</sup> From the landing of this staircase these rooms were entered through a grand round headed archway (which now contains a 20<sup>th</sup>-century fire-door).<sup>41</sup> This archway has pilaster jambs and a moulded arch with keystone set within a wooden surround with tall pilasters supporting a moulded entablature (fig. 7.41). It formed an impressive entrance to the Earl's new suite of rooms, through a small lobby, with an inserted sash window. This arch can possibly be identified as that mentioned in the accounts for June 1716; '20<sup>th</sup> Paid J. Dimbleby for himself, boy, J. Chapman & his son assisting at ye Arch...in full for all works to this times - £8 3s 8d'.<sup>42</sup>

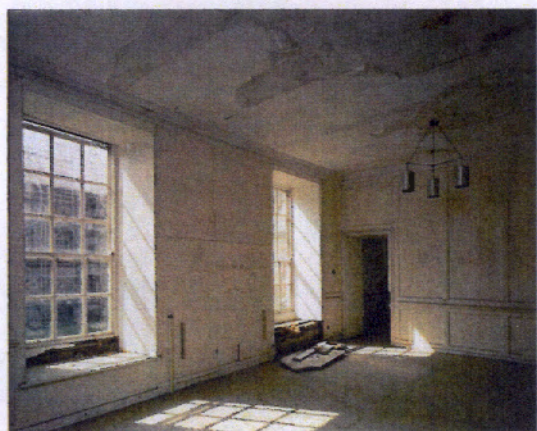
**Figure 7.42** The eastern panelled room in the North Lodging Block.  
© English Heritage BB039799

These rooms which were remodelled as the 6<sup>th</sup> Earl's private suite were given flat plaster ceilings, bolection moulded doorcases and full height panelling divided by a dado rail. The west room (fig. 7.43) retains its moulded plaster coving and complete panelling on its south, east and west walls. The western section of this room was partitioned off to form a lobby and bathroom [N.2.18, N2.19] sometime after 1913.<sup>43</sup> A now blocked fireplace with tall external stack was added on the north wall, to replace the former gable stack. The east room (figs 7.10 and 7.42) also retains most of its panelling, though that to the south wall has been partly removed. The former closet doorway to west end of the north wall has been blocked with an internal window. The upper panels to the east wall and the western half of the north wall have been boarded over. The scar of the lost central chimney piece on the north wall has recently been uncovered. Its insertion meant the blocking of the late 15<sup>th</sup>-century window visible on the north front. Two

The room is shown in a photograph, featuring a large window on the left, a smaller window on the right, and a doorway in the background. The walls are covered in wood paneling, and the ceiling is flat plaster.

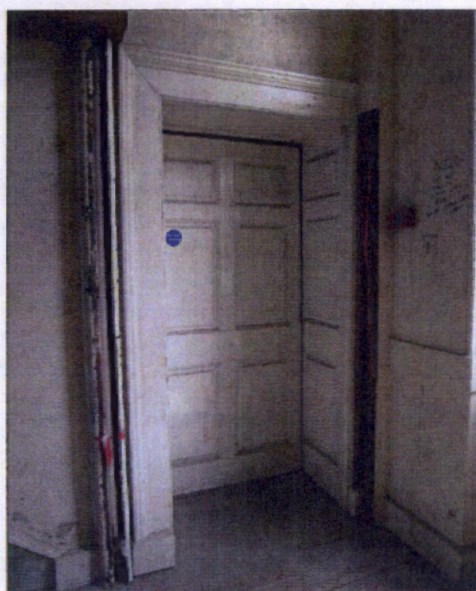
**Figure 7.44** The doorway to the Long Gallery.

This section of the north range, between the east range (see Ch. 10) and the gatehouse, was almost entirely rebuilt around 1740 for John Fane, 7<sup>th</sup> Earl of Westmorland (fig. 7.2), most probably to the designs of Roger Morris, as part of his plans to rebuild almost the entire house.<sup>46</sup> The timber staircase, known as the Devil's Stair, sited at the junction with the east wing was retained, but altered. These alterations included the insertion of a plaster wall between the two lower flights and the boxing in of the newels and handrails of the flights visible to anyone visiting the new Library on the first floor. The doorway on the first floor leading from this staircase to the Long Gallery (fig. 7.44) has a moulded timber frame with inner raised-and-fielded panelled reveals and a matching six-panel door which was also introduced as part of these alterations.<sup>47</sup>

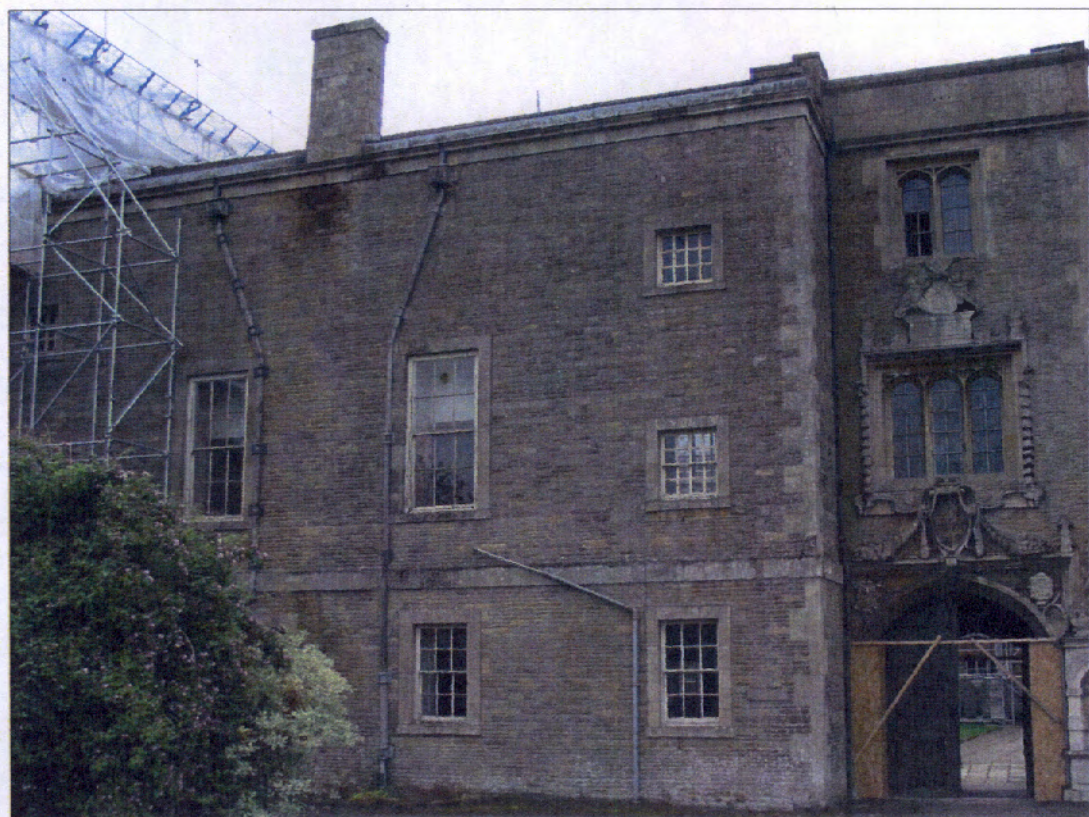
Figure 7.45 The north front of the Library Block.

The new Library block was rebuilt in the Palladian style.<sup>48</sup> The courtyard façade (fig. 7.2) matches that of the court elevation of the south range built at the same time (fig. 9.2). It has a rusticated basement with three windows each with four bold keystone-type voussoirs and above the ashlar *piano nobile* has three large sash windows in moulded stone surrounds topped with moulded cornices. The façade is topped by a Doric entablature. The northern façade of the Library block (fig. 7.45) is of rubble stone with flush ashlar quoins and a plain first-floor band. The windows are mostly small square, irregularly spaced, sashes in ashlar surrounds. The two large sash windows at first-floor level were originally blind, the present sashes were inserted in the mid-20<sup>th</sup> century when this block was remodelled internally. According to the 1858 plan of Apethorpe Hall (see fig. 1.6), a closet projected out from behind the east staircase at first-floor level and the blocked opening for this closet can still be identified on the stonework of the north façade. The rainwater heads to either side of the central wall chimney stack are dated 1818. This stack was originally surmounted by a weather vane linked to the Library overmantel below.

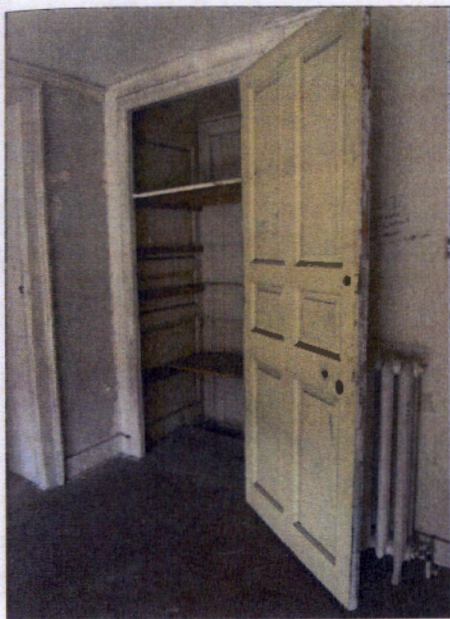
*Figure 7.47 The former west doorway to the Old Dining Room, now a cupboard. Pete Smith 2006*

1622-24, as part of these additions. A doorway was also added which now survives in the form of a cupboard (fig. 7.47) in the lobby to west. This deep doorway retains its original outer door, with eight raised-and-fielded panels and its similarly panelled inner sides forming the interior of the cupboard. The 1858 plan also shows that the Old Dining Room was entered from the east staircase landing through a doorway at the south end of the west wall, which has since been blocked.

47. This doorcase is very similar to one in the west wall of the Old Dining Room (7.2.v.) (fig. 7.47) and to another in the south wall of Lady Violet's Room (see Ch. 6), both are now cupboards.

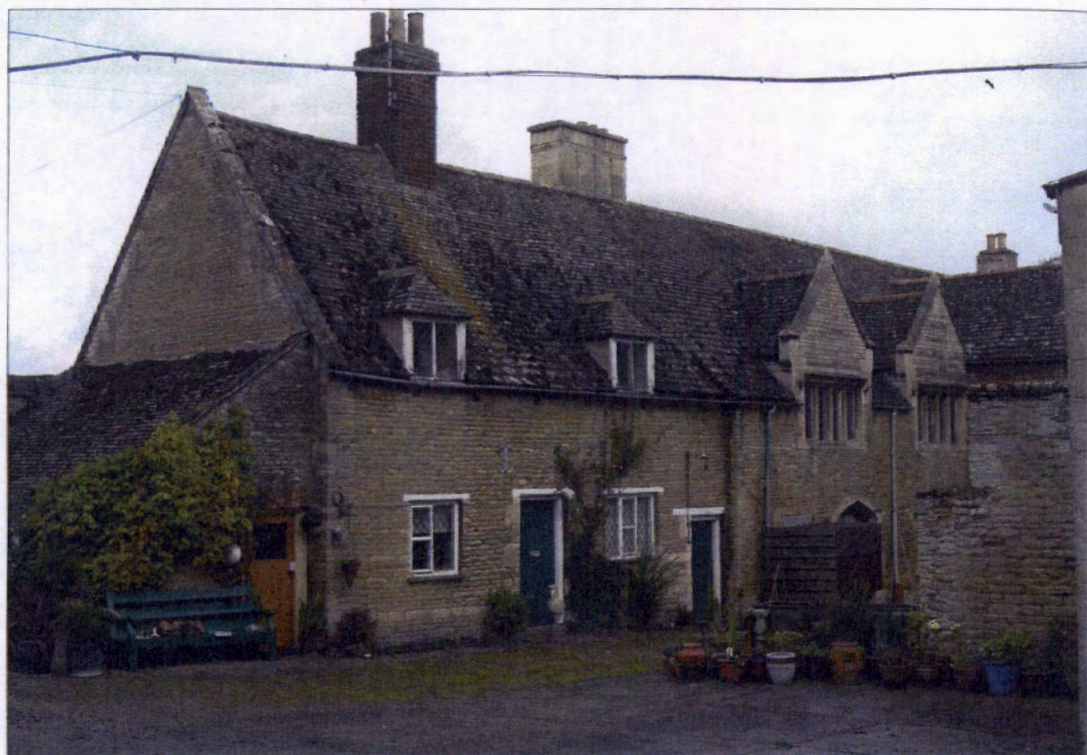
**Figure 7.48** *The south front of the Gardener's Cottage.*

Attached to the western end of the north range, and facing into the back court, is the Gardener's Cottage (fig. 7.48). This cottage was probably added in the late 18<sup>th</sup> century, for it does not appear on Bonney's early 18<sup>th</sup>-century sketch plan (see fig. 1.9). This two bay, lobby entry cottage has a central brick ridge stack and a single coped gable to the west. The roof to this cottage section survives largely unaltered (fig 7.49). It is pegged with a number of carpenter's assembly marks visible. It has two sets of staggered purlins with no collars or ridge piece. The gable wall dividing this cottage from the former Brewhouse, visible in the roof space, is of built of brick. Presumably this original stone gable was rebuilt in brick when the cottage was added. The south front of this cottage (fig. 7.48) is set back slightly from the remainder of the north range. It has a central doorway with plank door flanked by a two-light window to the left and a three-light window to the right, beyond to the right another doorway set slightly lower gives access down to the boiler room to the east. All these openings have timber lintels. Above there are two, two-light hipped dormer windows. All these windows have diamond leaded casements. Attached to the west gable wall of this cottage is a lean-to with a curved corner wall, a pantile roof and a single doorway; it was probably built as a washhouse, with a former privy beyond.

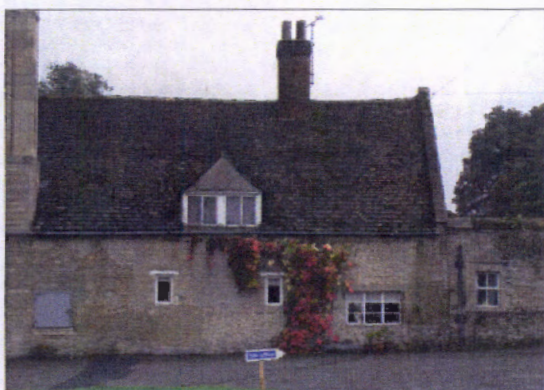
**Figure 7.50** *The north front of the Gardener's Cottage.*

The north (fig. 7.50) front has two single-light windows with timber lintels to the east with above a single gabled dormer with two, two-light casement windows. Evidence

for an earlier window with a flush ashlar frame can be seen to the left of this modern window. It was set higher than the present window, at the same level as the windows to the east. Attached to the west is a section of the wall that originally enclosed the back yard. This has had a window inserted into it which lights the washhouse behind. This wall links the cottage to the main gateway, with square stone gate piers, which forms the main entrance to both the rear courtyards.

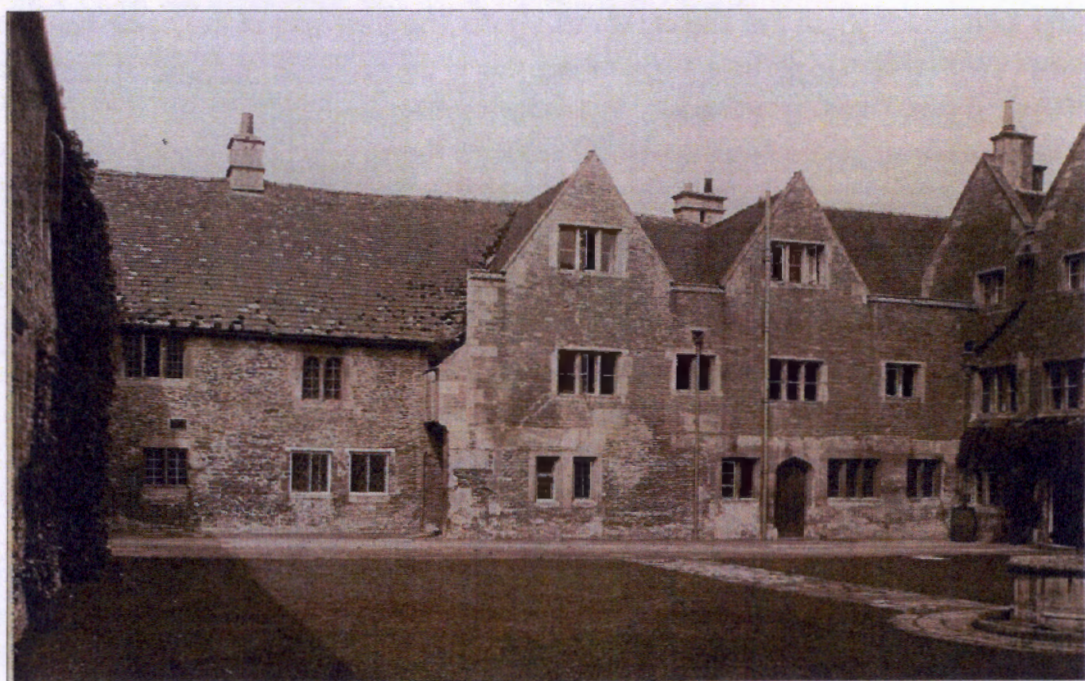
*Figure 7.51 The south front of the Service Range, showing the double gabled addition of 1818.*

The majority of the south front of the service range has been masked by the gabled corridor, probably added in 1818 (fig. 7.51), and only the wall to the west is visible.

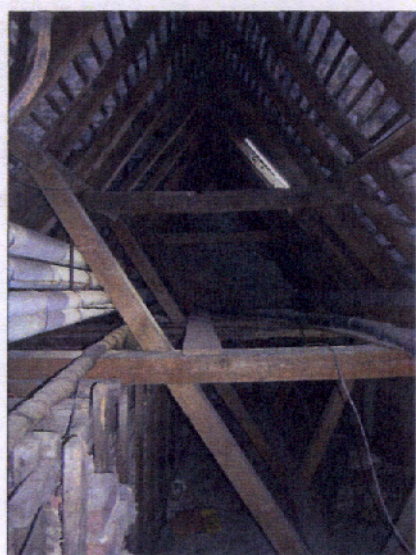
*Figure 7.52 The roof over the Archway passage.*  
*Pete Smith 2006*

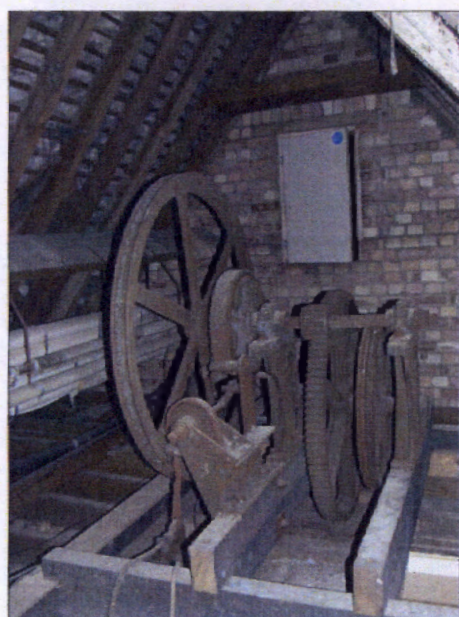
*Figure 7.53 The redundant lift mechanism.*  
Pete Smith 2006

These alterations included the conversion of Dr Bonney's Room, below the Library, into a bathroom and the insertion of a corridor on the ground floor of the service range to the south of the scullery, pastry and larders. It also included the virtual rebuilding of the former Brewhouse at the western end of the north range. The eastern end of the double-height Brewhouse was converted into an open well staircase and the western section became part of the boiler house and coke store for the new central heating system, also inserted at this time. On the first floor a new bedroom was created. The roof space above the staircase still contains the pulley mechanism for the lift introduced by Blomfield (fig. 7.53), which has subsequently been removed. The south front of the former

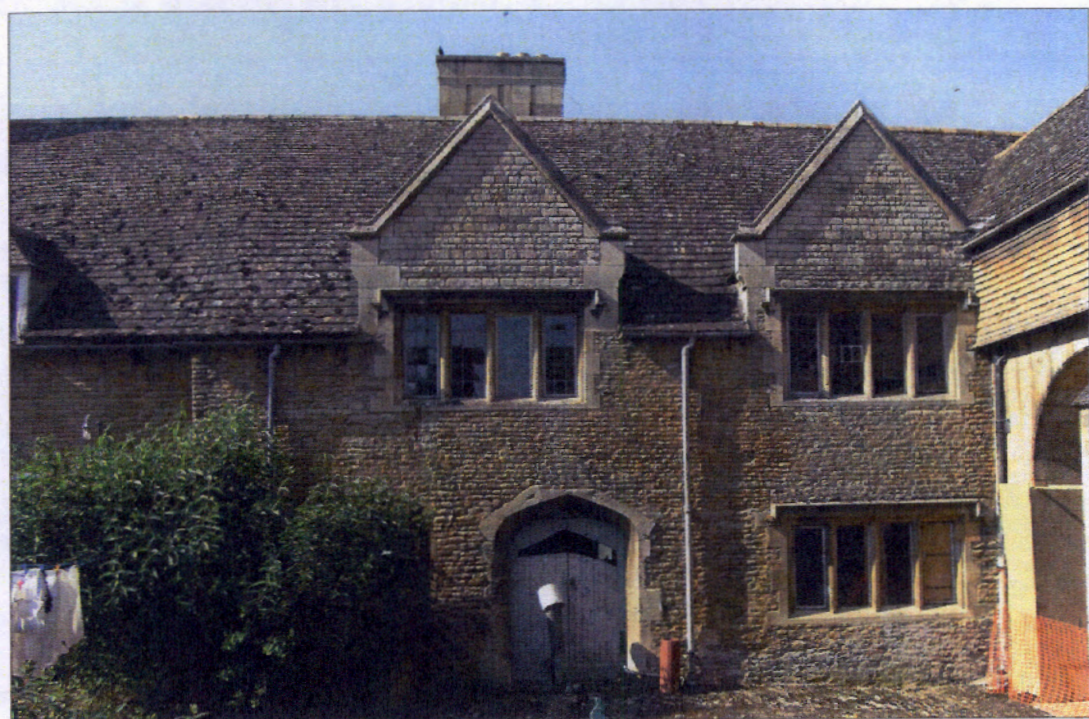
*Figure 7.54 The south front of the former Brewhouse, as rebuilt by Blomfield.*

Brewhouse range was completely rebuilt or refaced by Blomfield (fig. 7.54). It has an ovolo-moulded four-light mullion window with hood mould and above two similar windows set into through-eaves gabled dormers lighting the new stair and bedroom. To the left is a stone chamfered doorway with a four-centred arch which may well be an original 18<sup>th</sup>-century doorway that appears to have been widened by the insertion of a chamfered block in the centre of its lintel. This doorway may have been widened to allow better access to the new boiler room and coke store.<sup>61</sup> The north front of the
