## CHAPTER 7: THE NORTH RANGE

### 1 Introduction

The north range constitutes the whole of the northern section of the house, comprising the ranges to the north sides of the main court, the service court and the back yard. The north façade (fig. 7.1) of this range faces onto Walnut Tree Court and contains the gate tower, which forms the main entrance to the house. This range was probably built in two phases for Guy Wolston in the second half of the 15<sup>th</sup> century. The Kitchen and the service range to the west probably formed part of the first phase of building and the remainder of the range was added when the house was expanded a few years later. The gardener's cottage beyond was added in the mid-18<sup>th</sup> century.

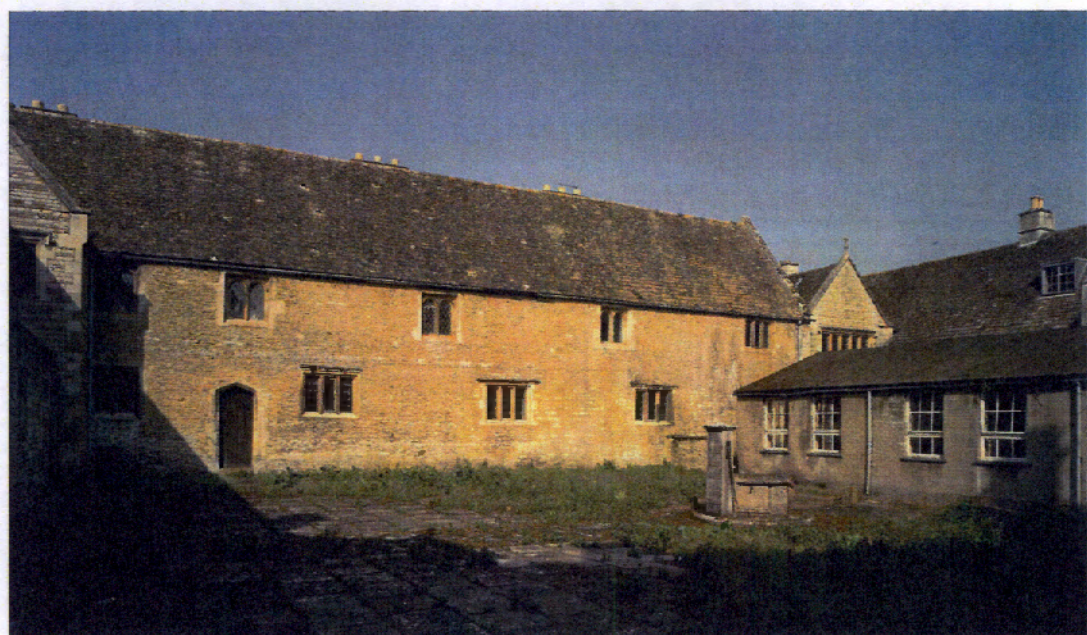
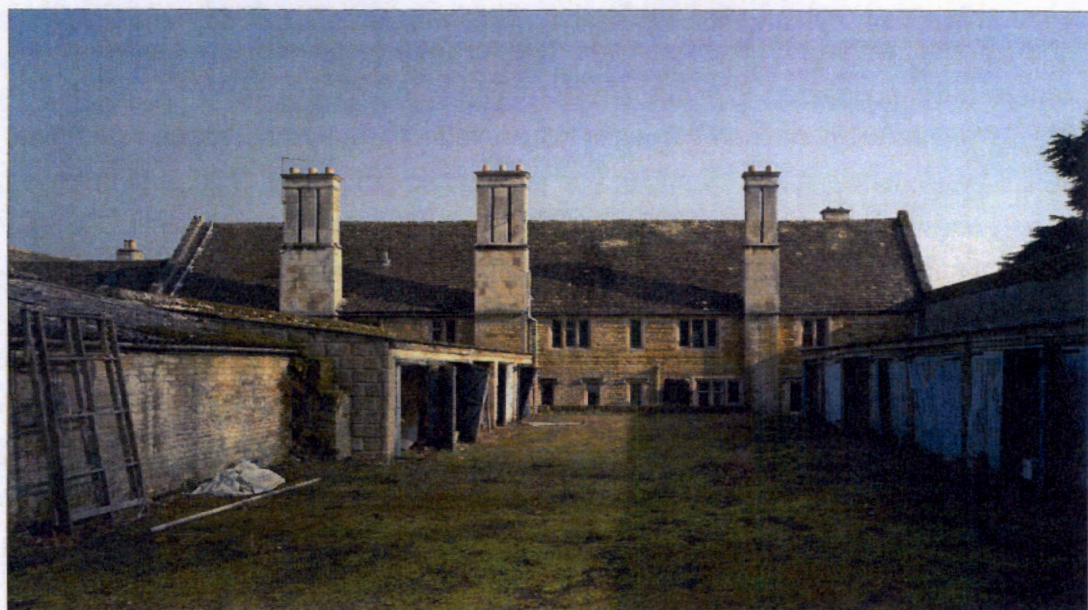
Figure 8.1 West Range, view from south-east, 2005.

This part of Apethorpe Hall is an unpretentious structure, with little architectural elaboration (figs 8.1 and 8.2). Standing two storeys high, it is built of rubble with ashlar dressings and has a pitched roof covered in Collyweston slate. The gables, to north and south (see fig. 11.1), have parapets and gabled finials. Early 20<sup>th</sup>-century photographs show that the south finial then carried a weathervane. While some original doorways and windows survive, most were replaced in later centuries. All but one of the chimney stacks date from the 20<sup>th</sup> century. Buttresses supporting the

Figure 8.2 West Range and Back Yard from west.

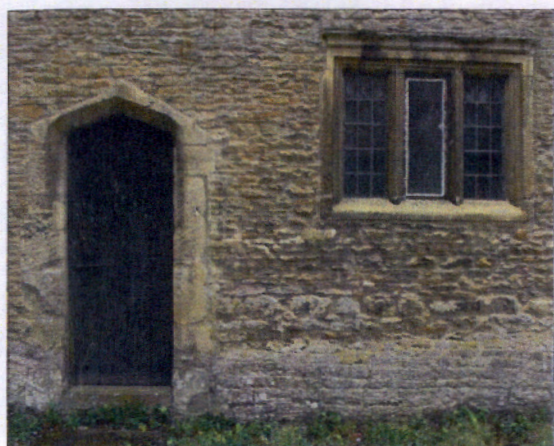
**Figure 8.3 Laundry doorway and window, detail.**  
*Kathryn Morrison 2005*

Original features of the building include one doorway (fig. 8.3), located on the east elevation. In 1858 this opened into the wash-house. It has a four-centred head and a continuous broad chamfer with pyramid stops.

first-floor windows on the east elevation (see fig. 8.1) are of this type, as is the two-light ground-floor window immediately south of the former wash-house doorway (fig. 8.3). These seem to be *in situ* and give a good idea of the character of the medieval building. A single-light window of similar design, set in the south gable (see fig. 11.1), is absent from a photograph of 1909.<sup>8</sup> Despite having modern brick reveals, it may be a genuine 15<sup>th</sup>- or 16<sup>th</sup>-century window, possibly reset from another part of the house.
