## No. 24

### Feature:

Doorway

**Diana Sutherland, 'Apethorpe Hall, Geological Report  
on the Stonework', Report for English Heritage,  
February 2006**

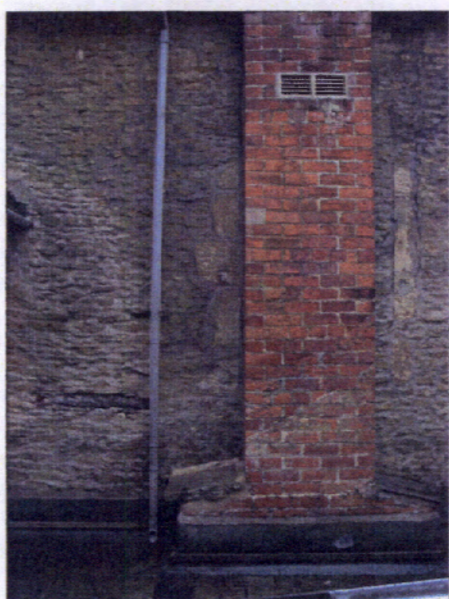
Figure 24.1

The existence of a feature in this position was indicated by two vertical lines of stone quoins, to either side of a brick stack, on the exterior face of this wall (fig 24.1). To the east of this, at sill level, a piece of timber is set horizontally into the wall facing.

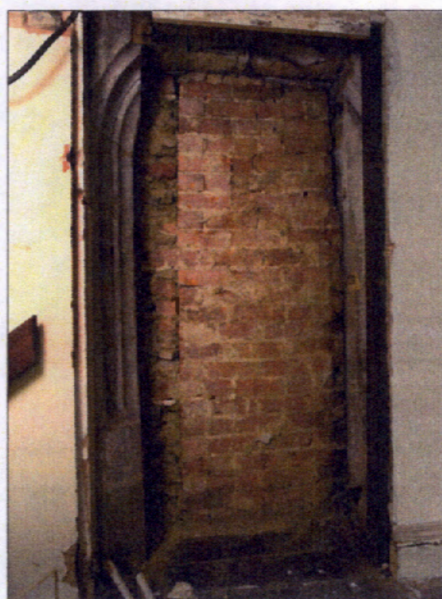
Figure 24.2

The removal of modern plaster from the interior of the Old Great Chamber revealed a damaged late medieval stone doorway, with a four-centred head (cut to make the opening square-headed) and continuously moulded surround (figs 24.2, 24.3 and 24.4). The moulding comprises: a shallow hollow chamfer, a fillet, a deep hollow chamfer, a fillet and a shallow hollow chamfer. This has very simple horizontal stops to east and west. In terms of its construction, it is interesting to note that the doorway has an extremely thin keystone. The aperture is blocked with red brick (measuring: 0.23m x 0.115m x 0.07m).

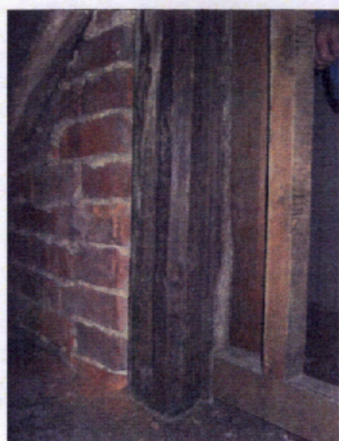
Figure 25.1

At ground-floor level the form of the north newel post can be seen within an under-stairs closet, where it was never concealed by boxing (fig 25.1). This same newel rises through the staircase for its full height, and can be glimpsed once again above the 19th-century boxing, under the attic landing (fig 25.2). The corners of the newel are chamfered and the centre of each face hollowed, with a cyma (or ogee) moulding to either side of the hollow.

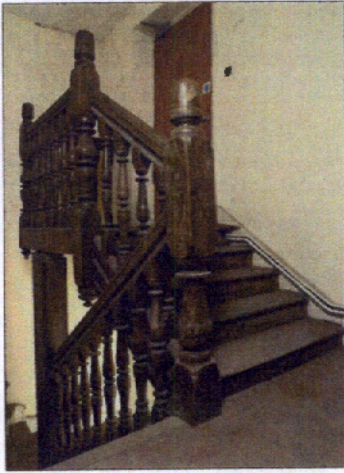
*Figure 25.3*

The complete form of the south newel, complete with acorn finial, can be seen at attic level (fig 25.3). At first-floor level the newel has been boxed in. Removal of the capping has revealed the sawn-off base of the acorn finial (fig 25.4).

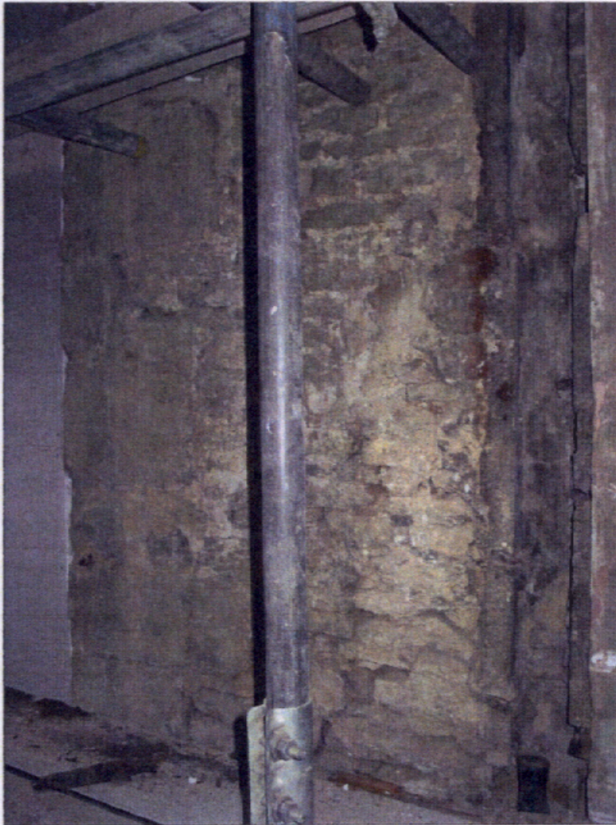
*Figure 26.1*

The north-west corner of H2.11 can be seen from the east end of the Orangery passage, at first-floor level. The west wall is of rubble, including the gable, and is neatly quoined to the north (fig 26.1).

This feature suggests that this block did not continue westwards, but ended at this point. It is worth noting that the west wall is aligned with the former 'garden wall' which ran along the west side of the hall range.

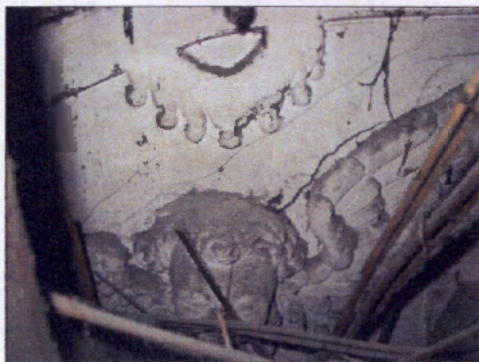
Figure 27.2

The north and south ends of the frieze are curved, where they would have abutted covings on the long walls of the Drawing Room. The frieze comprises a backdrop of strapwork, against which a series of motifs are symmetrically arranged. These motifs comprise: a cherub (fig 27.2, underneath the curved end of the frieze), a rusticated pilaster (fig 27.3), a grotesque head (fig 27.4), a rusticated pilaster, a grotesque head, a rusticated pilaster and a cherub (once again, underneath the curved end of the frieze). The strapwork (fig 27.5) includes foliate volutes and plain scrolls. The pilasters have moulded caps, directly under the surviving ceiling.

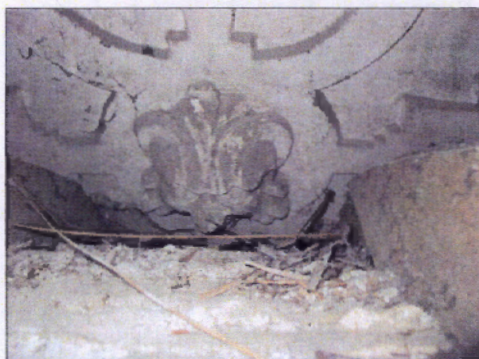
Figure 27.4

A decorated plasterwork frieze and associated ceiling (figs 27.1 to 27.7) survives along the top of the east wall of S2.02, the Drawing Room, behind the coving of the existing ceiling of 1622-24. This frieze was revealed by the lifting of the gypsum plaster floors of the attic rooms, prior to carrying out conservation work on the ceilings below (see: A.J. Goode, *Report of the Inspection of Gypsum Plaster Floors, Apethorpe Hall, Northamptonshire*, nd (2005)). The frieze is difficult to view and photograph, as it is below deep joists (fig 27.1).

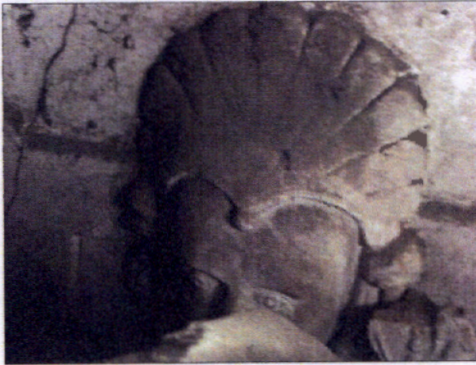
Figure 28.1

A decorated plasterwork frieze survives on the west wall of the Great Chamber, behind the cove. It can be glimpsed through the laths of the coving which runs along the entire length of the north wall of the room (fig 28.1).

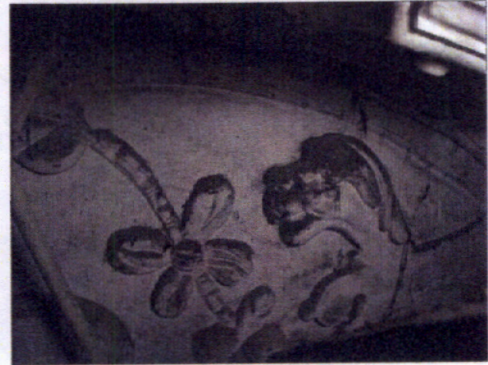
Figure 28.2

This frieze is decorated with a human head, volutes (one issuing an animal head), floral swags and strapwork (fig 28.2, 28.3 and 28.4). The ceiling above it is 0.45m deep.
