Church of St Edward and the Market Place, Leek, Staffordshire Geospatial Survey of Standing Medieval Crosses

Research Report Series 051-2016

Geospatial Survey of Standing Medieval Crosses

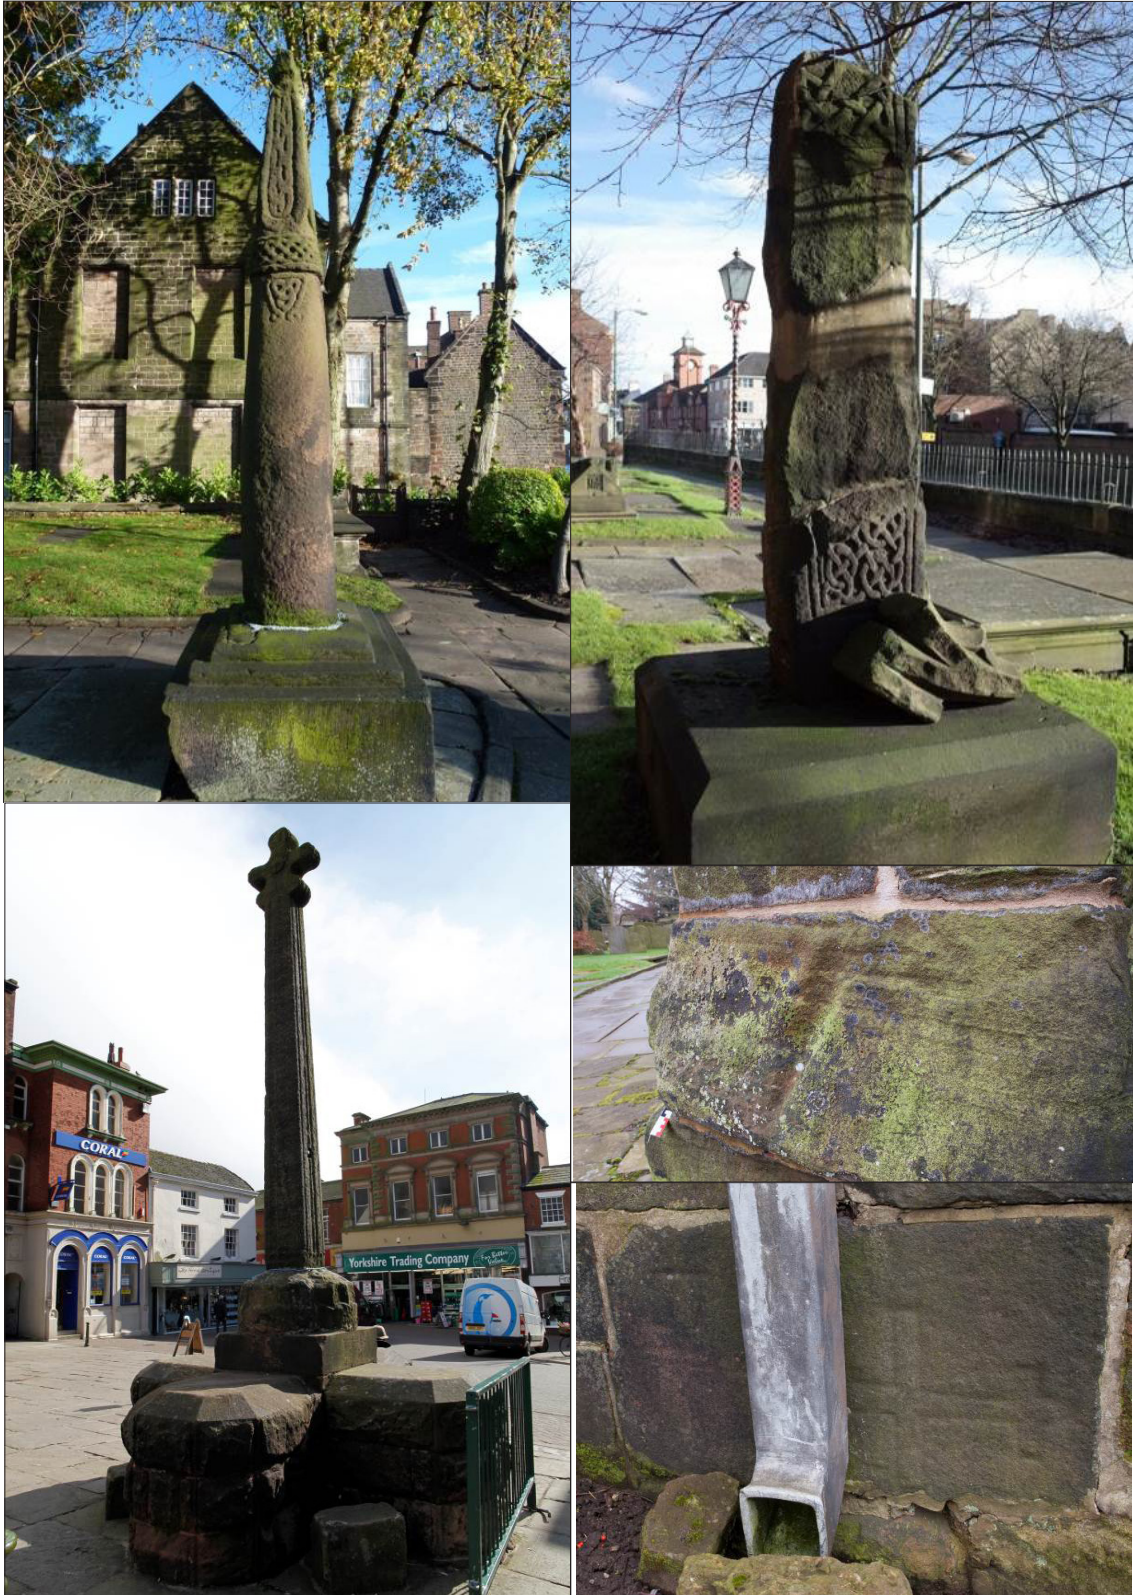
Figure 1: (Top left) Anglo-Saxon cross UID 1012656 with rounded shaft. (Top right) reconstructed Anglo-Saxon cross UID 1012657. The fragments at the base do not belong to the cross. (Bottom left) later medieval market cross in Leek marketplace. (Bottom right) arrow sharpening grooves and a Norman grave cover from the exterior walls of St Edward's church. Images not to scale.

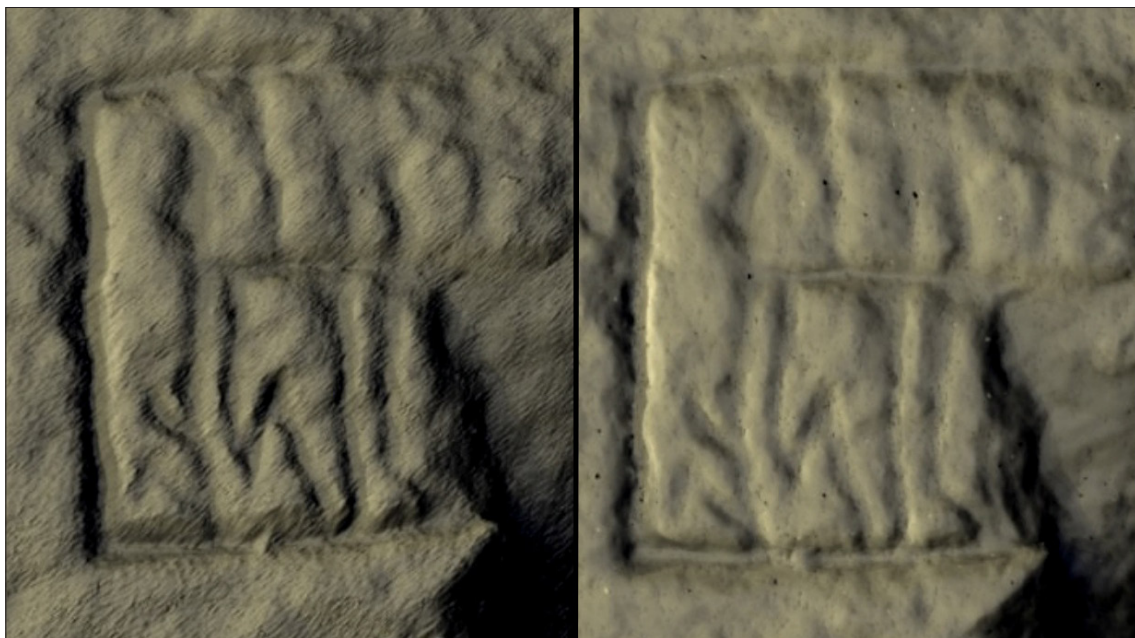
Figure 5: Virtual raking light from the left side of both PTM images. Left: PTM image from laser scan data. Right: PTM image from SfM photogrammetry. Note how the depths of the shadows are greater from the laser scan data, and the better clarity of several of the lower line of runes, although striping features across the surface. The symbol on the bottom left looks substantially different between the datasets.

From visual analysis of the PTM files alone, it is clear that the clarity of the runes varies depending on the angle of raking light from both datasets. When the light is positioned to the left side, the inscription looks more deeply incised on the laser scan model, as deeper and darker shadows are cast over its surface (figure 5). However, raking light from above the carvings defines the runes better in the photogrammetric model, as the stippled and grainy surface of the laser scan model appears more noisy, making them more difficult to discern (figure 6).

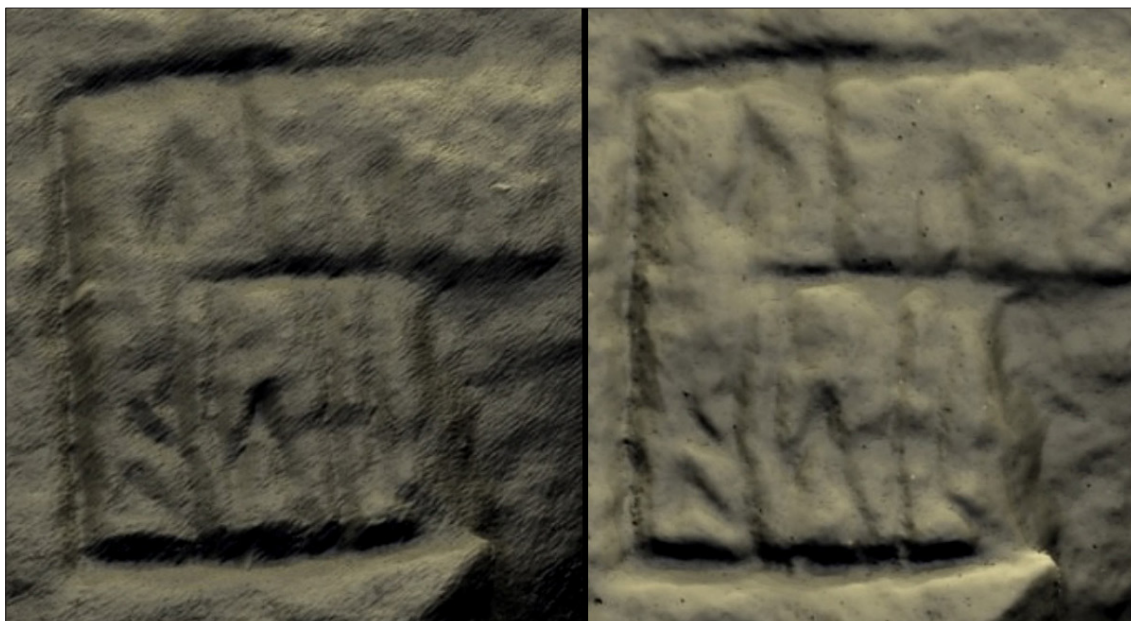
Figure 6: Virtual raking light from above both PTM images. Left: PTM image from laser scan data. Right: PTM image from SFM photogrammetry. Note how the grainy texture of the laser scan model, affected by striping, makes it difficult to see detail in the top row of runes in comparison with the SFM image.

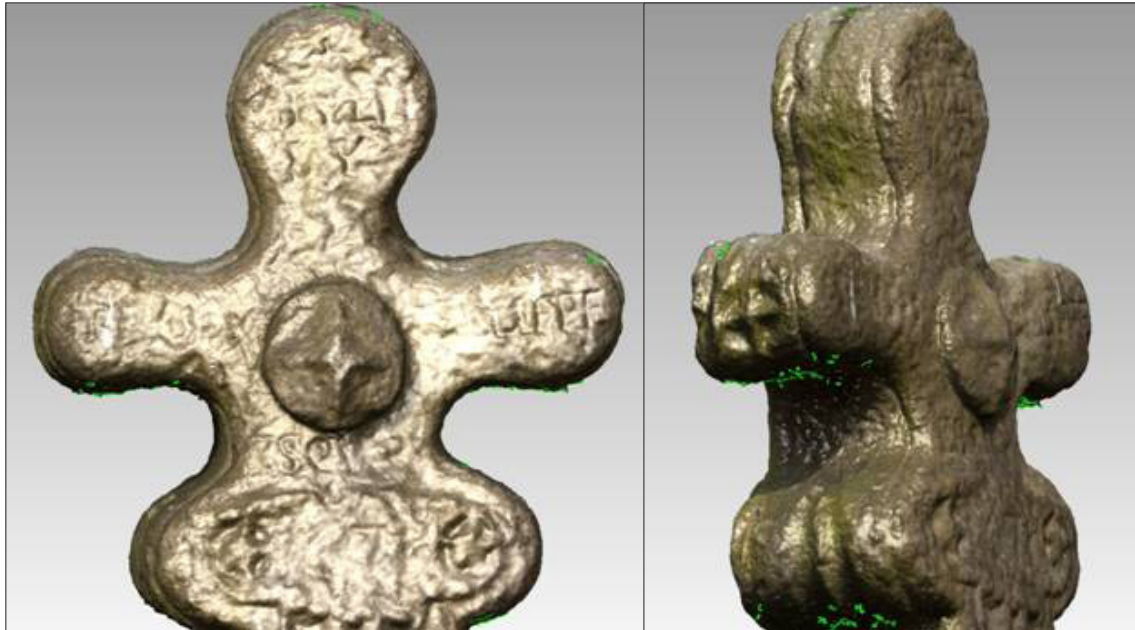
Figure 10: (Left) south-facing side of the market cross head, viewed in Geomagic with virtual lighting to highlight the engravings and carved decorations on the cross arms. (Right) the left side cross arm features an engraved cross encased in a circle, on its end. The green areas indicate gaps in the mesh, where 3D data was missing.

The motif of a wheeled cross is carved on the ends of the horizontal cross arms, the centre of both faces of the cross, and on either side of an oval collar below the cross head, suggesting these were original decorations. It is possible that two concentric circles and a star-like motif on the northern face could be original features, however, the substantial erosion on both faces makes this difficult to confirm without closer

On the southern face of the cross, several inscriptions are present; on the top cross arm are some ambiguous uppercase letters. The right arm features an inscription that appears to read 'CLIFFE', but the weathered condition of the cross makes it difficult to determine if any preceding letters exist. Directly below the central cross-in-circle are more Latin letters, potentially reading 'E S e'. It is possible that the oval-shaped collar below the cross head contained a date, between the two wheeled-cross decorations, but weathering has obscured this and it is not visible on the 3D model.

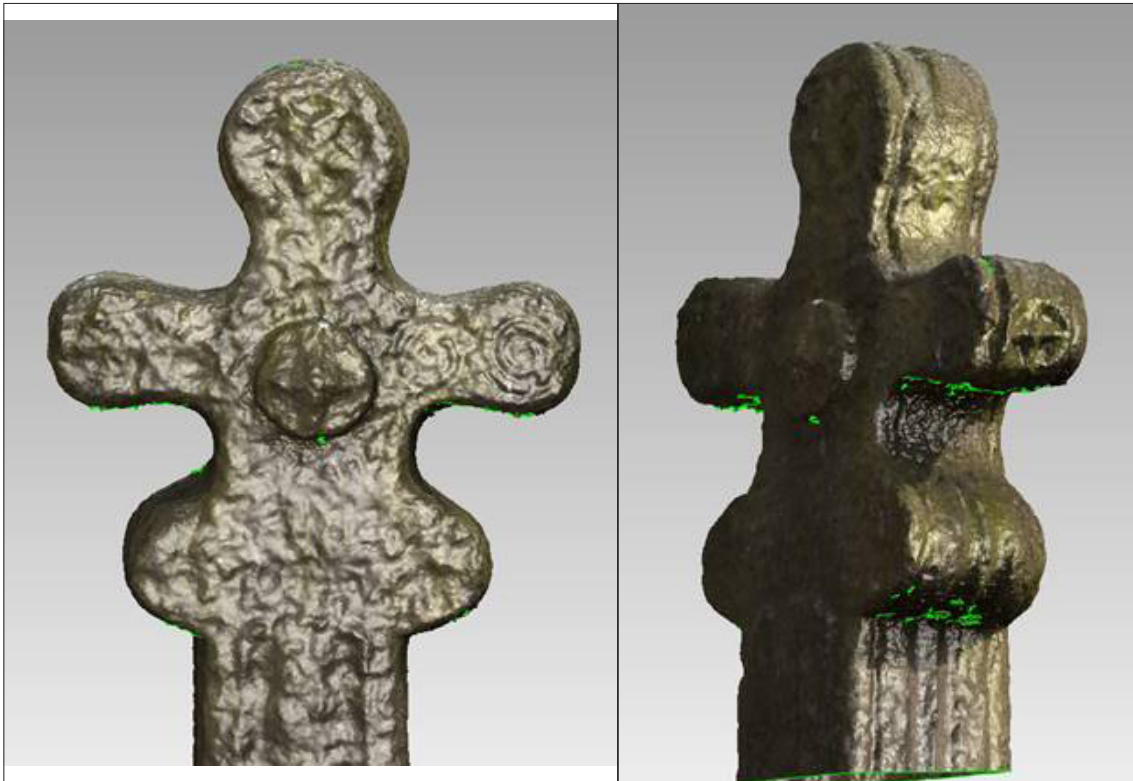
Figure 11: (Left) north-facing side of the market cross head, in Geomagic. Note the two concentric circles on the right cross arm, and the star-like motif on the upper cross arm. (Right) an engraved cross within a circle mirrors a similar decoration on the other horizontal cross arm, potentially suggesting these decorations were carved at the same time.

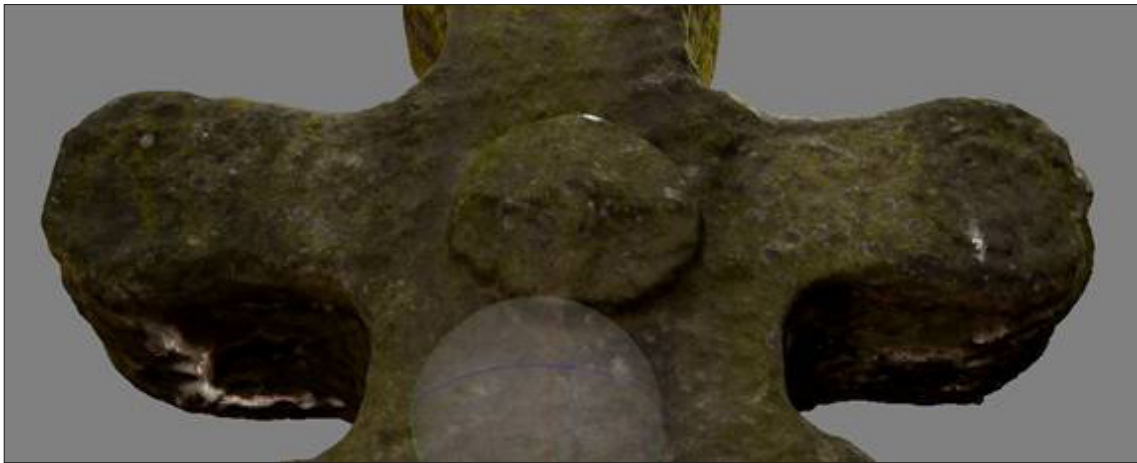
Figure 13: SFM model of the market cross. Note the uneven texture of the undersides of the cross arms, and also a rather pixelated area on the right cross arm, from a lack of photos and high resolution imagery.

Similar conditions persisted when the photography of this cross taken from the telescopic mast, although the use of the shutter-priority setting allowed sharp images to be taken. Whilst this was highly beneficial, a compromise had to be made in using this setting rather than aperture-priority, in that the photography taken from height was slightly less sharp than that taken from ground level, although it was not out of focus. Despite this problem, the resulting 3D meshes and textures were of an even quality throughout, apart from the undersides of the cross arms (figure 13). This however, was to be expected in the SFM processing, as little of the photography was able to capture these difficult to reach areas.
