## 9. THE LATER 19TH CENTURY AND EARLY 20TH CENTURY

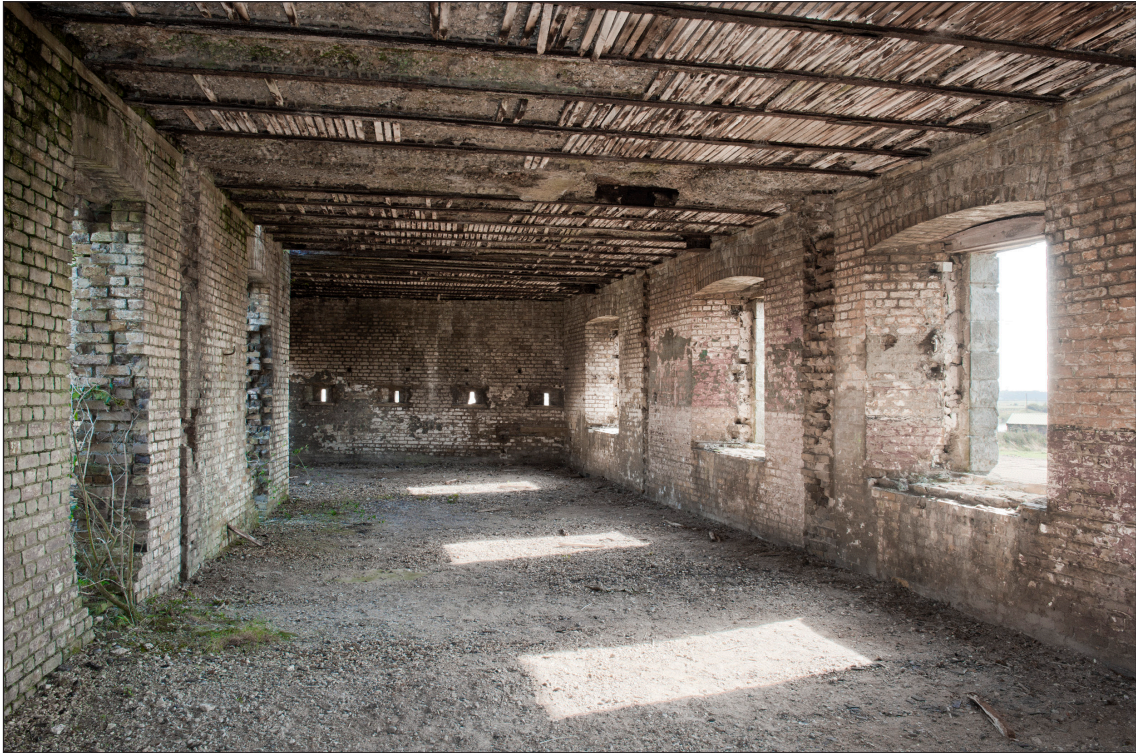
*Figure 39: The space formerly occupied by the Bar, NCOs' Room and Tap Room, looking east. (DP097515)*

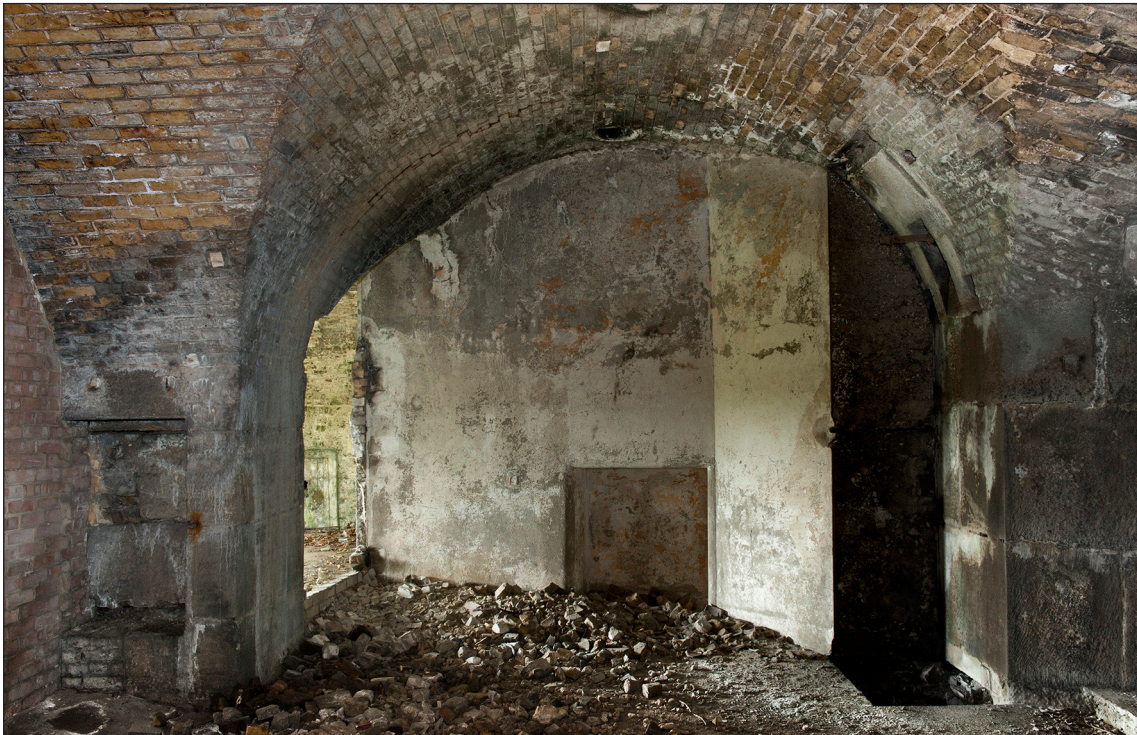
*Figure 41: View from Casemate 2 west into Casemate 3 where the gun position has been filled with a concrete traverse and an ammunition recess created. (DP097588)*

Each redundant gun position was filled with concrete but its associated living casemate was left open. Modifications to the bombproof roof were difficult to identify due to vegetation growth and deterioration of the surface and it is not clear whether the concrete was poured through specially created holes in the vault or barrowed in from the interior of the fort. Tip lines and shuttering marks are visible in the concrete exposed by removing the timber boxing from the ammunition lifts in casemates 2, 6 and 8. To compensate for the loss of floor space around each gun the opportunity was taken to provide recesses for ready-use ammunition. These are incorporated into the traverse in the flanks of each gun position with the surrounding walls rendered and whitewashed. In Casemate 8 the speaking tube has been relocated and now rises up against the position of the ammunition hoist cover.

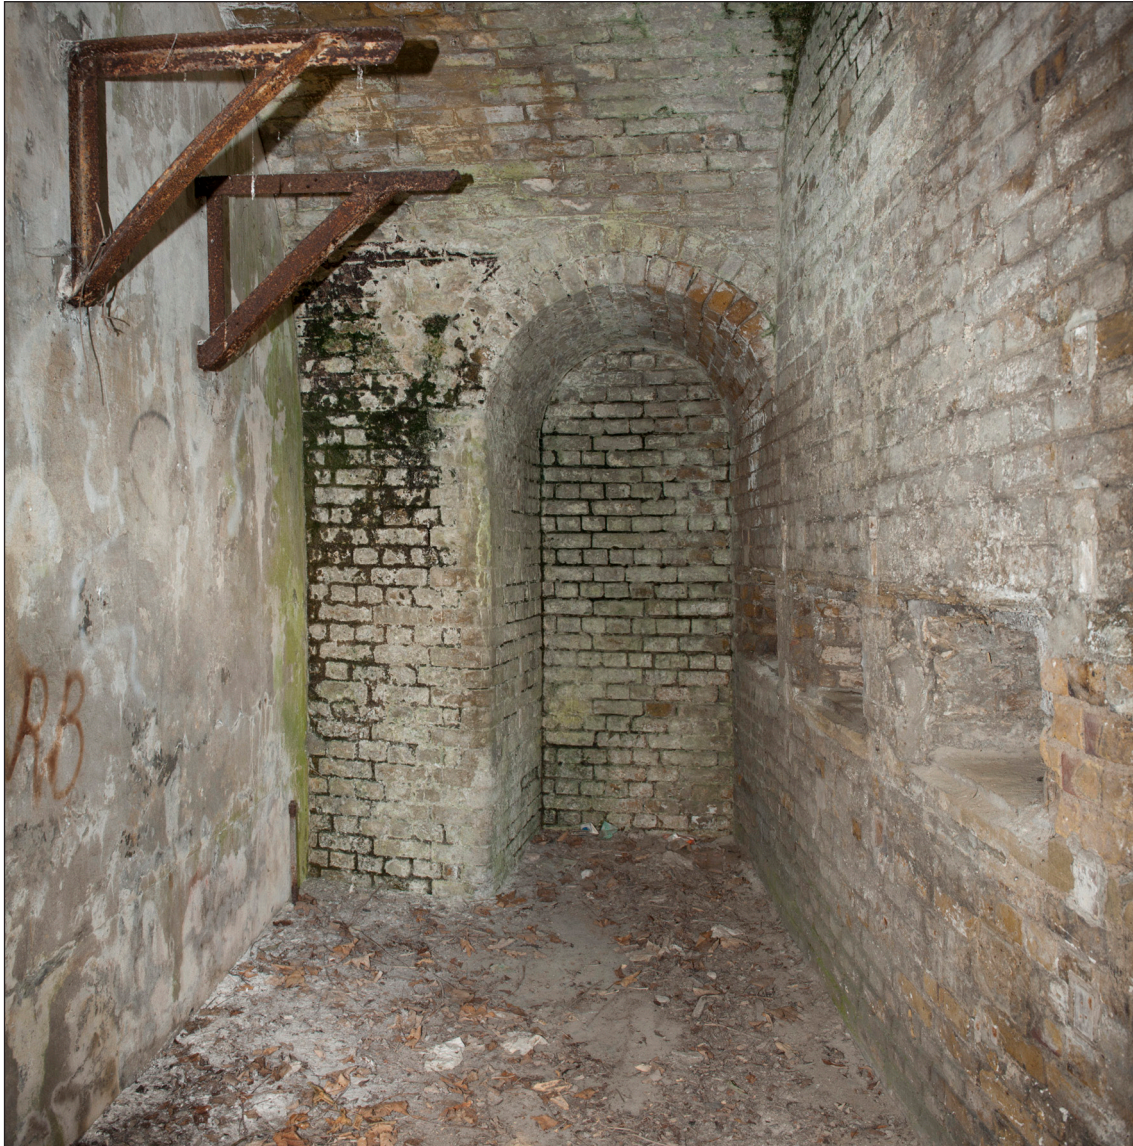
*Figure 42: The south-east corner of Casemate 1. To retain access to the loopholes in the bastion wall on the right-hand side of the picture this corner of the casemate was not filled with concrete when the rest of the position was converted to a traverse. The smooth concrete wall of the traverse is on the left-hand side (the brackets are later additions). (DP097610)*

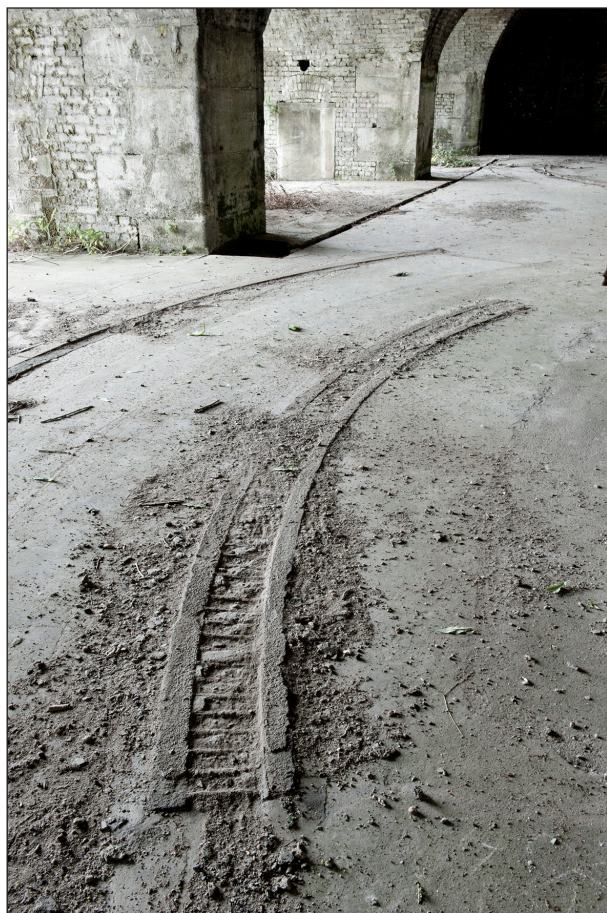
*Figure 43: The cogged racer rail in Casemate 12 suggesting that alterations were made to the carriages in this casemate. (DP097629)*

embedded in granite sets date from the original construction of the fort and the mounting of the 11-inch RMLs. The inner racer of this phase is 11.5 cm wide and positioned 2.4m from the face of the gun shield. A cement-filled channel (presumably where a racer rail has been removed) in an arc of granite sets set at 4.04m from the shield face is witness to the position of the outer racer. Cracks in the concrete floor show where this racer would have extended into Casemate 9 before it was infilled. This set of racers was replaced with rails embedded in concrete. The 6.5cm wide wrought-iron inner racer of this set is closer to the shield, at 1.31m from the inner face. Its associated outer racer is set at 3.79m from the shield face in a channel, 30cm wide, which has been cut out of the concrete leaving a formed edge on one side.

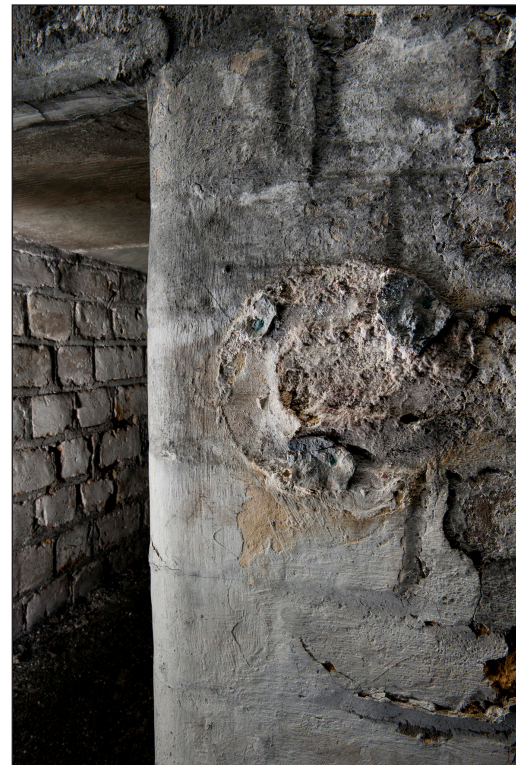
*Figure 44: Lightbox to No 13 Cartridge Store showing the position of a copper number plate. (DP097434).*

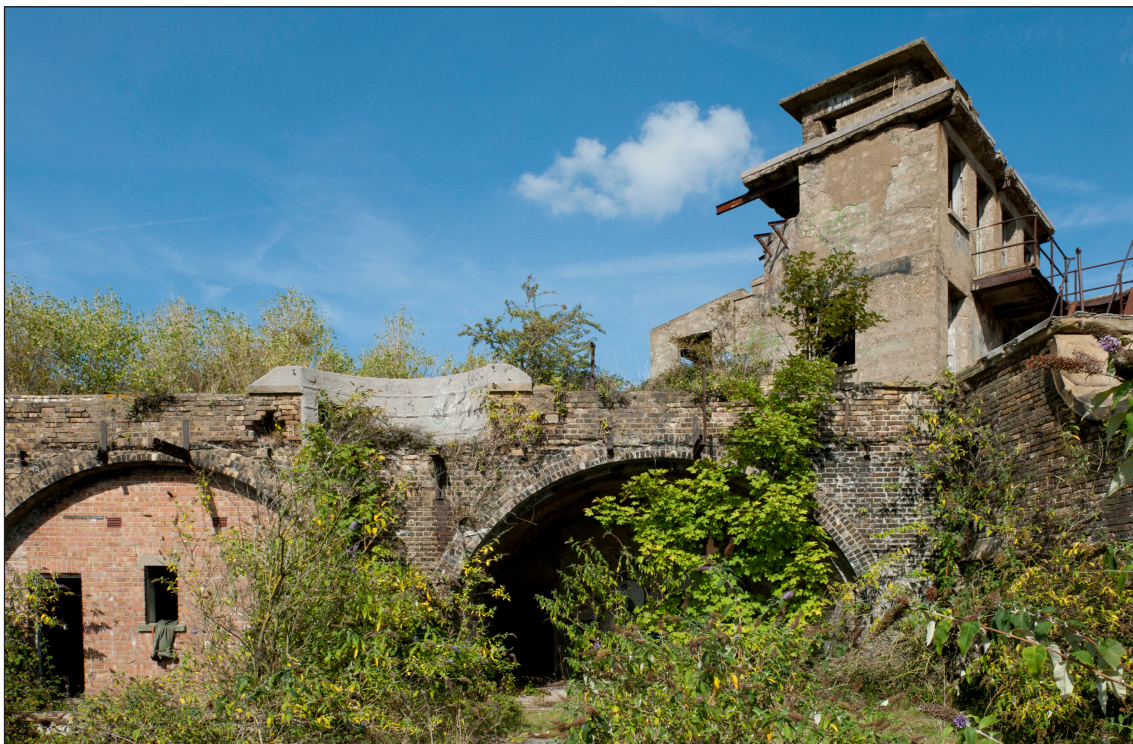
*Figure 45: Exterior of Casemates 2 and 3 showing the semi-circular recess for the DRF position and the stanchions for its associated walkway set in the parapet wall above the casemates. The circa 1913 Battery Observation Post can be seen above. (DP 097568)*

The three DRF positions are located at the inner edge of the roof of the casemated battery and were served by a metal walkway (labelled balcony on the 1899 plan) that ran below the parapet. Each position is different, with a semi-circular parapet to the northern position, above casemates 2 and 3 (Fig 45 and 54), a rectangular parapet to the central one above Casemate 7 and a V-shaped parapet to the southern one which is located above Casemate 15 adjacent to the end wall of the open battery. The 1899 plan shows that all incorporated the standard centrally-placed pillar for the mounting of the DRF telescope. The recesses are very neatly inserted into the parapet. The surrounding brickwork in the relevant section of parapet has been taken down and rebuilt to form the corners of each recess. The recesses were neatly capped with a moulded-stone parapet but this is now incorporated into the base of a shallow barbette which has been covered in asphalt and blended into the casemate roof. There is no visible evidence for the DRF pillars.

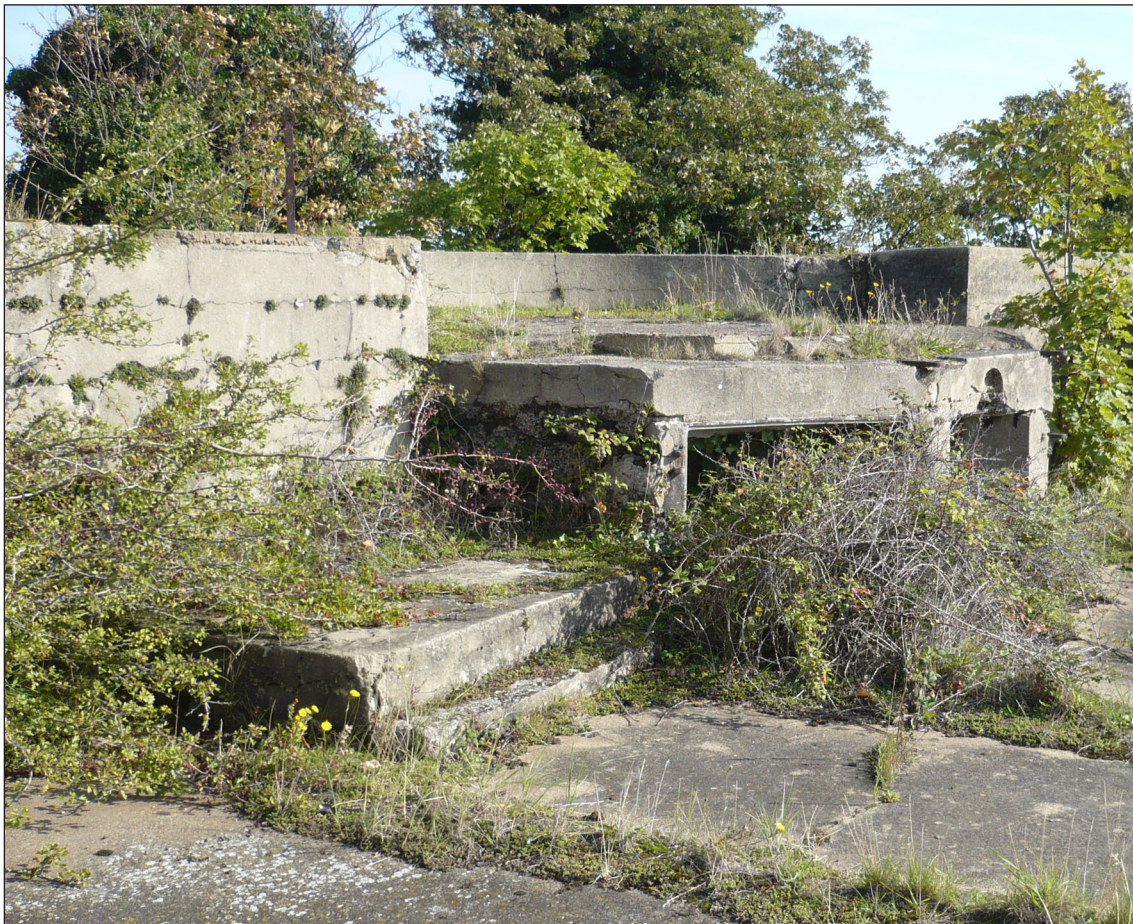
*Figure 46: Shallow steps protruding from one of the flank walls of the 12-pounder battery which may represent the remains of an earlier rooftop battery*  
© Historic England

Fragmentary evidence for an early rooftop battery possibly survives at Cliffe (App Fig 8). Two of the three gun positions were probably subsumed in the later 12-pounder QF positions at the south end of the roof above casemates 14 and 15. The third gun position may have been at the north end of the roof above Casemate 6, incorporated in the south flank wall of a later 12-pounder position. Projecting from this wall is a flat concrete slab with a single broad step down on to the roof which does not appear to be related to the 12-pounder battery and in form resembles the set of shallow steps found at the rear of the 6-pounder positions in the East Tilbury battery (Fig 46).

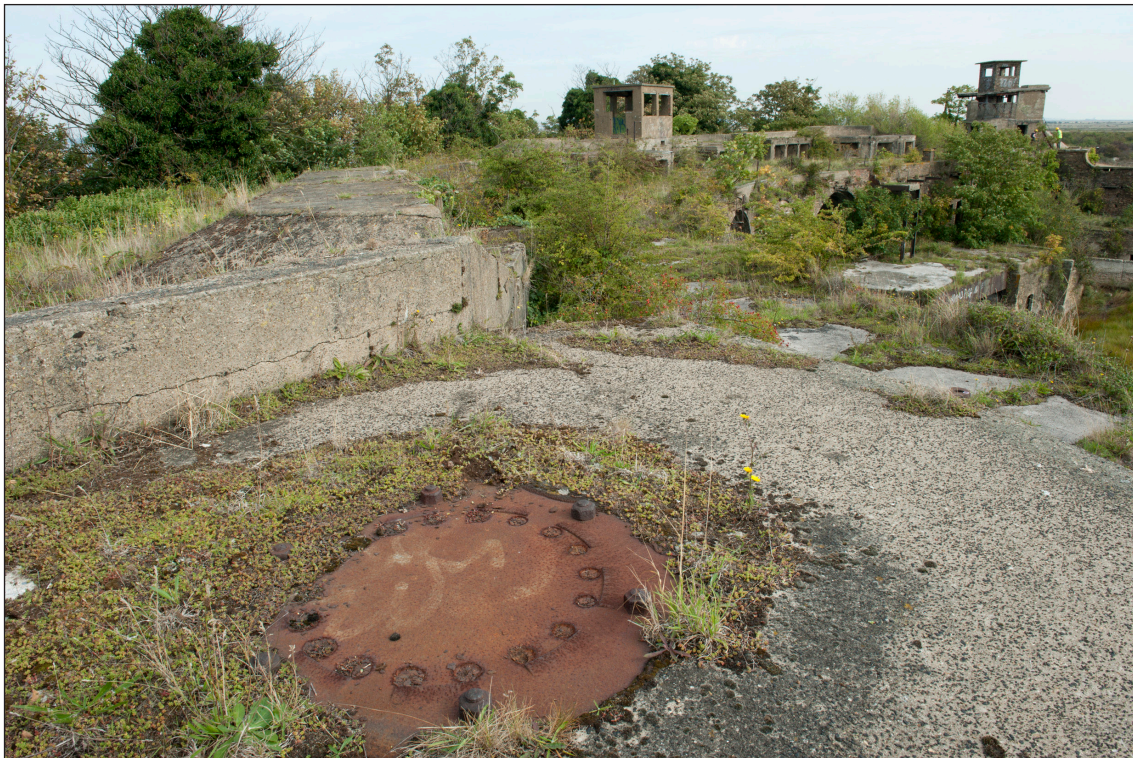
*Figure 47: View of the north end of the fort roof from the 12-pounder B group, with a holdfast for this weapon in the foreground. The hut in the centre of the photograph dates from the Second World War; beyond it are the 6-inch gun positions and the associated BOP tower. (DP097739)*

As built the holdfast consisted of a circular metal plate, fixed into the concrete platform with six large hexagonal securing bolts towards the outer edge set for a radius of 0.48m (1ft 7in). Within the ring of bolts is a circle of raised flanges and within them nine pairs of holes. The plate was placed centrally in the polygonal gun floor and was the standard pattern of holdfast for the small calibres of QF guns (Lowry 1995, 94). This arrangement is shown on the 1899 plan (TNA: WO78/4963; App Fig 3) but only No 1 position (to the north) in the B group survives in its original form (Fig 47; App Fig 8). The other two surviving emplacements exhibit an array of adaptor plates and additional bolts that relate to later mountings. In common with all examples of this type of emplacement, all have the metal fittings for a removable protective rail around the rear face.

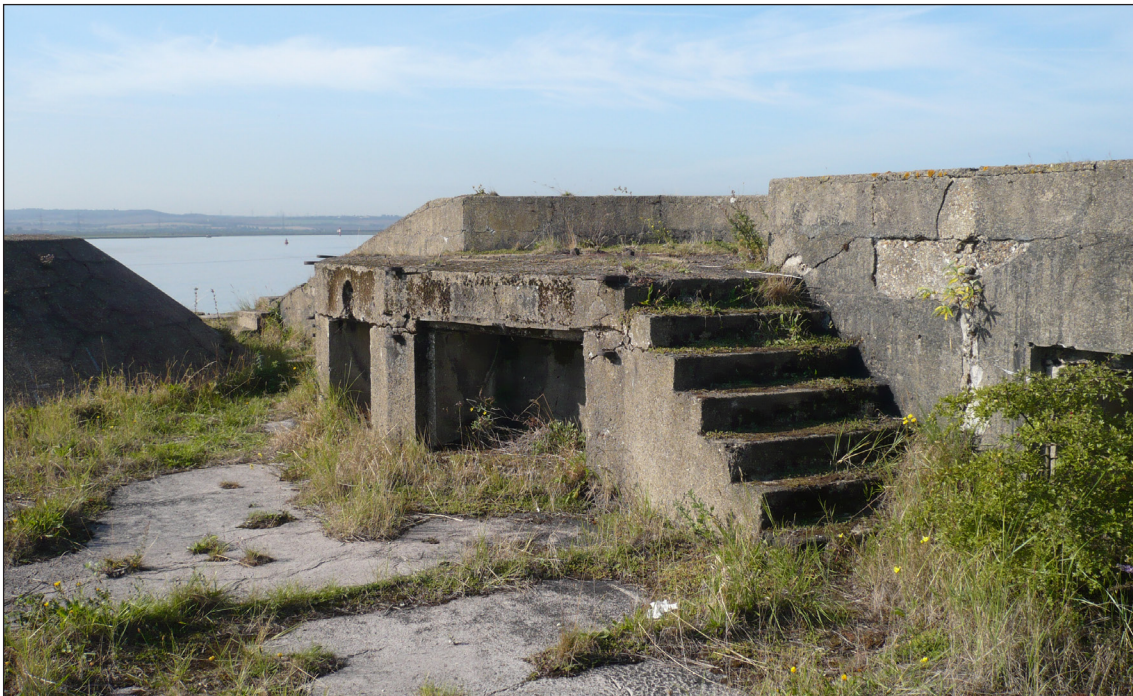
*Figure 48: The most southerly of the surviving 12-pounder gun emplacements with ammunition lockers, steps to the gun floor and metal brackets for the guard rail visible at the rear of the emplacement. © Historic England*

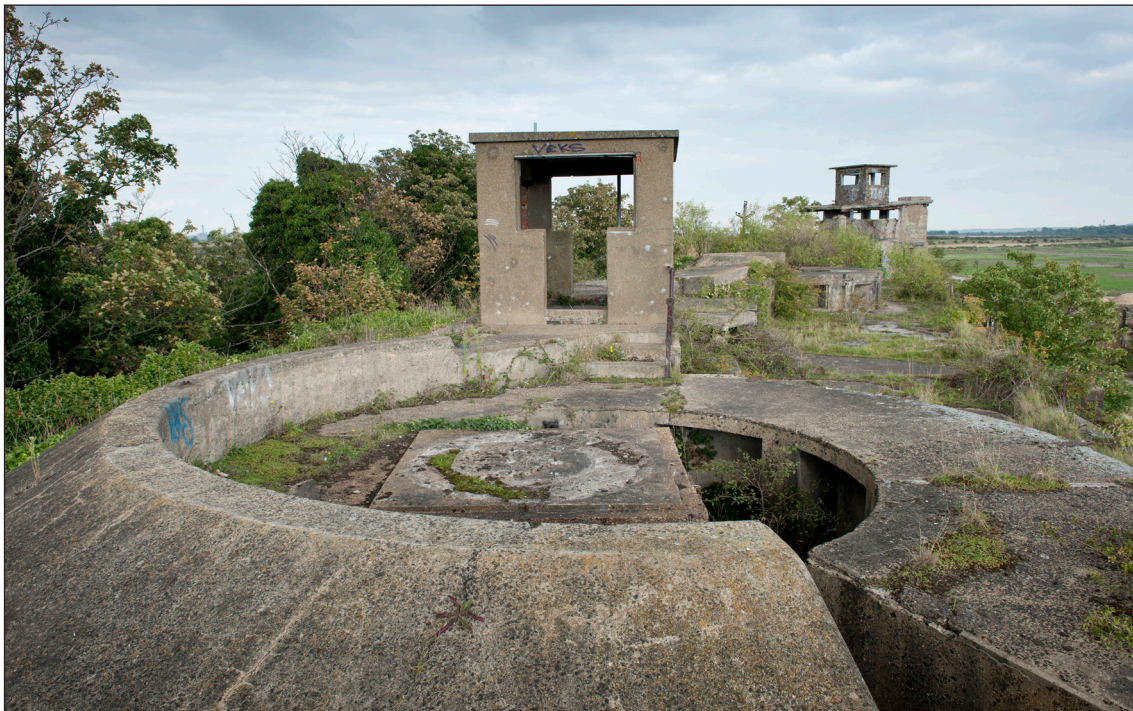
*Figure 51: The western barbette of the 6-inch gun emplacements, the large concrete block (for mounting a Second World War 6-pounder gun) cast in the original gun pit can be seen in the centre of the photograph. (DP097671)*

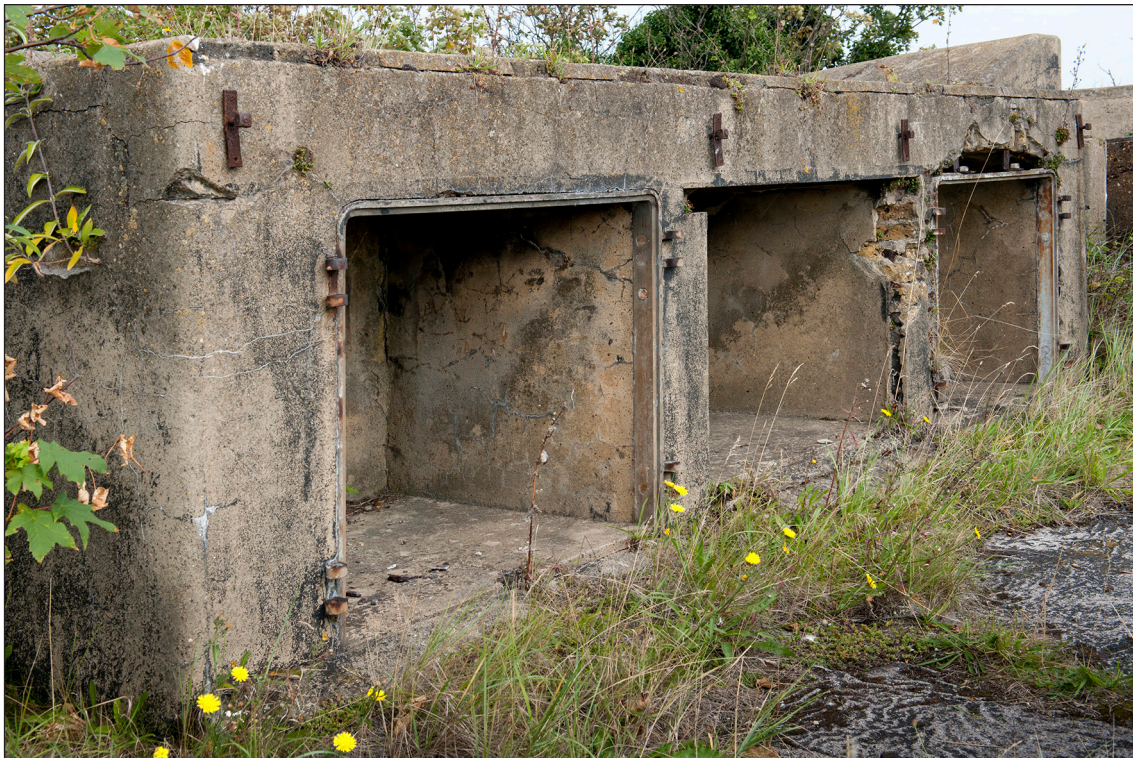
*Figure 52: Ammunition lockers associated with the western 6-inch gun position. Hinges for doors on the two flanking cartridge lockers are visible as well as bolts that carried a rain hood above all three lockers. (DP097746)*

recesses for the storage of cartridges and shells. Gun position 1 has five lockers in the outward/working floor face and four in the pit face. The external lockers measure 0.9m high, 0.9m deep and 1.07m wide and all have rebates for a metal frame and a pair of pintle hinges at each side for mounting doors. This is usually evidence for cartridge storage but the 1913 plan (Fig 50) clearly labels two of the recesses for shell storage. The design of 6-inch positions at Landguard (which is thought to conform to the generic plan for these positions) was provided with a large number of cartridge recesses and a single shell recess in the wing wall (Brown et al 2004, 48). This recess is present in the wing wall to the east of gun position 1 but is equipped as a cartridge recess and labelled on the plan as such. As is conventional for these positions, a row of large bolts above the lockers indicates the position of a galvanised hood for suspending a waterproof curtain over the ready-use lockers (Fig 52). The hood is indicated on the section in the 1913 drawing with the notation 'expanded metal'. The remains of two bulkhead light fittings can be seen above the lockers along with a junction box and the course of a connecting metal conduit indicated by a pronounced mortar line.

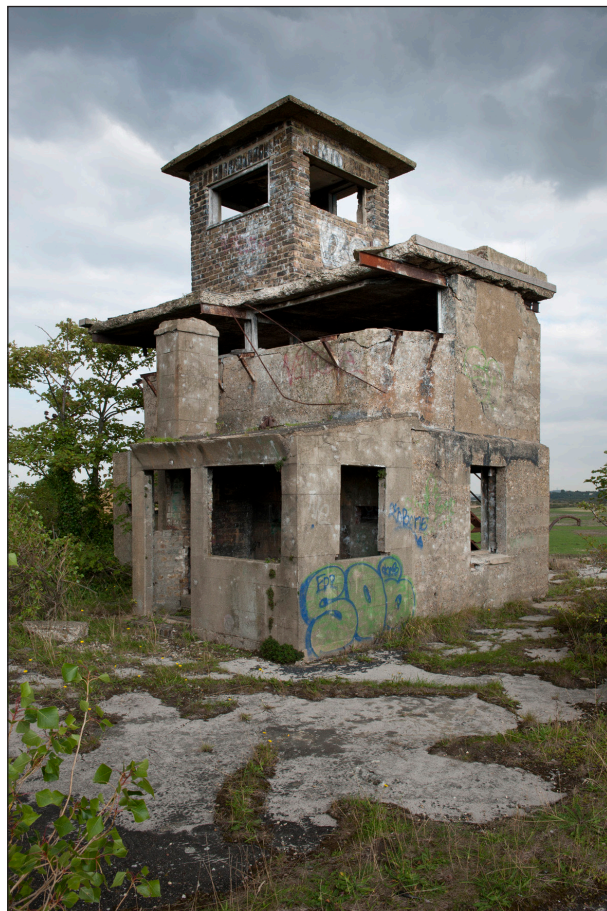
*Figure 53: The Battery Observation Position looking east. The chimney stack of the projecting single-storey structure obscures the view from the observation slits. The hut on the roof dates from the Second World War. (DP097671)*

The combined BOP and ELD at Cliffe is built on the north-east end of the roof above Casemate 1 and adjacent to gun position 1 of the 6-inch battery (Fig 53; App Fig 8). It is orientated to face west with views across the Thames to Coalhouse point. Unlike the Landguard (Brown et al 2004, 48), Heugh

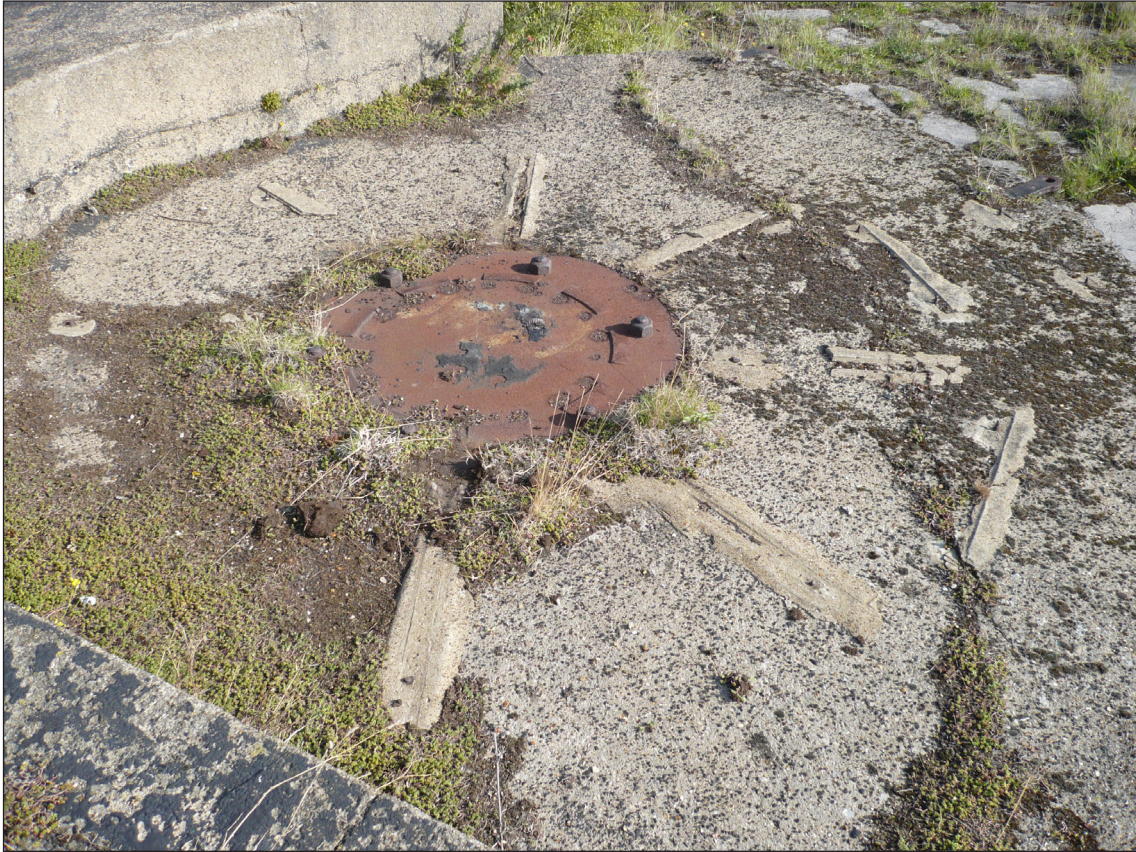
*Figure 57: Most southerly 12-pounder emplacement with possible evidence of adaptation at a later date. (DP097777)*

Evidence in the former B group of 12-pounder gun positions, above casemates 10 through 14, suggests that these gun positions were also reused. The southern-most of the two emplacements has the same holdfast plate which has been drilled with two extra holes at the very eastern edge and is covered over with a layer of bitumen which may be part of the very new coat of black paint covering the 6-inch barbette and the parapet that can be seen on the 1941 British Pathe newsreel. A series of 7 or possibly 8 radiating cement scars are visible beyond the holdfast plate. Each scar has a stud at each end and a witness mark for a batten or plate suggesting that it may have supported a platform around the gun. Two pairs of similar scars beyond the holdfast to the east may relate in some way to the firing angle of the gun (Fig 57).

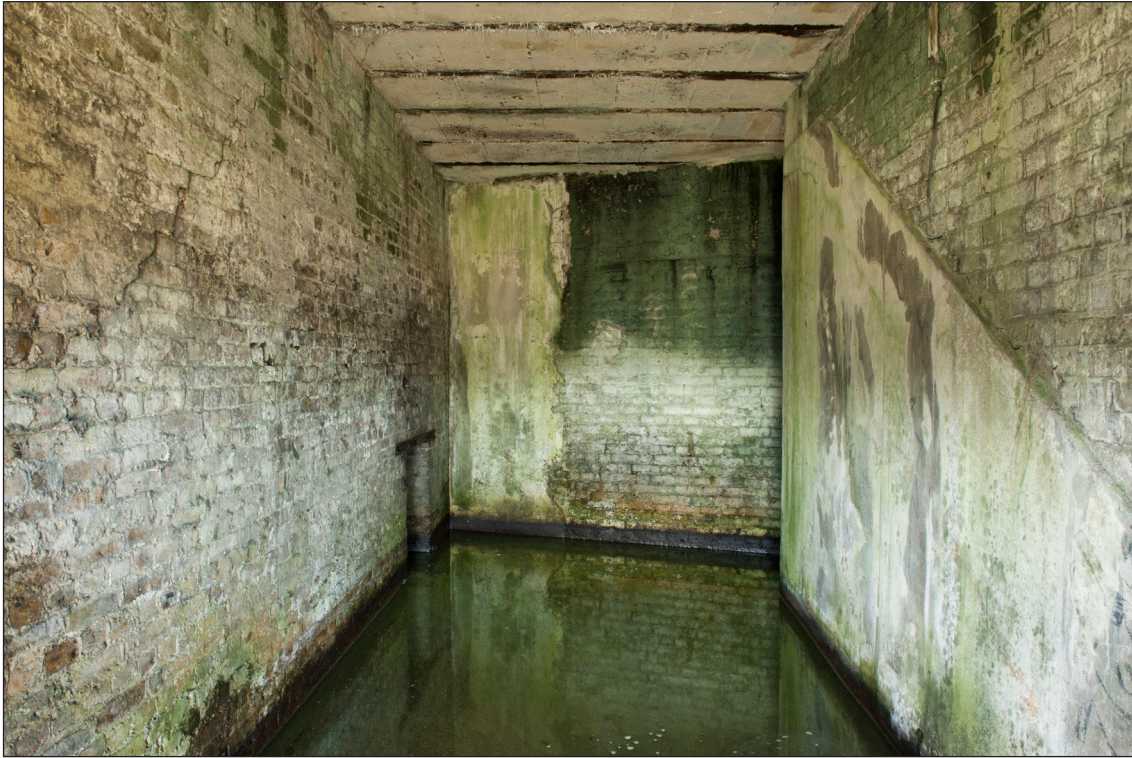
*Figure 63: The interior of the coal store with the coal hatch at the base of the left hand wall and the render on the right hand wall marking the line of the original traverse. (DP097545)*

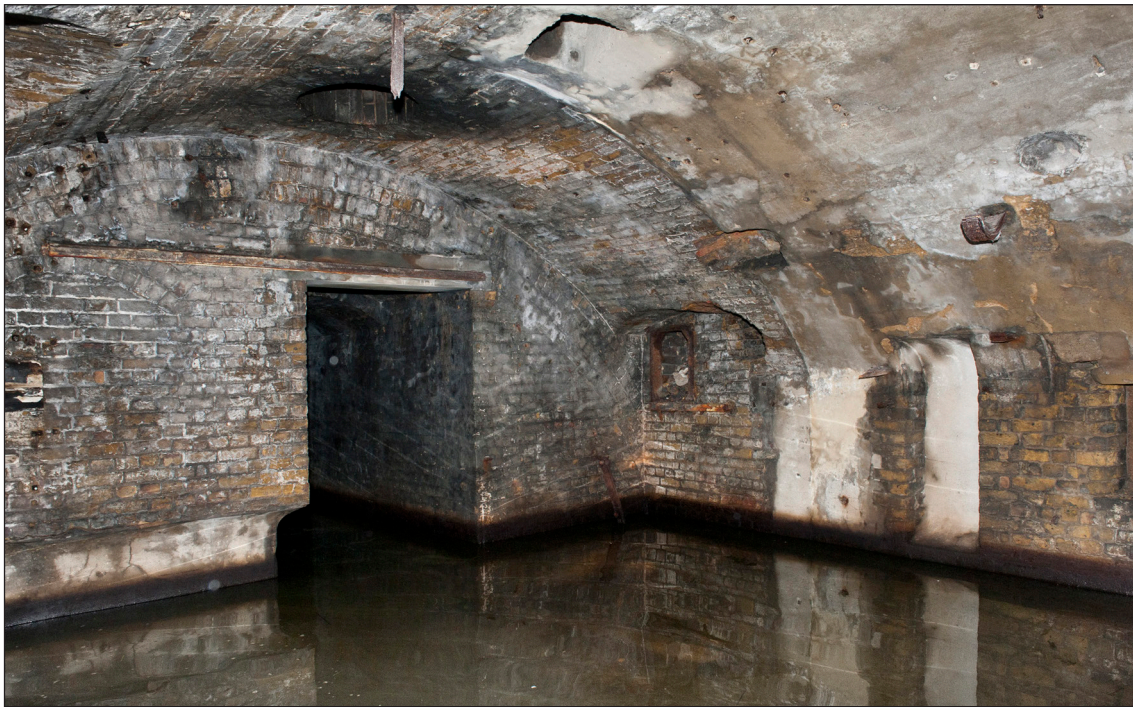
*Figure 64: The interior of the Engine Room looking west. The entrance to the Torpedo Store is in the centre of the frame and to its left is the segmental head for the entrance to the caponier. In the vault, and surrounded by light coloured concrete, is the shaft pierced for the driving wire to the north slipway. The projecting iron strap is possibly a support for a pulley wheel. The deep recess at the foot of the wall on the left marks the course of the sea water supply pipes to the surface condenser. On the right the blocked arched headed opening for the shifting passage has a metal framed opening for a flue rodding point inserted in its centre. (DP097535)*

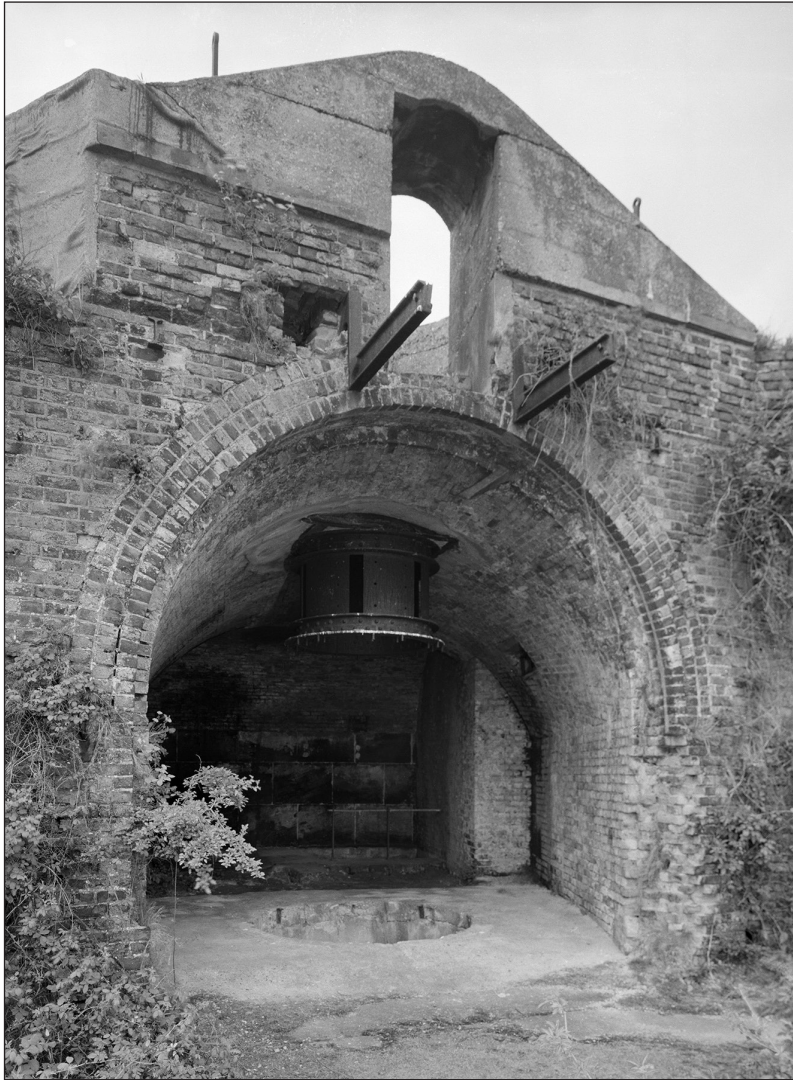
*Figure 66: The gable end of what was probably the original Brennan observation position above Casemate 15. The later concrete cone for the rising tower installation appears to have engulfed the earlier handrail stanchions. (bb93\_20789)*

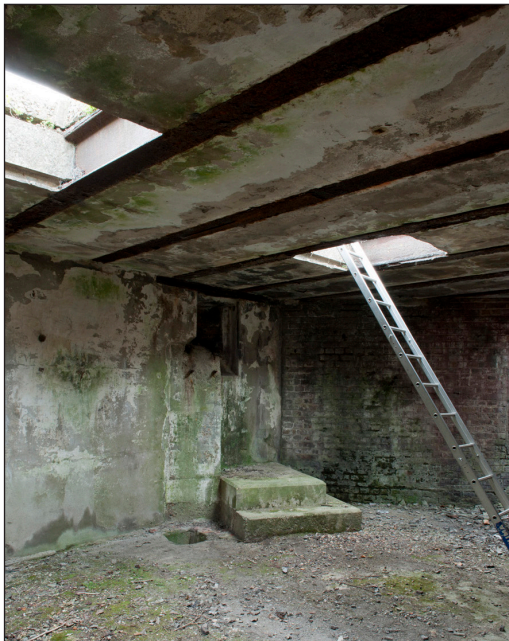
*Figure 67: The opening for the north slipway pulley beam in the concrete block that occupies the embrasure of the former northern open gun position. It is located just below the ceiling with the securing studs for a pulley and the shaft leading down to the Engine Room on its left side. On their right is the short flight of concrete steps for access to the pulley beam. (DP097783)*

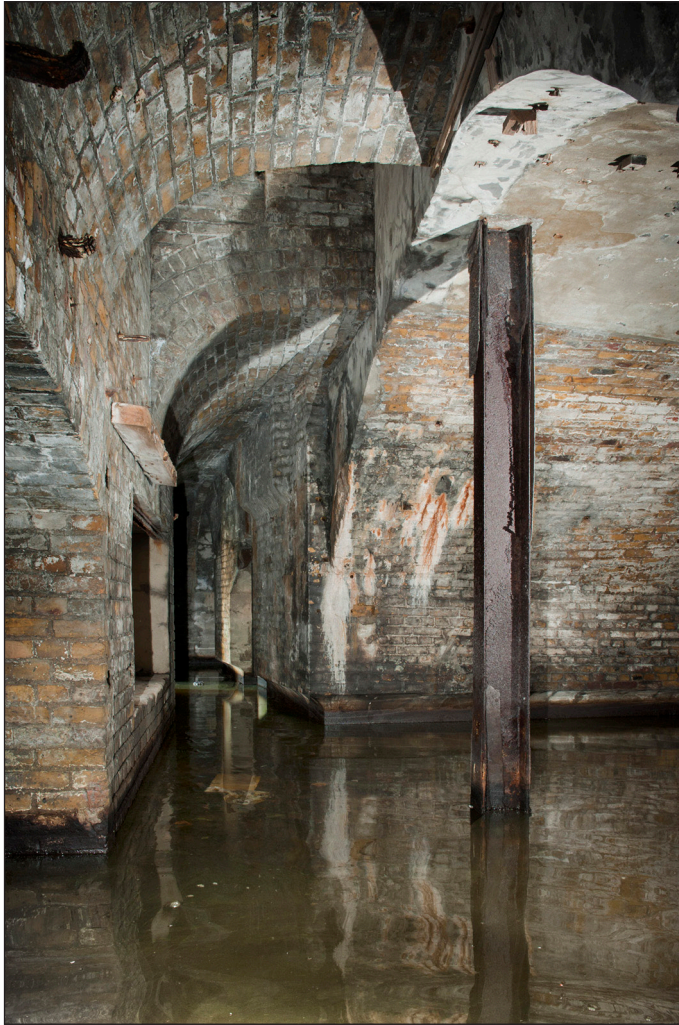
*Figure 68: The former lighting passage running at the rear of the Brennan Installation. The Engine Room is in the vaulted casement to the right with the later condenser tank and pumps in the adjacent casemate, the entrance to which is just visible at the end of the passage. The rectangular recess visible in the wall on the left side may be connected with the support for the engine steering beam. The manhole that opens into the former open gun emplacement above is in the cut out section of the lighting passage vault. (DP 097528)*

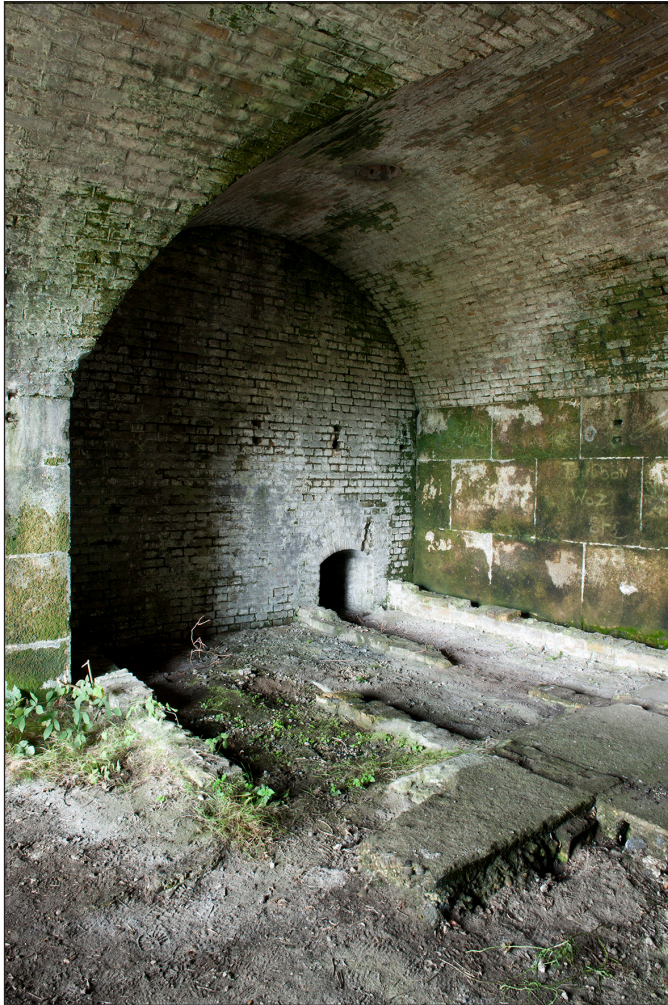
*Figure 69: The southern wall of Casemate 15 showing the low tunnel that may have been inserted to enable the installation of the machinery for the rising tower. (DP097642)*

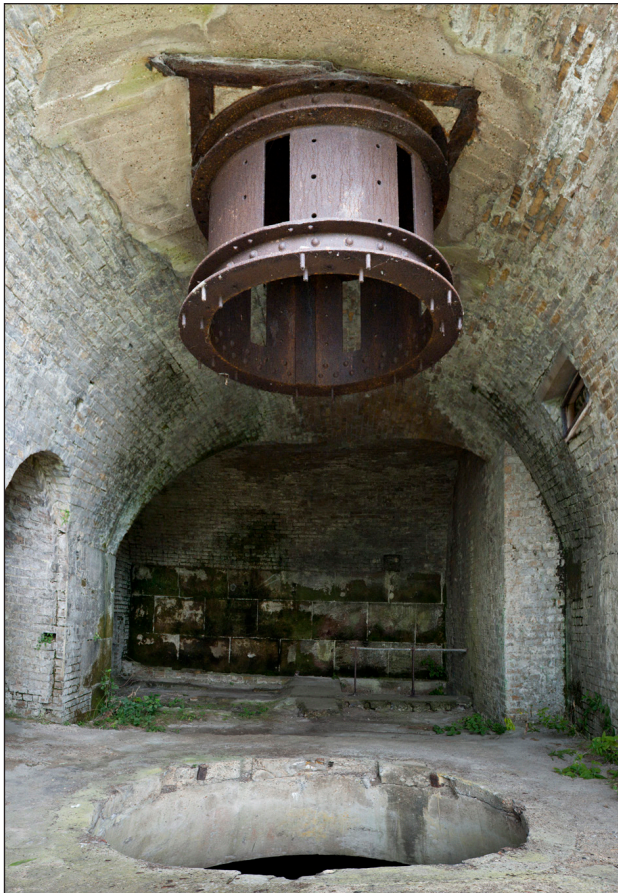
*Figure 70: The interior of Casemate 15 looking west with the iron collar for the rising tower set in the vault. The corresponding hole visible in the floor opens into the former lighting passage and casemate below. On the right hand side of the photograph is the corner of the brick wall inserted to support the 6-pounder gun battery on the roof. The arched doorway on the left hand side of the picture leads to the former open gun positions. (DP097638)*

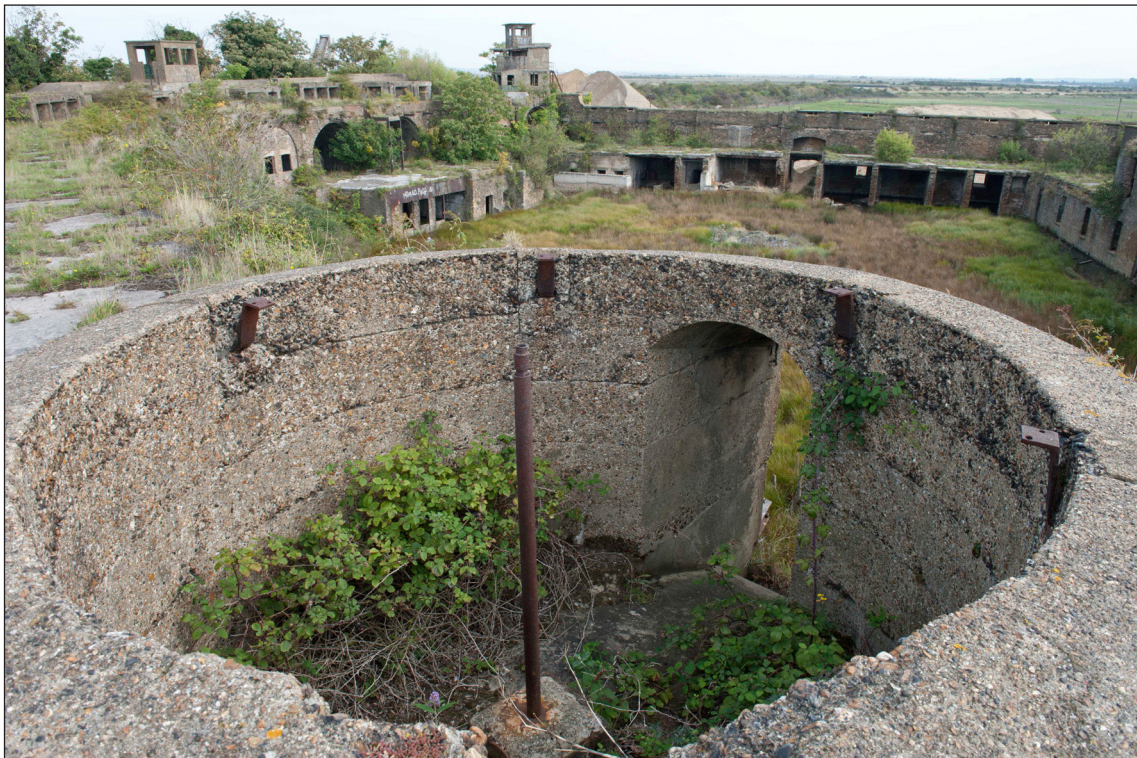
*Figure 71: The interior of the collar for the rising tower looking north. The horizontal marks in the sides of the cone mark successive pours of concrete. The steeply sloped ramp between the interior of the cone and the opening in the gable end of the earlier observation position can be seen on the right hand side of the picture. The rod set in the centre is thought to be a mounting for a Second World War light machine gun sitting on an inserted timber floor. (DP097558)*

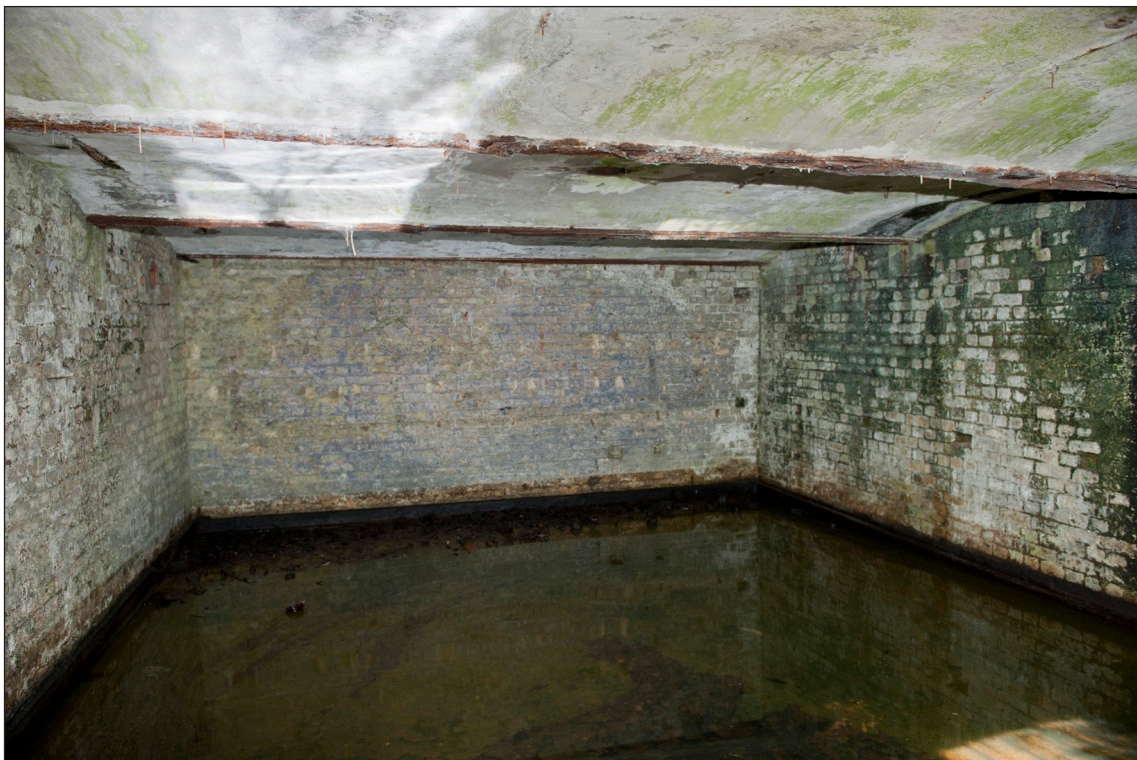
*Figure 72: The interior of the Test Room [72] showing the vaulted roof and the various marks on the walls showing the positions of the connection boards and benches. (DP 097565)*

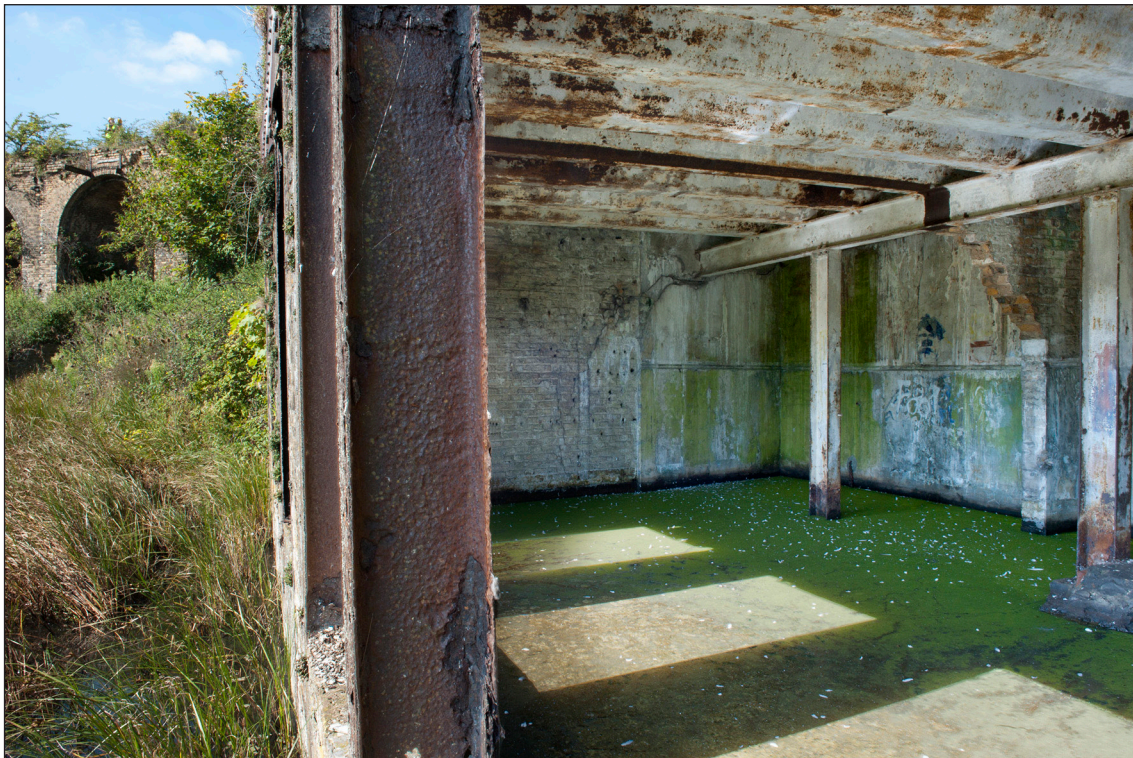
*Figure 73: The interior of the Engine and Dynamo House [70, 71]. The later (presumed Second World War) steel-beam and ribbed-section roof can be clearly seen. The black stripe running across the roof indicates the position of the former dividing wall between the Engine and Dynamo Rooms. The corner of the engine base can just be seen to the right of the picture. (DP 097558)*

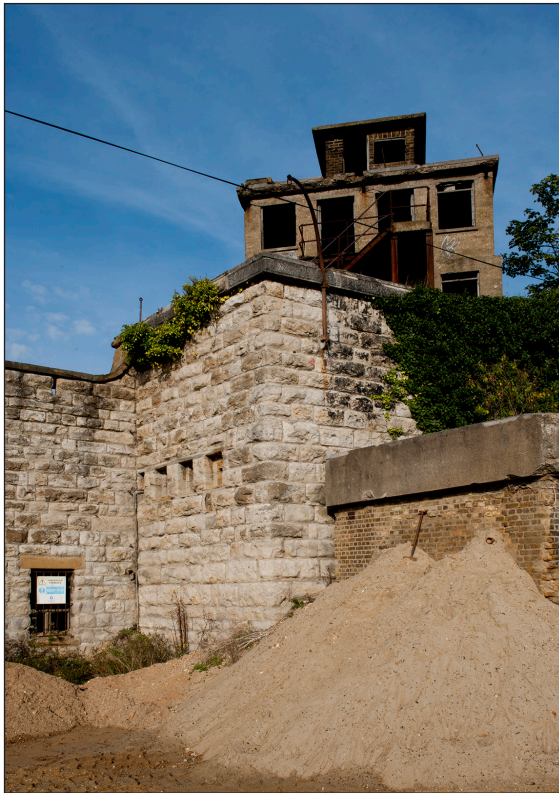
*Figure 74: The external oil store located outside the north-east bastion. (DP097698)*
