## 9. THE LATER 19TH CENTURY AND EARLY 20TH CENTURY

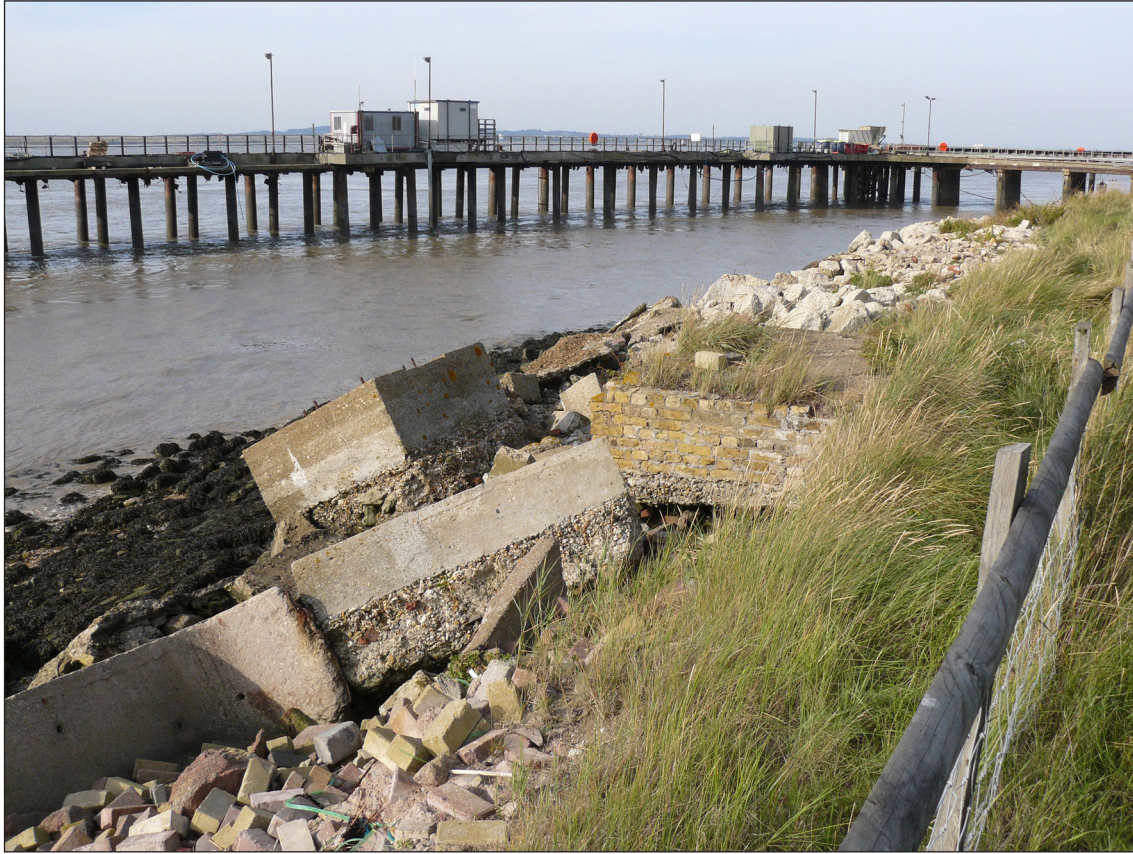
*Figure 75: The possible remains of either a brick-built Submarine Mining Observation Post or a fixed-beam searchlight position on the shoreline to the north of the fort. (DP 097726)*

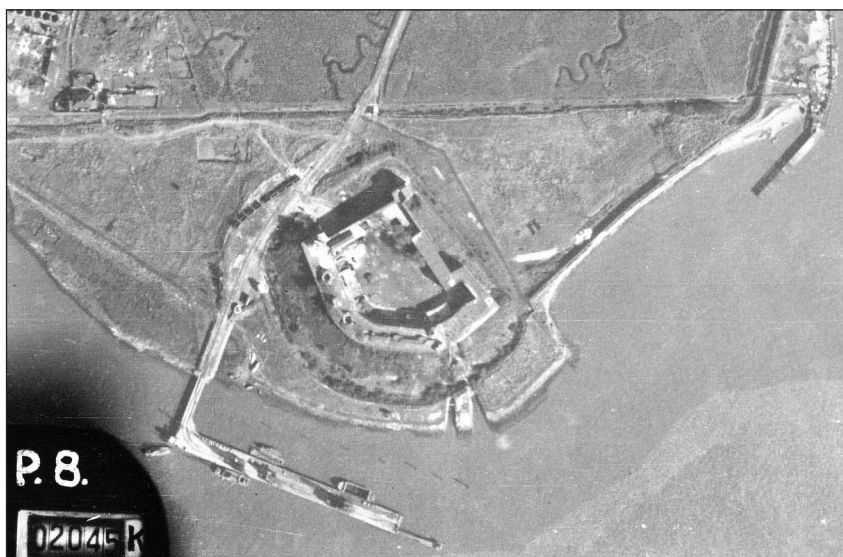
*Figure 76: Cliffe Fort on an extract from an aerial photograph taken in 1941. The areas with white highlights may indicate construction work. RAF 26/UK/1455 2045 14-March-1941 Historic England (HEA) RAF Photography*

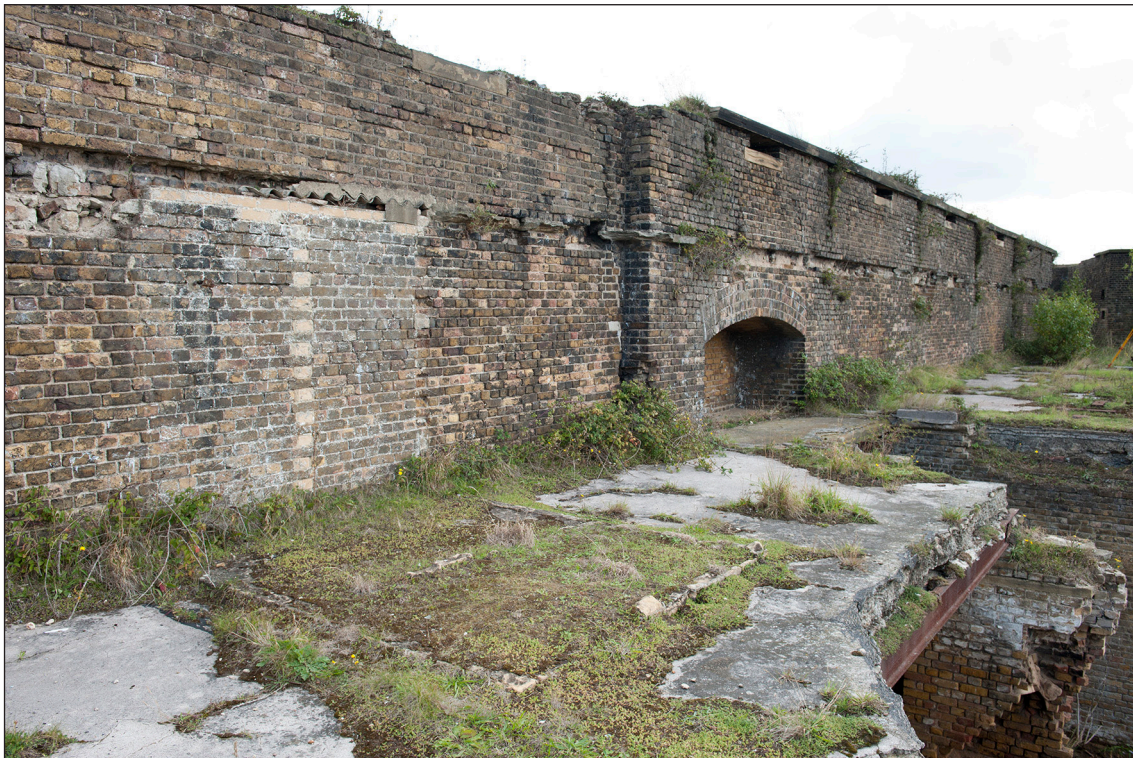
Figure 77: Former position of the possible signals hut on the roof of the entrance range. (DP097582)

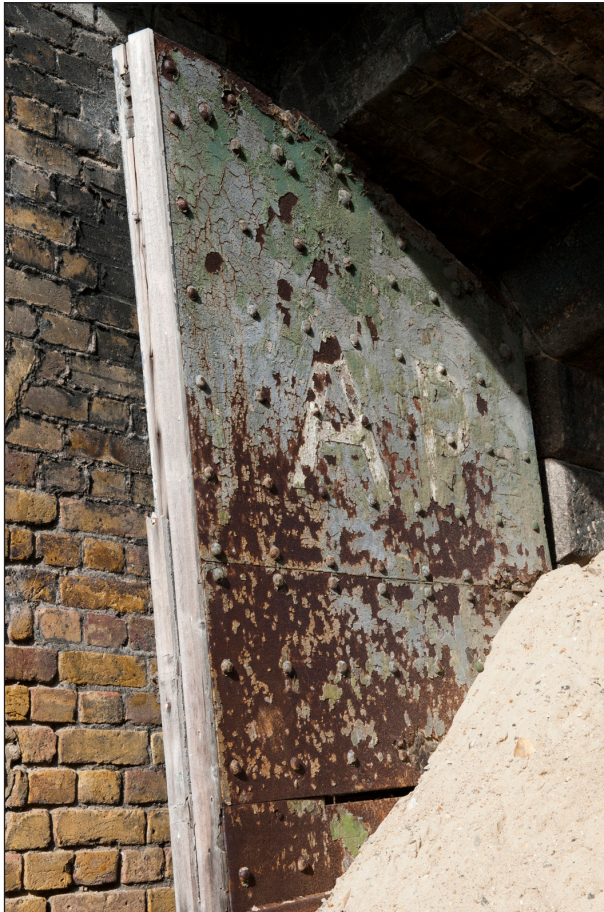
*Figure 78: The right-hand leaf of the front doors to the fort. Evidence for the occupation of the fort by the Royal Naval Auxiliary Patrol is provided by the letters 'A P' on a background of flaking naval grey paint. (DP097676)*

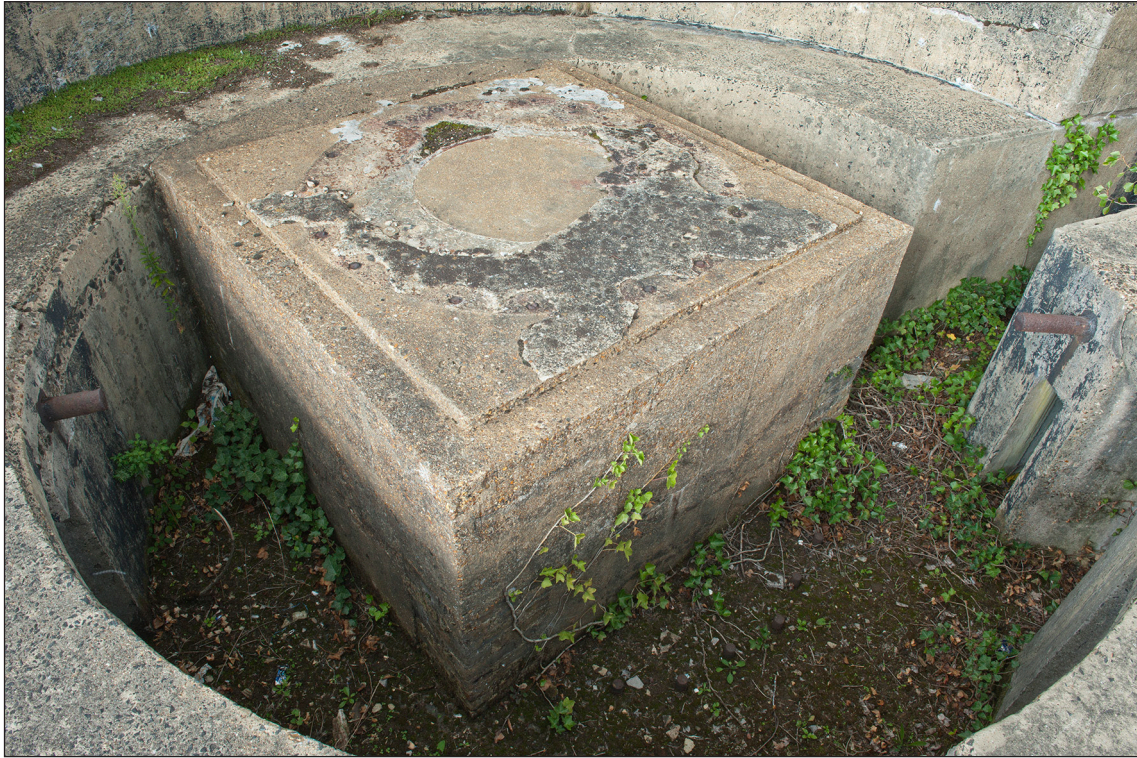
*Figure 79: Concrete block inserted to modify the 6-inch gun emplacements during the Second World War. (DP097671)*

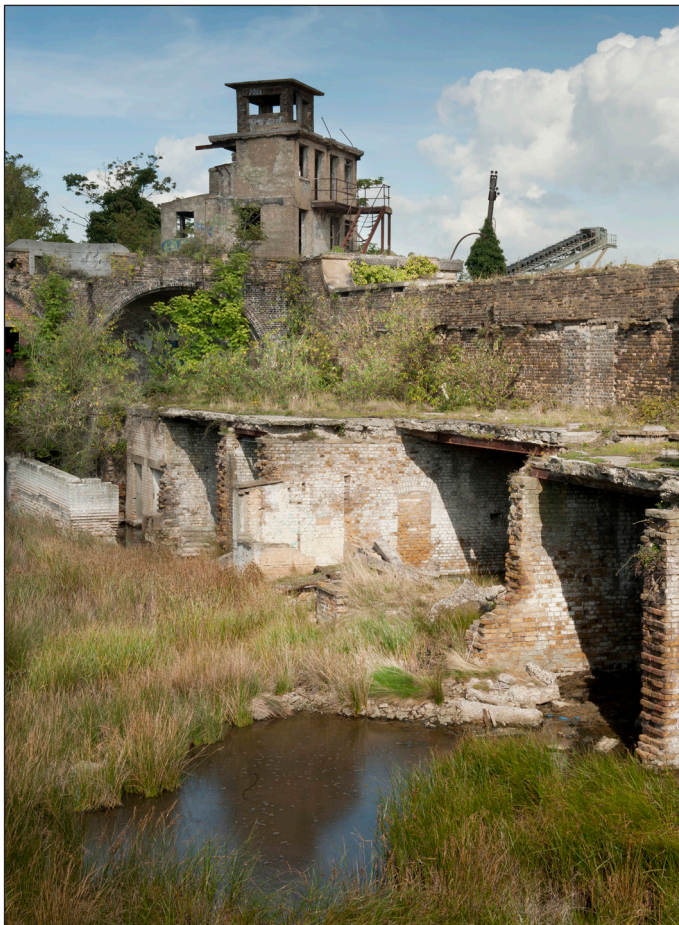
*Figure 80: The north end of the East range. In the foreground are the remains of the Guard House and the cell block. Beyond them are the Ablutions and Latrines with their new front wall and the heavily weathered modesty wall in front. On the right hand side of the picture, the lighter coloured patch on the parapet wall is the position of the brick outbuilding to the demolished timber hut which extended from here to the left hand side of the frame. (DP097523)*

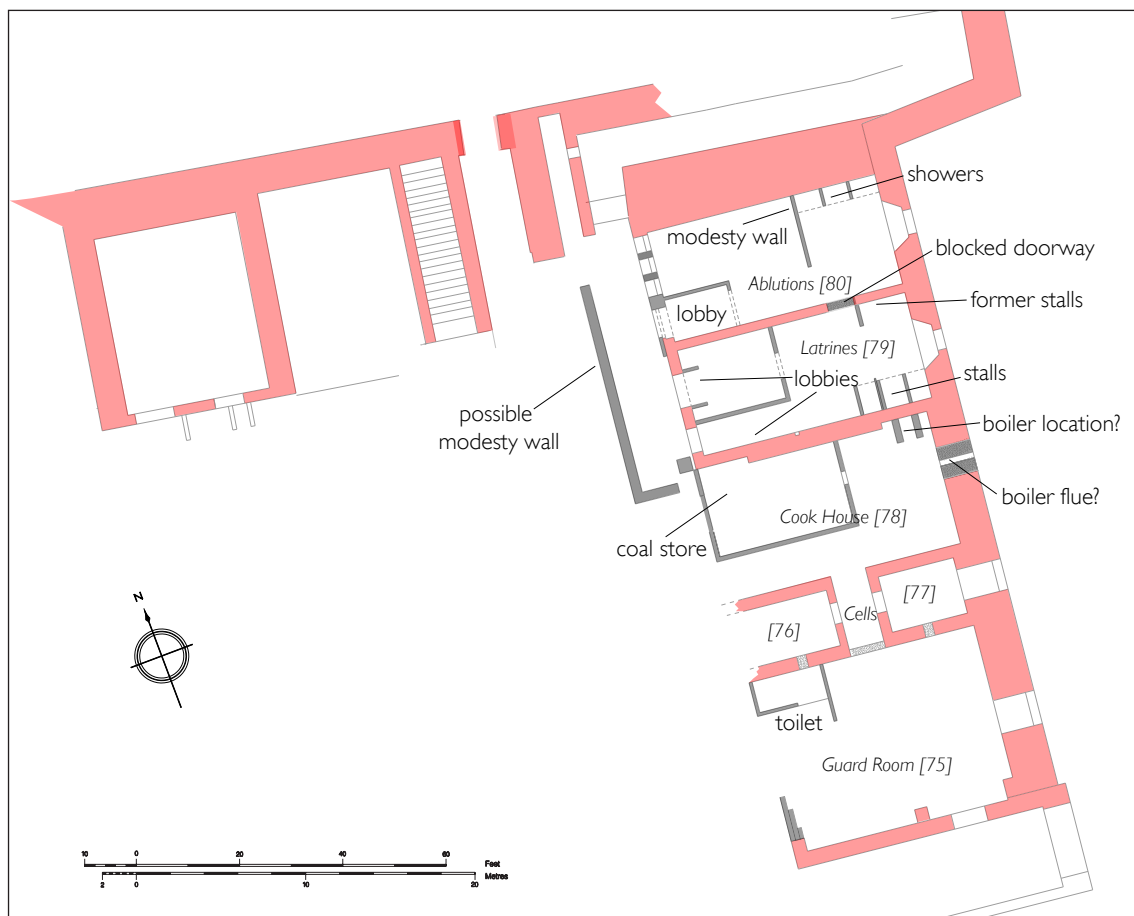
Figure 81: Sketch survey of the rebuilt northern end of the entrance range based on field measurements and the 1899 basement plan (TNA: WO78/4963). The possible Second World War additions and alterations are shown in light grey.
