THE HISTORICAL DEVELOPMENT  
OF IGHFIELD HALL FARM BARN  
IGHFIELD, NORTH SHROPSHIRE

# The historical development of Ightfield Hall Farm Barn, Ightfield, North Shropshire

**Susie Barson & Richard Bond**  
**Historical Analysis and Research Team**  
**English Heritage**

**October 1997**

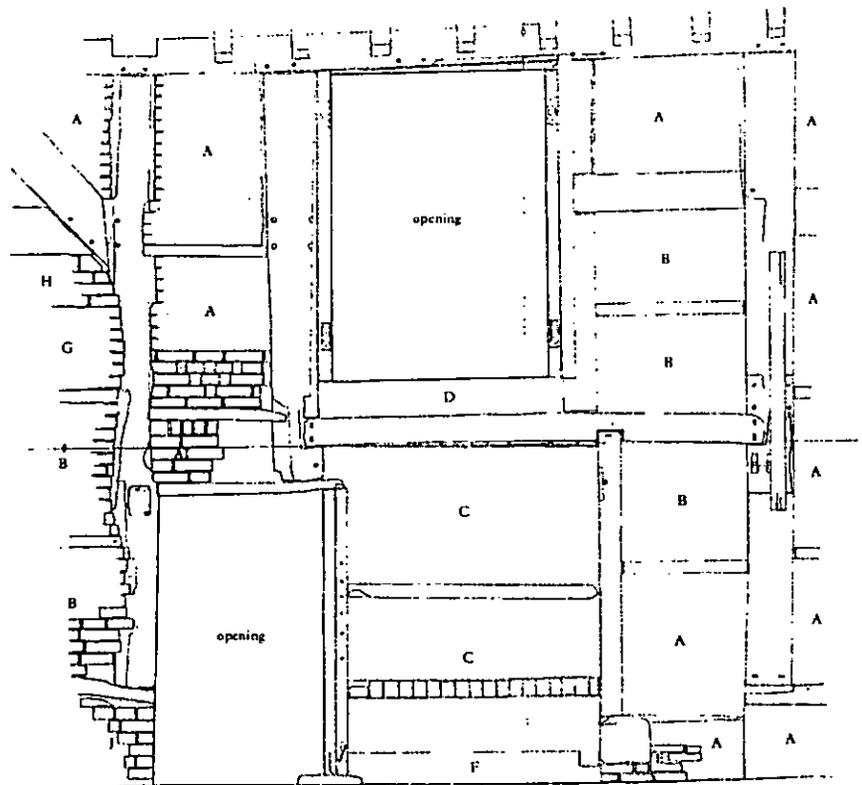
**Figure 24** External elevation of west wall, bay 3, showing location of areas of historic brickwork.

Main Timber-framed Barn

*West Elevation (Bay 3)*

Much of the earliest panel infill brickwork survives (*type A*) on both east and west elevations. Bricks are typically 230-235 x 110-115 x 65-70mm, orange/purple in colour with large pebble inclusions, irregular arises and a rough texture to faces. Shallow, horizontal stacking creases were observed on stretcher faces, almost certainly created during the drying process. No surface vitrification was noticed although the bricks had been well fired. They are laid in stretcher bond and set in a hard lime/sand mortar, difficult to remove from the bedding faces. Geometric ventilation patterns, typical of the later eighteenth century, survive within the brickwork infill of the upper walls of bays 2 and 4. They were positioned to aid the drying of stored crops but, surprisingly, they only appear to have been placed on the eastern elevation, making cross ventilation difficult.
