MEDIEVAL
DETACHED KITCHEN
AT LITTLE BRAXTED HALL, LITTLE
BRAXTED, ESSEX

An Historical Assessment

Historical Analysis & Research Team
Reports and Papers (First Series, 50)
1998

NOVEMBER 1998

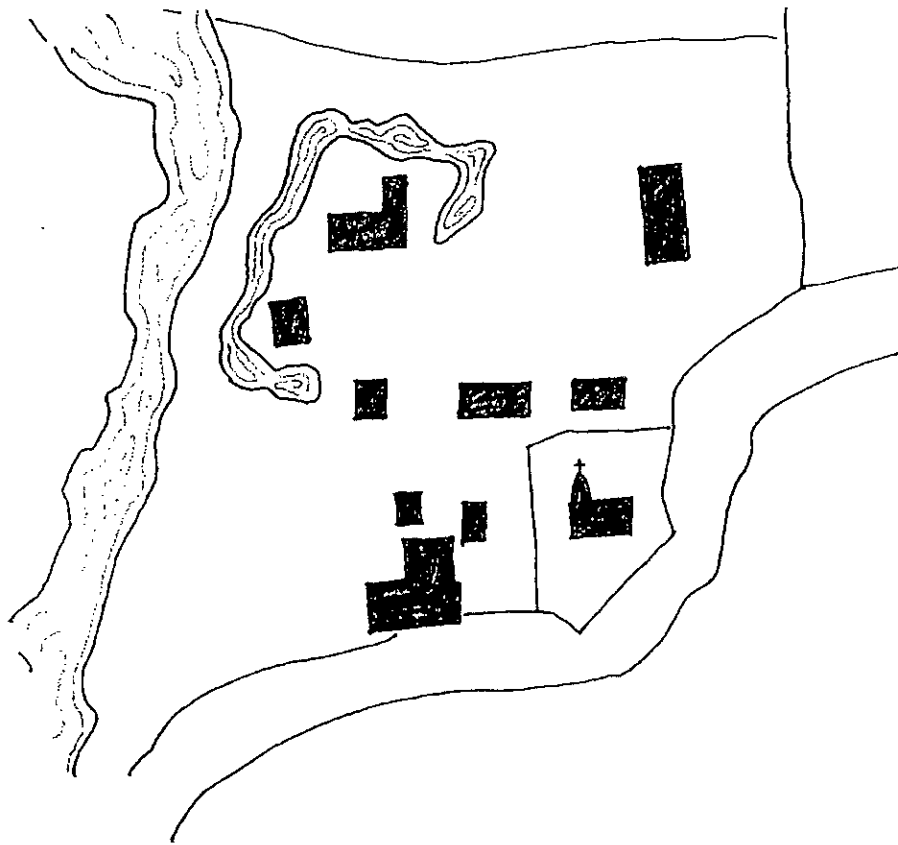
Figure 1 Detail of Rush Estate map of 1784 (traced from original). North to top.

- 2.3 In 1774 the estate was owned by Jacob Pattison, a major Essex landowner who held a large amount of property in and about Witham. By 1784 the estate had passed to WB Rush, who was in turn leasing the property to F KING.⁴ Two estate maps, dated 1784 and 1792, whilst by no means accurate as measured surveys, do nevertheless give a clear indication of the layout of the fields and buildings which then made up the property (*figs 1 - 3*). The two maps are fairly similar in terms of what they show, although the actual shape of the moat and the size of the buildings relative to one another varies considerably. Both maps depict an L- shape building within the moat which can only have been the former manor house, known to have existed up until the 1960-70's (see description below). A square-plan structure close to the house is likewise clearly the medieval kitchen, or rather combined dovecote and stable, as it would have been used by this time (inexplicably this is not shown on the 1792 map).

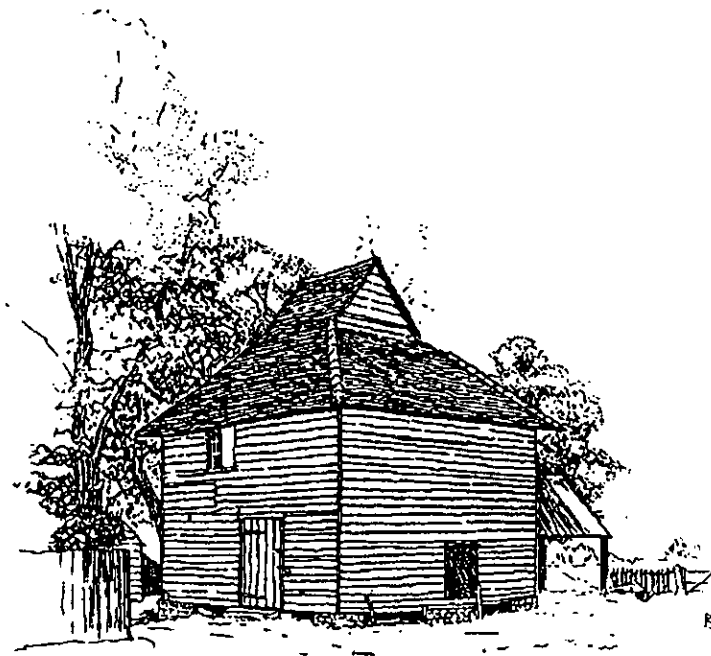
FINCHINGFIELD—CORNISH HALL.

A large square cote (10 ft. by 19 ft.) standing east of the old farm house, part of the complex of farm buildings. It has a very stout timber framing of old oak, covered with old tarred weather-boarding, the whole standing on dwarf brick piers. It has an old timber board floor. The pyramidal tiled roof continues forming the typical, two gabled lover, with a range of entrances on the west side only (now). Within there is a stout alighting beam. Nests covered all four sides, but are now entirely cleared. A floor has been inserted but the timbers of this are old, so that one may surmise that the cote is at least sixteenth century work. The cote is used as a granary and store, and is in good weather proof repair. The door faces south.

Figure 16 Cornish Hall, Finchingfield, Essex. From 'Pigeon Cotes and Dove Houses in Essex' by Donald Smith, 1931

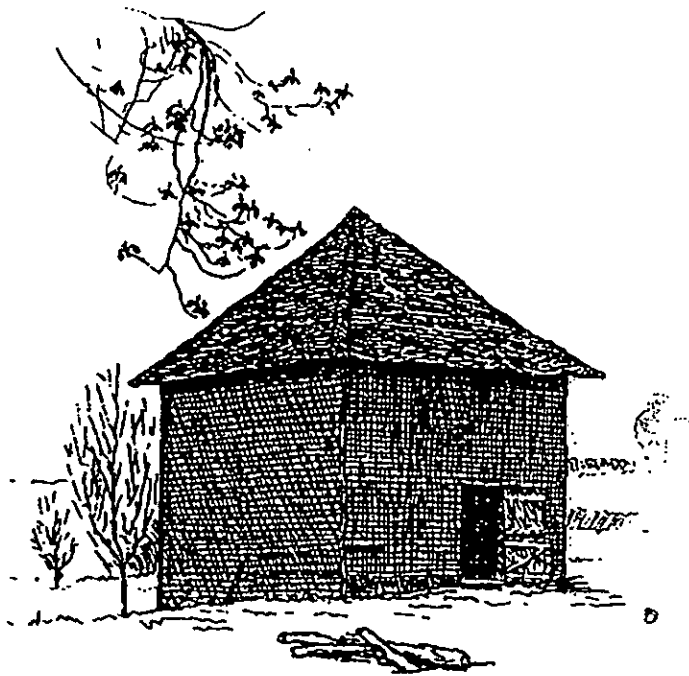
LITTLE BRAXTED—THE HALL.

Here, within a few yards distance are all the essentials of an old self-contained Manor—manor house, homestead moat, church, water-mill, and dove house. The latter is noteworthy, as being the largest solely timber built (with exception of a very low brick base) cote in Essex. It is approximately 22 ft. square, interior measurement. It stands to the north of the present Hall, within the old moated enclosure. It is of very stout timber framing, of two bays supported upon timber sills. The tiled pyramidal roof has been badly completed, covering the loss of the lower. No nests remain but all the timber uprights are bored for nest supports. The structure has been somewhat badly used, but there appear to have been lights in both south and west walls. Entrance is on the south side. The cote is now used for stabling purposes, there being a manger along the length of one side. This cote, quite as large as many a farm cottage, must have housed a very large number of pigeons indeed.

- 5.1 On the basis of the evidence presented in this report, it would appear that the kitchen at Little Braxted is an extremely rare example of a once common but now all but forgotten building type in medieval England. Whether the kitchen is truly a unique survival is as yet impossible to say with any certainty. Whilst the existence of the building has been known about for some time, it is only relatively recently that its significance has been fully recognised. It is clear that as recently as 1931 the building remained completely misunderstood in terms of its original function (*fig 19*), suggesting the possibility that some of the other larger dovecotes described by

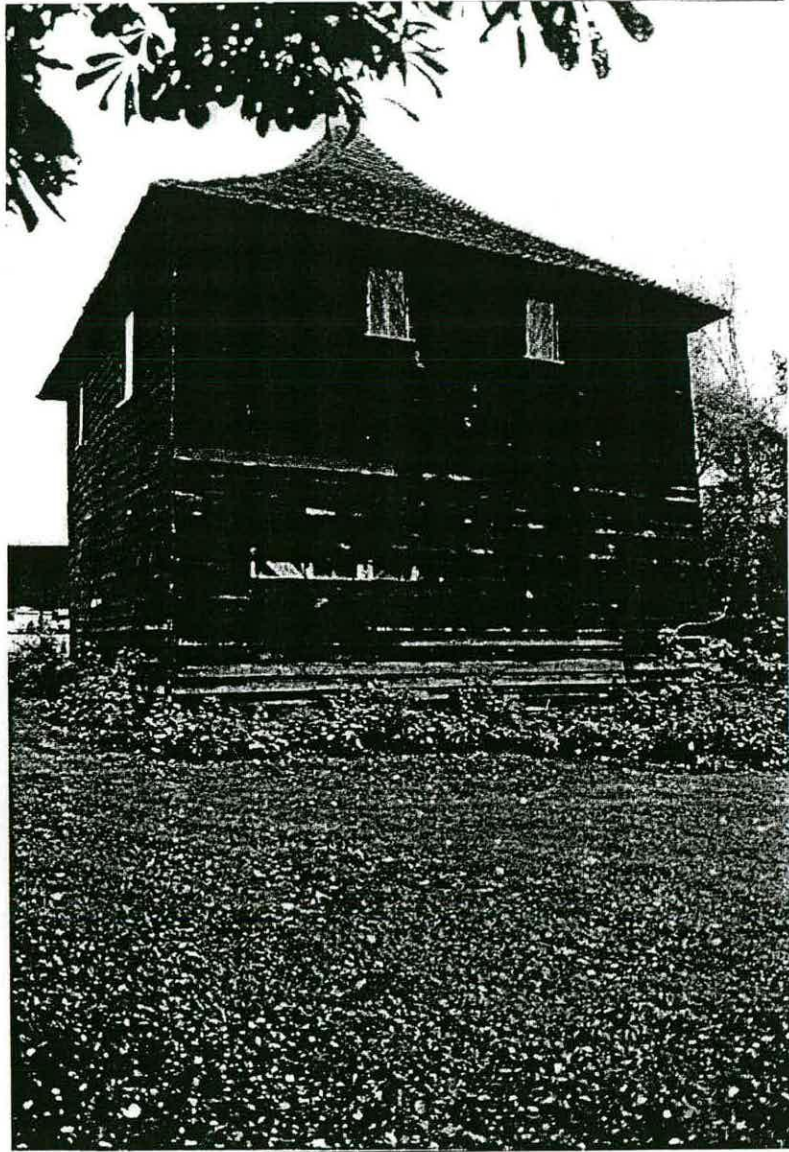
Figure 21 Kitchen at Little Braxted. View from north. Photograph taken October 1998.

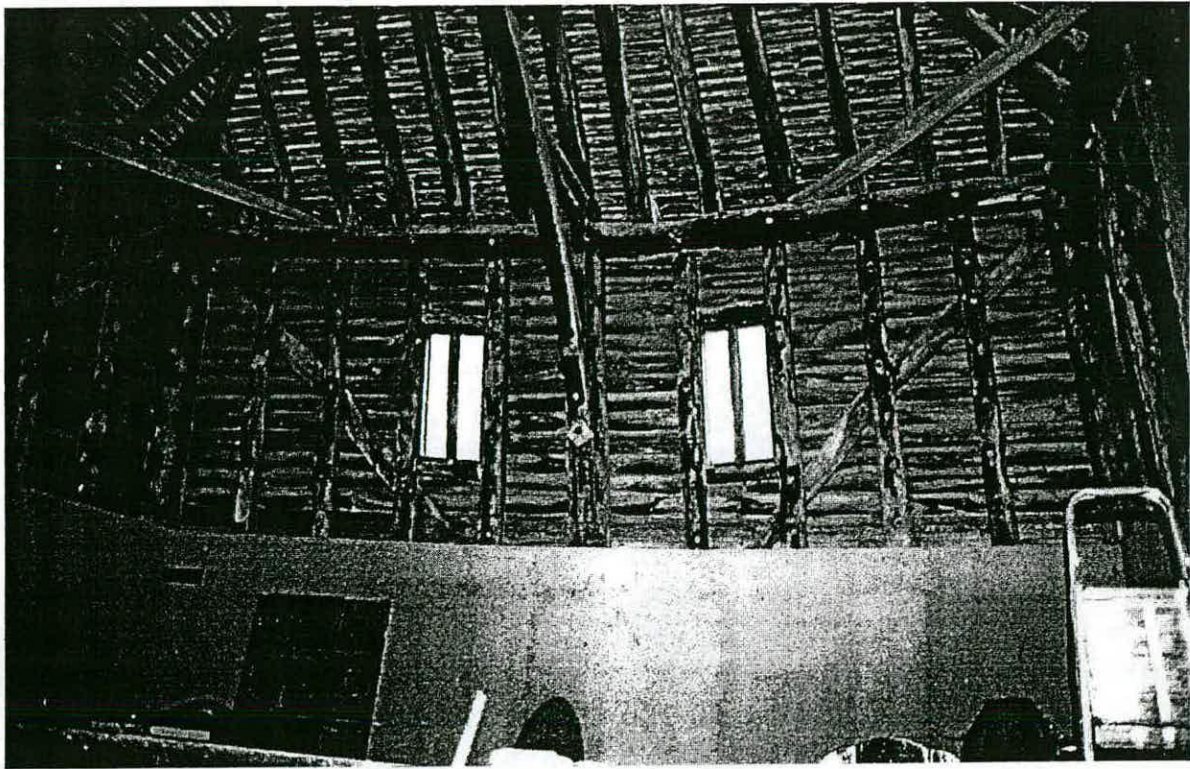
Figure 22 Interior of building, view to west. Photograph taken October 1998.

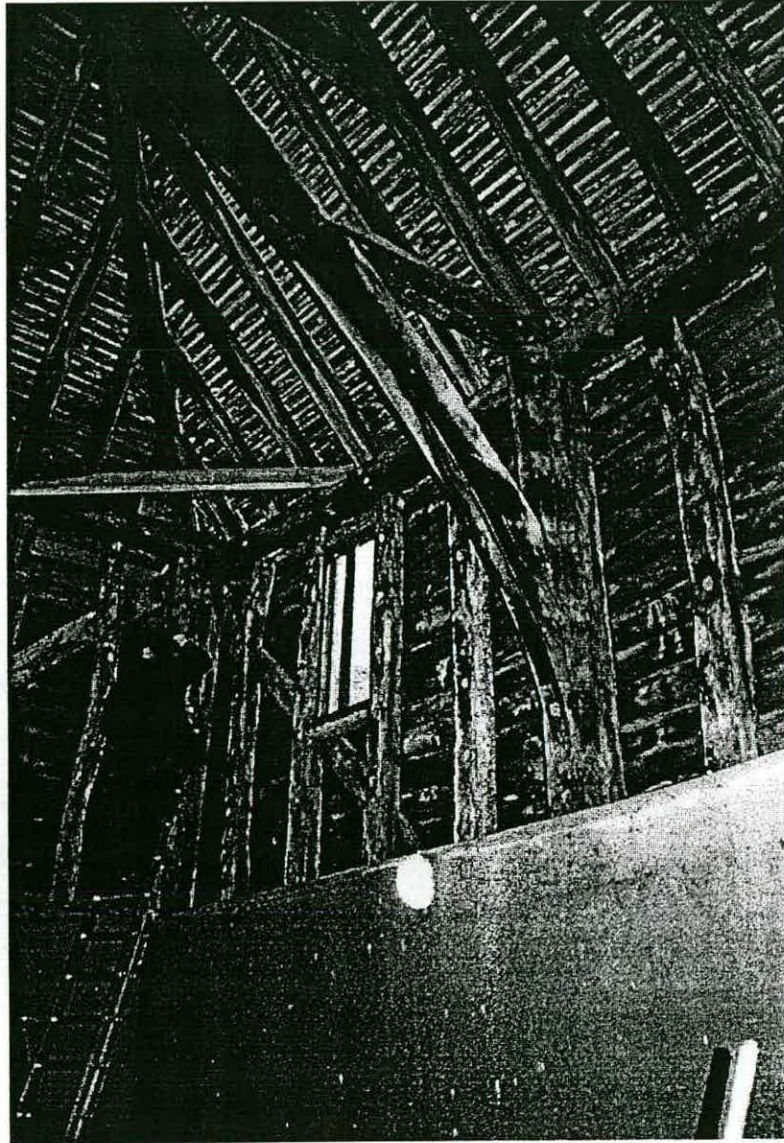
Figure 23 Interior of building, view to north-east. Photograph taken October 1998.

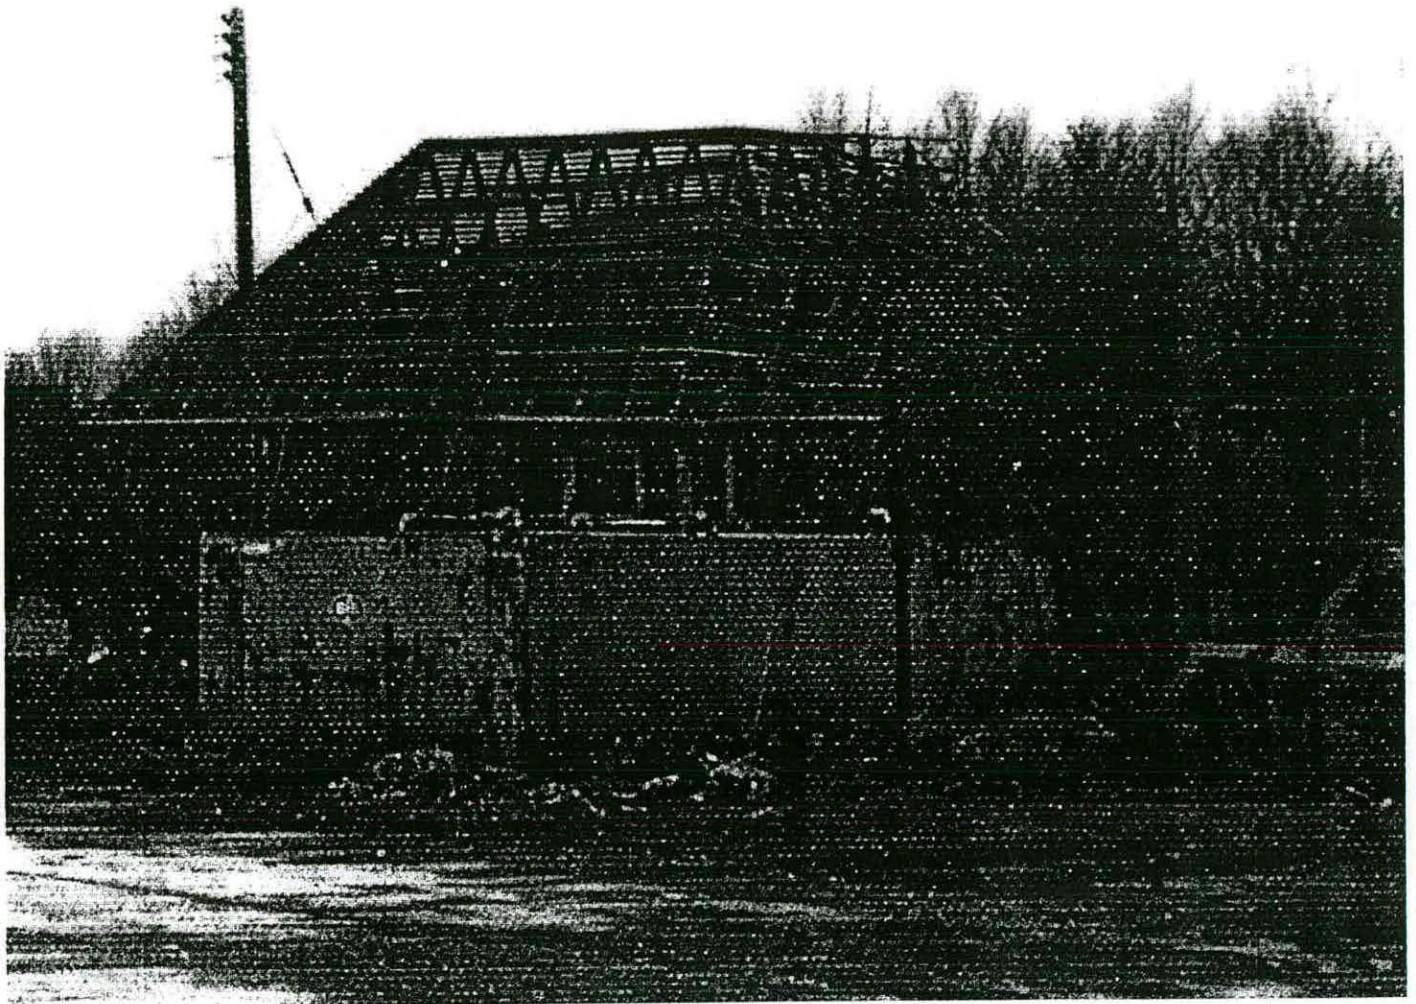
Figure 28 Detail of figure 27, showing exposed timber-framed construction of 'The Old House', formerly standing in farmyard of Little Braxted Hall.
