No. 143 LOWER CLAPTON ROAD  
HACKNEY, LONDON

*A Study of the Historical Development of the House*

## **143 LOWER CLAPTON ROAD, HACKNEY, LONDON**

### **A study of the historical development of the house**

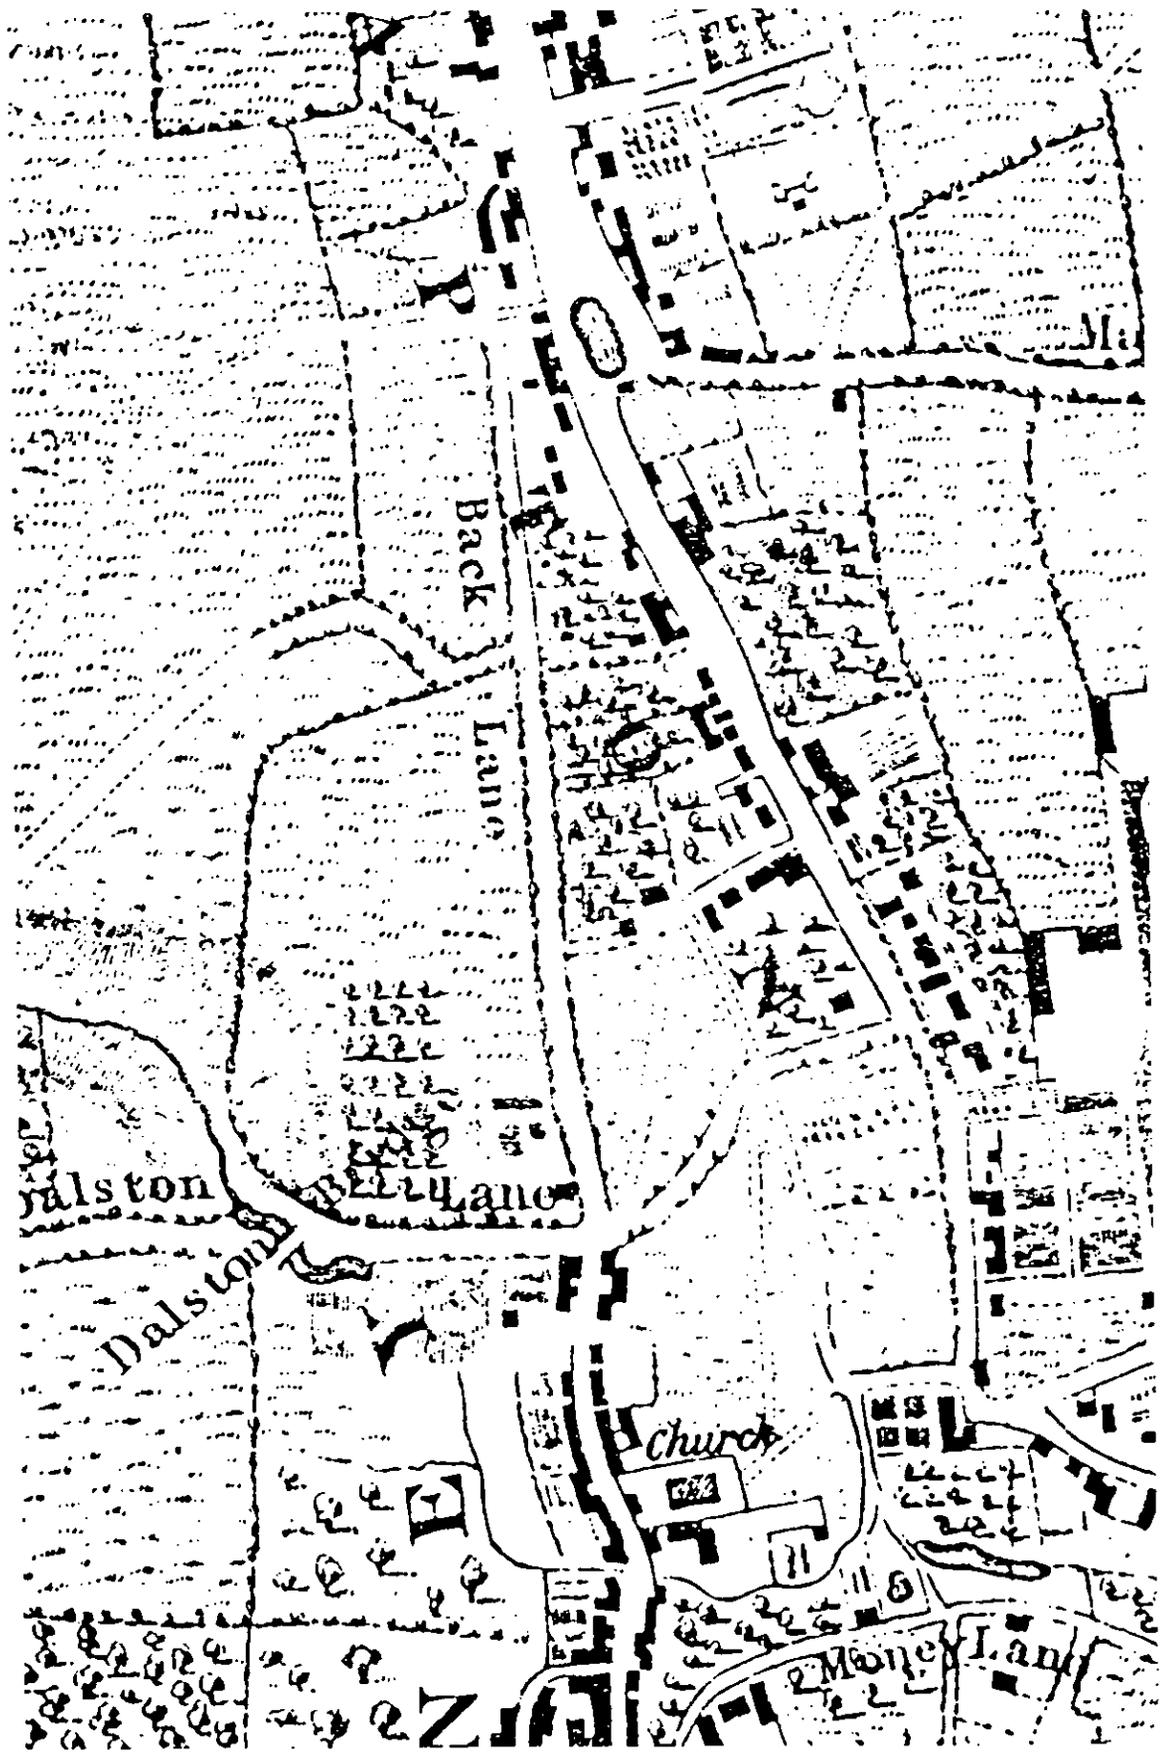
Figure 1. Rocque's map of 1745

Rocque's map of 1745 (fig.1) shows this area of Lower Clapton Road as reasonably well built up on both sides. Although by no means entirely accurate, the map does attempt to give some indication of the shape and relative size of individual buildings. On what appears to have been the site of the present house the map shows a small building of rectangular plan. This building, along with its neighbouring property on either side, stood on a long, narrow parcel of land which extended from Lower Clapton road (formerly Clapton street) to Clarence road (formerly Back lane).

Rocque's map of 1745. Map shows that there were houses along both sides of Lower Clapton road by this date.

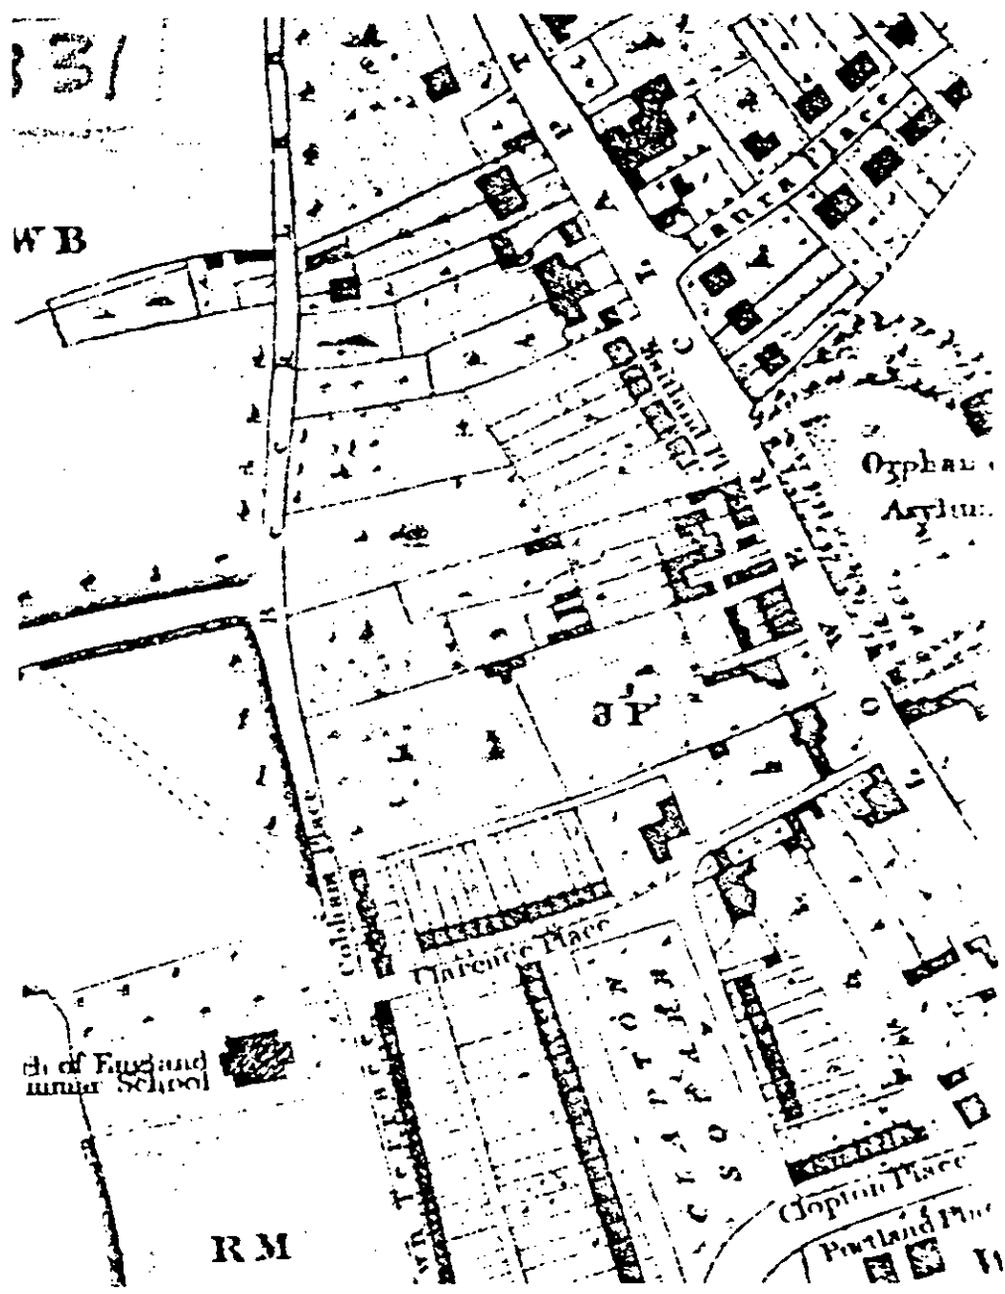
Figure 2. Starling's map of 1831

The house is not clearly identifiable on maps as the present house until the publication in 1831 of Starling's map showing lands belonging to the Tyssen Estate (fig.2). This map shows the house as being of rectangular plan with a rear extension to the north side. This projection probably represents the canted bay built to the rear of the house by 1814, and a row of former outbuildings on this side of the rear yard.

Starling's map showing lands belonging to Tyssen Estate, published 1831. Map shows house as being of rectangular plan with rear extension.
