The Fleece, Westgate Street, Gloucester, Gloucestershire

Tree-Ring Analysis of Oak and Elm Timbers

Martin Bridge and Cathy Tyers

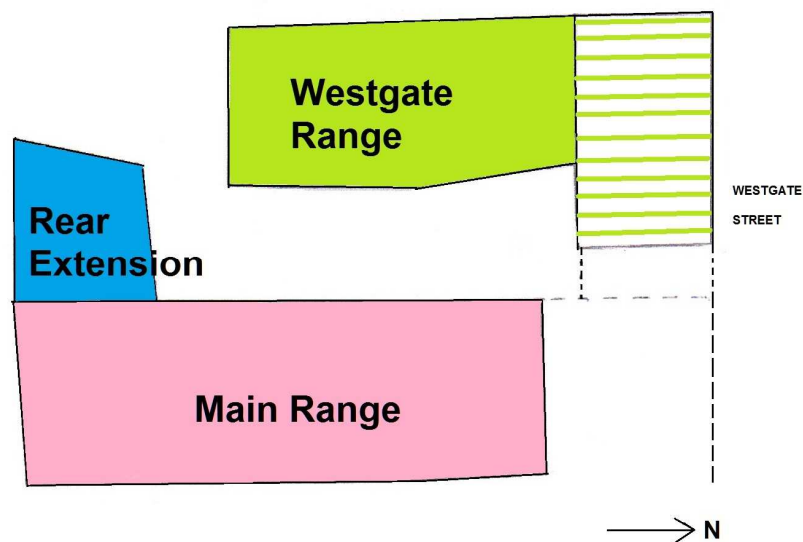
Figure 4: Plan of the site showing the relationship between the main range/rear extension and Westgate range. The section fronting the road (green stripes) is counted as part of the Westgate range, but was built later.

The Fleece, a Grade 1 listed building, sits in a prominent position on Westgate Street in the historic centre of Gloucester approximately 200m south of the Cathedral (Figs 1–3). The complex under investigation consists of a long main range with a later extension and the Westgate range (Fig 4).

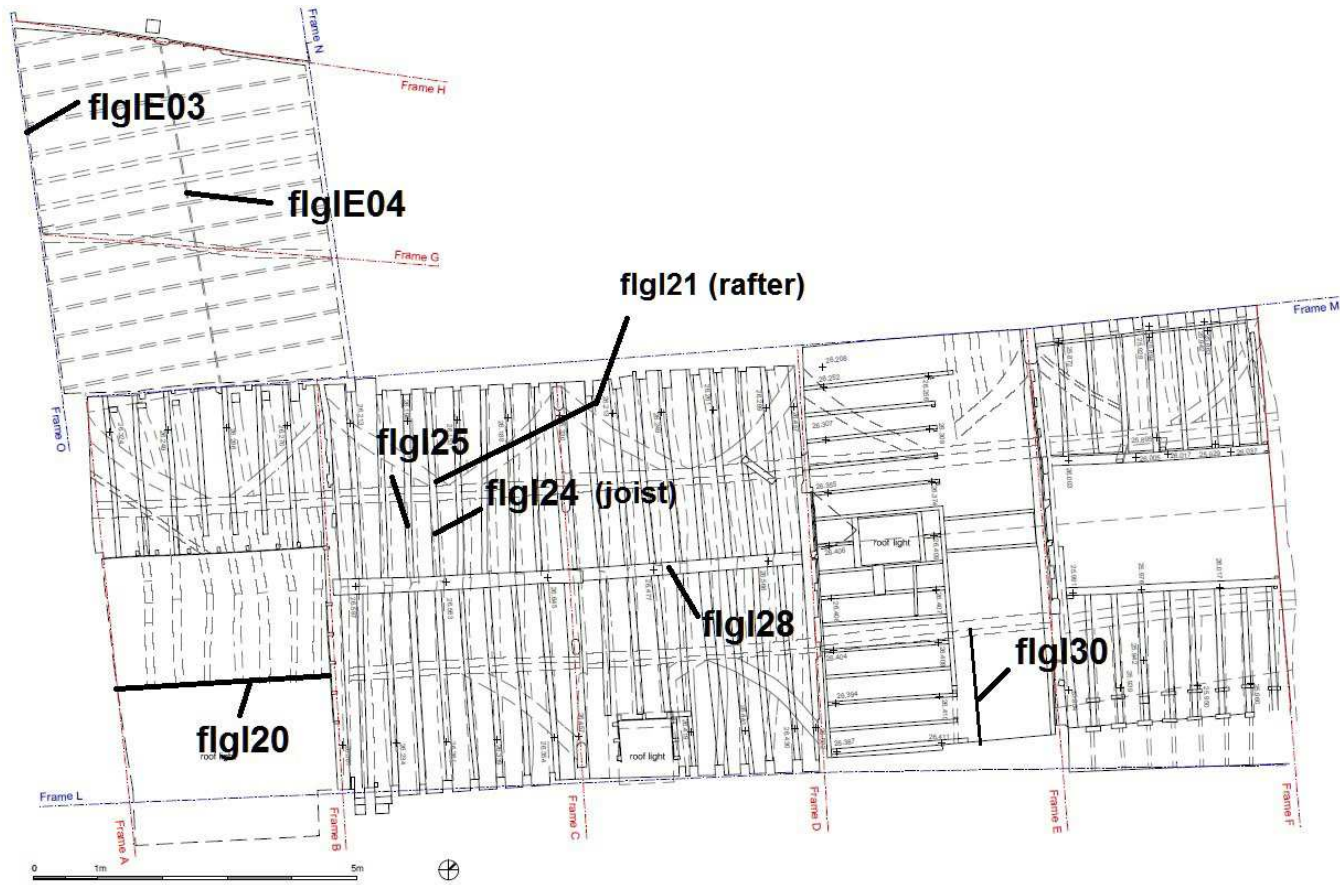
Figure 8: Plan of the roof areas of the main range and southern extension, showing timbers sampled (after Butler Hegarty Architects)

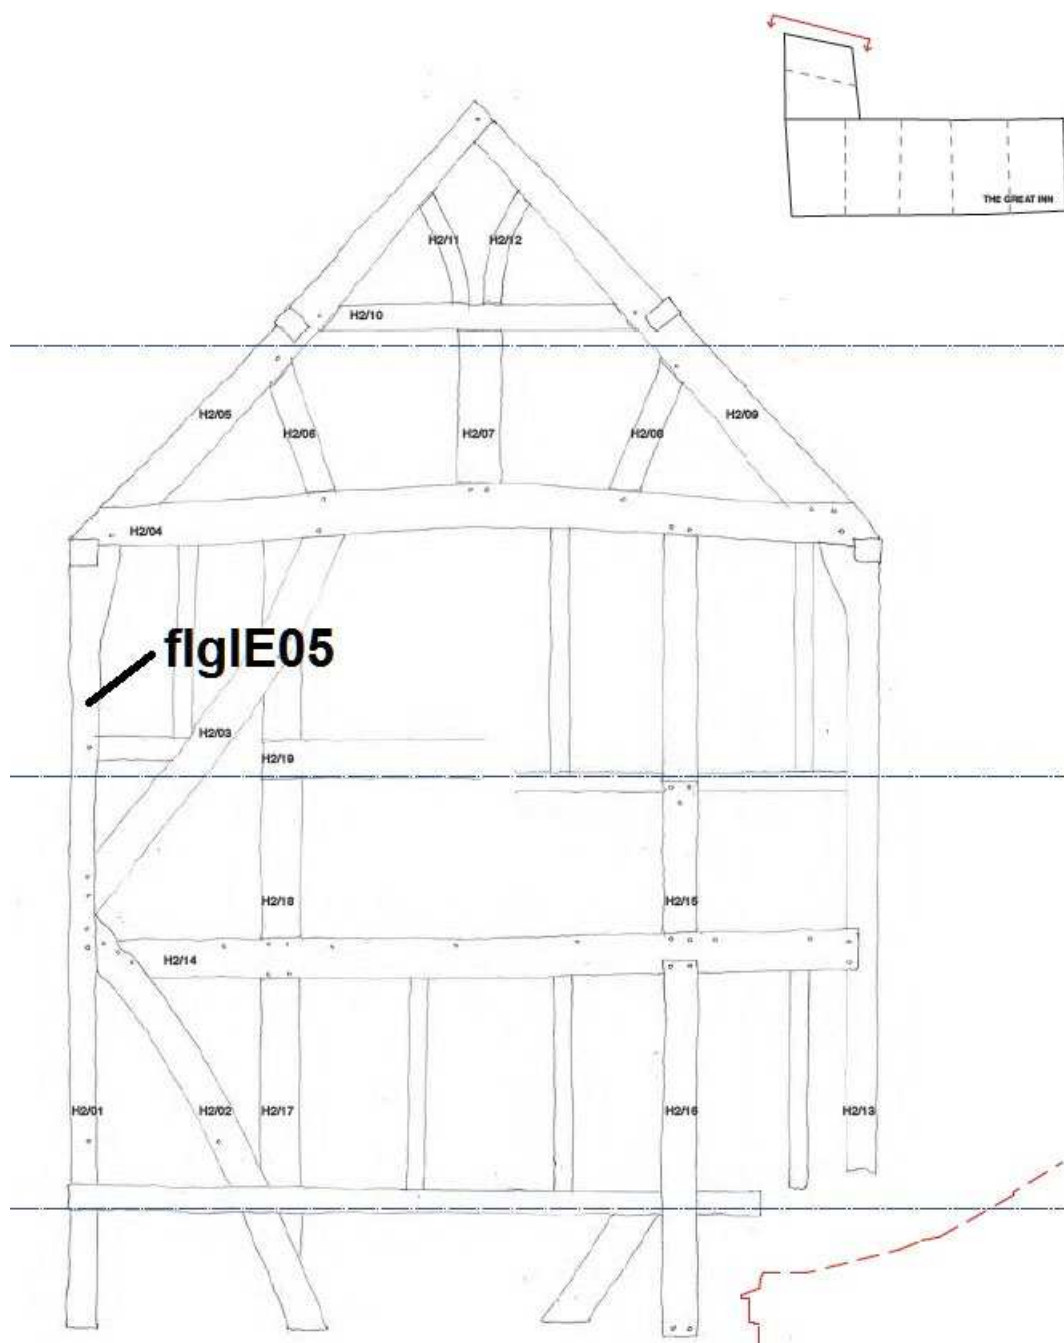
Figure 16: Drawing of the west wall of the southern extension showing the timber sampled (after Butler Hegarty Architects)

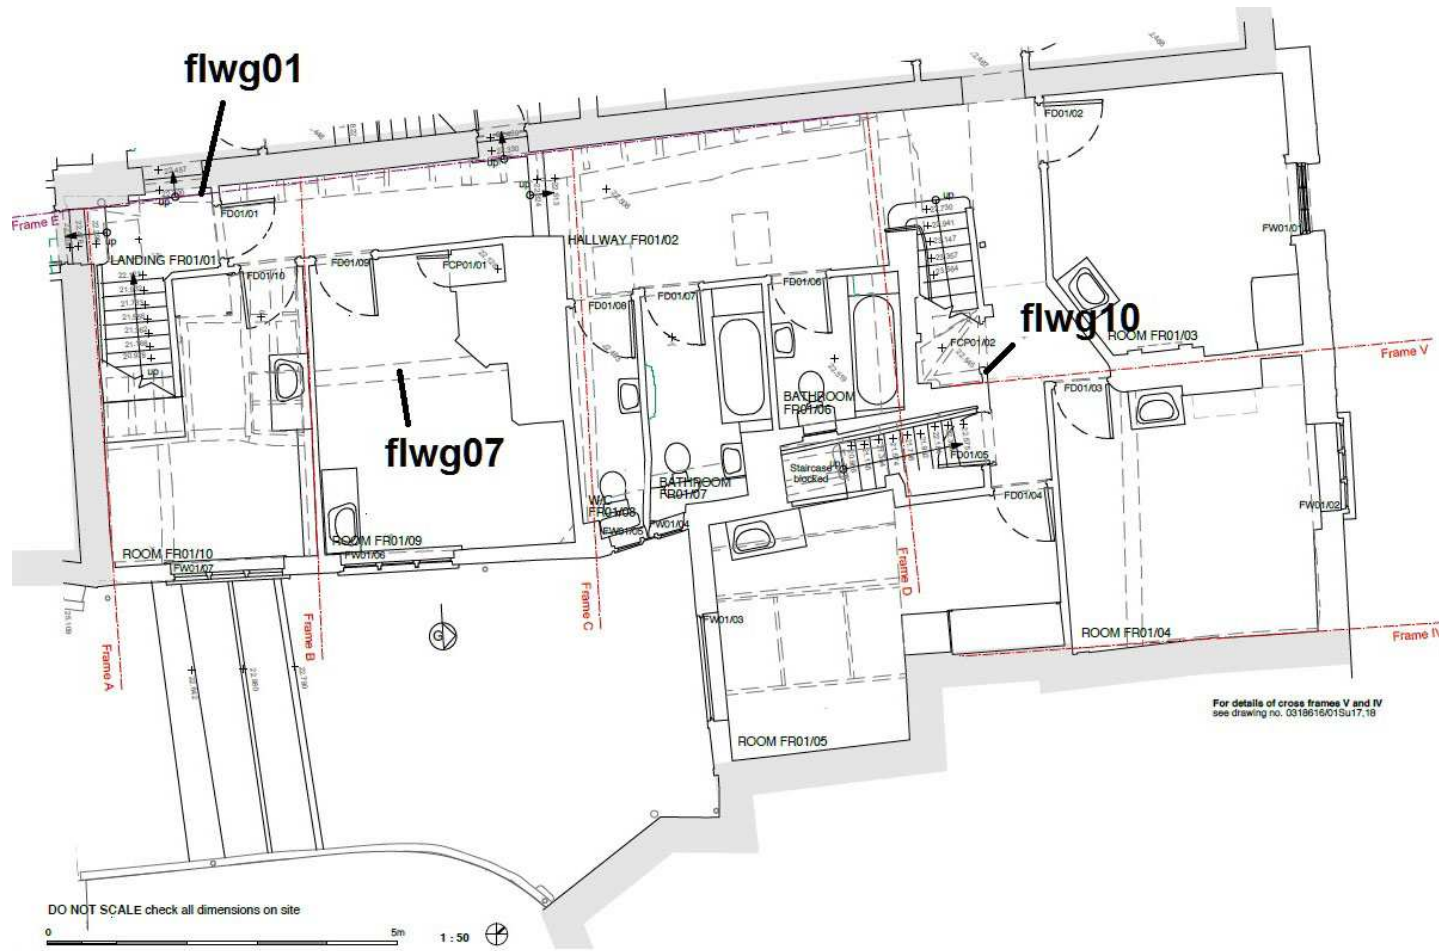
Figure 17: Plan of the Westgate range showing the locations of some of the sampled timbers (after Butler Hegarty Architects)

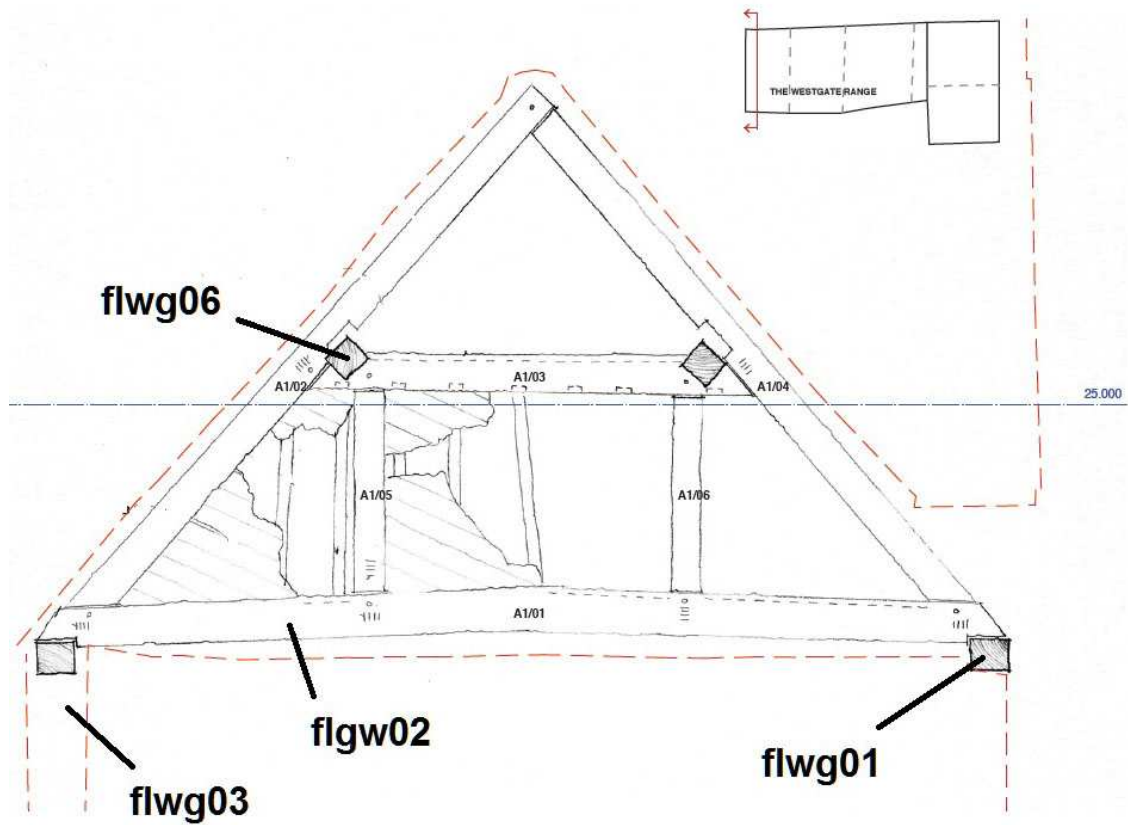
Figure 18: Drawing of frame A of the Westgate range showing timbers sampled (after Butler Hegarty Architects)

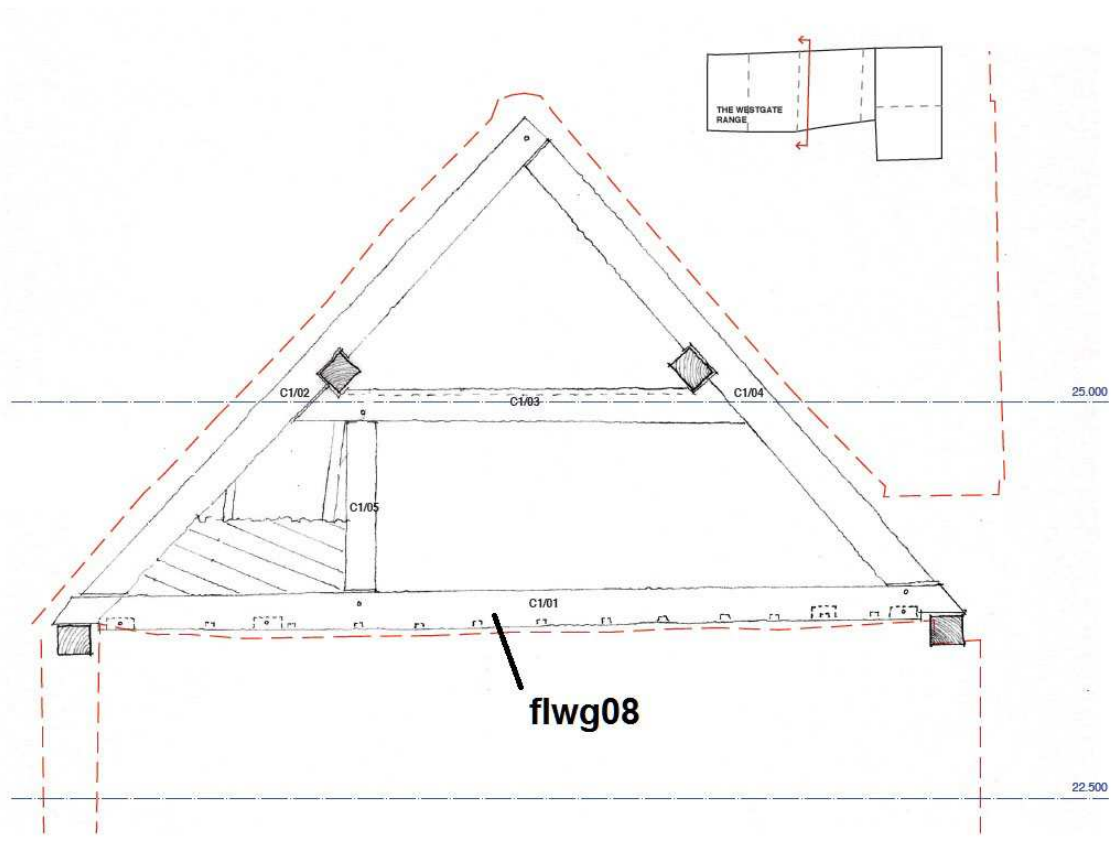
Figure20: Drawing of frame C of the Westgate range showing timber sampled (after Butler Hegarty Architects)
